## **Downtown Juneau Landslide and Avalanche Hazard Assessment**

PRESENTED TO  
**City and Borough of Juneau**

APRIL 27, 2022  
ISSUED FOR USE  
FILE: ENG.EARC03168-01

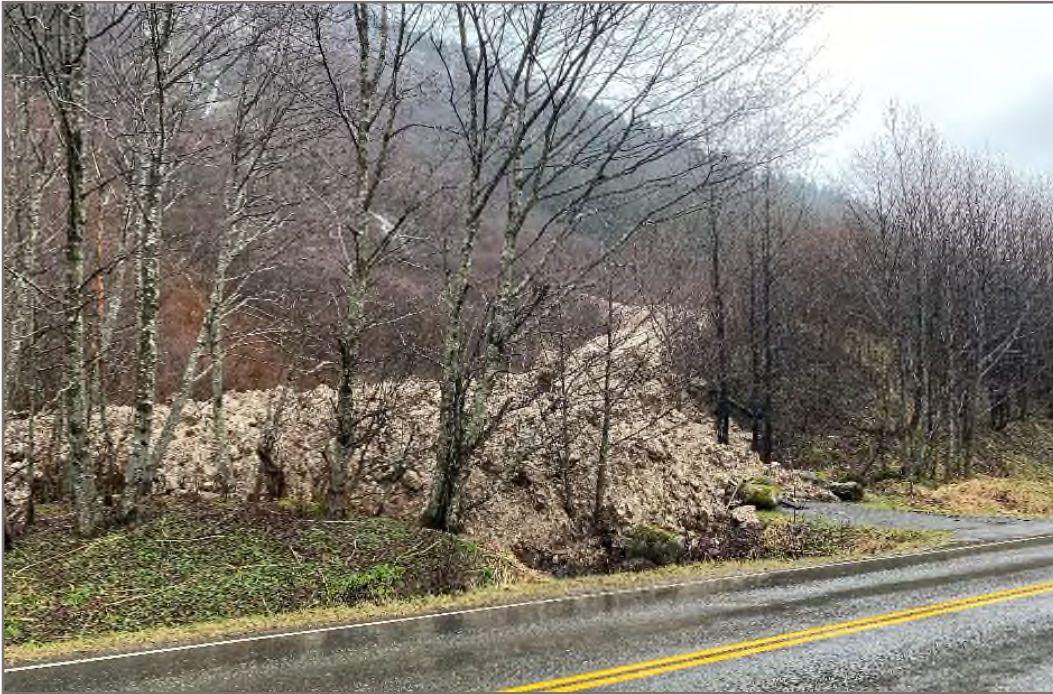
**Photo 23:** Looking upslope (northeast) from Thane Road into the Snowslide Creek (T011) avalanche path (Photo Credit: CBJ Dec 4, 2020. The photo location is shown on Figures 1.4 and 1.5). Wet avalanche flow was diverted by the earthfill diversion berm toward the northern boundary of the Severe (red) hazard zone.

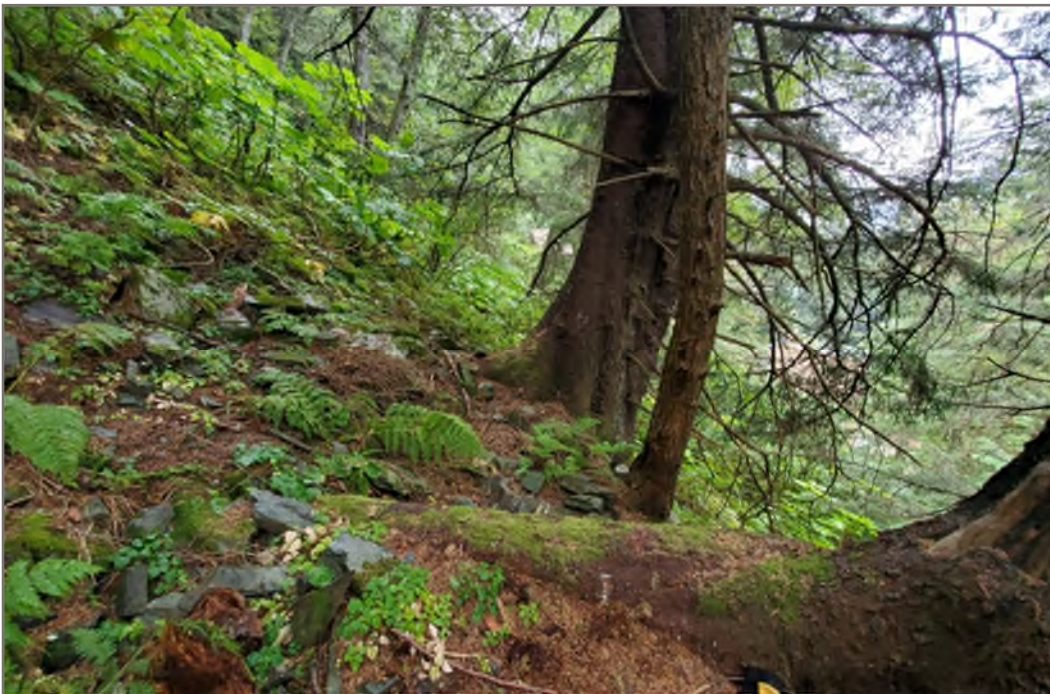
**Photo 36:** Impacts visible on trees in the J000 Mud Flows path. Rock on the surface indicates that this damage is likely attributable to rockfall rather than avalanches, but shows a similar process.

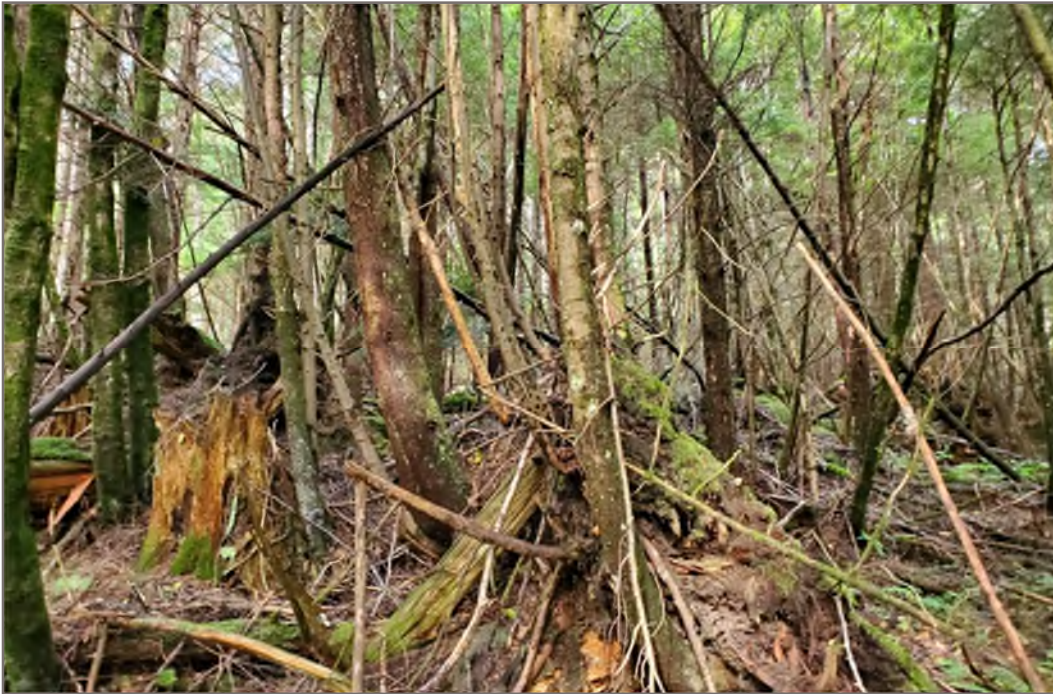
**Photo 37:** Extensive avalanche impacts and debris observed in northern part of Behrends Avenue path, upslope of 1800 Glacier Avenue. At least two distinct events can be observed, including the event that caused the trees to bend and re-grow straight (pistol-butt) and the event that damaged trees and deposited woody debris.

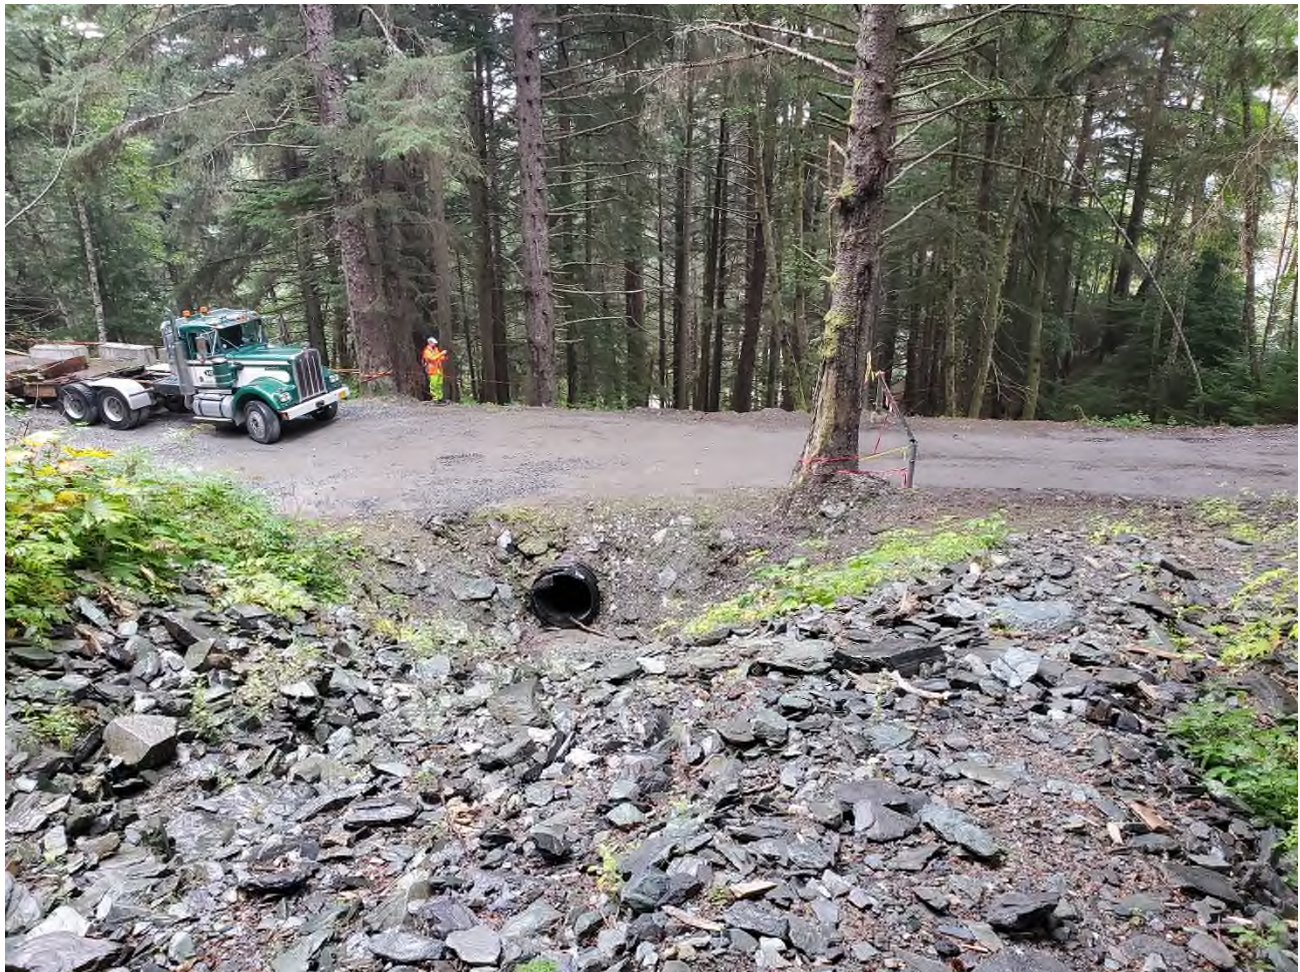
**Figure 4: Looking down towards the Gold Creek Flume Trail from the Bathe Creek debris flow gully. Note the large amount of debris in and alongside the gully, as well as the scarring on the tree beside the road that extends to at least 6 feet above ground surface. This gully is very active, and the debris that is deposited at the road crossing is regularly cleaned up. This road crossing has the potential to divert debris flows into the residential community downslope and to the west, especially if more than one surge of debris occurs before the debris can be cleaned.**

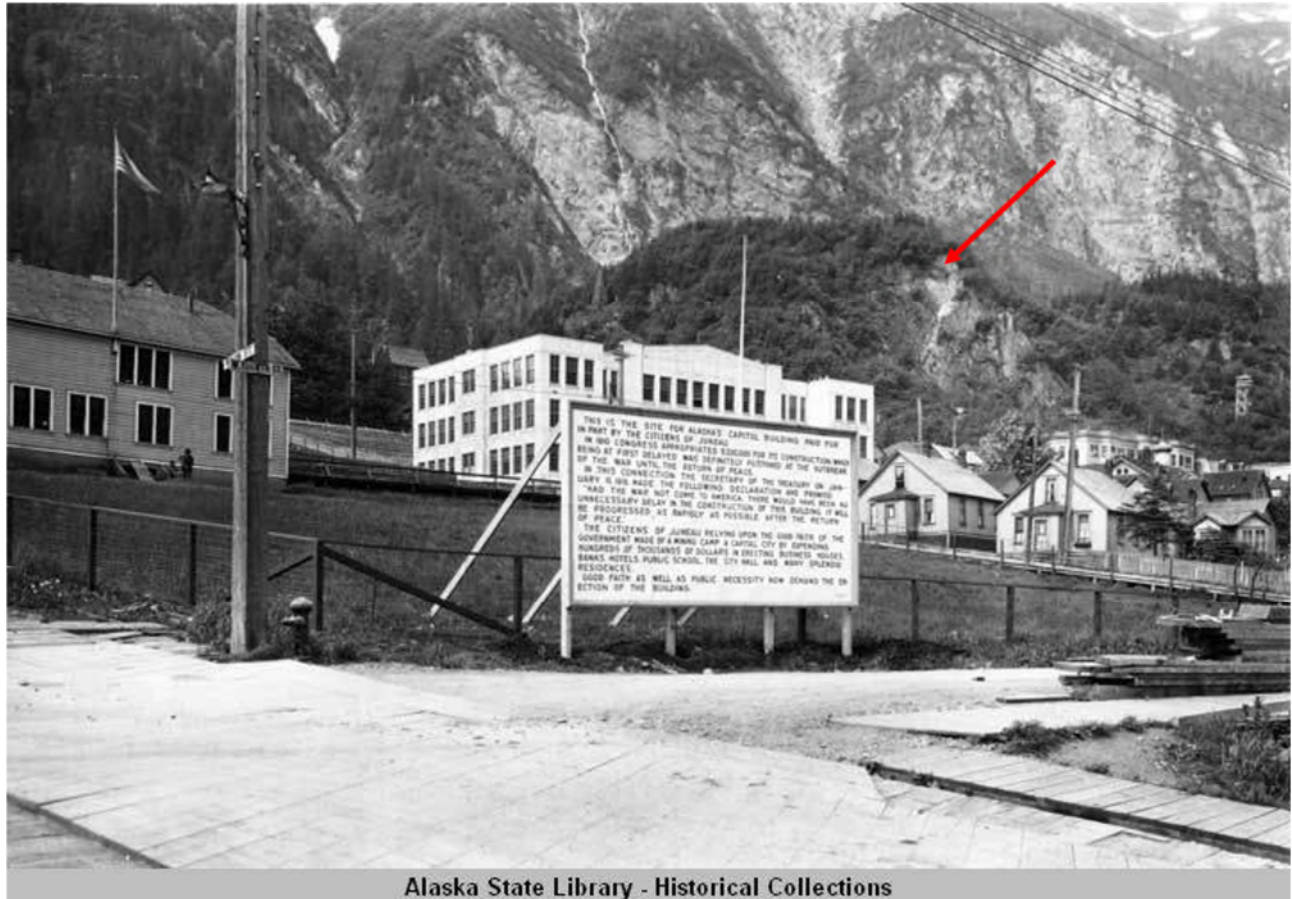
**Figure 6: Looking north towards the Juneau Public School. Rockfall/rockslide scar on Decker Hill/Mt. Maria in the background was the likely origin of the October 18, 1913 landslide event (red arrow). The rock slope immediately to the right of the red arrow appeared more active (less reforestation) than the slope to the left in 1918, and some of the debris might also have originated from there. See Figure 13 for present-day view of Mt. Maria. (Photo credit: Alaska State Library – Historical Collections, [ASL-Juneau-Capitol-Building-1](#), Alaska State Library Place File. Photographs. ASL, ca. 1918.)**

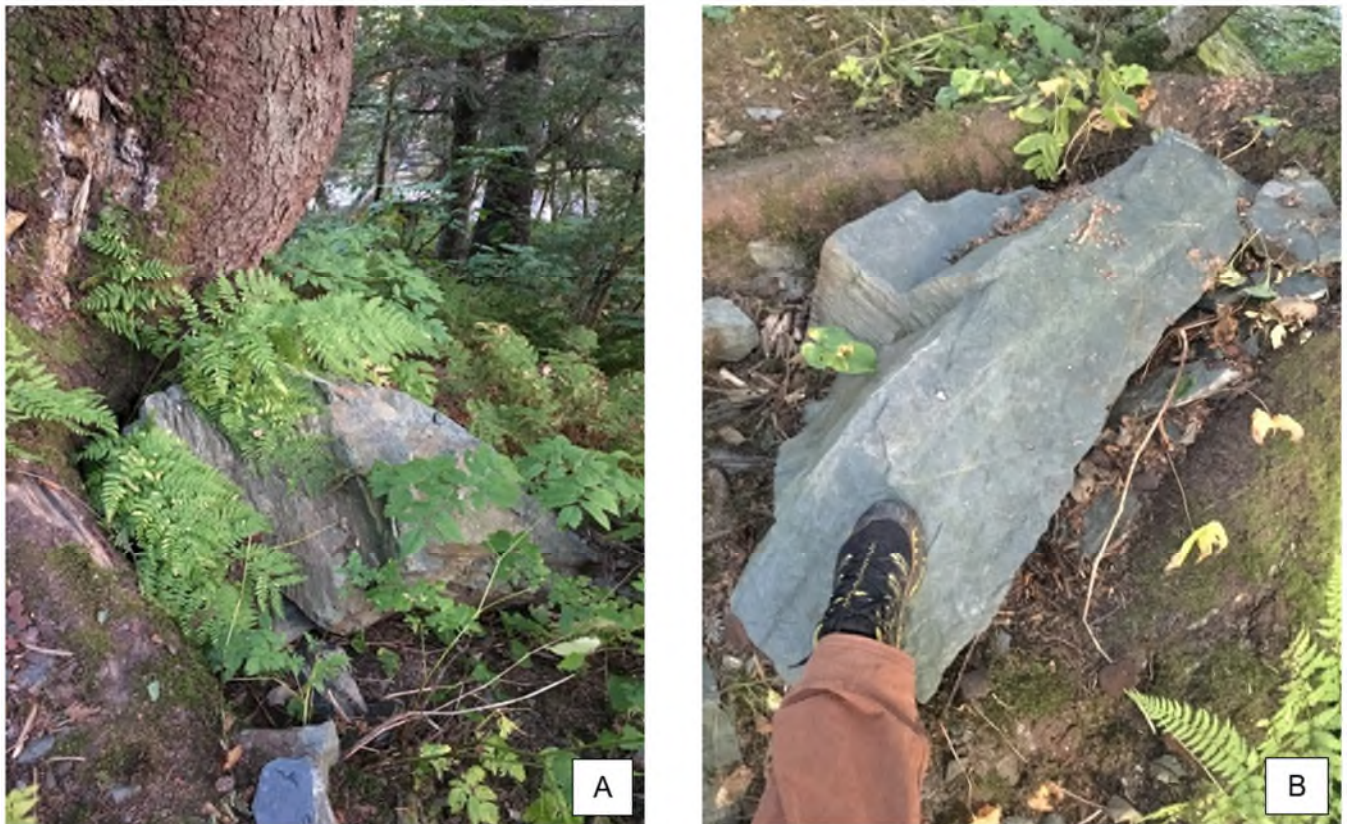
**Figure 7: Photos from Tetra Tech’s main report, at the southwest end of Mt. Maria above Basin Road at Harris and 7<sup>th</sup> Street. Photo P24 (Figure 7A) shows a tree damaged by rockfall. Photo P25 (Figure 7B) shows the typical size of some of the fallen rocks.**

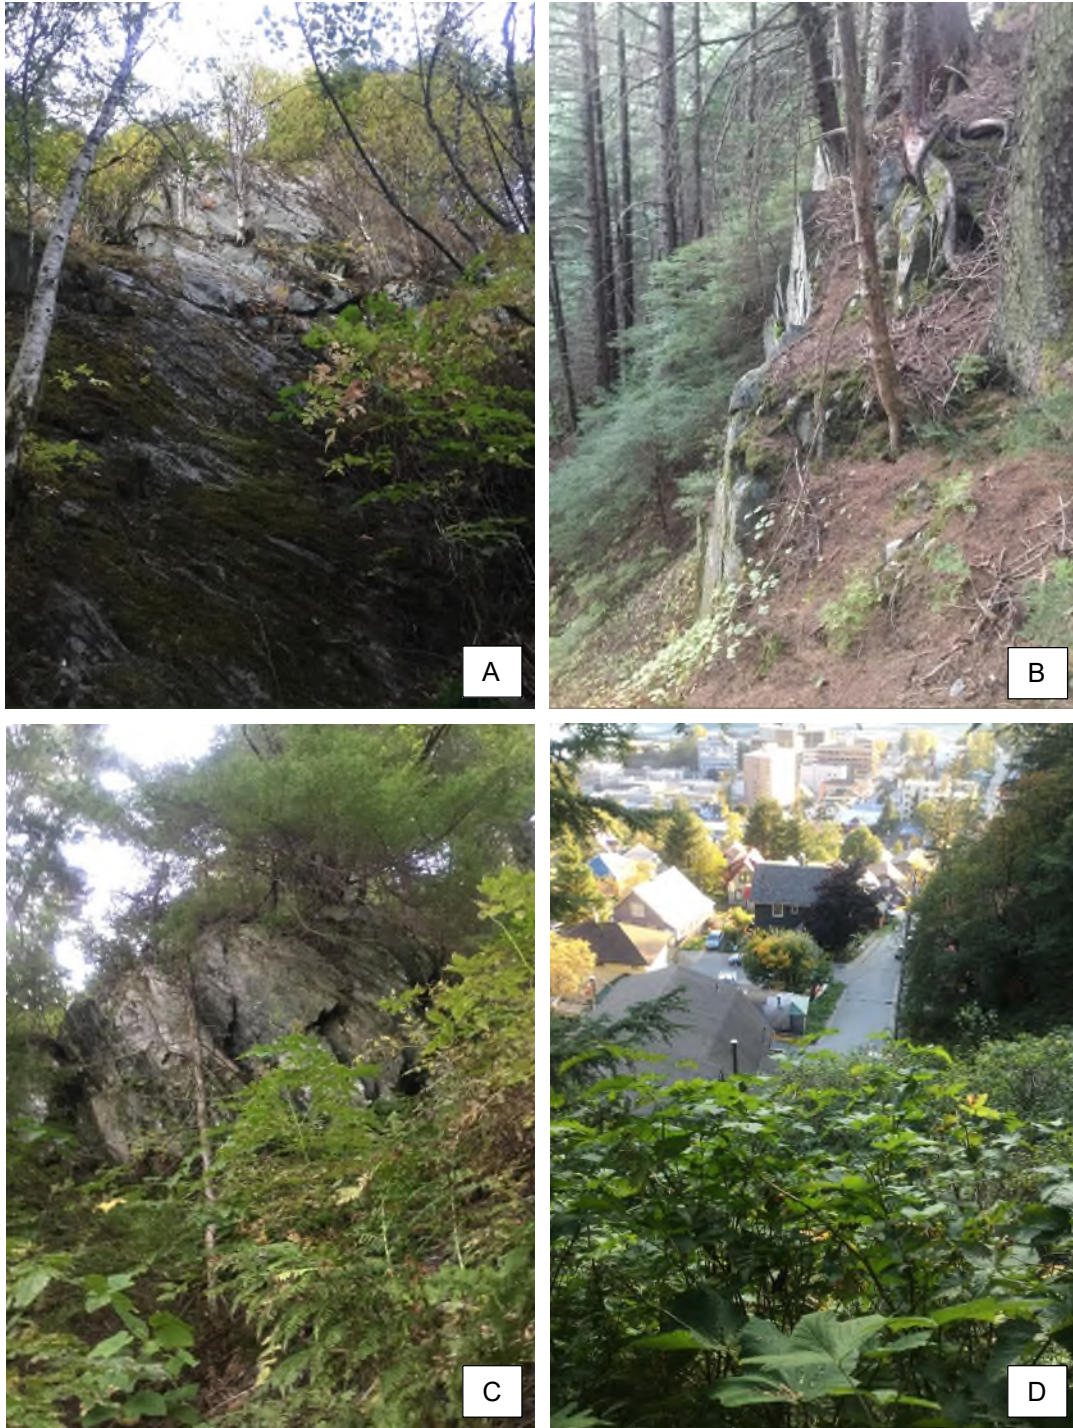
**Figure 8: Rockslide track and cliff above rockfall at left-hand blue arrow on Figure 5 (Figure 8A); typical rock bluff above 6<sup>th</sup> Street at red arrows on Figure 5 (Figure 8B); rock cliff with detached blocks above corner of 6<sup>th</sup> Street and Nelson Street at right-hand blue arrow on Figure 5 (Figure 8C); and talus deposit below rock cliff, 6<sup>th</sup> Street visible below (Figure 8D).**

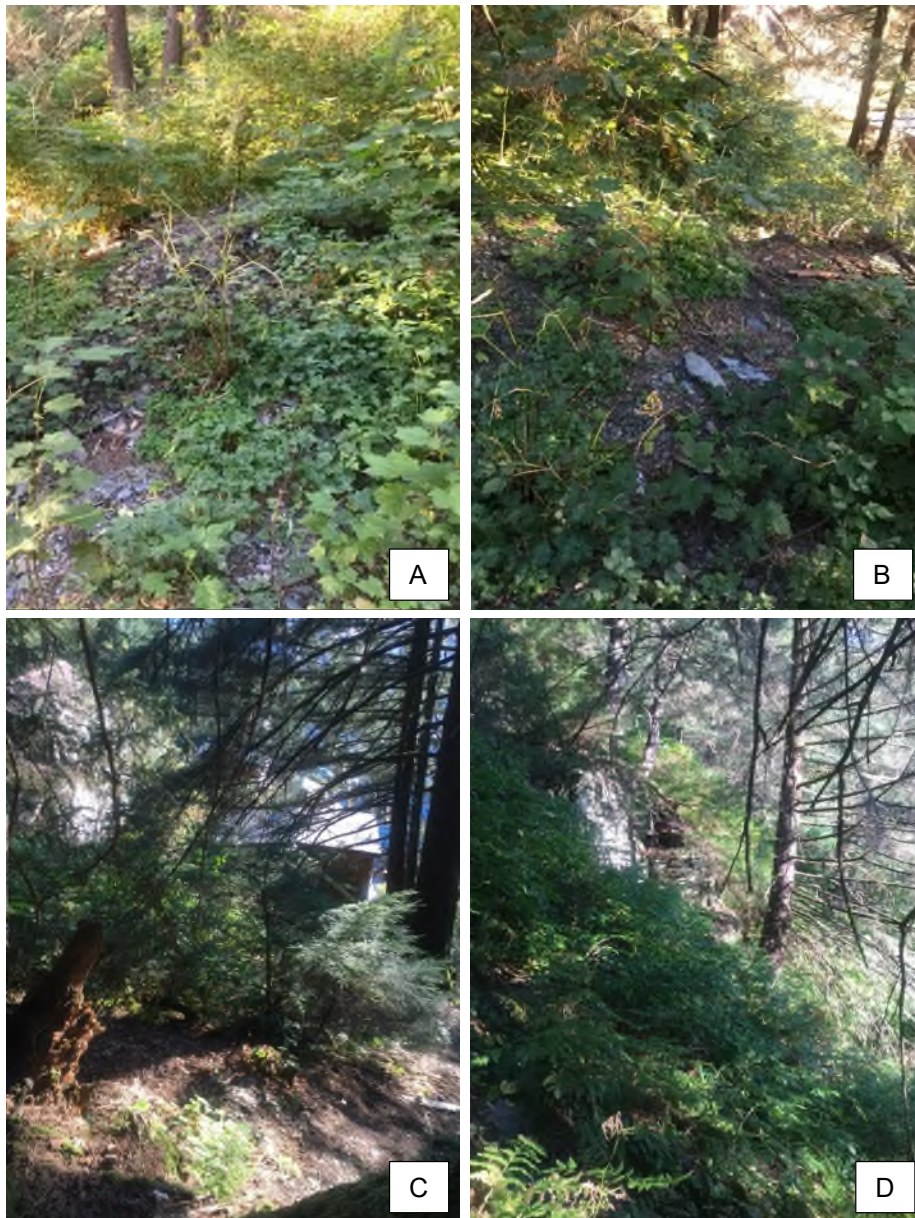
**Figure 9: Active debris slide paths above Nelson Street are shown in Figures 9A and 9B; rock bluffs and broken or damaged trees above Nelson Street are shown in Figures 9C and 9D.**

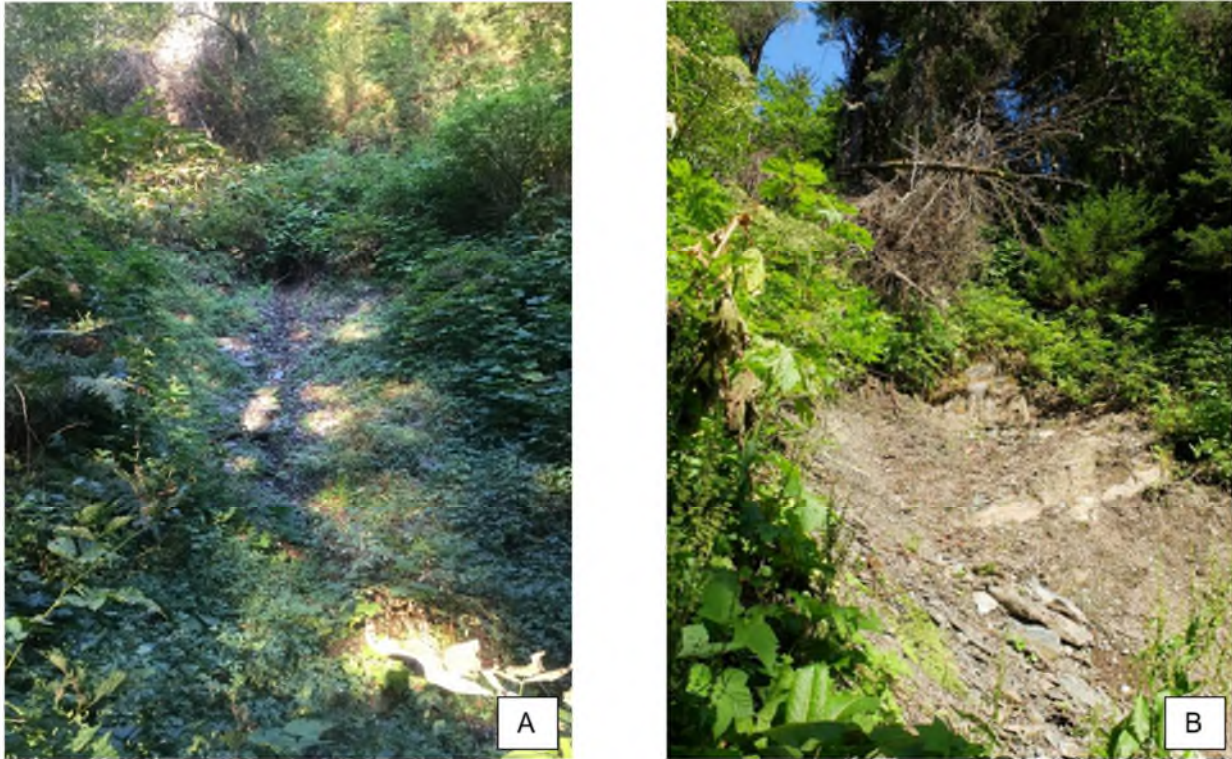
**Figure 17: Compare Tetra Tech’s photo from September 10, 2019 (Figure 17A) with residents’ photo from August 1, 2021 (Figure 17B) at the same location. Slope instabilities appear to be ongoing in the historical slide path locations.**

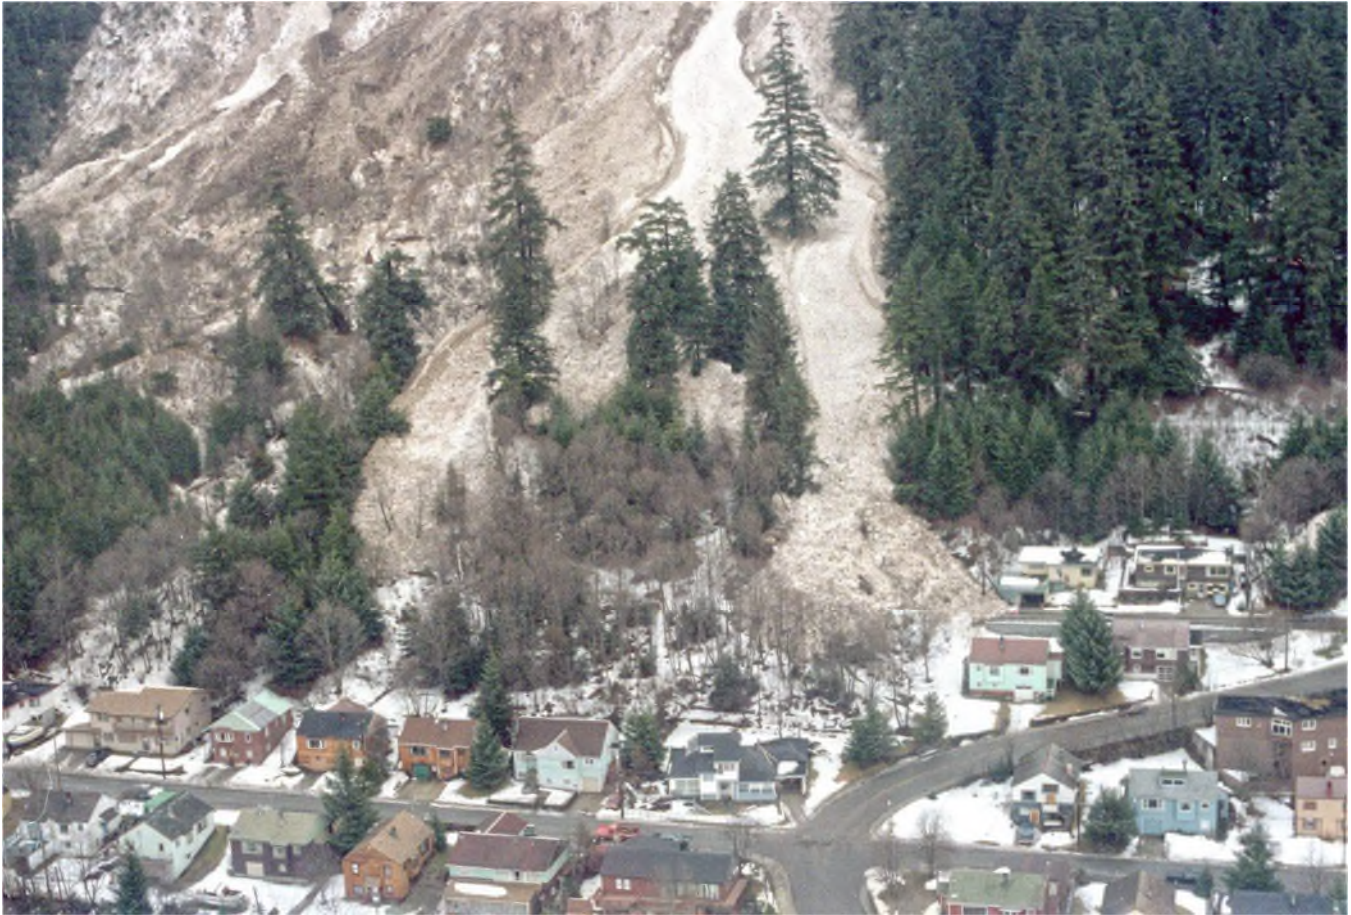
**Figure 7: The aftermath of 1985 avalanche, looking north from just south of Behrends Avenue and Highland Drive. This event was the longest running avalanche in the Behrends Subdivision since the destructive 1962 event. The photo clearly shows the destructive potential of this avalanche and the way it came right into the community and was close to damaging/destroying many structures. However, it only damaged one house on Troy Avenue, the one on the right. (Photo credit: Dan Bishop 1985.)**

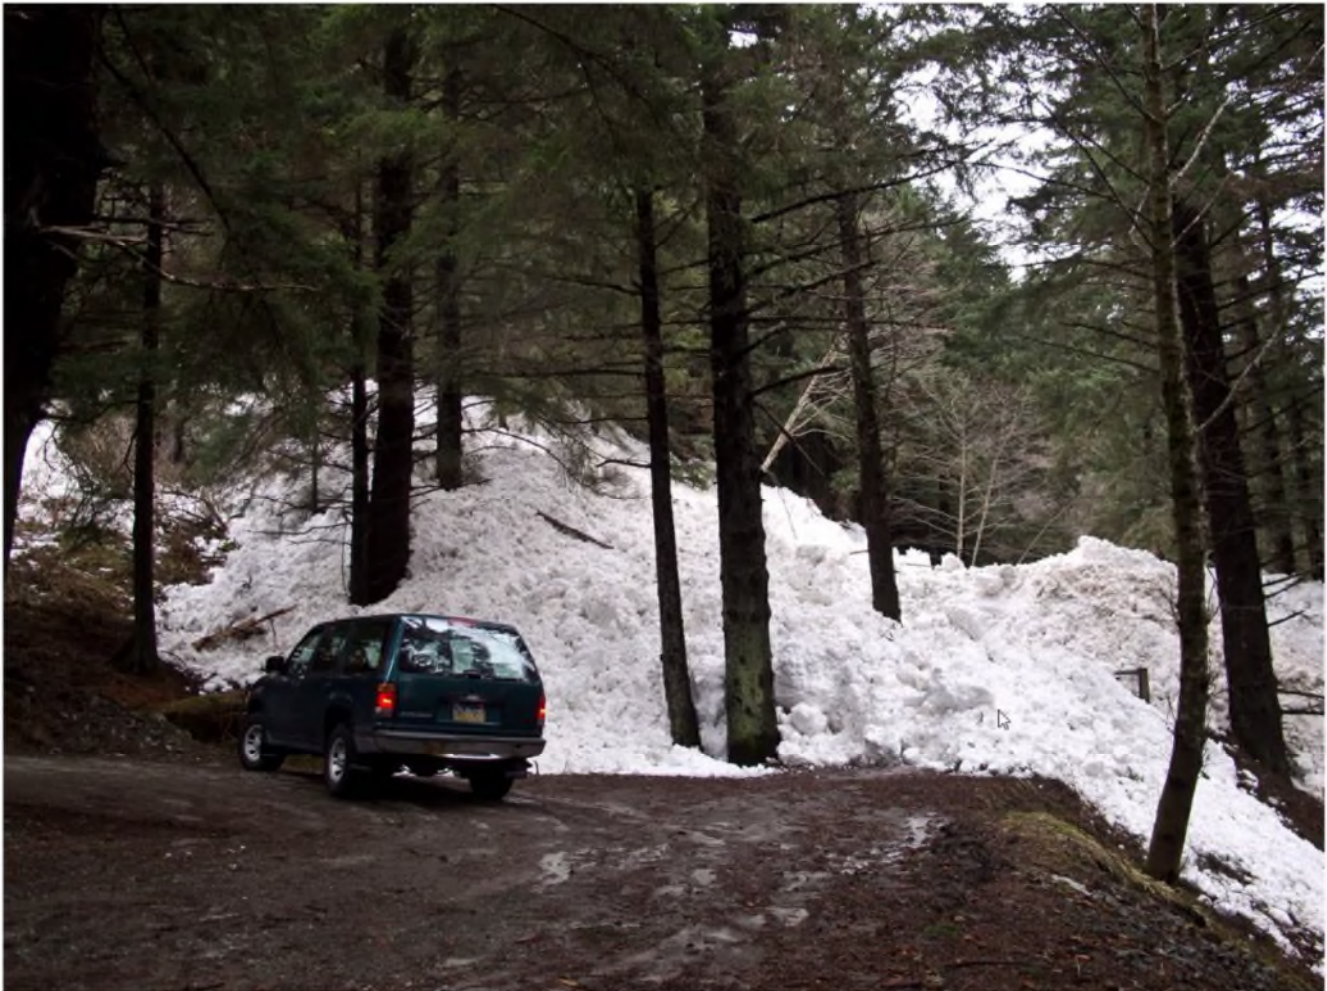
**Figure 8: This photo illustrates a Size D3 avalanche within a Severe (red) hazard zone. The avalanche occurred in 2012 in the Bathe Creek avalanche path. This highlights a hazard area that is both frequent (more frequent than a 30-year return period) and destructive, with an impact pressure greater than 600 lbs/ft<sup>2</sup> (30 kPa), capable of both burying/destroying a car and destroying a wood frame residence. (Photo credit: Mike Janes (AELP).)**

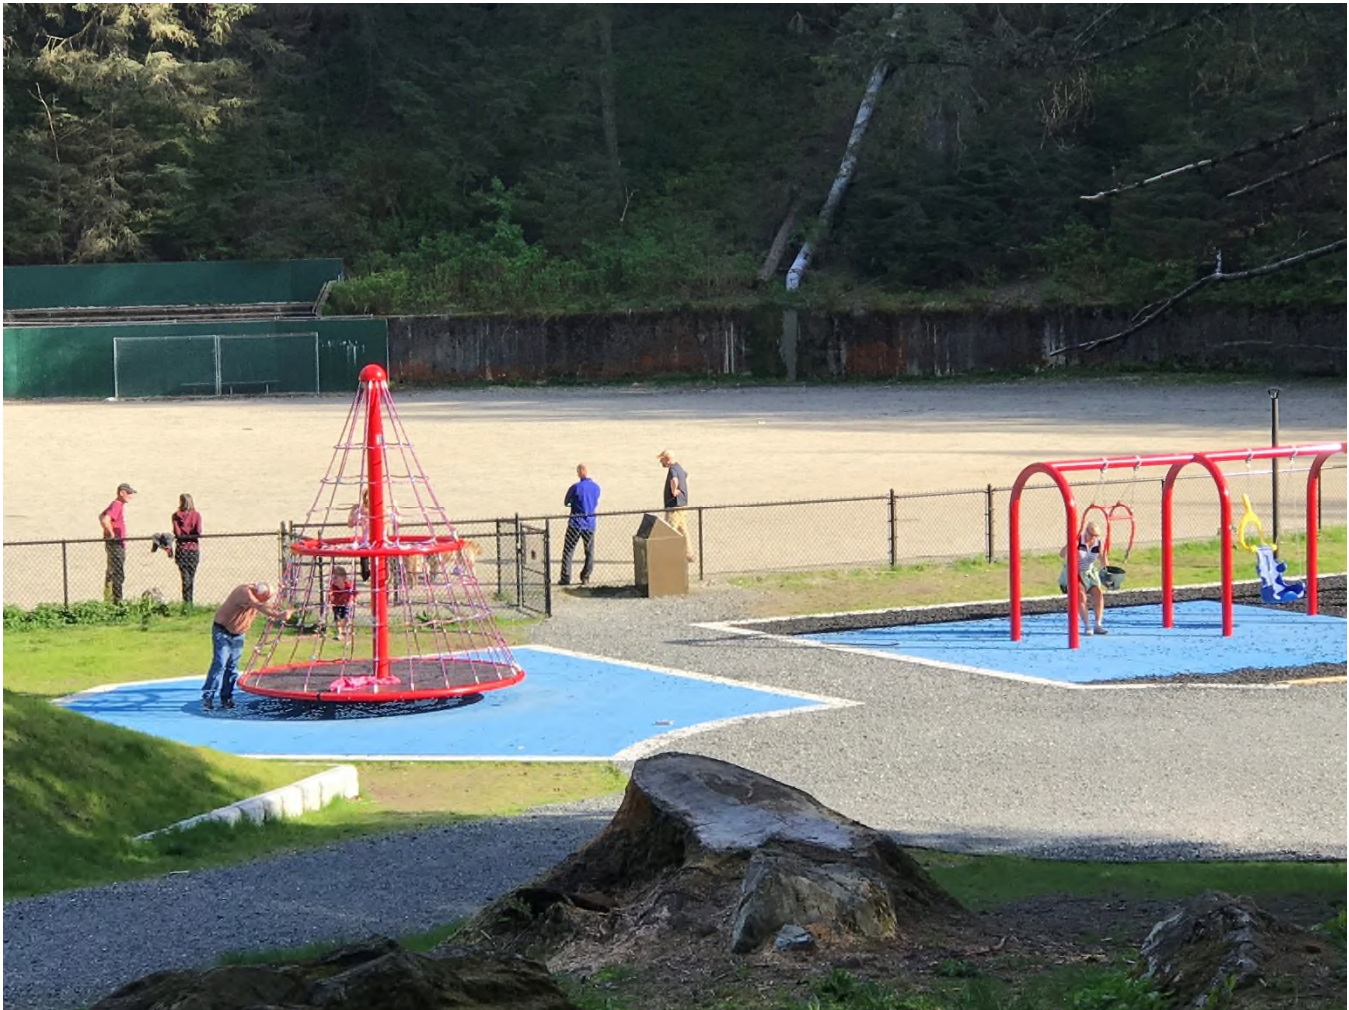
**Figure 16: Looking southeast at the steep slopes around Cope Park at the ball diamond. Note the retaining wall at the toe of slope here, which is mapped as having a *High* hazard. (Photo credit: [CBJ Parks & Recreation 2022.](#))**

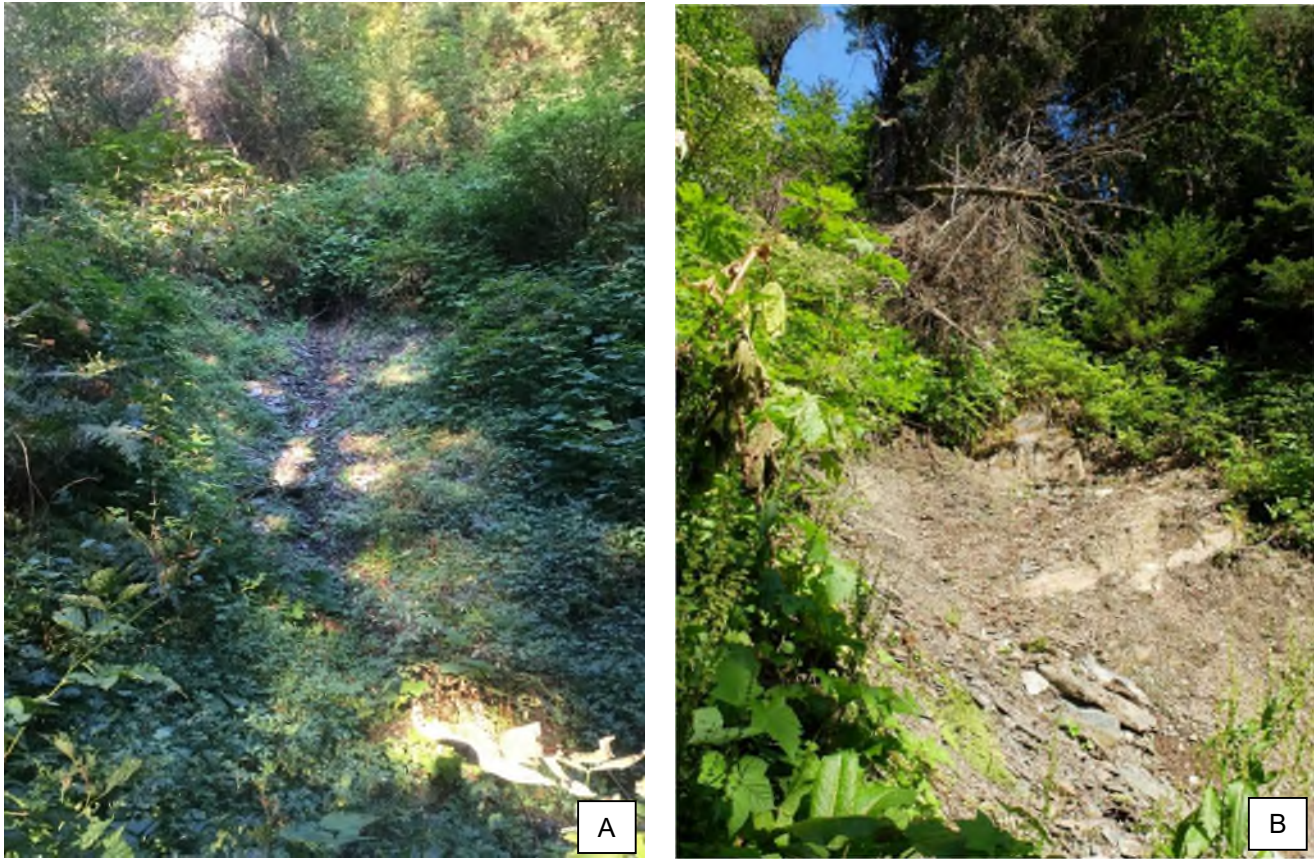
**Figure 18: Compares Tetra Tech’s photo from September 10, 2019 (Figure 18A) with residents’ photo from August 1, 2021 (Figure 18B) at the same location. Slope instabilities appear to be ongoing in the historical slide paths located above Nelson Street on a slope with a landslide hazard designation of Severe. See Technical Memo #3 for more information about the slopes around Starr Hill.**

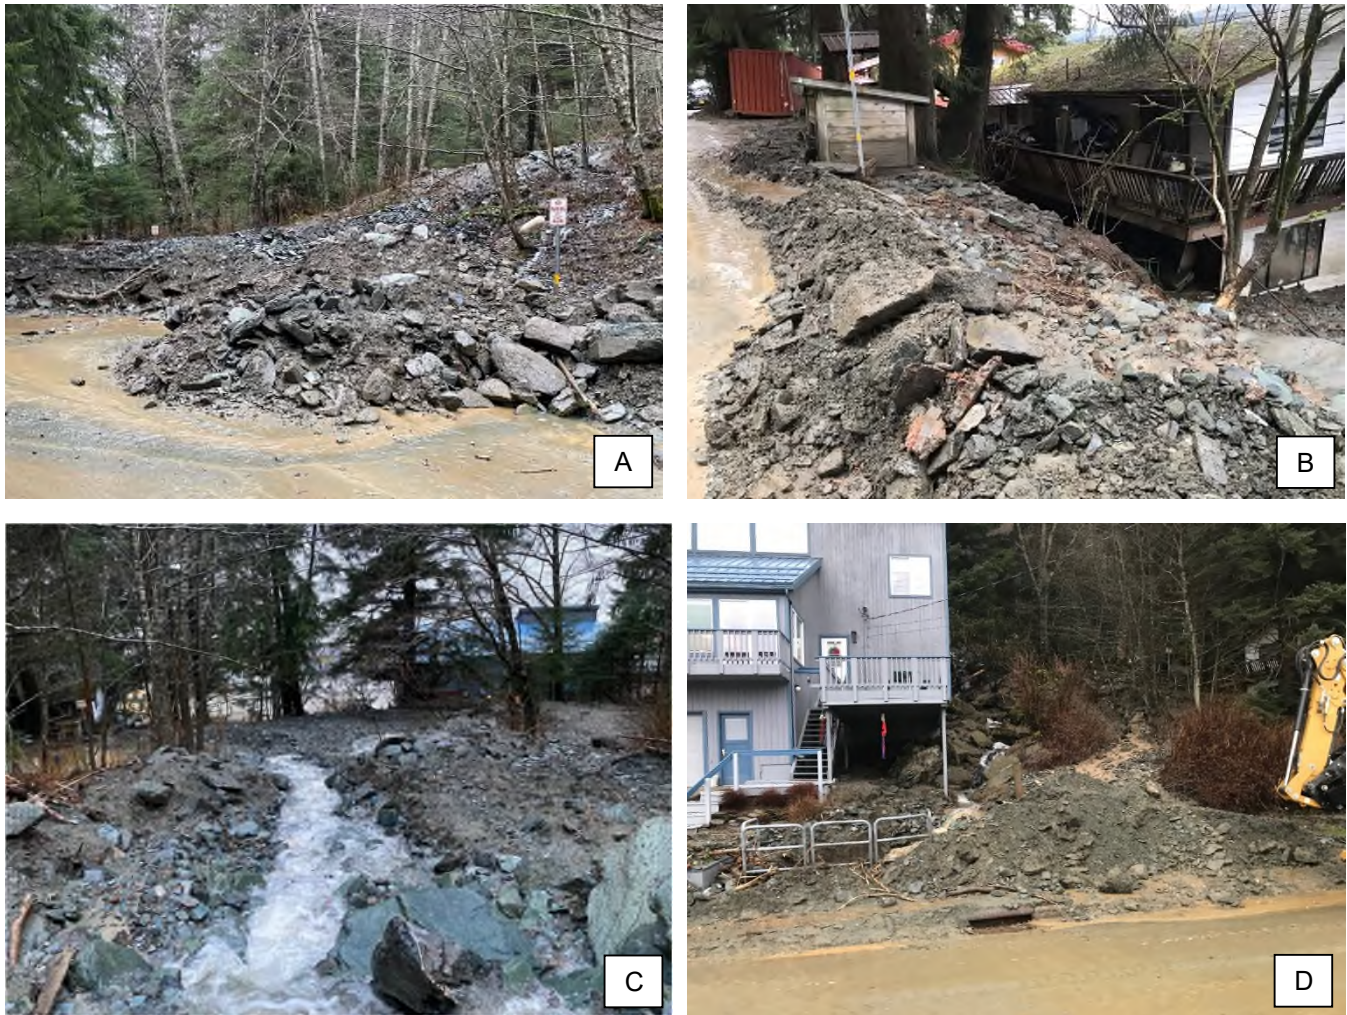
**Figure 20: The Wickersham debris slide in the White Subdivision is an example of a landslide in terrain with a Severe landslide hazard designation. Figure 20A: Part of the debris deposit at the northwest end of Wickersham Avenue on the uphill side; Figure 20B: Debris on the downhill side of Wickersham Avenue; Figure 20C: Debris running down along the swale between Wickersham and Glacier Highway; Figure 20D: Debris deposit at Glacier Highway, filling a concrete sump behind the railing. (Photo credits: CBJ December 4, 2020.)**
