To:	Teri Camery (CBJ)	Date:	April 27, 2022
c:	Alix Pierce (CBJ)	Memo No.:	2
From:	Rita Kors-Olthof, Vladislav Roujanski, Shirley McCuaig	File:	704-ENG.EARC03168-01 / 704-ENG.EARC03168-02A
Subject:	Landslide Designations and Boundaries – Bathe Creek and Highlands Downtown Juneau Landslide and Avalanche Hazard Assessment

1.0 INTRODUCTION

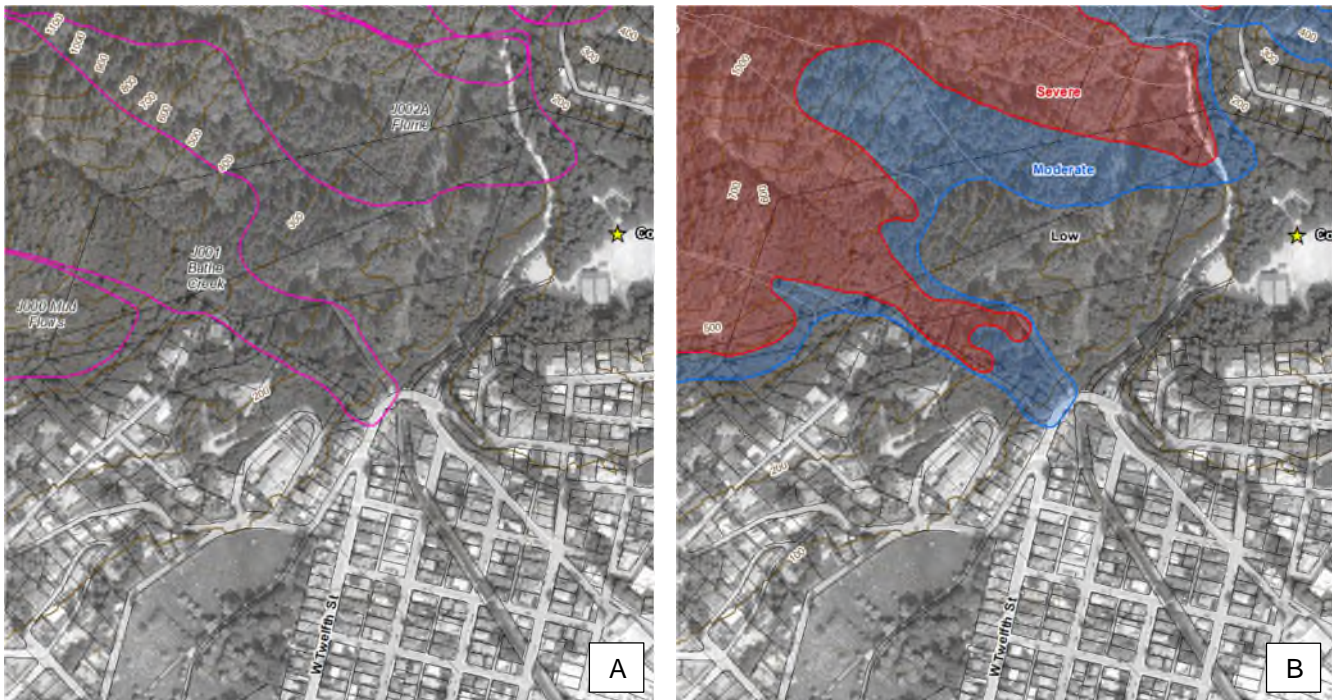
Figure 1: Excerpts from Figure 2.2c Avalanche Path Mapping Detail (Figure 1A) and Figure 2.3a Avalanche Hazard Designation Mapping Overview (Figure 1B).

Response: See response to Item 3 above regarding the irregular “curlicues and “projections.” Bathe Creek is an example of where adjacent terrain units affect the shape of this terrain unit. In general, because the processes are not the same, avalanche path boundaries should not be expected to match landslide hazard boundaries. Compare the excerpts from the avalanche path and hazard mapping in Figures 2.2c and 2.3a (Figure 1 below) with the surficial geology and major gully features in Figures 1.3b and 1.5b (Figure 2 below). The boundaries of wet avalanches might sometimes approximate the boundaries of debris flows in the same terrain feature, a resemblance that would necessarily depend on the size and mobility of each event. In this case, they could be similar but not identical.

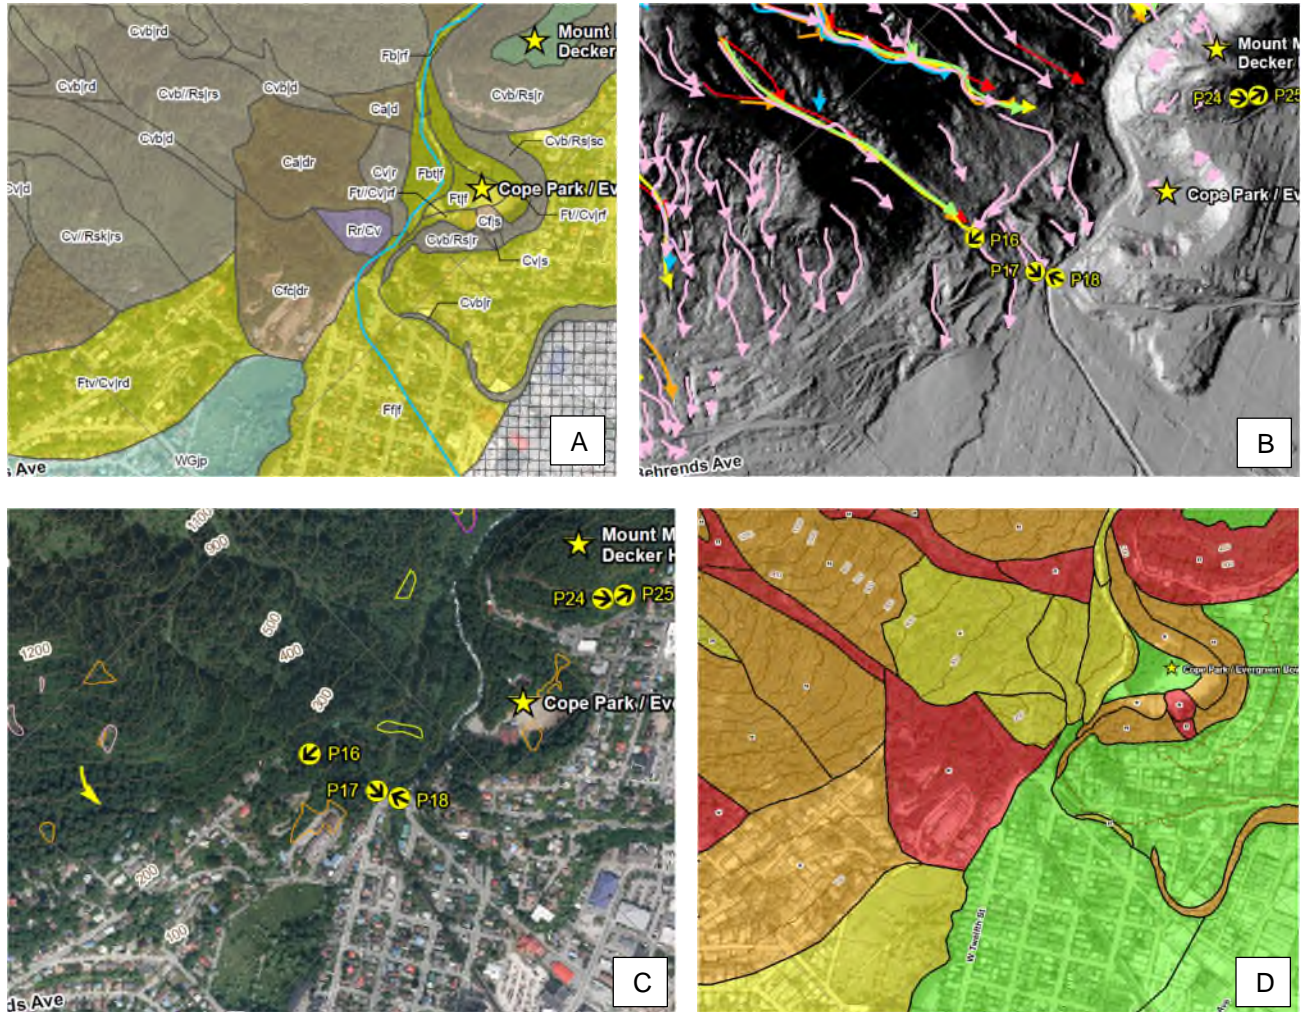
Compare the surficial geology and the major gully features shown in excerpts from Figures 1.3b and 1.5b (Figures 2A and 2B below). In the case of Bathe Creek, the shape of the *Severe* area reflects the shape of the cone/fan and the upslope gully that is the source of the debris, as shown below in the excerpt from Figure 1.6c (Figure 2D). Finally, even though the fan itself only displays occasional activity (remobilization of old debris flow material), as shown in the excerpt from Figure 1.4b (Figure 2C), the debris flows originating from upslope govern the hazard designation, as they are what has formed the fan and what will continue to do so in the future.

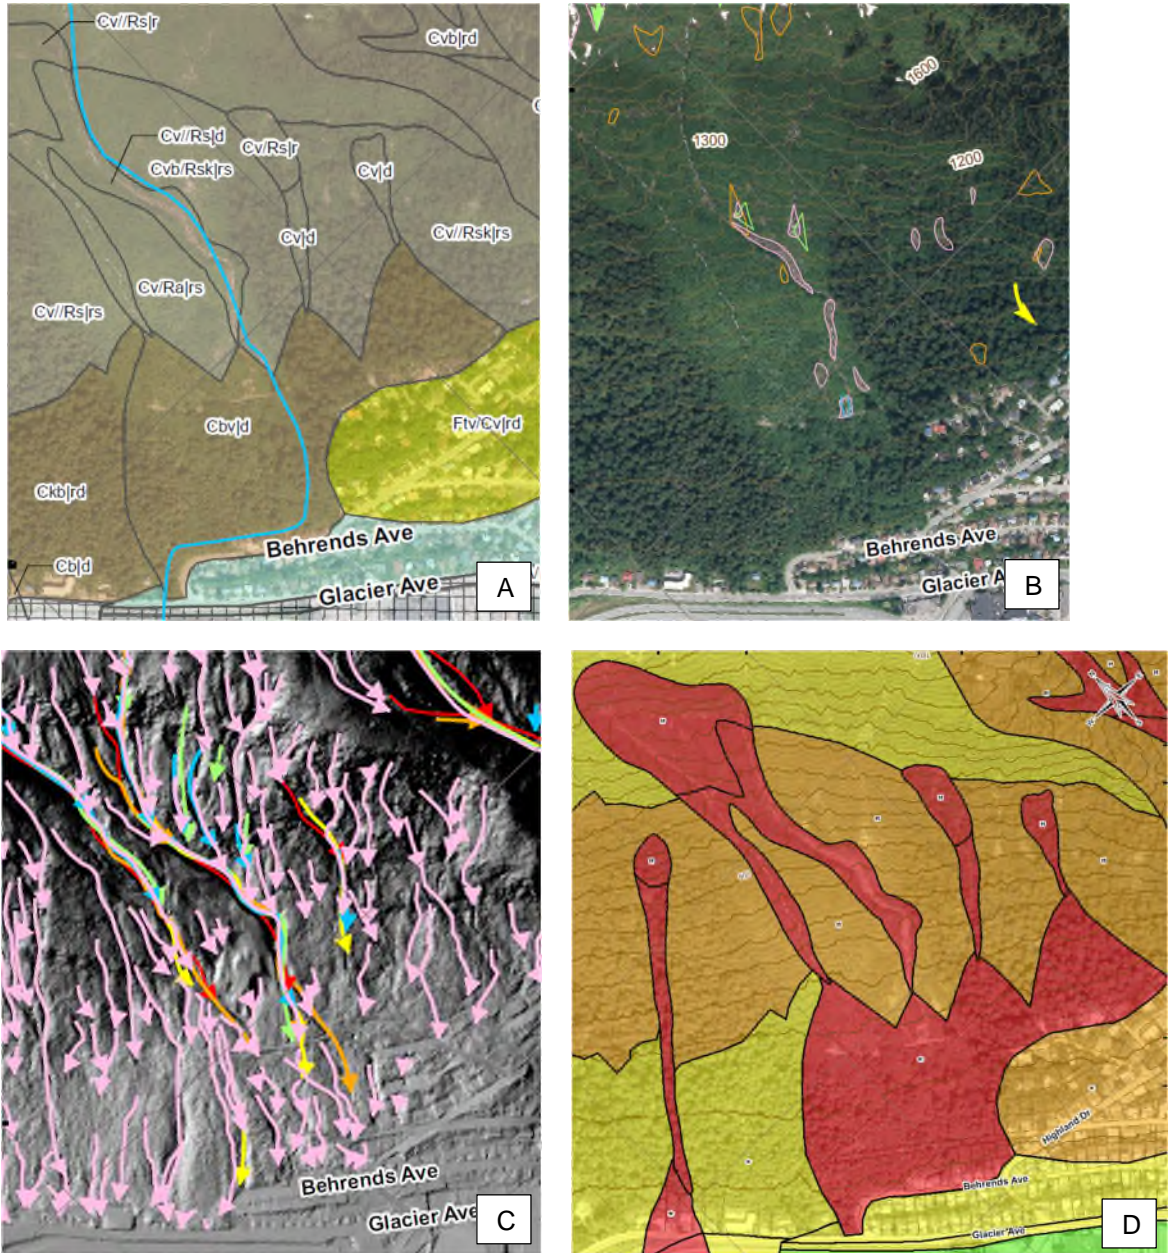
Response: The basis for the *Severe* hazard designation is not Swanston’s report, but rather Tetra Tech’s independent determination of the characteristics of the terrain units based on surficial geology mapping, historical air photo record analysis of slope movement features and gully erosion features, as well as incident reports and field observations. See also responses to Items 1 and 4 above. Specific to the *Severe* areas mapped in this part of the study area (Figure 1.6b and 1.6c), these are all colluvial areas (Figure 1.3b) that receive debris from several active gullies upslope (Figure 1.5b), including the previously mentioned Bathe Creek gully (see Figure 2 above), and several active gullies above Behrends Avenue and the west end of Highland Drive (see Figure 3 below). Several of the two dozen debris slides that occurred in various years in the immediate map area (Figure 1.4b) happened within gullies (compare Figures 3B and 3C below). The excerpt from Figure 1.4b (Figure 3B below) is also a good example of an avalanche track (area with no trees) that does not correspond perfectly with landslide activity and location.

While it is possible that houses have stood in one location for many years without being affected by a landslide, it does not mean there is nothing going on above them on the slope. If that activity has not reached a particular house yet, the resident may just have been lucky so far.
