To:	Teri Camery (CBJ)	Date:	April 27, 2022
c:	Scott Ciambor (CBJ)	Memo No.:	5
From:	Rita Kors-Olthof, Vladislav Roujanski	File:	704-ENG.EARC03168-02A
Subject:	Landslide Hazard Designations at Telephone Hill and Gastineau Avenue Downtown Juneau Landslide and Avalanche Hazard Assessment

1.0 INTRODUCTION

This Technical Memo #5 provides some additional explanation for anticipated future slope instabilities within the landslide hazard designations mapped as *High* or *Severe* on the slopes of Telephone Hill (Figures 1 and 2) compared to the areas mapped as *High* or *Severe* on the slopes along and above Gastineau Avenue.

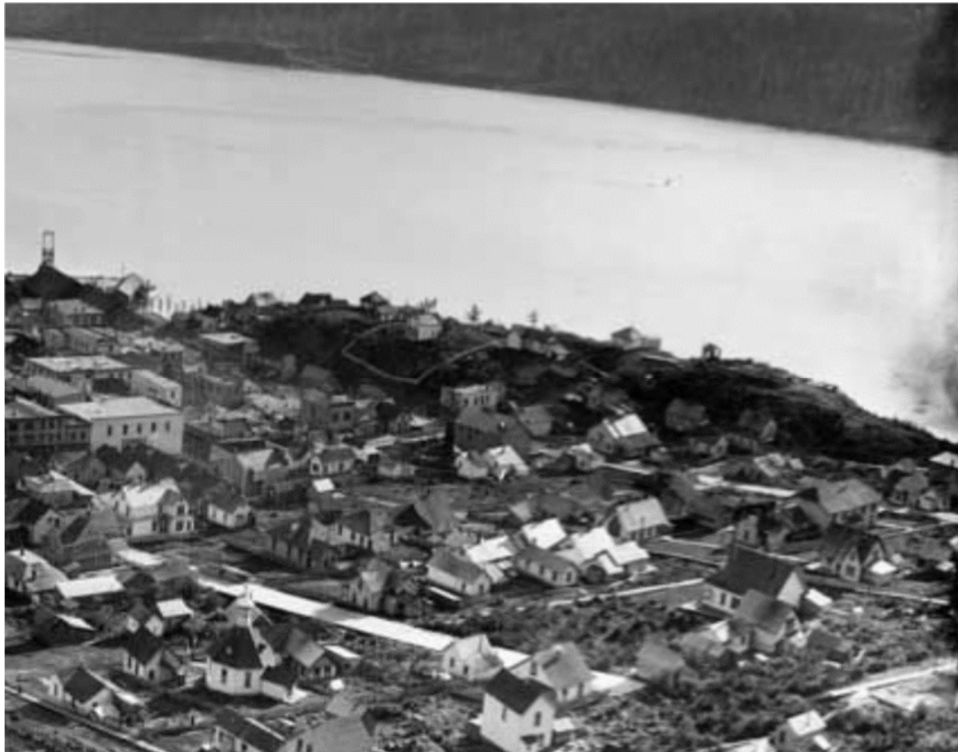
It is useful to first consider a view of Telephone Hill from Mt. Maria in the historical photo taken in about 1896, prior to the Juneau development that has gradually obscured the slopes (Figure 1). The prominent bedrock ridge seen in this photo was mapped by Miller (1975) as undifferentiated Tertiary or upper Mesozoic rock with an unconformity, suggesting that some material was scoured off at some point in geological history, and the bottom of the upper layers does not match the top of the lower layers. Although the top of the ridge is gently sloped, the sides of the ridge are quite steep. In locations where a thin veneer of colluvium covers the bedrock, this material could be more prone to mass movement than other materials such as a blanket of colluvium or glacial till (Tetra Tech 2021a).

Figure 1: Looking south towards Telephone Hill and Gastineau Channel from Mt. Maria, circa 1896, early in the development of Juneau, when structures along the toe of slope at Willoughby Avenue were supported on wharfs, and before fill began to be placed along the shoreline to extend the useable land area. (Photo credit: Excerpted from Alaska State Library – Historical Collections, [ASL-P87-0753](#), Winter & Pond, ca. 1896.)

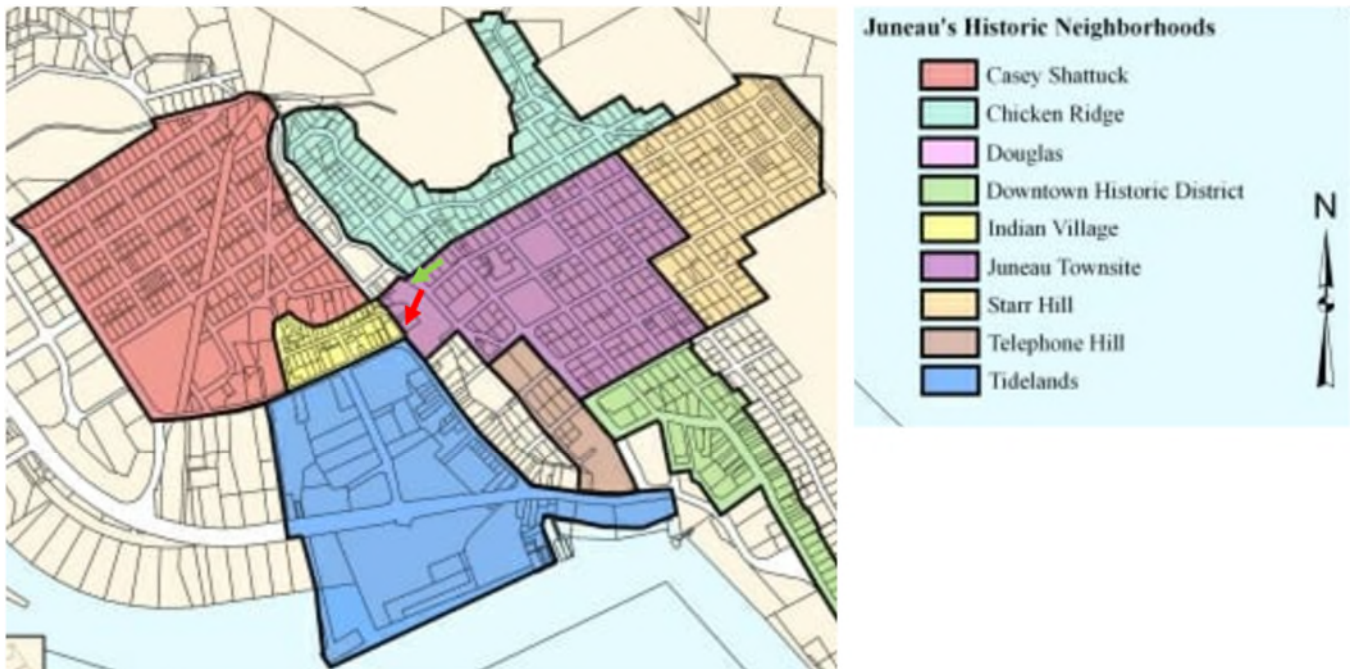
On September 7, 1923, the Juneau Daily Empire reported that a landslide “of about 100 feet occurred on the hill between Calhoun Avenue and Willoughby Avenue, at the foot of Dixon Street.” The slide had occurred early that morning due to the heavy rainfall of the preceding few days. The slide pushed a large unoccupied two-storey frame house off its foundations, moving it several feet. No damage was reported to the house, except that its “underpinnings” had been torn out. In addition, the slide also destroyed “part of the stairway leading from Calhoun Ave. to the Indian village” (The Alaska Daily Empire 1923). This landslide occurred in colluvium and appears to have been directly downslope of the fork at Dixon Street and Calhoun Avenue, in an area that still experiences periodic landslides, at the northwest corner of the Juneau Townsite in CBJ’s [Historic Neighborhoods](#) mapping.

Figure 2 Excerpt of map of Downtown Juneau’s [Historic Neighborhoods](#) (CBJ 2022), showing selected historical landslide locations. The 1923 landslide is shown running downslope from Calhoun Avenue and the southeast end of Dixon Street to a little above the present-day Willoughby Avenue (red arrow). Landslides still occur at Calhoun Avenue, originating upslope of Dixon Street (green arrow).

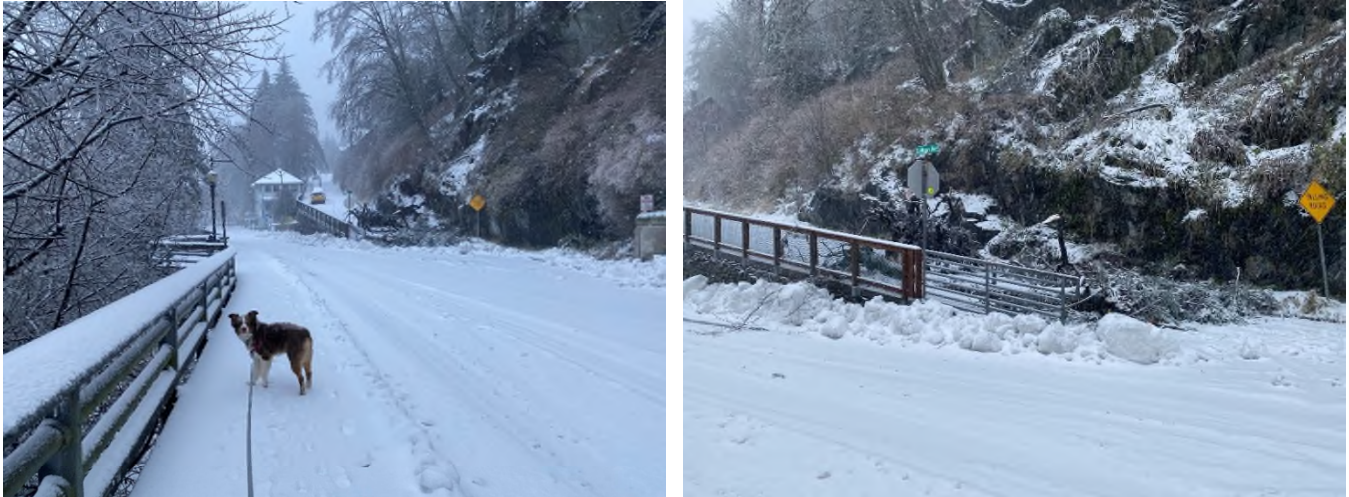
CBJ has reported that debris slides occur regularly at the fork between Dixon Street and Calhoun Avenue, between the northwest end of the retaining wall on Calhoun, and just downslope of the West 6th Street cul-de-sac. This location overlaps the southwest corner of Chicken Ridge, and the northwest corner of the Juneau Townsite in CBJ’s [Historic Neighborhoods](#) (CBJ 2022) mapping, and its location is shown in Figure 2. Rocks on the road have been reported after large storm events in at least the past two years. Trees or pieces of large woody debris are less frequent, occurring at roughly five-year intervals (email communications: July 20, 2021; A. Pierce, T. Camery, Q. Tracy, V. Roujanski, and R. Kors-Olthof). Google Street View suggests that debris appears to originate at a

bedrock bluff partway upslope towards West 6th Street, and could consist of soil, rocks, trees, or other large woody debris, and other organic debris that typically lands on Dixon Street, requiring cleanup to restore road access, as seen in Figure 3. Part of the slope, between Dixon Street and Main Street upslope, is occupied by a building, but some debris seems to originate from the lower slope below the building too.

Figure 3: Typical debris slide deposit at the fork between Dixon Street and Calhoun Avenue. In the left-hand photo, note the fork in the road at center-right, and the northwest end of the retaining wall at the right edge of the photo. The downslope edge of Calhoun at the railing is supported by another retaining wall. In the right-hand photo, note the presence of a steep cutslope into apparent weathered bedrock, with a thin veneer of colluvium. The debris from this landslide event extends an estimated 40 feet northwest of the end of the metal railing. The distance along the toe of slope along Dixon/Calhoun is about 110 feet between the northwest edge of the debris and the northwest corner of the upslope retaining wall. (Photo credits: CBJ, provided July 16, 2021.)

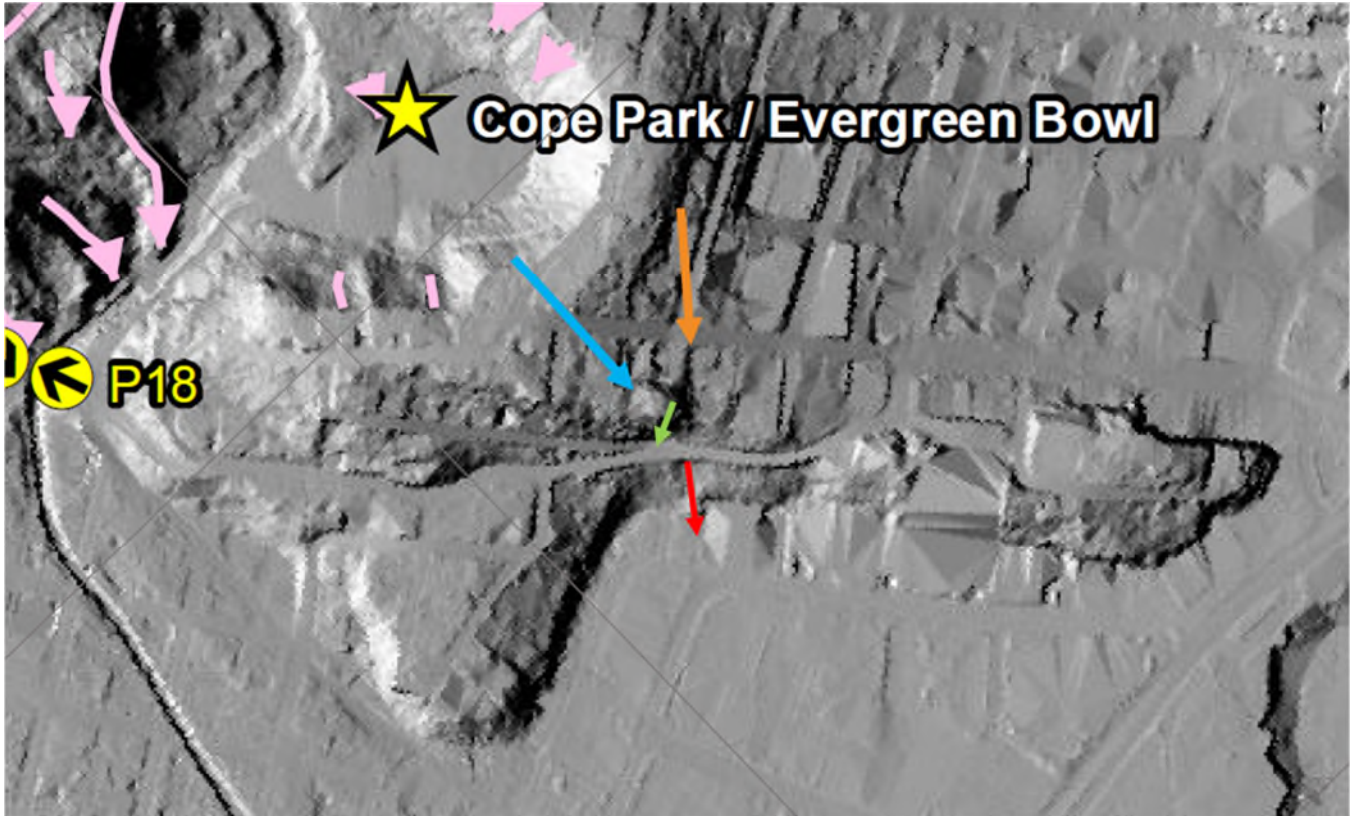
There are a great many retaining walls visible on Dixon Street, Calhoun Avenue, Goldbelt Avenue, parts of Main Street, and connecting streets. Some of these retaining walls were apparently used to construct houses and associated landscaping to make more efficient use of the slope, but numerous retaining walls along roads appear to be necessary to create or maintain access to properties, or to reduce landsliding along steep slopes. In adjacent locations that lack retaining walls, many slope sections have either deciduous trees or grasses, suggesting that shallow debris slides might be fairly common. However, the specific location shown in Figure 3, and the landslide downslope in 1923 at almost this exact location, do suggest that there is something particular about this site that causes it to be exceptionally prone to slope failure. An excerpt of the LiDAR in this area provides a possible explanation (Figure 4).

Figure 4: Just off the southwest end of West 6th Street, there is a prominent bedrock knoll (blue arrow), and an adjacent gully (downslope of the orange arrow) that both potentially contribute to repeated debris slides at this location that regularly run out onto Dixon Street (green arrow). The gully is also directly in line with what appears to be a scar from the 1923 landslide that moved from Calhoun Avenue down to Willoughby Avenue (red arrow). See also Figure 2.

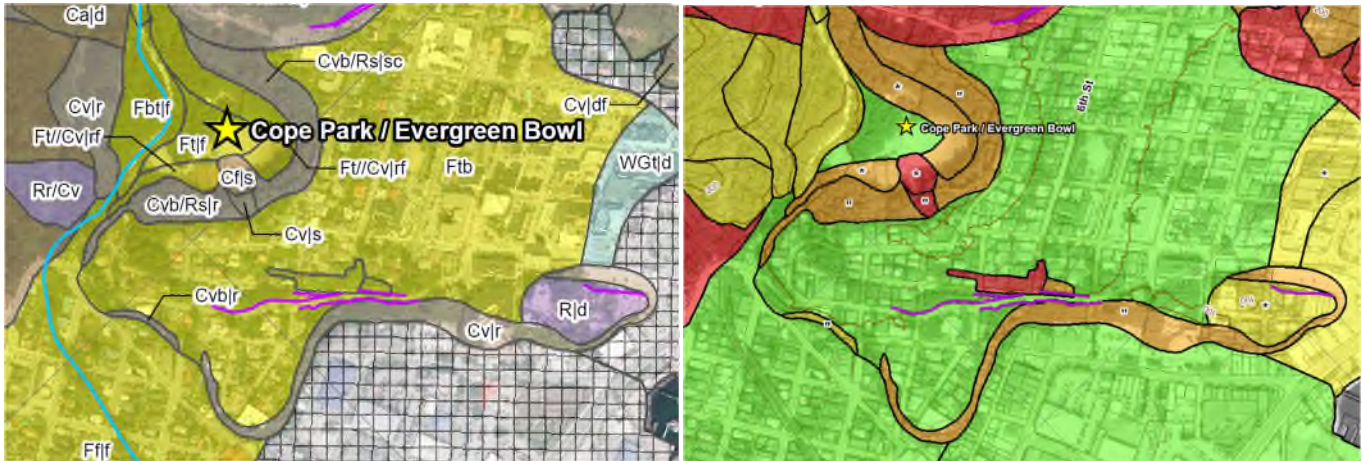
A summary of Tetra Tech’s mapping along Telephone Hill, Juneau Townsite, and Chicken Ridge is shown in Figure 5, with surficial geology on the left and landslide hazard designation mapping on the right. There is a clear correlation between the types and shapes of the surficial geology units and the landslide hazard designations at that location. In Figure 6, the colluvial areas are distinguished by the vegetation visible along slopes where it is difficult to construct housing or other structures.

Figure 5: Excerpts from Figure 1.3b Surficial Geology (left) and Figures 1.6c Landslide Hazard Designation Mapping (right). Surficial geology corresponds closely to landslide hazard designations.

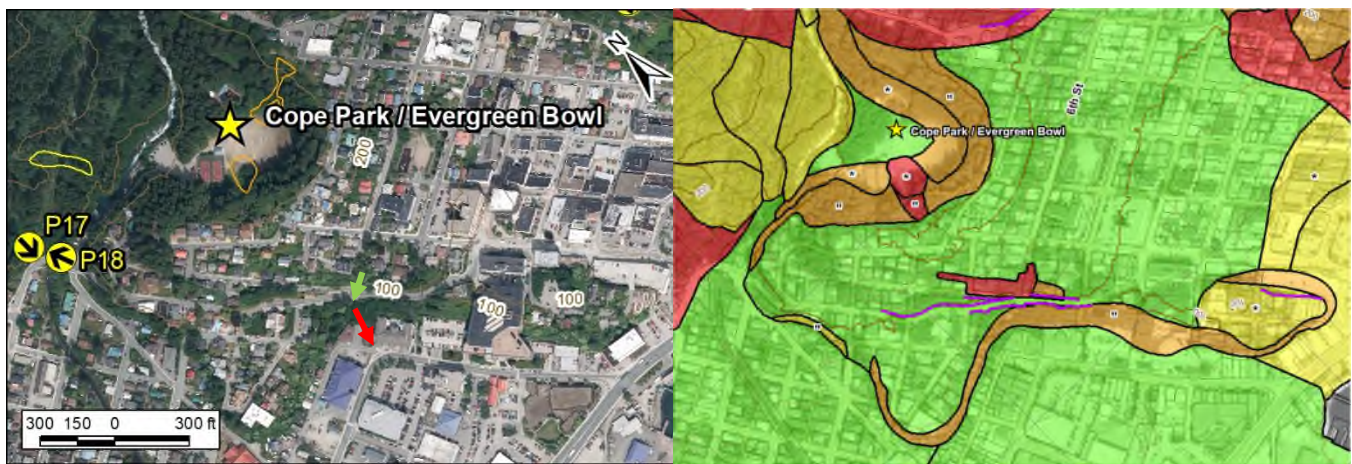
Figure 6: Excerpts from Figure 1.4b Slope Movement Features and Figure 1.6c Landslide Hazard Designation Mapping. On the left-hand image, the 1923 landslide is shown running downslope from Calhoun Avenue and the southeast end of Dixon Street to a little above the present-day Willoughby Avenue (red arrow). Landslides still occur at Calhoun Avenue, originating upslope of Dixon Street (green arrow). On the right-hand image, the hazard mapping from 1987 has been restored and updated above Calhoun Avenue, based on the debris slides reported by CBJ.

Depending on the date of construction of the Calhoun Avenue upslope retaining wall, the area currently shown as *High* in Figure 6 could be downgraded to *Moderate*, but the area shown as *Severe* should remain as is due to the high frequency of debris slides at that location.

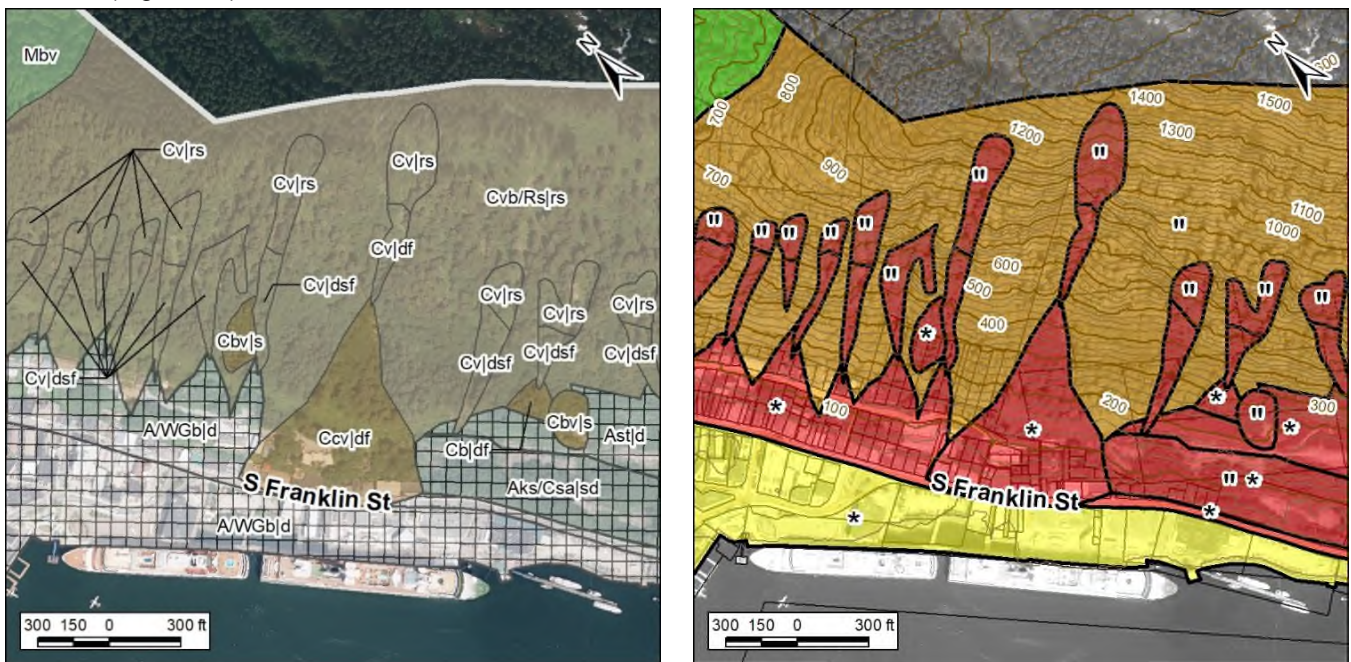
A summary of Tetra Tech’s mapping near the northwest end of Mt. Roberts is shown in Figure 7, with surficial geology on the left and landslide hazard designation mapping on the right. There is a clear correlation between the types and shapes of the surficial geology units and the landslide hazard designations at that location. The same correlations can be seen in the side-by-side comparisons of slope movement features (Figure 9) and gully erosion features (Figure 10).

Figure 7: Excerpts from Figure 1.3b Surficial Geology (left) and Figures 1.6c and 1.6h Landslide Hazard Designation Mapping (right) near the northwest end of Mt. Roberts. Surficial geology corresponds closely to landslide hazard designations.

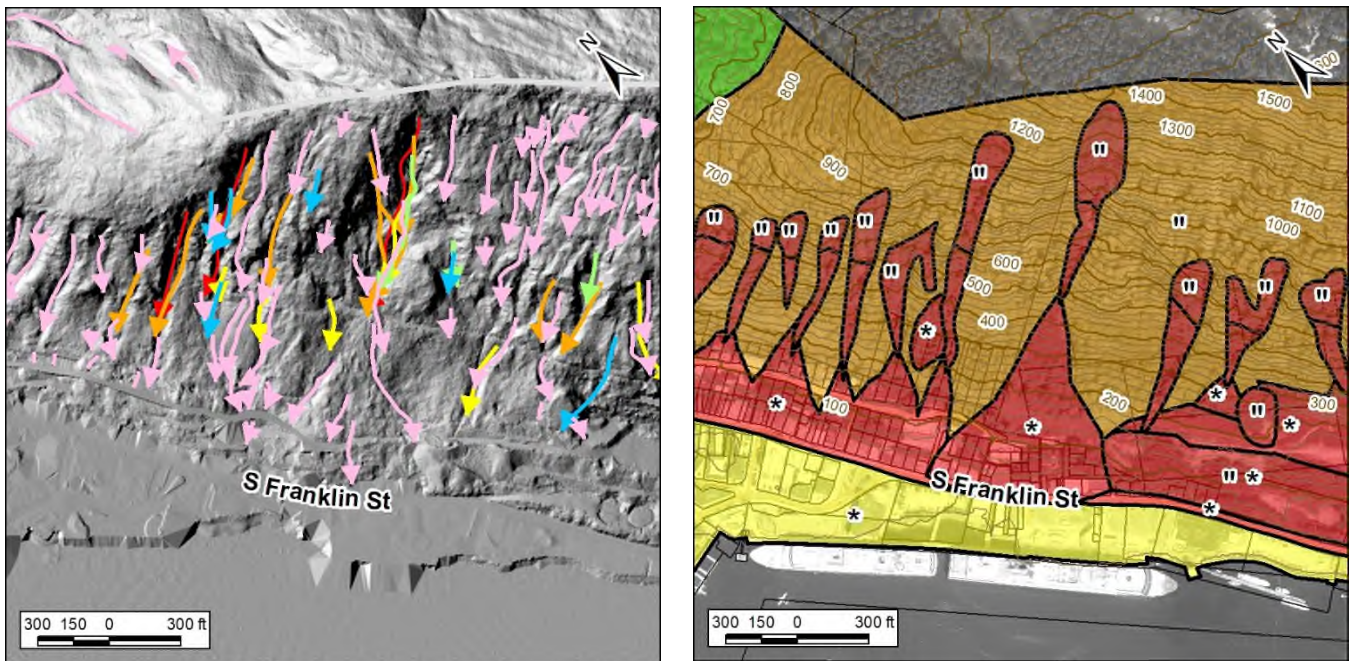
Figure 9: Excerpts from Figure 1.5b Gully Erosion Features (left) and Figures 1.6c and 1.6h Landslide Hazard Designation Mapping (right) near the northwest end of Mt. Roberts. Multiple colours in gullies mean more activity than gullies that only have one colour.

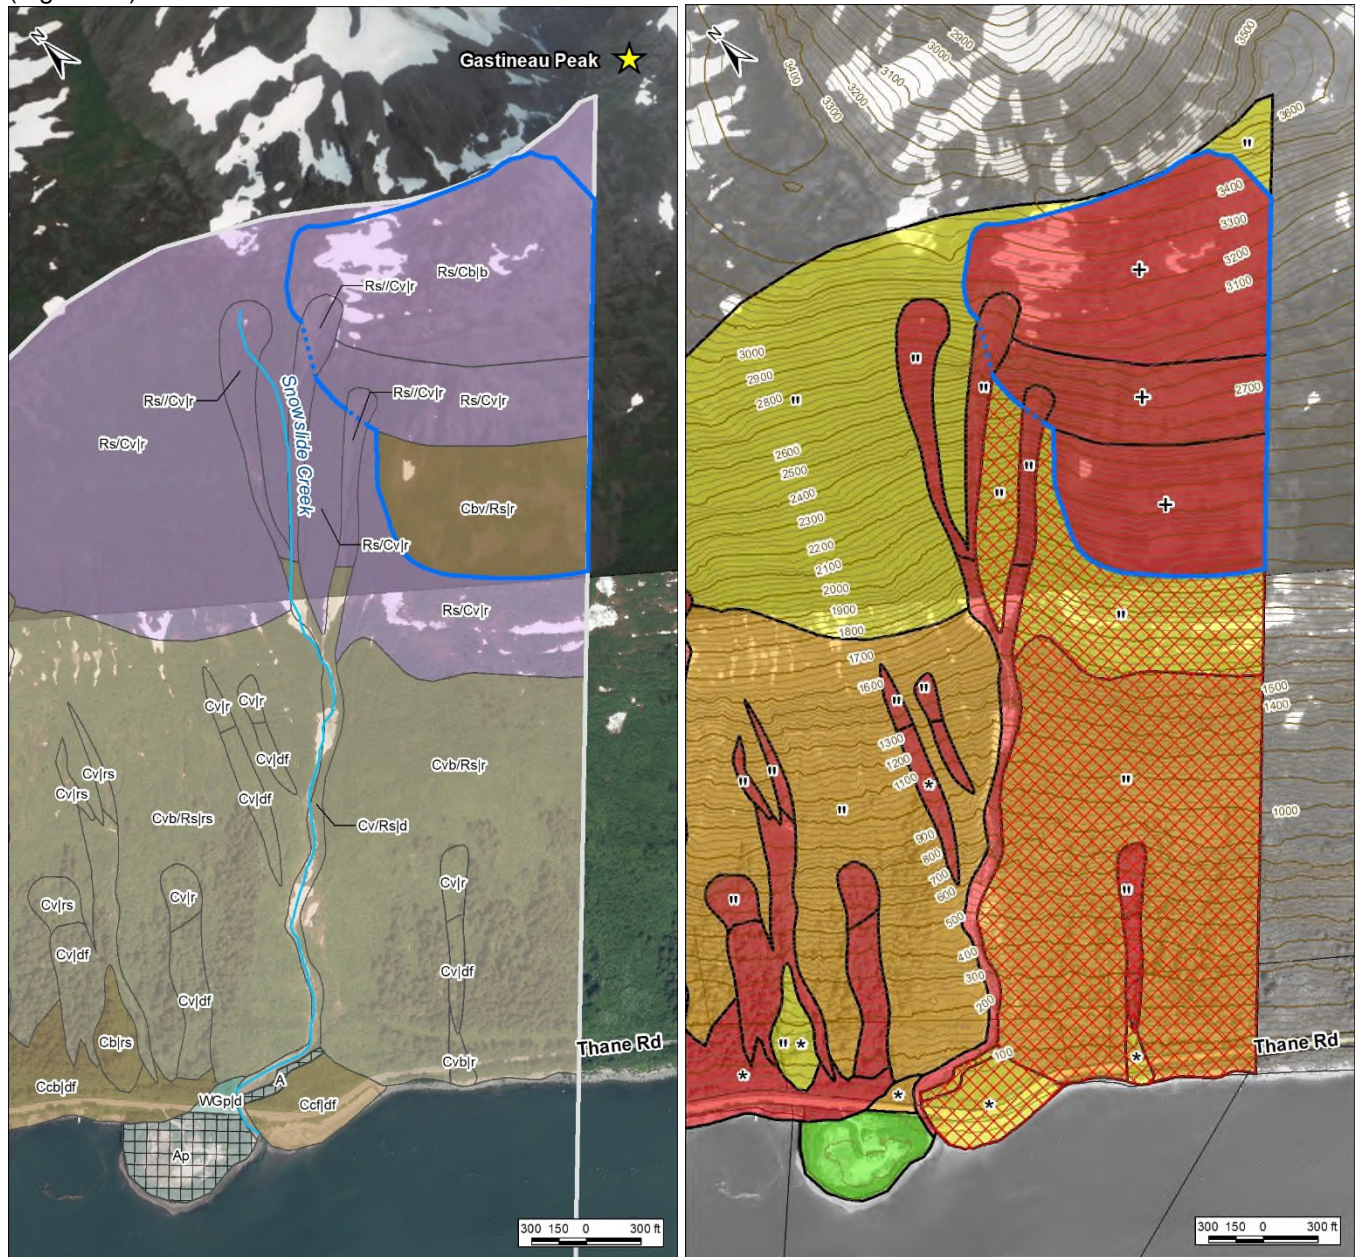
The same comparisons can be made further southeast along the slope, for example, for the terrain at Snowslide Creek, with surficial geology on the left and landslide hazard designation mapping on the right (Figure 10). Once again, there is a clear correlation between the shapes of the surficial geology units and the associated landslide

Figure 10: Excerpts from Figure 1.3c Surficial Geology (left) and Figures 1.6e and 1.6f Landslide Hazard Designation Mapping (right) at Snowslide Creek at the southeast end of the Study Area. Again, surficial geology corresponds closely to landslide hazard designations.

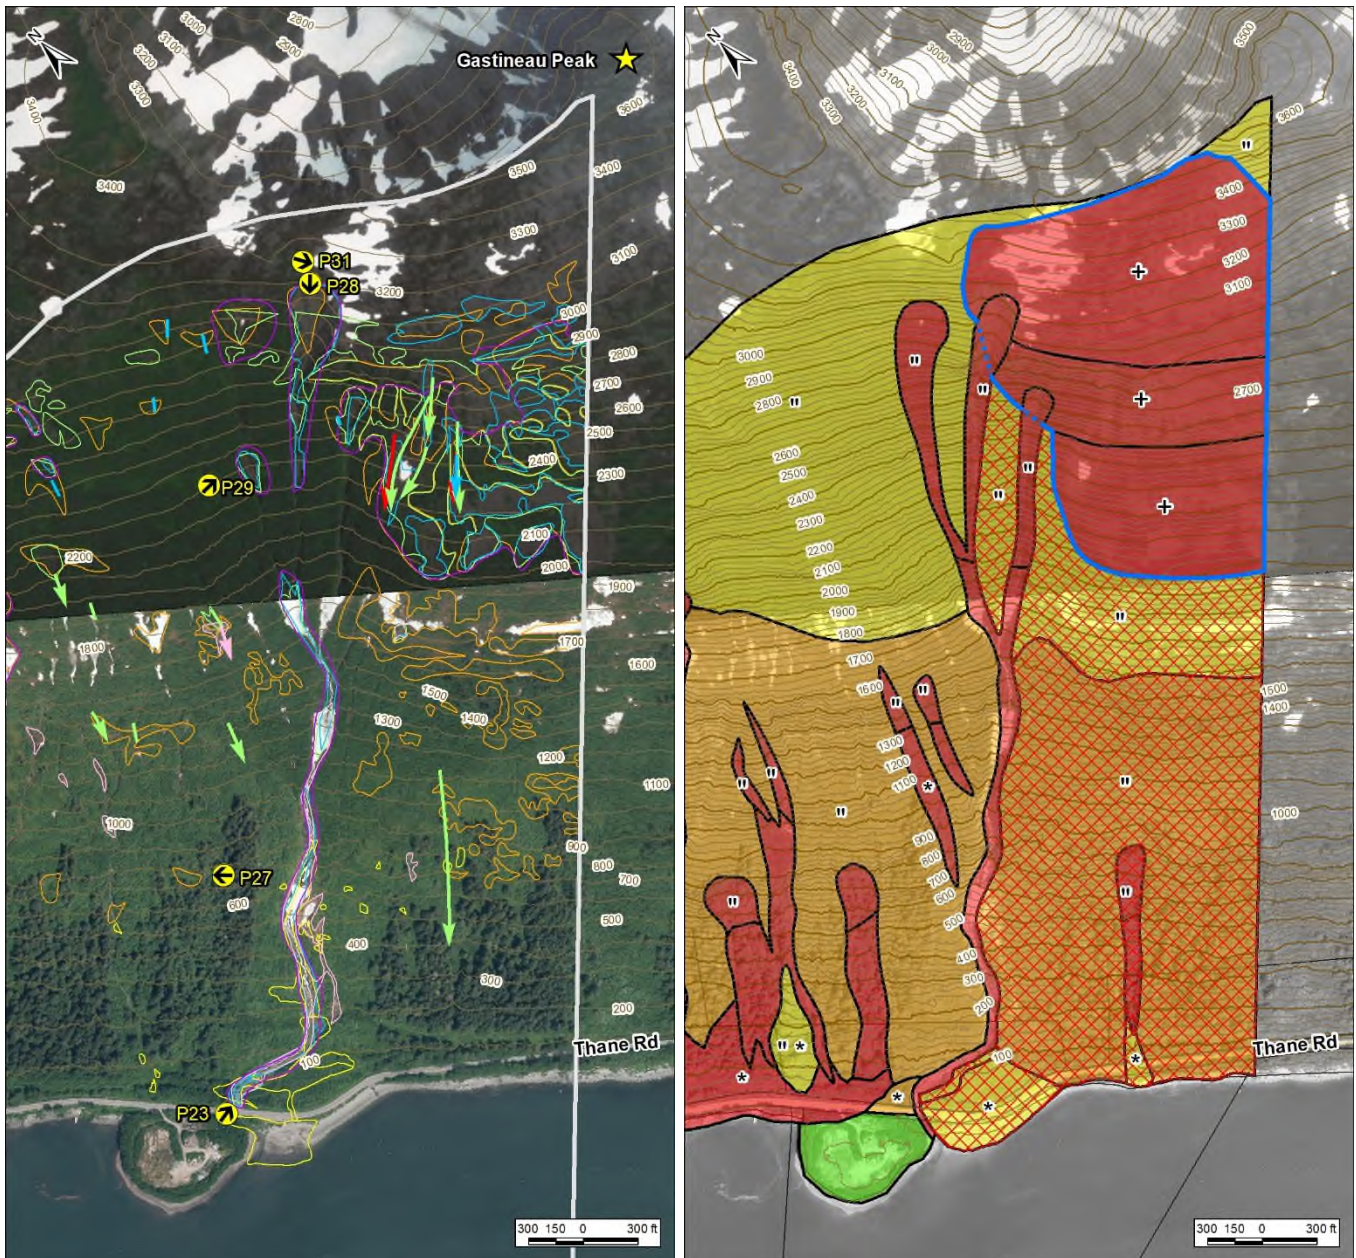
Figure 11: Excerpts from Figure 1.4c Slope Movement Features (left) and Figures 1.6e and 1.6f Landslide Hazard Designation Mapping (right) at Snowslide Creek at the southeast end of the Study Area. This comparison shows that many slope movement features, such as debris slides, are located on open slopes that typically have a *Moderate* or *High* landslide hazard designation. The exception in this part of the Study Area is the suspected deep-seated bedrock slide on the open slope at the top right of each image, with lots of slope movement features and a *Severe* landslide hazard designation. Slope movement features that take place within gullies contribute to a *Severe* landslide hazard designation, shown dramatically here at Snowslide Creek.

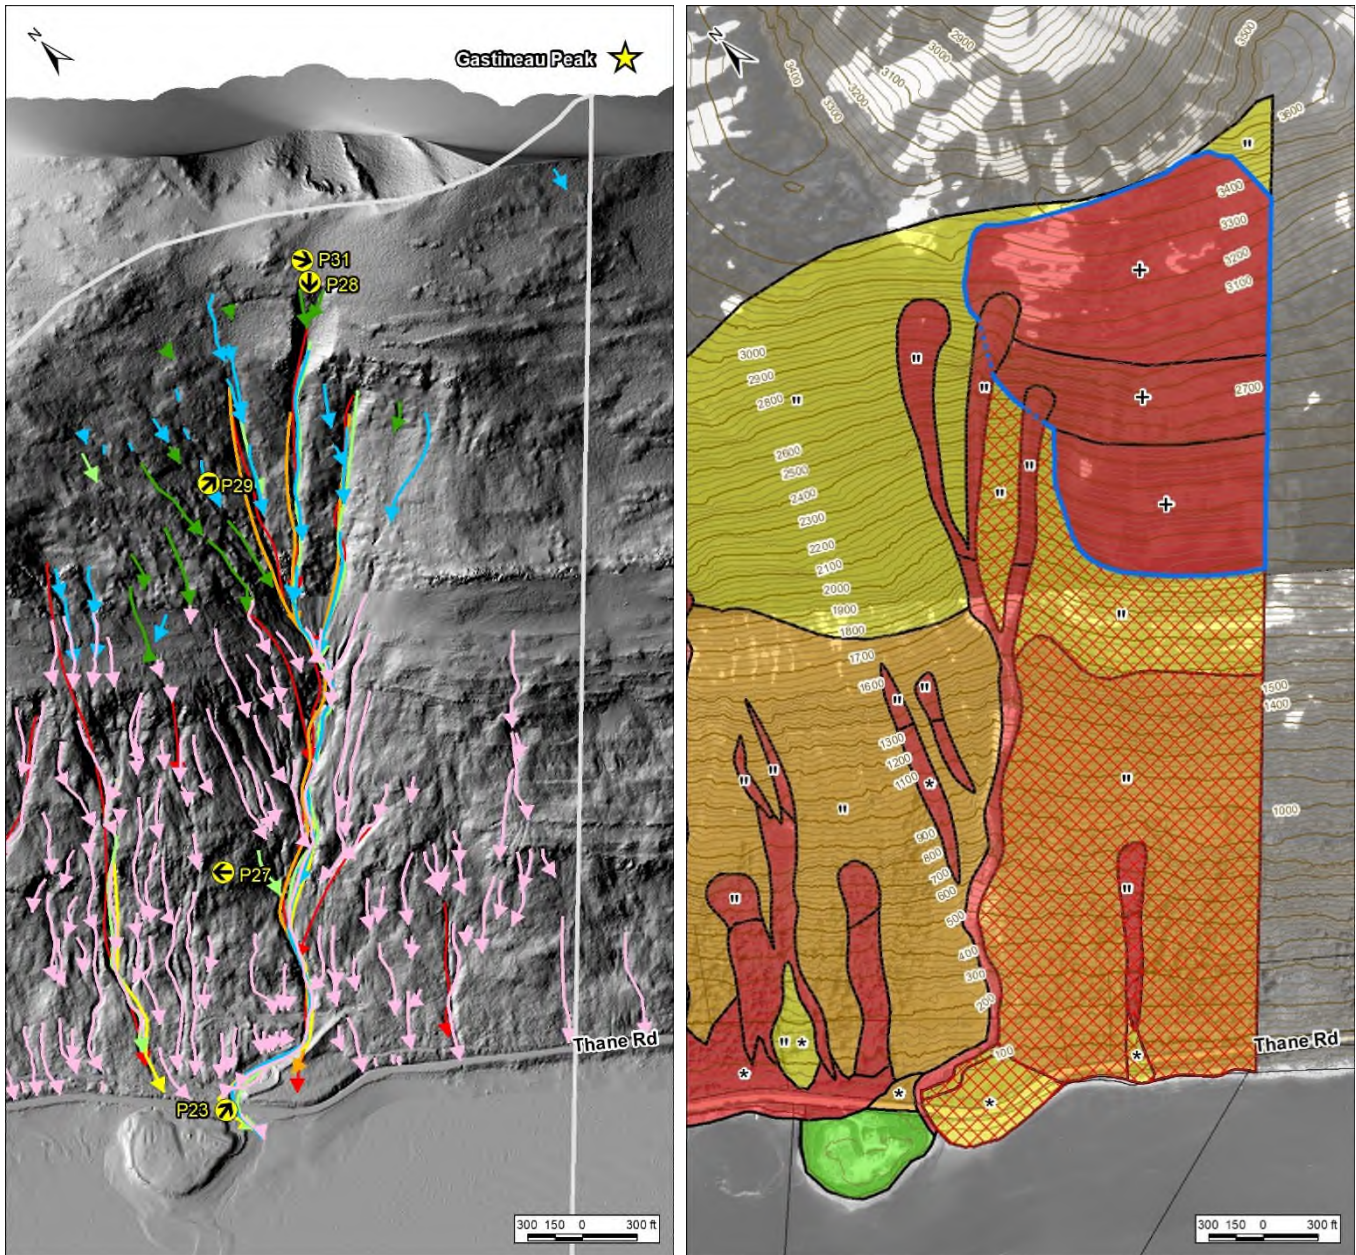
Figure 12: Excerpts from Figure 1.5c Gully Erosion Features (left) and Figures 1.6e and 1.6f Landslide Hazard Designation Mapping (right) at Snowslide Creek at the southeast end of the Study Area. In this comparison, the reason for the Severe landslide hazard designation at highly active gullies becomes clear. The more colours of arrows (representing different years of air photos in which erosion was observed), the more likely that a Severe rating is required. Note that minor gullies on otherwise open slopes do not elevate the rating for the open slopes, which are generally rated *High* for the lower slopes and *Moderate* for the upper slopes.
