(C3) RFP No. E22-101
Design and Construction Administration Services for the
Treadwell Arena Roof Replacement

Date: Aug 26, 2016
To: Steve Tada *Serving Alaska Since 1935*
CBJ Engineering
From: Dan Fabrello
RE: Treadwell Roof

TREADWELL ICE ARENA
LEAK REPAIRS DESIGN PH I
JUNEAU, ALASKA

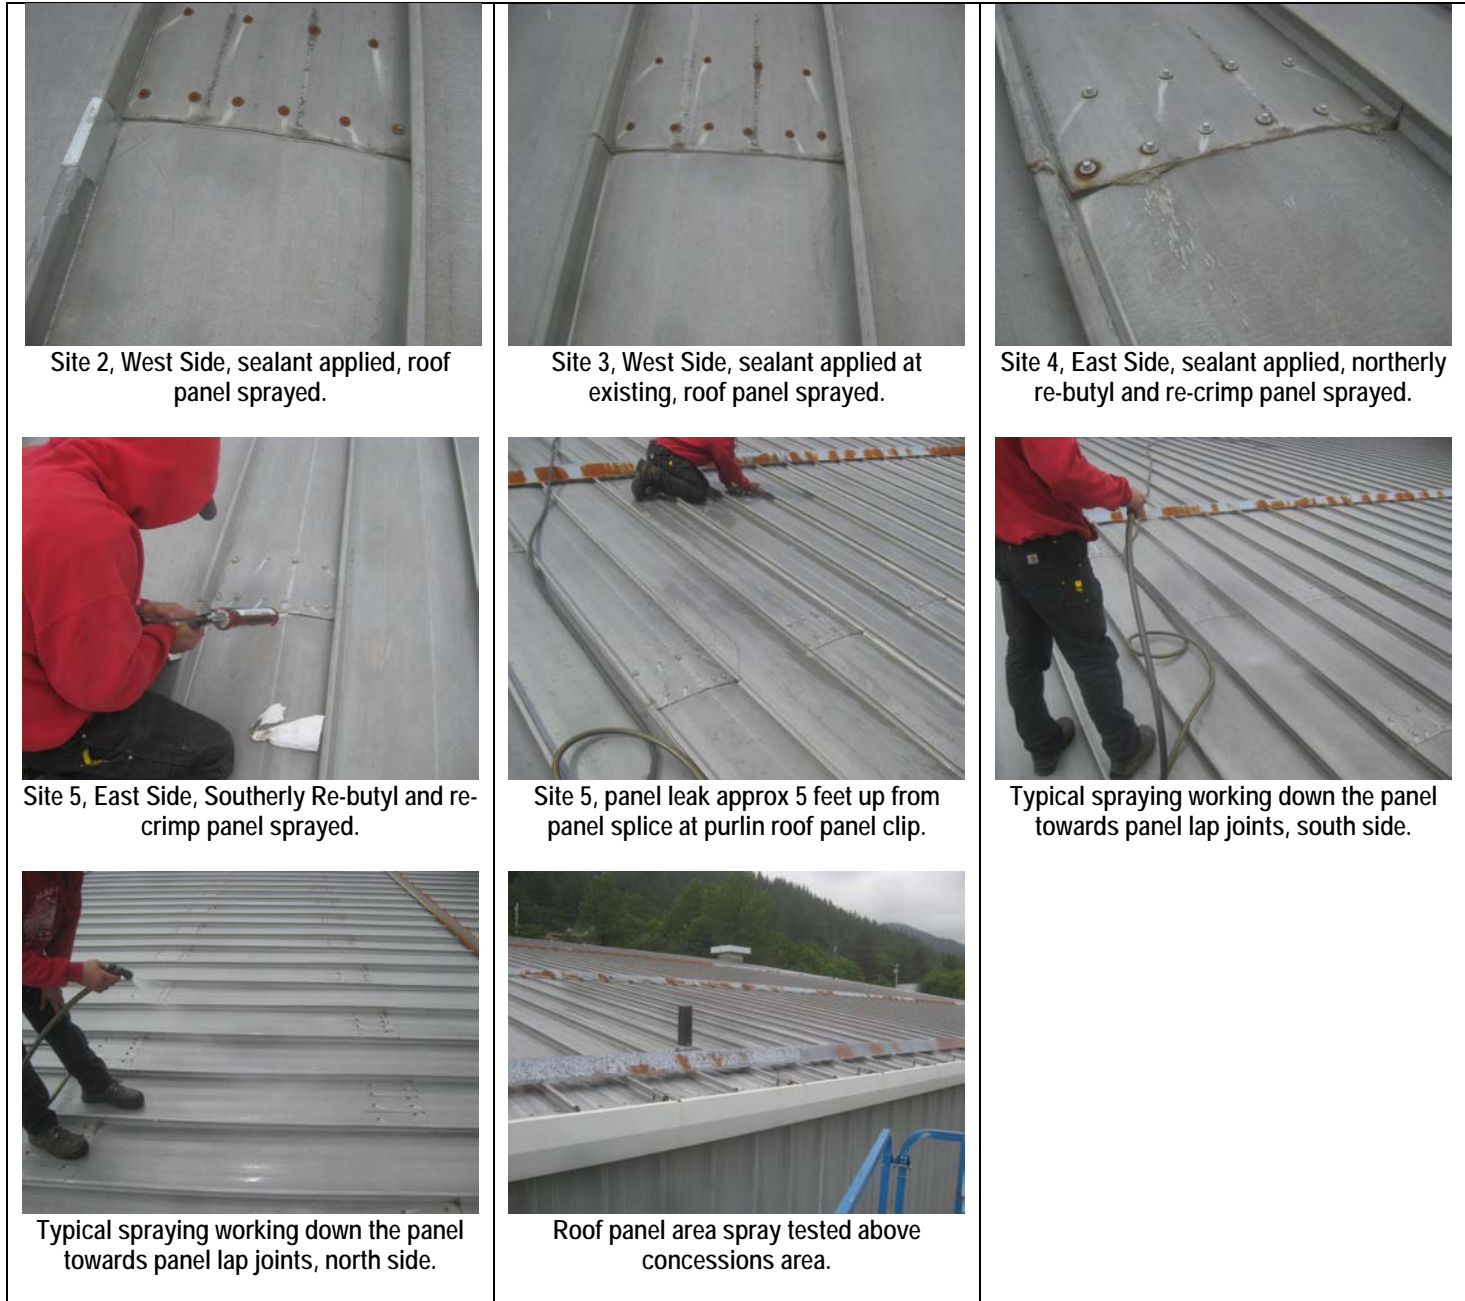
Images from Spray testing 7-6-16

- a. Roof panel lap fasteners:
No sign of water intrusion was detected.
 - b. Roof panel laps and seams (each side of vertical leg):
Water was detected on interior side of roof. Water intrusion did not appear to be from roof panel laps where sealant had been applied, (note these areas previously leaked when sprayed). The water intrusion detected appears to be coming from the panel ribs where the material laps and crimp onto each adjacent panel. Water intrusion appeared to be more prevalent at roof panel clip locations. The clips appear to be holding the panel crimp apart allowing water to enter the interior and travel down the underside of the panel rib.

- c. The roofing panel crimps down the length of the roof vary on their tightness of crimp. It appears there are other locations other than crimps at panel clip that may be allowing water to infiltrate during wind and rain events.

- i. Roof panel laps at rib seams are existing and of original construction at this location with no prior repair work performed. No sealant was applied to panel rib seams. Spay test water was directed down the roof panel as described in item Site 6 I. A & B.
 - a. Roof panel eave fasteners:
No sign of water intrusion was detected.
 - b. Roof panel seams (each side of vertical leg):
Water was detected on interior side of roof. Water intrusion appears to be from roof panel rib seam laps. The water intrusion detected appears to be coming from the panel ribs where the material laps and crimp onto each adjacent panel. Water intrusion appeared to be more prevalent at roof panel clips. The clips appear to be holding the panel crimp apart allowing water to enter the interior and travel down the underside of the panel rib.

Previous investigation has identified the leak points on the roof, but effective corrective procedures have not been identified. We recommend that procedures for sealing the leaking standing seam joints be field tested. Once an effective corrective procedure is determined the design team can effectively identify the work for contractors to bid on. The following are investigative steps recommended:

It is recommended that mockup flashing embedded in butyl be placed at the roof panel laps. Once the flashing is inserted a placement of a single component polycarbon/polycarbonate elastoplastic sealant injected into each of the roof panel lap seams is recommended. Hand tool the sealant at each roof panel lap. Hand crimp roofing panel ribs at mockup flashing 24" each side of inserted flashing. At roof panel clip locations, if possible, inject the polycarbon/polycarbonate elastoplastic sealant into and between the upper and lower roof panel sections at each roof panel clip. Sealant should extend 24" each side of roof panel clip. Hand crimp roofing panel ribs approx 24" above and 24" below each roof panel clip along the length of the roof panel rib. The scope of mockup work would be limited to areas described in attached documents. Areas should be observed and monitored regularly for signs of water infiltration during high wind and rain events. Once repairs that eliminate water infiltration are identified a scope of work would be developed for contractor bidding.

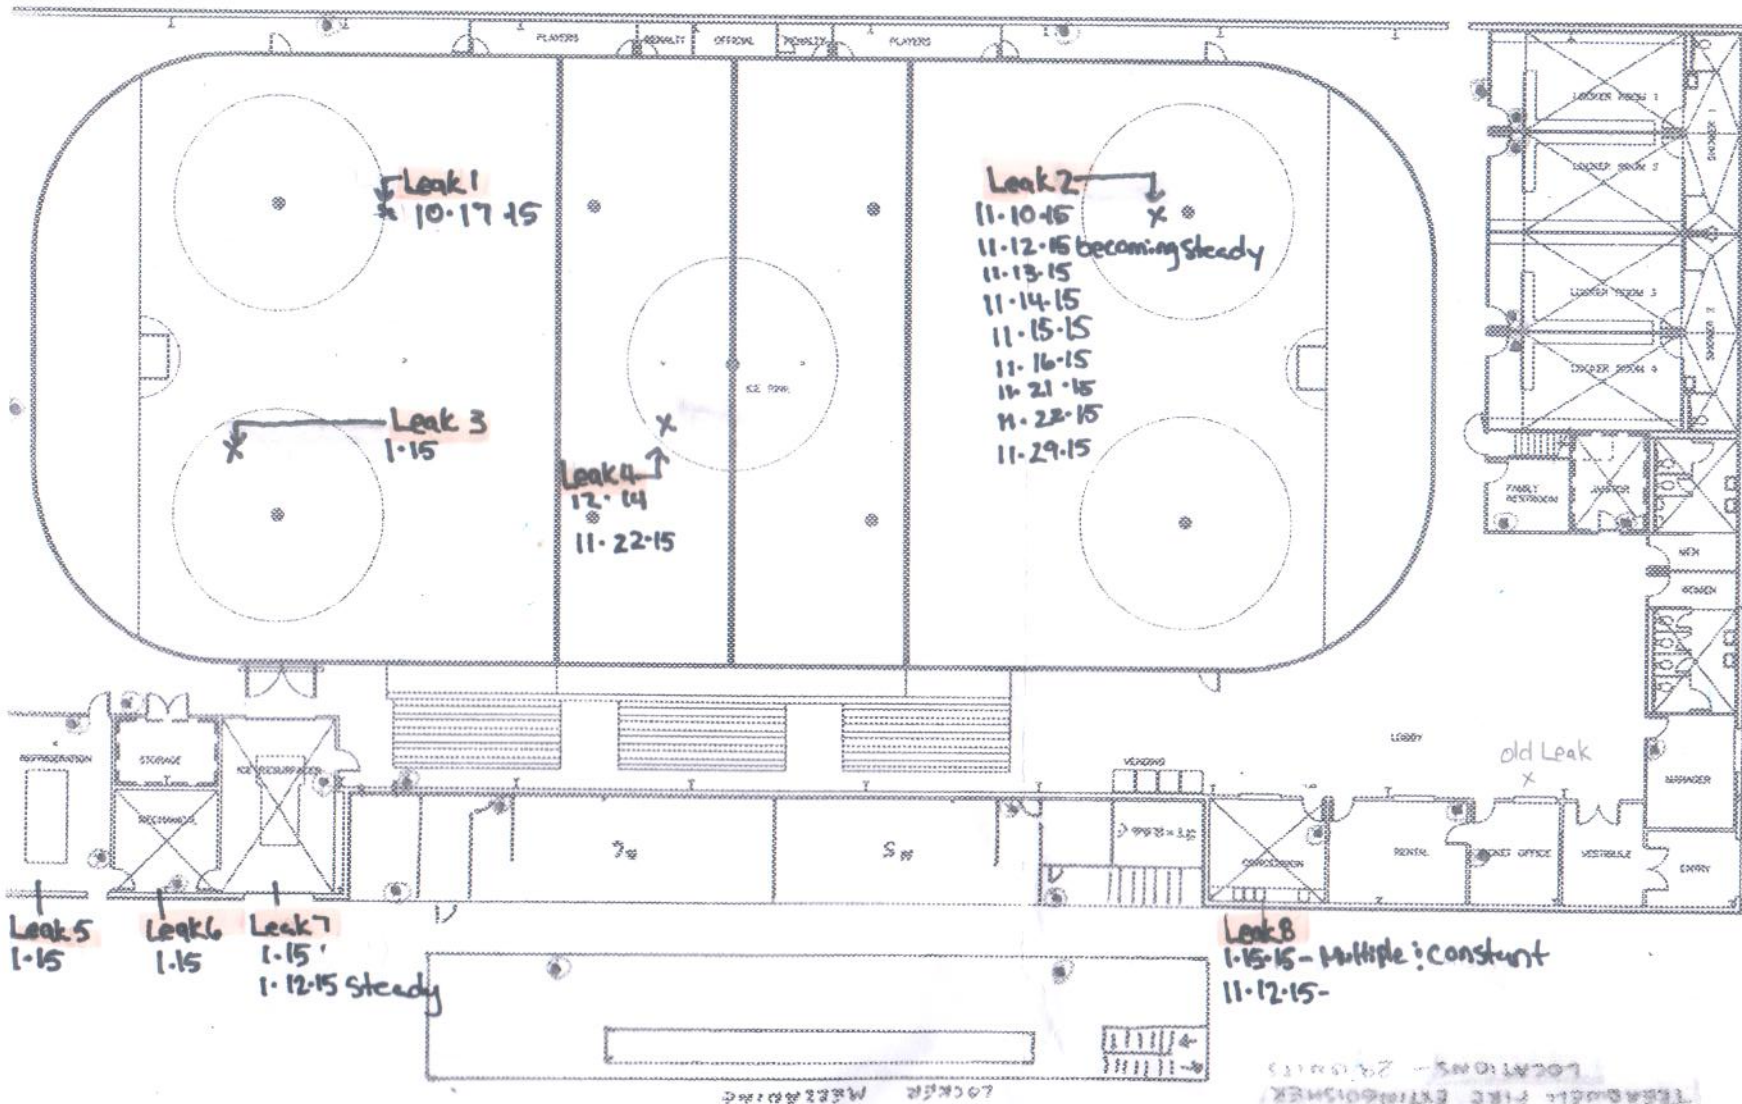
Leak 1
10-17-15

Leak 2
11-10-15
11-12-15 becoming steady
11-13-15
11-14-15
11-15-15
11-16-15
11-21-15
11-22-15
11-29-15

Leak 3
1-15

Leak 4
12-14
11-22-15

Leak 5
1-15

Leak 6
1-15

Leak 7
1-15
1-12-15 steady

Leak 8
1-15-15 - Multiple; constant
11-12-15-
