**BRH ADMIN BUILDING EXTERIOR EVELOPE REHAB  
Contract No. BE23-199**

**ADDENDUM NO.: ONE**

# Siding & Window Investigation

8/30/2022  
Jensen Yorba Wall, Inc.  
Dan Fabrello

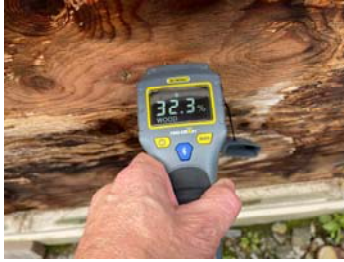
Water damaged plywood substrate with elevated moisture readings.

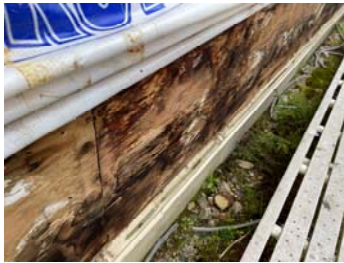
Plywood substrate behind weather barrier with decay and fungus present.

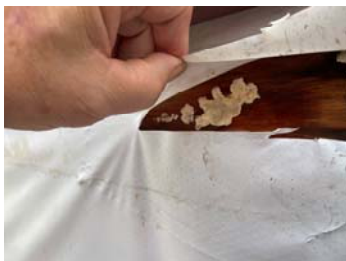
Fungus growth typical all levels of the wall.

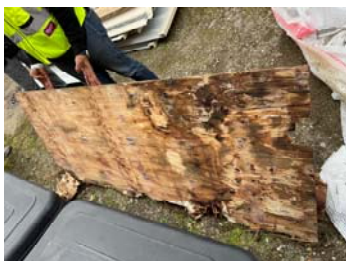
Backside of removed plywood substrate sheet from base of wall.

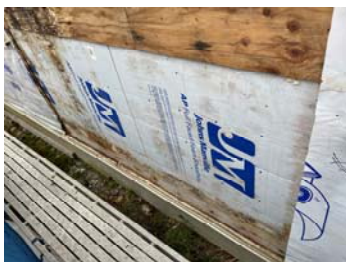
View of polyiso insulation behind plywood substrate at base of wall.

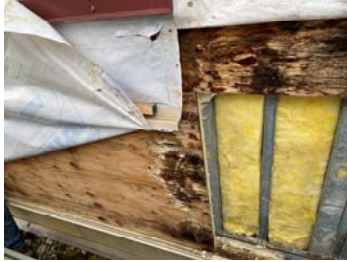
Metal studs and batt insulation beyond polyiso. Batt insulation and studs appeared in good shape.

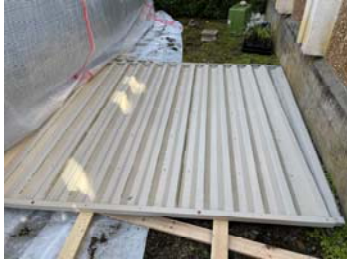
Typical siding panel. Siding panels were ganged together and installed in large sections with exposed fasteners through face and perimeter trim.
