DOWNTOWN LIBRARY SELECTIVE CLADDING REPLACEMENT Contract No. BE20-235

CBJ JPL Window Replacement Project

Field Observation Notes – Summary

Investigation of Failed Siding Panels

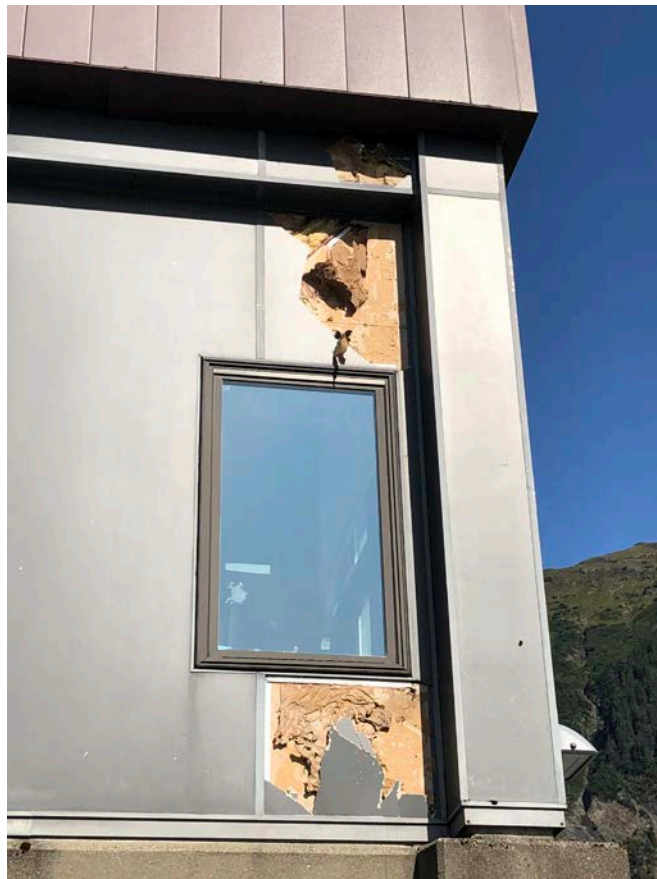
Figure 1:

Carver assisted in demoing one full height panel & one soffit panel on the South elevation. See **Figure 1** for full extent. The exterior panels are set in panel clips w/ sealant and glued to ½” gypsum sheathing without a weather barrier. See **ATTACHED** for As-Built Wall Section.

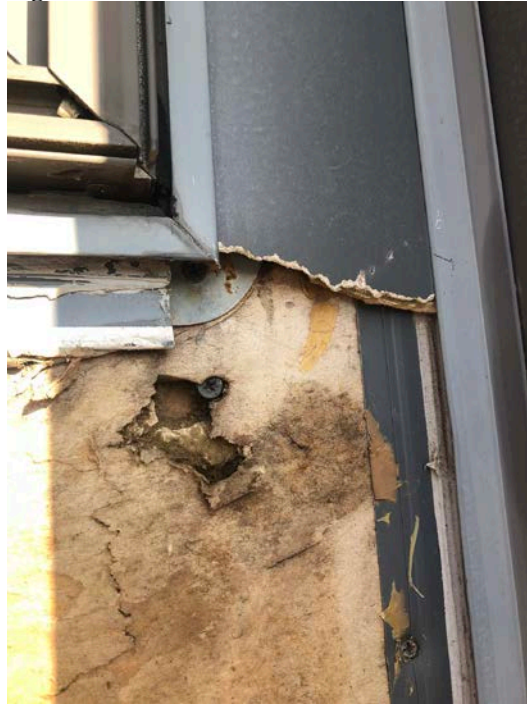
The gypsum sheathing showed evidence of water infiltration the full extent, with pockets of significant degradation around the window, see **Figures 2-8**.

Figure 2: Rot at Sill

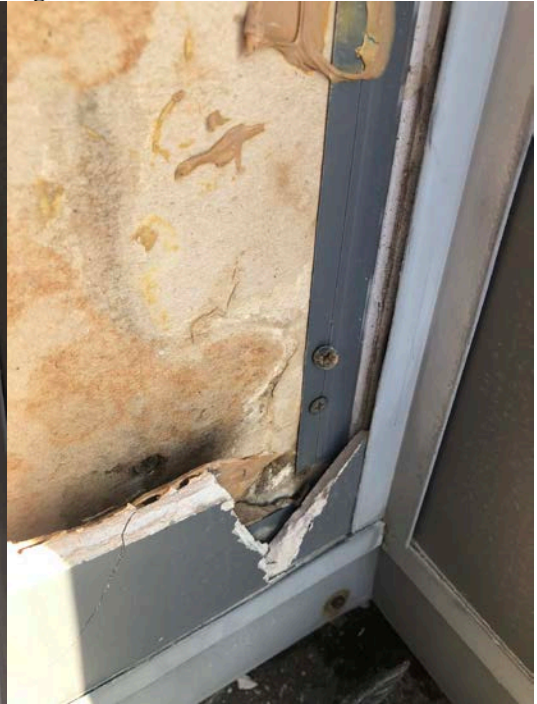
Figure 3: Rot at Bottom of Panel

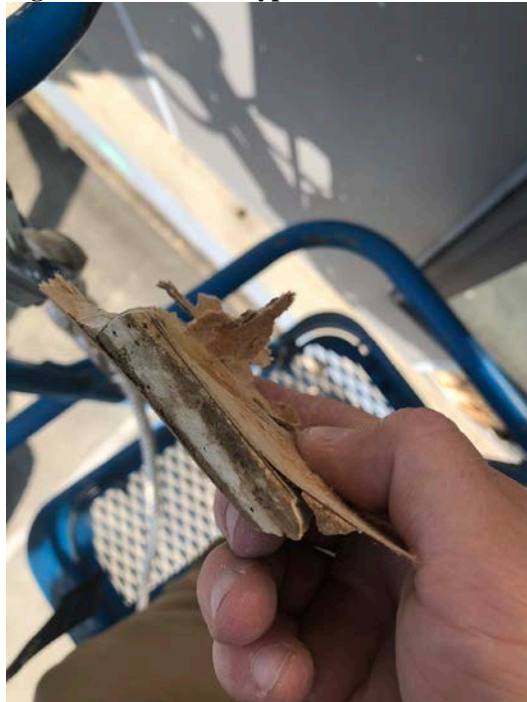
Water is infiltrating the entire wall system at the panel clips due to sealant degradation over time. Without a water repellent material behind the exterior panels to create a drainage plane – the water is collecting and saturating the gypsum sheathing. Through freeze/thaw the collected water is cracking the exterior panels. While the windows are probably (?) sealed to the gypsum, the lack of a barrier lap is allowing water into the interior cavity.

Figure 4: Saturated Gypsum

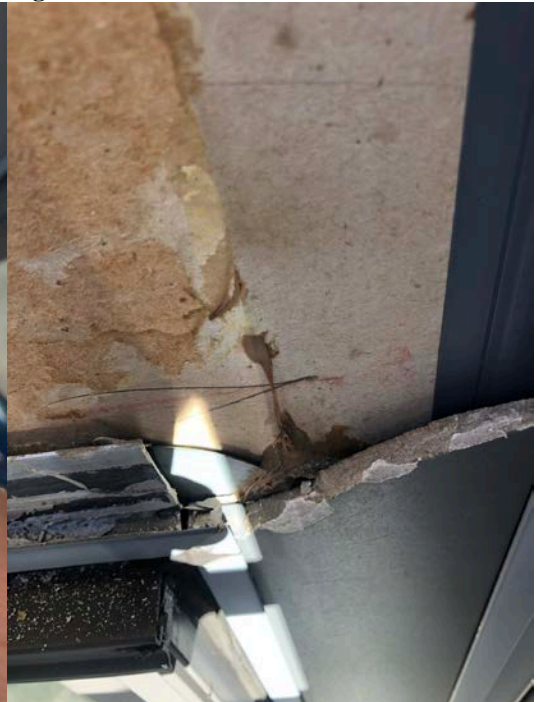
Figure 5: Rot at Window Jamb

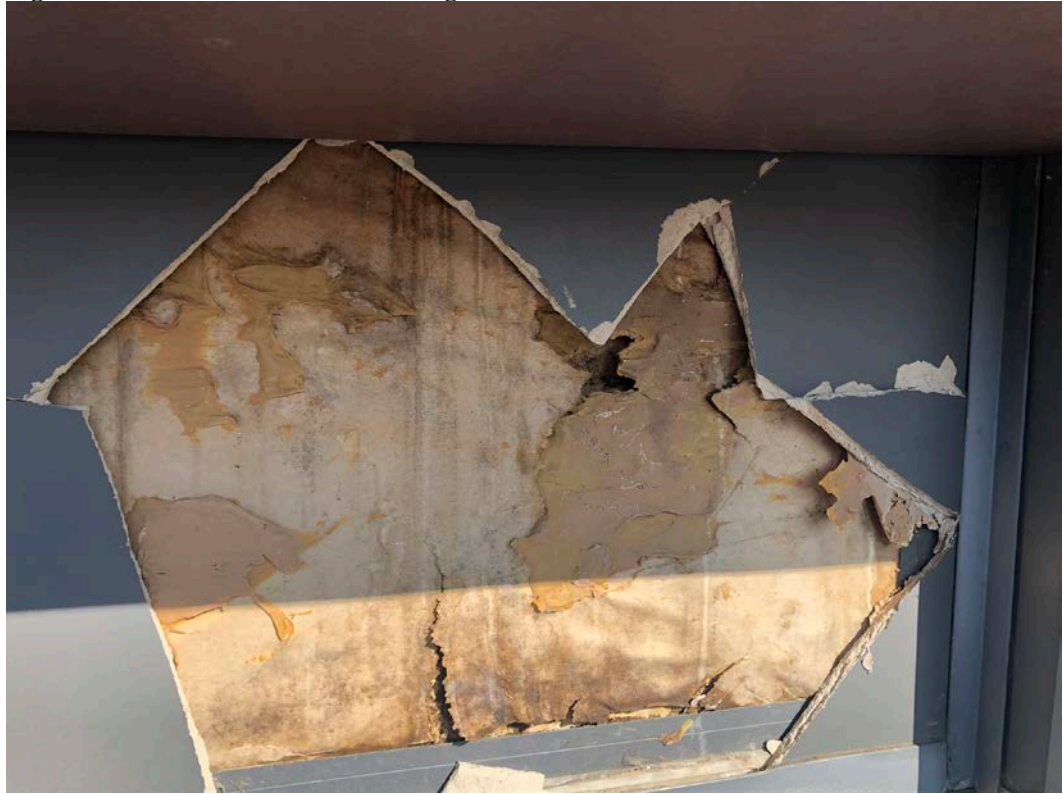
Figure 6: Water Infiltration and damage at Soffit Panel

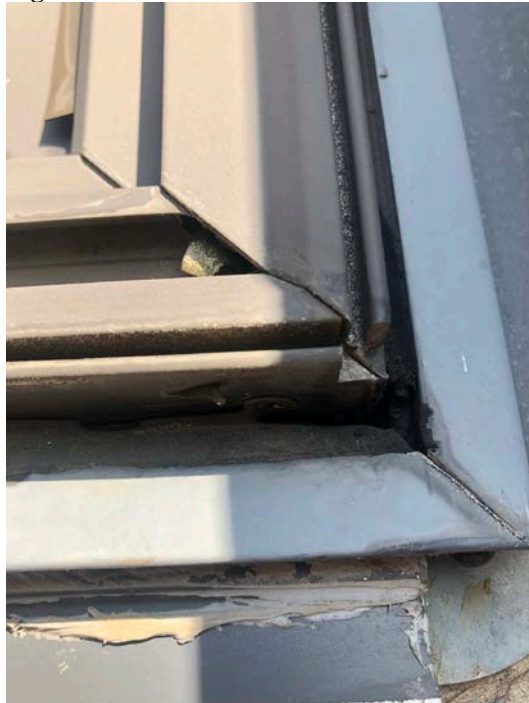
Figure 7: Sealant failure at window

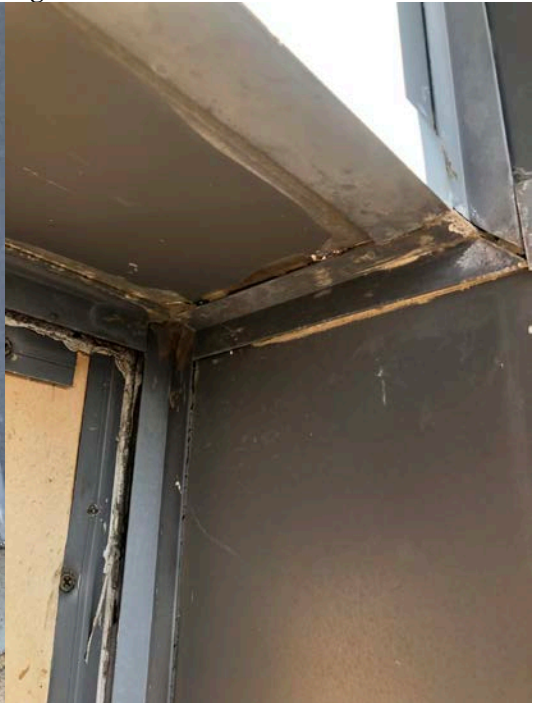
Figure 8: Sealant at Soffit
