**INFORMATION TO BIDDERS**  
for

**Contract No. BE21-030**  
**Augustus Brown Pool**  
**Upper Roof Replacement**

Brent Fischer  
Parks & Recreation Department  
City and Borough of Juneau  
155 S. Seward St.  
Juneau, Alaska 99801Re: Augustus Brown Swimming Pool  
Partial Roof Inspection  
R&M Project No. 971496

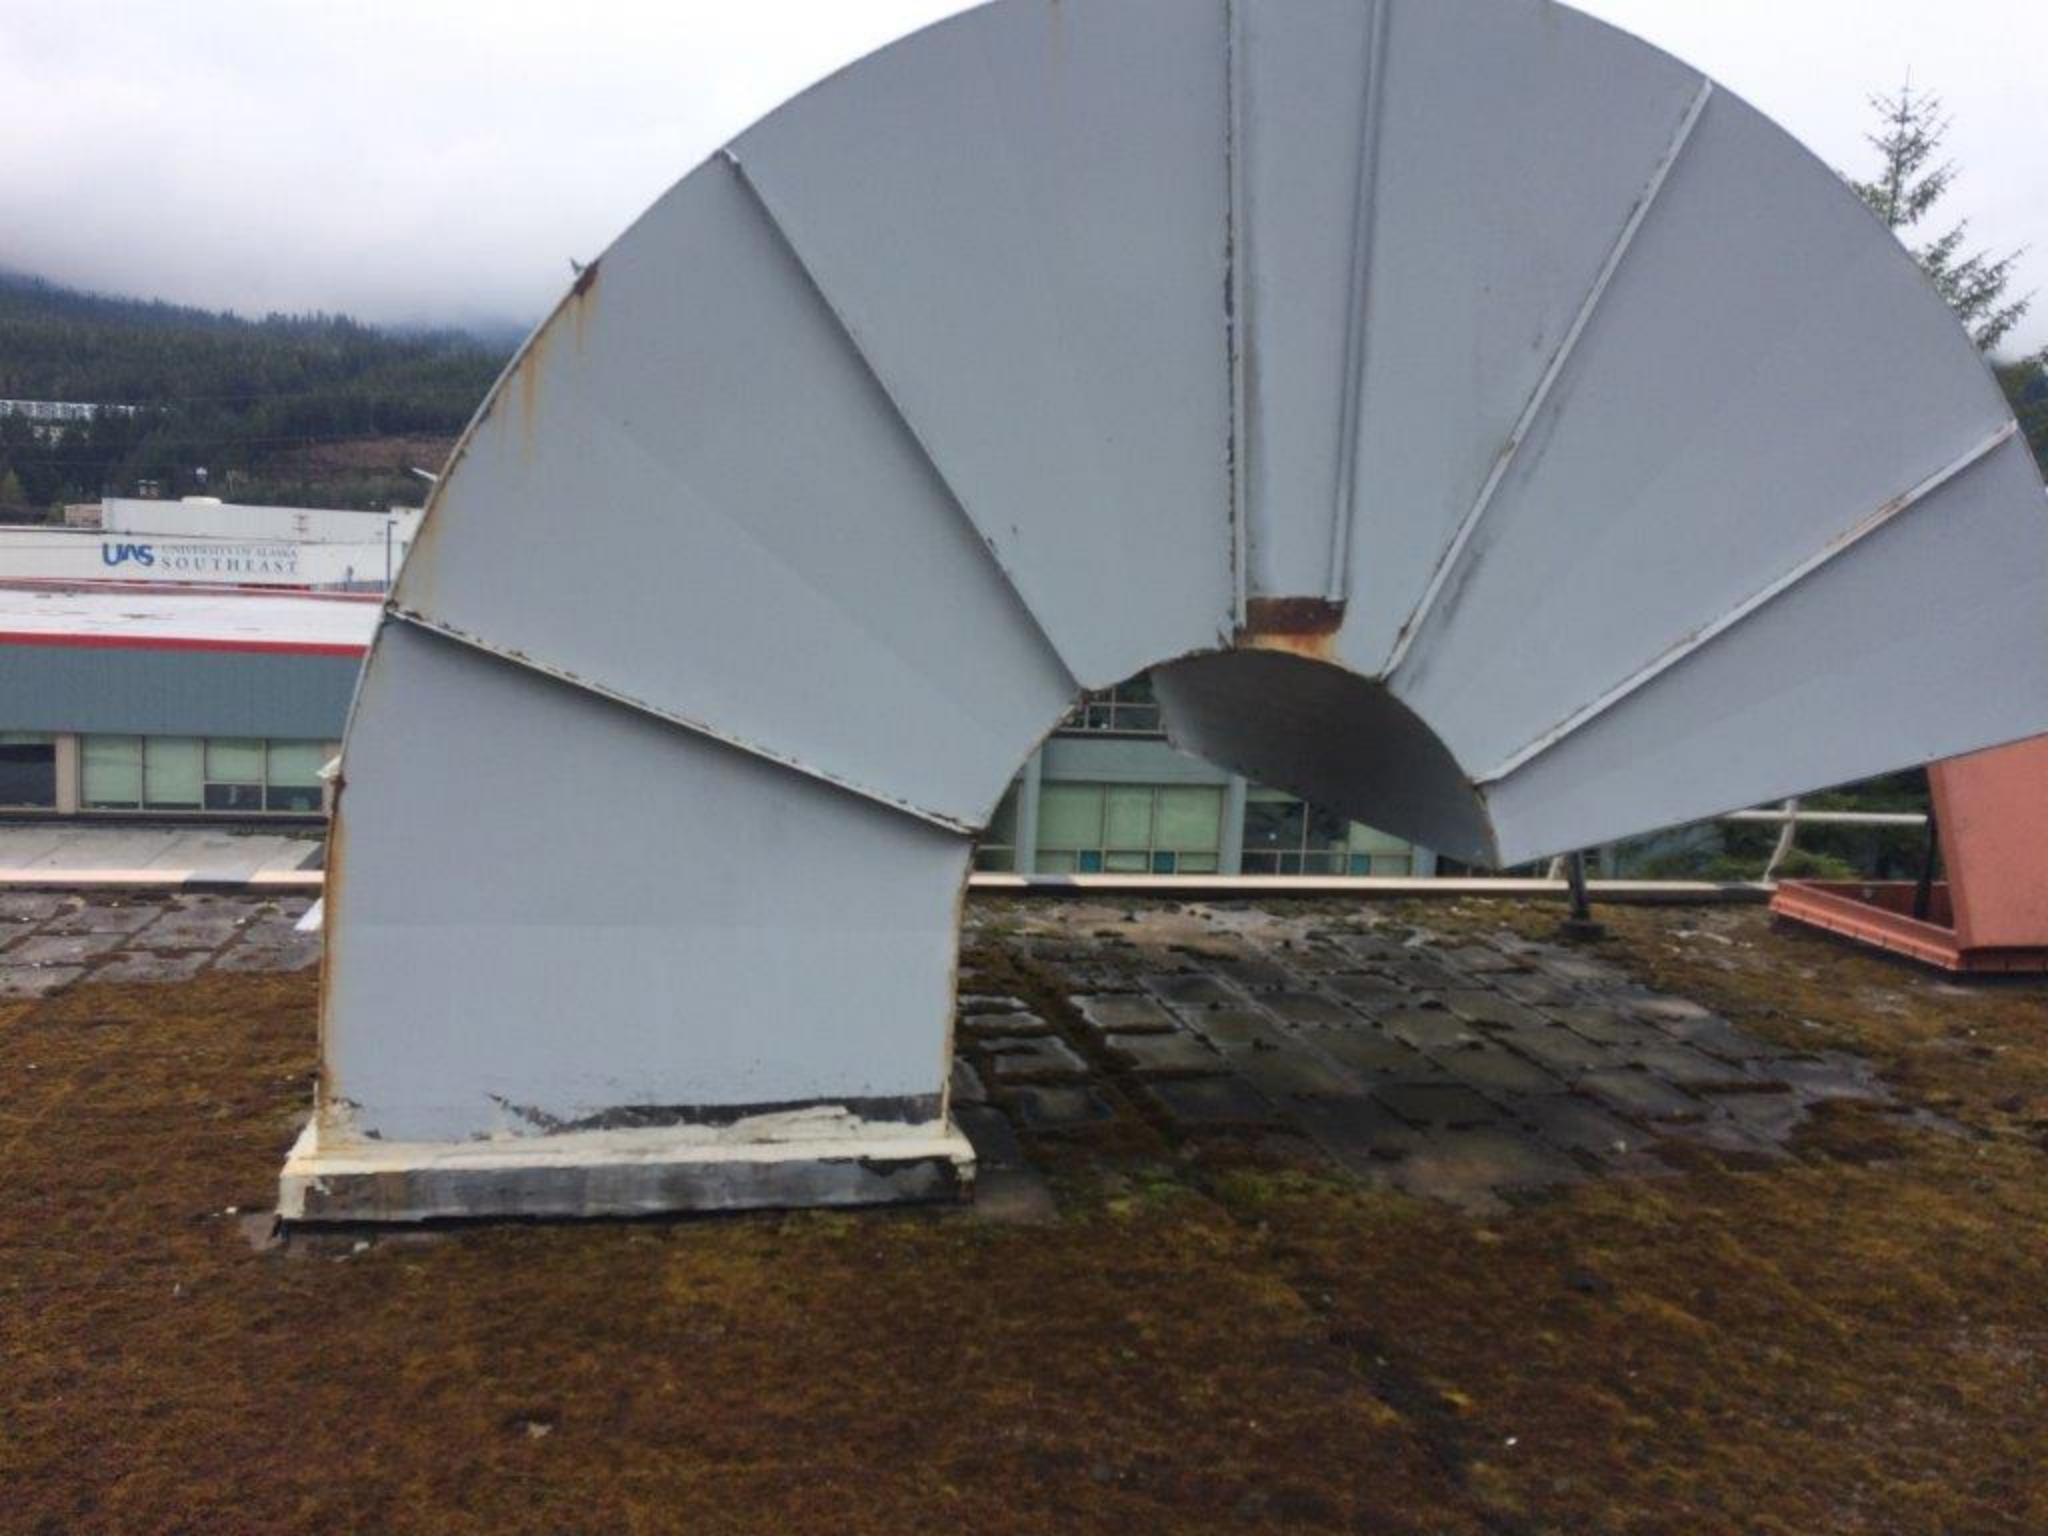
- Item 1: Image 1: AB Pool Intake Snorkel to be removed
- Item 2: Image 2: AB Pool Flat Roof Ponding – View to N.E.
- Item 3: Image 3: AB Pool Flat Roof Ponding – View to North
- Item 4: Image 4: AB Pool Flat Roof Interior Staining
- Item 5: Image 5: AB Pool Flat Roof – View to South
- Item 6: R&M Memo

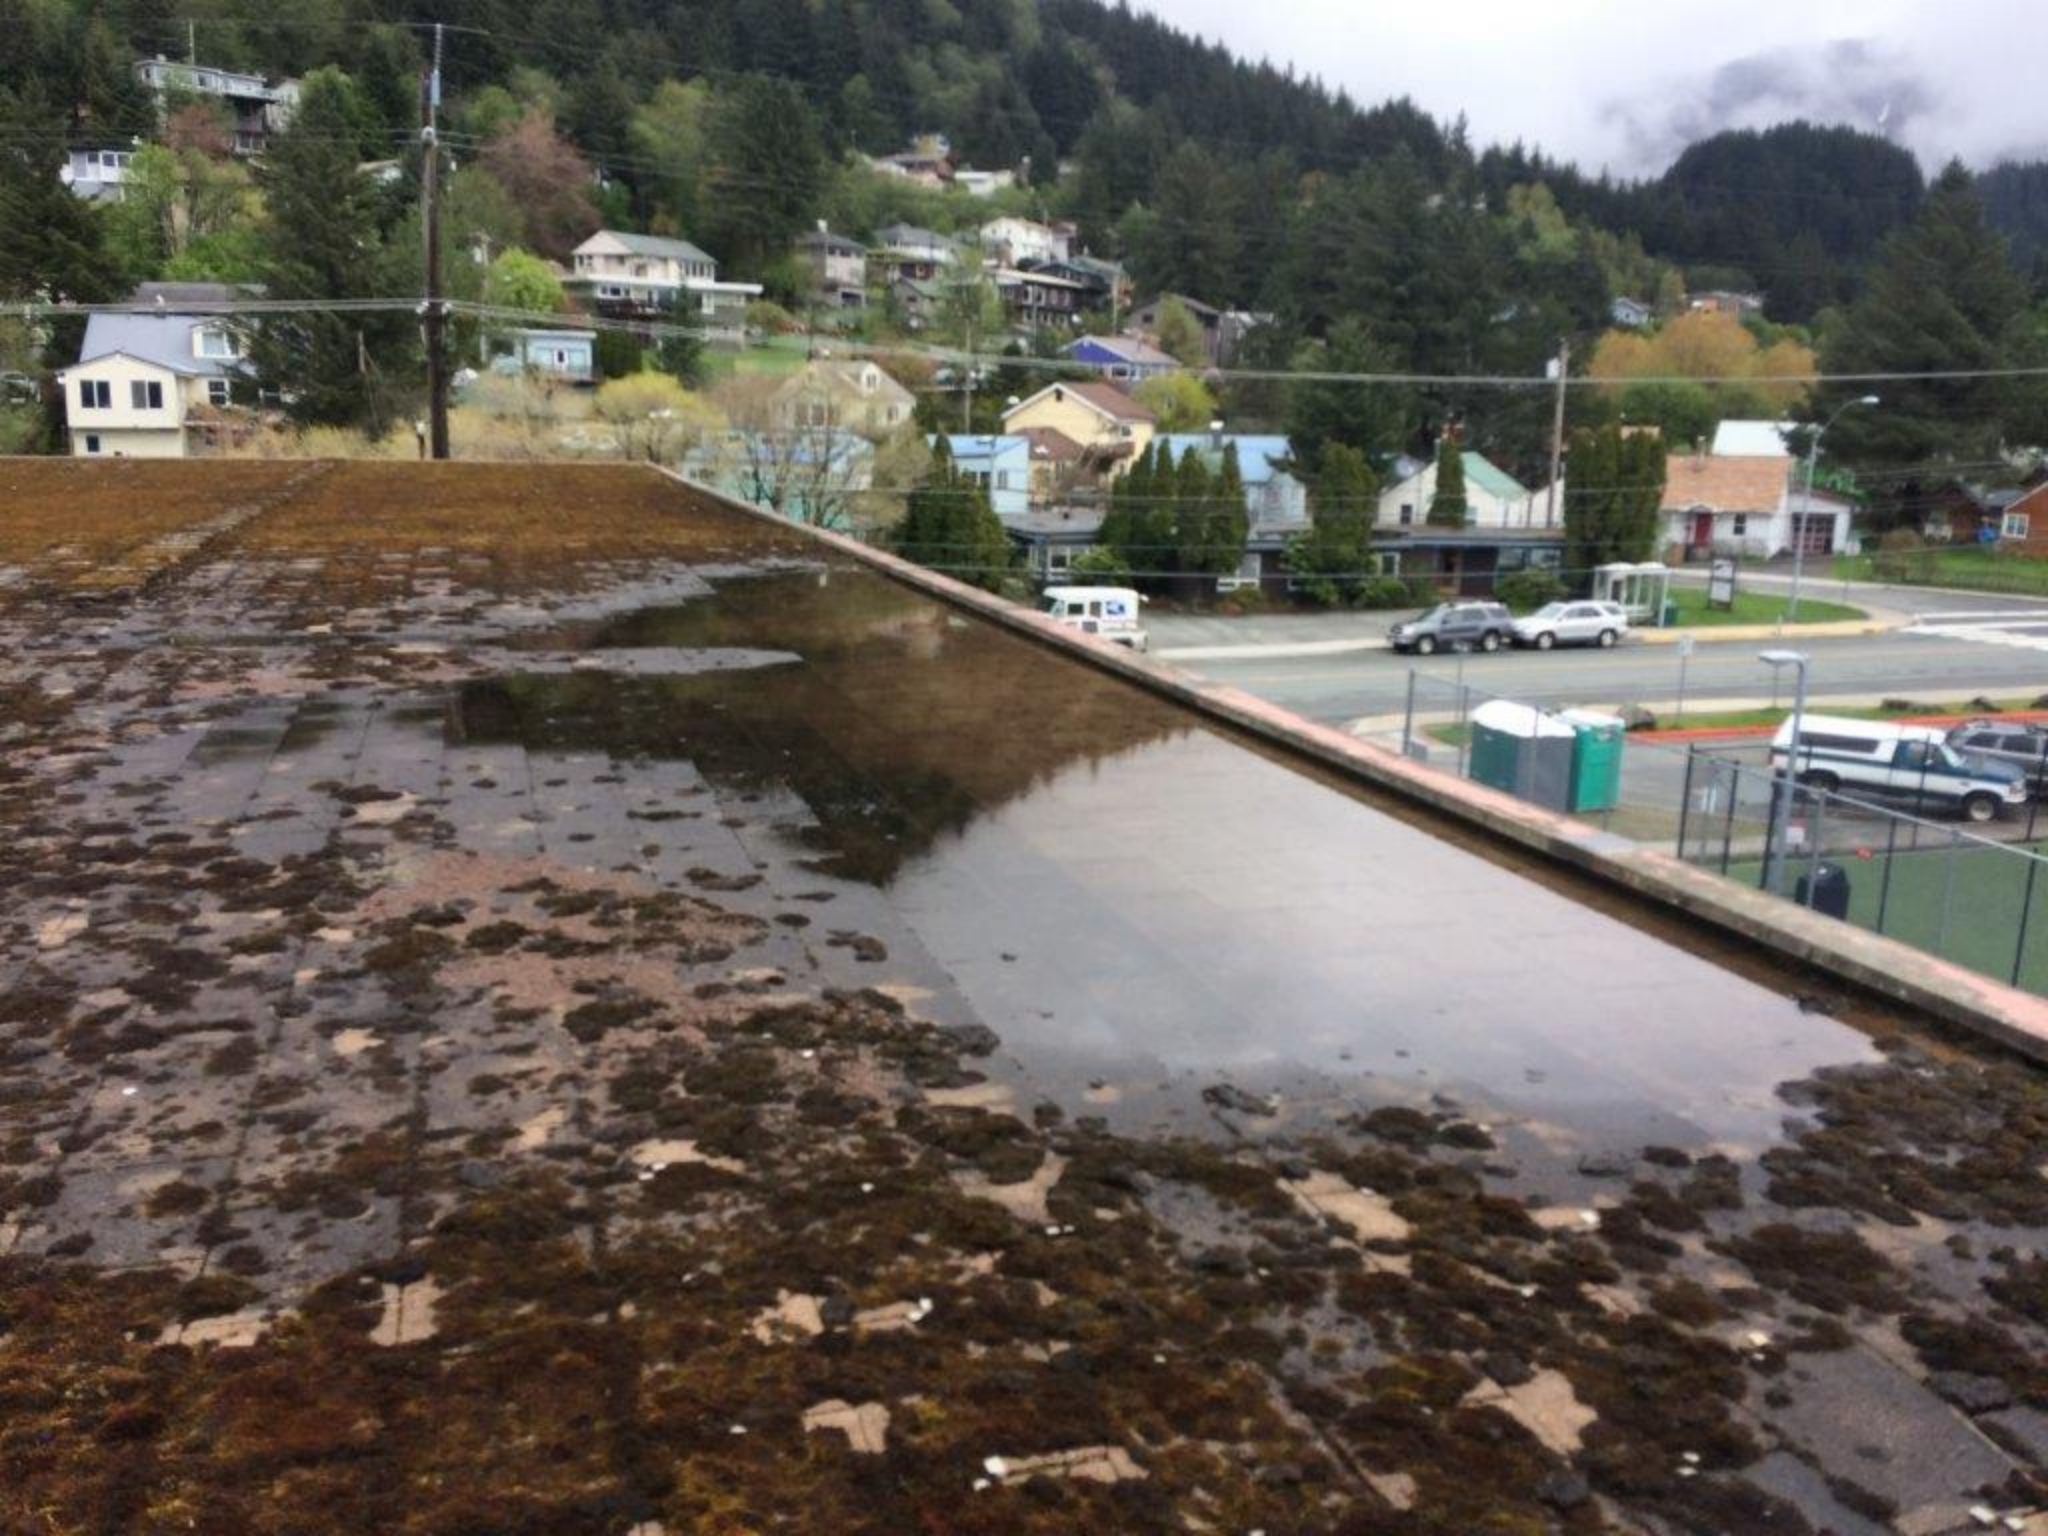
1. Roof leaks, in the past, had resulted in ponding of water above the vapor barrier resulting in saturated insulation material adjacent to the roof drain.
