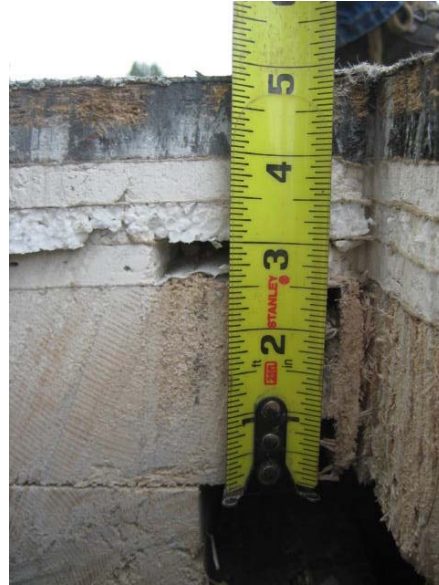
7. Holes cut allowed visual inspection of the original and addition roof construction and we were all shocked to find the following roof assembly at addition: 3x wood deck, 1/2" gypsum board, 1/2" polystyrene insulation, 1/2" gypsum board, 1/2" built-up roof, 1/2" OSB, and then new roof membrane. Dave estimated that roof assembly has an R-value of ~6 and we noted that no new insulation was installed during reroof that occurred in mid 90s. For comparison purposes new roof areas have an R-value of ~36.

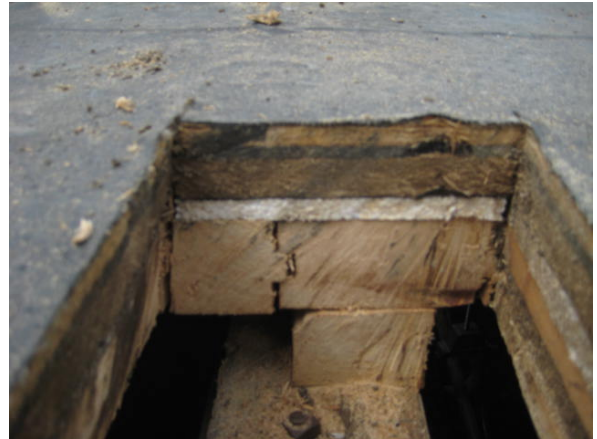
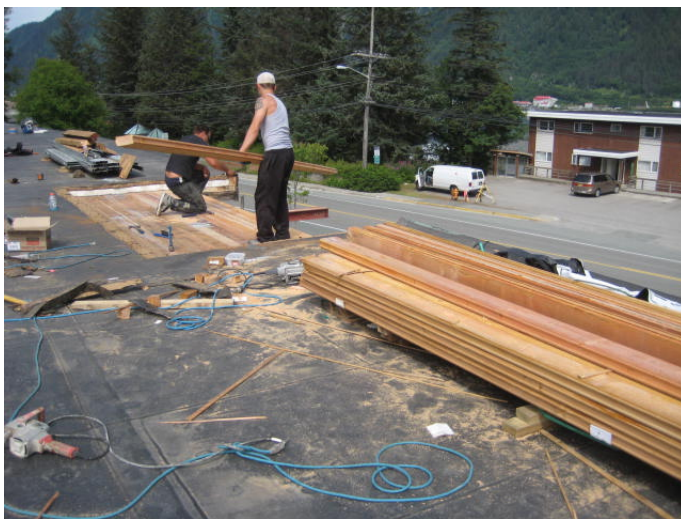
8. The original roof assembly was no better than that addition with the following composition: 3x wood deck, 1/2" polystyrene insulation, 1" fiberboard, 1/2" built-up roof, 1/2" OSB, and then new roof membrane. Unfortunately, the roof appears to be in decent shape despite debris and ponding noted in earlier report and probably has 5-10 years of useful life before replacement should be contemplated. However, this time frame may be shortened if energy prices continue to climb.
