Gastineau Elementary

Douglas, Alaska

Facility Condition Survey Report Prepared June 2005

By NorthWind Architects, LLC, PN&D Inc., Haight & Associates,
Murray & Associates, and City & Borough of Juneau Engineering
Department

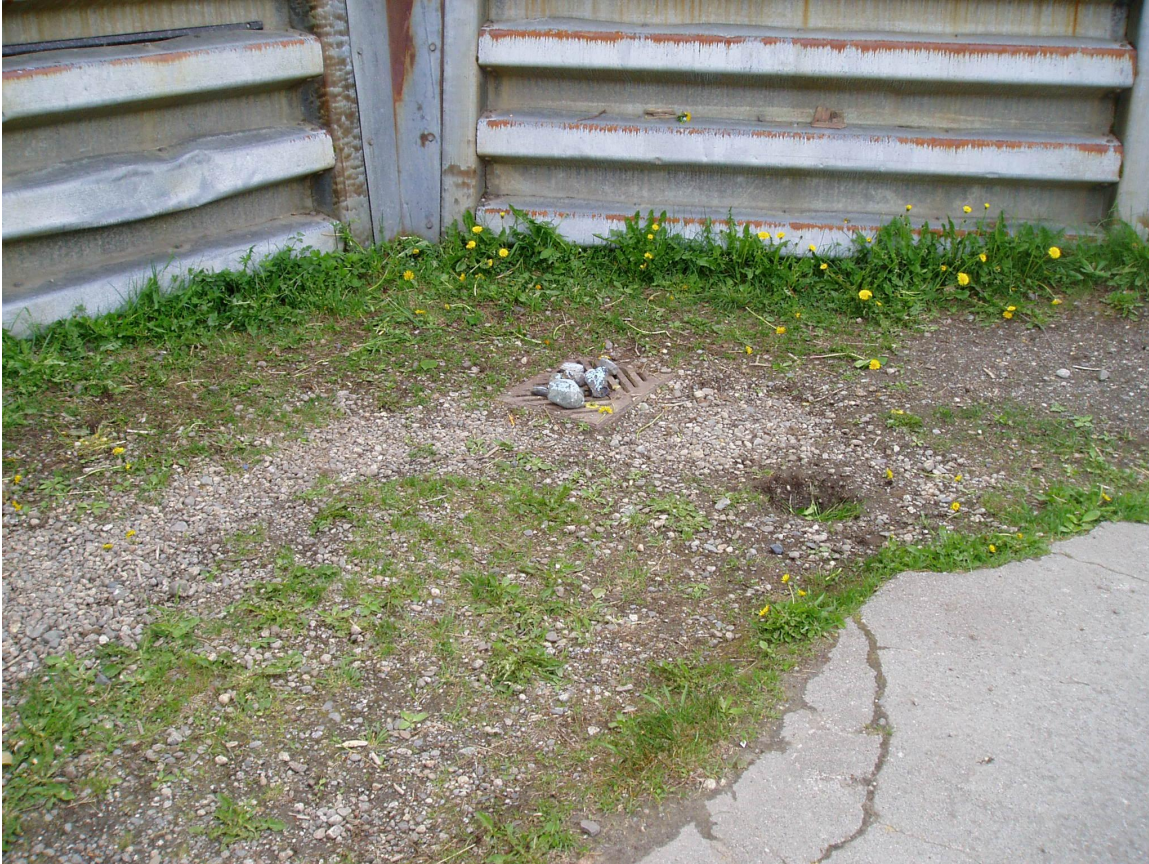
0153-1 Catch Basin Aprons

Catch basins at yard drains should have concrete aprons around to prevent gravel and other small debris from collecting in the catch basin. Concrete aprons will reduce cleaning maintenance and will improve the function of the drains.

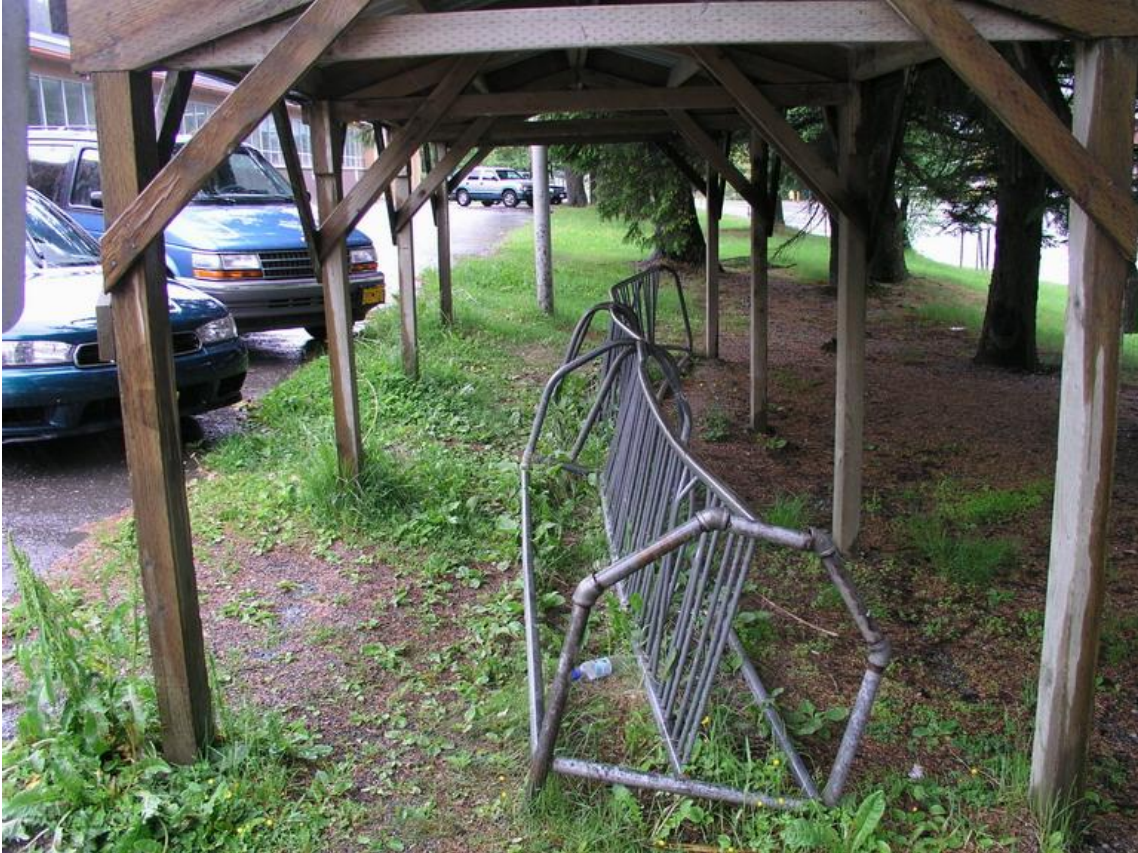
0141-2 Bike Racks

Existing bike racks are in poor condition; bolted assemblies are loose and may pinch fingers, bike locking bars are bent and starting to rust, and bike racks are not anchored to grade.

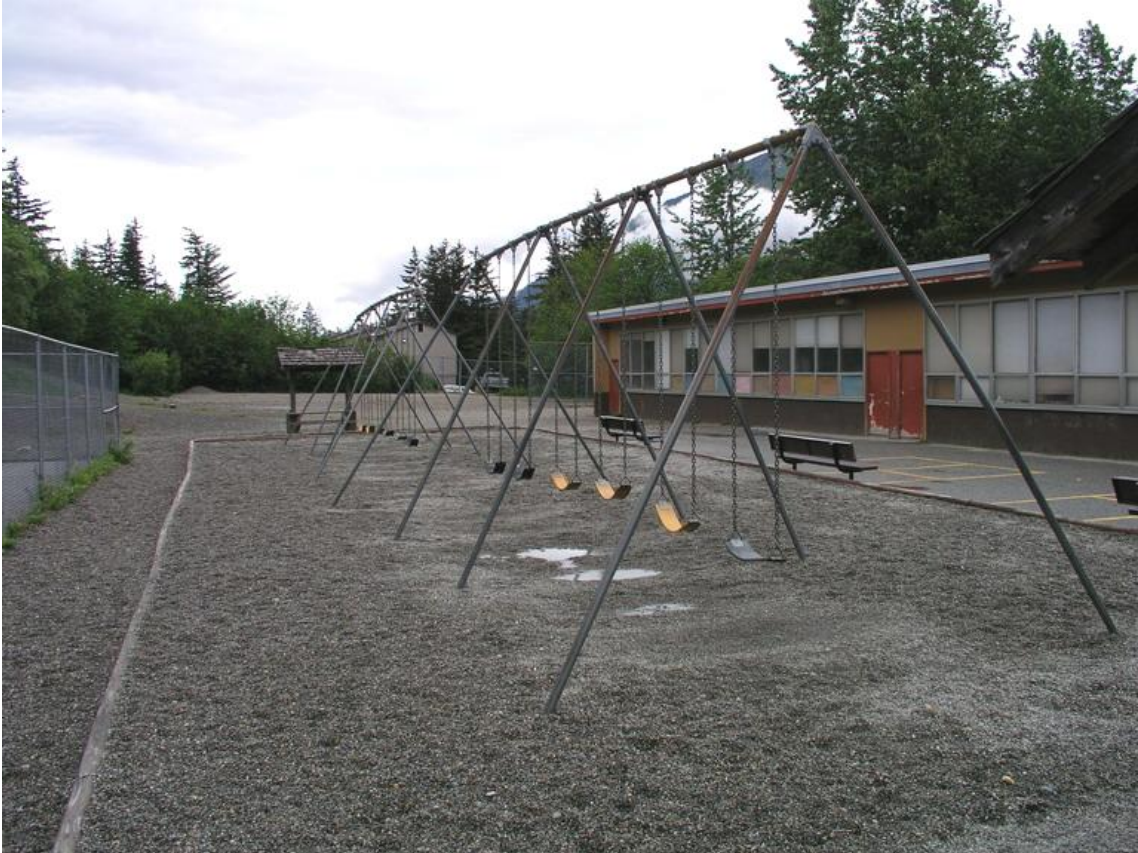
0141-3 Pea-gravel surrounding swing-sets

At areas immediately below swings the pea-gravel is scraped away and /or compacted.

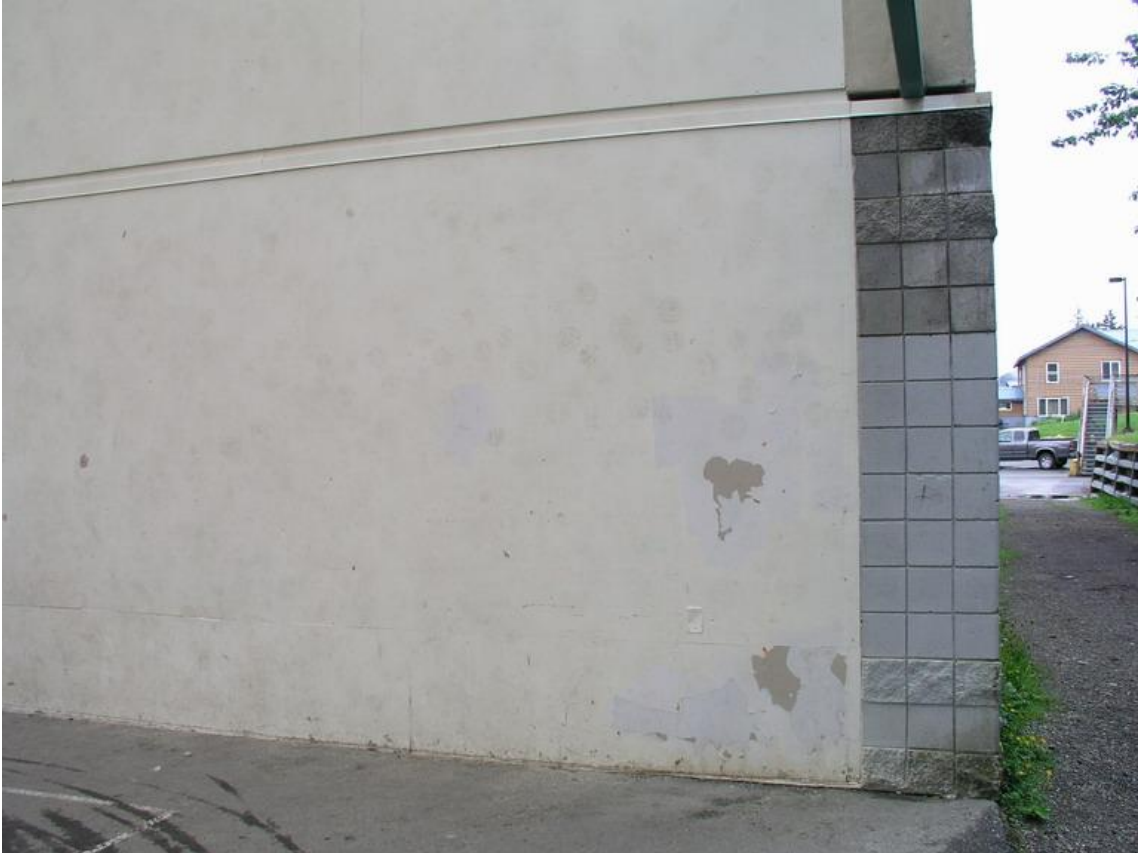
0142-1 Deteriorating painted wall surfaces inside covered court area

Painted surfaces below elevation 10'0" above finished court surface are subject to physical abuse due to both vandalism and regular permissible court use.

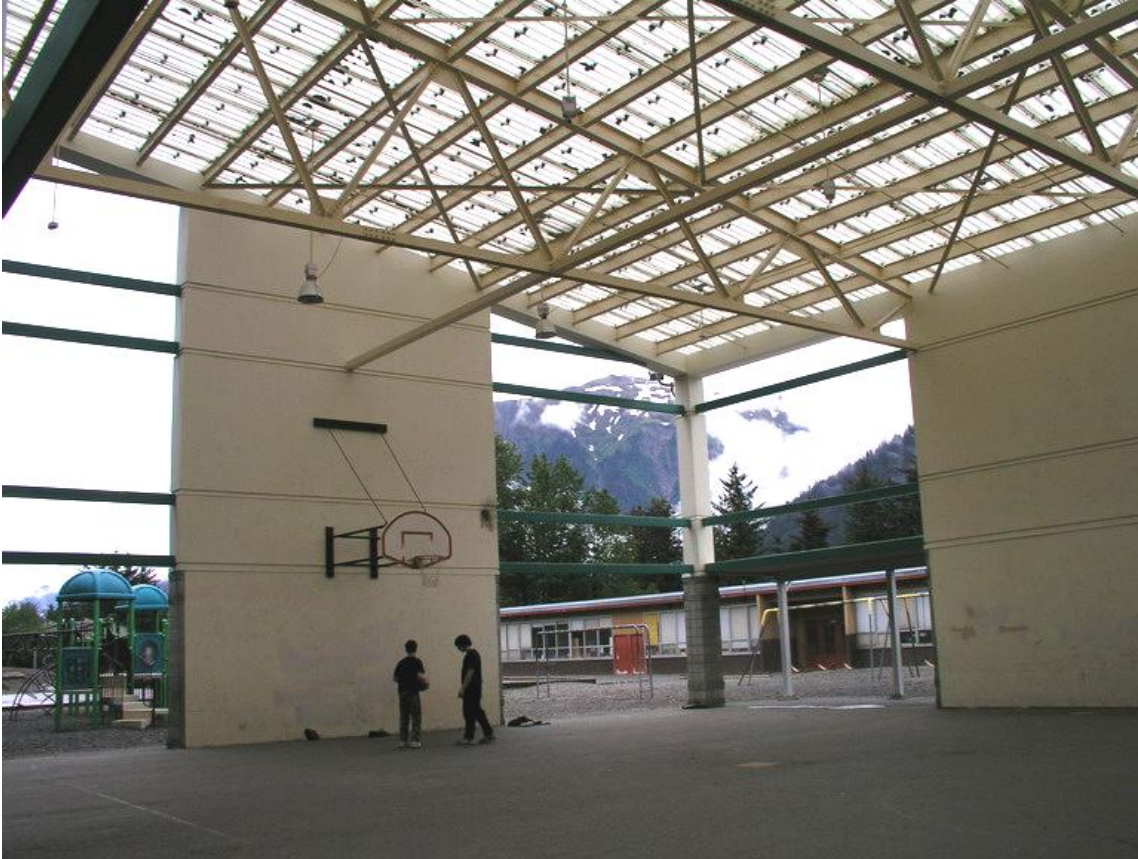
0142-2 Deteriorating painted court markings inside covered court area

Painted court markings are wearing off and are becoming difficult to read due to and regular permissible court use.

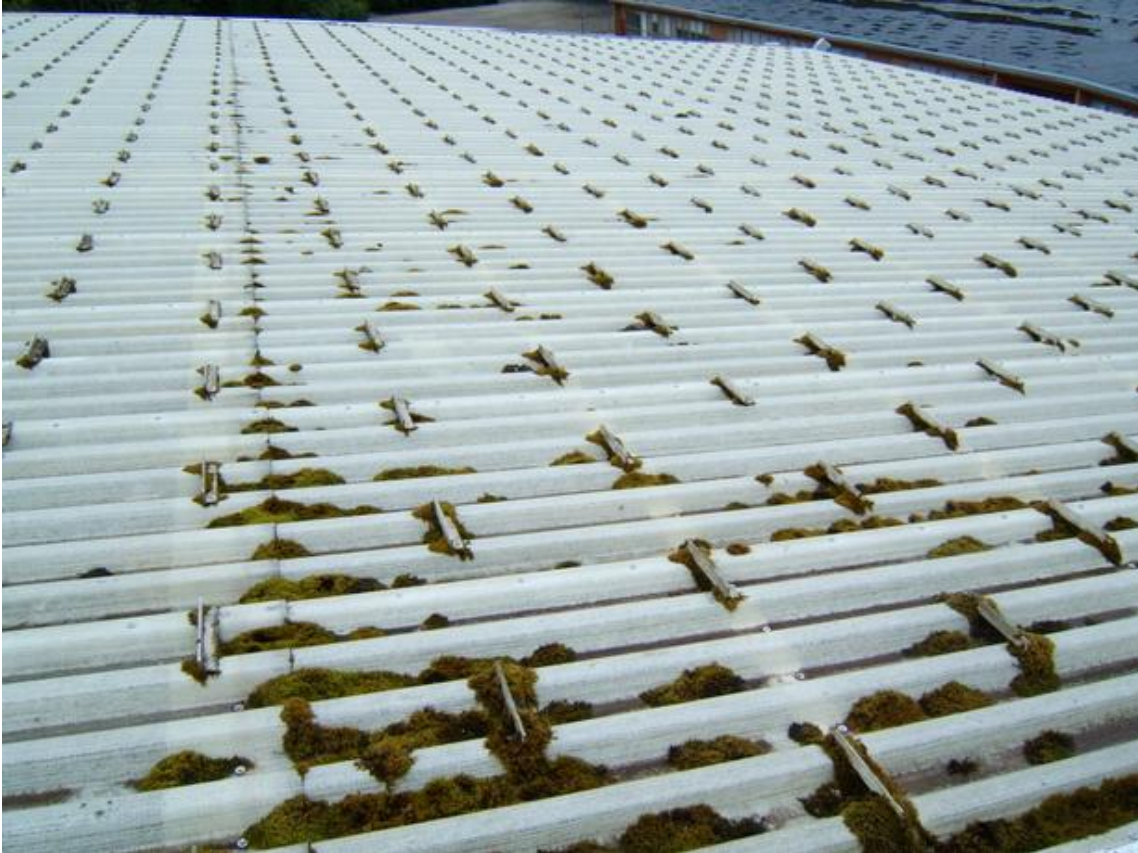
0142-3 Moss and debris accumulation on court roof assembly

Snow stops on corrugated fiberglass panel court covering have caused the accumulation of debris and promoted heavy moss growth. This reduces the amount of light transmitted to the space below, adds a permanent dead load to the roof structure as water is retained in the organics on the roof surface, and will eventually result in premature deterioration of the fiberglass panels.

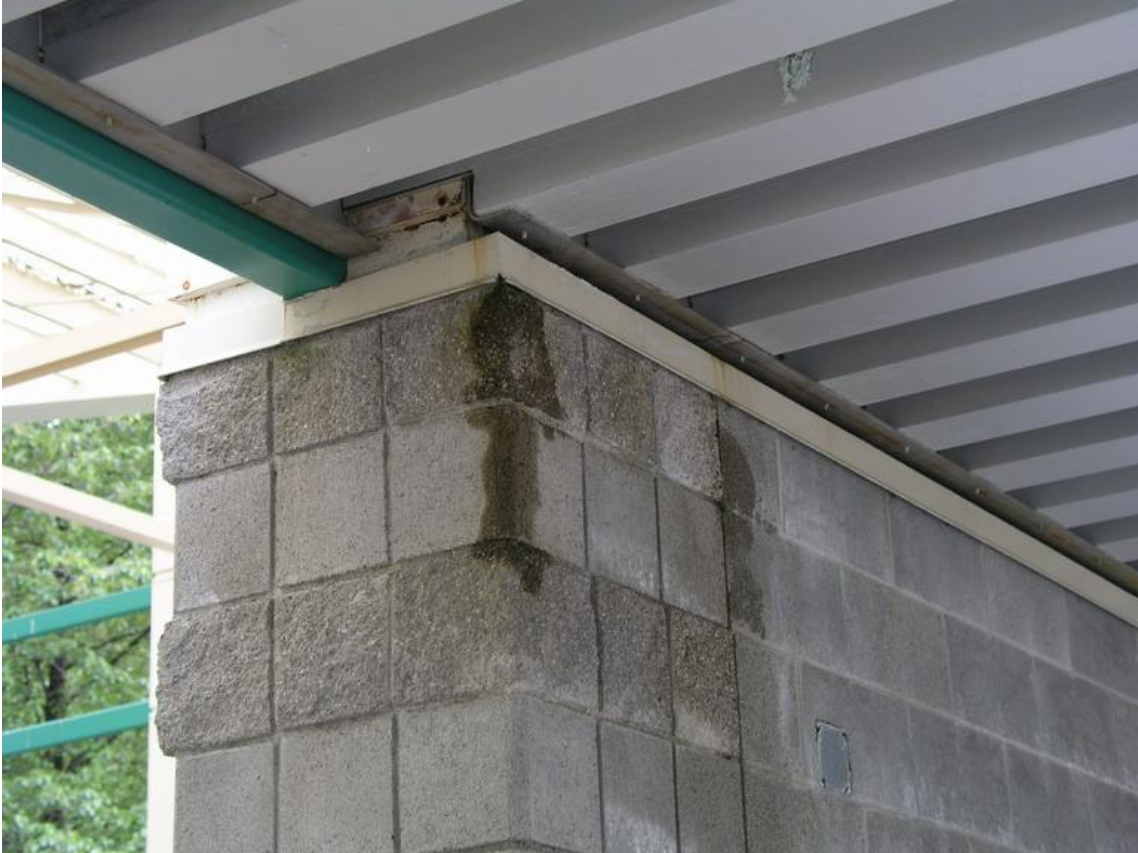
0142-4 Dirt and debris accumulation on aluminum canopy assembly

Flat roof is accumulating dirt which is plugging drainage channels and overflowing roofing assembly. While the canopy is unharmed, the adjacent wall areas are being damaged by this flooding.

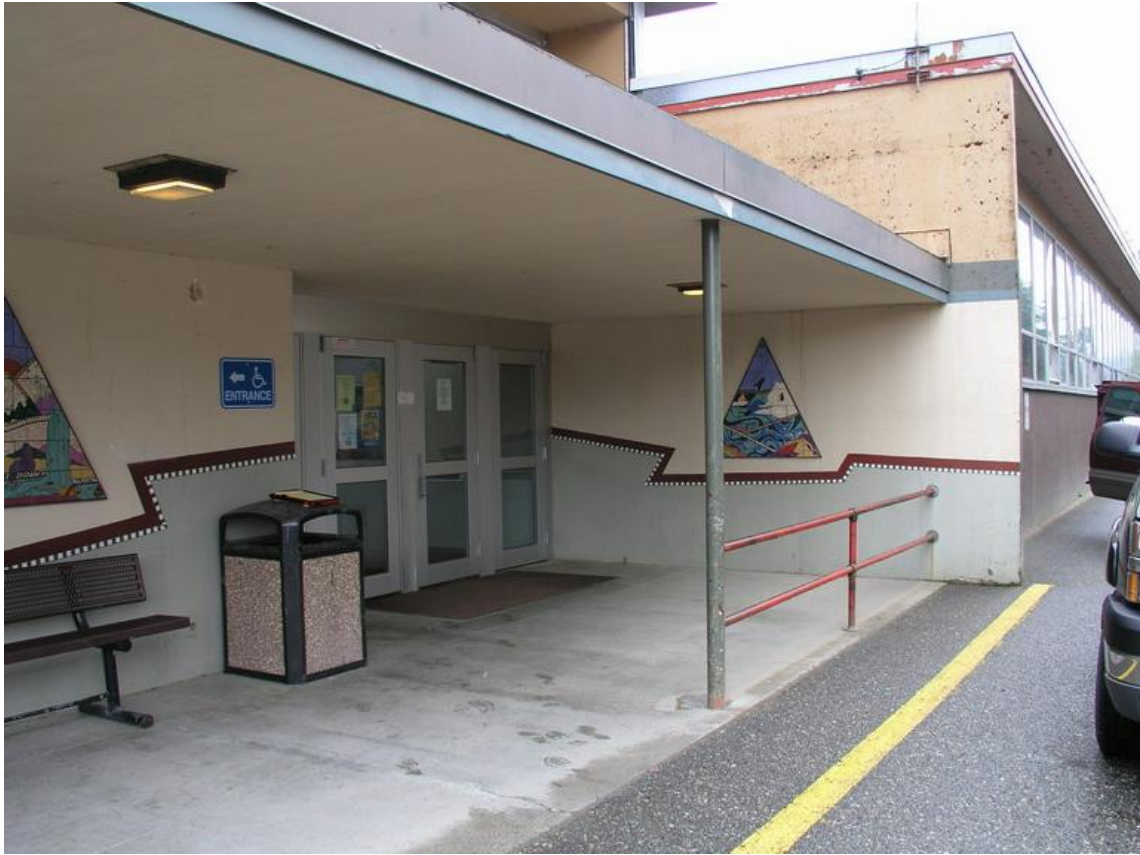
0142-5 Concrete board soffit @ main entry canopy.

If new dry pipe sprinkler system is provided at this canopy, the existing cement board soffit, possibly an ACM, will need to be removed and replaced with new concrete board soffit, as part of the work.

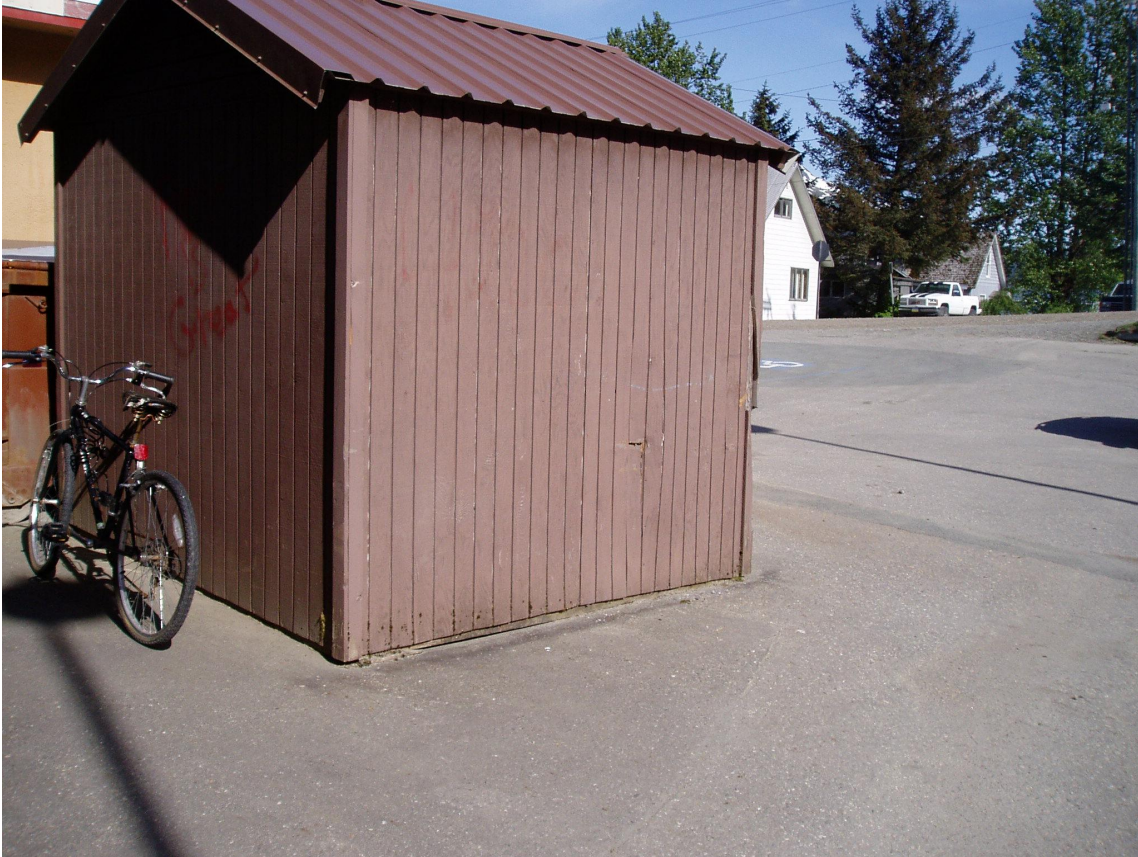
0143-1 Damaged Siding

The siding has been impacted and is broken in one location. The lower levels of the siding also exhibit moss growth.

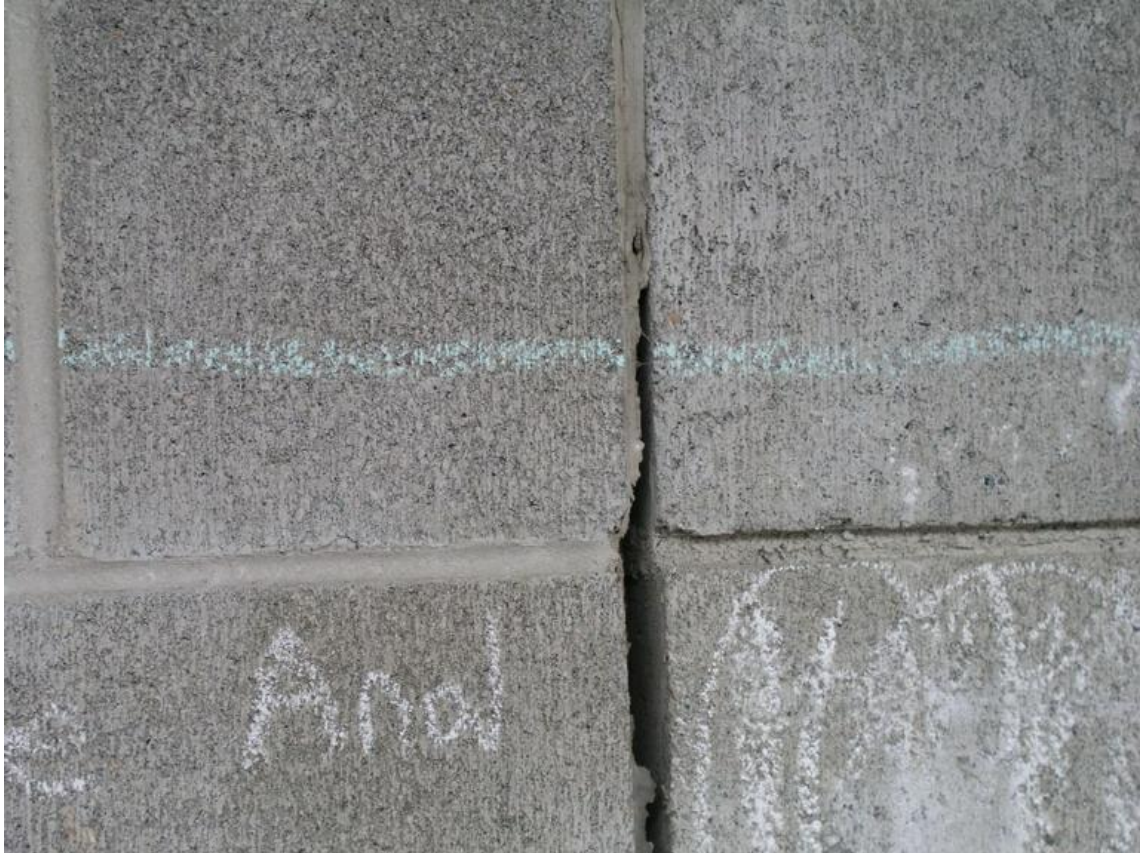
0411-3 Failing sealant joints at CMU veneer

Sealant materials have failed and are largely missing at all CMU control joints up to elevations 6' above surrounding outdoor walking surfaces.

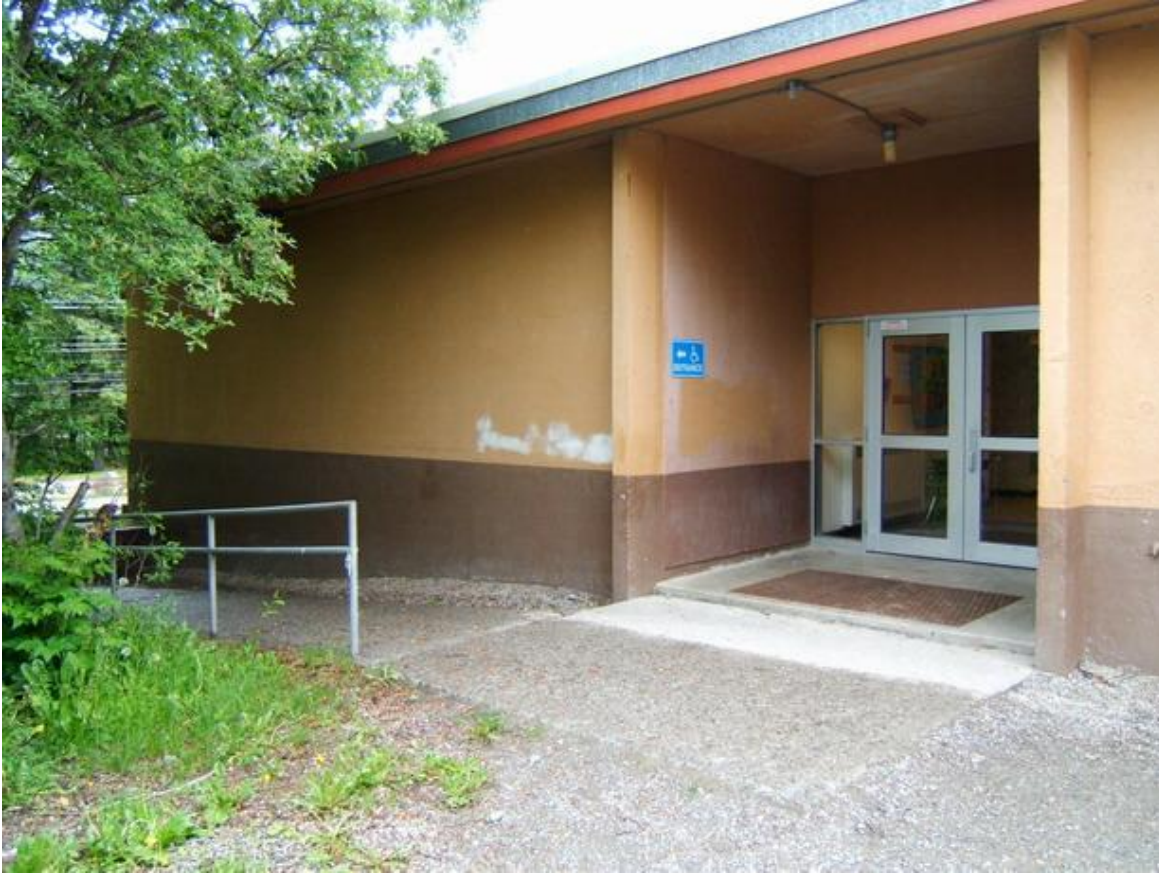
0411-5 Deteriorating paint finish at precast concrete.

Existing precast wall surfaces are not as highly textured as the site-cast elements, and exhibit fewer cracks. Although moss and mold growth is not as great a threat, the paint system is fading and in some places peeling.

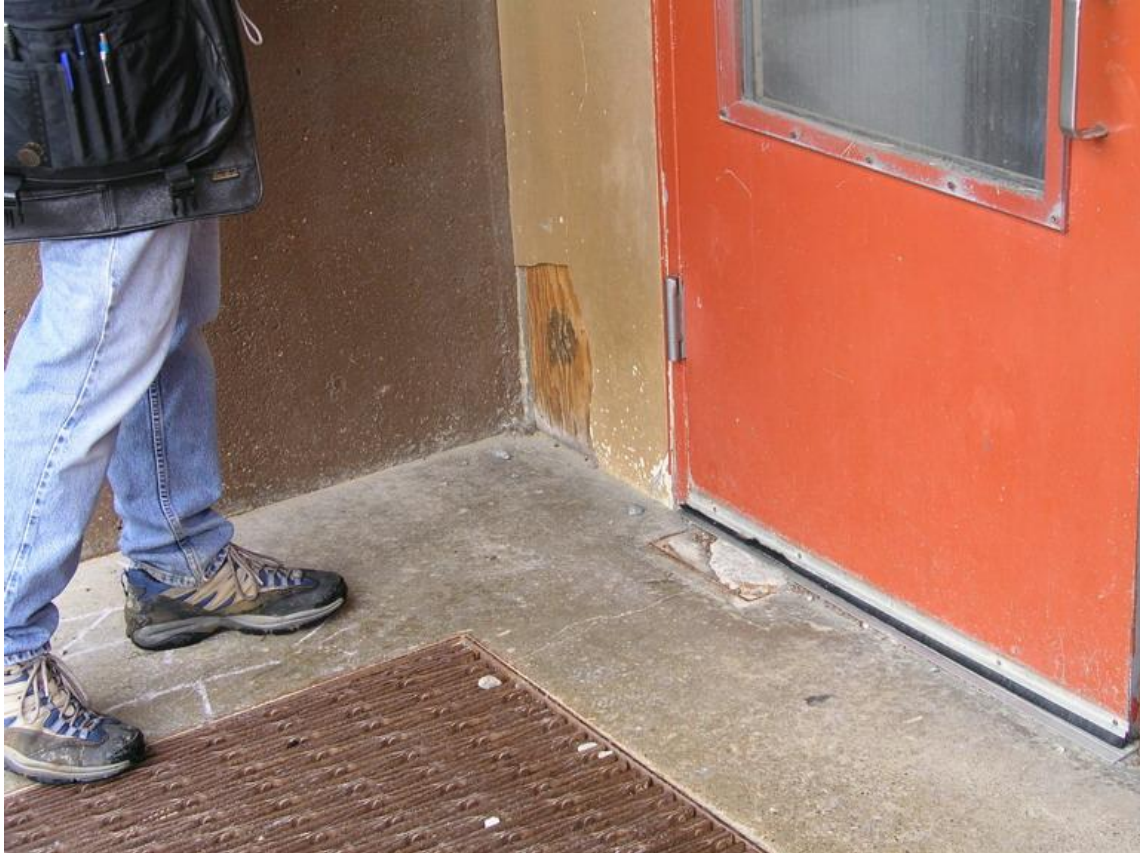
0411-6 Damaged concrete board wall panels

In these areas, several of the concrete panels have been damaged as illustrated in the photo above.

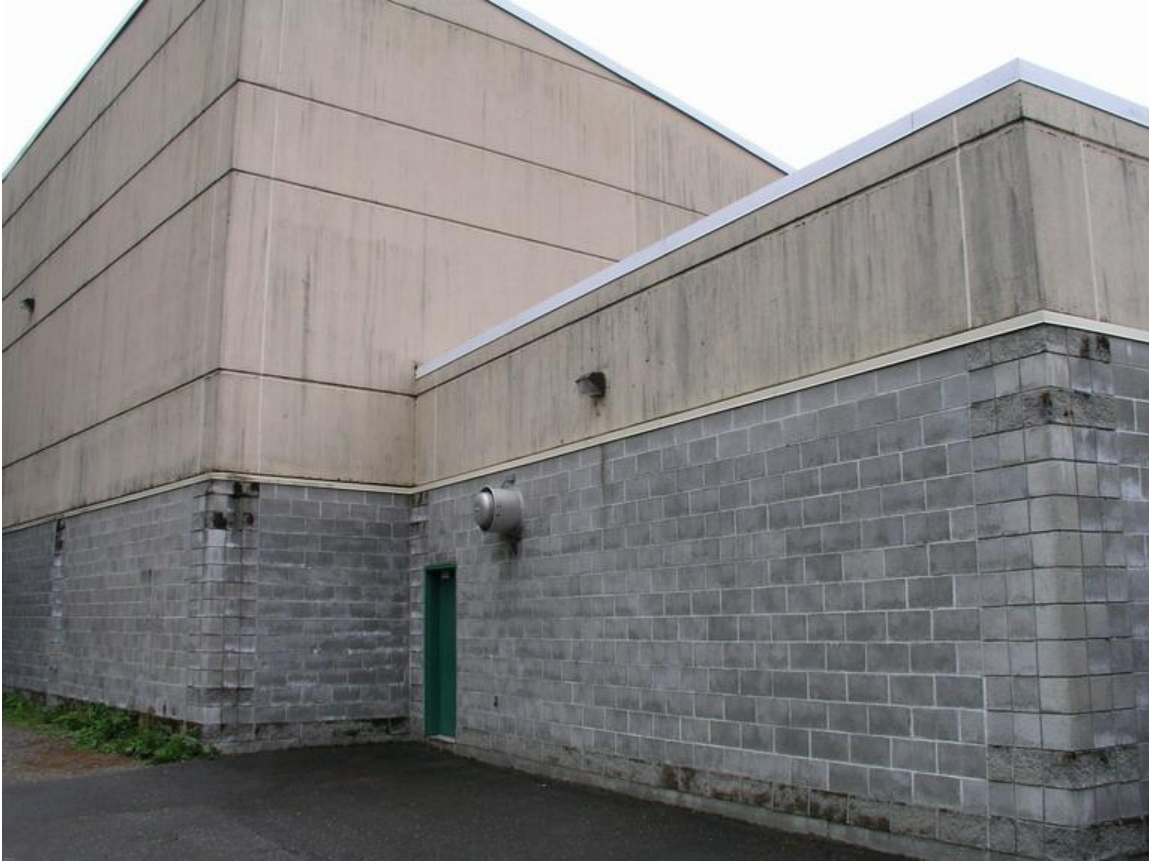
0411-7 CMU veneer cleaning and sealing

CMU veneer is fostering organic growth, and is efflorescing.

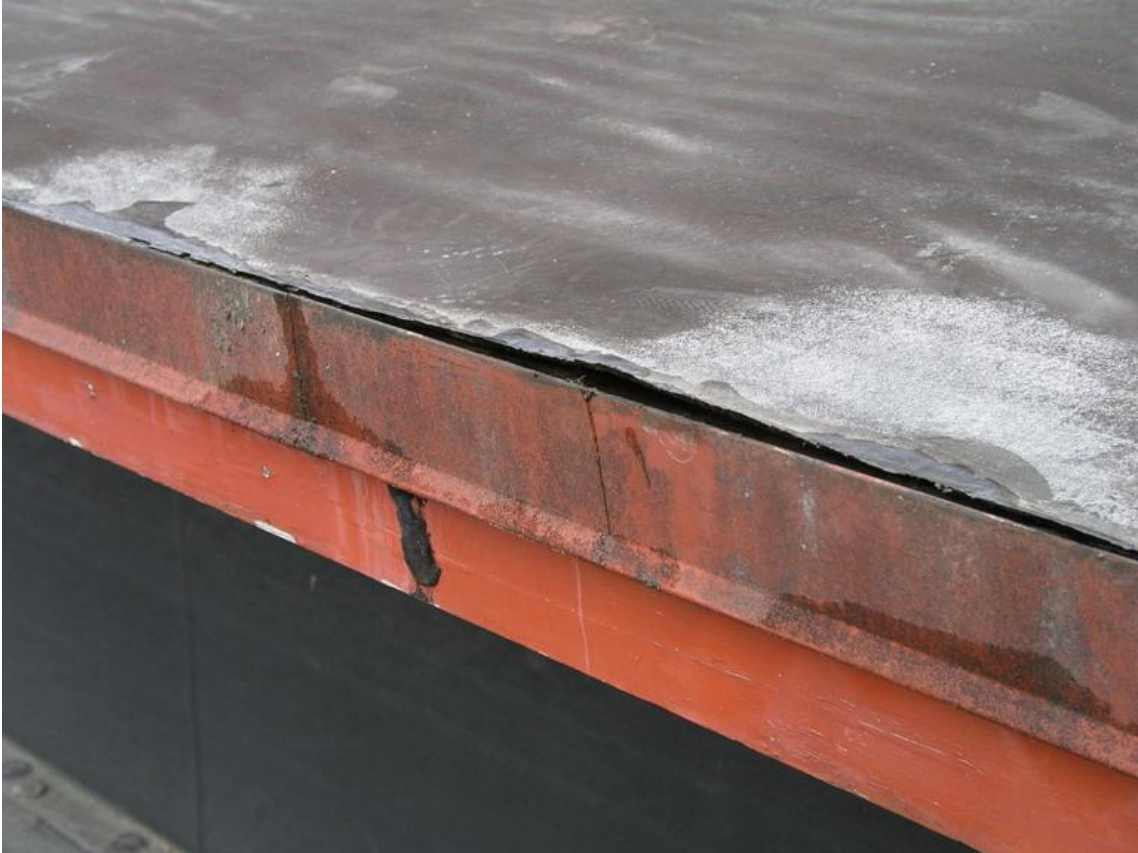
0412-2 Wood and painted sheet metal fascias

Wood surfaces are peeling. Painted sheet metal surfaces are starting to deteriorate at edges. This condition is typical at the Library/Computer Room roof.

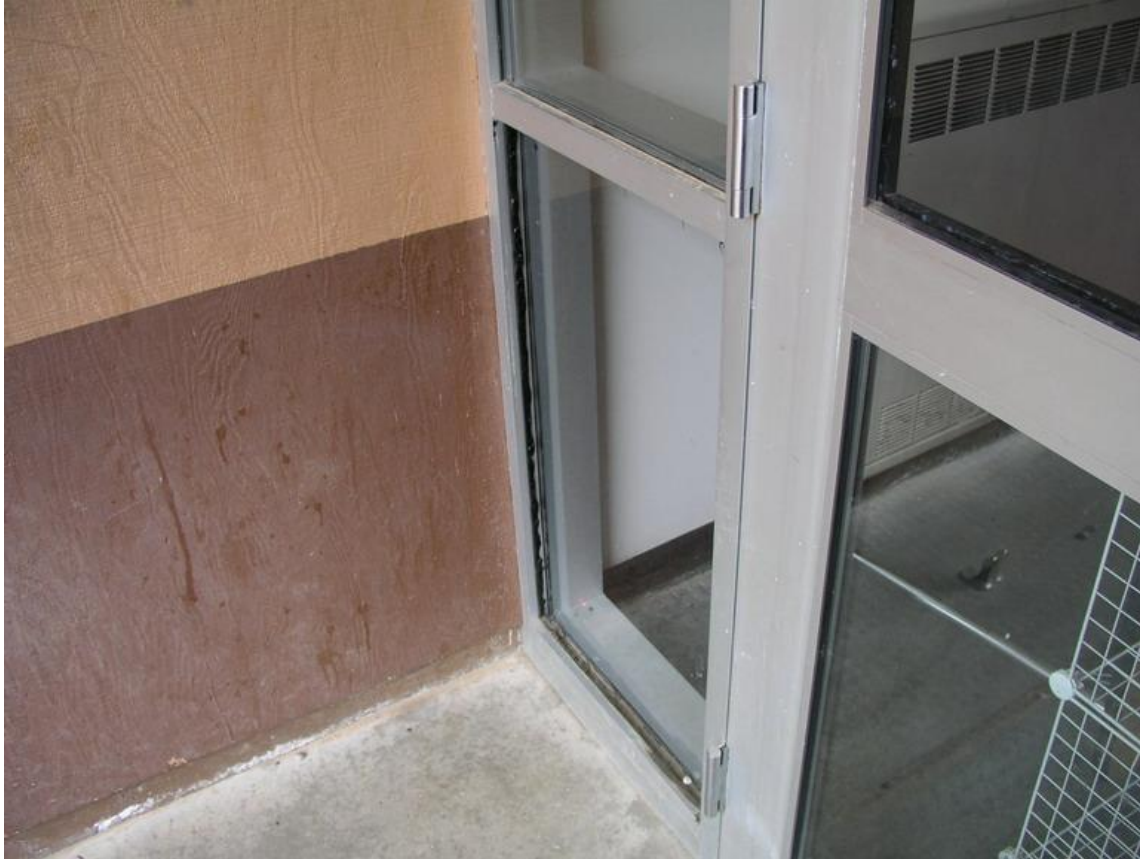
0431-3 Repairs at North hallway door assembly

One insulated glazing sidelight in the storefront assembly is broken. All four insulated glazing panels in the pair of doors have been broken and replaced with plastic glazing, which is getting scratched.

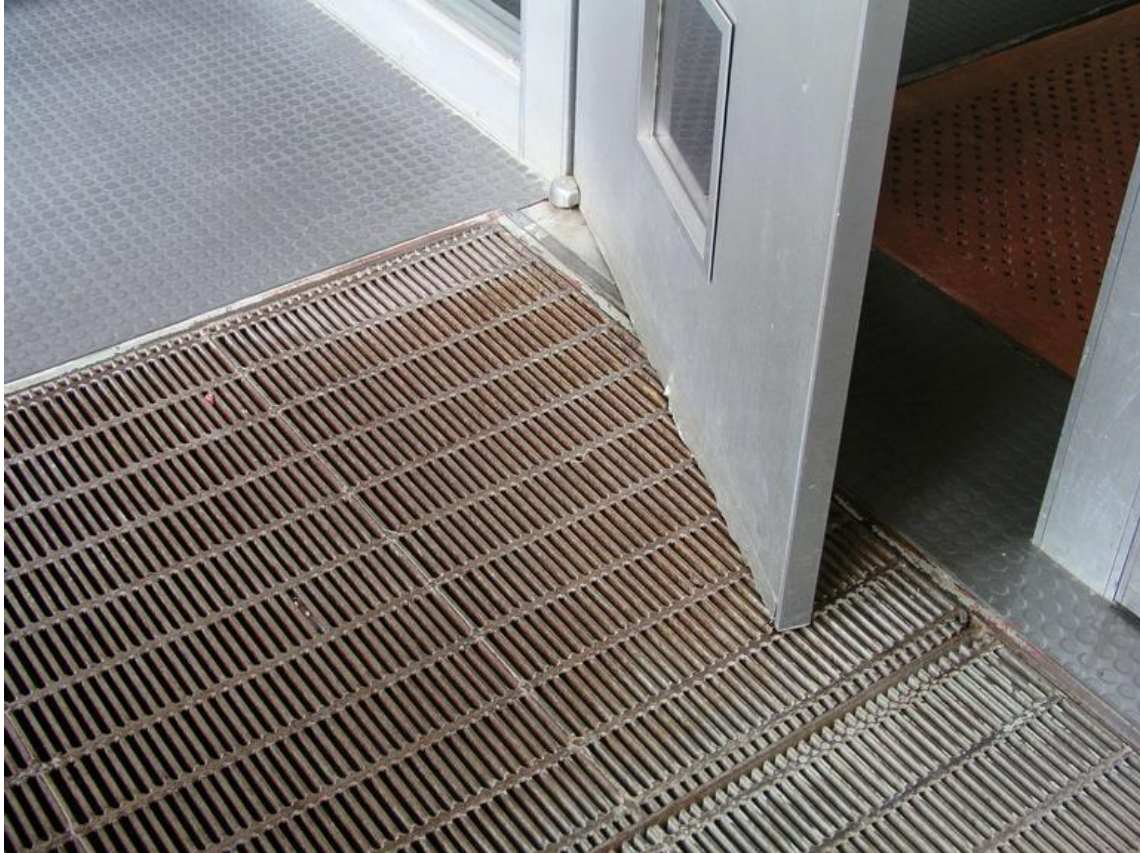
0431-4 Steel grating jams interior vestibule doors.

The walk-off grating in front of the interior vestibule doors is deformed and in several locations jams the out-swinging doors. This could be a life-safety issue if the condition develops where the doors can not be opened.

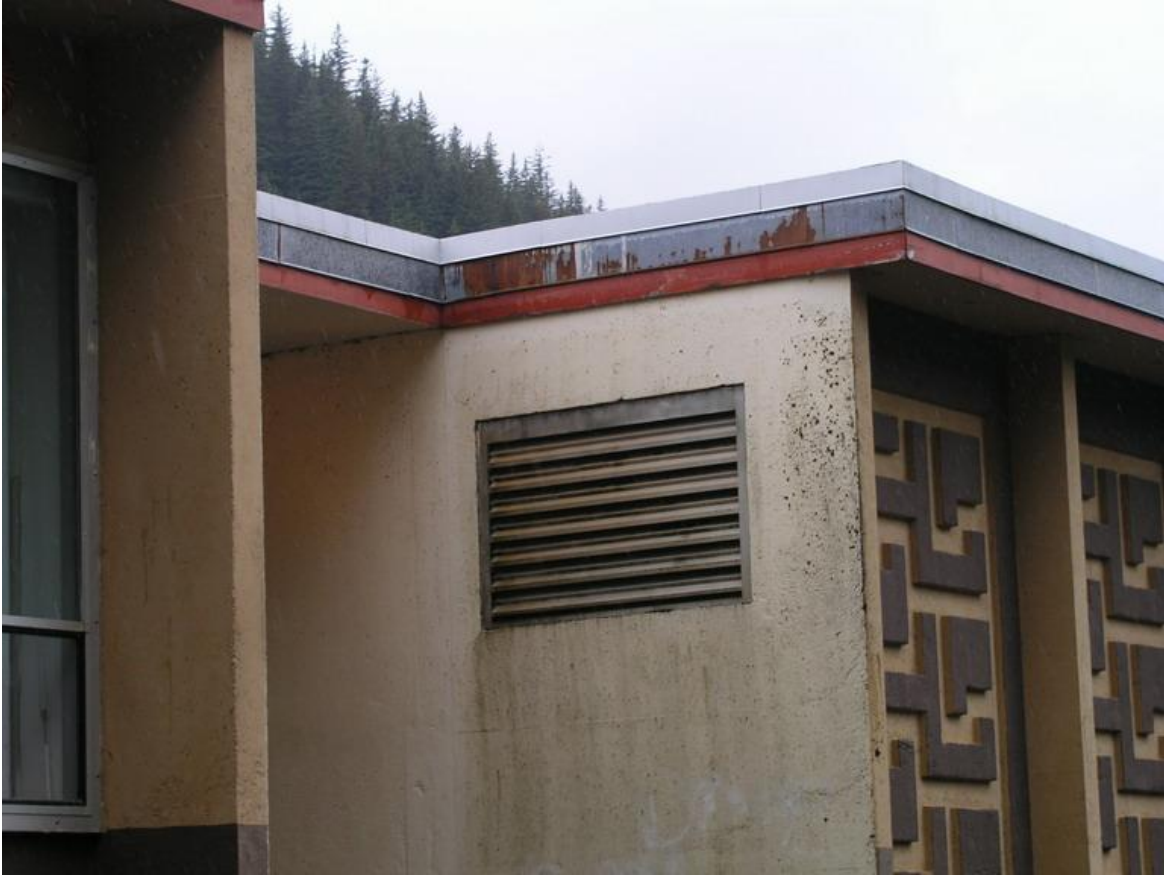
0441-1 Clean and Paint Louvers

Louvers at 1958-65 portions of the building are dirty and showing signs of corrosion at three locations.

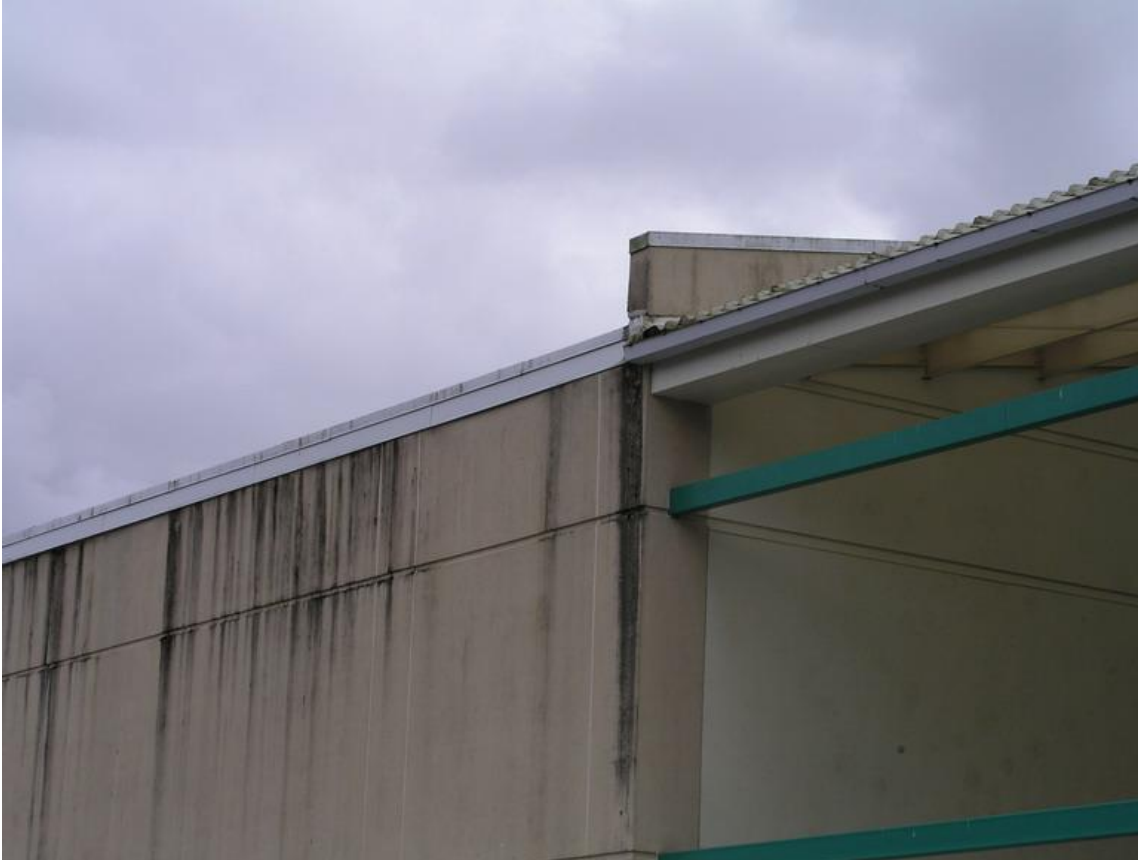
At the Outdoor Covered Play Area, is filled with debris and overflows in heavy rainfall, as water mark on wall suggests in photo above. Gutter and down-spout at all other areas should be cleaned.

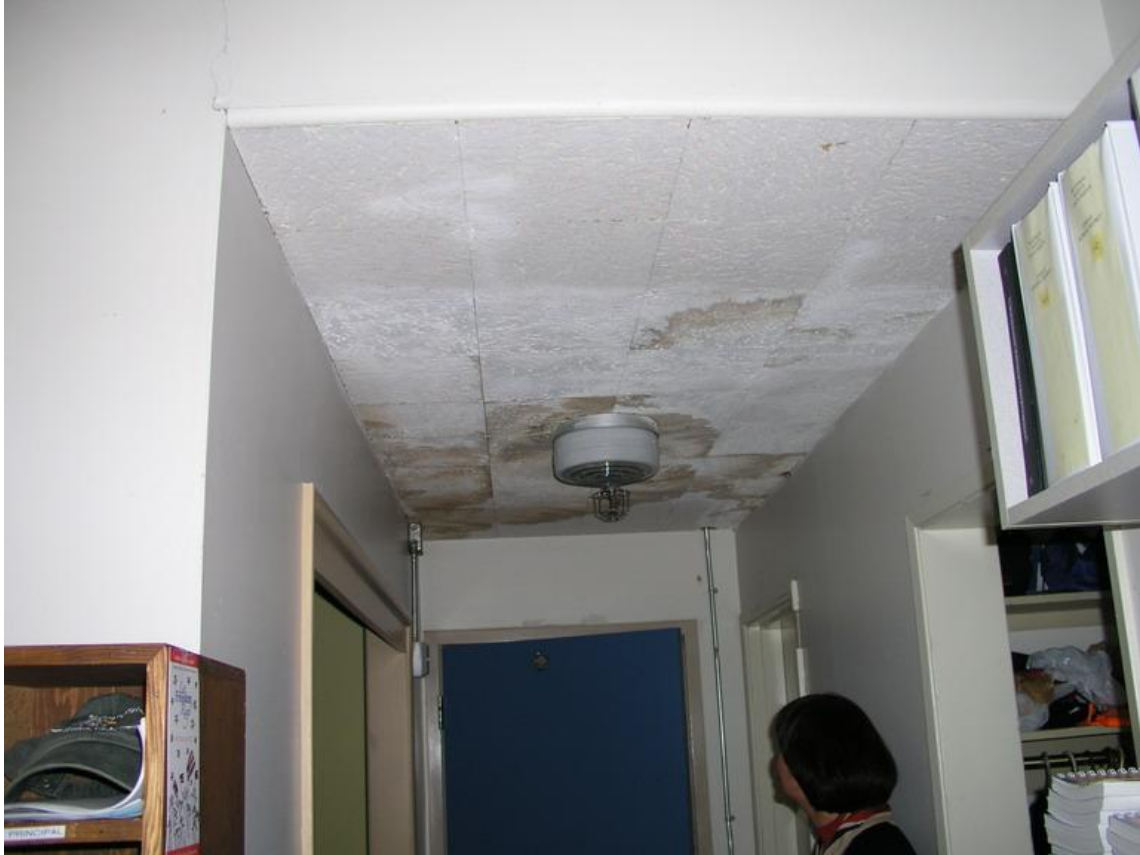
0612-1 Water damaged soffit at Admin area

Water leakage from the old roof has damaged this soffit area. The area is approximately 4'x8'. Soffit is clad with 12x12 ACT. Ceiling tile should be tested for asbestos containing material prior to removal.

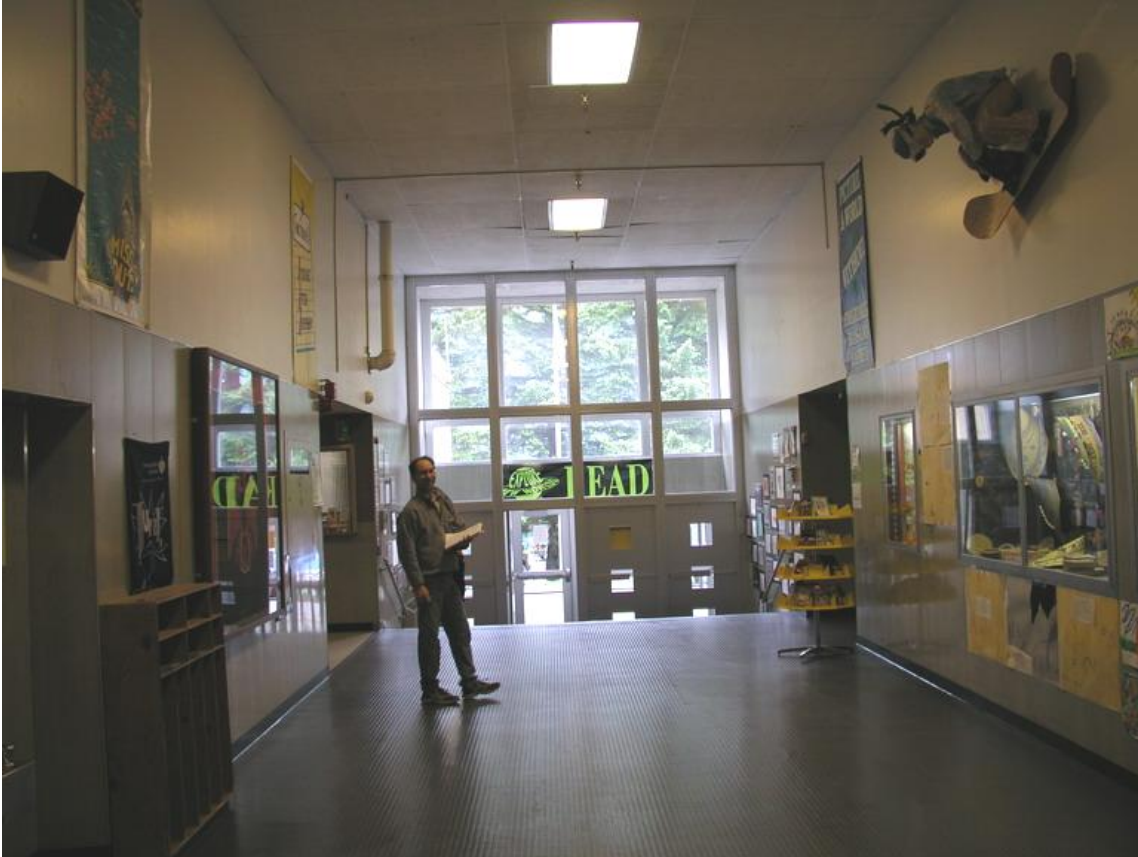
0641-2 Dark wall materials in 1958 building Commons restrict educational experience.

Commons finishes are durable, but color and organization are dark and oppressive.

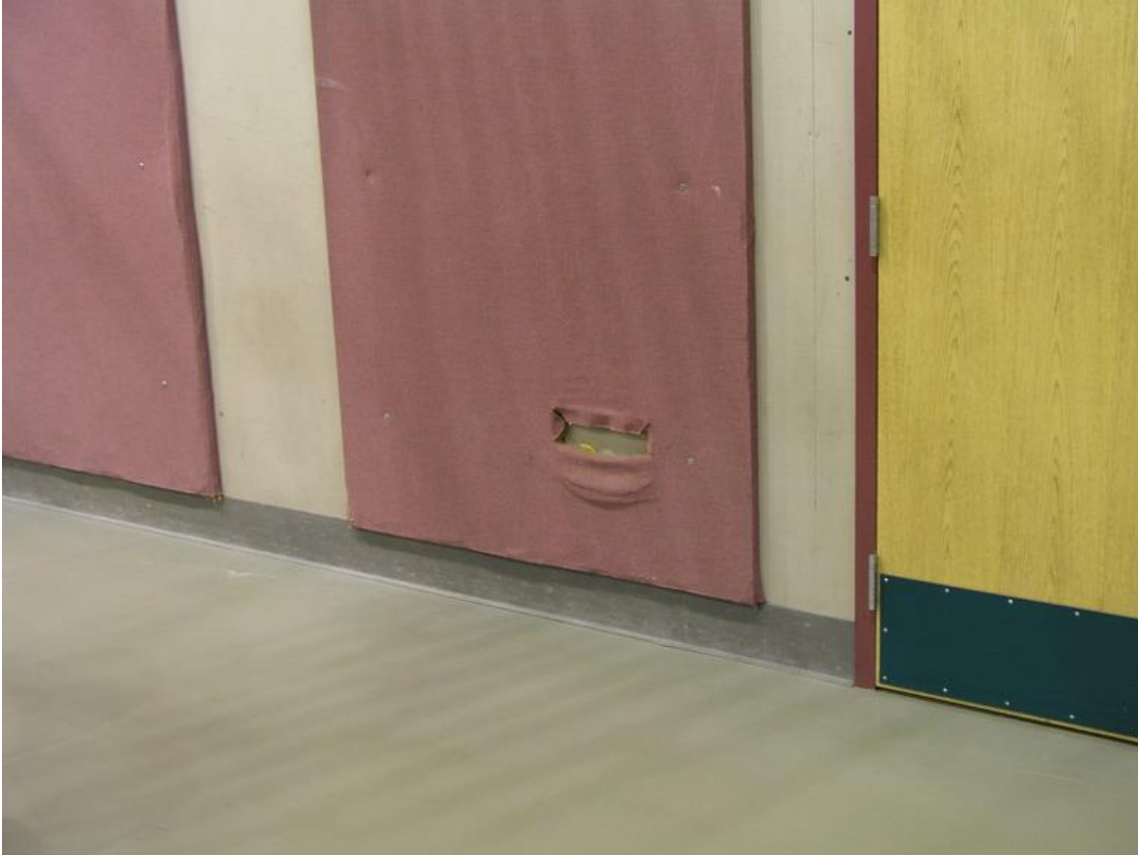
0641-4 Replace court end acoustic wall panels at gymnasium.

Cloth Faced Acoustic pads at court ends are not standing up to abuse of gymnasium use.

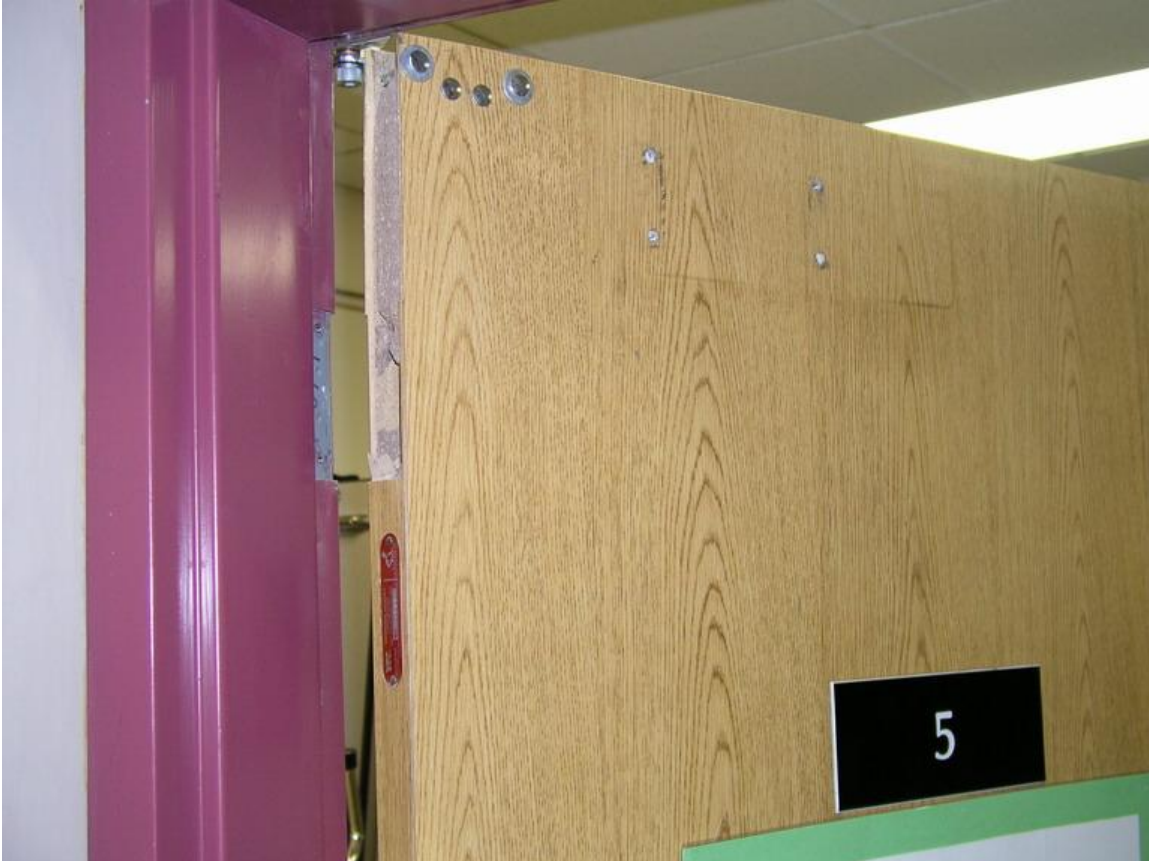
0651-1 Missing ADA signage

Doors in the 1991 addition are not equipped with ADA signage.
