Gastineau Elementary

Douglas, Alaska

Facility Condition Survey Report Prepared June 2005

By NorthWind Architects, LLC, PN&D Inc., Haight & Associates,
Murray & Associates, and City & Borough of Juneau Engineering
Department

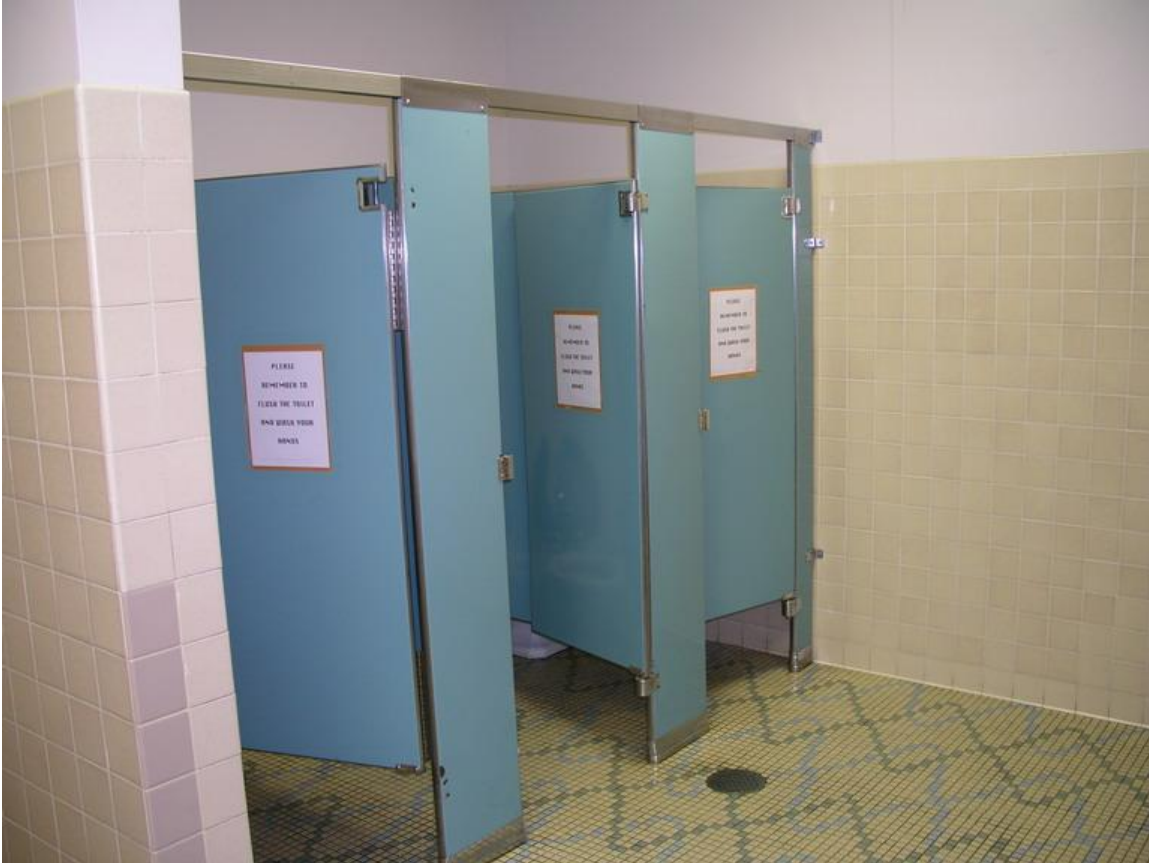
0651-2 Toilet Partitions

Toilet partitions are wearing out and should be replaced with new.

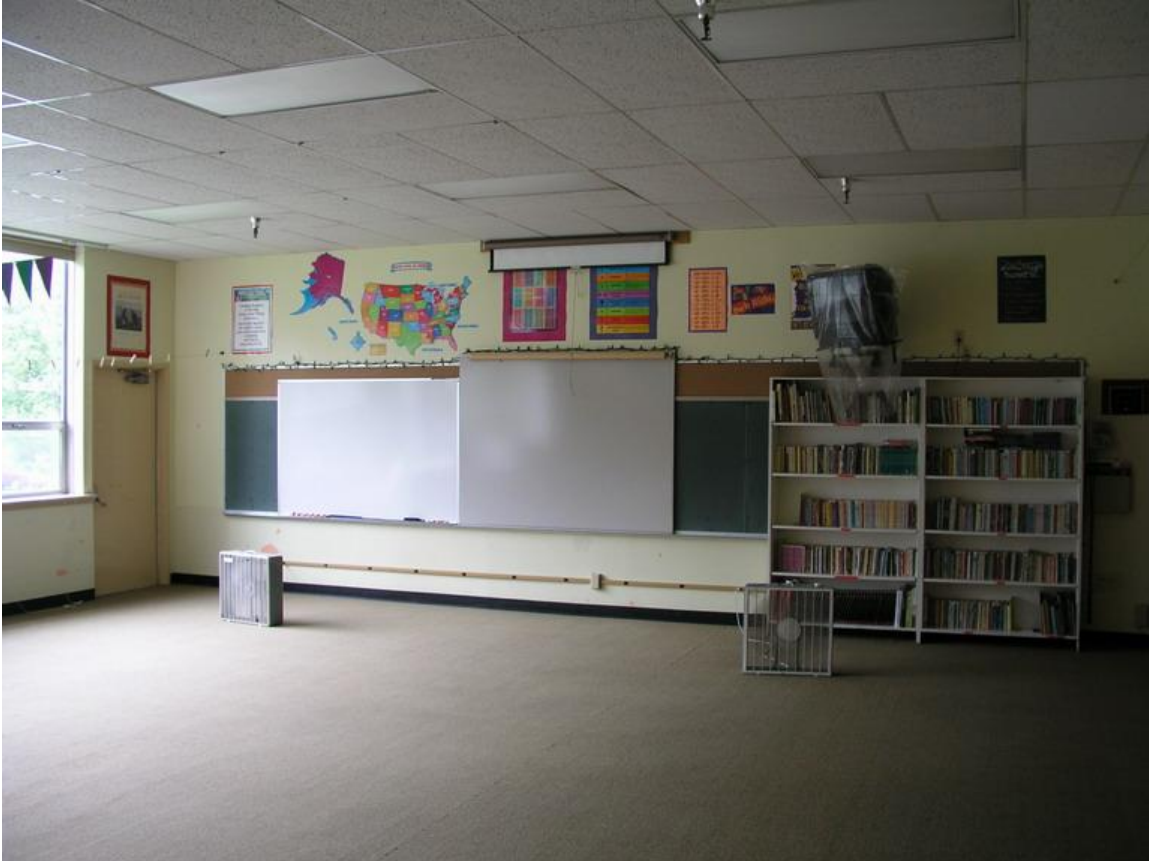
0651-3 Marker Board Replacement

Temporary marker boards have been applied over existing chalkboards in classrooms. This does not provide the necessary marker board area for teaching.

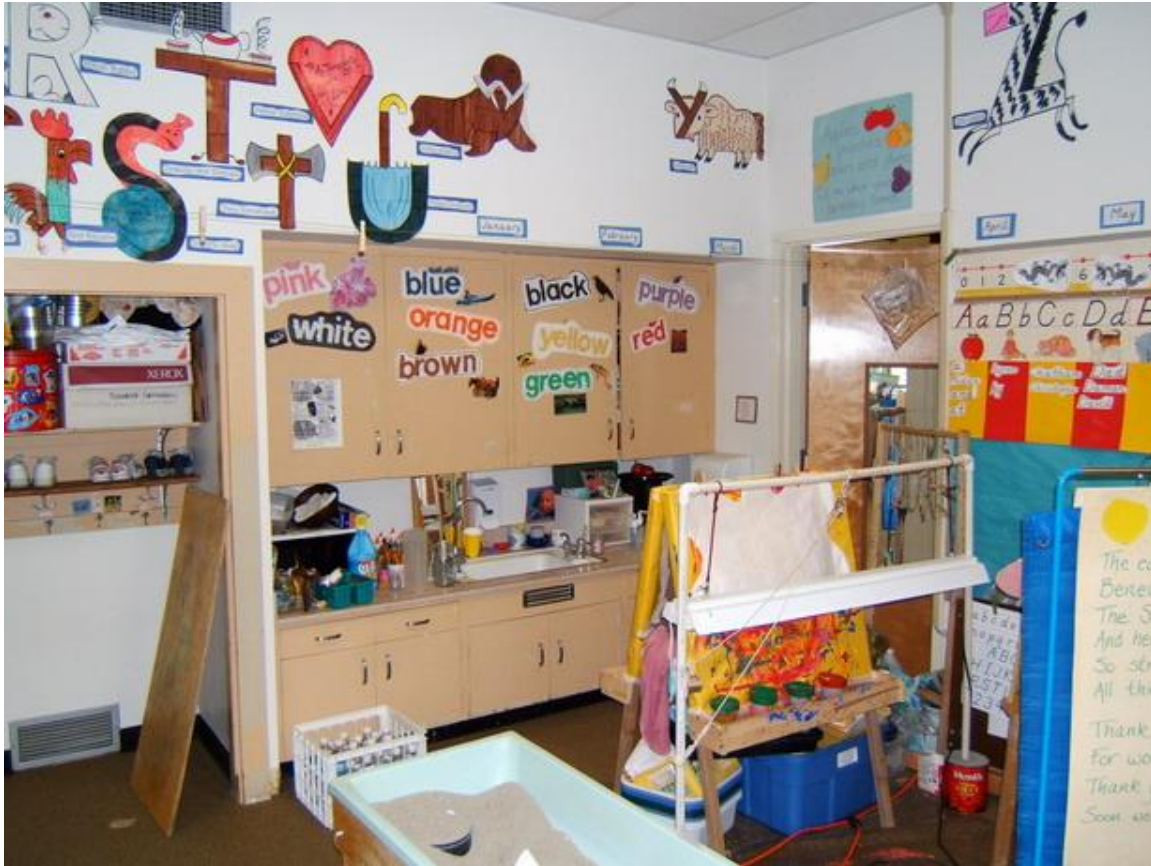
0652-1 Antiquated millwork at 1958 classrooms

Existing millwork is antiquated, requires regular painting and maintenance, and is not ADA compliant.

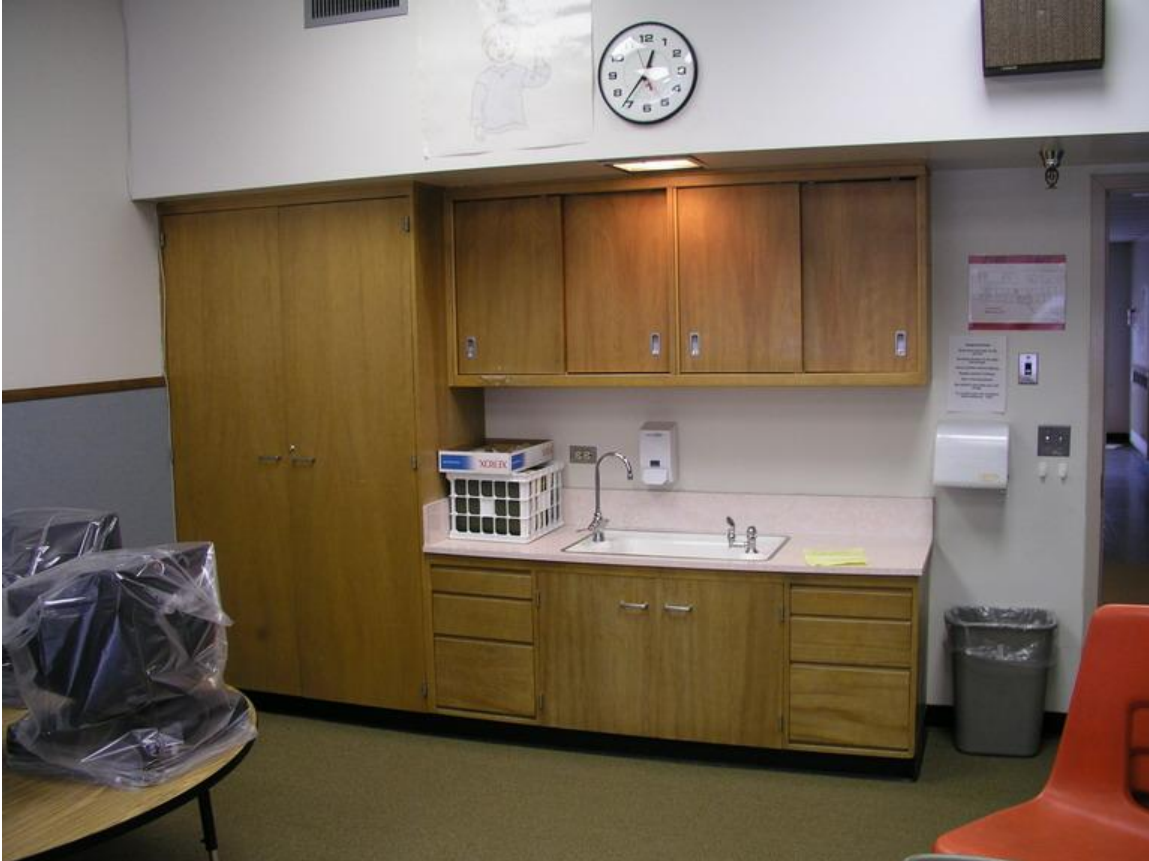
0652-2 Refinish millwork at 1965 classrooms, ADA compliant

Existing millwork finish is wearing out and sink is not ADA compliant.

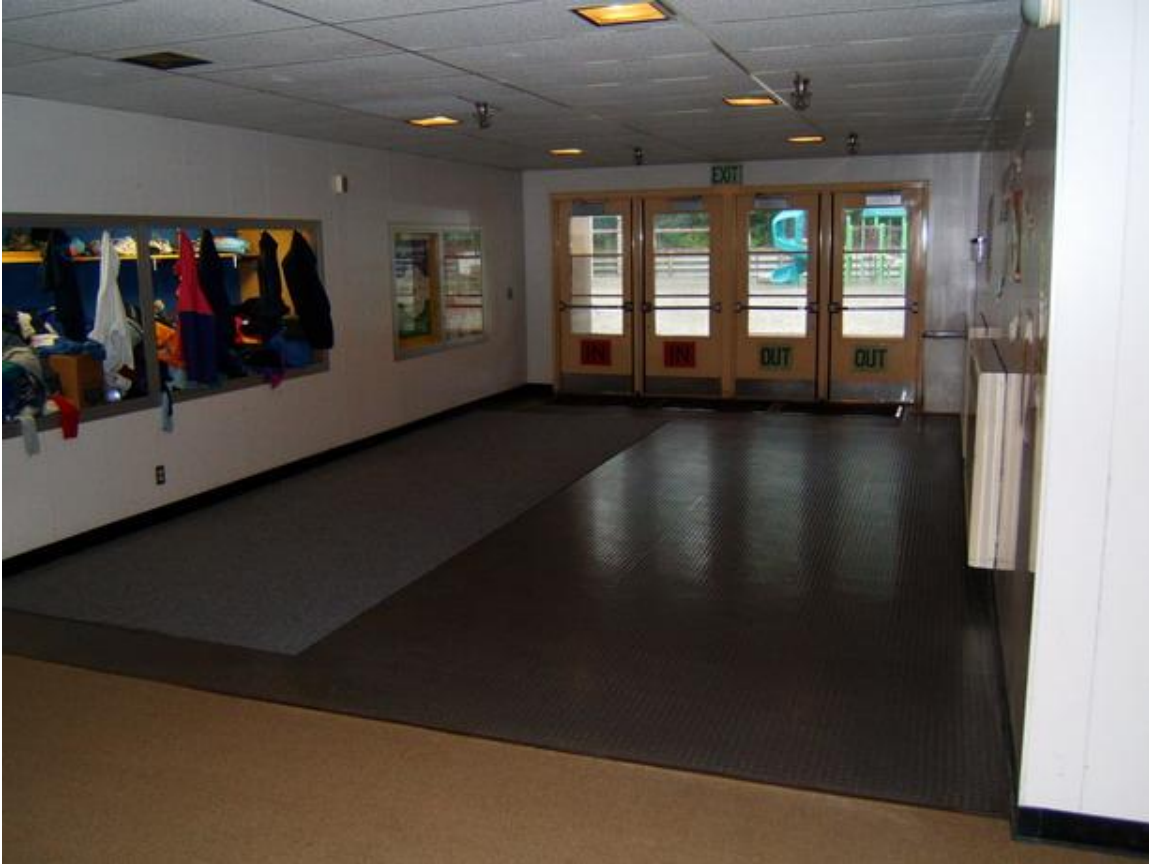
0652-3 Hallway coat storage

Existing display case has been converted to a coat storage area and a lost-and-found.

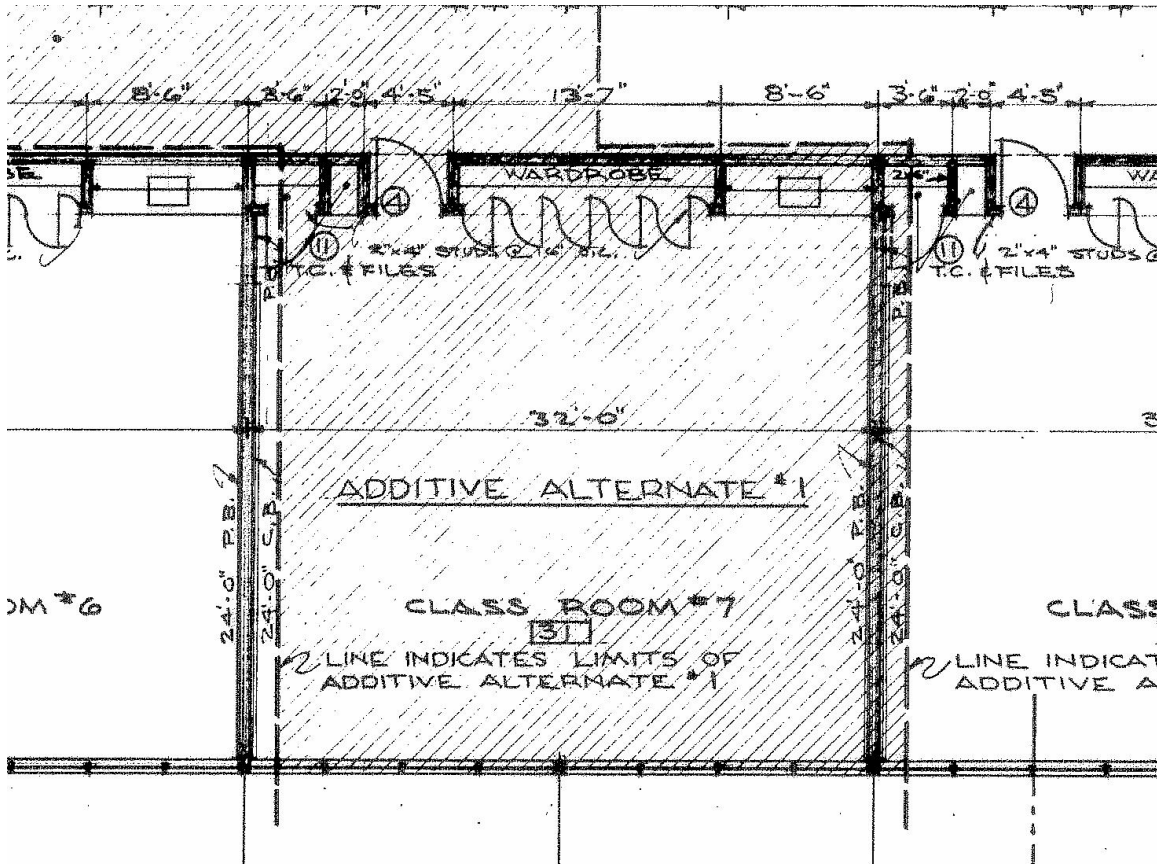
0652-4 Inefficient Classroom Storage

Typical classroom design has ~13 LF of wardrobe space that contains one overhead shelf and a closet rod for coats. This is an inefficient use of storage space in classrooms that lack storage.

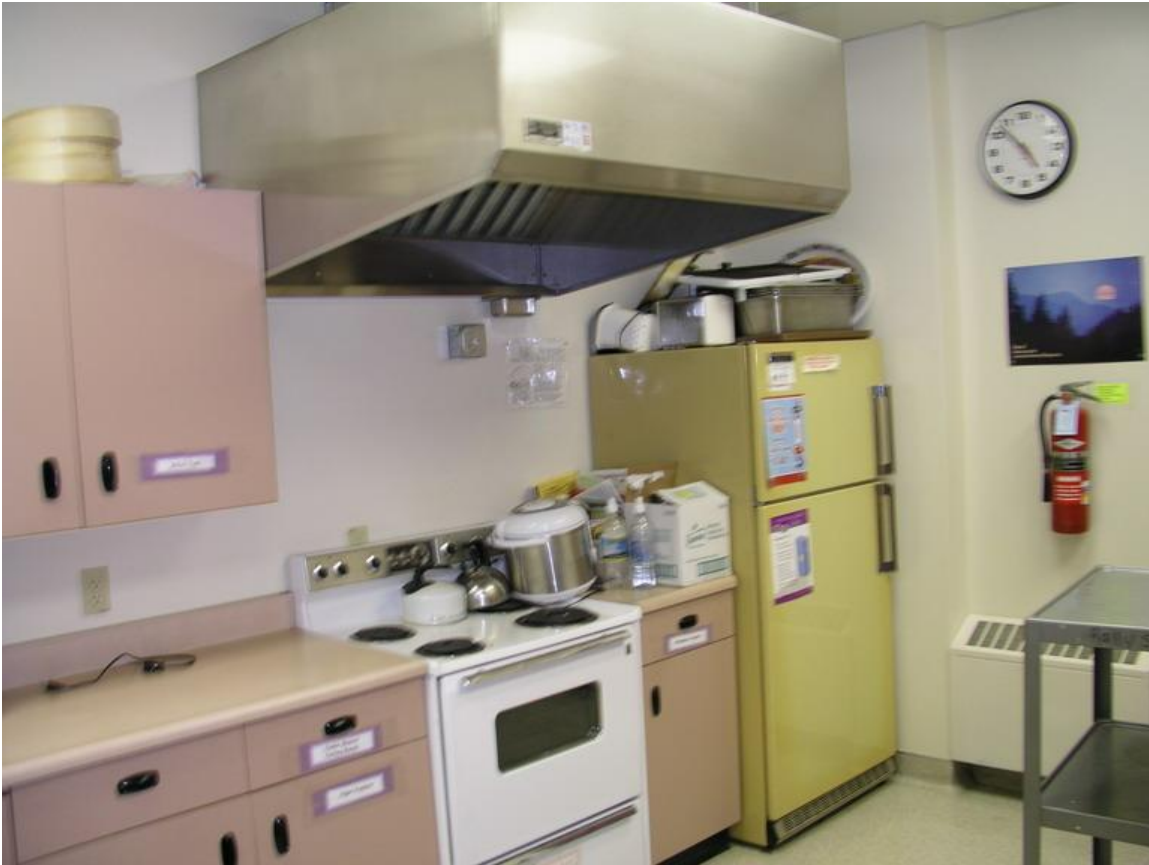
Cabinets, tops, and range hood in this area are in good condition and should last indefinitely. The refrigerator and range are older models and will have a limited lifespan of 5-7 years.

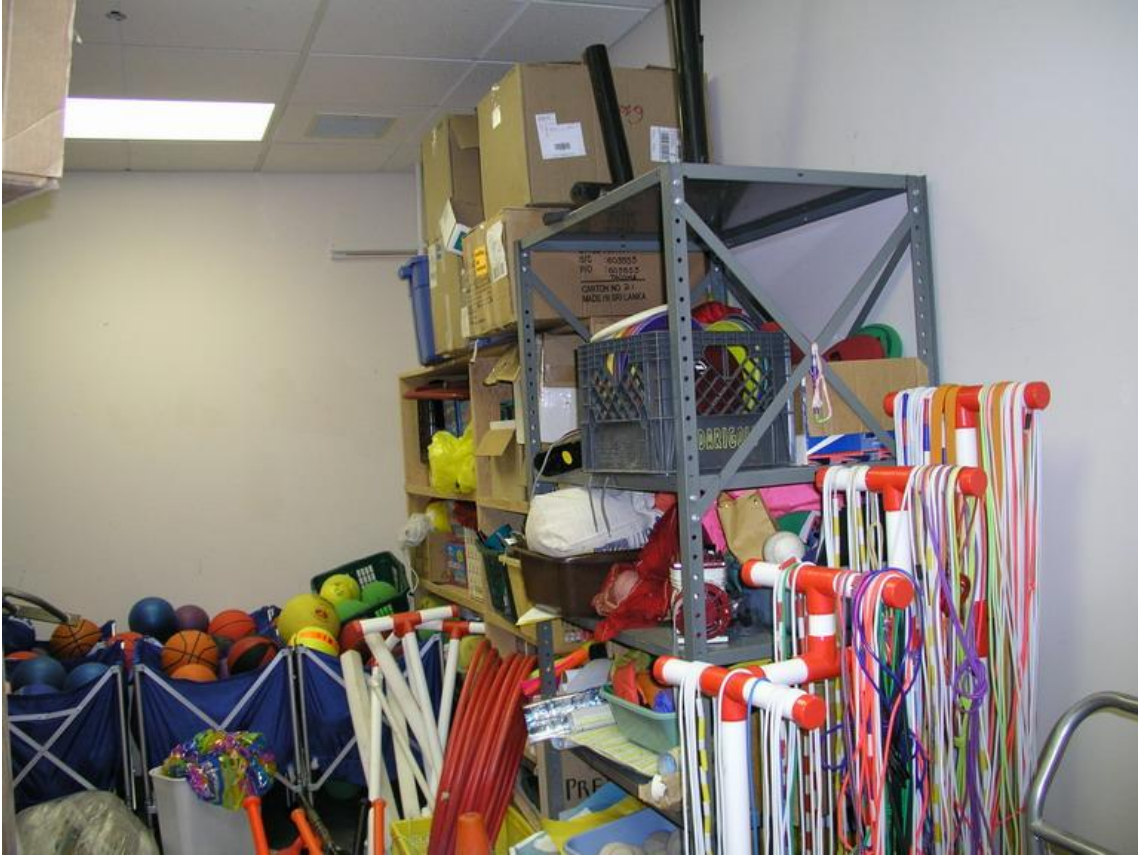
1018-2 Seismic bracing at Storage shelving

Storage room shelving throughout the facility is not seismically braced. Specific locations occur at the Gymnasium Storage Room 4A, 4B, 4C, and 5, at most classrooms with high shelving.

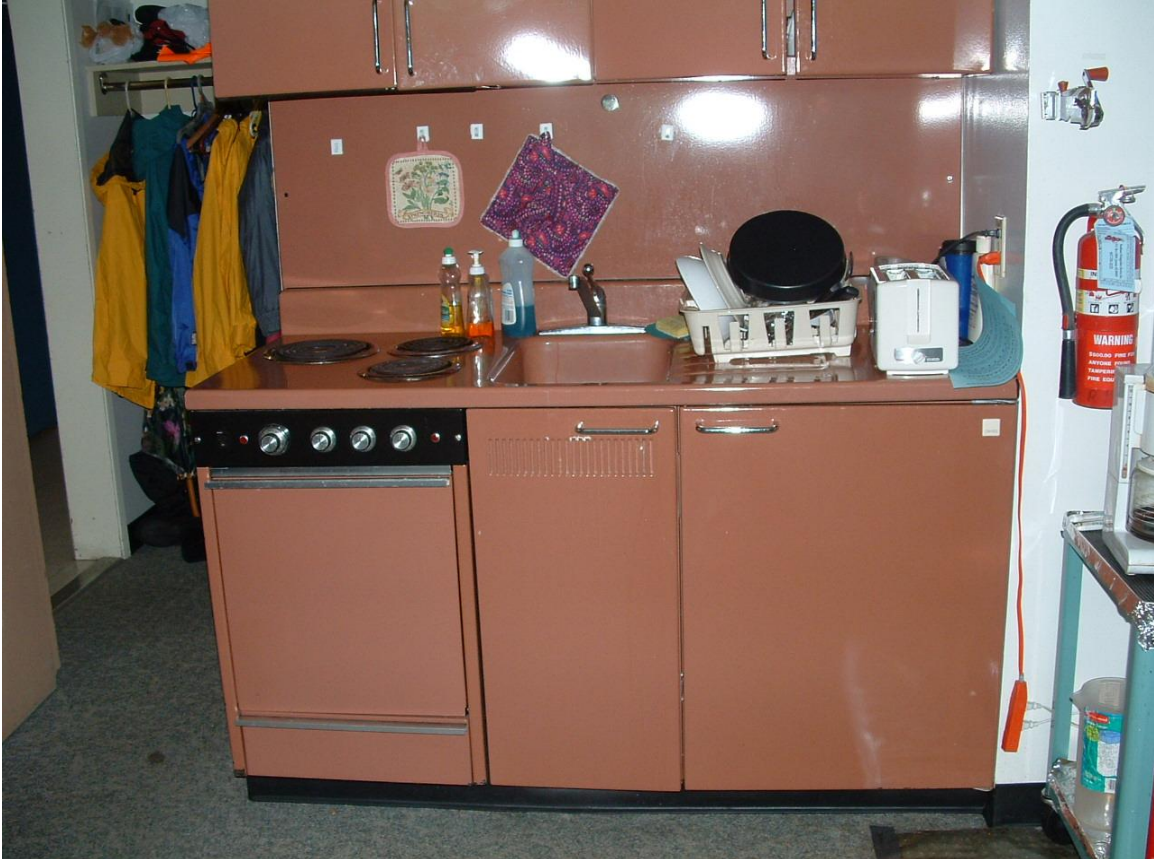
0811-9 Teacher's Lounge

Integral casework, sink, stove is past service life.
