To:	Teri Camery (CBJ)	Date:	April 27, 2022
c:	Scott Ciambor (CBJ)	Memo No.:	3
From:	Rita Kors-Olthof, Vladislav Roujanski, Shirley McCuaig	File:	704-ENG.EARC03168-01 / 704-ENG.EARC0168-02A
Subject:	Mapping Overview at Starr Hill Subdivision and Additional Information Downtown Juneau Landslide and Avalanche Hazard Assessment

2.1 Mapping Overview at Starr Hill Subdivision

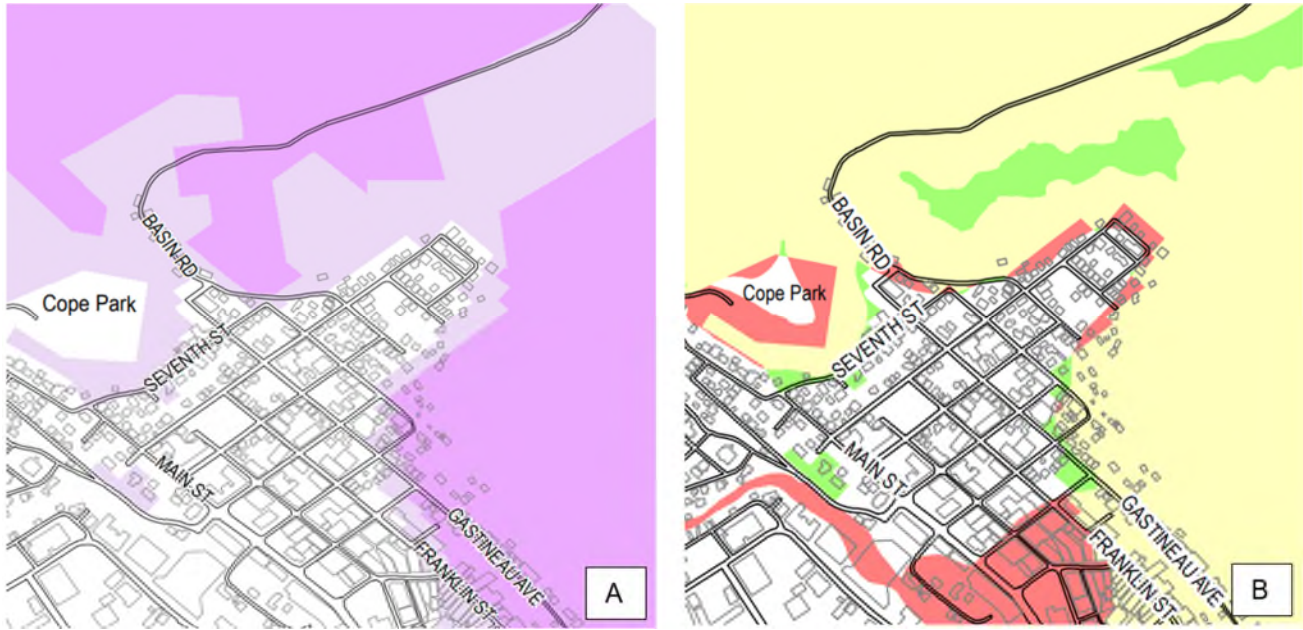
As seen in Figure 1 below, the main difference between the 1987 adopted hazard mapping and the new 2021 proposed hazard mapping is that many of the former *Moderate* areas surrounding Starr Hill (colored in pale lavender on Figure 1A) are now designated *High* or *Severe* (colored in dark pink on Figure 1B).

The 1987 adopted hazard mapping is understood to have been based on Swanston (1972). However, the 1987 mapping follows property lines, resulting in numerous right-angle corners in the hazard boundaries. The 2021 mapping does *not* follow property lines. It follows hazard designations based on terrain features, such as surficial geology, geomorphology (evidence of past and more recent slope movement types accentuated by vegetation patterns), and activity levels for slope instabilities as seen from the air photos and confirmed by field observations. For instance, along 6th Street, between East Street and Nelson Street, the lower boundary of the new 2021 proposed hazard zone does *not* arbitrarily stop at the upslope property lines of the affected properties as it does in the 1987 mapping. The same is true upslope of Nelson Street, and upslope of 5th Street, where the lower boundary of the 2021 proposed hazard mapping does *not* arbitrarily stop at the upslope property lines of the affected properties.

Figure 1: Excerpts from CBJ’s 1987 adopted hazard mapping (Figure 1A) and comparison of 1987 adopted hazard mapping and 2021 proposed hazard mapping (Figure 1B) at the Starr Hill subdivision.

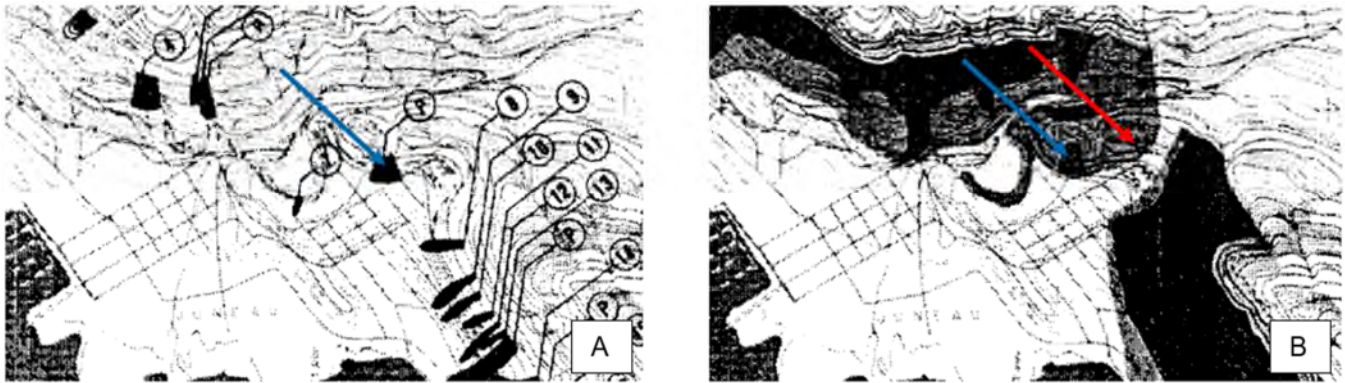
Figure 2: Excerpts from Swanston (1972) – Figure 5 – Historic Landslide Deposits (Figure 2A) and Figure 6 – Mass Wasting Hazard Areas (Figure 2B).

In Swanston’s Figure 5, “P” means “Prehistoric” (before 1880). A prehistoric slide area was noted on the south side of Mt. Maria (blue arrow in Figure 2A). In Swanston’s Figure 6 (Figure 2B), hazards for mass wasting (landslide) hazard areas are shown, with *Potential* Hazards marked in gray, and *High* Hazards marked in black. The prehistoric slide is shown as a *High* Hazard area (blue arrow in Figure 2B). A small cliff with a talus deposit above the corner of 6th and Nelson Streets was also designated as being in a *High* Hazard area (red arrow in Figure 2B).

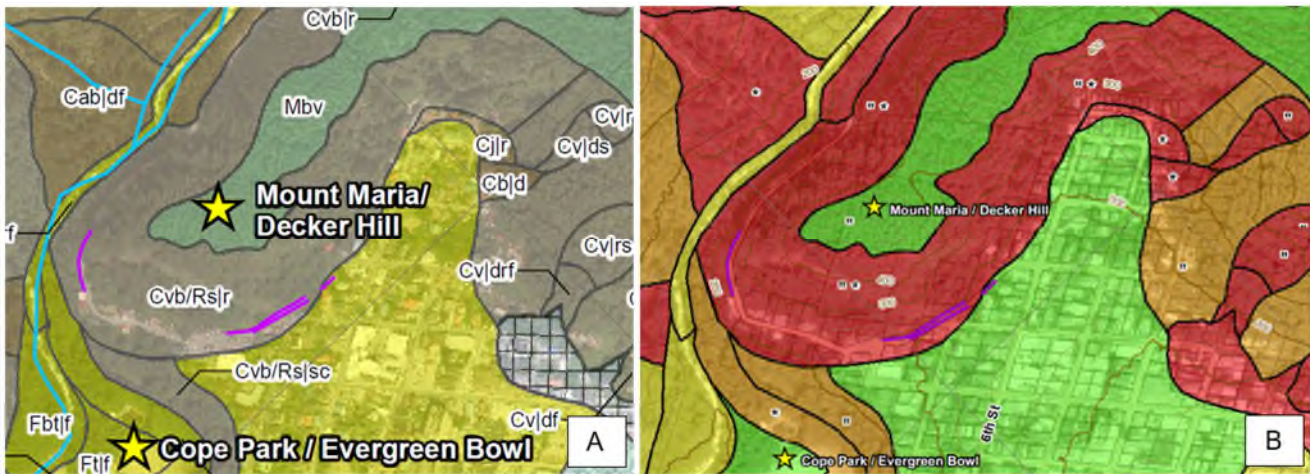
Figure 3: Excerpts from Tetra Tech Figure 1.3b Surficial Geology (Figure 3A), and Figures 1.6c and 1.6h Landslide Hazard Designation Mapping (Figure 3B).

Severe hazard designations are assigned to the areas subject to rockfall, debris slides, and debris flows, as shown on the surficial geology map in Figure 3A. Areas with a *High* hazard rating were assigned based on the results of the semi-quantitative analysis. These areas are expected to experience rockfall that damages but does not always knock out trees, and as such are a less severe hazard than a debris flow or debris slide that removes everything in its path. Evidence of this type of rockfall activity was identified during the field investigation.

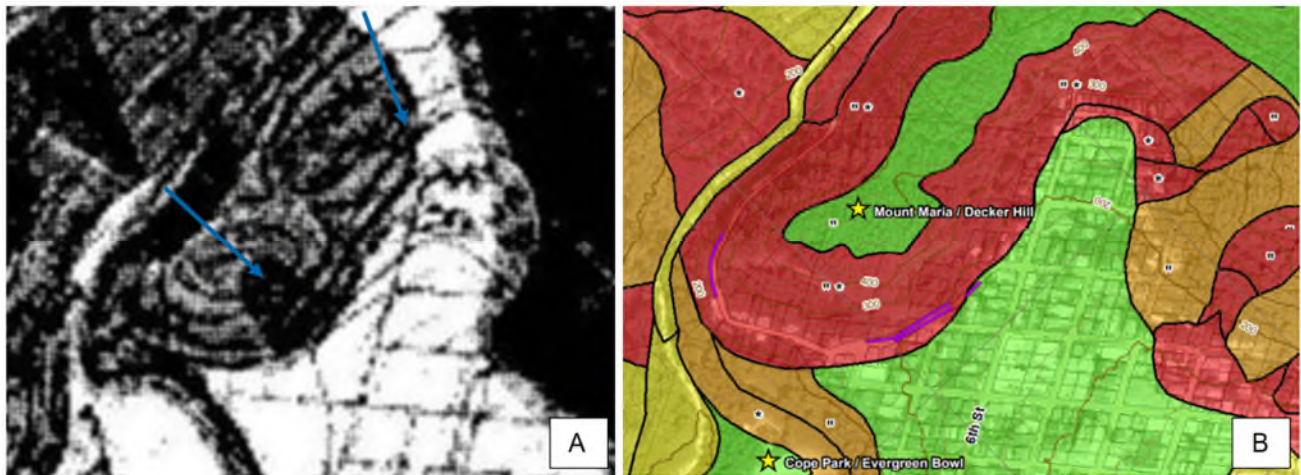
Figure 4: Comparison of Swanston’s Figure 6 (Figure 4A) and Tetra Tech’s Figures 1.6c and 1.6h Landslide Hazard Designation Mapping (Figure 4B). Swanston (1972) uses *Potential Hazard* (gray) and *High Hazard* (black), designated in the 1987 adopted mapping as *Moderate* and *Severe* hazards. Tetra Tech uses *Low* (green), *Moderate* (yellow), *High* (orange), and *Severe* (red) hazard designations.

As shown in Figure 4A, Swanston mapped most of Mt. Maria on the Starr Hill side as having a *Potential Hazard* (gray area), except at the prehistoric slide area and a small cliff above the corner of 6th and Nelson Streets, which were designated as being in *High Hazard* areas (blue arrows). These two areas are also shown with blue arrows in Figure 5. Heading northeast along 6th Street from Basin Road towards Nelson Street, the lower boundary of Swanston’s *Potential Hazard* area was mapped progressively closer to 6th Street.

Along the entire southeast edge of Starr Hill, including a portion of the mapped lots, Swanston (1972) marked an area of *Potential Hazard*, with *High Hazard* marked further upslope on Mt. Roberts. The lower boundary of Swanston’s *Potential Hazard* area begins at about Harris and 4th Streets, becoming progressively closer to 5th Street heading northeast. The northeast corner of Swanston’s mapped landslide hazard area curves to the north to encompass the terrain southeast and northeast, upslope of the corner of Nelson and 5th Streets. Swanston did not designate hazards along or above the northwest part of Nelson Street. CBJ’s 1987 adopted map called that area *Moderate* (Figure 1A).

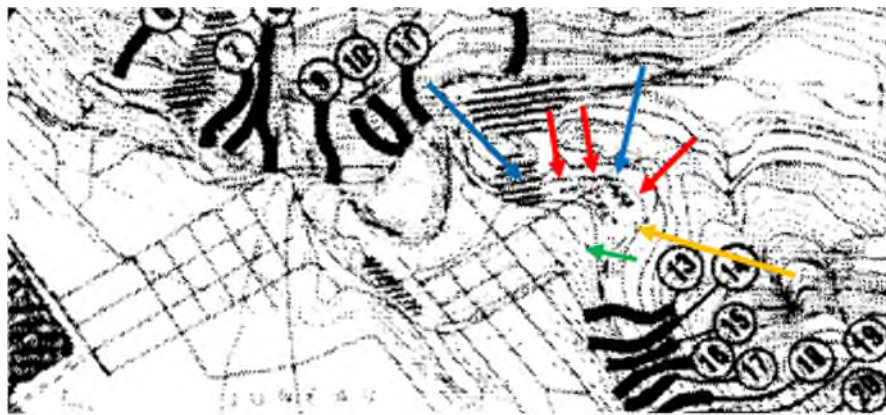
Swanston’s mapped rockslide hazard appears to continue around the corner to Nelson Street (more red arrows in Figure 5), although that is less clear due to the poor scan quality of Swanston’s mapping. The presence of rockfall/rockslide hazard areas along Nelson Street did not appear to be reflected in Swanston’s hazard mapping (Figure 4A).

On the southeast side of the subdivision, Swanston (1972) also found a record of a “slump” that occurred on November 27, 1935, at “5th Street above Kennedy” Street that did not cause damage. Swanston did not map that feature; however, nor did he detail the active slope processes at that location. The debris flow feature identified by Tetra Tech between Kennedy and Park Streets and upslope (southeast) of 5th Street, might be related to the “slump” mentioned by Swanston (located at approximately the orange arrow on Figure 5). That significant debris flow gully (called G000 Park in the new avalanche mapping) appears to be a different debris flow than the feature identified by Miller (1975), which is located slightly to the southwest, between East and Kennedy Streets (green arrow on Figure 5).

At that location, Miller (1975) showed a debris flow about 85 yards long that he reported as a 1972 event. Due to this location being located at the edge of one of the air photos, and possibly due to regrowth of vegetation since 1972, Tetra Tech’s review of the 1977 air photos was inconclusive. However, Google Street View (July 2011 imagery), near the southeast end of the paved part of East Street, clearly shows the aftermath of a recent debris flow and/or erosion type event from upslope of the road at 415 East Street. The 2013 imagery also suggests disturbed ground between the house closest to the road and the next house located almost due east at 622 4th Street.

Figure 5: Excerpt from Swanston (1972) Figure 7 – “Mass Wasting Channels and Rock Slide Areas.” Striped map areas are rockslide hazard areas; heavy numbered lines are mass movement channels.

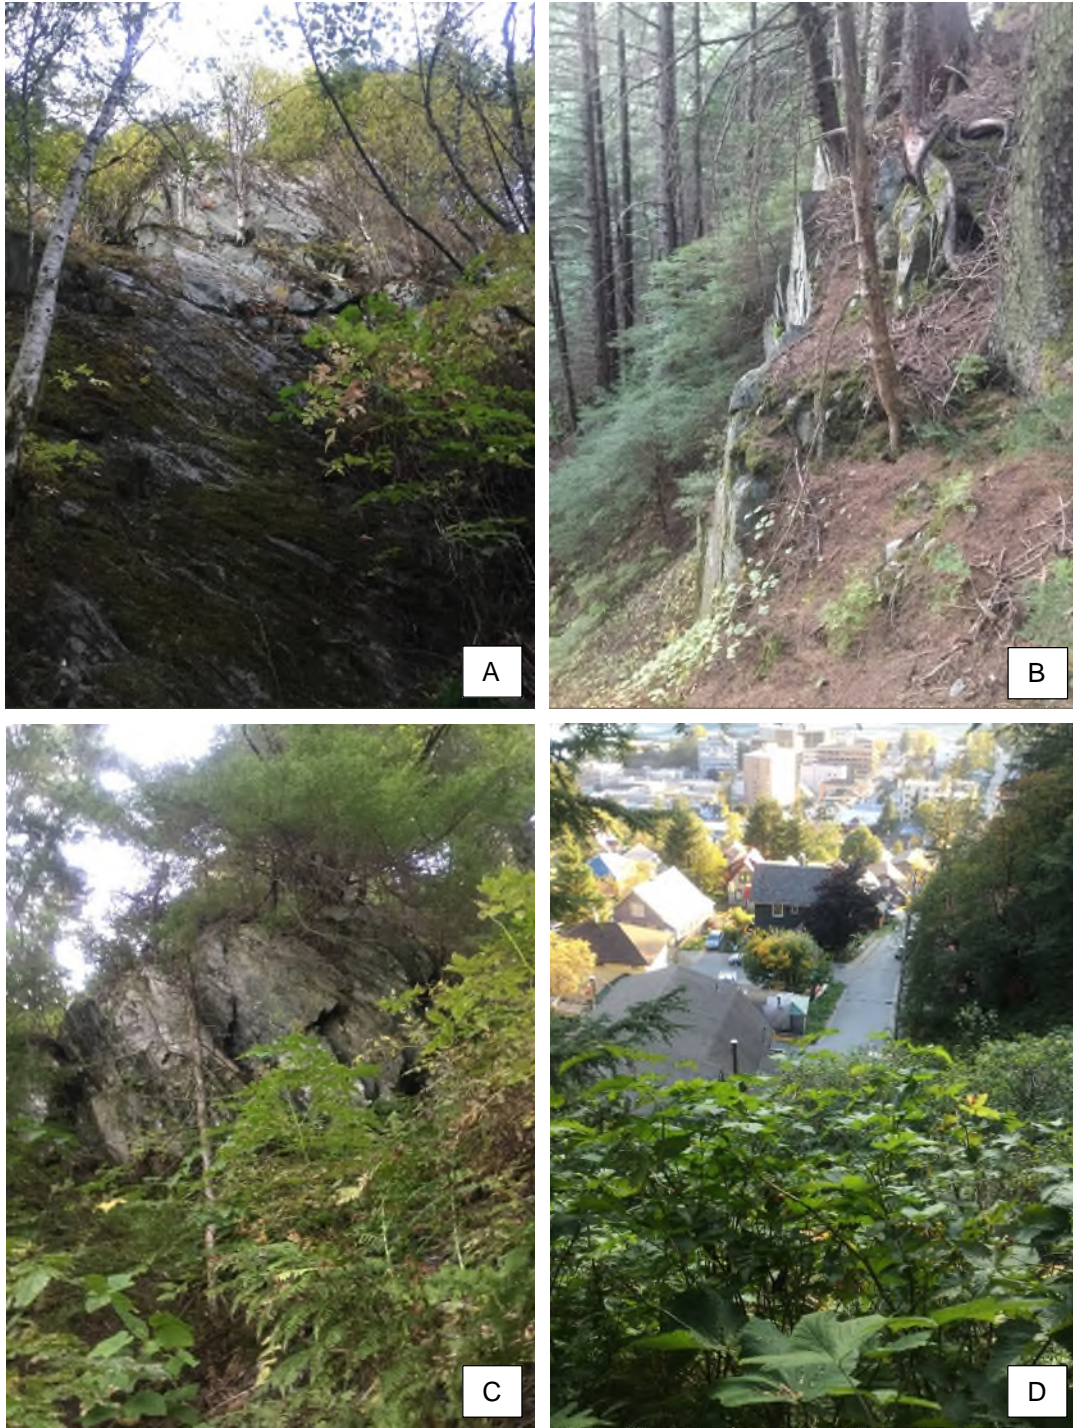
Figure 8: Rockslide track and cliff above rockfall at left-hand blue arrow on Figure 5 (Figure 8A); typical rock bluff above 6th Street at red arrows on Figure 5 (Figure 8B); rock cliff with detached blocks above corner of 6th Street and Nelson Street at right-hand blue arrow on Figure 5 (Figure 8C); and talus deposit below rock cliff, 6th Street visible below (Figure 8D).

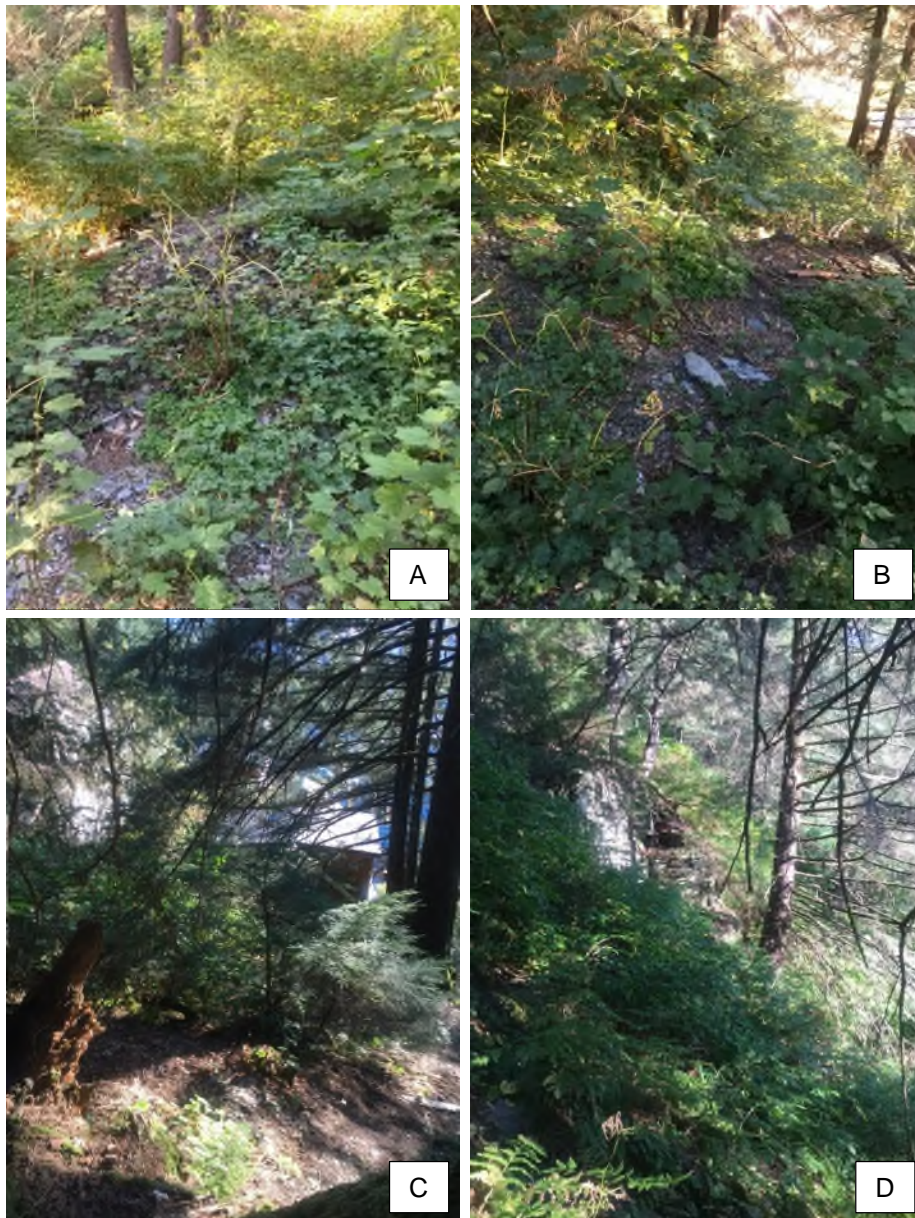
Answer: Upslope of Nelson Street, there are debris slides and rockfall (Figures 12 and 15). Due to additional information about landslides above Nelson Street and around the corner above 5th Street that was received during the public review process, the hazard in this area is now mapped as Severe (Figure 3B). Figure 9 shows some examples of active debris slide paths and rock bluffs above Nelson Street. See Question #3 for information on the effects of historical forestry activities on this slope and to see where the most prominent landslide paths are located. See Questions #5 and #6 for information on the slopes above the corner of Nelson and 5th Streets. See Question #12 for information on the possible effects of the old Mt. Roberts Trailhead.

Figure 9: Active debris slide paths above Nelson Street are shown in Figures 9A and 9B; rock bluffs and broken or damaged trees above Nelson Street are shown in Figures 9C and 9D.

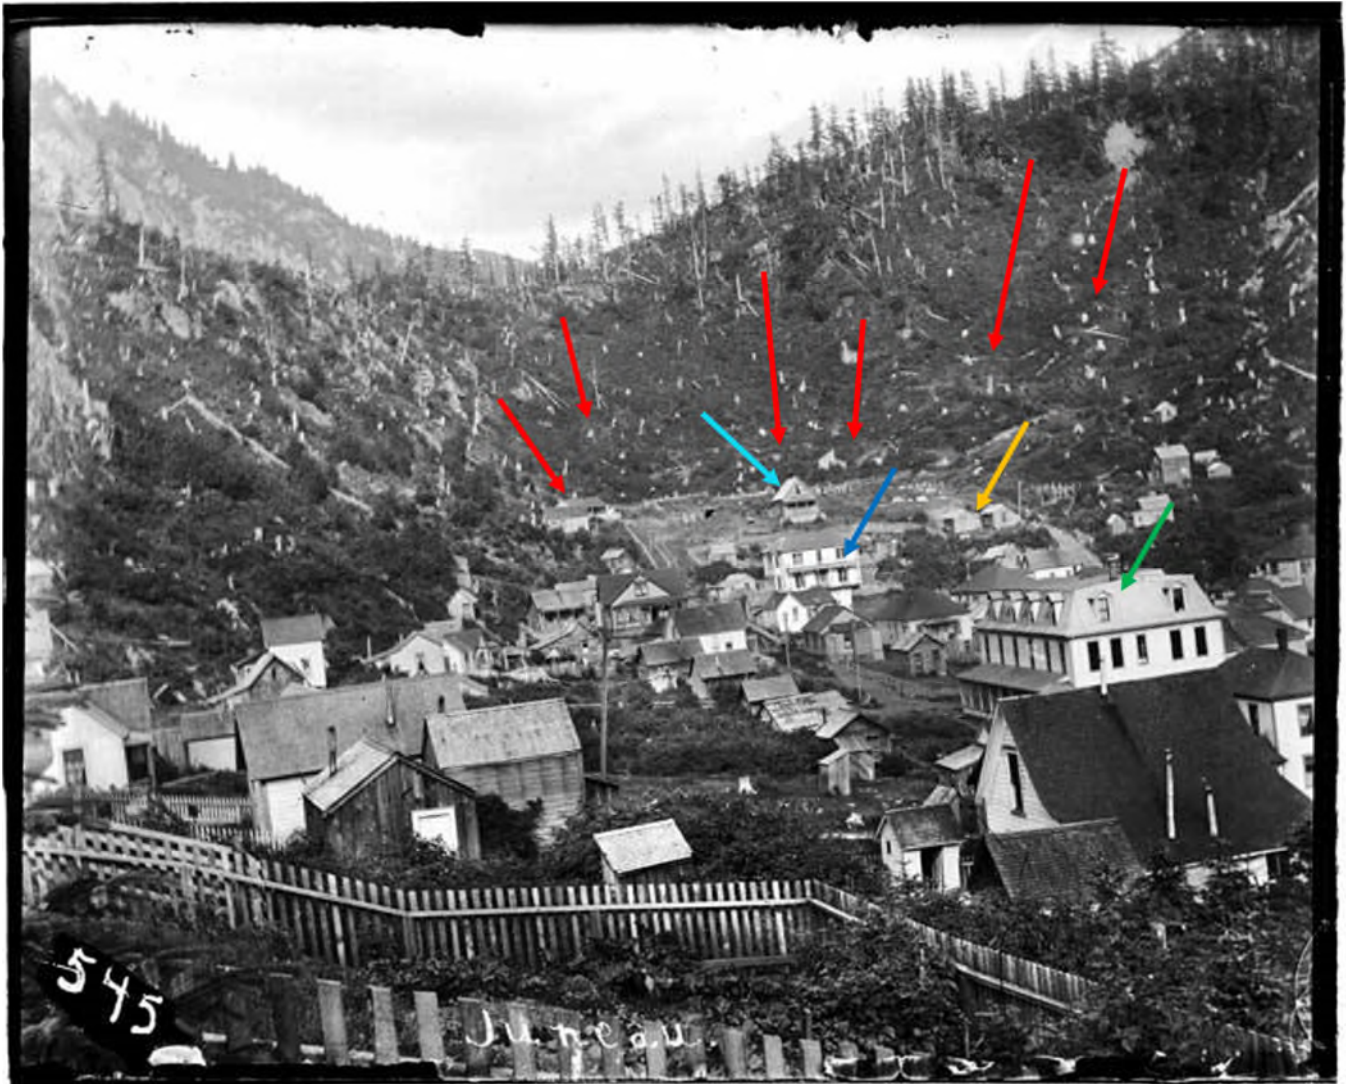
Figure 10: Looking east-northeast toward Starr Hill from top of Chicken Ridge, 7th and Franklin Streets, July 1901. Slopes appear to have been recently clearcut (within the previous few years) with numerous stumps visible. There are some swales and slope sections with few or no stumps, indicating that this slope was not uniformly forested prior to clearcutting (red arrows). At least two recent soil debris slides are visible above what appears to have been Park Street in 1901. (Photo credit: Alaska State Library – Historical Collections, [ASL-P1-506](#), Vincent Soboleff Photograph Collection, ca. July 1901.)

Landmarks shown in Figure 10 include the Distin-Dawes-Pelto House at 529 East Street (blue arrow), St. Ann's Hospital staff residence (green arrow) at the south corner of 6th and Harris Streets, apparent precursors to the Lund Houses I and II at 504 and 510 Kennedy Street (yellow arrow), and the Mitchell House at 715 – 6th Street (aqua arrow), based on the Inventory of Historic Sites and Structures (1986) and various historical photos from the Alaska State Library. Some of the dates and descriptions are uncertain in the inventory, and it is possible that changes or additions have been made to some of the structures that still exist. As well, some of the structures present in this photo no longer exist, or were replaced with other structures. Park Street appears to have been the approximate upper end of the developed area in 1901, since the earliest houses above Nelson Street were built in 1928.

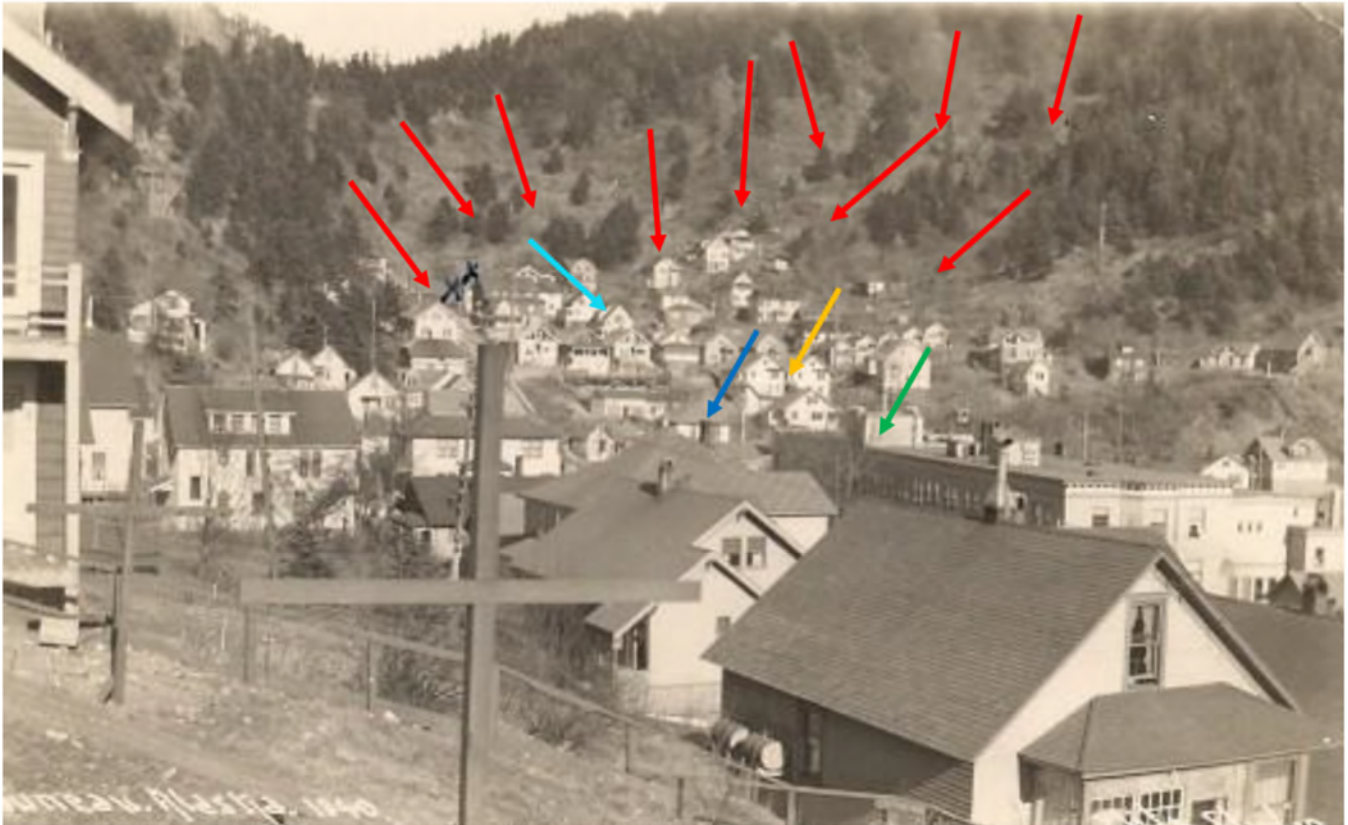
Figure 11: Looking east-northeast, this view of Starr Hill in 1940 is from a little further southwest of the view in Figure 10, and somewhat foreshortened. After more than 40 years of tree growth after clearcutting, the swales and gullies where no coniferous trees grow are especially clear in this photo. Selected swales and gullies are shown with red arrows; several other swales and gullies are also visible between the red arrows. (Photo credit unknown.)

Landmarks shown in Figure 11 include the Distin-Dawes-Pelto House at 529 East Street (partly obscured, blue arrow); St. Ann's Hospital (green arrow) at the south corner of 6th and Harris Streets, with the newer concrete section northeast of the green arrow (replacing the former staff residence), and the older wooden section to the southwest; the Lund Houses I and II at 504 and 510 Kennedy Street (yellow arrow); and the Mitchell House at 715 – 6th Street (aqua arrow), based on the Inventory of Historic Sites and Structures (1986) and various historical photos from the Alaska State Library. Some of the dates and descriptions of structures are uncertain in the inventory, and it is possible that changes or additions have been made to some of the structures that still exist. As well, some of the structures present in this photo may no longer exist, or were replaced with other structures. Nelson Street was the upper end of the developed area in 1940, with most of the houses above Nelson Street built by then.

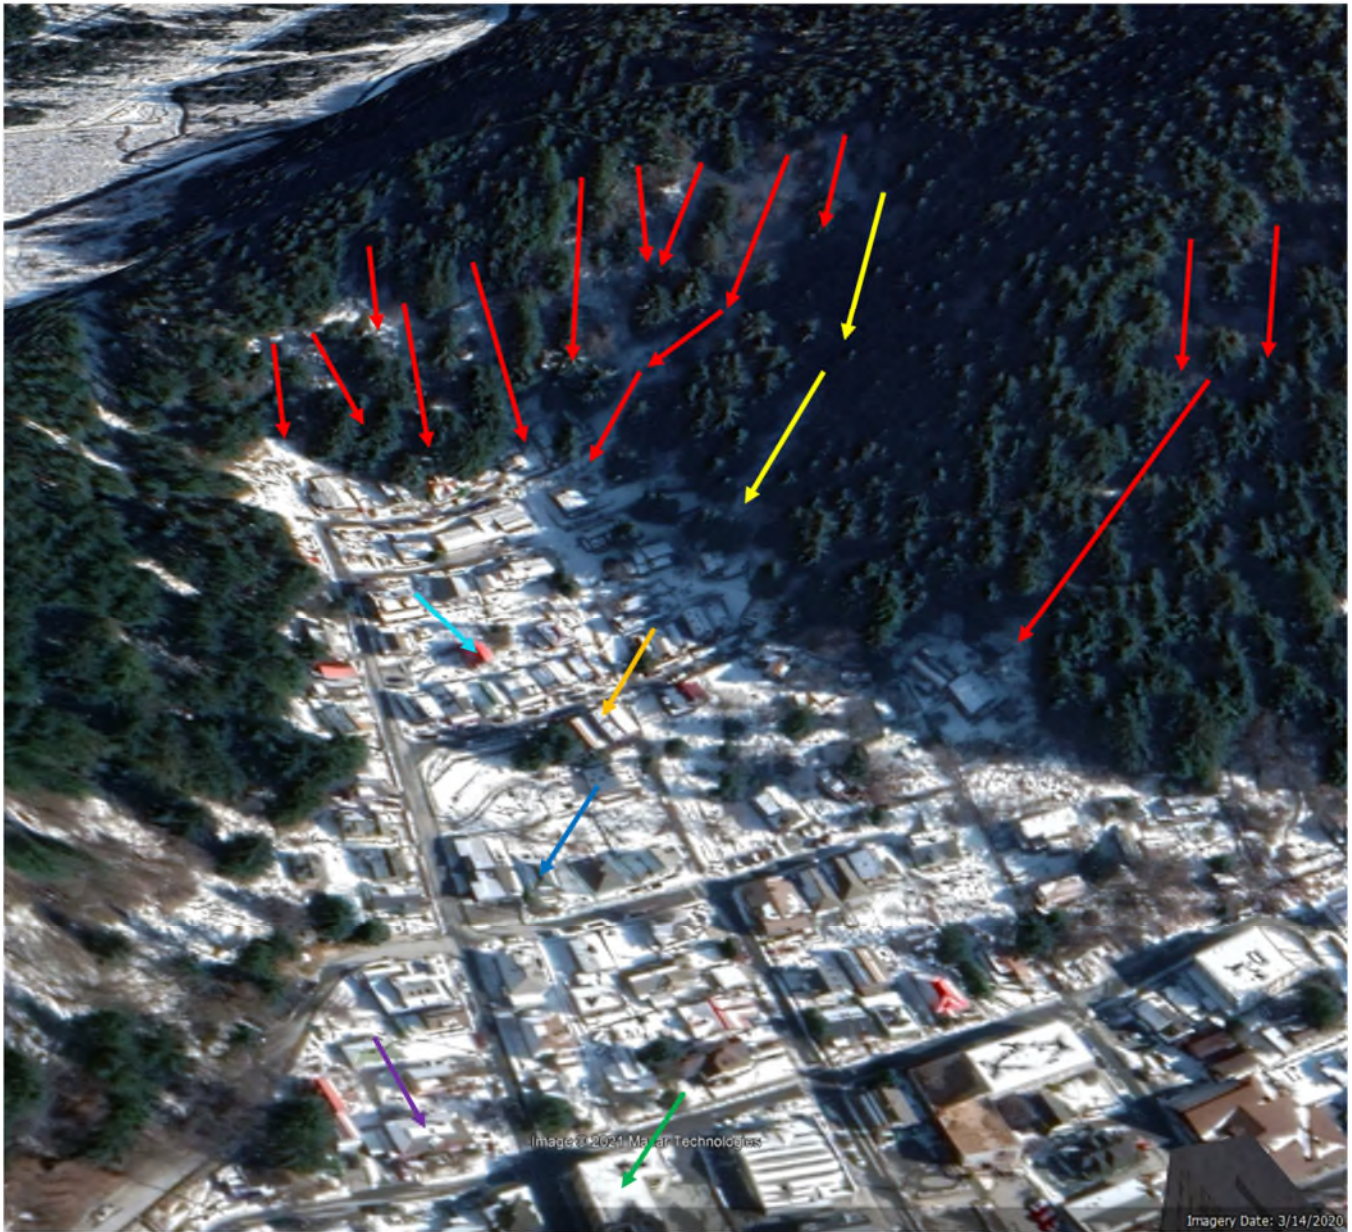
Figure 12: Looking east-northeast, this Google Earth view is from an eye elevation of about 1,100 feet and at a snowy time of year (March 2020), so that the areas without coniferous trees can be seen more easily. The same swales and gullies that lack tree cover that were seen in the 1940 photo (Figure 11) are still visible in 2020, along with a few more. The landmarks are the same as in Figure 11, although St. Ann’s Hospital is now called St. Ann’s Center, and a new landmark at Nelson House II has been added below Basin Road (purple arrow). (Image credit: Google Earth 2022.)

In Figure 12, one of the main gullies (shown with two bright yellow arrows, ending between Park and Kennedy Streets) is the G000 Park debris flow gully. See Figure 15 for more information about this gully.

On the right-hand side of Figure 12, for the area southwest of the G000 Park gully, there are two red arrows high on the slope and a longer red arrow on the lower slope. The two upper red arrows on Figure 12 show the main areas of slope instability activity higher on the slope and, as seen on Figure 15, this instability is related to the rock bluffs/cliffs upslope, resulting in rockfall/rockslides. The geology mapping shows that debris slides can occur in this terrain too. The lower longer arrow indicates a transition zone where most of the rockslide or debris slide material continues downslope. Due to the open-slope environment, this slope is not as hazardous as the debris flow gullies on either side. However, the prominent toe of slope at the edge of the residential area clearly shows the edge of this terrain unit, and the considerable proportion of ground with sparse or no tree cover upslope is indicative of ongoing slope instabilities. This is why this slope section has a *High* hazard designation.

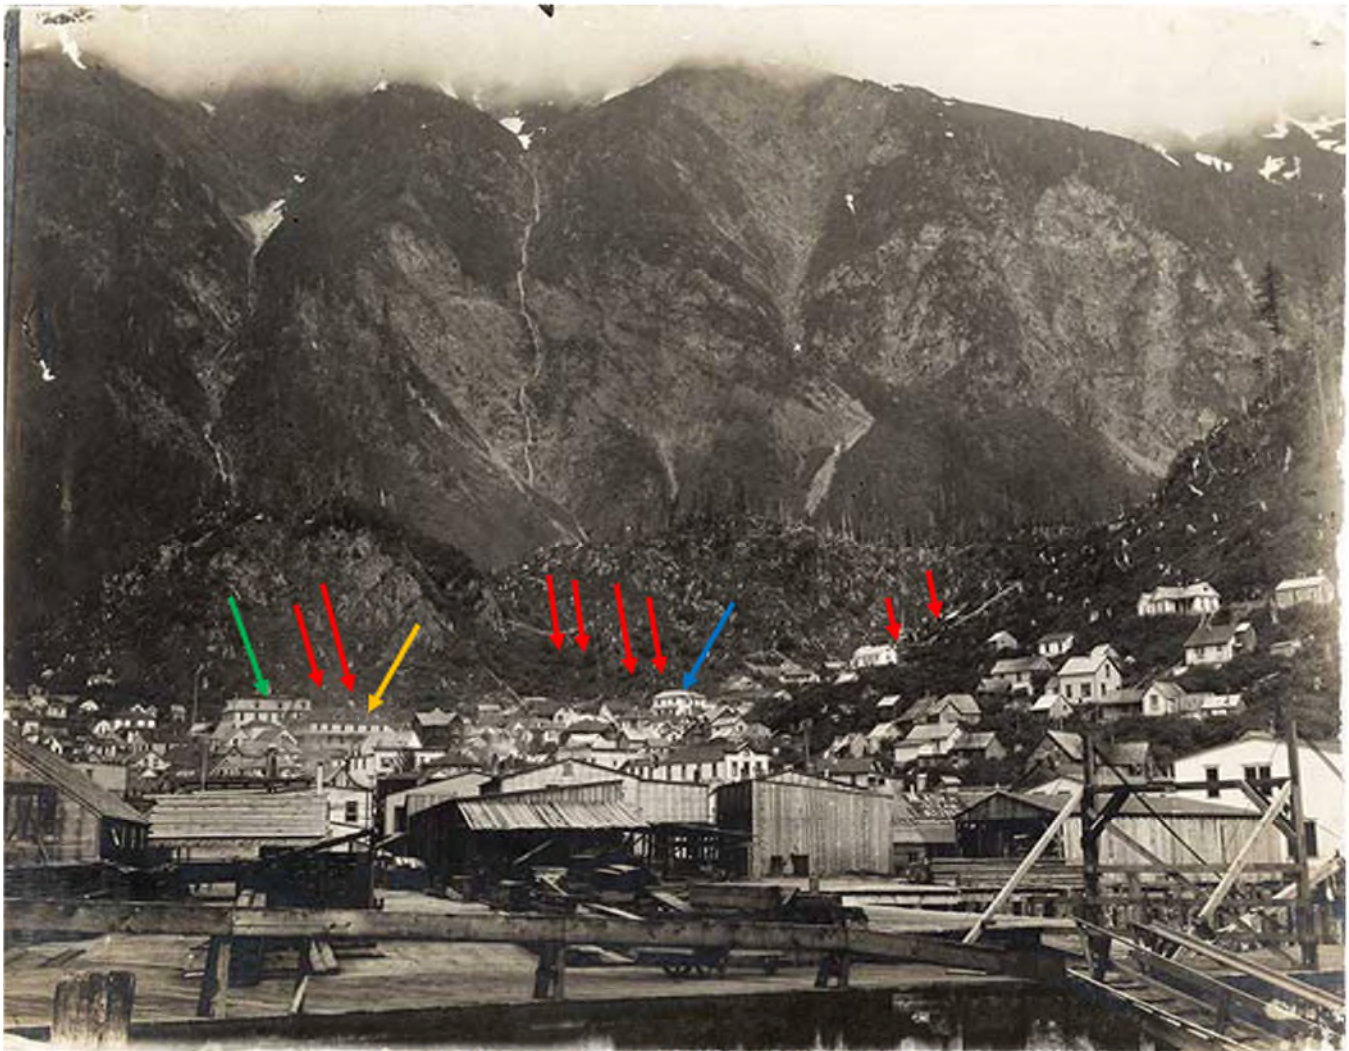
Figure 13: Looking north toward Starr Hill from the waterfront. Mt. Juneau is in the background. Slopes appear to have been recently clear-cut with numerous stumps visible above the buildings. The exposed rock slope on the west end of Mt. Maria (Decker Hill) is the location of the pre-historic rockslide, where in 1913 another major rockfall event would occur. (Photo credit: Alaska State Library – Historical Collections, [ASL-P334-16](#), Ark A. Tower Photograph Collection, June 8, 1902.)

The perspective of the 1902 photo (Figure 13) makes it more difficult than the 1901 photo (Figure 10) to see the slope details, and apparent logging debris remaining above the upper end of 6th Street also obscures the slope. However, there are some swales and slope sections with few or no stumps visible, indicating that the Mt. Maria slope was not uniformly forested prior to clearcutting (red arrows). Above 6th Street, areas lacking forest cover appear to be associated with the rock bluffs visible upslope. Landmarks include 529 East Street at the blue arrow, St. Ann's Hospital staff residence (green arrow). Just to the southeast along 5th Street (in the foreground of the staff residence) were the Church of the Nativity, the chancellery, and St. Ann's Hospital (later the school, and now the Parish Hall, orange arrow), based on the Inventory of Historic Sites and Structures (1986) and various historical photos from the Alaska State Library.

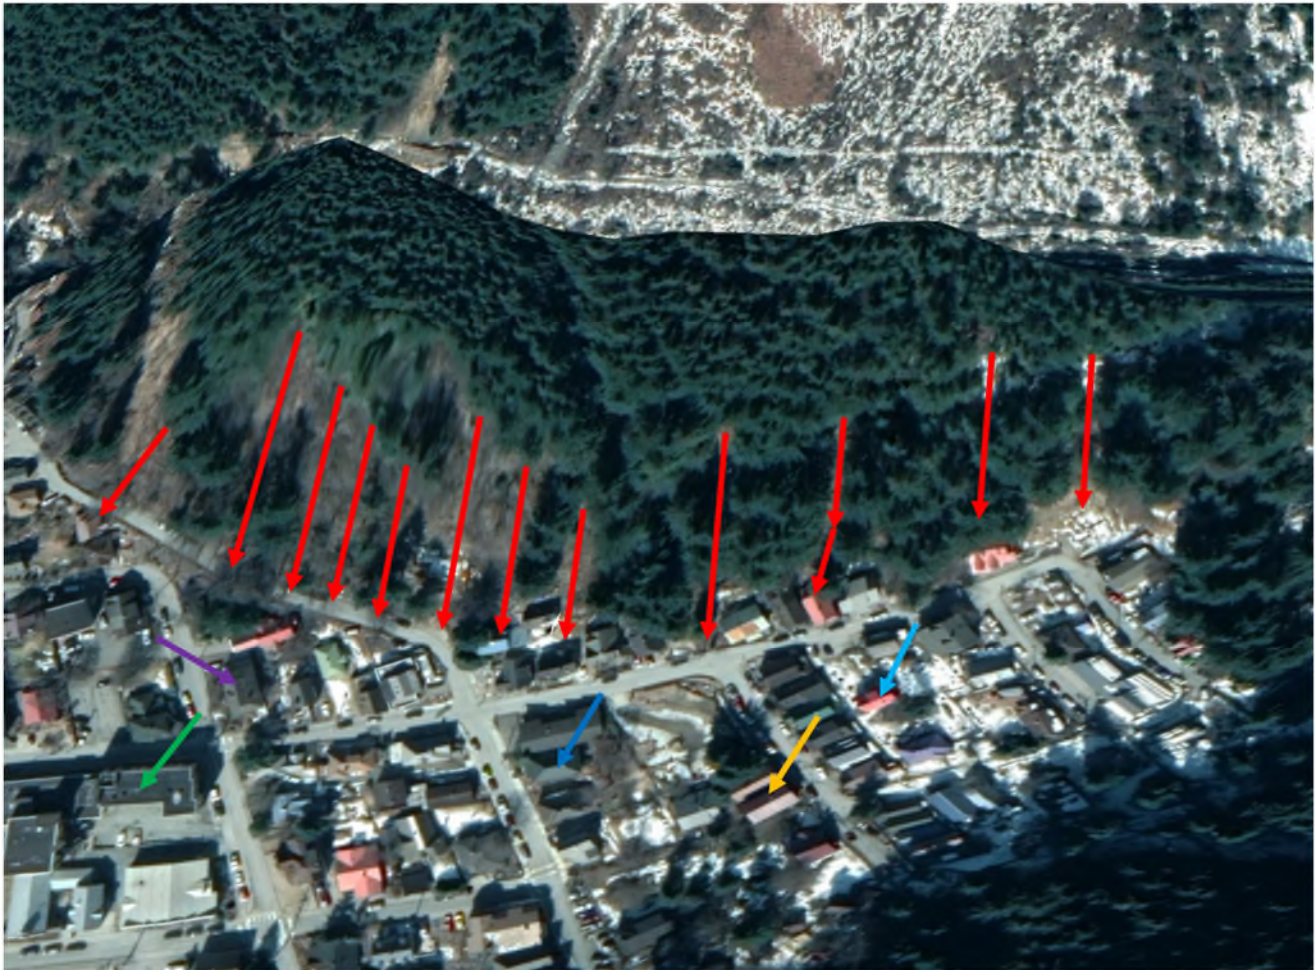
Figure 14: Looking north-northwest, this Google Earth view is from an eye elevation of about 1,100 feet in early spring (April 2020), so that the slopes currently lacking coniferous trees can be seen more easily. Several of the swales and slope sections lacking tree cover that were seen in the 1902 photo (Figure 13) are still visible in 2020, along with a few more slide paths (red arrows). The apparent alignment of the paths lacking trees is slightly different in Figures 13 and 14, due to the different perspectives of the images. The landmarks in Figure 14 are the same as those in Figure 12. (Image credit: Google Earth 2022.)

At the top ends of all the paths are rock bluffs or cliffs (Figure 14), which are the source of the rockfalls and rockslides that periodically scour out lower-growing vegetation along the paths, or damage mature trees alongside the paths if the debris is large enough. A couple of the paths seen in 1902 between Kennedy and Park Streets are obscured by trees in 2020 but are likely still present under the tree canopy. Some of the swales that seem to end mid-slope in this image likely continue further downslope under the tree canopy. In some areas of the slope, there are still some trees below rock bluffs, but they tend to be smaller than the trees on slopes not regularly affected by rockfall or rockslide debris (Figure 7). On the far left, the path shown crossing Basin Road represents the rock debris that impacted 712 Basin Road about 12 years ago (CBJ 2020).

Three cutlines are visible in Figure 14: on the left, the powerline above Basin Road; in the middle, where an old cutline crosses over to the north side of Mt. Maria; and, on the right, parallel to 6th Street, another old cutline crosses above the corner of 6th and Nelson Streets into Last Chance Basin. The latter two cutlines may be related to old mining infrastructure, and/or powerlines.

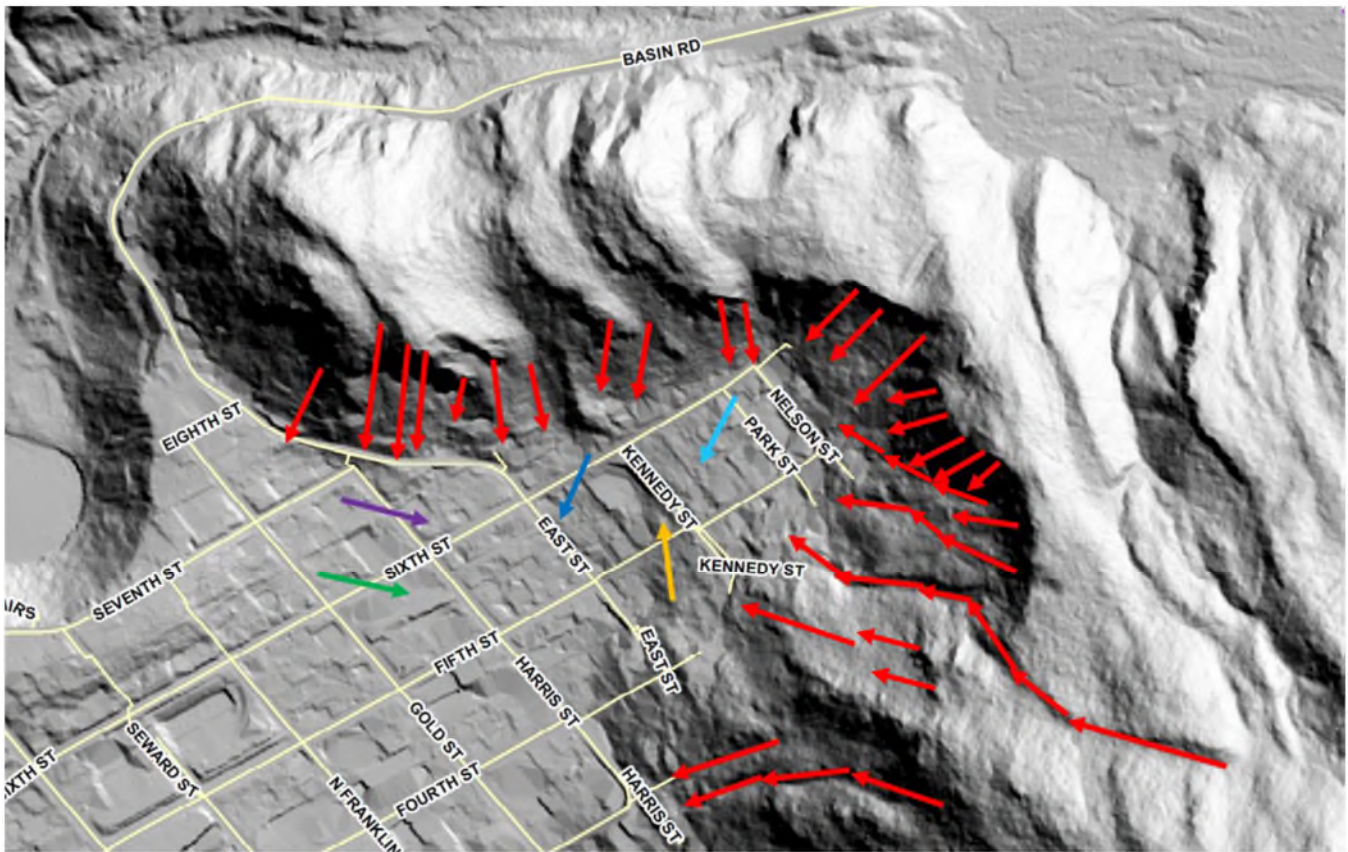
Figure 15: This excerpt from the 2013 LiDAR image shows several bedrock cliffs and bluffs above Basin Road, 6th Street, Nelson Street, and the north end of 5th Street. Fieldwork identified numerous active rockfalls/rockslides as well as some debris slide areas that confirm the observations from the LiDAR and the air photo mapping (Figures 6, 7, and 8). Apparent landslide locations shown are based on poorly-vegetated slopes, swales and gullies seen on Google Earth that are also visible on LiDAR hillshade models (red arrows). Landmarks are as for Figure 14. (Image credit: CBJ 2013.)

The longest red arrow in Figure 15 shows the location of the debris flow gully within the G000 Park avalanche path. This gully appears to receive water and debris not only from the local slopes immediately above 5th Street, but also from surface drainage swale or gully that originates further upslope along the Mt. Roberts crest.

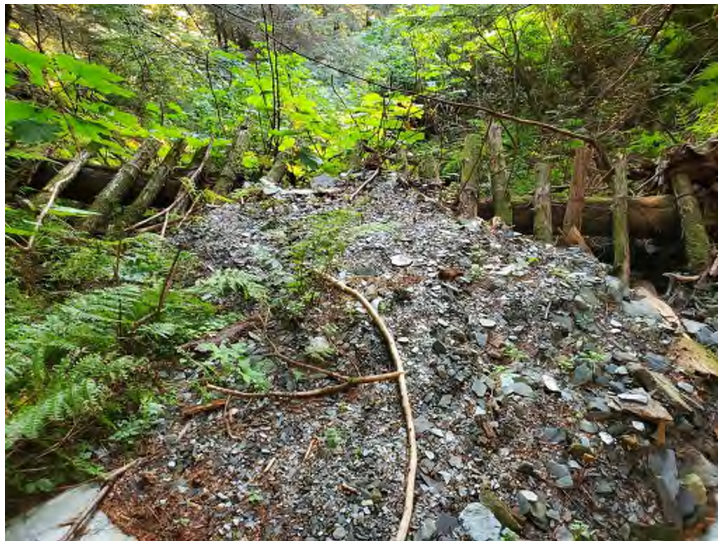
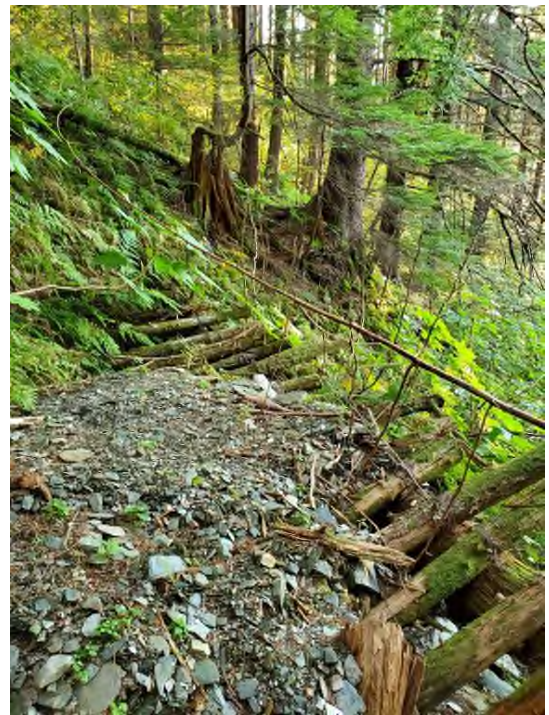
Figure 16: Photos from the fieldwork in September 2019 showing one of the existing debris-flow mitigation structures that were built by homeowners living below the G000 Park debris flow path above Starr Hill. This structure has captured debris material from one or more mass-wasting events and measured about 8 feet wide by 7 feet long by 2 feet deep.

Depending on the size of the next debris flow, the structure shown in Figure 16 could retain a little more debris or, instead, it could collapse, be overrun by debris, or even be completely scoured out by a larger debris flow that could originate from further up the gully. The same applies to the other structures documented by residents. Debris can incorporate both large and small woody debris, as seen in these photos and the photos supplied by residents of the mid and upper reaches of the gully. The upslope portion of this debris flow feature is bowl-shaped, indicating the potential for small debris slides from the side slopes to fail and entrain debris in the gully, of which there is a significant amount. The particle size of the material that can be moved by a debris flow is

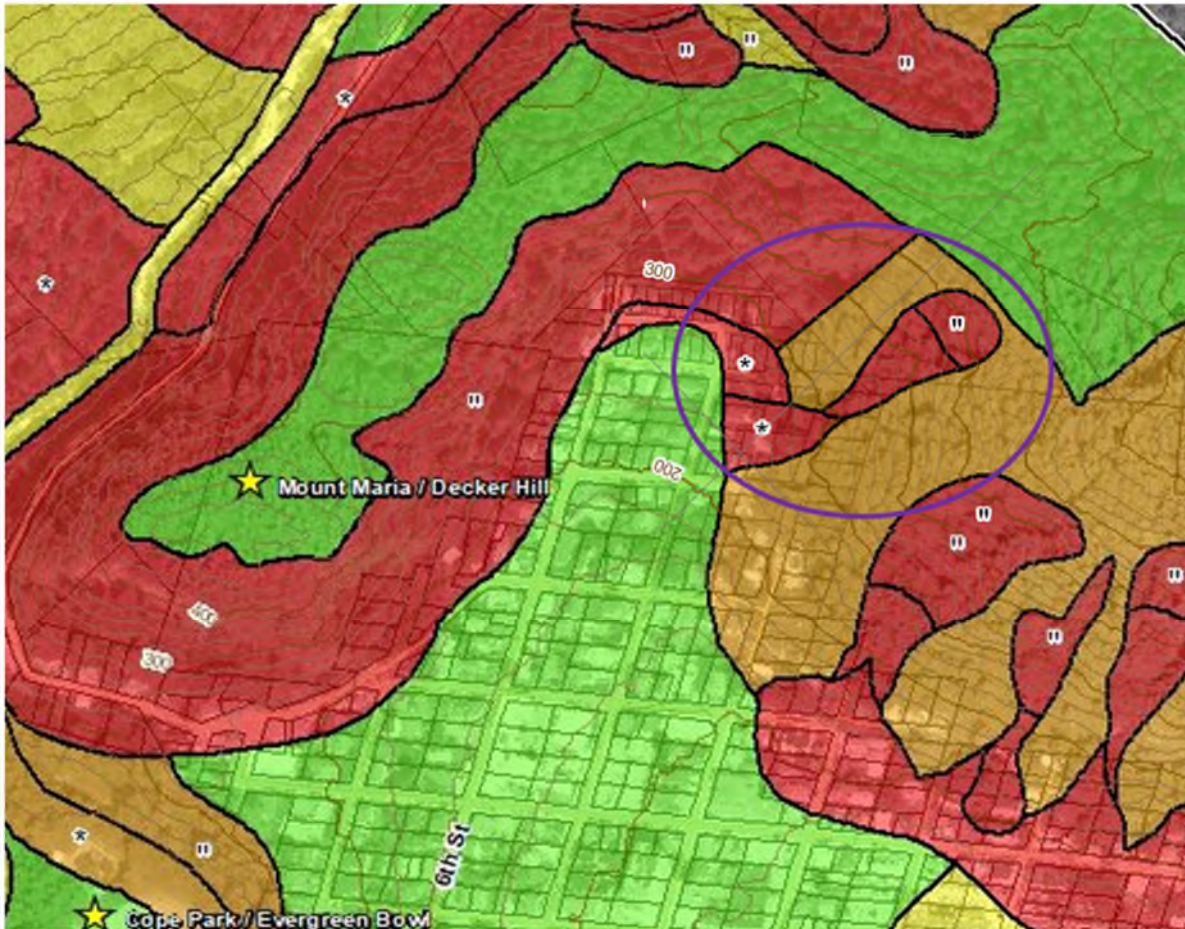
Figure 18: Excerpt from the landslide hazard designation mapping. The purple outline shows an area where residents requested more information to understand the shapes of the mapping units and the reasons supporting the hazard designations.

Specific to this area of Starr Hill, it is now known that a resident has identified a recent landslide event in a *High* hazard zone (see Question #6 above), which also happened to be within one of the apparently odd-shaped hazard units (Figure 18, purple outline). This area has now been updated, resulted in a shifting of the hazard boundary above the corner of Nelson Street and 5th Street. Note that the *Severe* hazard zone mapped at the toe of slope is due to this area being a deposition zone for slide debris.
