SUBJECT: National Pollutant Discharge Elimination System (NPDES) Facility Inspection Report.
Permit Number AK-002321-3 for the City and Borough of Juneau, Juneau Douglas Wastewater
Treatment Plant.

APDES INSPECTION REPORT

Permit Number	Announced / Unannounced	Facility Type	Receiving Waters	Weather	Inspection Date
AK0023213	Announced	Domestic	Gastineau Channel	Clear	09/15/2014

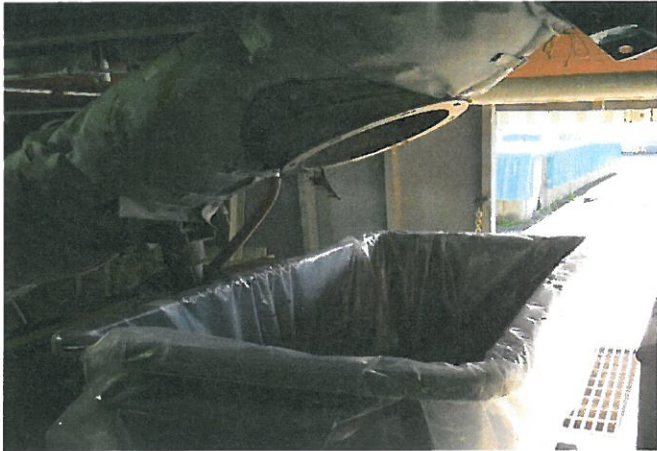
Photo 01

Grit Bin

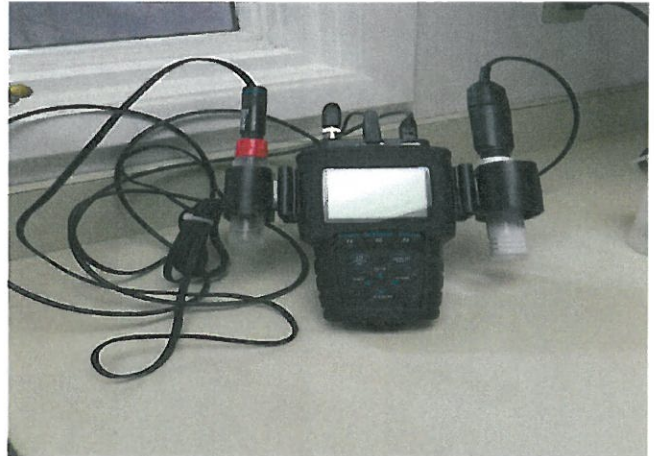
Photo 02

Orion pH and DO Meter

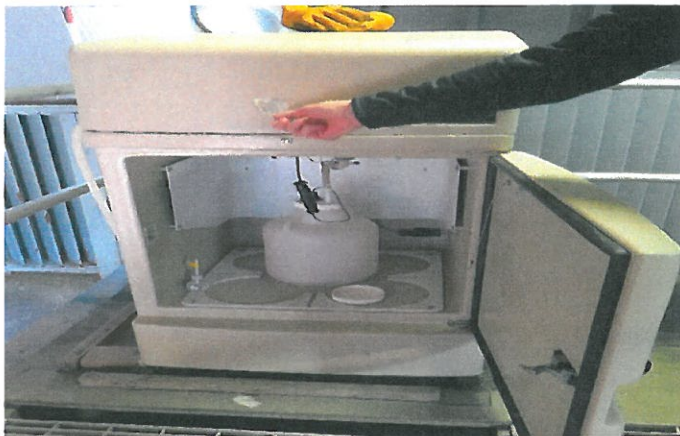
Photo 03

Composite Sampler

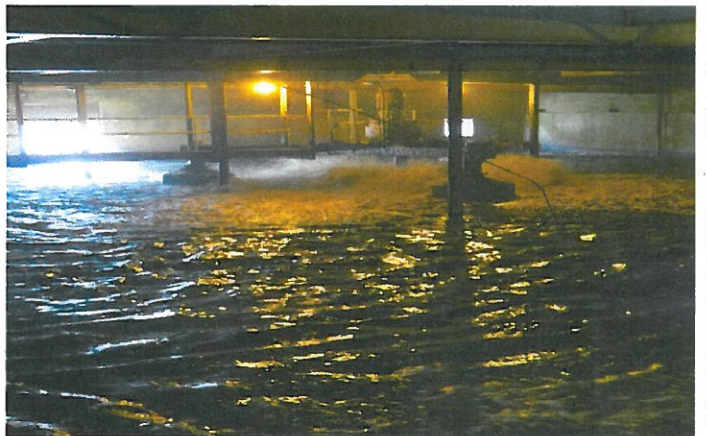
Photo 04

- According to previous ADEC inspections, the catwalks over the aeration basins have been unstable and deteriorating for a number of years making it unsafe for the operators to enter the building and perform operations and maintenance. ADEC acknowledges that plans have been made to replace these catwalks, however at the time of the inspection, the dates the replacement is to occur were unknown.

Aeration Basin

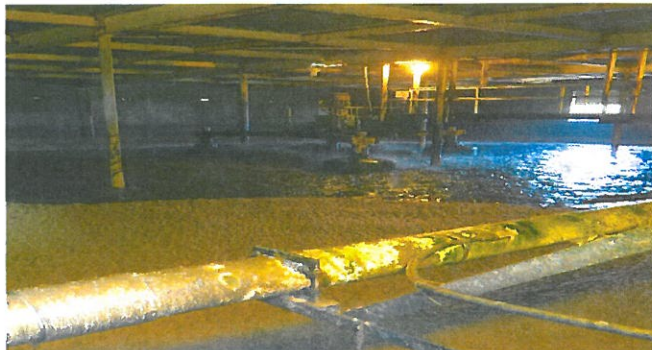
Photo 05

Digester

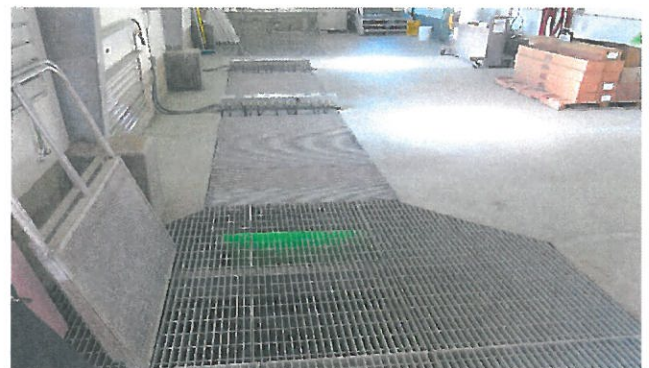
Photo 06

UV Disinfection

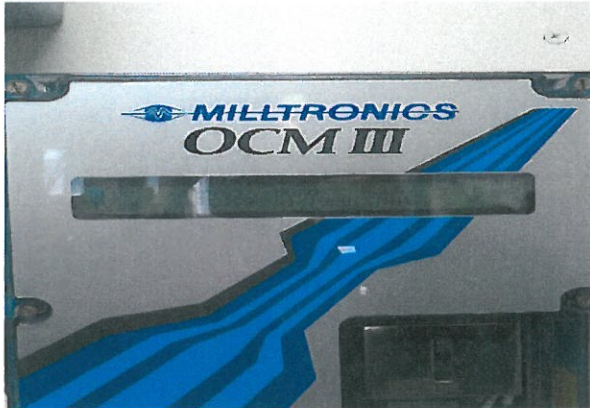
Photo 07

Milltronics Flow Meter

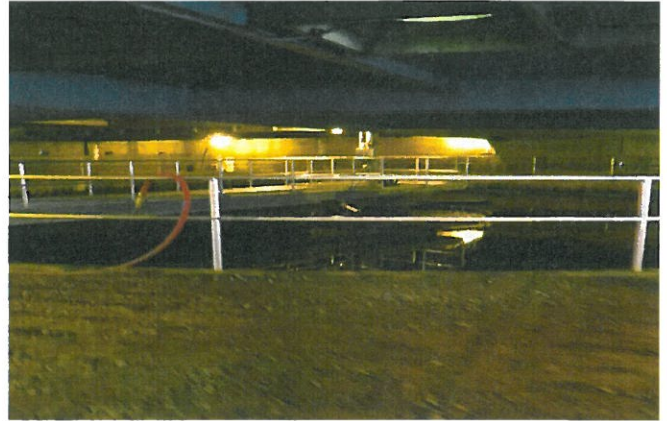
Photo 08

Clarifier

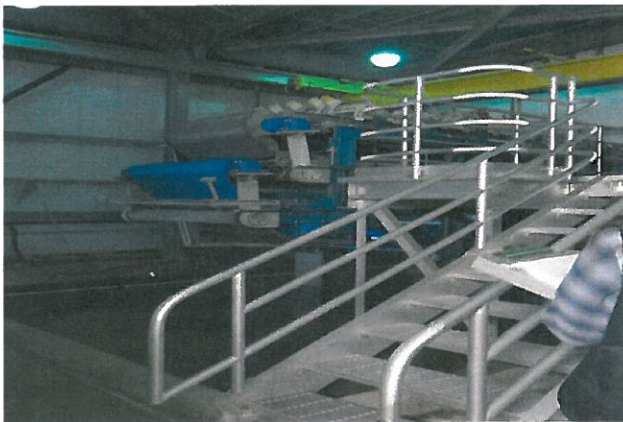
Photo 09

Belt Filter Press

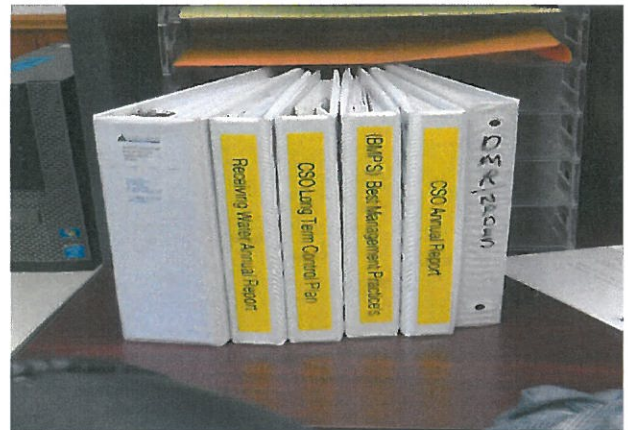
Photo 10

Document Binders

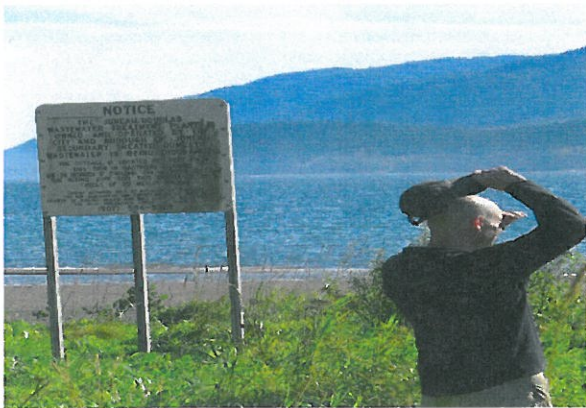
Photo 11

Outfall Signage

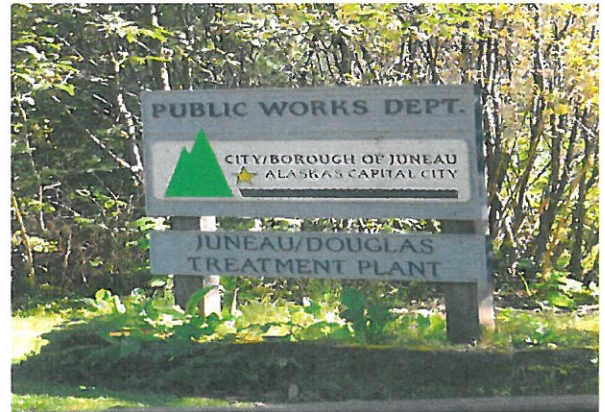
Photo 12

Entrance Signage
