Subject: FY 11 Marine Passenger Fee Proceeds Recommendations

AUGUST 19, 2009

# JUNEAU CENTENNIAL HALL ROOF CONDITIONS ASSESSMENT

Jensen Yorba Lott, Inc 522 W 10<sup>th</sup> St. Juneau, AK 99801 907-586-1070

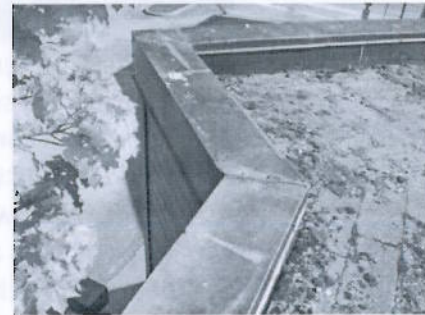
The perimeter walls are capped with aluminum coping and a continuous aluminum wall flashing. Virtually none of the roof or wall membrane is exposed to the exterior. The flashing has an exposed fastener at the inside face, and a concealed retainer clip at the outside face. This was a wise choice because of the large number of ravens, crows and seagulls that regularly frequent the Centennial Hall Roof.

We recommend that the metal parapet flashing be replaced with aluminum of similar gage and configuration as the existing flashing. The walls are made from treated wood and plywood, either preservative treated or fire retardant treated. Either one can be reactive to ferrous metals. The aluminum has fared very well in this application and we recommend repeating it. We suggest that the aluminum not be painted, but rather be dark bronze anodized to match the existing building.

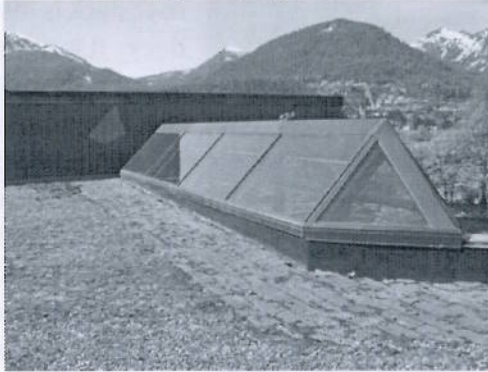
There is a large sloping skylite structure at the south side of the building. The base of the skylite includes a counterflashing similar to a Fry "Springlok" type counterflashing so that the membrane roofing can be removed without disturbing the skylite frame.

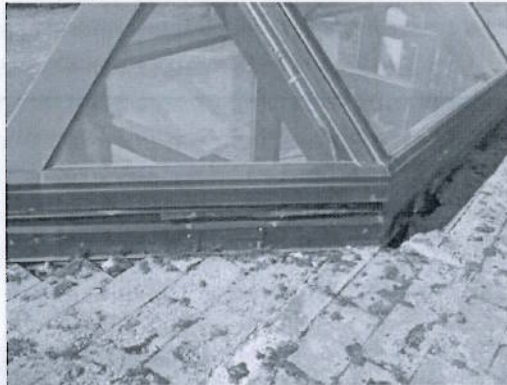
The skylite system itself is a wet glazed system, and is glazed with silicone sealant and appears to be in good condition.

The skylite is faring very well, and while it could be considered for resealing, it does not appear to be a critical at this time. The silicone sealant is essentially a 50 year product, and is only halfway through its service life. Since it is not leaking, we suggest it remain in place.

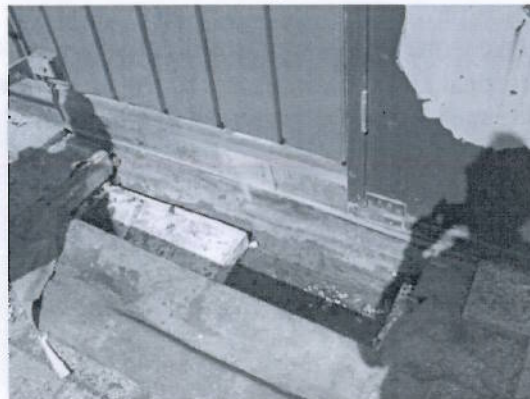
At some point after the original construction leaks at the perimeter walls were experienced. These leaks were apparently due to a lack of expansion capability at the roof to wall connection. When the roof is heavily loaded, such as after a snow event, roof deflection can break the roof membrane along the roof to wall joints. As a result, a follow on project occurred, in which the original asphalt wall flashing was replaced with a Firestone EPDM membrane, over what appears to be a closed cell foam rod which is used as a roof to wall expansion joint. The membrane was bedded to the existing roof membrane and the insulation re-installed. This

measure apparently corrected the leaks. This appears to be the only modifications to the roof assemblies since the original construction.

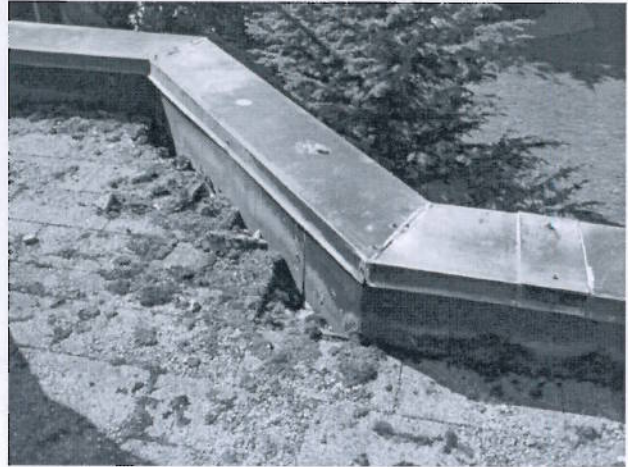
The roof is reported to leak in a few areas but has generally performed well. The IRMA roof configuration is a poor insulator, as much of the heat desired to be saved is in fact washed down the roof drains. This is especially true in the dead level configuration of this roof where a constantly flowing stream of water runs between the insulation and the roof membrane. The ballast stones

are barely visible in a number of locations due to the heavy moss build up. The ballast pavers are significantly deteriorated in many locations, so much so that they crumble upon contact. The extruded insulation contains a significant amount of water. According to manufacturer Dow Corning, the exposed insulation is subject to freeze thaw cycles, often while wet. Eventually the expanding water crystals begin to break down the insulation, forming voids that fill with water, repeating and speeding up the process. The membrane is well protected, and is likely in fair condition. The prognosis is uncertain. We exposed the membrane at two

Virtually all materials above the roof membrane should be replaced. Since the IRMA configuration is significantly less energy efficient than other options, we believe the best solution would be to remove all roof materials down to the asphalt roof membrane which could be used as a use it as a vapor barrier and install a conventional exposed membrane roof over an appropriate thickness of tapered insulation. However, the existing asphalt membrane is likely not fully adhered to the base materials below since it was a ballasted assembly. In similar applications we have mechanically installed a separation board over the existing membrane and proceeded with the roof assembly. However, the existing concrete deck that occurs in a significant area of the roof can make this approach problematic on two regards. The mechanical fasteners can be difficult to install into a concrete deck, and could be potentially difficult to remove in future roof replacement projects. It is appropriate to consider the roof replacement as two separate problems- the existing roof membrane/deck and all other roof components. They will be considered in the following Roof Options section.

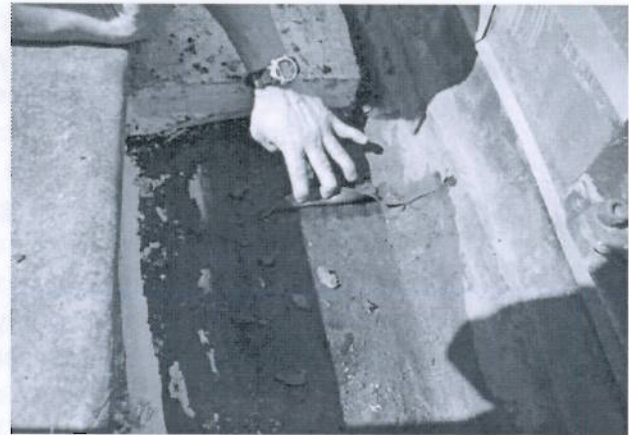
locations, at the roof to wall joint and in the field next to a roof drain. At 24 years of age, the asphalt roof membrane has served a long service life and appeared to be in good condition. At the roof to wall joint there is concern about the base flashing on two regards. First, the adhesives used to connect and seal the EPDM seams is breaking down.

Secondly, the connection of the EPDM base flashing to the asphalt membrane is an unusual condition requiring intermediate materials which likewise can be breaking down.

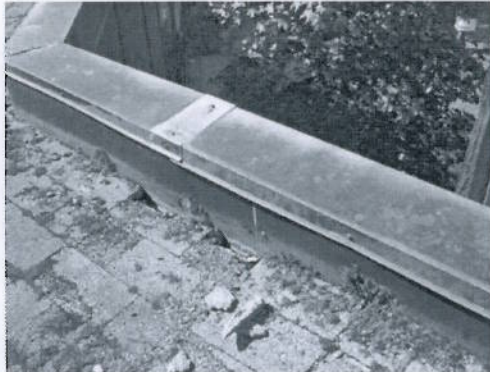
The aluminum flashings are in fair condition. The aluminum is not badly deteriorated, but the factory finish is beyond its useful life. The fasteners are likewise disintegrating.
