CBJ DOCKS & HARBORS BOARD
OPERATIONS COMMITTEE MEETING AGENDA
For Tuesday, February 15, 2011

Subject: DeHart's Marina Condition Assessment
Inspection Report

Appendix B

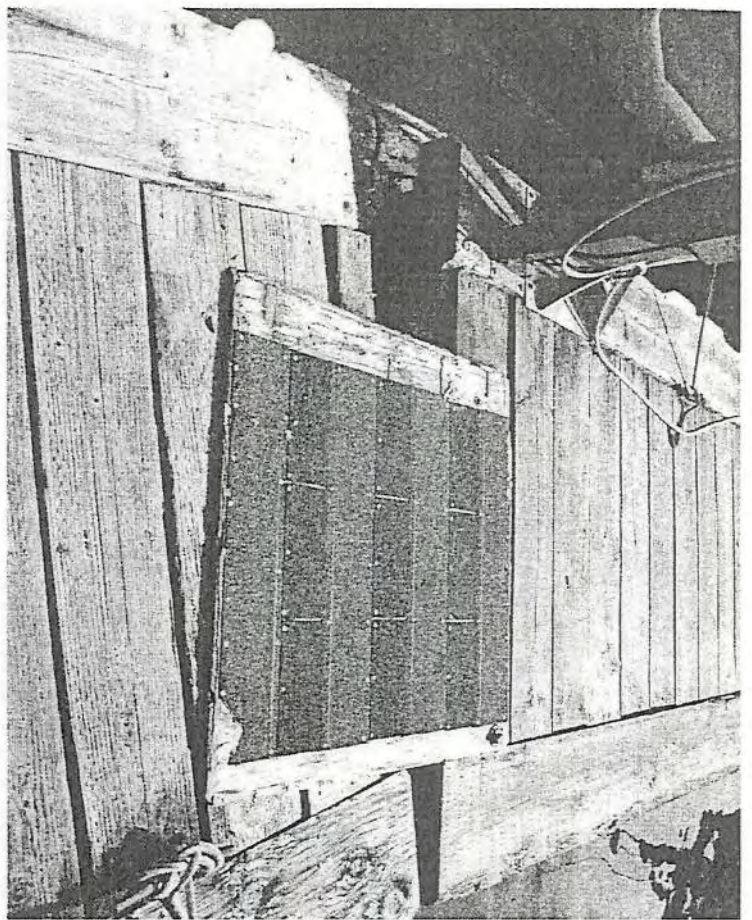
Site Inspection July 23 2004 07.JPG
Plywood Transition Plate

- g) The plywood transition plate between the two portions of Float A is old and in poor condition.
- h) Seven of the bullrails show significant rot or have significant splits. They are in poor condition.

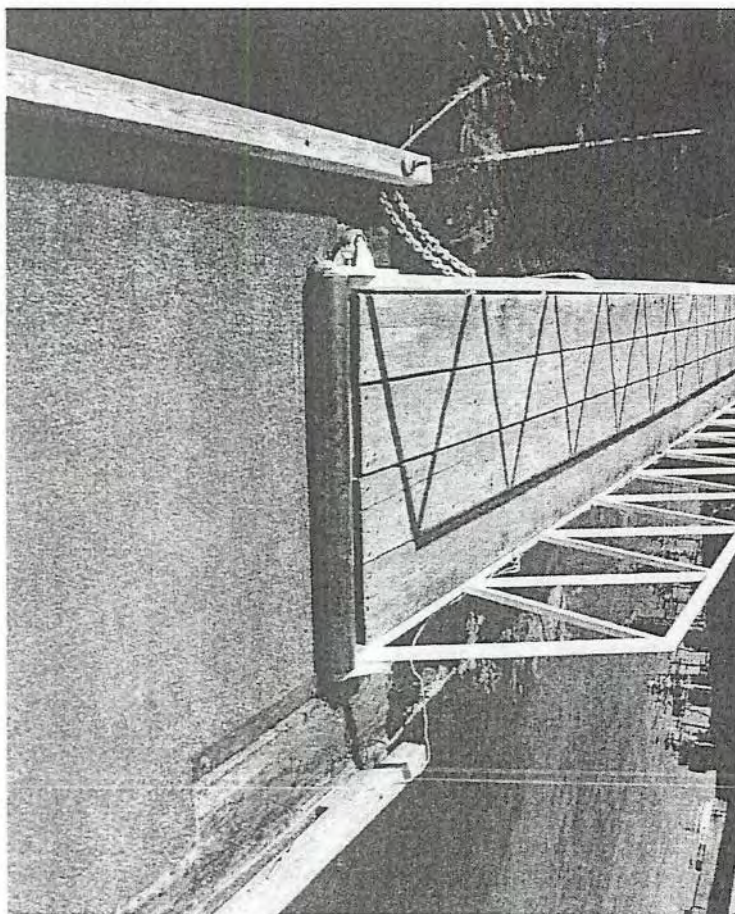
Site Inspection July 23 2004 13.JPG
Secondary Gangway (Transition Plate Missing)

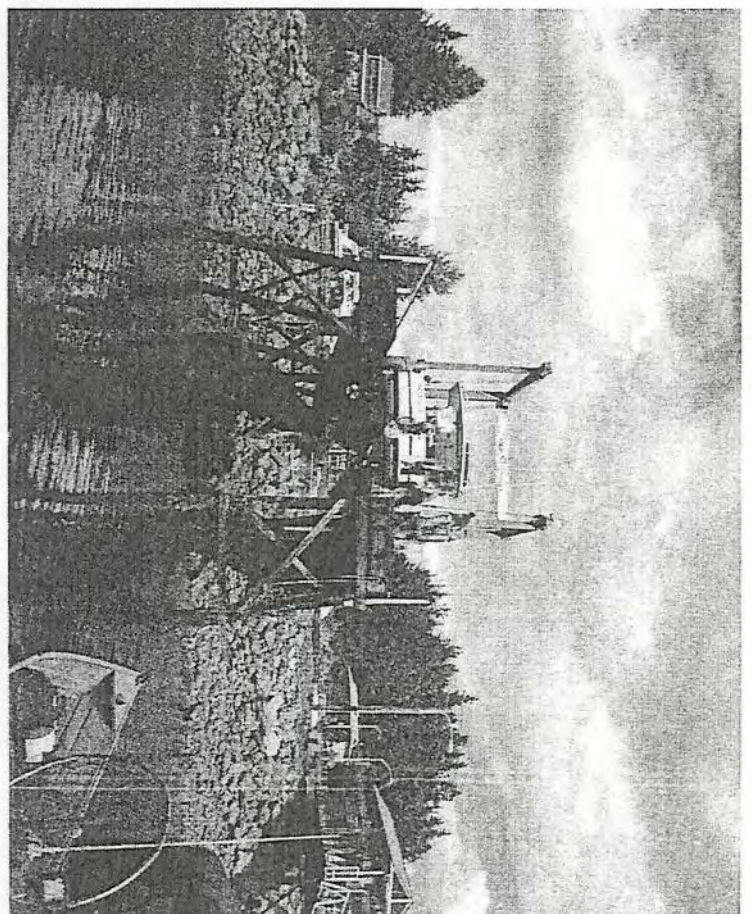
Site Inspection July 23 2004 23.JPG
Haul Out

- a) The piles are in good condition except for two that are split at the top.
- b) Six of the ten pile caps are either split or display rot.
- c) Three of the deck planks are in poor condition.
- d) Two end struts are split and are in poor condition.
- e) There are 29" side openings in the railing. This violates the 2000 International Building Code requirement that restricts side openings to an opening that a 4" sphere can pass through, unless access is restricted to the site.

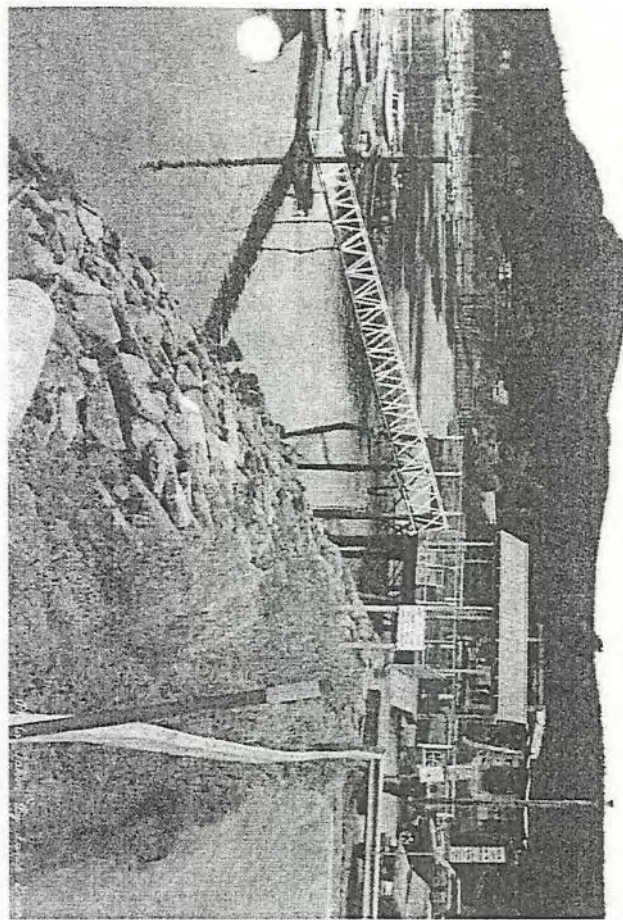
Site Inspection 07-26-04 05.jpg
Access Trestle and Main Gangway

- a) The deck planks were drilled in four places and are in fair condition.
- b) The pile caps, stringers, and rails are in good condition.
- c) The piles are in good condition except for the southeast pile, which was split at the top and is in poor condition.
- d) One of the cross-braces exhibits rot and is split.

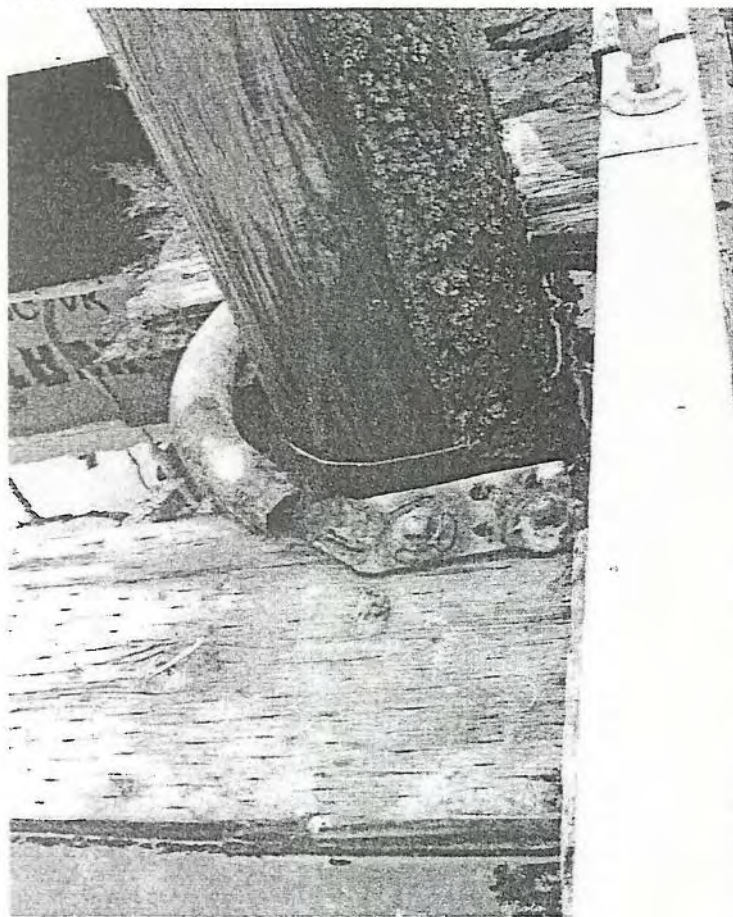
- c) Most of the keeper timbers are missing steel pipe hoops, and one of the hoops is broken.
- d) The piles all show significant wear and the treatment is worn through on many of the piles. Two of the piles have splits in them and are in poor condition.

Site Inspection 07-26-04 11.jpg
Broken Pile Hoop

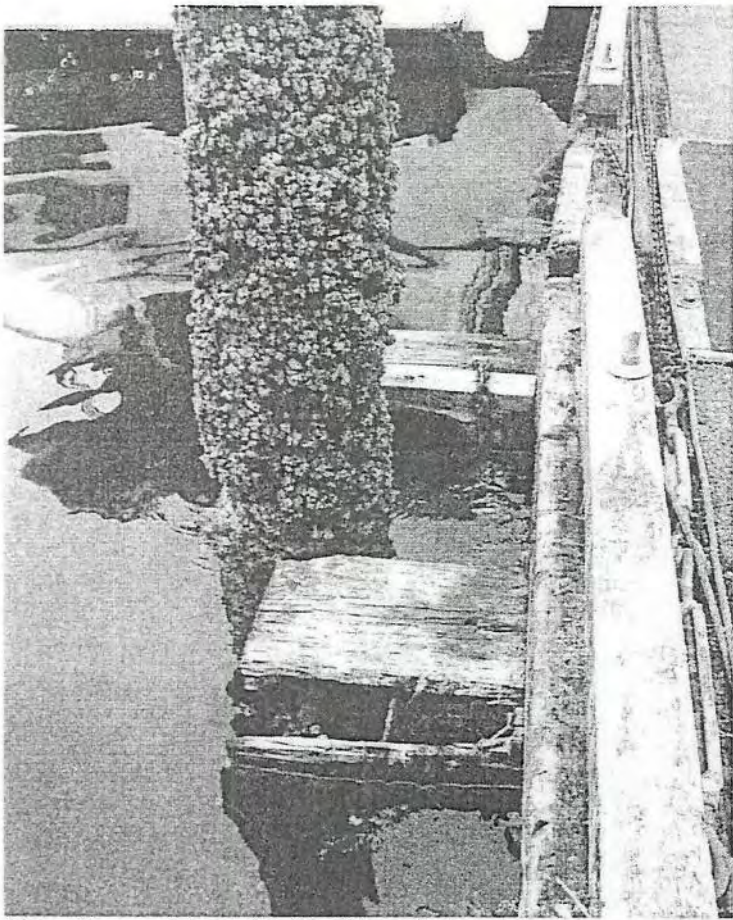
- a) The deck planks were drilled in 38 places and all samples exhibit some degree of rot. These are of very poor condition.
- b) The keeper timbers all show rot and wear from rubbing on piles. These are in poor condition.

Site Inspection 07-26-04 15.jpg
Keeper Timber

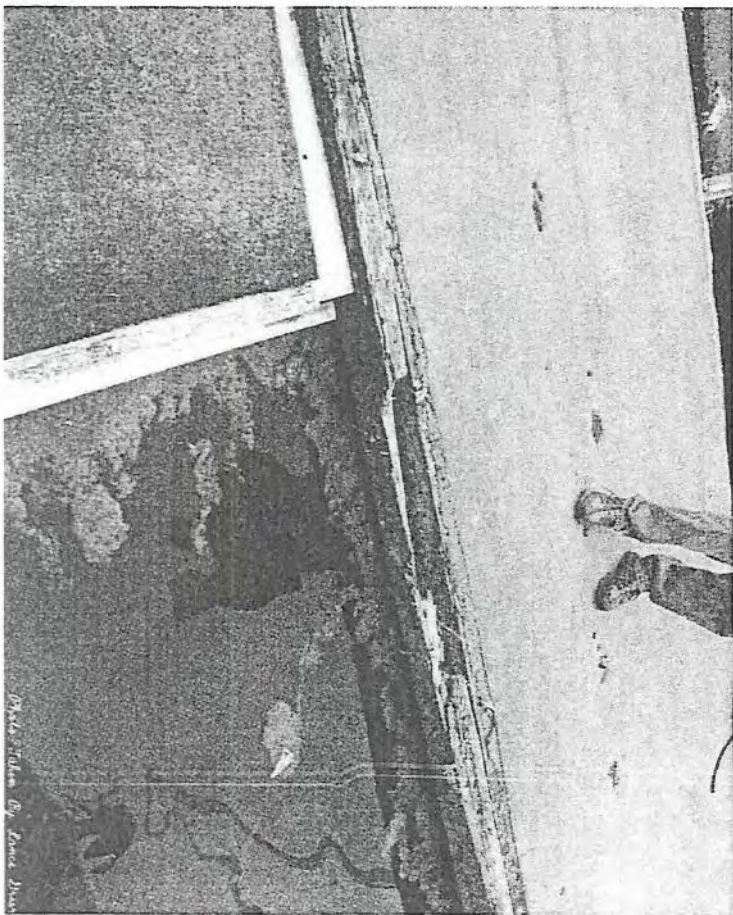
Site Inspection 07-26-04 33.jpg
Deck Rot

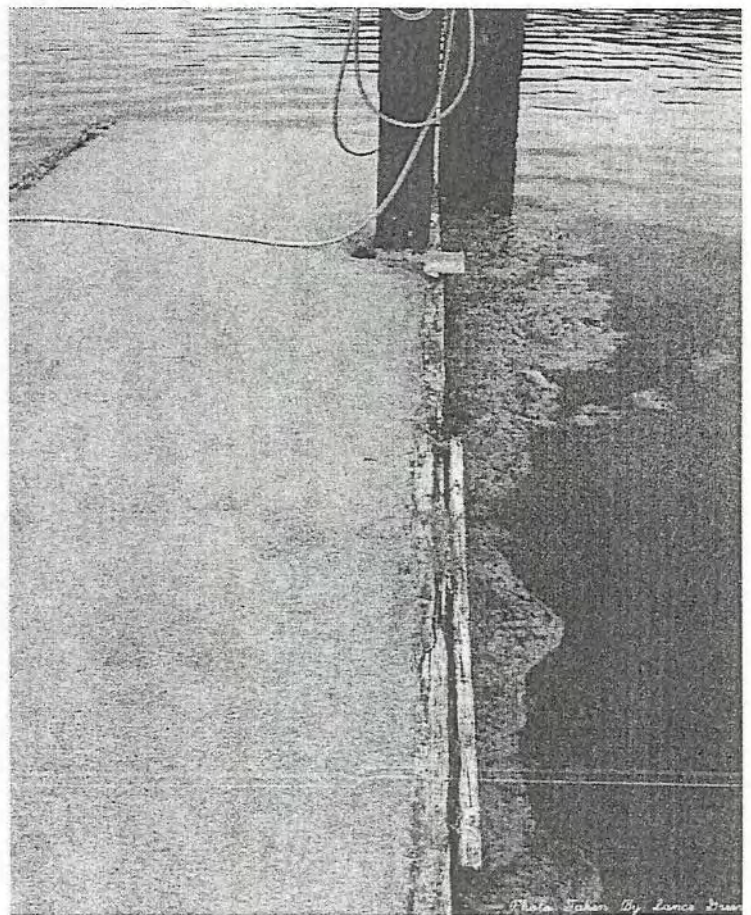
Site Inspection 07-26-04 35.jpg
Deck Rot

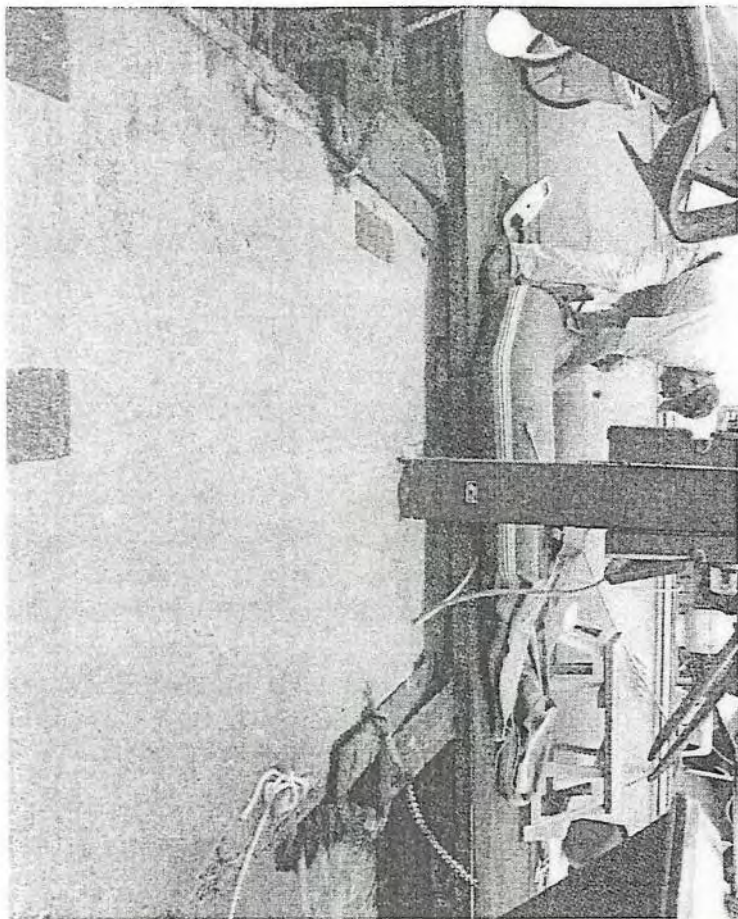
- c) All the connections between the main float and the concrete fingers are very worn and loose.
- d) All the keeper timbers display rot and were worn. These keeper timbers are in poor condition.

Site Inspection 07-26-04 43.jpg
Loose Connection (Float C - T-Float)

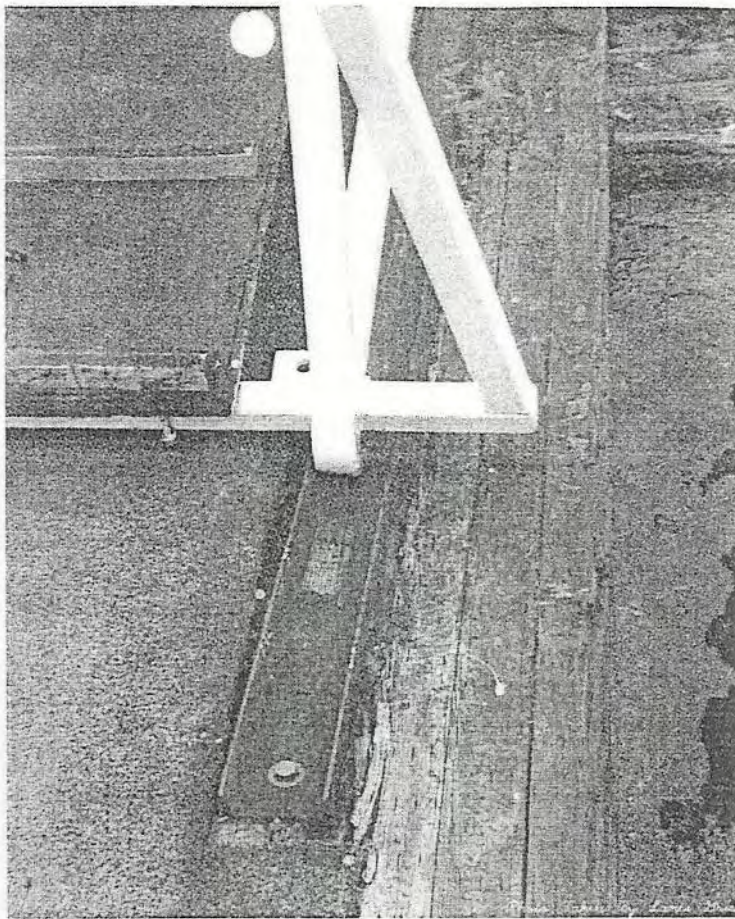
Site Inspection 07-26-04 50.jpg
Bottom of Gangway

- a) The decking is in good condition.
- b) The hinges at the top of the gangway are in good condition.
- c) The rollers at the bottom of the gangway are weathered and in fair condition.
- d) There is no separate handrail, which violates the 2000 International Building Code requirement that requires a separate handrail.
- e) There are 30" side openings in the railing. This also violates the 2000 International Building Code requirement that restricts side openings to no larger than a 4" sphere can pass through.
