City & Borough of Juneau  
Parks & Recreation  
Facilities Maintenance  
400 D Street  
Juneau, AK 99801

**MARINE PARK PARKING GARAGE CORROSION PROTECTION  
REPORT ON EXISTING SYSTEMS  
May 25, 1994**

## MARINE PARK PARKING GARAGE CORROSION PROTECTION REPORT ON EXISTING SYSTEMS May 25, 1994

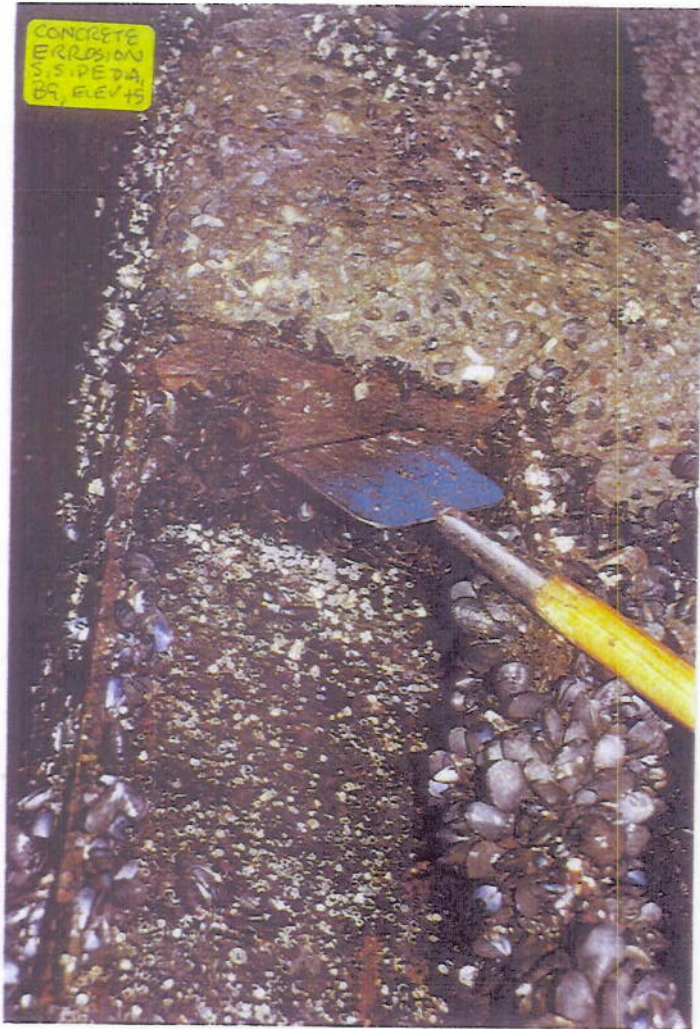
For line "A" through line "C" the coating condition was good, given its age. Observed corrosion, rust staining and metal loss was associated with localized coating defects. Only modest corrosion losses, < 1/16- inch, were observed for the steel piling from elevation -2 to the pile caps. Coating defects, and the related corrosion and staining, were observed in association with the flange tips (figure 1), pile driving template welding (figure 2) and with logs and timbers trapped in the piling network (figure 3). Rust staining was also observed associated with the concrete diaphragms located at elevation +5 and with web concreting extending from that elevation up to the pile caps (figure 4).

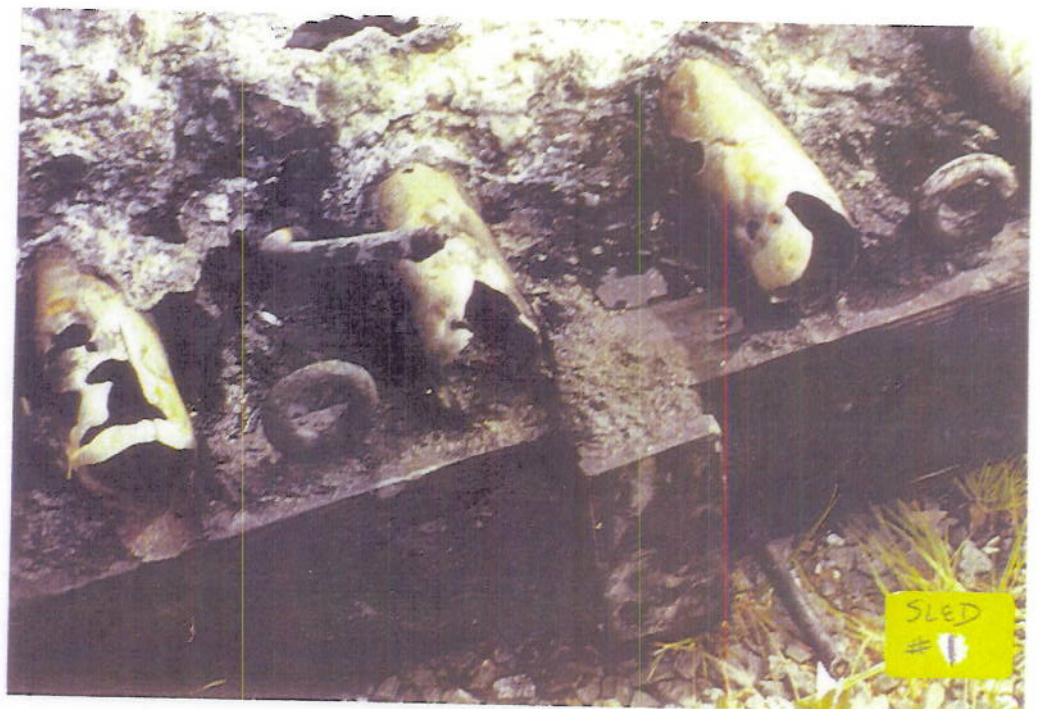
The sleds were not fabricated as shown in Detail Q of NCL Drawing CP-2. No steel bus bar was used. Rather the AWG# 4 armored cable was connected to the steel pipe core of one of the four anodes by a thermite weld. Three additional short pieces of AWG# 4, HMW/PE wire replaced the steel bus. The cables run from anode-to-anode on each sled in a "daisy-chain" of steel anode cores, thermite welds and wire (figure 7).
