SUBJECT: Gold Creek Annual Inspection of Completed Projects Report

I traveled to Juneau on 4 May 2009 to inspect the Gold Creek channel. I made a courtesy call to the City and Borough of Juneau, but they declined to accompany me on the inspection.

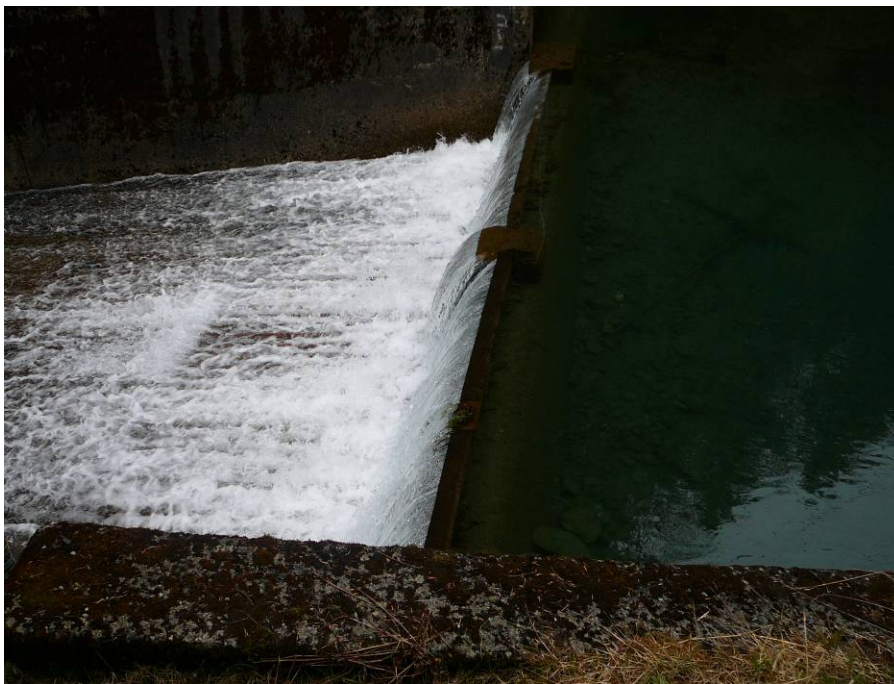
Figure 1.

The debris basin was clear of debris. A view of the basin and the sill is shown in figure 1.

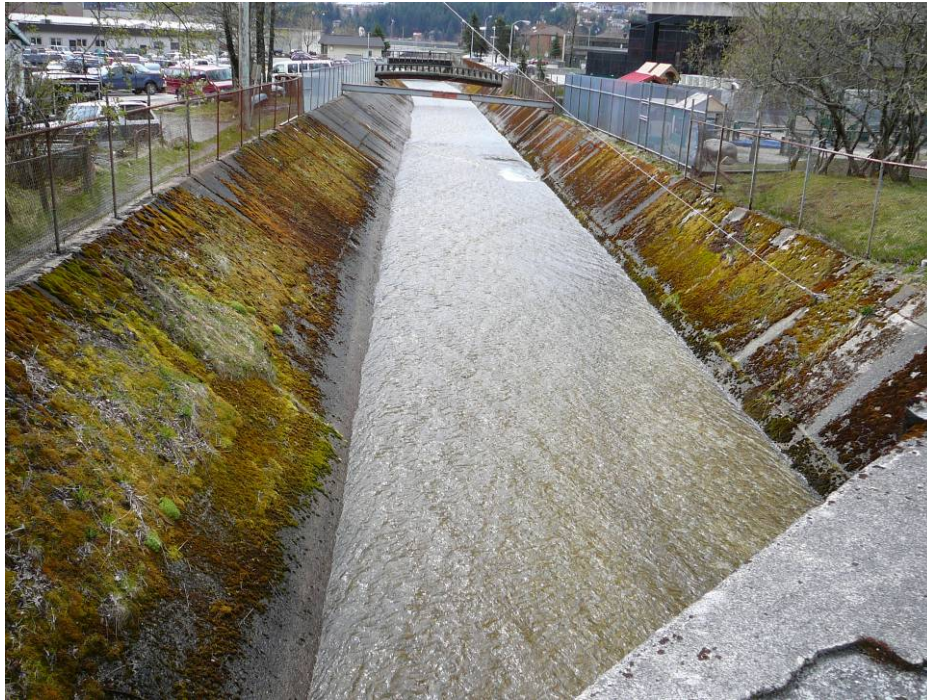
Figure 2.

Moss along the channel walls is the most common problem, as shown in figure 2. Care must be used, to remove moss without removing concrete

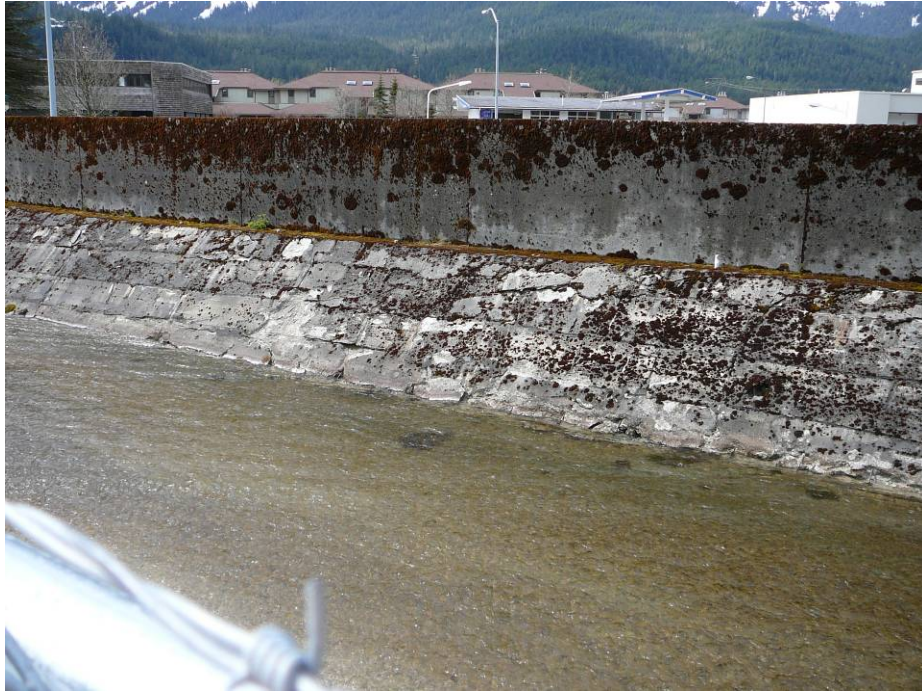
Figure 3.

There is a large area of spalling on the north side, downstream of the Federal Building. This appears to involve a poorly-bonded thin layer of concrete placed over the original wall, rather than spalling of the original concrete. This is shown in figures 3 and 4.

Initially, any exposed cracks need to be sealed and eroded areas near the floor need to be patched. In the longer term, the moss and any deteriorated concrete need to be removed and a more suitable coating, such as high-strength shotcrete, applied.

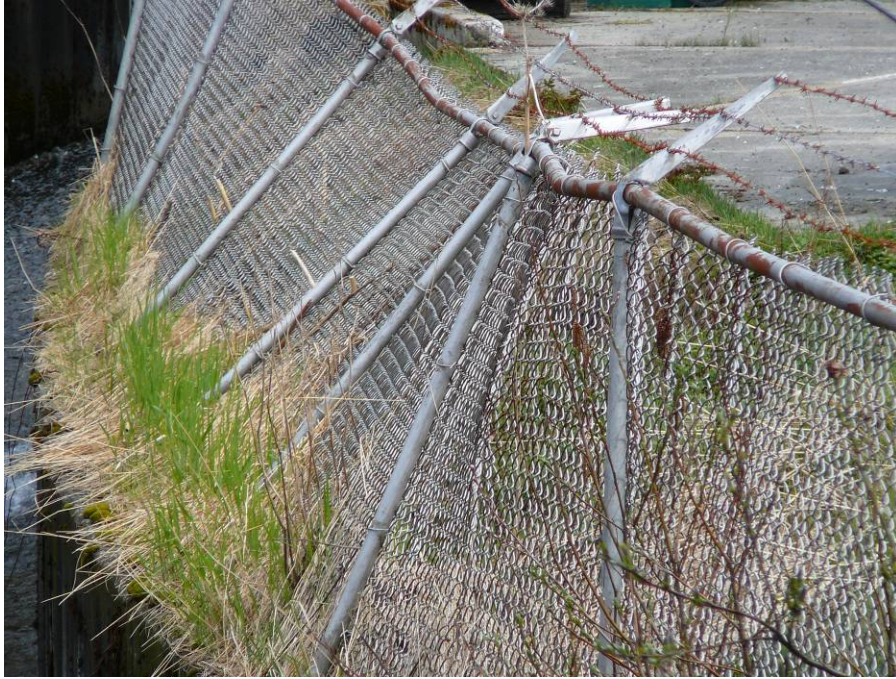
Figure 5.

The fence along Capital Ave. near the 11<sup>th</sup> St. cross walk needs immediate repair as it could be a hazard to young children. A view of this section of fence is shown in figure 5.
