## INTERIOR & EXTERIOR INSPECTION OF THE AUKE LAKE WATER TANK

Juneau, Alaska

June 2001  
00-2098C

**RE: FINAL REPORT – Interior and Exterior Inspection of the  
Auke Lake Potable Water Tank**

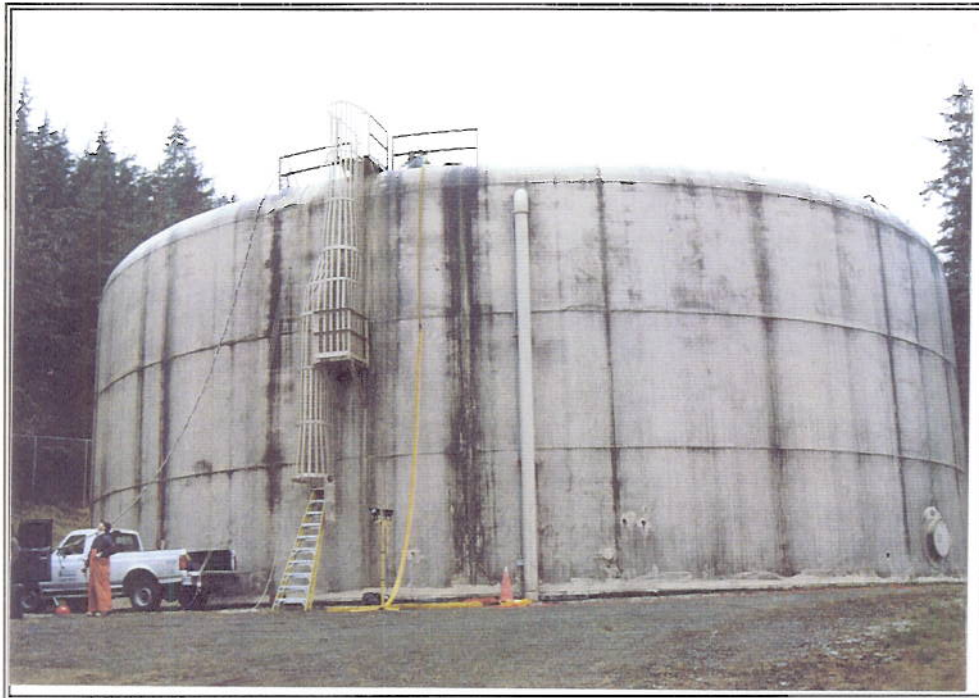
**PHOTO No. 1:** Auke Lake Tank, General View - Note the arrangement of the ladder, overflow pipe, and access man hole. The dark streaks apparent on the tank are dirt in areas of runoff. The tank coating was found to be greater than 99% intact.

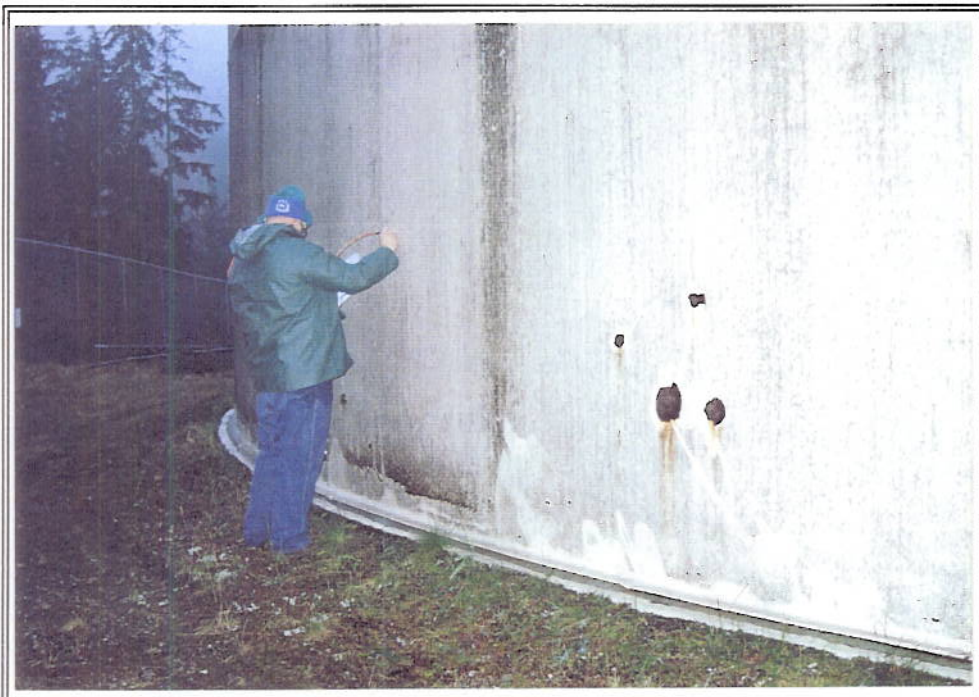
3. There are no areas of concentrated coating failure. However, Tier C, the ground panel, displays the most number of areas of coating failure.
4. Several of the areas with coating failure were noted to have been treated with a maintenance application of a black colored product. This material appears to be a sprayed application of a rust converter material.

**PHOTO No. 2:** Tier C, Ground Panel, 7:30 Position - Note the four areas of coating failures with corrosion and the otherwise good condition of the protective coating. The inspector is taking ultrasonic thickness measurements of the steel.

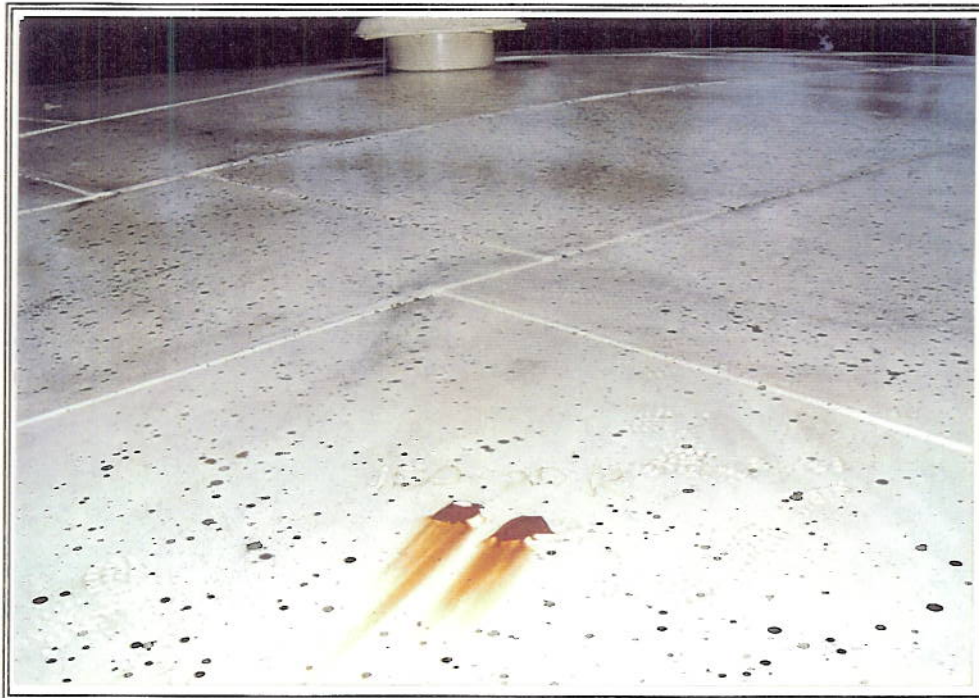
**PHOTO No. 3:** Tank Top, 1:30 Position - Note the two areas of coating failure with corrosion. Measurement showed both areas to be less than 6 inch in diameter. Note the center roof vent in the distance (top center).

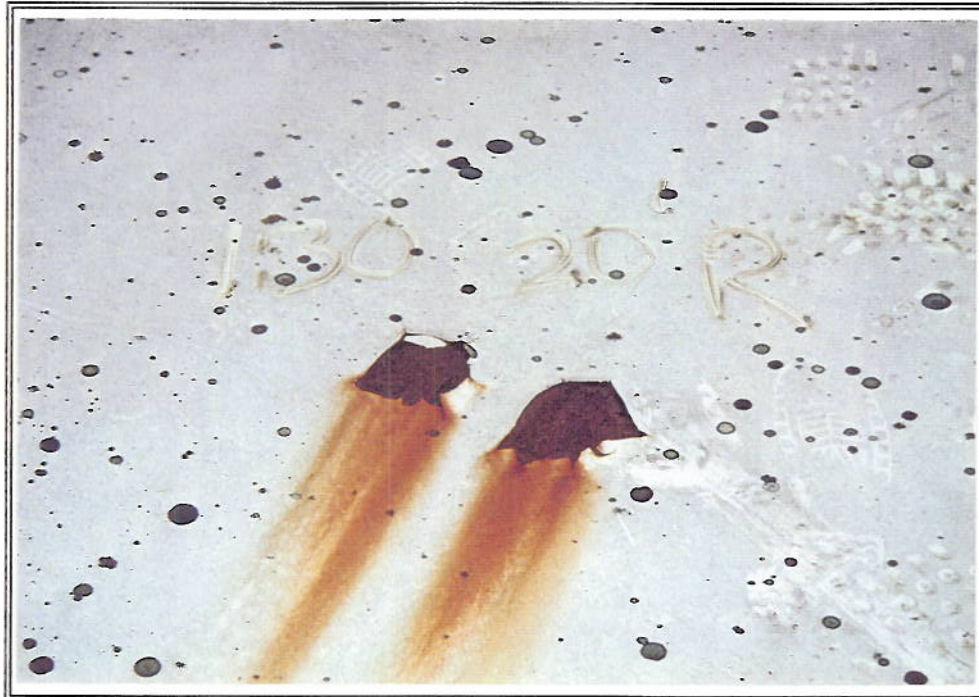
7. Inspection of the tank top revealed small diameter black spots sporadically covering the entire surface. These spots were found to be lichen. When cleaned, no damage or deterioration of the underlying coating was noted.

**PHOTO No. 4:** Tank Top, 1:30 Position - A close-up of the coating failures shown in Photo No. 3 above. The circular black spots visible on the coating were found to be lichen. When these areas were cleaned, no damage to the underlying coating was noted.

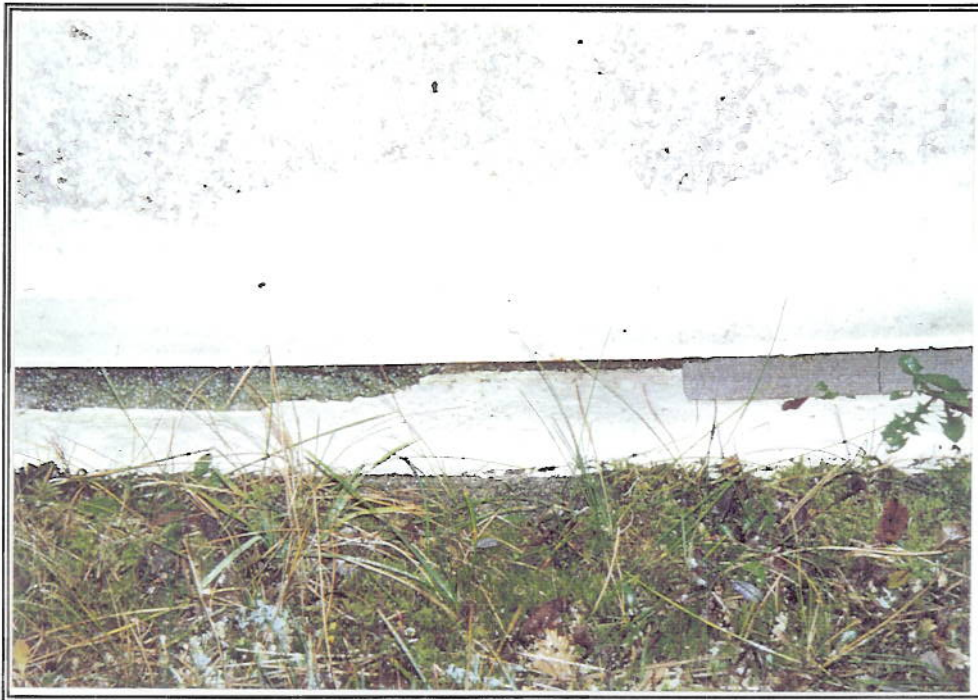
13. The grout at the tank base was found to be broken and/or missing at various locations around the perimeter. Vegetation and moss was also noted to be growing in several of these deteriorated areas. The coating material that was applied over the grout was found to be in generally poor condition and to be peeling.

Significant damage was noted to the grout material between the tank base flange and the concrete foundation ring. This damage may allow water to penetrate beneath the tank resulting in possible washout of the supporting sand fill. It is recommended that the grout be repaired.

**PHOTO No. 5:** Ringwall Foundation, 2:00 Position - Note the small section of the grout that is missing from between the bottom flange of the tank and the concrete ring foundation. This condition was found to be typical around the perimeter of the tank.

1. **Spot Repair of Localized Damage to the Concrete Foundation Ring Grout –**  
**(Estimated Cost = \$ 3,500)** Repair will require:
  - a. Cleaning and surface preparation of the damaged areas.
  - b. Application of appropriate cementaceous patching compound. (Epoxy grout should not be used due to the differential thermal expansion between the concrete and the grout material.)

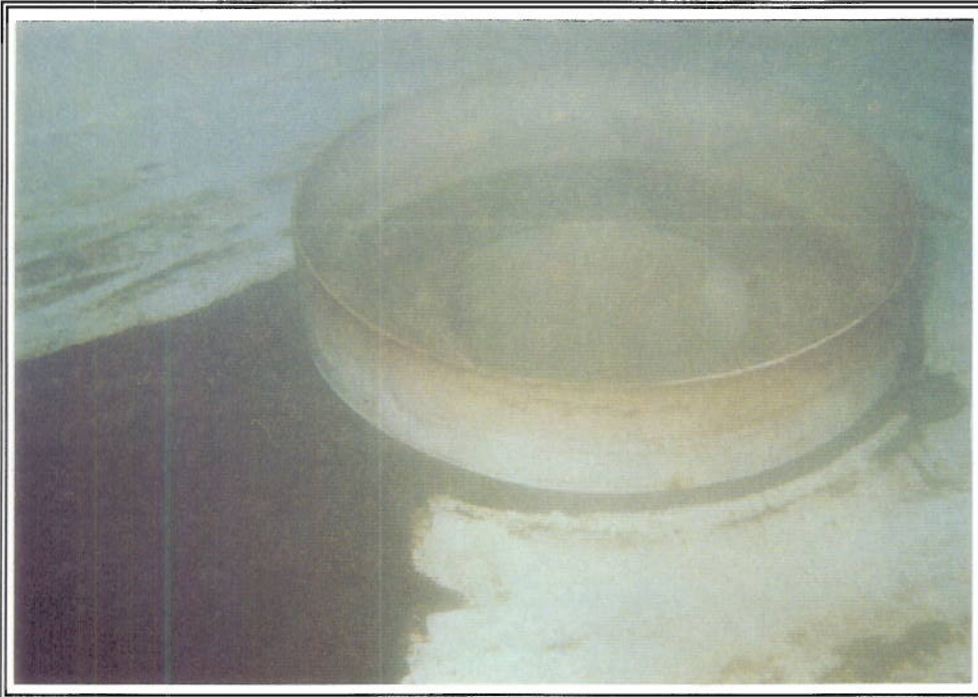
**PHOTO No. 6:** Tank Interior, Bottom, Tank Outlet - Note the good condition of the coating on the tank outlet and the floor of the tank. Sediment, typical of that removed from the tank can be seen to the left of the outlet pipe. Additional cleaning and sediment removal was conducted prior to inspection of the tank floor.

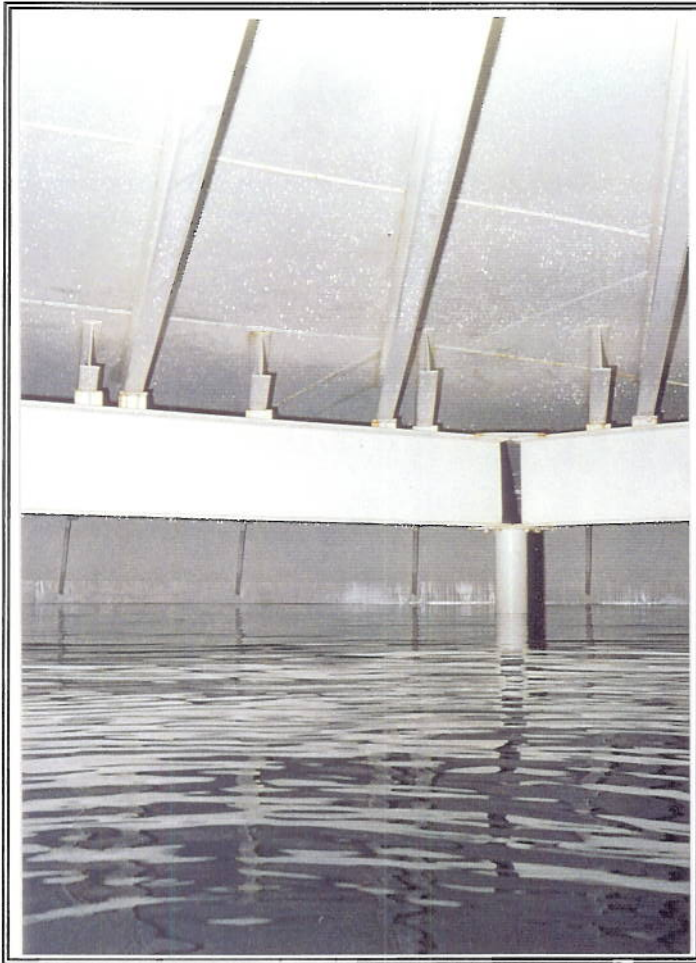
5. Rust bleeding was noted on several of the steel roof support members. This damage was found to be associated with the corners of the members and is minor in nature at this time. No observable coating failures were identified at these sites.

**PHOTO No. 7:** Tank Interior, Above Water -  
Note the typical good condition  
of the interior coating. A minor  
amount of rust bleeding is  
evident around the edges of the  
roof support members.

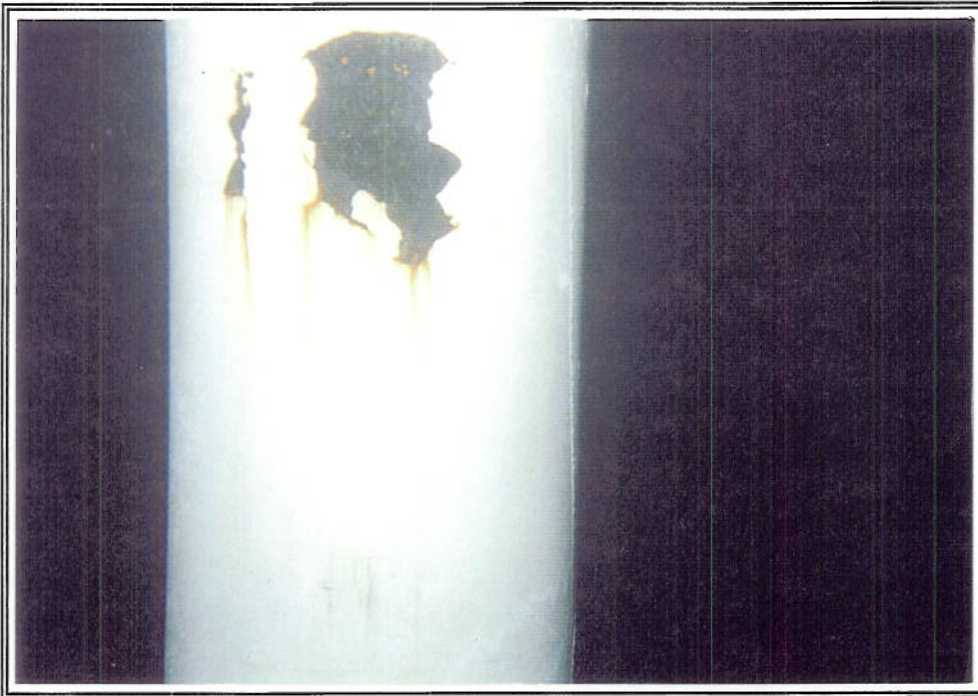
4. The area of most concentrated coating failure was noted on the center support column at the Tier B, middle panel elevation. Measurement revealed an area of coating failure and corrosion of approximately 8 square inches.

**PHOTO No. 8:** Tank Interior, Tier B Middle Panel - Note the area of failed  
coating identified at the approximate middle of the center  
support column. The damaged area measures approximately 8  
square inches. Also note the minor amount of surface  
corrosion.

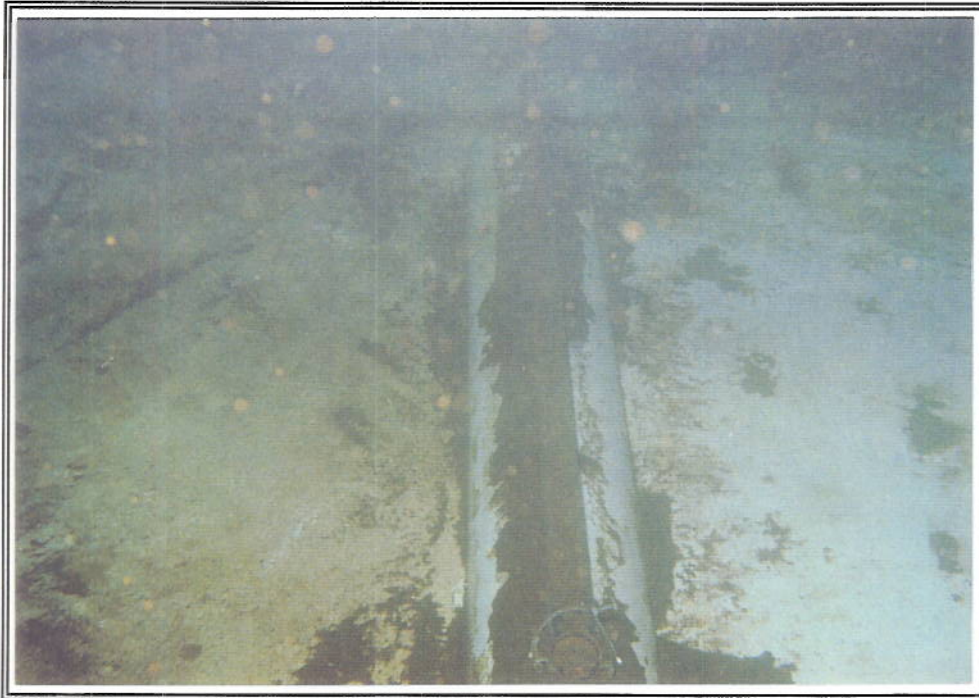
**PHOTO No. 9:** Tank Interior, Bottom - Note one of the cathodic protection system anode attached to the bottom. The anode is supported atop a semi-cylindrical PVC base. Inspection did not reveal any damage to the anodes.

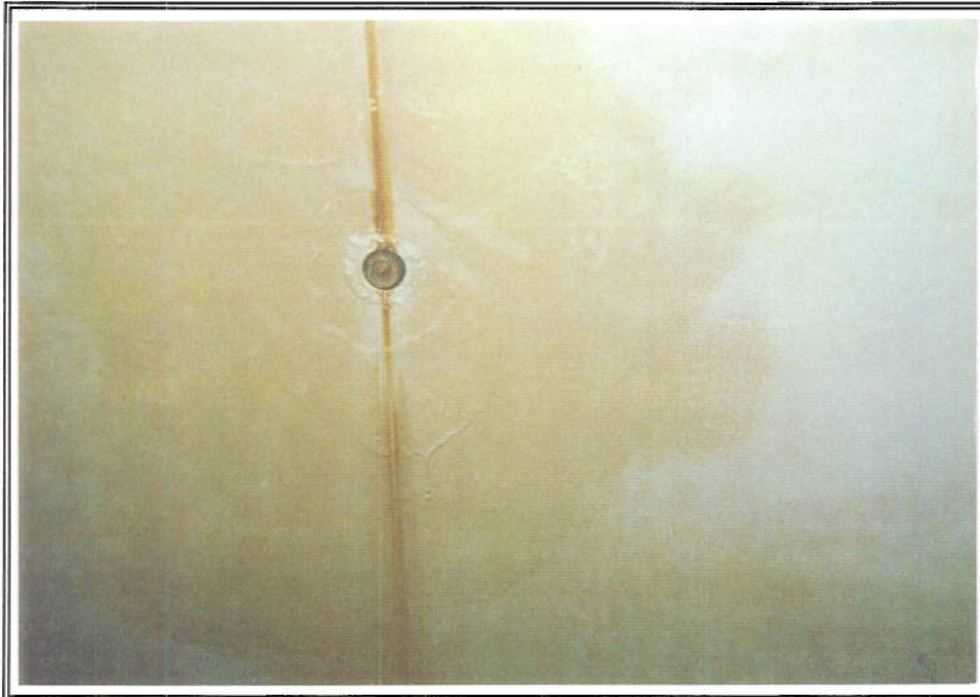
7. The interior portions of the roof access hatch, manholes, and pipe inlets were also found to be undamaged.
8. Inspection of the cathodic protection system identified one of the reference cells, located at the 11:50 position, to be broken. The exposed end of the cell was found to have been broken off flush with the wall mount. The tip of the reference cell was found on the floor.

The cathodic protection system appears to be operating well at this time. However, the internal reference cell was found to be broken off flush with the tank wall. Inspection did not reveal any apparent cause of this damage. Further investigation by CBJ's cathodic protection consultant appears warranted to more thoroughly assess the current adequacy of the system and to develop possible repair alternatives. No other maintenance or repair of the cathodic protection system appears warranted at this time. Additionally, we recommend that the cathodic protection system routinely undergo testing and adjustment to ensure adequacy of this protection system.

**PHOTO No. 10:** Tank Interior, Tier C, Bottom Panel, 11:50 Position - Inspection showed the cathodic protection system reference cell to have been broken off flush with the tank wall.

**2. Repair of the Cathodic Protection System Internal Reference Cell –  
(Estimated Cost = \$ 6,000) Repair will require:**

- a. Draining of the Tank (Cost not included within the above "Estimated Cost")
- b. Installation and wiring of a new reference cell.

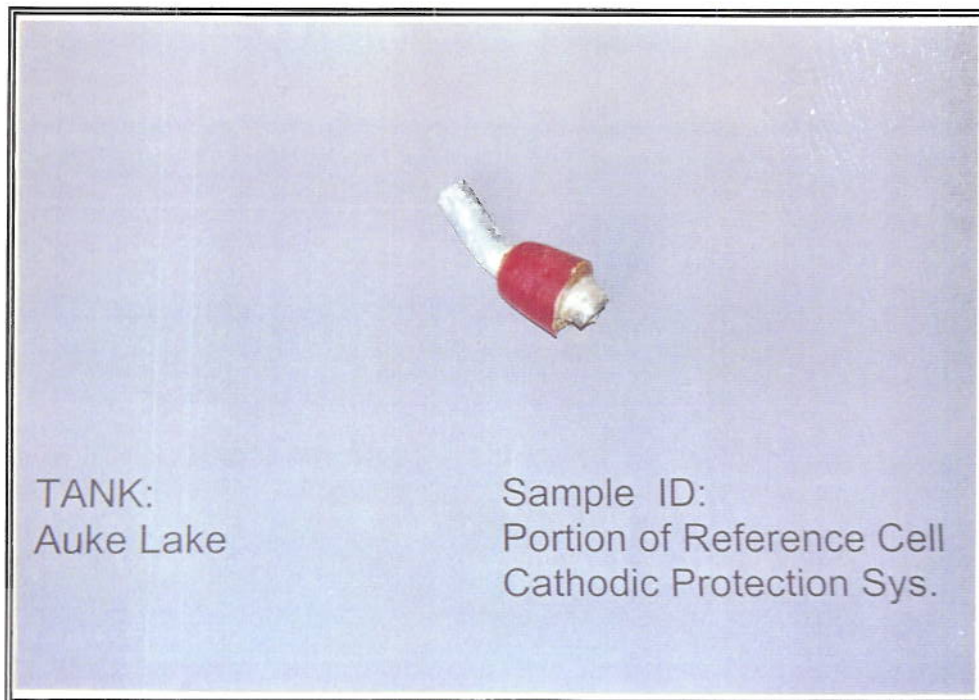
**PHOTO No. 11:** Cathodic Protection System, Damaged Reference Cell - This portion of the reference cell was found on the tank floor beneath the reference cell location at the Tier C, Bottom Panel, 11:50 position.

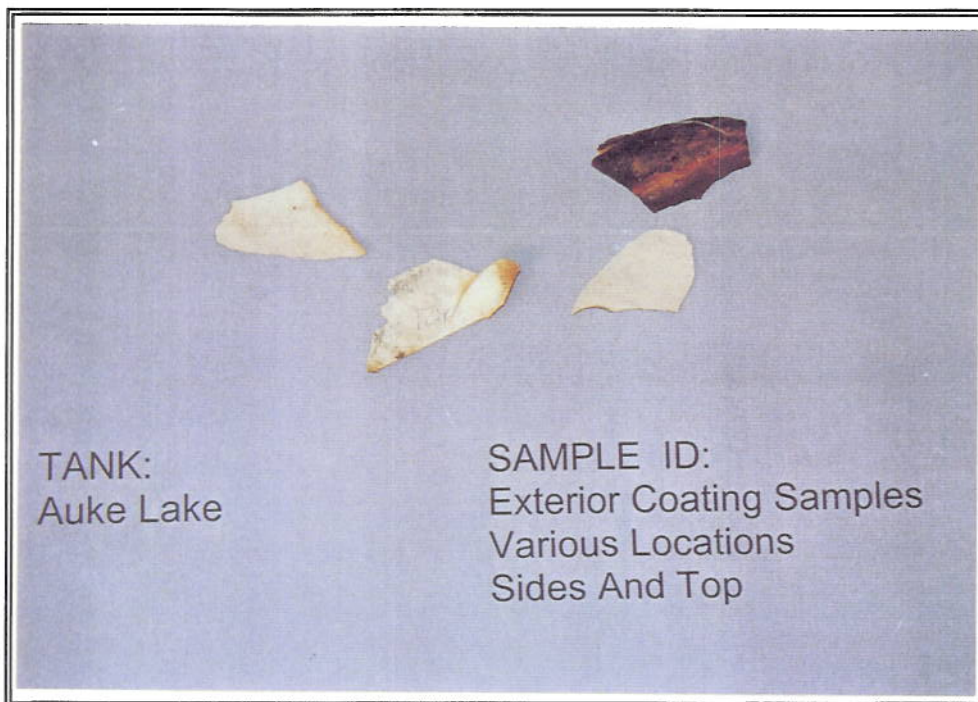
**PHOTO No.12:** Tank Exterior, Coating Samples - These samples were collected from various locations on both the top and the sides of the tank, where exterior coating failures were identified.
