PHASE I ENVIRONMENTAL SITE ASSESSMENT

**5871 CHURCHILL WAY
JUNEAU, ALASKA**

JULY 3, 2012

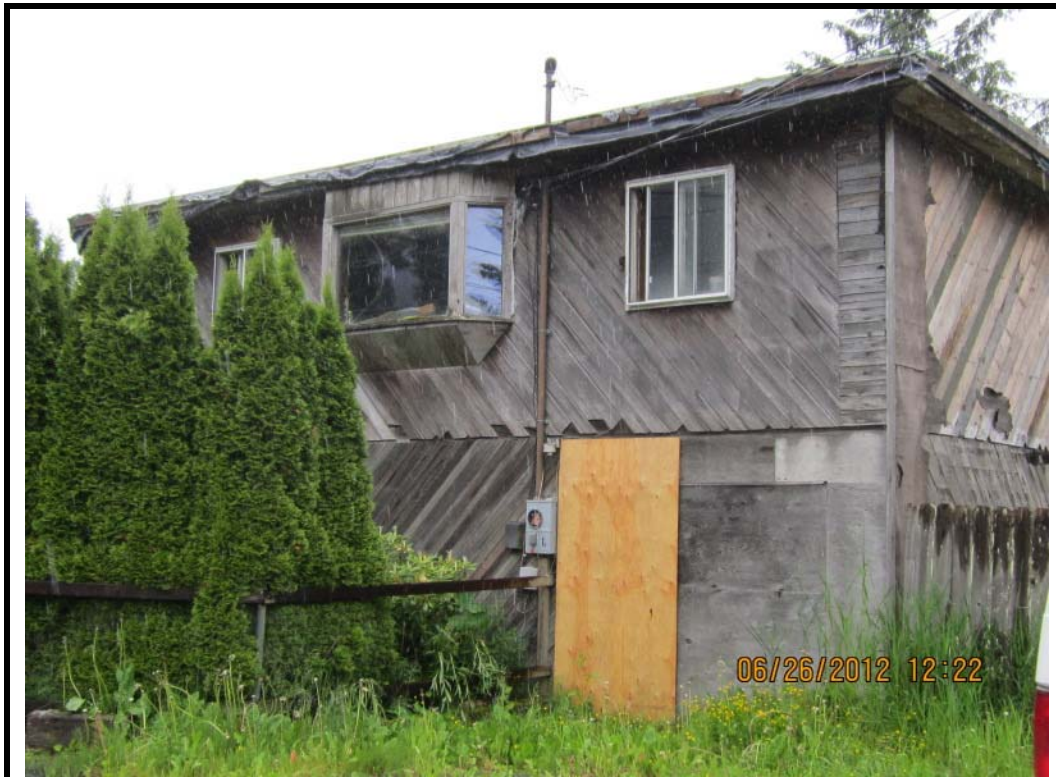
Photo 1: Front of residence, showing east side.

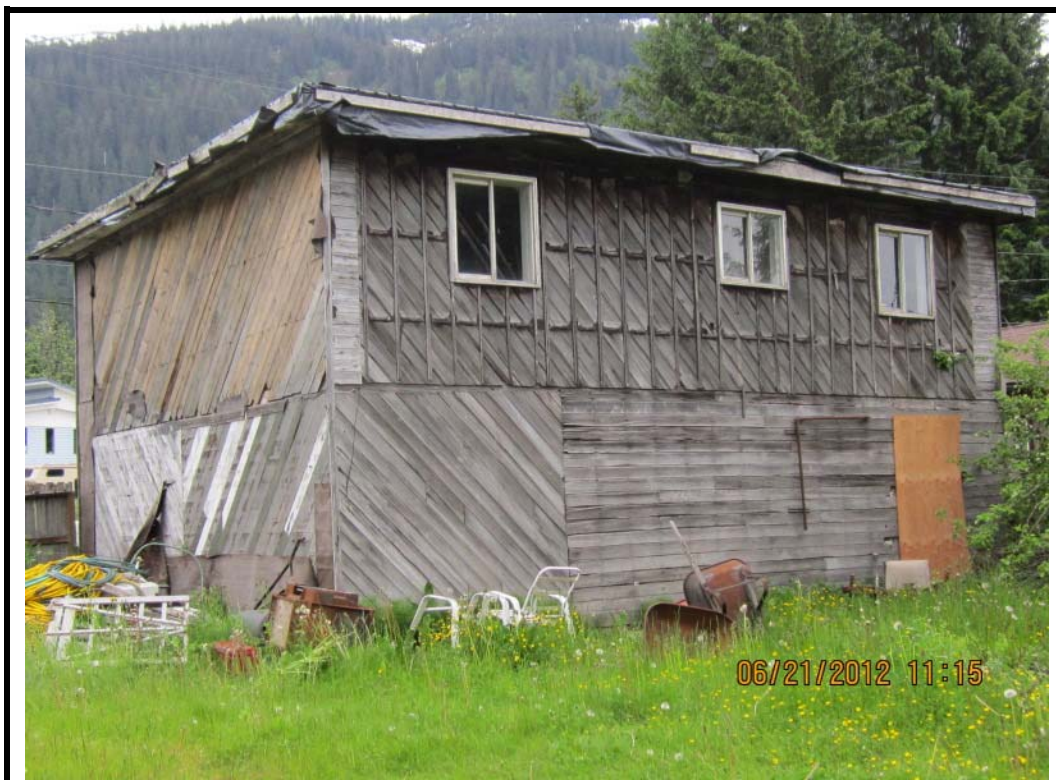
Photo 2: Rear of residence, showing west side.

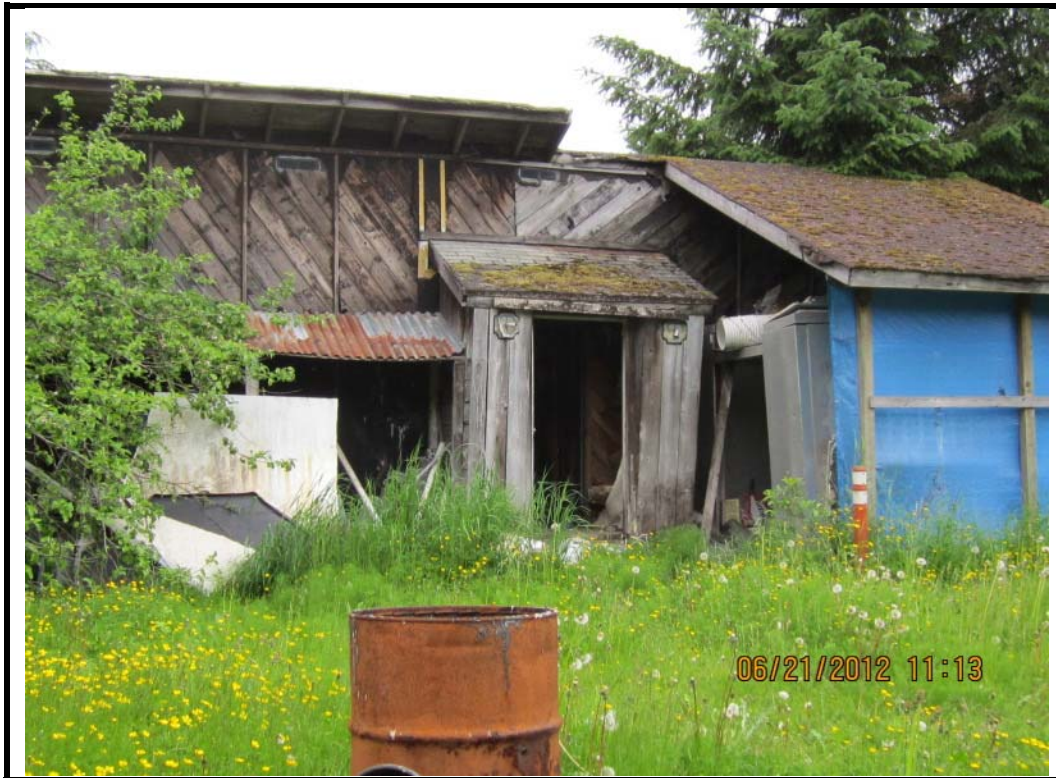
Photo 3: Large shed.

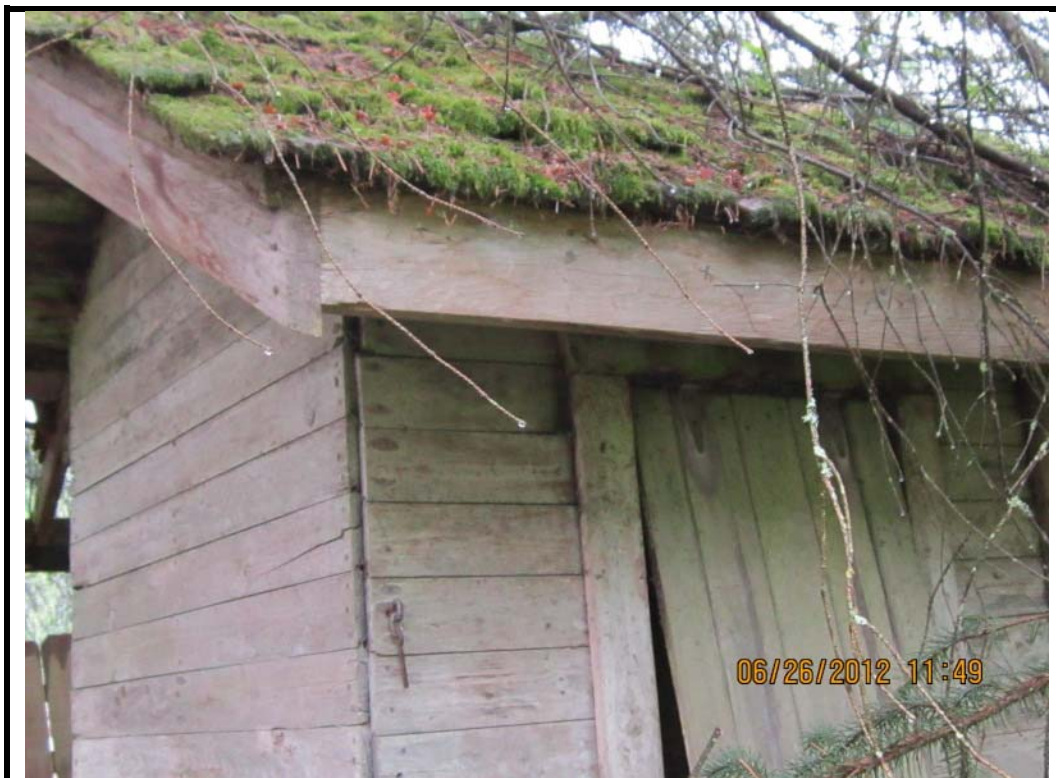
Photo 4: Small shed, underneath tree in backyard.

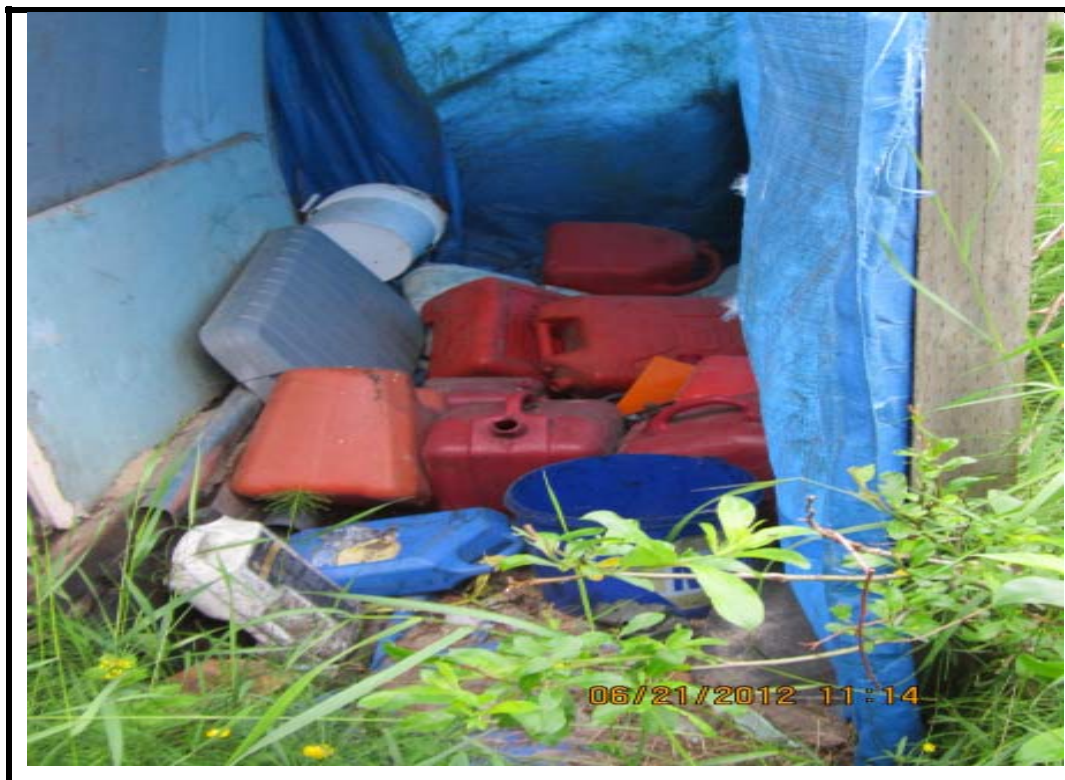
Our site visit also located several hazardous materials or containers used for hazardous materials, e.g. plastic fuel containers and car batteries, within large shed. These items, in addition to the items found inside the residence, are documented and presented in

Photo 5: Plastic hazardous materials storage jugs in large shed area.

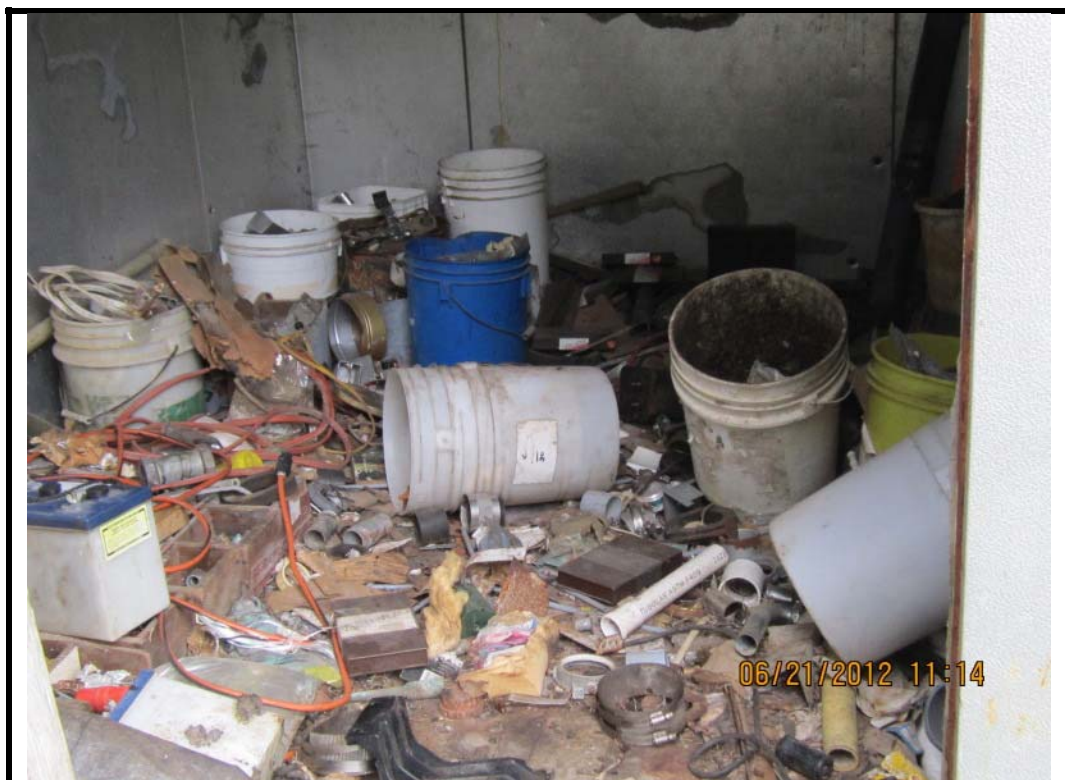
Photo 6: Hazardous materials in large shed area.

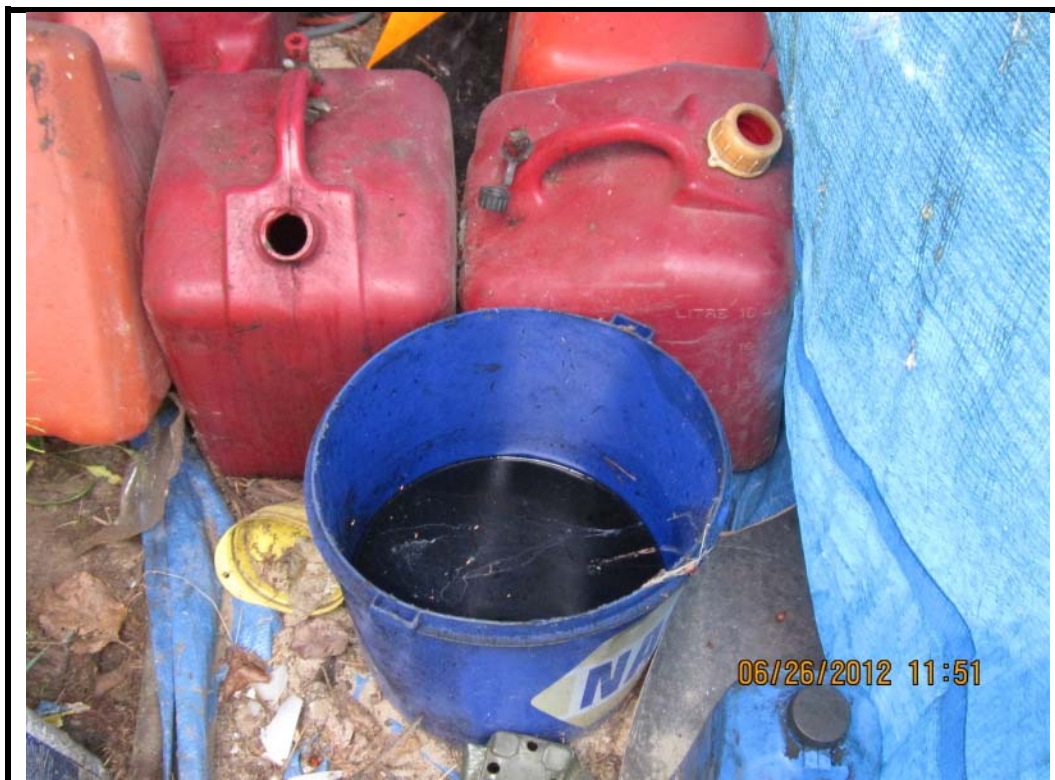
Photo 7: Used oil in large shed.

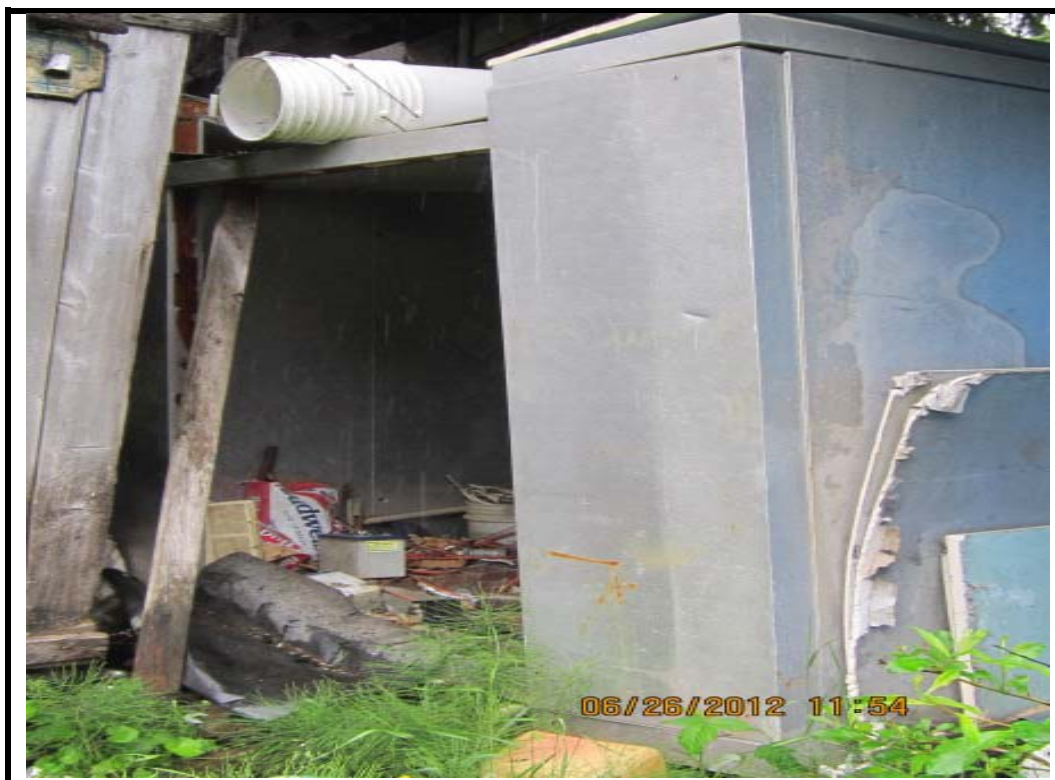
Photo 8: Large shed is partially constructed of old freezer, potential hazmat.

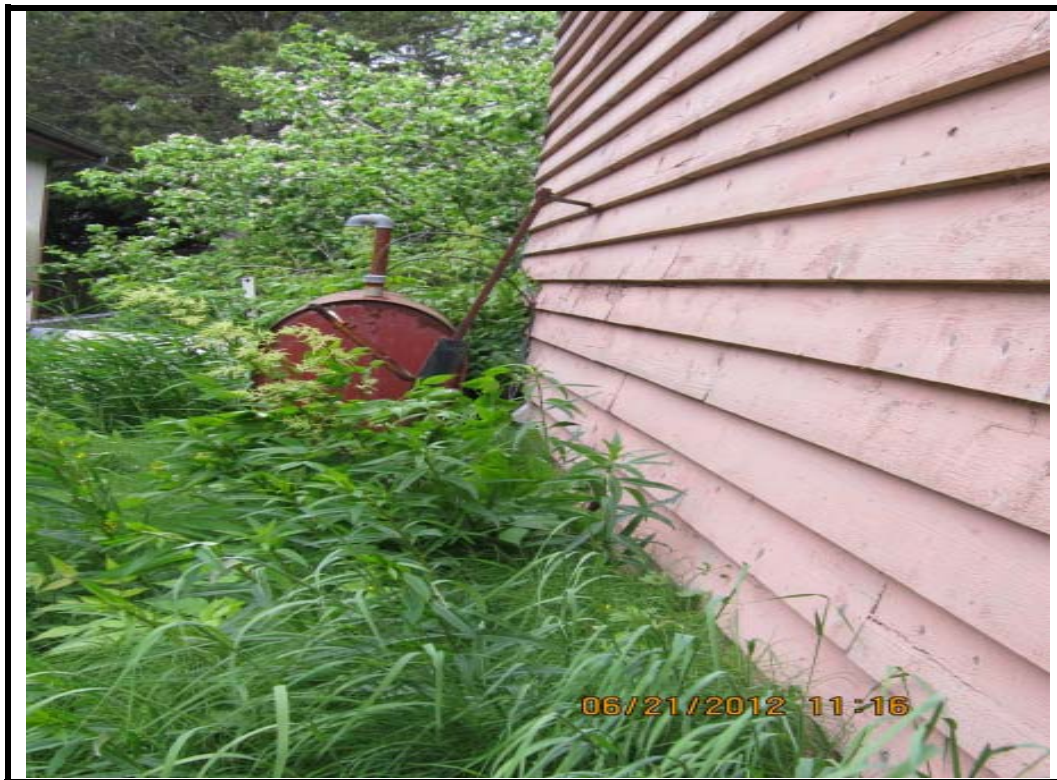
The home has an AST located on the western corner of the south side of the residence. The AST was used to store heating fuel to heat the home but was found to be empty at the time of inspection. We assessed the AST for petroleum contamination by advancing three soil borings to five ft bgs in the vicinity of the tank. A garden hose was observed to be taped to the discharge valve of the tank (see Site photographs).

Photo 9: Aboveground fuel storage tank on South side of residence.

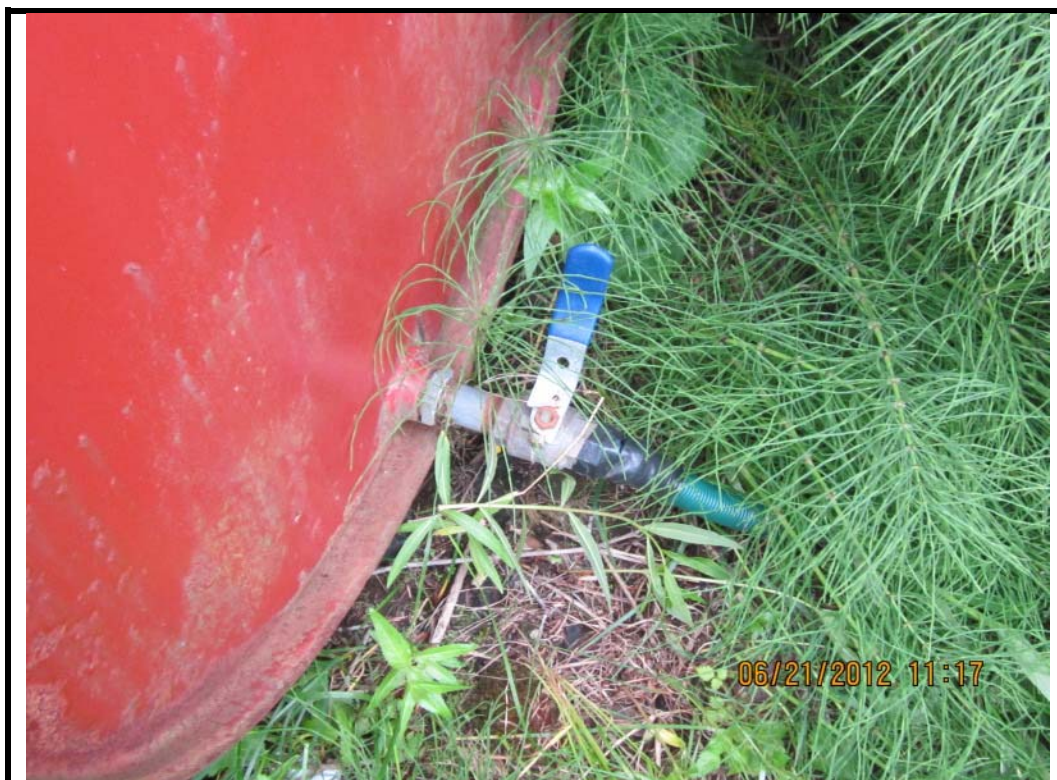
Photo 10: Improper fuel line connection on AST. Area of soil contamination.

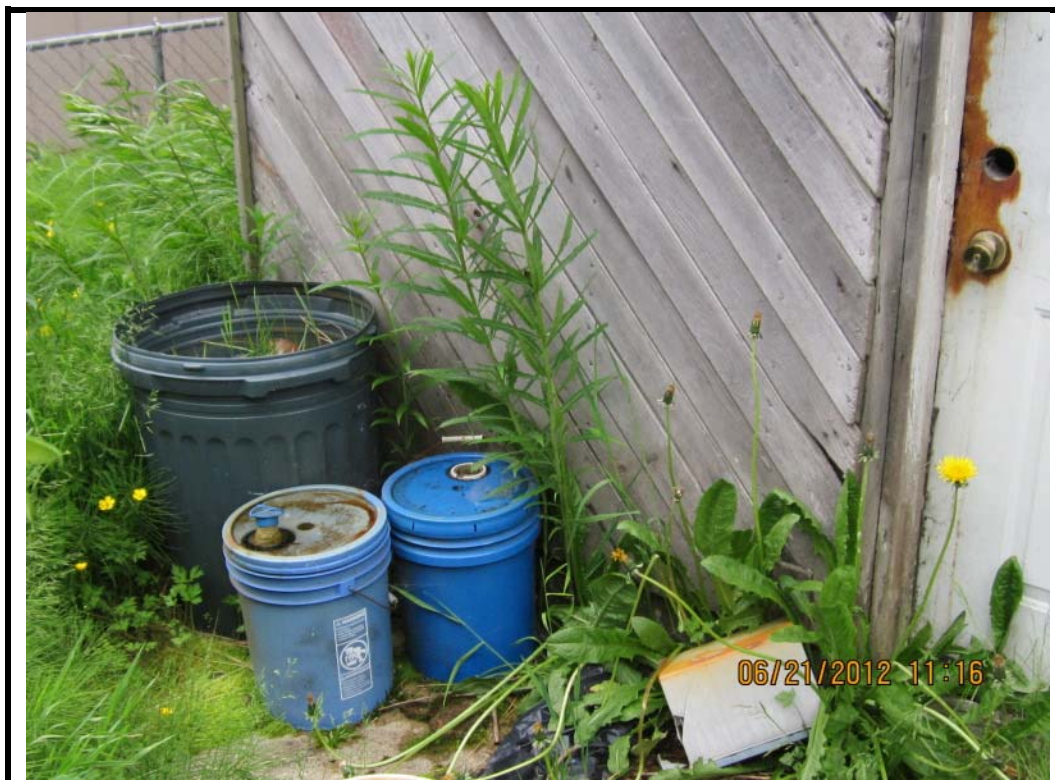
Photo 11: *Hazardous materials outside of residence.*

NORTECH recommends the removal of the solid waste from the property. The structures located on site are in poor condition. The on-site residential structure was constructed prior to 1978. Due to its early construction date, it may contain ACM and/or other potentially hazardous materials may have been used during its construction.

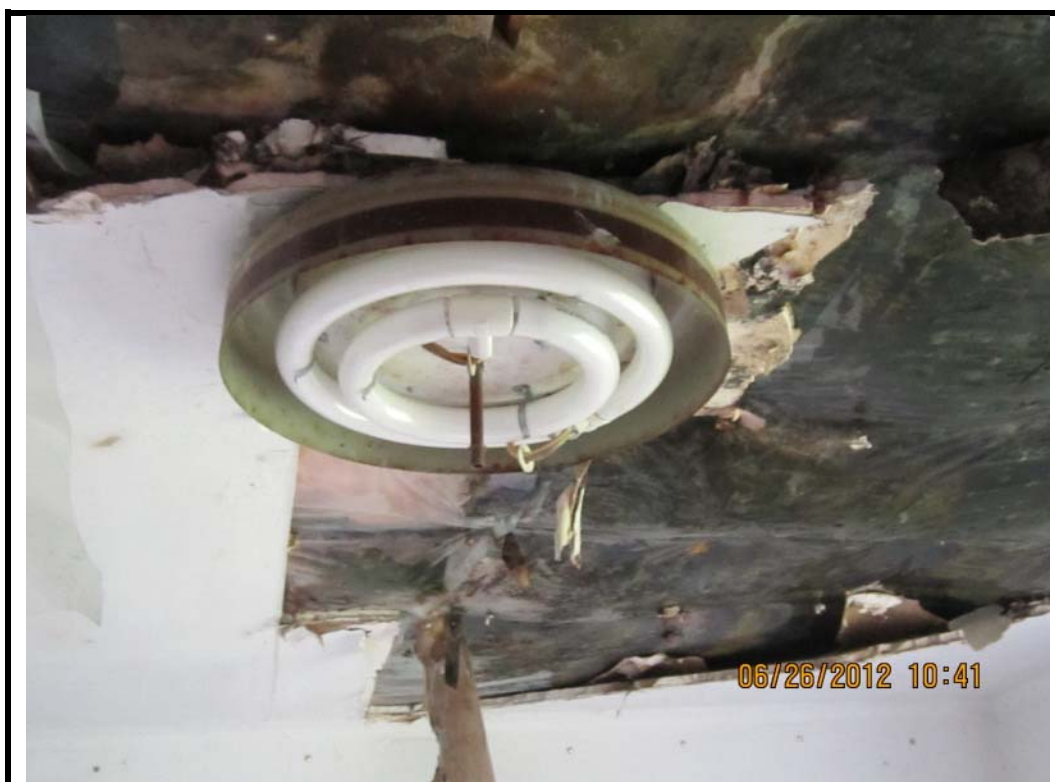
We began by performing a Site walkthrough to identify possible environmental concerns on the property. We then assessed the interior of the residence on the property. One roll of paper labeled as asbestos paper was identified in the rear/south entryway room. Our site walkthrough also located several known household hazardous wastes including fluorescent light bulbs, PCB containing ballasts, aerosols cans, paint, and fire extinguishers.

Photo 12: *Example of hazardous materials identified inside residence.*

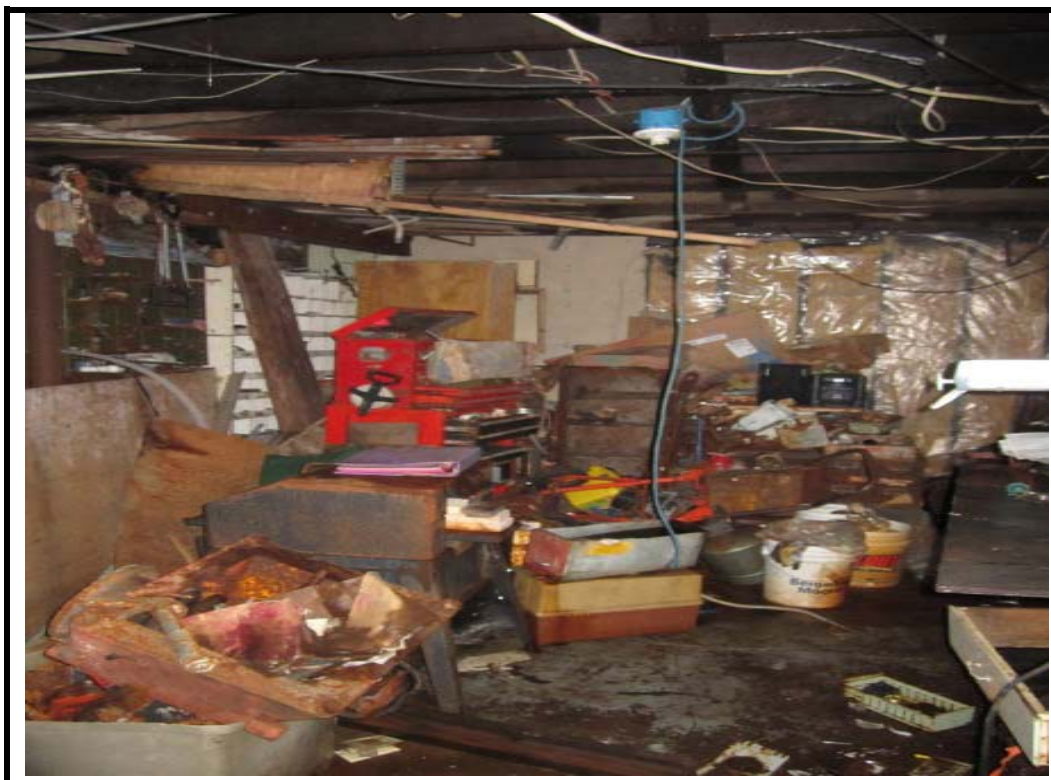
Photo 13: Residence garage/room 6. Most hazardous materials identified in residence are stored in this room.

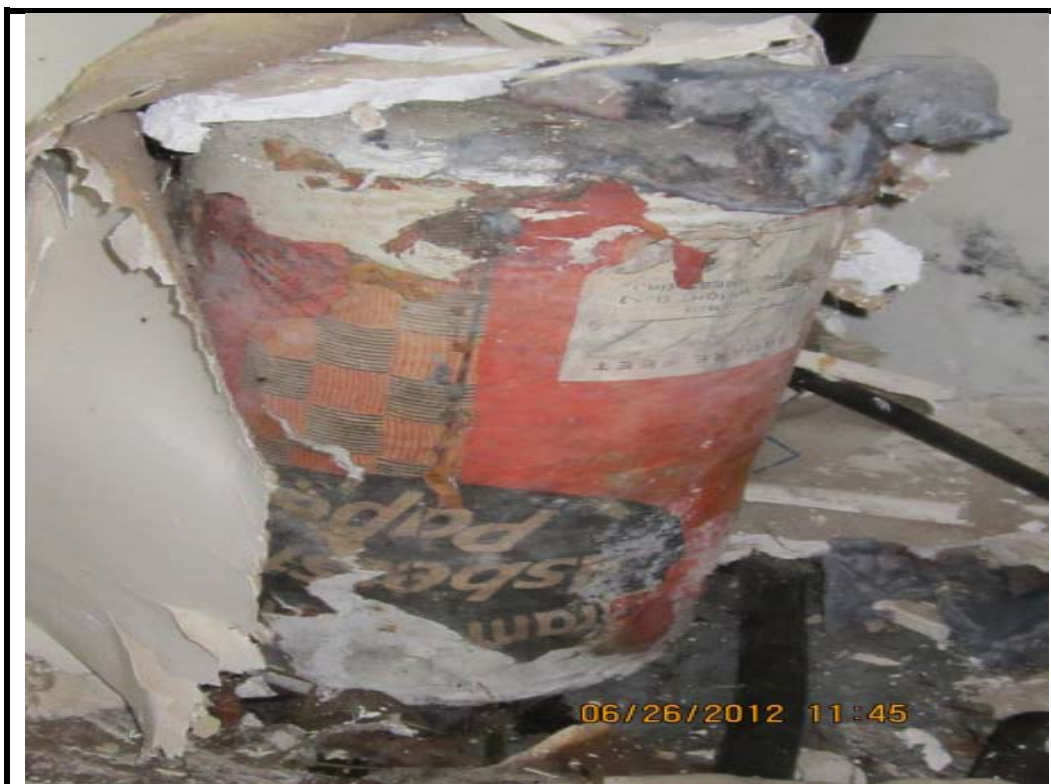
Photo 14: Hazardous material identified in Room 1. Asbestos paper.
