**PRE-DEMOLITION
HAZARDOUS MATERIALS ASSESSMENT
5871 CHURCHILL WAY
JUNEAU, ALASKA**

JULY 3, 2012

Tamara Rowcroft
Juneau Housing Trust
PO Box 32045
Juneau, AK 99801

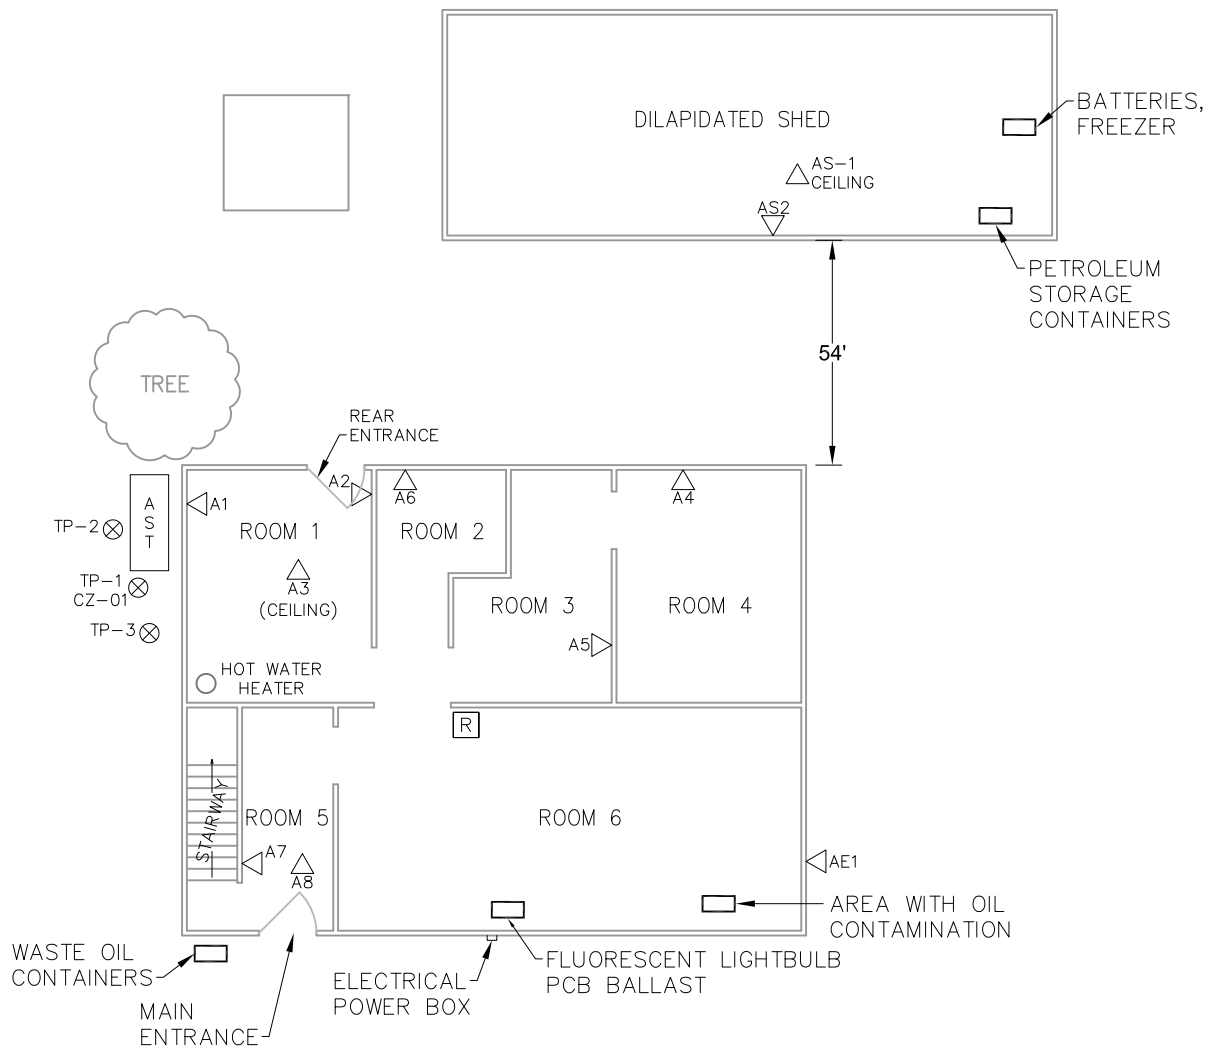
Site Map – First Floor and Outer Buildings
 5871 Churchill Way
 Juneau, Alaska

The first floor of the residence consists of a stairwell and front entry room, a bathroom, a storage and/or bedroom, a rear entryway utility room, and a shop room with an additional entrance. The majority of household hazardous materials were identified in the shop room (room 6).

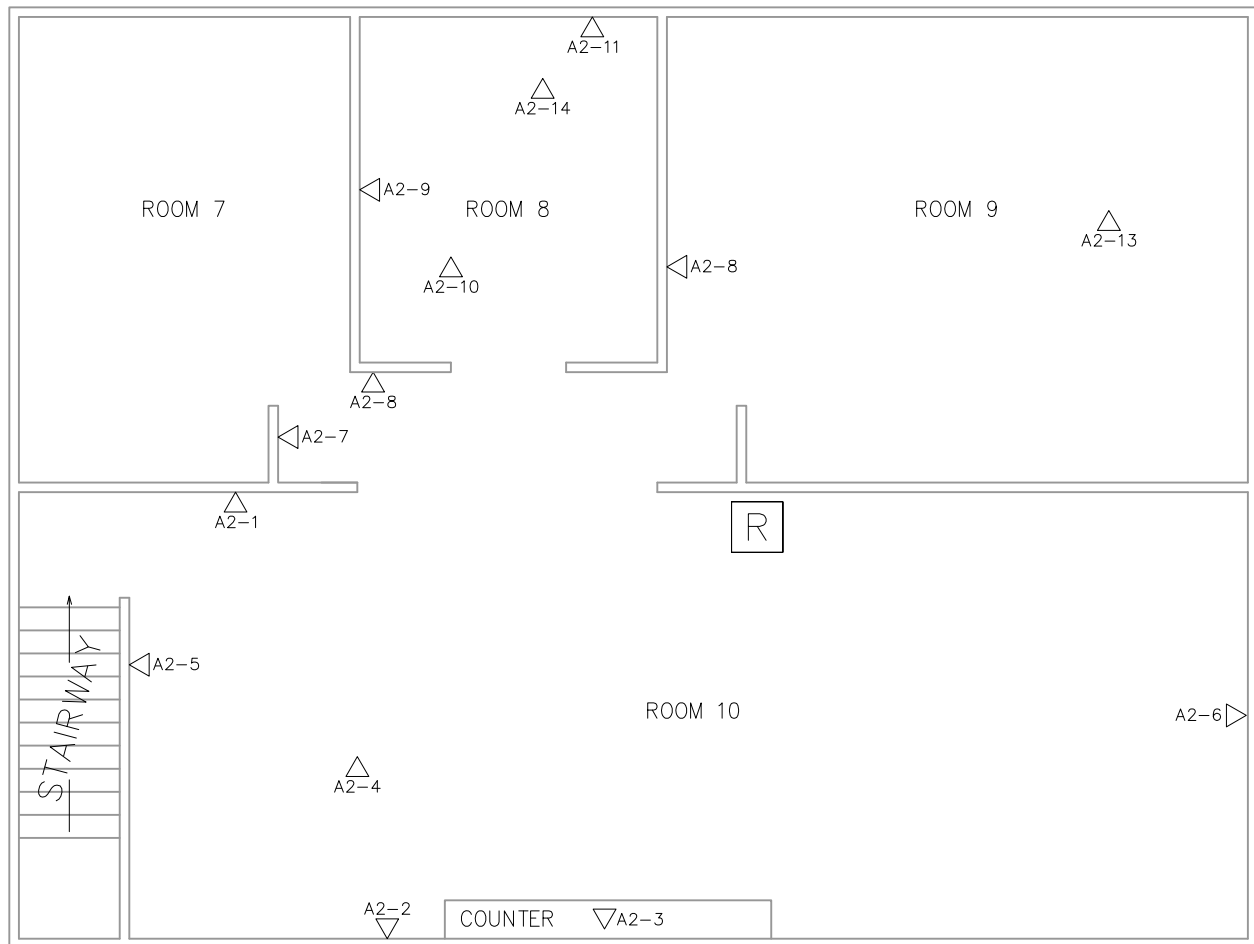
Site Map – Second Floor
 5871 Churchill Way
 Juneau, Alaska

Inside the home **NORTECH** observed other hazardous household use materials. The residence itself has two stories and three entrances. The second floor of the home consists of two bedrooms, a bathroom, and an apparent kitchen and living room area. Items identified on the second floor are categorized on a room by room basis. Room number nomenclature is shown on Figures 3 and 4 of Appendix A. Hazardous materials include:

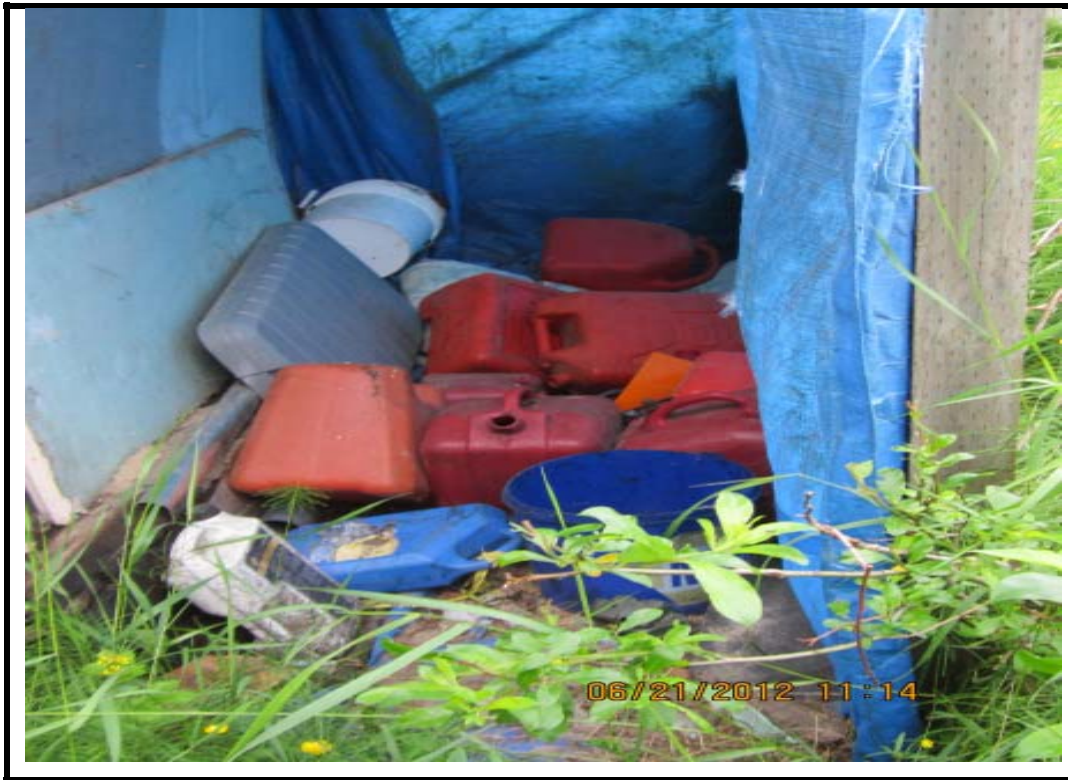
Photo 5: Plastic hazardous materials storage jugs in large shed area.

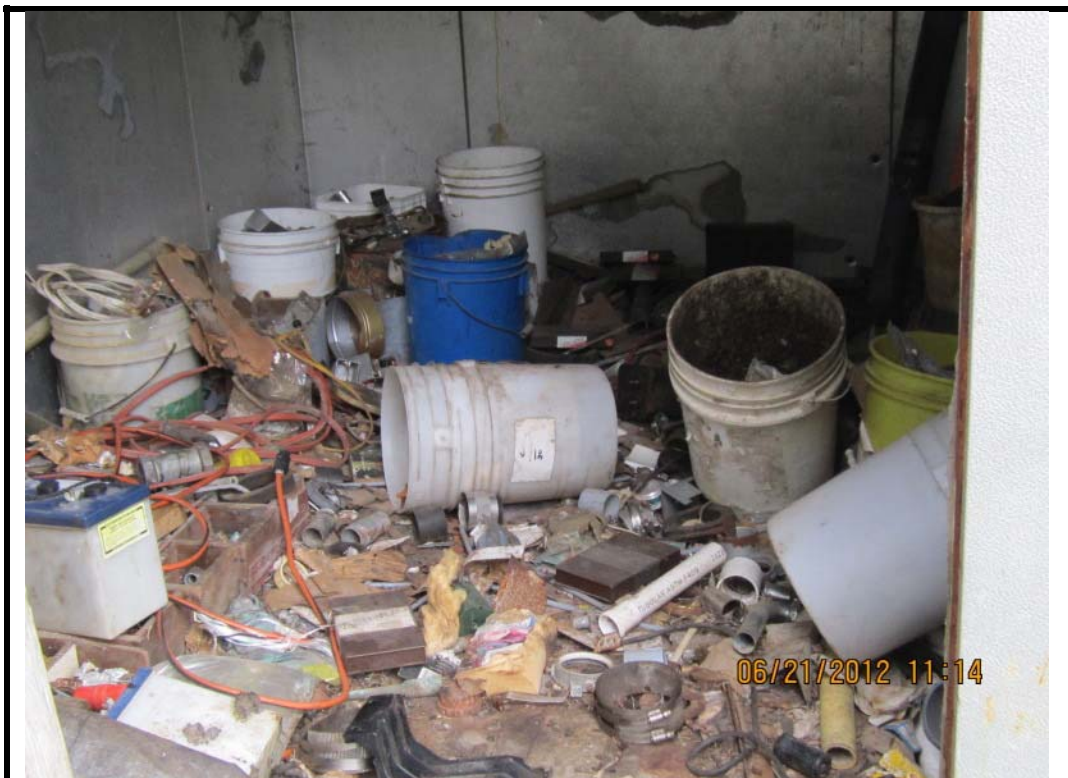
Photo 6: Hazardous materials in large shed area.

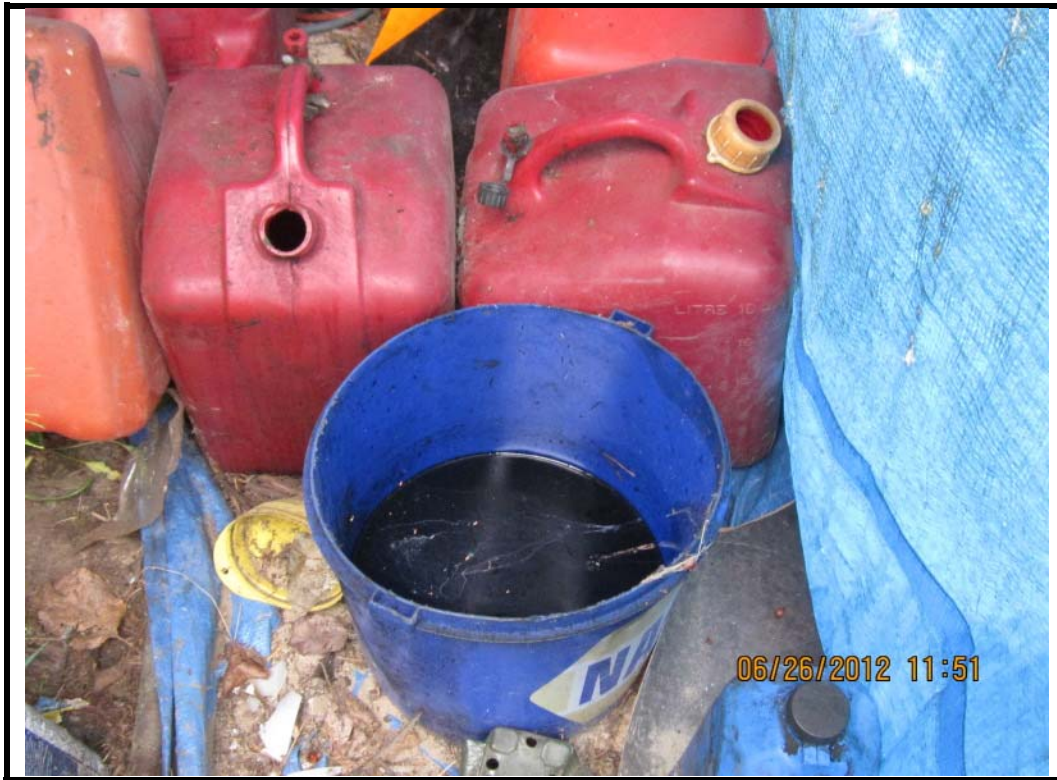
Photo 7: Used oil in large shed.

The Juneau landfill does not accept hazardous chemicals. Disposal for the household use chemicals, the bucket of used oil, and fluorescent light bulbs should be coordinated through the City and Borough of Juneau Household Hazardous Waste Disposal event. CBJ's next Household Hazardous Waste Disposal event is scheduled for August 19th, 2012.

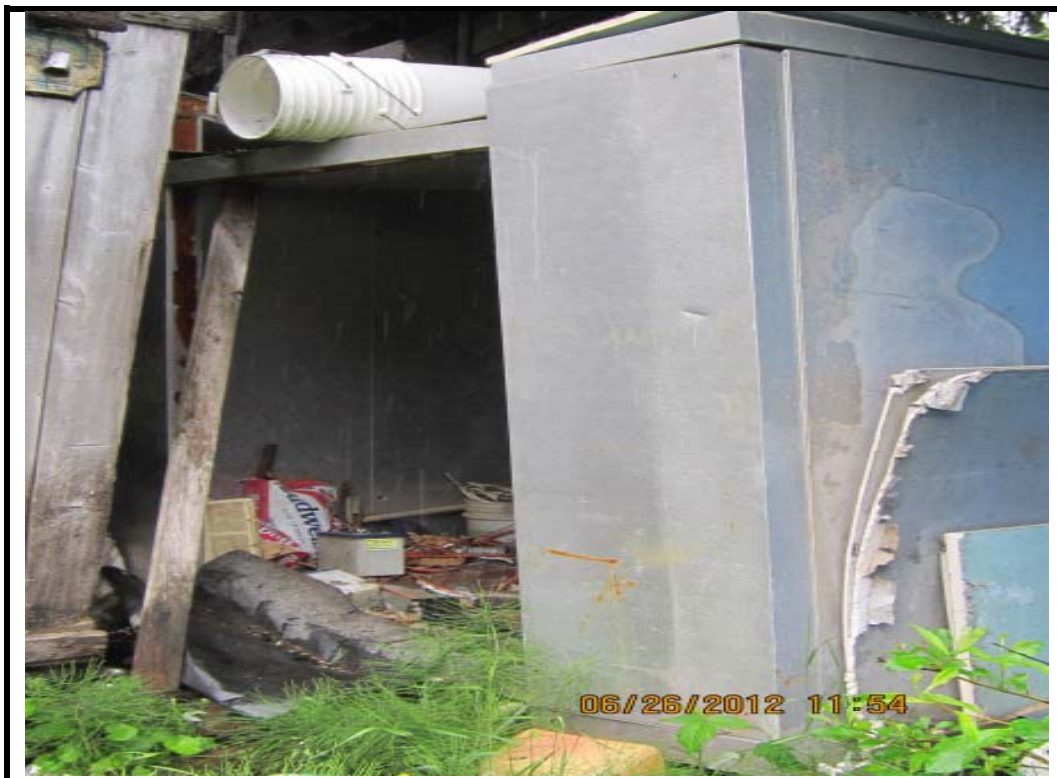
Photo 8: Large shed is partially constructed of old freezer, potential hazmat.

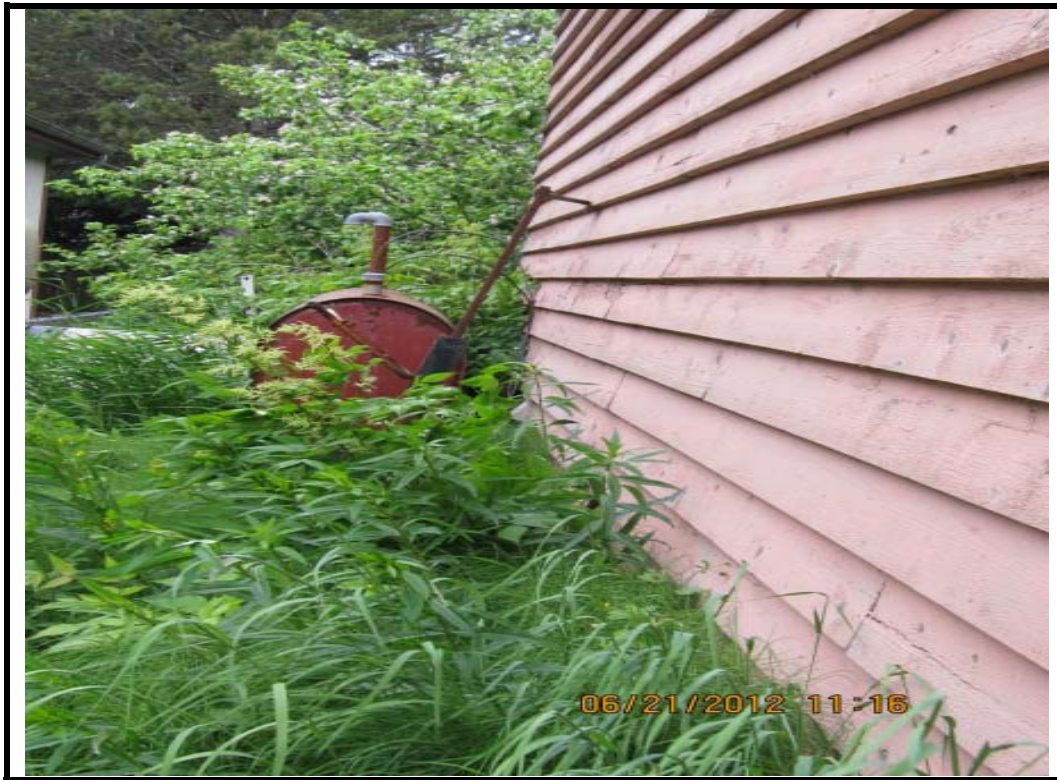
Photo 9: Aboveground fuel storage tank on South side of residence.

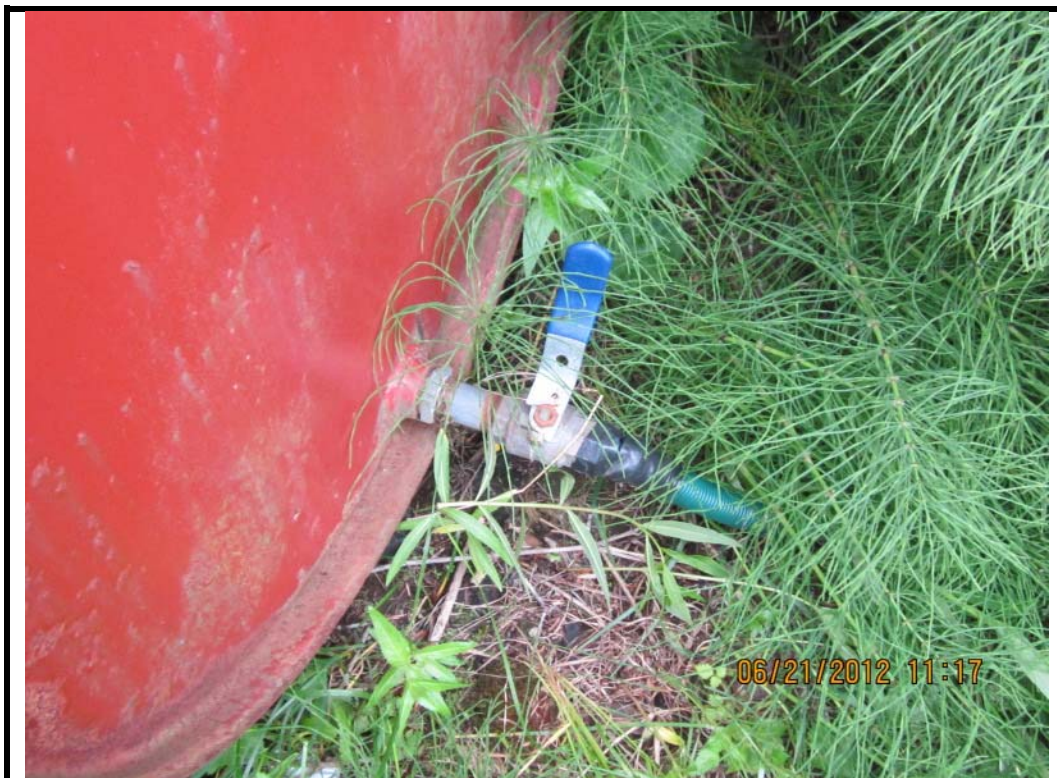
NORTECH assessed the AST on June 21, 2012. We advanced three soil borings to a depth of five ft bgs. Field screening petroleum contamination was present from the ground surface to about two ft bgs on the east end of the tank where an improper piping connection was present. One soil sample was submitted to SGS Environmental Services in Anchorage, AK for analysis of diesel range organics (DRO) content by method AK102 to determine contamination concentrations.

During the AST assessment field screening indicated petroleum contamination is present from the ground surface to about two-ft bgs. One sample was submitted to SGS for laboratory analysis of DRO concentration. Sample CZ-01 contained **3320 mg/kg** (ppm) of DRO; above the ADEC cleanup level of 230 mg/kg. The contaminated soils appear to be less than one yard in volume; however, contamination may be present underneath the foundation of the residence that could not be quantified. Petroleum contaminated soils will require proper disposal.

Photo 10: Improper fuel line connection on AST. Area of soil contamination.

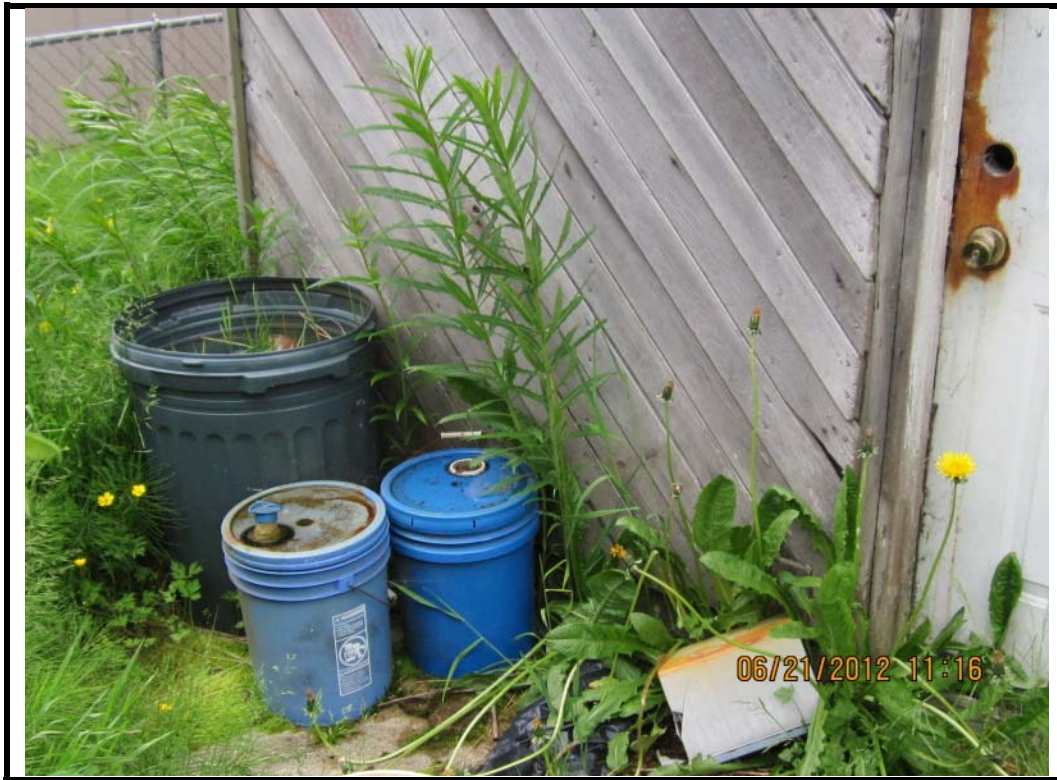
Photo 11: *Hazardous materials outside of residence.*

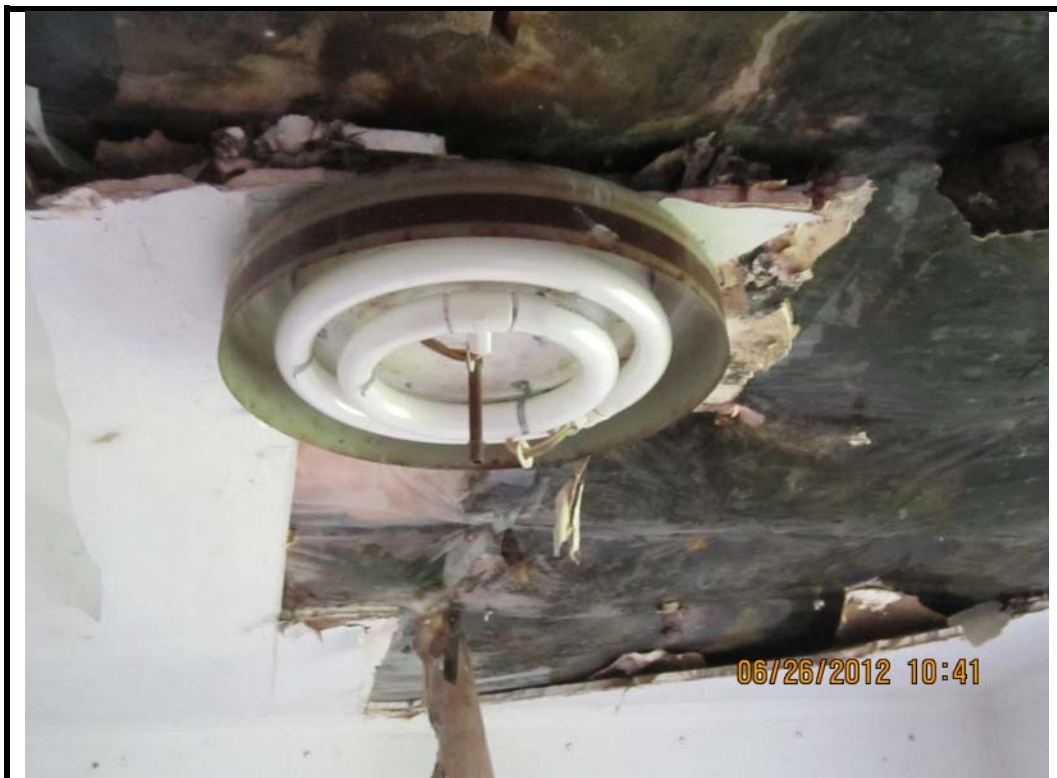
Photo 12: *Example of hazardous materials identified inside residence.*

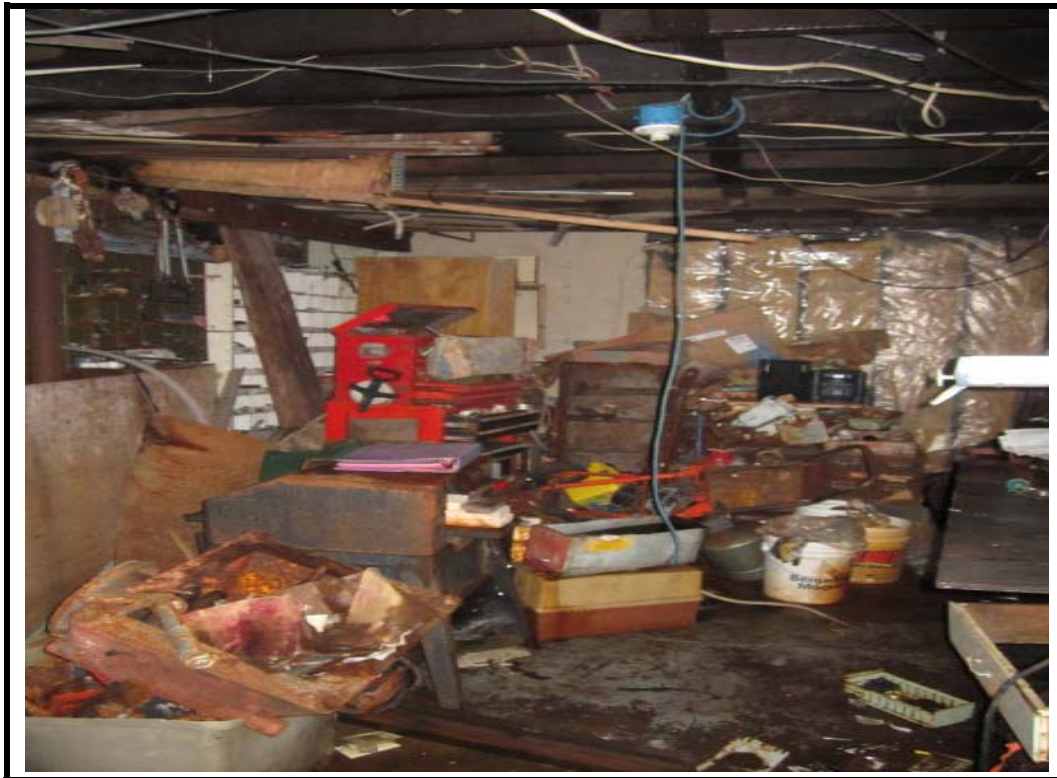
Photo 13: Residence garage/room 6. Most hazardous materials identified in residence are stored in this room.

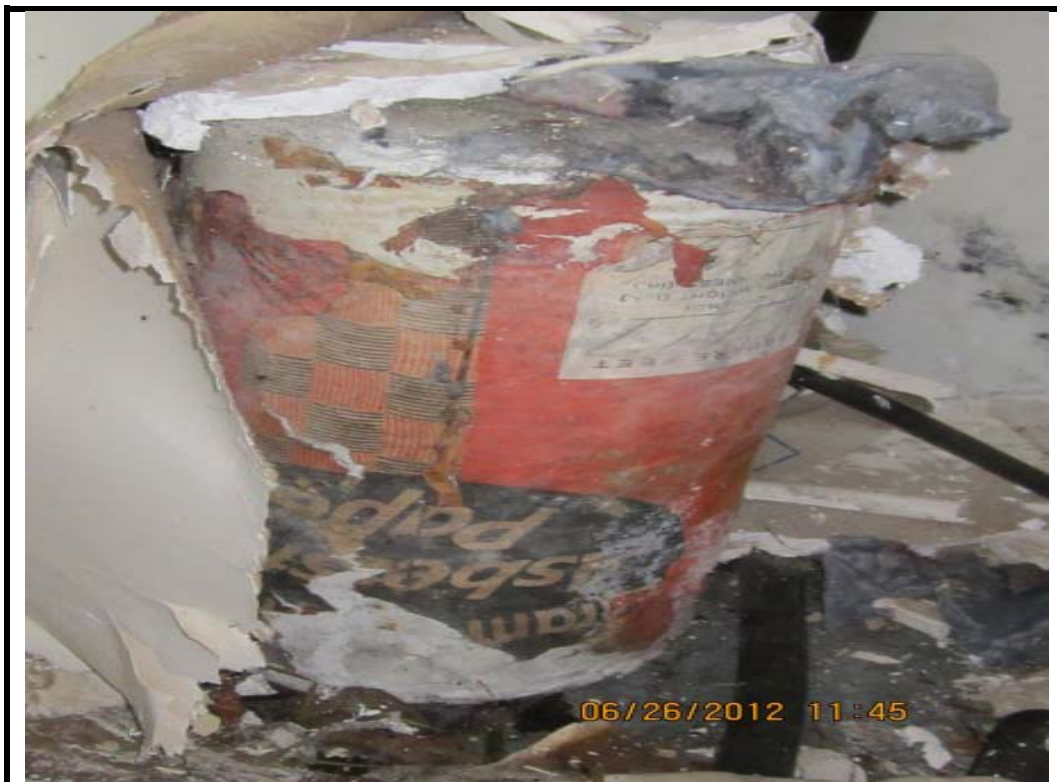
One item of asbestos was identified during Site assessment. A roll of asbestos paper located in Room 1 will require proper disposal.

Photo 14: Hazardous material identified in Room 1. Asbestos paper.

Twenty-five suspect ACM samples of building materials were sent to EHS Laboratories in Richmond, Virginia for PLM analysis. Laboratory analysis confirmed that asbestos was not detected in any of the building material samples submitted. One roll of asbestos paper will require proper disposal at a CBJ Household Hazardous Waste Collection event.
