CBJ CORROSION CONTROL PROJECT  
H-PILE PHOTOS

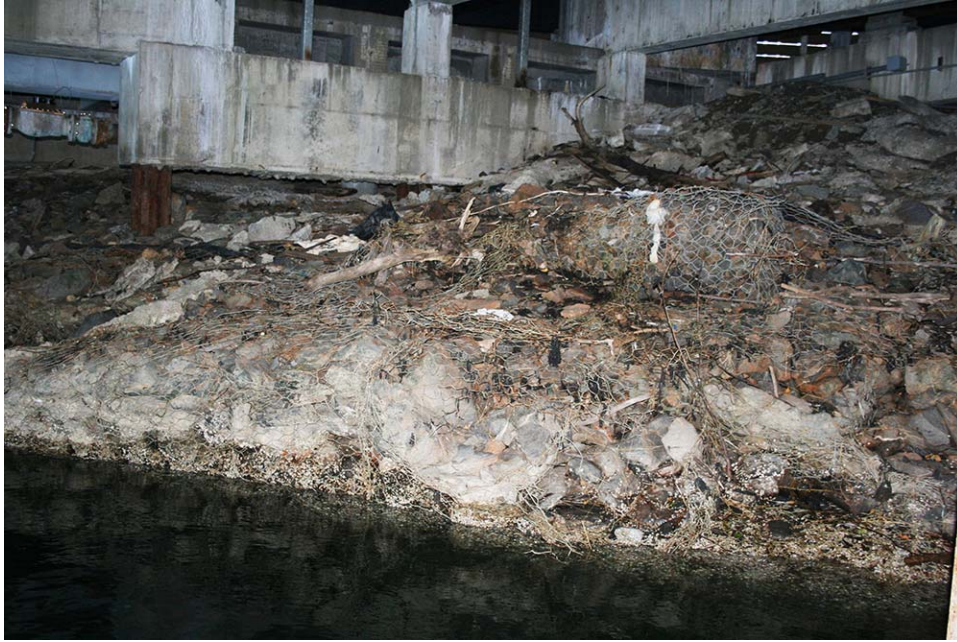
D Line, Piles 9 & 10 from Southwest (Note Gabions)

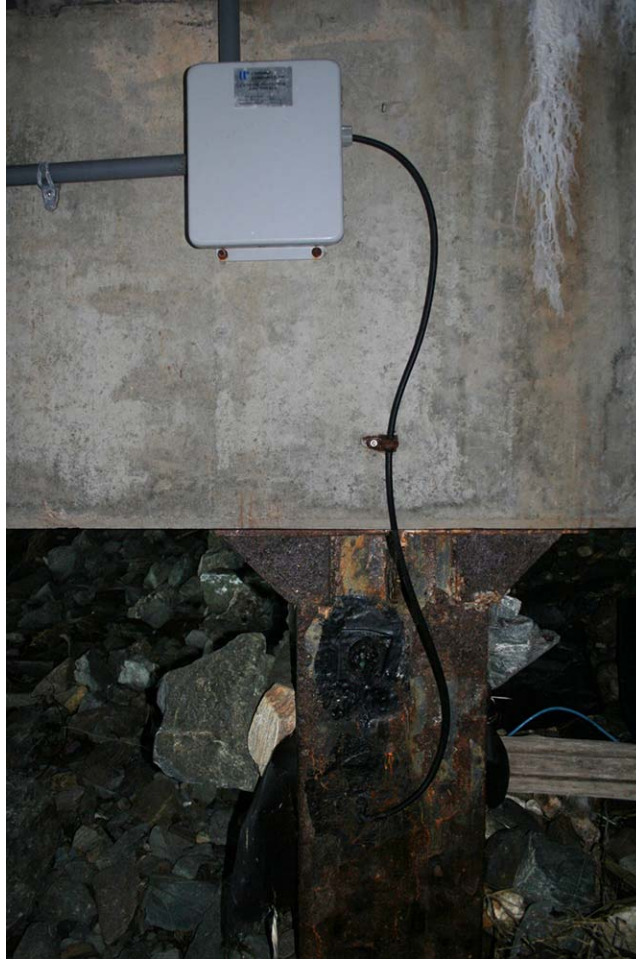
F.5 Line & J-Box from South (Note Rocks Trapped in Mortar in Left Web)

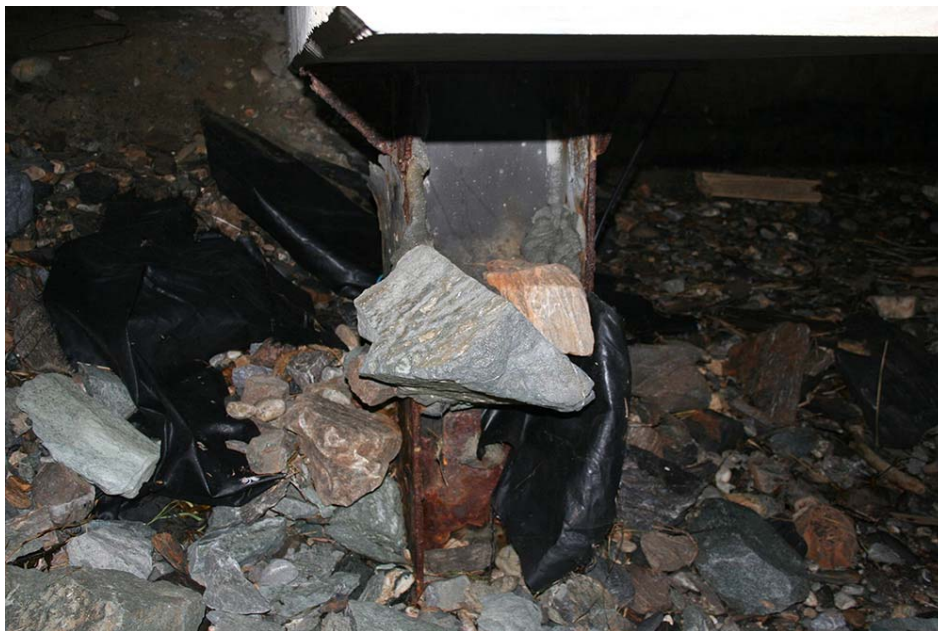
F.5 Pile from West (Note Rocks Trapped in Web in Concrete Bleed from Casting Beam)

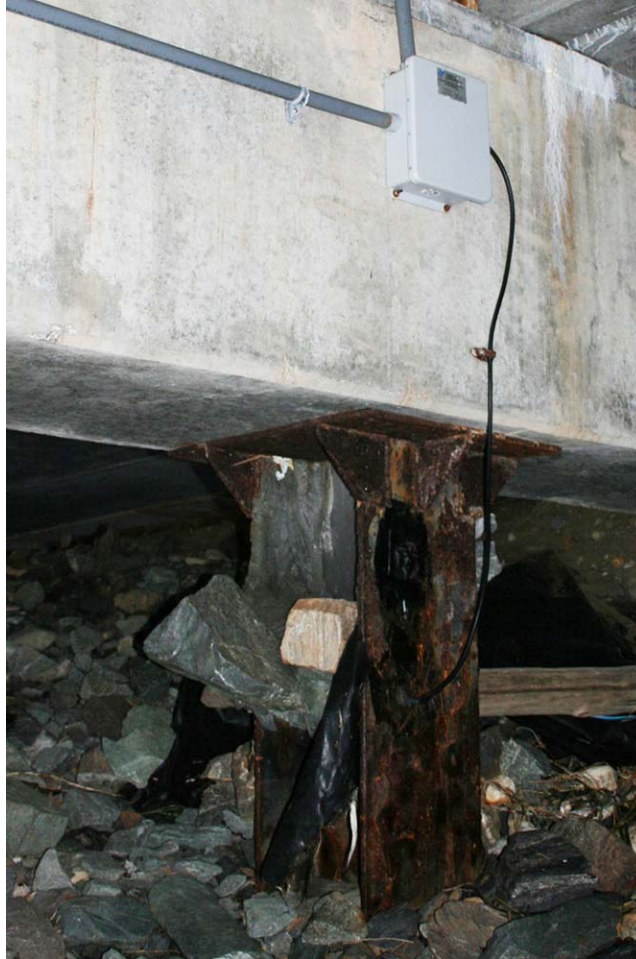
F.5 Pile from Southwest (Note Rocks Trapped in Web from Concrete Bleed when Casting Beam)
