**MENDENHALL VALLEY WASTE WATER TREATMENT PLANT SBR BUILDING ROOF
REPLACEMENT**

Condition Assessment Report

Project: MR E13-156 Mendenhall Valley Waste Water Treatment Plant
Roof Condition Assessment

Date: 06/26/15
07/23/15
10/02/15

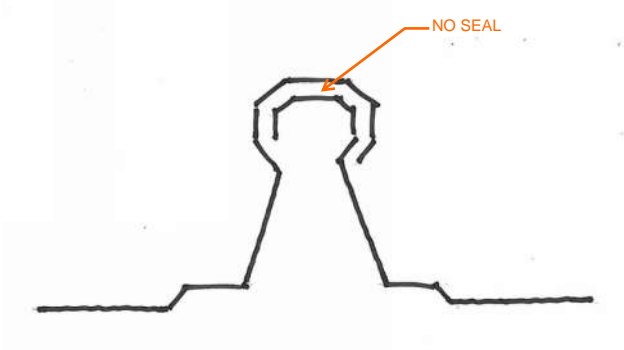
Roof Assembly – Panel Joints

A detail of the typical clip-lock assembly is shown here. At panel joints, the ribs interlock, but by design are not seamed, relying simply on their profile geometry to hold adjacent panels together. Joints therefore are relatively loose and can be pulled apart by hand. Other clip-lock systems incorporate a continuous gasket or bead of sealant to help ensure that the joint is watertight for its length in case it becomes inundated with water backed up by an ice dam or driven by high wind. The system employed on the MVWWTP does not include this seal. Because joints are loose, open paths are available for infiltration along the entire length of each joint over the entire roof.

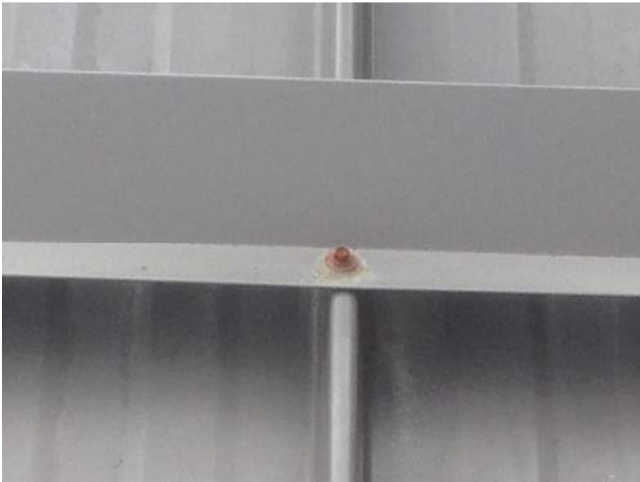
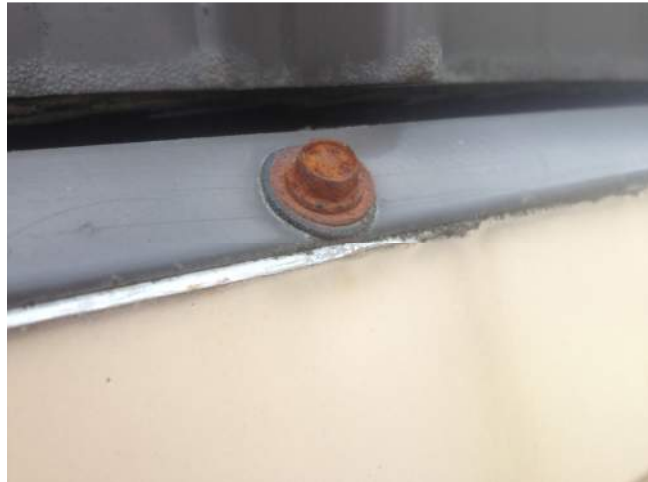
Roof Assembly – Penetrations

Snow guards, flashings and other accessories are typically fastened with gasketed screws penetrating the metal roof panels. Gaskets are aged and brittle, the fasteners themselves are rusted and in cases worn along with the surrounding steel by years of thermal expansion/contraction cycles where no compensation for this movement was designed for. It is likely that most penetrations are no longer water-tight.

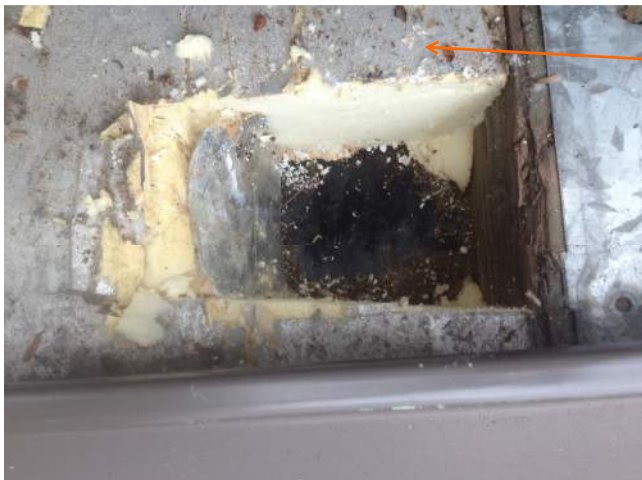
Roof Assembly - Air/Water Barrier

Modern metal roof systems, especially for low-slope applications, incorporate a weather barrier membrane directly below the metal panel system. It is assumed that the metal panels will work more as rain-screen assembly preventing bulk moisture from entering, but allowing some infiltration which will be prevented from entering the structure by the membrane barrier. The MVWWTP roof system has no membrane barrier. The photo below shows the top face of the roof insulation where the insulation abuts a typical horizontal PT wood furring strip. While the foil face of the insulation may act as a barrier where it occurs, joints like the one shown here between insulation and furring and joints between insulation panels are open. Any infiltration through the metal roof panels will run down through these joints and collect on the paper-backed air/vapor retarder sheet, which we assume is also not continuous and suffers many penetrations, and wet and even saturate the roof insulation. Moisture is visible on the air/vapor retarder sheet at the bottom of this core-out.

NO BARRIER MEMBRANE - MOISTURE WHICH PENETRATES METAL ROOF PANEL ASSEMBLY ENTERS DIRECTLY INTO INSULATION CAVITY AND STRUCTURE BELOW

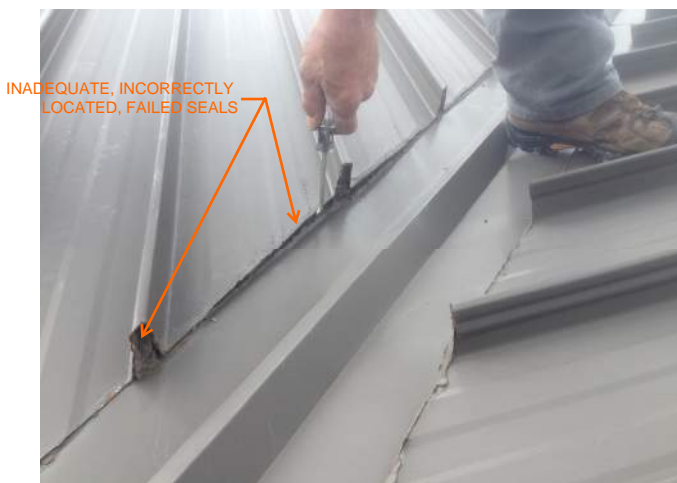
Typical Valley

A number of deficient details were identified at typical valleys. Primary among them is the seal between roof panels and valley flashing. When water ponds or is driven by wind or gravity against this joint, this seal is the only thing preventing water from entering the system between valley flashing and the roof panels. Typically, two parallel, continuous beads of sealant are required uphill, or “dry” side of any fasteners on the low edge of the roof panels where they lap valley flashing. Here, there appears to be a single bead along the bottom edge of the roof panels themselves, exposed to UV and failing. Rib openings should also be sealed. Seals here are poorly applied, missing or failed.

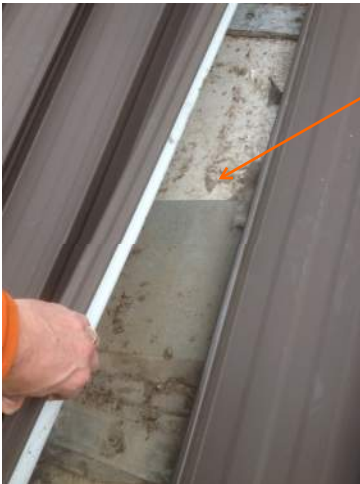
Once water infiltrates valley flashing, it encounters the valley pan. Seen pictured below, the pan extends 24” each way from the valley centerline. Beyond that, there is no protection – water runs directly through joints in poly-iso insulation. The pan is also through fastened with gasketed fasteners whose gaskets are failing and for which no allowance for thermal movement has been made. Whenever possible, continuous metal roof components should be anchored with clips to allow the normal thermal expansion and contraction which occurs with changes in temperature.

IN LOW SLOPE CONDITION, LITTLE PONDING NEEDS TO OCCUR BEFORE WATER LEVEL IS ABOVE EDGE OF VALLEY PAN, AND ENTERS INSULATION CAVITY AND STRUCTURE

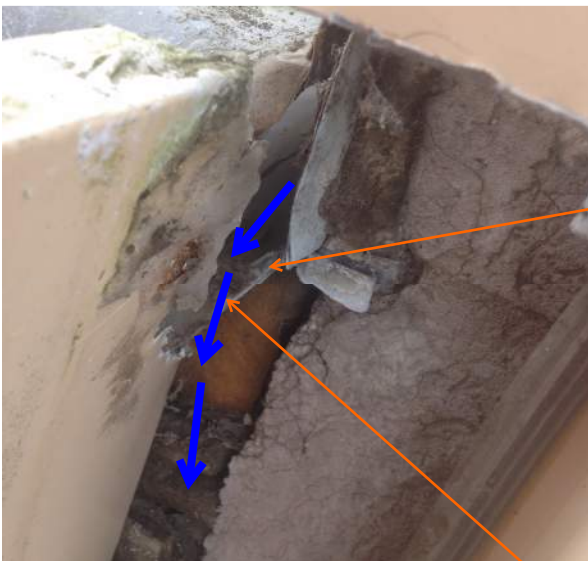
The valley termination is likely the primary point of infiltration, which is consistent with leak patterns in the interior. In the photo below, the valley pan is shown terminating flush with the exterior wall, behind the downspout conductor box. Based on evidence above, we assume there is significant water flow between the valley flashing and the valley pan. This water will tend to flow directly into the roof and wall cavity below at this and at similar locations.

VALLEY PAN SEEMS TO TERMINATE BEHIND CONDUCTOR, WITH NO BARRIER BETWEEN TERMINATION AND OPEN WALL CAVITY. AT THIS POINT WHERE THE ACCUMULATED INFILTRATING MOISTURE FLOW IS POTENTIALLY THE GREATEST, THE PAN DIRECTS THAT FLOW INTO THE STRUCTURE

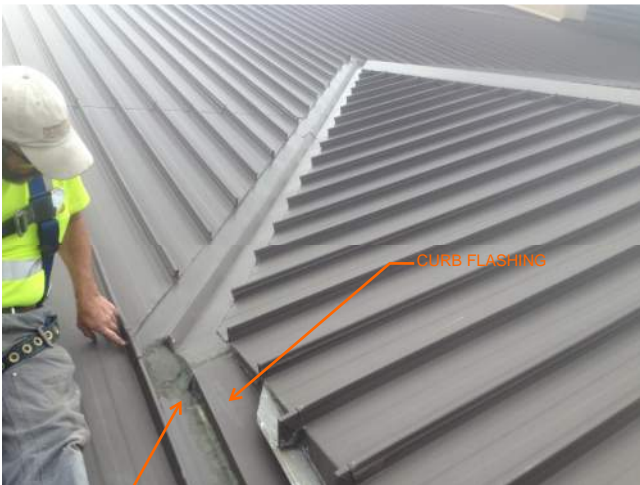
RAKEWALL VALLEY

A number of deficient details were also identified at the rake wall valleys. Primary among them is the roof panel to curb flashing detail. In the photo below one can see the roof area which feeds a single rake wall valley. In modest to heavy rain events, particularly if any damming occurs at the valley termination, this valley will be full. The water tightness of the valley assembly should be reliant on the return leg or rib of the roof panel under the curb flashing which should be roughly where shown in the photo to the right. The liberal application of sealant at the outer joint, however, may indicate that the return leg is inadequate or absent.

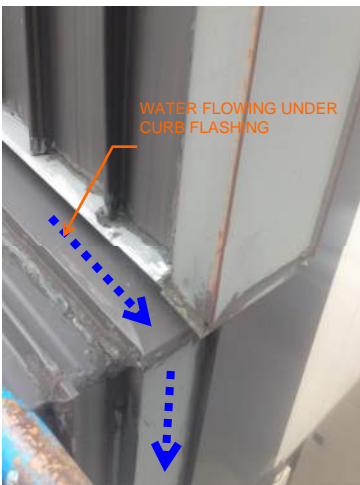
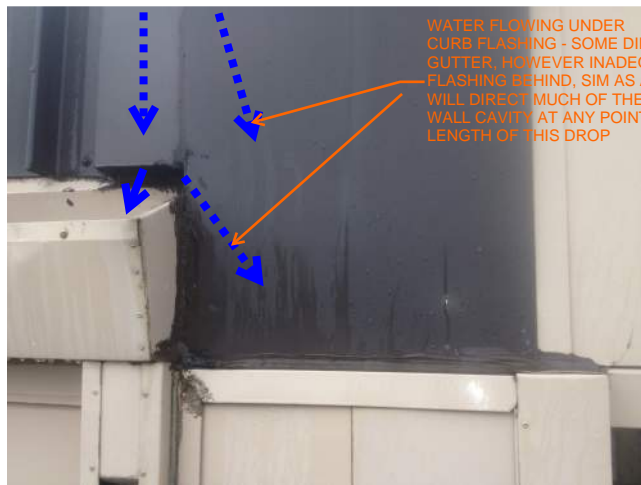
Whether the return leg is adequate/absent or not, water that makes it under the curb flashing must also be managed at rake wall valley terminations. At these conditions, the roof panel itself is acting as the pan flashing. This pan flashing presumably terminates flush with the exterior wall assembly, similar to typical valley terminations, which puts it behind the fascia metal, therefore behind the gutter. It is doubtful that there is adequate moisture protection inboard of this termination – water therefore is likely free to flow into the wall cavity.

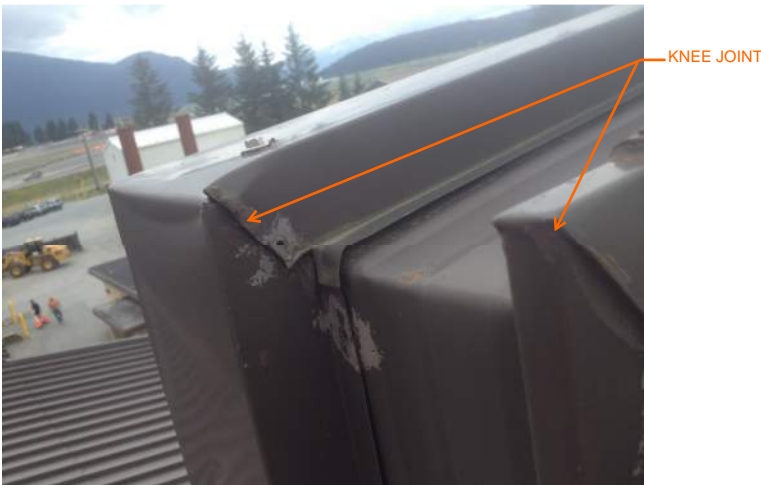
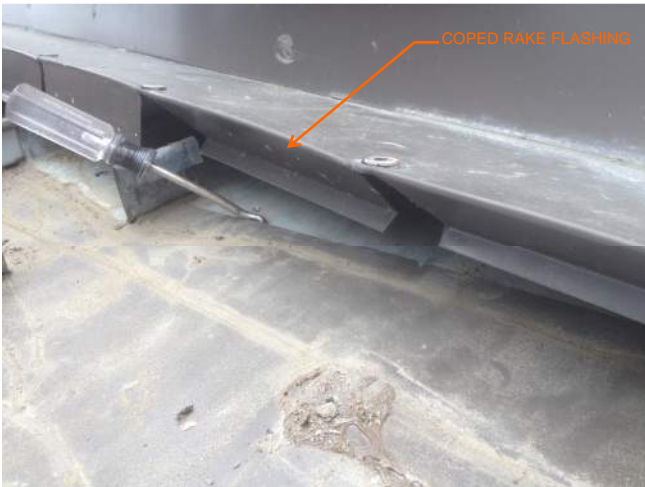
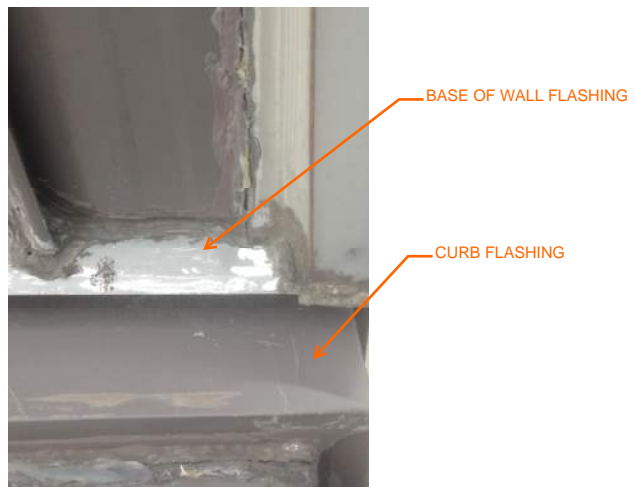
Rake Walls

Rake walls are also contributing to infiltration. Where the roof panels fold down at the eave, the knee joint is multi-faceted, w/ open joints and missing fasteners. At the base of the walls, we find coped rake flashing at grid F and curb flashing at grids 7 and 8 which do not provide an adequate seal, particularly where valley water ponds against rake walls. At grid 7 and 8 rake walls, base of wall flashing is back-sloped and holds water, causing corrosion. The base condition of rake walls in general is deficient, but there are other problems unique to the grid F rake wall.

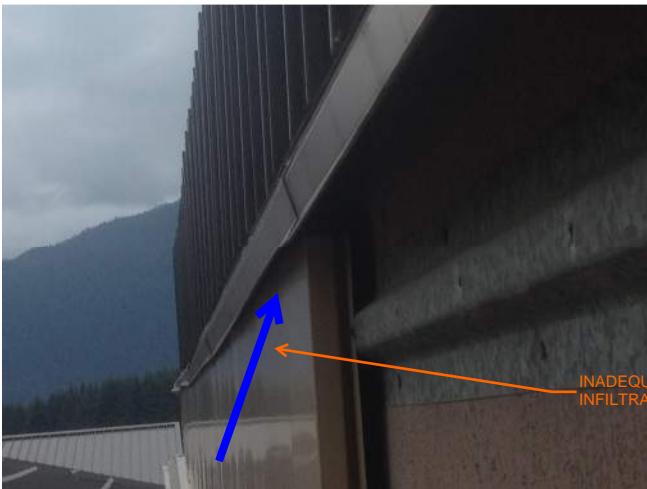
At the roof to wall cladding joint, material lap is inadequate allowing infiltration, especially wind-blown. At the wall base towards the west end (and down the west facing rake on grid 2.5), the flashing detail includes a substantial overhang without adequate counter flashing and/or closure at its underside. This detail creates a wind catch, focusing windblown precipitation into the wall assembly. And as described above, this wall (and likely all others at Influent Pump Sation wing walls) have exterior insulation, and no apparent vapor barrier or weather barrier. The exterior insulation is saturated, likely from a combination of infiltration, and condensation in the absence of a vapor barrier. Either way, moisture present inside this rake wall assembly contributes to moisture infiltration into the building.

INADEQUATE AND OPEN LAP PROMOTES INFILTRATION

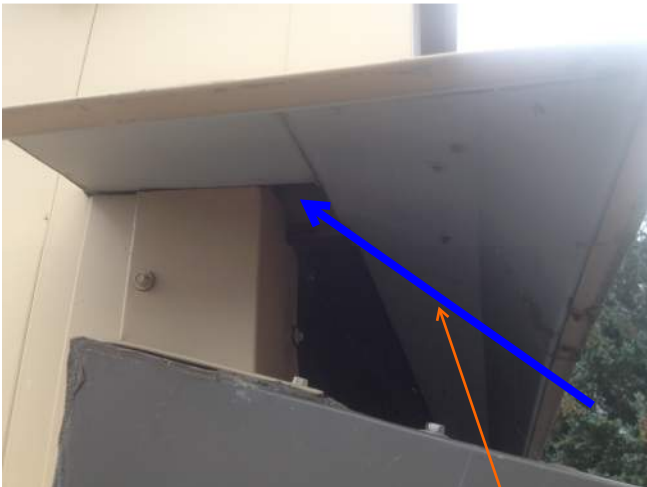
WIND-CATCH PROMOTES INFILTRATION

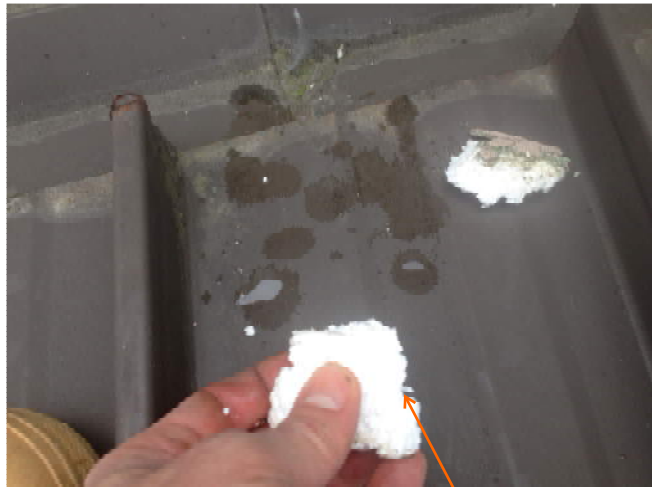
SATURATED EPS

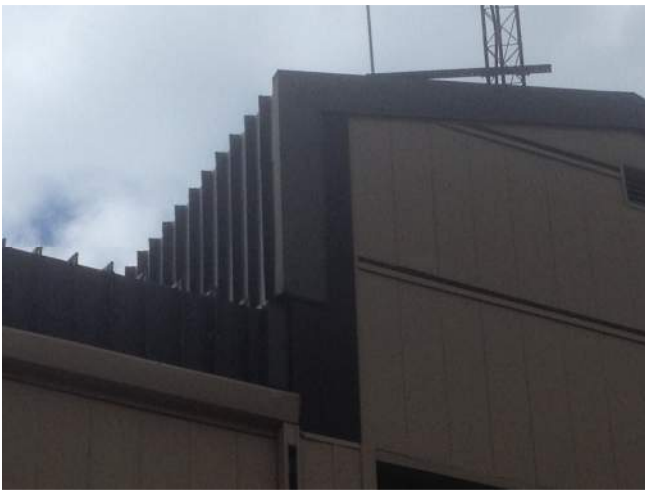
Grids 7 and 8 Rake walls

At grids seven and eight, the rake walls are clad exactly as the roof is, with the same lack of joint seals and the same penetrations. This is a framed wall assembly and appears to be dry beneath the vertical roof panel cladding. We assume there is a vapor barrier on the warm side of the insulation in this assembly. It is unclear what the nature and extent of any rake flashing is as its concealed by the curb flashing, but as discussed above, the system may rely on the rib of the roof panel which is lapped by the curb flashing. Infiltration occurring at the wall base in this case is more a product of improper rake valley flashing and not from significant infiltration into the rake wall above.

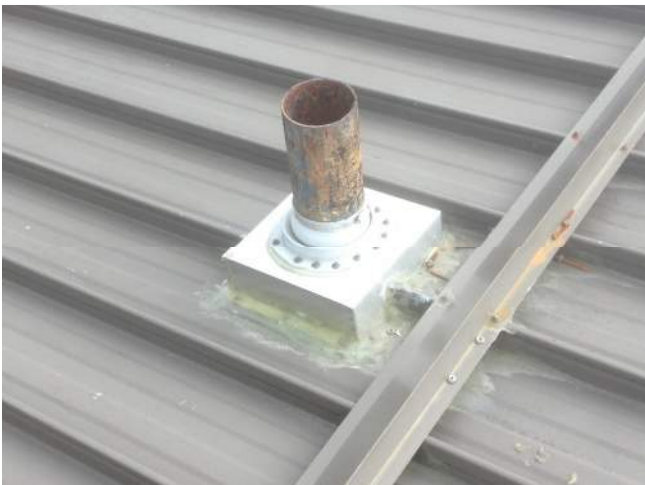
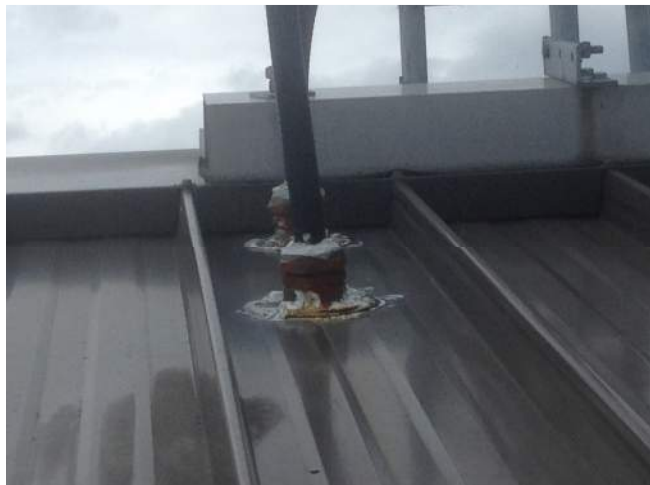
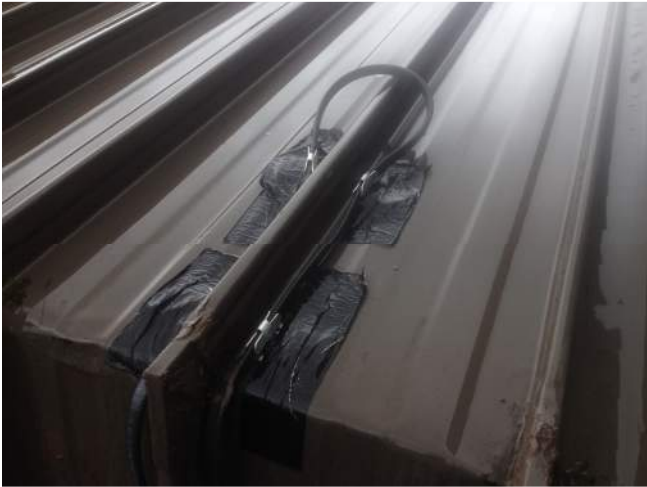
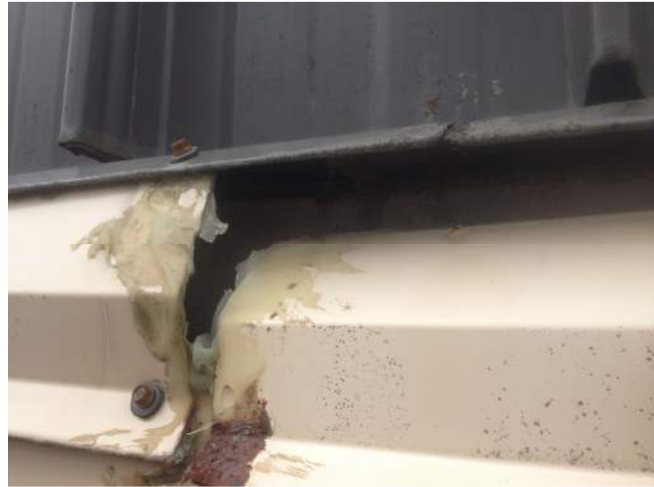
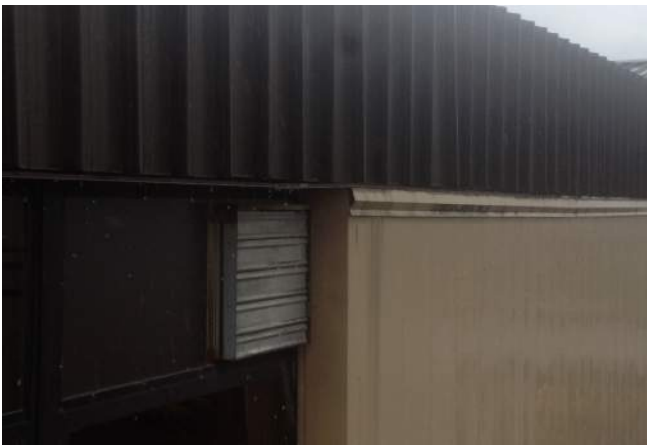
There are a number of unique details that may be contributing to infiltration. Plumbing vents and other penetrations are improperly flashed, or not flashed at all. Secondary systems such as the heat trace system on grid A is mechanically fastened directly through the roof panels, creating additional, impossible to protect penetrations. Existing flashings have been damaged and are no longer performing. And finally, though to our knowledge not presenting leaks, head flashings at wall penetrations occurring on the second floor appear to be back-sloped, and do not appear to allow for a means to shed water outside the adjacent metal cladding where, particularly with a back-slope condition, water will tend to travel.

Corrections for all conditions noted under Other Concerns should be considered with all three proposed approaches. In comparison to the cost of the more significant corrections, the cost to execute these will be minimal. In addition, regardless of the approach chosen, it is critical that the potential for ponding be completely eliminated. This can be achieved by the installation of heat trace along the length of and at the termination of all valleys to prevent ice/snow damming, and with regular maintenance to control debris damming.
