Downtown Juneau Landslide and Avalanche Assessment

Presentation for Public Meeting July 21, 2021

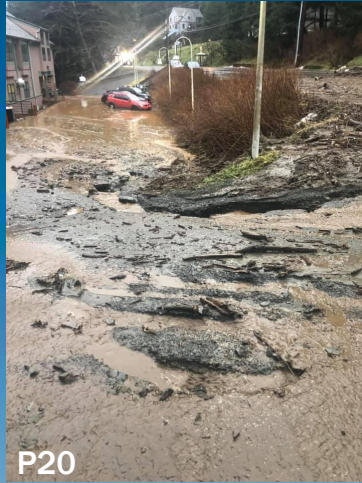
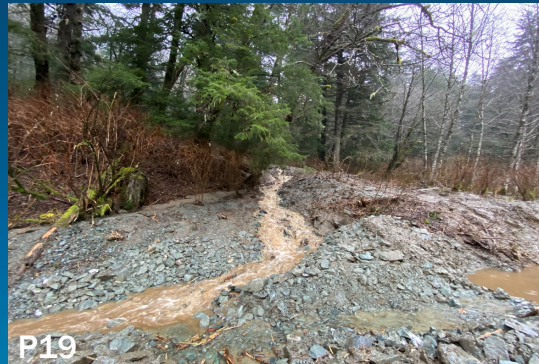
2020 AWARE Shelter Debris Flow

Here are a couple of photos from CBJ, taken on December 4th, 2020, at the debris flow at the AWARE Shelter. They're numbered the same as the photos in the report if you want to look at them again later. Photo P19 is looking southeast and upslope at the debris being deposited on Glacier Highway above the shelter. Photo P20 is looking northwest below Glacier Highway at the parking lot of the shelter, where the debris ended up.

More info: The National Weather Service reported about 6.5" of rain in 48 hours at the Juneau Airport on December 2nd, almost the same amount of rain that would usually fall in the whole month of December. A record-breaking 4.9" of that rain happened in 24 hours on December 1st. By the end of December, Juneau had received more than double its normal amount of precipitation for the month, at about 12.7". (Not a record for December – that was 13.6" in 1997.)

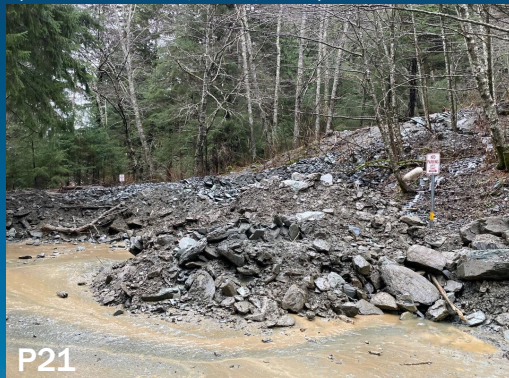
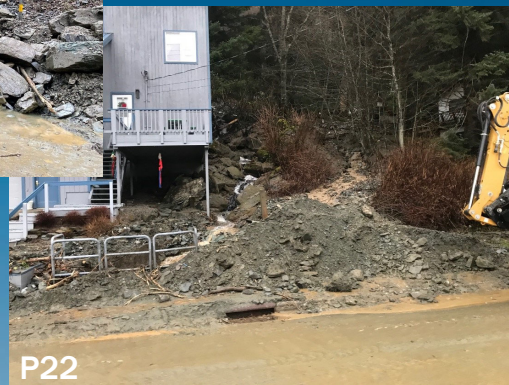
2020 Wickersham Debris Slide

Here are a couple more photos from CBJ, also from December 4th, at the debris slide at the northwest end of the White Subdivision. Photo P21 is looking diagonally upslope at the debris that landed on the northwest end of Wickersham Avenue in the cul-de-sac. Photo P22 is looking upslope at 2020 Glacier Highway where the debris ran out onto the road. The guardrail is located at the concrete sump, which appeared to have been mostly plugged with debris.

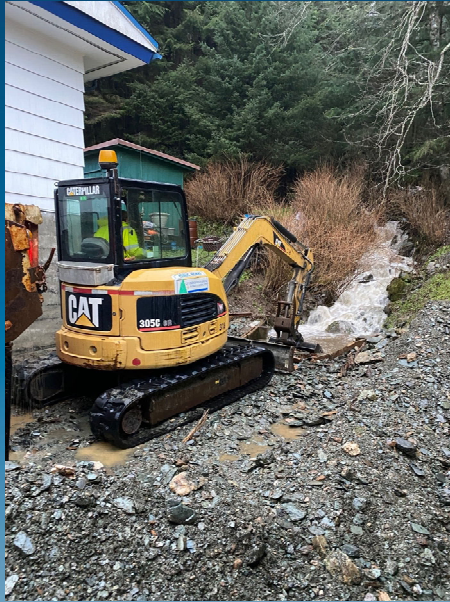
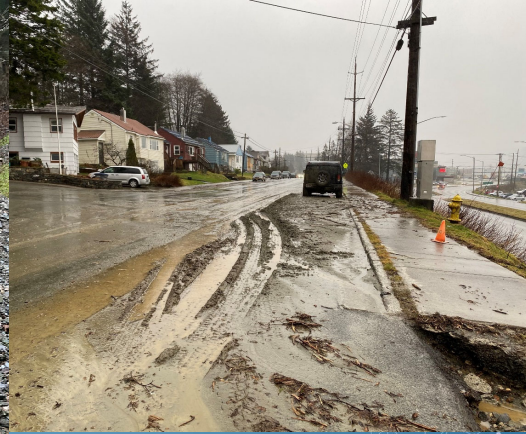
Behrends Avenue and Ross Way

These photos are from CBJ, taken on December 4th, 2020. On the left is the cleanup of debris near the northwest end of Behrends Avenue, on the uphill side of the road. The debris must've been carried by one of those gullies we saw on the LiDAR image. It looks like the gullies can carry a lot of water too. The photo on the right is looking southeast along Glacier Avenue, where Ross Way enters. Ross Way carried some debris and water from Behrends to Glacier. Debris can also run southeast on Behrends Avenue.

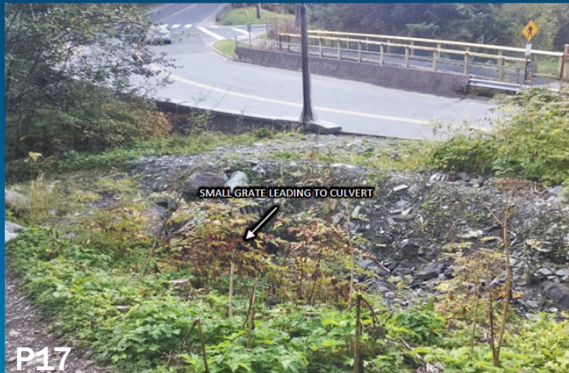
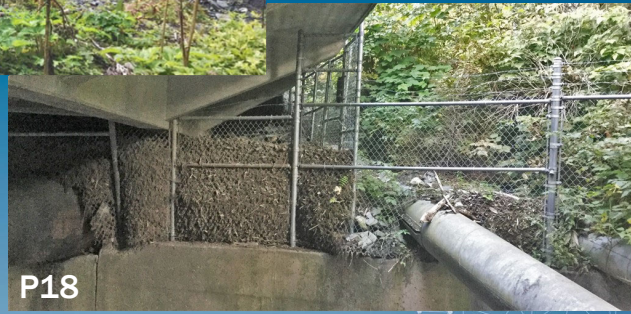
Irwin Street Bridge

Debris flow deposits are seen at the Irwin Street bridge over Gold Creek. Photo P17 is from the north bank of the creek, looking south at the debris deposited near the bridge. Photo P18 is looking north at the debris deposited under the bridge. These photos are from Tetra Tech's landslide fieldwork in September 2019.

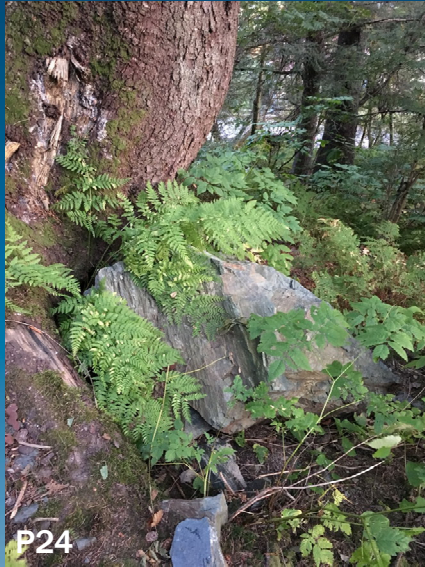
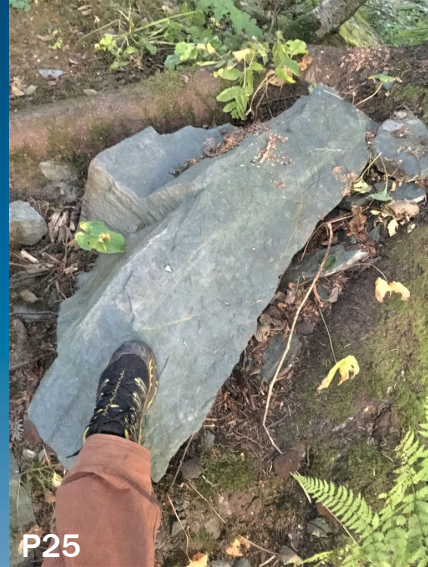
Rockfall is also common in Juneau. These recent examples (probably within the past 5 years) are from the slopes above Basin Road on the south side of Mt. Maria. Remember that stretched-out C-shape that we saw on the geology map? This rockfall area is in it. On Photo P24, we can see that a tree was damaged from rockfall. P25 gives an idea of the size of some of those pieces.

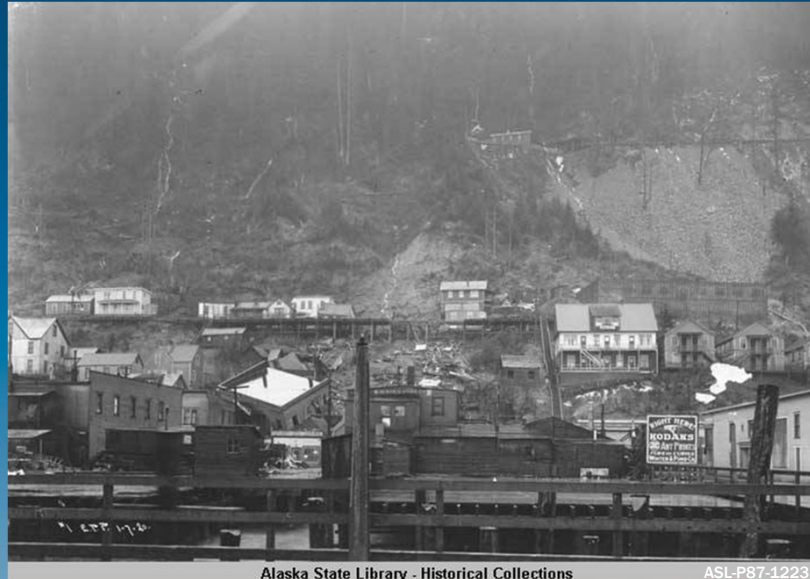
Debris slide January 2, 1920

Debris slides on January 2nd, 1920, killed 4 people, injured eight, and destroyed 16 buildings. Some buildings were destroyed by the debris directly, and others from buildings being pushed into them. Debris broke through into the back of Goldstein's Store. The 3 buildings marked with red X's seem to have been destroyed, and the next one downslope was apparently tipped over.

This photo is from a ship in the channel. Remembering the survey plans, you can tell that there are few buildings missing, and there's the tipped building. You can also see where the slide debris ran down through a trestle at Gastineau Avenue. Uphill from the tenements and the flats on the right, you can see the office, and higher still, there's the flume. It's not clear whether the overflow of the flume contributed to the debris slide, since there was also nearly 2" of rain in 24 hours. But we can see at least 2 places where concentrated water was running downslope.

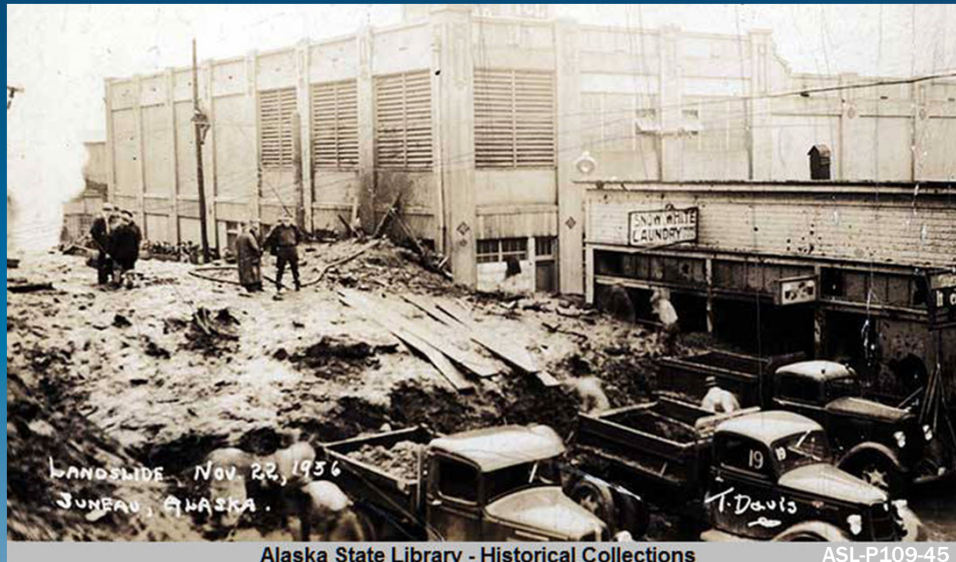
Debris slide – November 22, 1936

On October 16, 1936, a debris slide destroyed several buildings and buried one resident after nearly 1.5" of rain. Debris ran into the back of the Alaskan Hotel. We don't have a photo of that slide, but just over a month later, on November 22nd, nearly 4 inches of rain in 48 hours triggered another slide that caused 15 deaths. Debris covered South Franklin Street to a depth of 10 feet. The first slide was reported to be followed by a second that was up to 100 feet wide and 10 to 40 feet deep. This is the Juneau Cold Storage building on the south side of the road and about 200 yards southeast of Goldstein's, where the debris ran up another 3 feet onto the wall of the building and splashed muddy water 5 or 6 feet higher still. If the building hadn't been there, the slide debris probably would've gone further, so that's an adjustment that was made on the mapping.

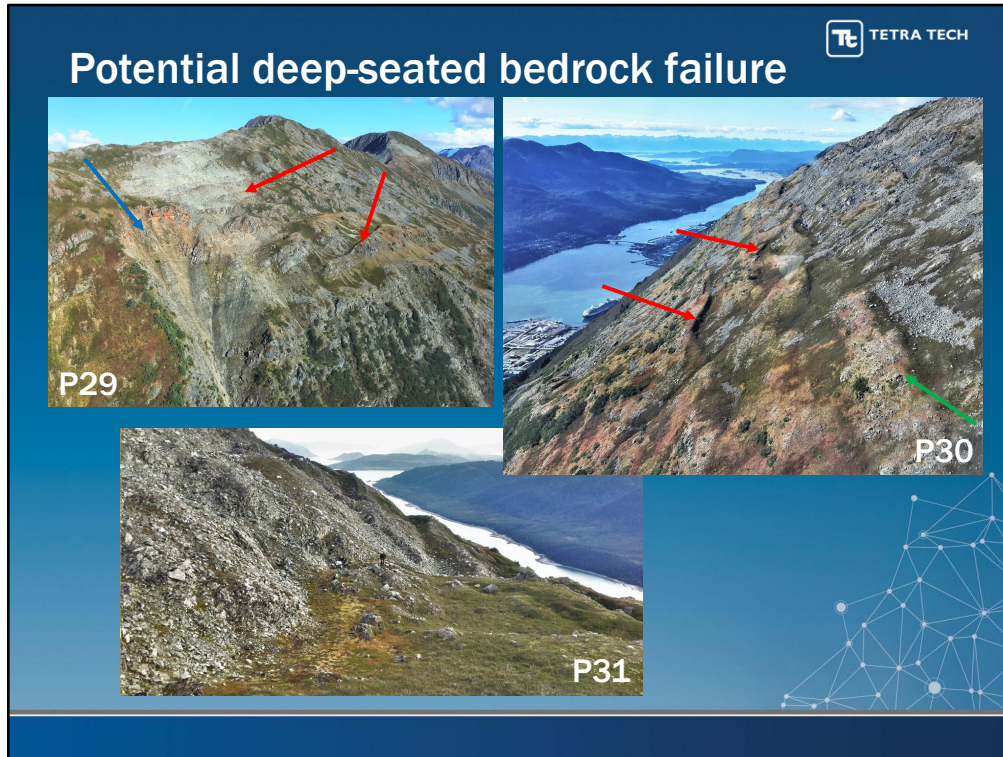
Photo P29 is looking east at the top of Snowslide Creek (at the blue arrow), and the bedrock slope to the southeast, where the Severe landslide hazard has been mapped. The red arrows are pointing at deformed, wavy and discontinuous bedrock features. These and multiple ridge-and-valley-like features suggest deep-seated creep in the bedrock.

Photo P30 is looking north at the same slope. Wavy lines at the red arrows suggest unstable bedrock, straight lines at the green arrow further southeast suggest stable bedrock.

Photo P31 is looking southeast at the area of bedrock creep. Potentially ploughed bedrock is on the left, and the ridge-and-valley structures can be seen along the skyline in the middle.

The upshot here is that this feature needs more investigation.
