**To:** Teri Camery (CBJ) **Date:** September 16, 2021  
**c:** Alix Pierce (CBJ) **Memo No.:** 3  
**From:** Rita Kors-Olthof, Vladislav Roujanski, Shirley McCuaig **File:** 704-ENG.EARC03168-01  
**Subject:** Responses to Public Comments Arising from Issued-for-Review Report (3<sup>rd</sup> Draft) and Landslide and Avalanche Hazard Public Meeting – July 21, 2021  
Downtown Juneau Landslide and Avalanche Assessment

This technical memo addresses some of the comments and questions that arose from Tetra Tech’s Issued-for-Review (3<sup>rd</sup> Draft) Report, Downtown Juneau Landslide and Avalanche Assessment, dated May 28, 2021, and the Landslide and Avalanche Hazard Public Meeting that took place on July 21, 2021.

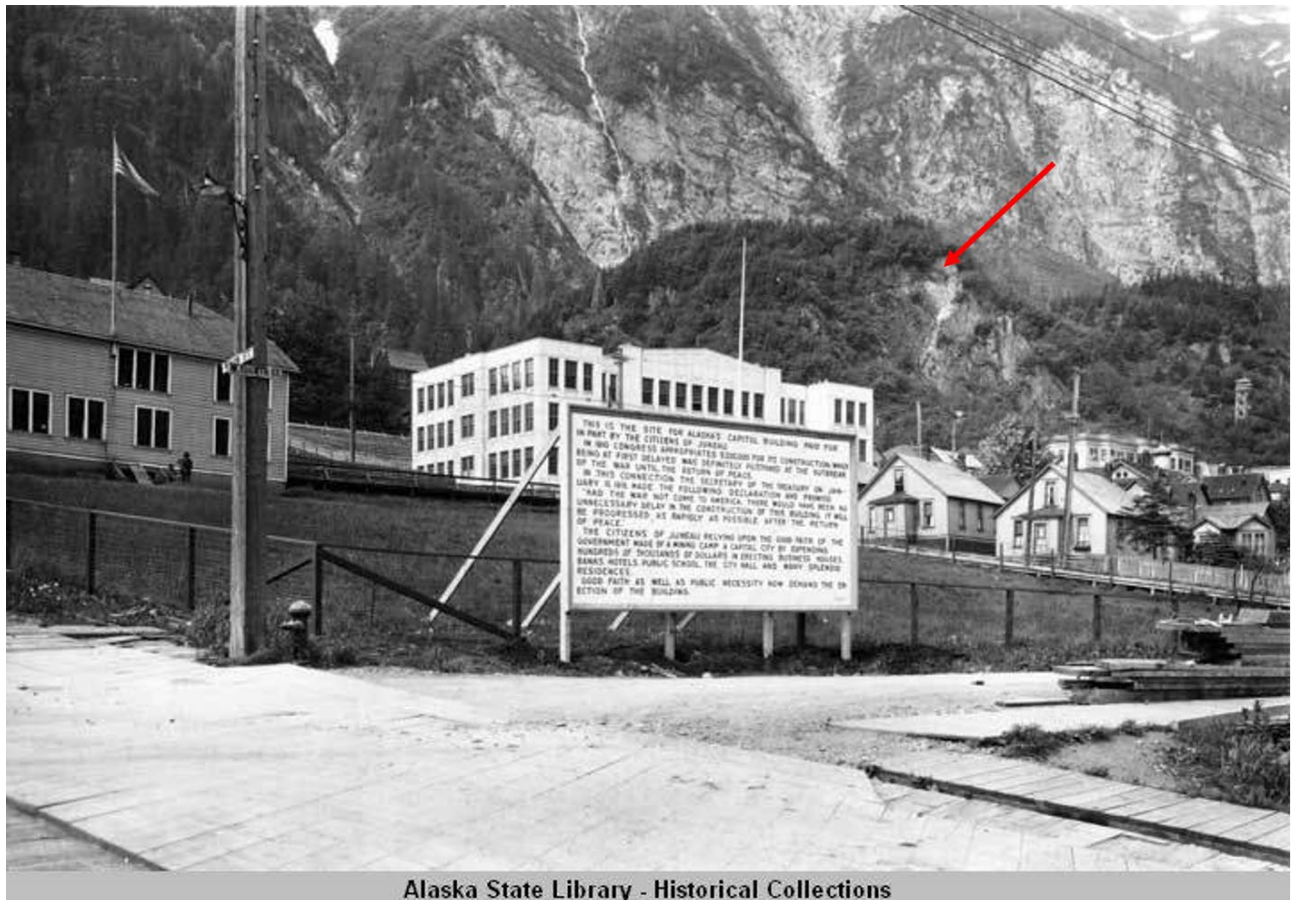
A news story about the 1913 event reported two large rocks, each several tons in weight, falling from the cliff on the side of Decker Hill facing town and above Basin Road (Figure 6). One of these rocks impacted a huge

**Figure 6:** Photo ASL-Juneau-Capitol-Building-1. Looking north towards the Juneau Public School, circa 1918. Rockfall/rockslide scar on Decker Hill / Mt. Maria in the background was the likely origin of the October 18, 1913 landslide event (red arrow). The rock slope immediately to the right of the red arrow appeared to be more active (less reforestation) than the slope to the left in 1918, and some of the debris might also have originated from there. See Figure 13 for present-day view of Mt. Maria.

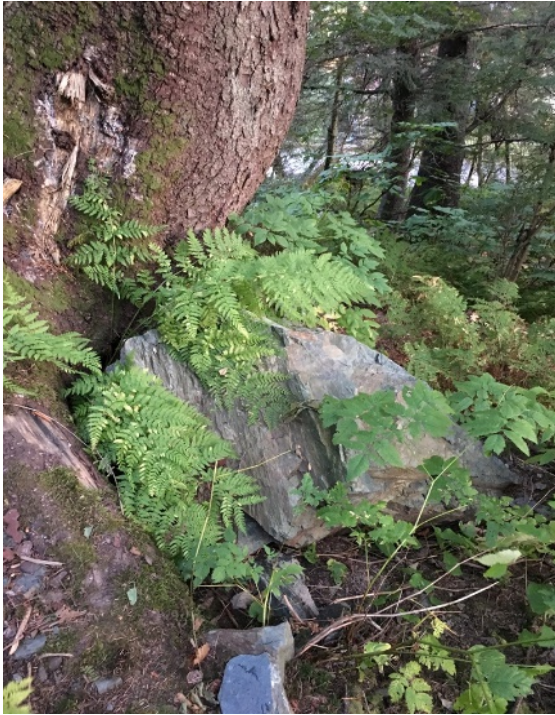
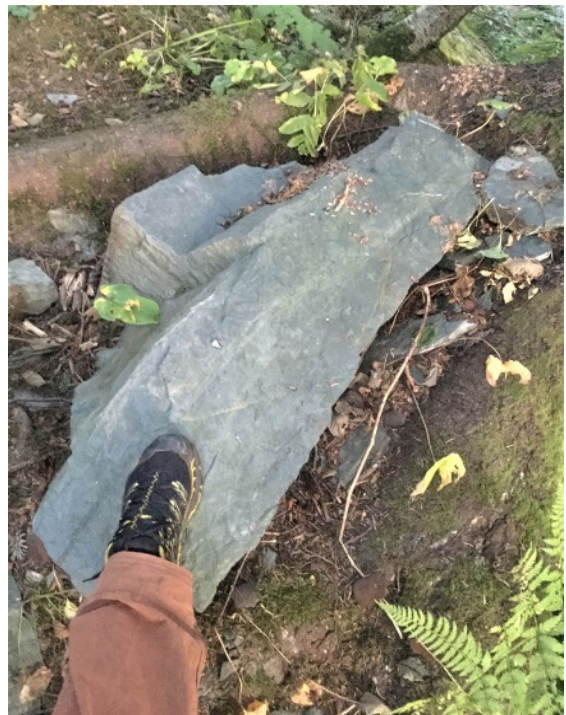
in their paths (Figure 7). Along the houses on 6<sup>th</sup> Street, the Severe zone affects the backyard, but might or might not affect the house. Figure 8 shows examples of rock bluffs, slide tracks, and talus. The housing itself obscures the effects of the rockfall activity – if a boulder rolls into a yard or onto the road, it is typically removed, so the evidence is no longer available for mapping. The boundary of the Severe hazard area for Mount Maria is thus very conservative and may well extend further southeast than that shown.

**Figure 7:** Photos from Tetra Tech's 2021 report, at the southwest end of Mount Maria above Basin Road at Harris and 7<sup>th</sup> Street. Photo P24 (left) shows a tree damaged by rockfall. Photo P25 (right) shows the typical size of some of the fallen rocks.

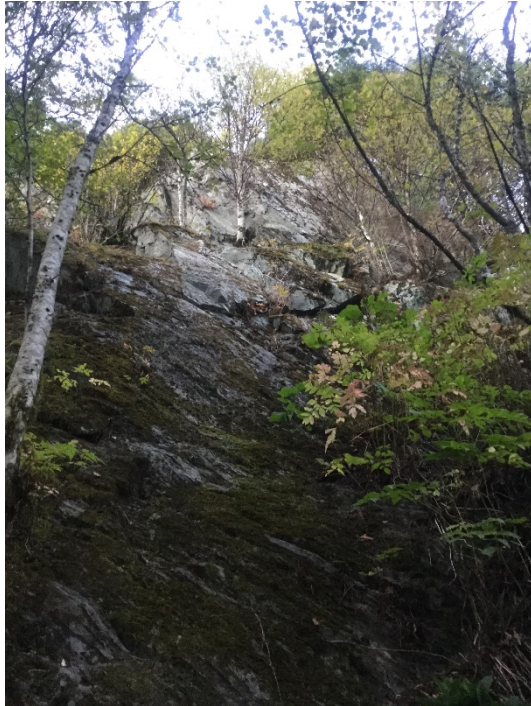
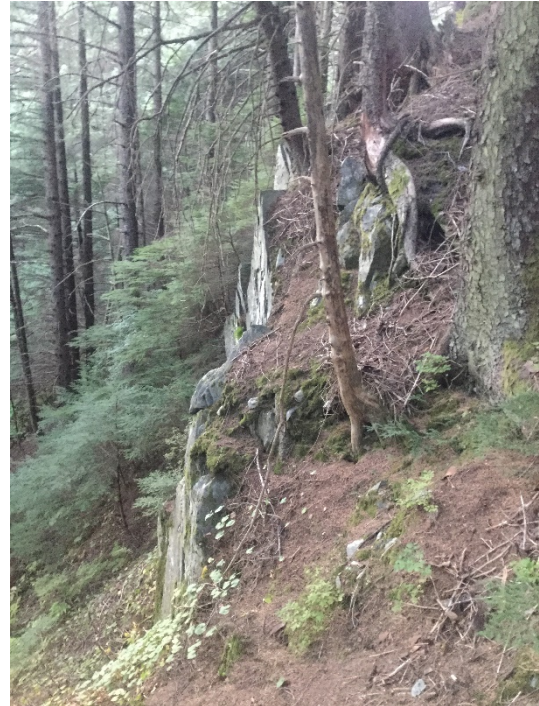
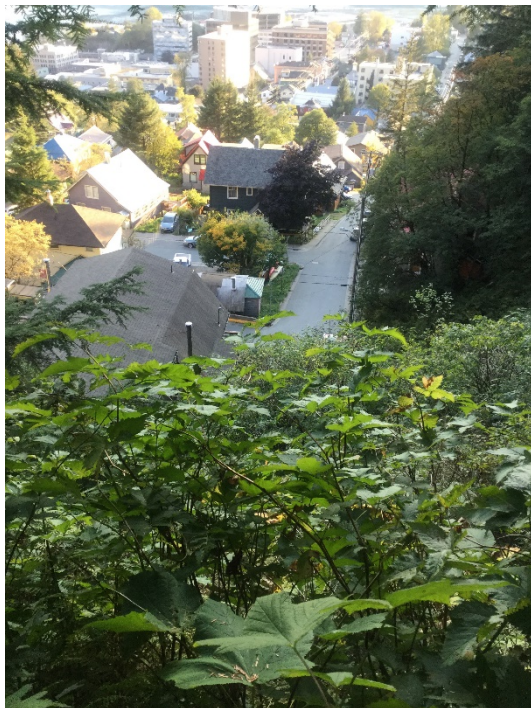
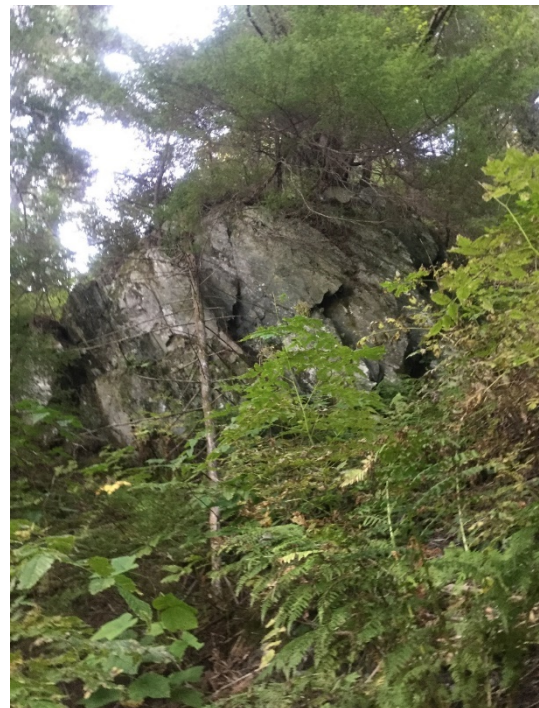
**Figure 8:** Clockwise from top left: rockslide track and cliff above rockfall shown in Figure 5; rock bluff above 6<sup>th</sup> Street; rock cliff with detached blocks above corner of 6<sup>th</sup> Street and Nelson Street; talus deposit below rock cliff, 6<sup>th</sup> Street visible below.

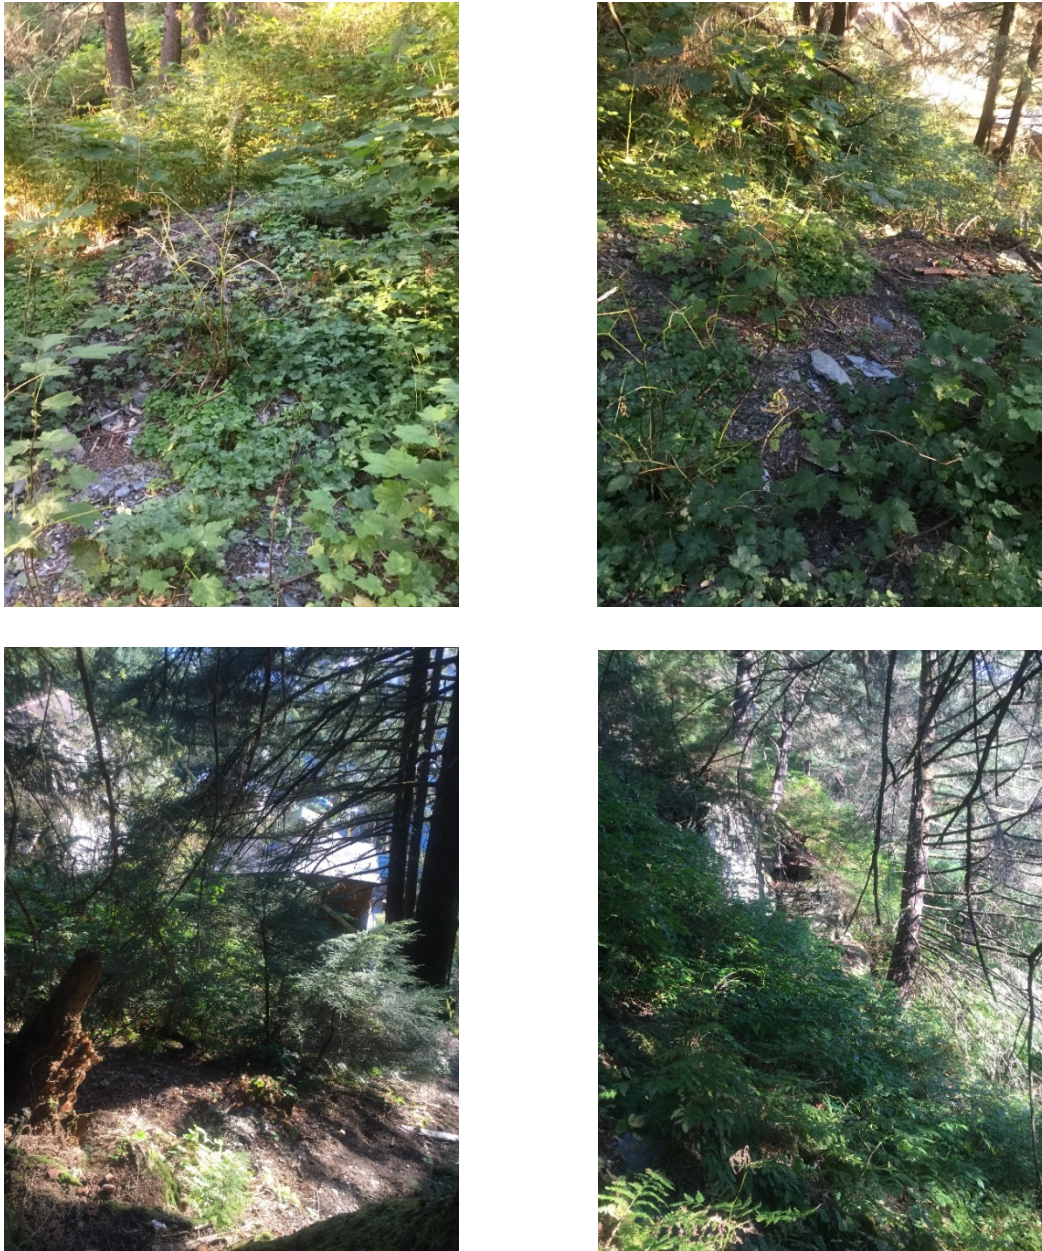
**Answer:** Upslope of Nelson Street, there are debris slides and rockfall. The hazard here varies from High to Severe, depending on location (Figure 4, right). The mudslides likely occur at areas of debris slides / flows shown on the surficial geology map (Figure 3, left), with some slide paths shown on Figures 11 and 14. Figure 9 shows some examples of active debris slide paths and rock bluffs above Nelson Street. See Question #3 for information on the effects of historical forestry activities on this slope and to see where the most prominent landslide paths are located. See Questions #5 and #6 for information on the slopes above the corner of Nelson and 5<sup>th</sup> Streets. See Question #12 for information on the possible effects of the old Mt. Roberts Trailhead.

**Figure 9:** Photos at the top show active debris slide paths above Nelson Street; photos at the bottom show rock bluffs and broken or damaged trees above Nelson Street.

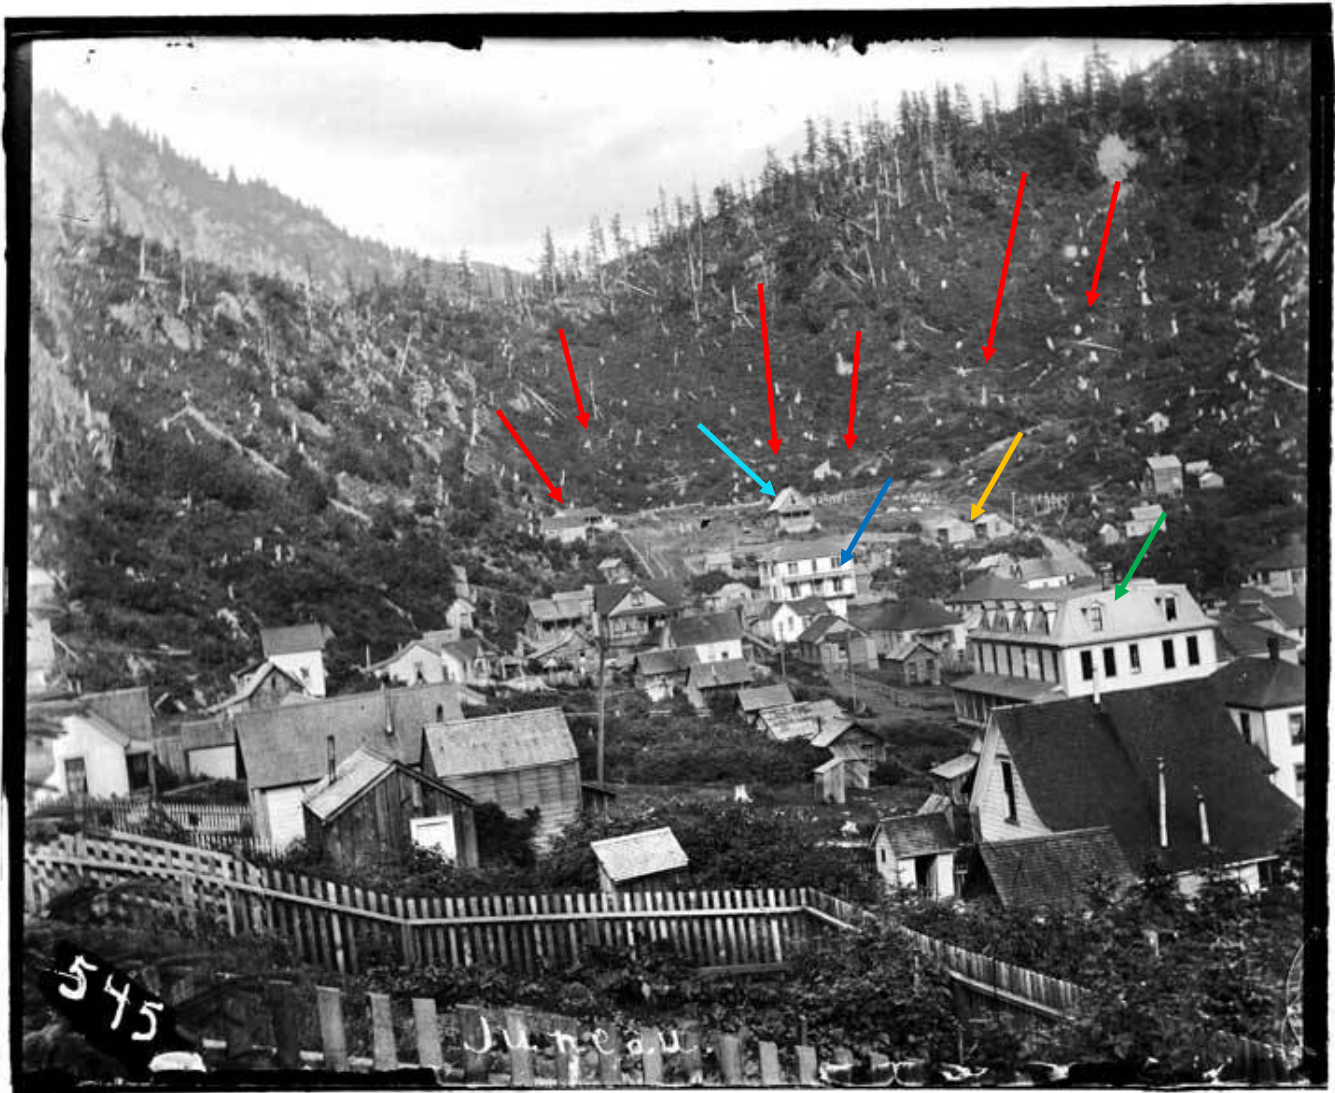
**Figure 9:** Photo ASL-P1-506 – Looking east-northeast toward Starr Hill from top of Chicken Ridge, 7<sup>th</sup> and Franklin Streets, July 1901. Slopes appear to have been recently clearcut (within the previous few years) with numerous stumps visible. There are some swales and slope sections with few or no stumps, indicating that this slope was not uniformly forested prior to clearcutting (red arrows). At least two recent soil debris slides are visible above what appears to have been Park Street in 1901.

Landmarks shown in Figure 9 include the Distin-Dawes-Pelto House at 529 East Street (blue arrow), St. Ann's Hospital staff residence (green arrow) at the south corner of 6<sup>th</sup> and Harris Streets, apparent precursors to the Lund Houses I and II at 504 and 510 Kennedy Street (yellow arrow), and the Mitchell House at 715 – 6<sup>th</sup> Street (aqua arrow), based on the Inventory of Historic Sites and Structures (1986) and various historical photos from the Alaska State Library. Some of the dates and descriptions are uncertain in the inventory, and it is possible that changes or additions have been made to some of the structures that still exist. As well, some of the structures present in this photo no longer exist, or were replaced with other structures. Park Street appears to have been the approximate upper end of the developed area in 1901, since the earliest houses above Nelson Street were built in 1928.

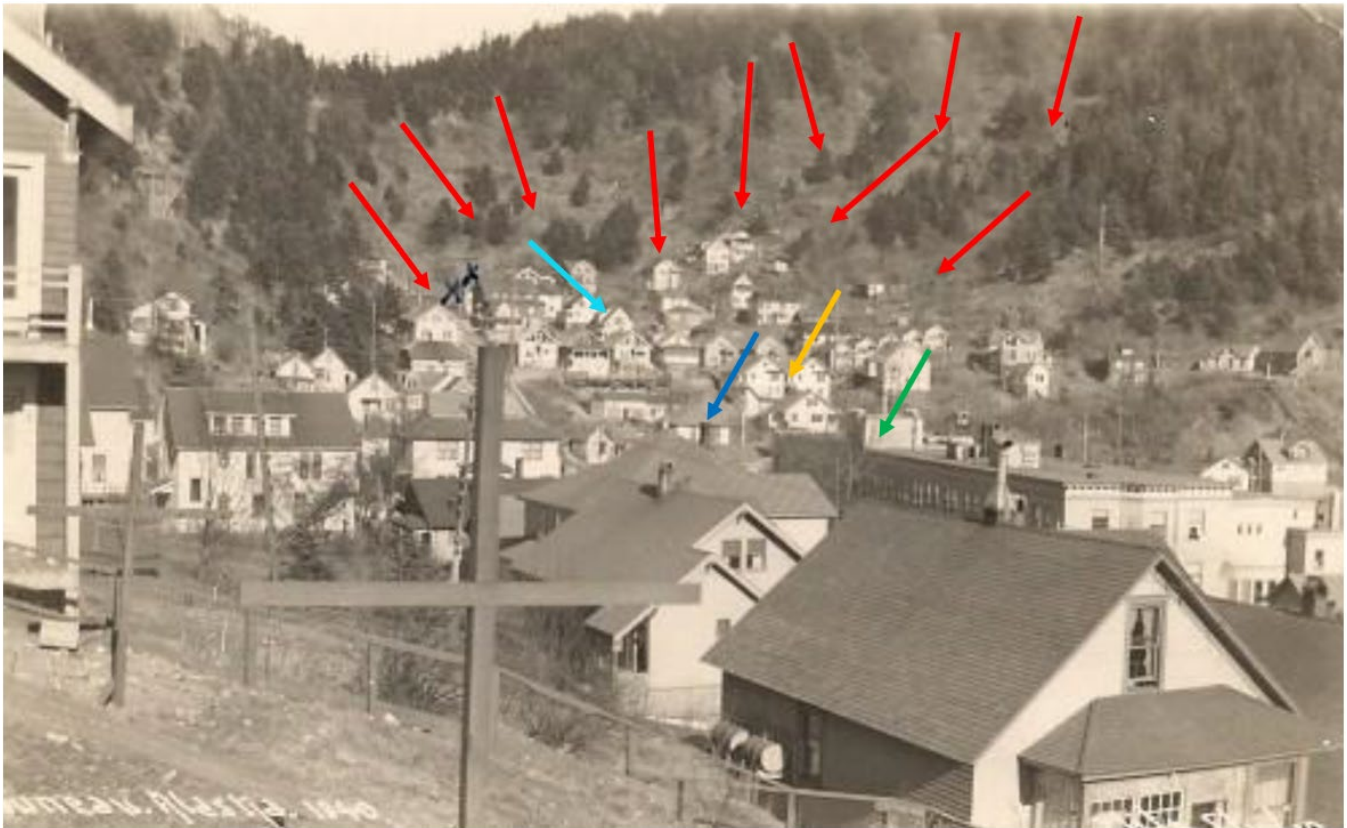
**Figure 10:** Looking east-northeast, this view of Starr Hill in 1940 is from a little further southwest of the view in Figure 9, and somewhat foreshortened. After more than 40 years of tree growth after clearcutting, the swales and gullies where no coniferous trees grow are especially clear in this photo. Selected swales and gullies are shown with red arrows; several other swales and gullies are also visible between the red arrows.

Landmarks shown in Figure 10 include the Distin-Dawes-Pelto House at 529 East Street (partly obscured, blue arrow); St. Ann's Hospital (green arrow) at the south corner of 6<sup>th</sup> and Harris Streets, with the newer concrete section northeast of the green arrow (replacing the former staff residence), and the older wooden section to the southwest; the Lund Houses I and II at 504 and 510 Kennedy Street (yellow arrow); and the Mitchell House at 715 – 6<sup>th</sup> Street (aqua arrow), based on the Inventory of Historic Sites and Structures (1986) and various historical photos from the Alaska State Library. Some of the dates and descriptions of structures are uncertain in the inventory, and it is possible that changes or additions have been made to some of the structures that still exist. As well, some of the structures present in this photo may no longer exist, or were replaced with other structures. Nelson Street was the upper end of the developed area in 1940, with most of the houses above Nelson Street built by then.

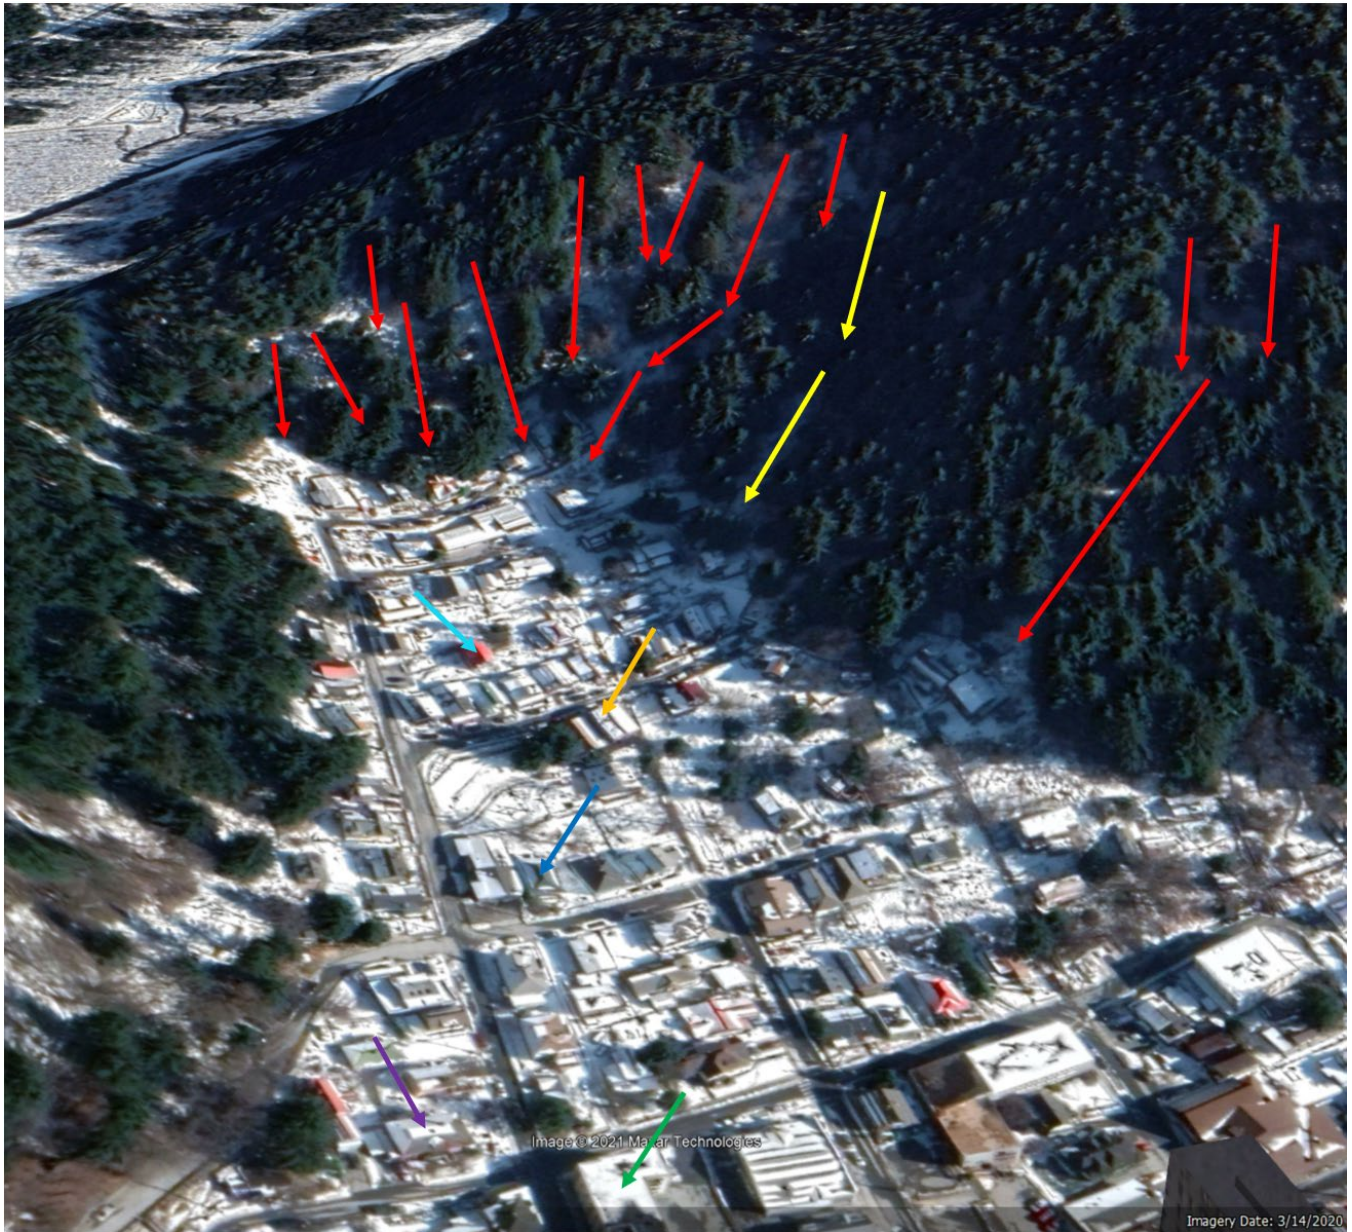
**Figure 11:** Looking east-northeast, this Google Earth view is from an eye elevation of about 1100 feet and at a snowy time of year (March 2020), so that the areas without coniferous trees can be seen more easily. The same swales and gullies that lack tree cover that were seen in the 1940 photo (Figure 10) are still visible in 2020, along with a few more. The landmarks are the same as in Figure 10, although St. Ann's Hospital is now called St. Ann's Center, and a new landmark at Nelson House II has been added below Basin Road (purple arrow).

In Figure 11, one of the main gullies (shown with two bright yellow arrows, ending between Park and Kennedy Streets) is the G000 Park debris flow gully. See Figure 14 for more information about this gully.

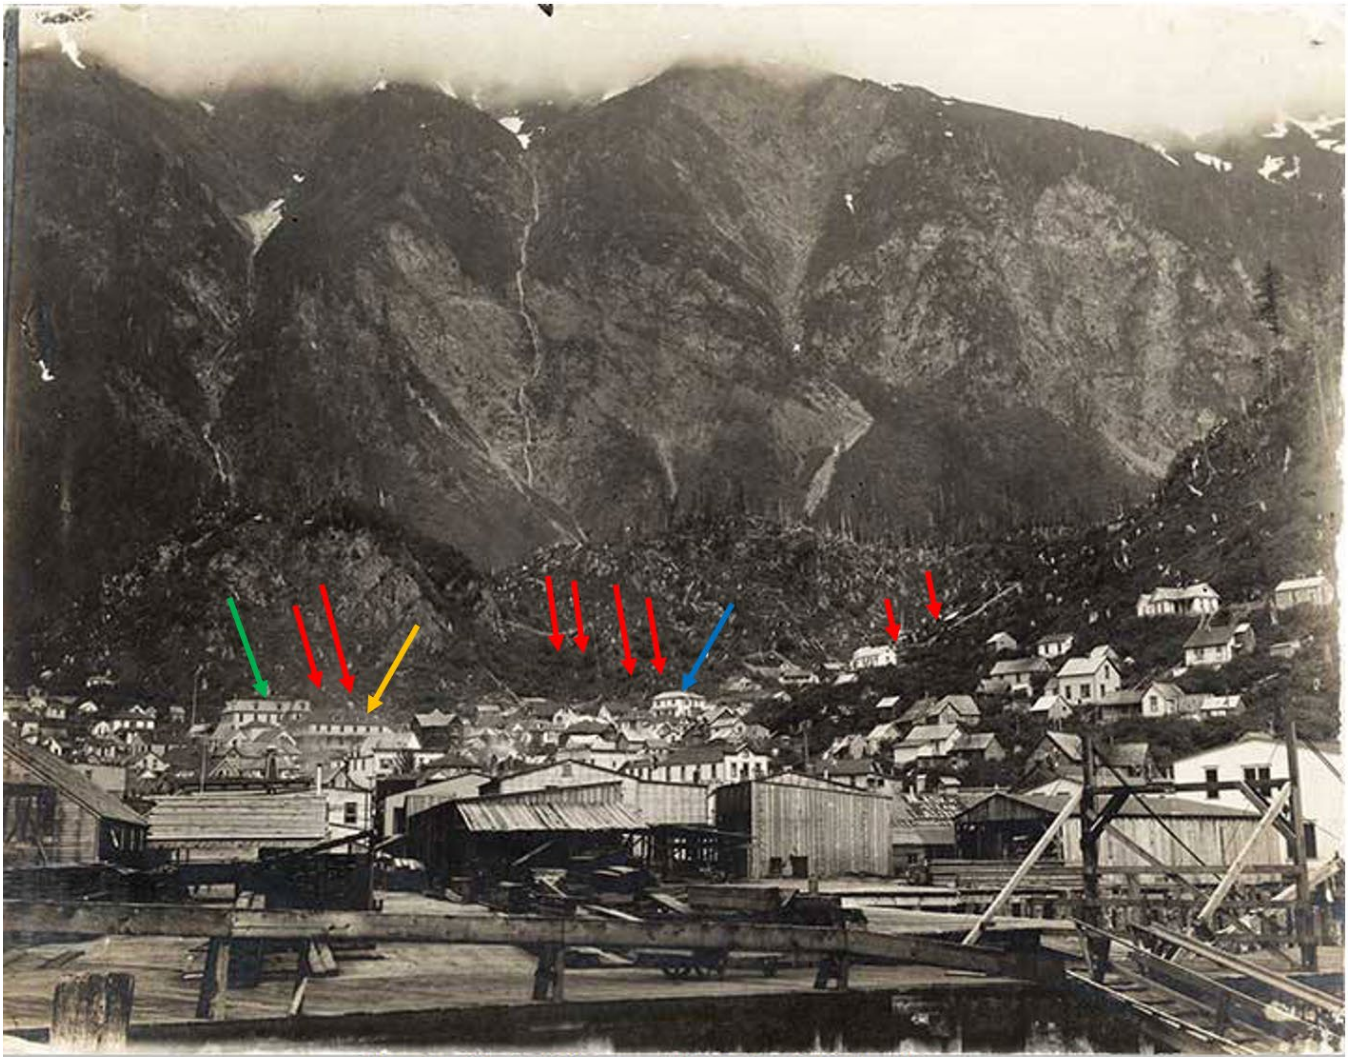
**Figure 12:** Photo ASL-P334-16 – Looking north toward Starr Hill from the waterfront, June 8, 1902. Mt. Juneau is in the background. Slopes appear to have been recently clear-cut with numerous stumps visible above the buildings. The exposed rock slope on the west end of Mt. Maria (Decker Hill) is the location of the pre-historic rockslide, where in 1913 another major rockfall event would occur.

The perspective of the 1902 photo (Figure 12) makes it more difficult than the 1901 photo (Figure 9) to see the slope details, and apparent logging debris remaining above the upper end of 6<sup>th</sup> Street also obscures the slope. However, there are some swales and slope sections with few or no stumps visible, indicating that the Mt. Maria slope was not uniformly forested prior to clearcutting (red arrows). Above 6<sup>th</sup> Street, areas lacking forest cover appear to be associated with the rock bluffs visible upslope. Landmarks include 529 East Street at the blue arrow, St. Ann’s Hospital staff residence (green arrow). Just to the southeast along 5<sup>th</sup> Street (in the foreground of the staff residence) were the Church of the Nativity, the chancellery, and St. Ann’s Hospital (later the school, and now the Parish Hall, orange arrow), based on the Inventory of Historic Sites and Structures (1986) and various historical photos from the Alaska State Library.

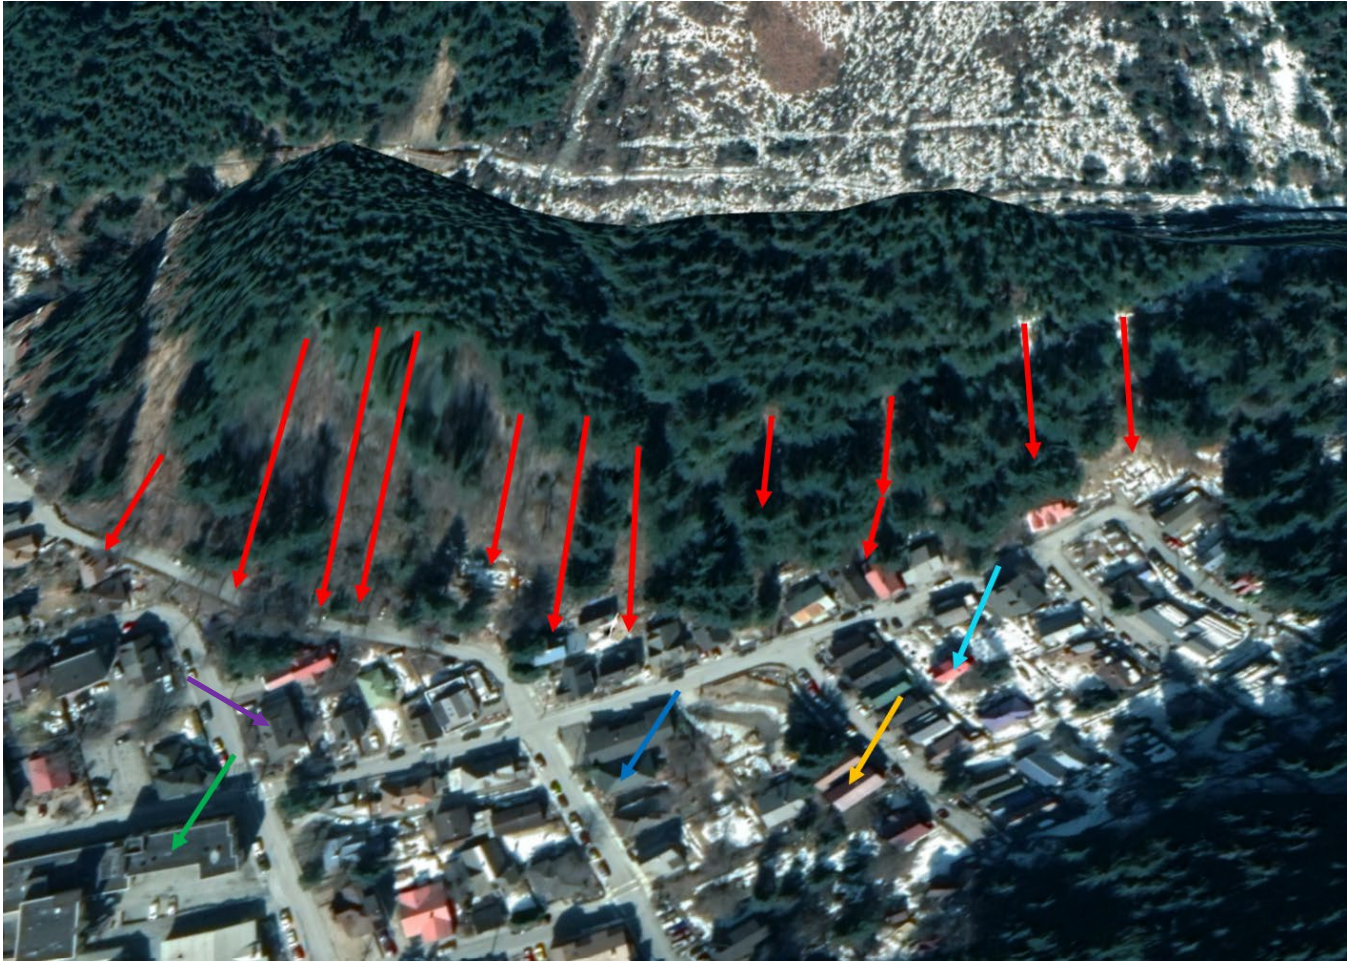
**Figure 13:** Looking north-northwest, this Google Earth view is from an eye elevation of about 1100 feet and in early spring (April 2020), so that the slopes currently lacking coniferous trees can be seen more easily. Several of the swales and slope sections lacking tree cover that were seen in the 1902 photo (Figure 12) are still visible in 2020, along with a few more paths (red arrows). The apparent alignment of the paths lacking trees is slightly different in Figures 12 and 13, due to the different perspectives of the images. The landmarks in Figure 13 are the same as those in Figure 11, except that the Nelson House II has been added here (purple arrow).

At the top ends of all the paths are rock bluffs or cliffs (Figure 13), which are the source of the rockfalls and rockslides that periodically scour out lower-growing vegetation along the paths, or damage mature trees alongside the paths if the debris is large enough. A couple of the paths seen in 1902 between Kennedy and Park Streets are obscured by trees in 2020 but are likely still present under the tree canopy. Some of the swales that seem to end mid-slope in this image likely continue further downslope under the tree canopy. In some areas of the slope, there are still some trees below rock bluffs, but they tend to be smaller than the trees on slopes not regularly affected by rockfall or rockslide debris (Figure 7). On the far left, the path shown crossing Basin Road represents the rock debris that impacted 712 Basin Road about 12 years ago (CBJ 2020).

Three cutlines are visible in Figure 13: on the left, the powerline above Basin Road; in the middle, where an old cutline crosses over to the north side of Mt. Maria; and, on the right, parallel to 6<sup>th</sup> Street, another old cutline crosses above the corner of 6<sup>th</sup> and Nelson Streets into Last Chance Basin. The latter two cutlines may be related to old mining infrastructure.

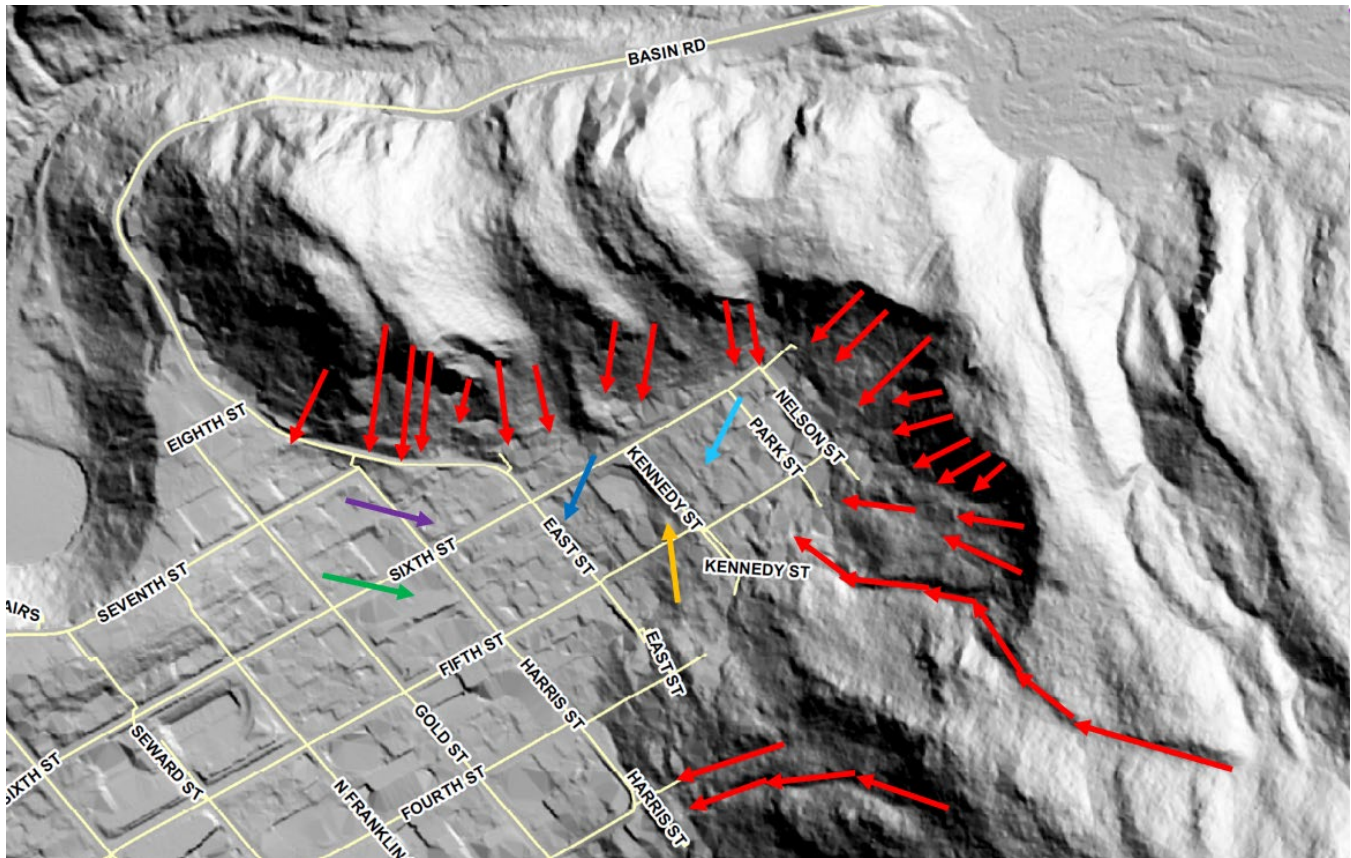
**Figure 14:** This excerpt from the 2013 LiDAR image shows several bedrock cliffs and bluffs above Basin Road, 6<sup>th</sup> Street, Nelson Street, and the north end of 5<sup>th</sup> Street. Fieldwork identified numerous active rockfalls / rockslides as well as some debris slide areas that confirm the observations from the LiDAR and the air photo mapping (Figures 6, 7, and 8). Apparent landslide locations shown are based on poorly-vegetated swales and gullies seen on Google Earth that are also visible on LiDAR hillshade models (red arrows). Landmarks are as for Figure 13.

The longest red arrow in Figure 14 shows the location of the debris flow gully within the G000 Park avalanche path. This gully appears to receive water and debris not only from the local slopes immediately above 5<sup>th</sup> Street, but also from surface drainage swale or gully that originates further upslope along the Mt. Roberts crest.

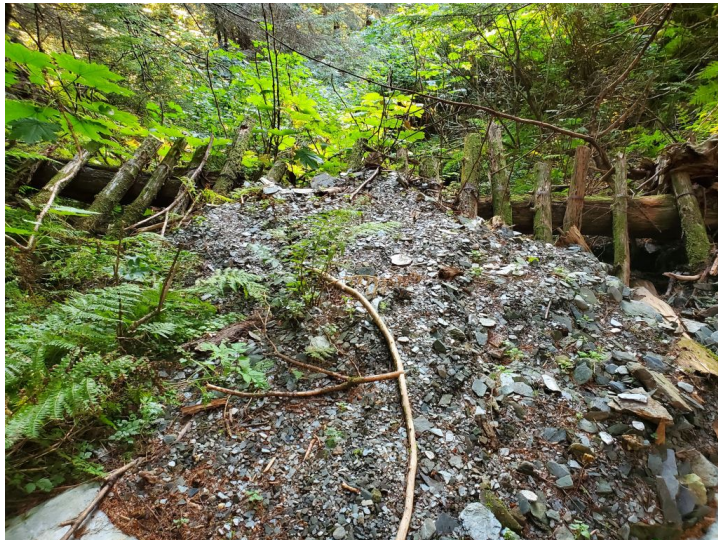
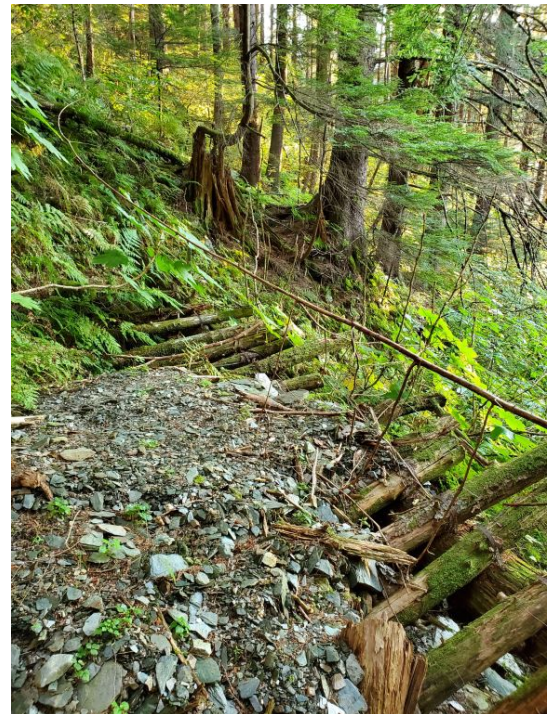
Although the residents have reported only two debris flow events in the past 35 years, this does not mean that the hazard is not significant. Based on the field observations, this debris flow gully has a high potential to affect downslope residences. Clearly, residents were concerned enough about the debris flow hazard to build structures to control debris flows, but these structures are not by any means engineered structures (Figure 15). Routing a debris-flow creek under a house also seems fraught, considering that the drain upslope has become plugged in the past, and that the slightest misstep upslope can create further havoc. (Case in point, the creek undercutting the stream bank and a fallen flowerpot blocking the flow in 2019.) Furthermore, as shown in Figure 14, it appears that this debris flow gully could potentially receive significantly more debris and water than just from the local slopes. As it stands, due to these multiple sources of hazard, Tetra Tech considers that this debris flow gully has been correctly designated as Severe.

**Figure 15:** Photos from the fieldwork in September 2019 showing one of the existing debris-flow mitigation structures that were built by homeowners living below the G000 Park debris flow path above Starr Hill. This structure has captured debris material from one or more mass-wasting events and measured about 8 feet wide by 7 feet long by 2 feet deep.

Depending on the size of the next debris flow, the structure shown in Figure 15 could retain a little more debris or, instead, it could collapse, be overrun by debris, or even be completely scoured out by a larger debris flow that could originate from further up the gully. The same applies to the other structures documented by residents. Debris can incorporate both large and small woody debris, as seen in these photos and the photos supplied by residents of the mid- and upper reaches of the gully. The upslope portion of this debris flow feature is bowl-shaped, indicating the potential for small debris slides from the side slopes to fail and entrain debris in the gully, of which there is a significant amount. The particle size of the material that can be moved by a debris flow is also important – some cobble- and boulder-sized material is also visible in the residents’ photos. Despite the mitigation attempts, debris slides/flows could result in enough volume to impact the houses below.

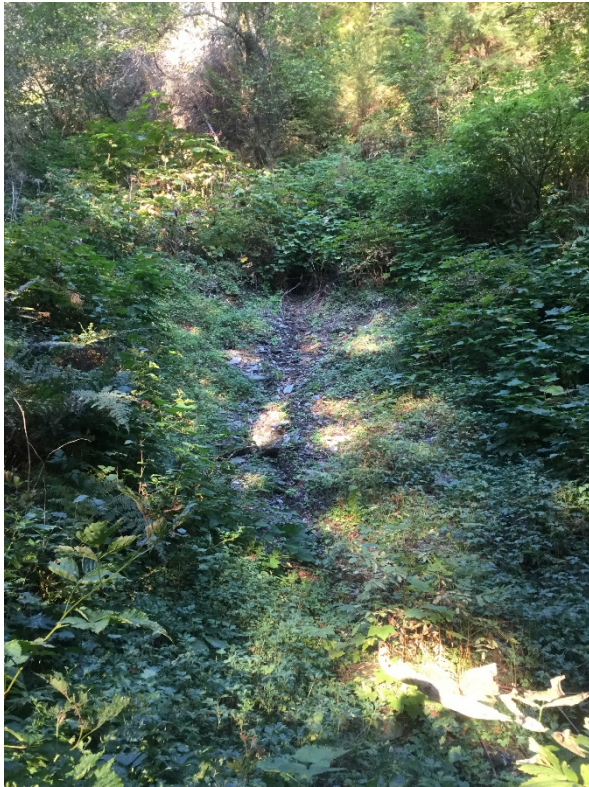
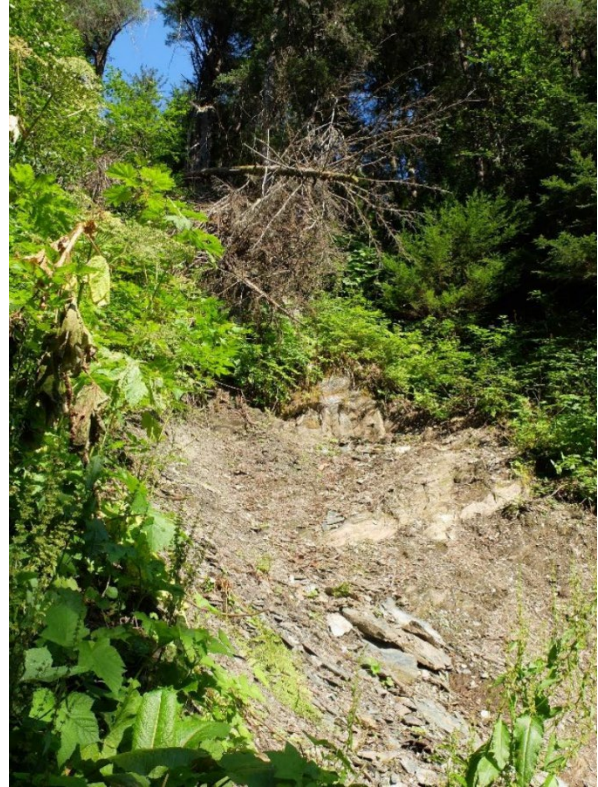
**Answer:** This question refers to the terrain mapped as High hazard (orange) upslope of the corner of Nelson and 5<sup>th</sup> Streets. The review of the slopes in Question 1 provides some useful background in the slope processes that are happening in this area of Starr Hill. Figure 14 shows clearly the very rough and disturbed terrain that has resulted from highly active slope processes, and Figures 9, 10, and 11 show the paths along which the most frequent landslides (debris slides/flows) tend to occur in this part of the slope. Furthermore, residents themselves have provided recent evidence of ongoing debris slides (Figure 16), indicating that the High hazard designation is warranted.

**Figure 16:** Compare Tetra Tech’s photo from September 10, 2019 (left) with residents’ photo from August 1, 2021 (right) at the same location. Slope instabilities appear to be ongoing in the historical slide path locations.
