# STRUCTURAL CONDITION SURVEYS

TELEPHONE HILL, JUNEAU, ALASKA

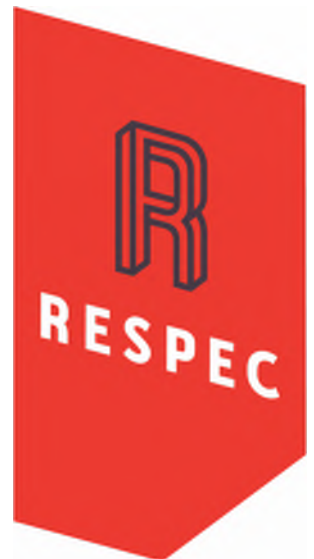
## EXECUTIVE SUMMARY

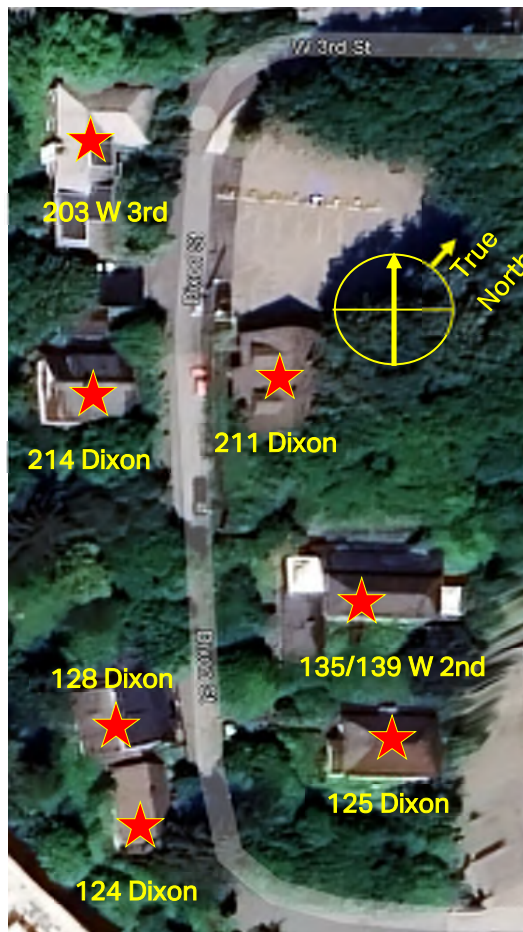
Figure ES- 1. Telephone Hill, Juneau, Alaska.

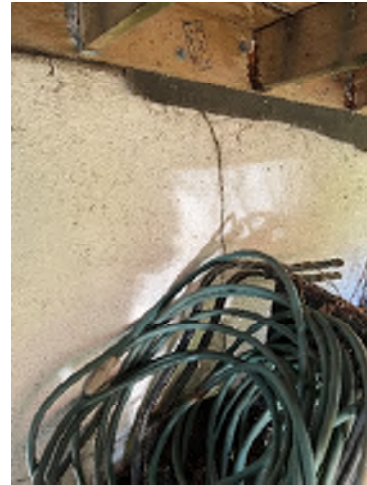
**Figure 1-2.** Large Concrete Crack on the South Wall.

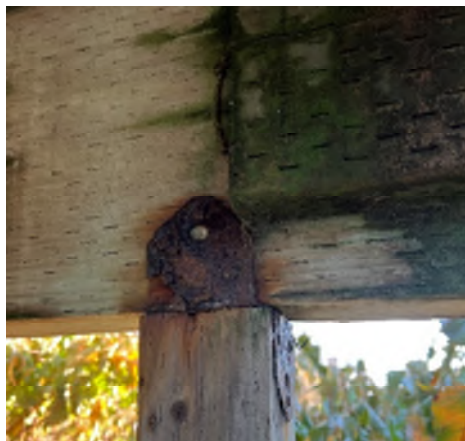
**Figure 1-3.** Rusty Hardware Connections on the Deck Framing.

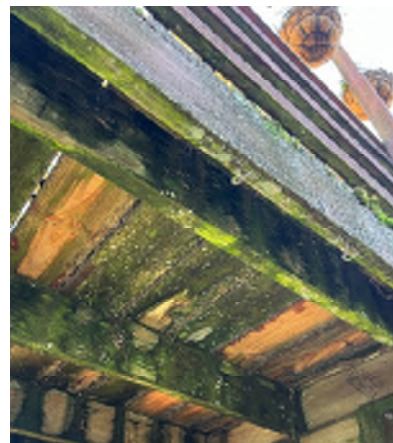
**Figure 1-4.** A Significant Amount of Moss on the West Side of the Deck Framing.

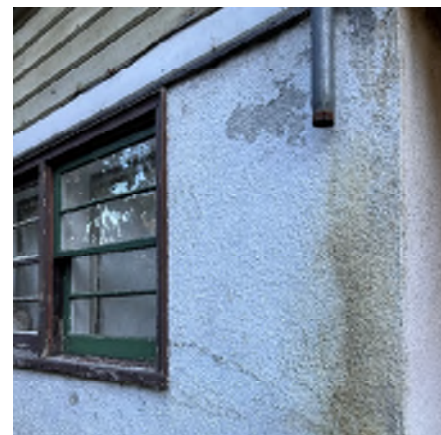
**Figure 1-6.** The Drainpipe Ends Abruptly in Mid-Air and Does Not Direct Water Away From the Foundation.

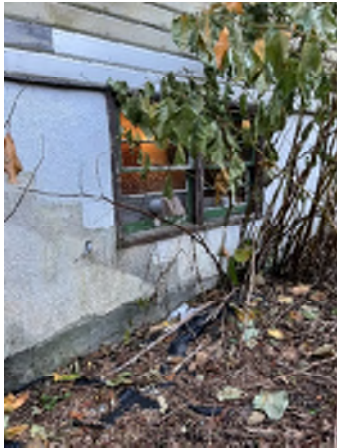
**Figure 1-7.** Replaced and Repainted Pieces of Siding.

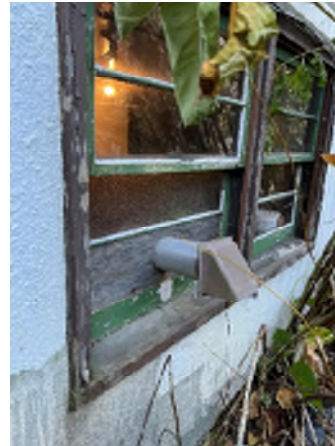
**Figure 1-8.** Rotten Window Sill.

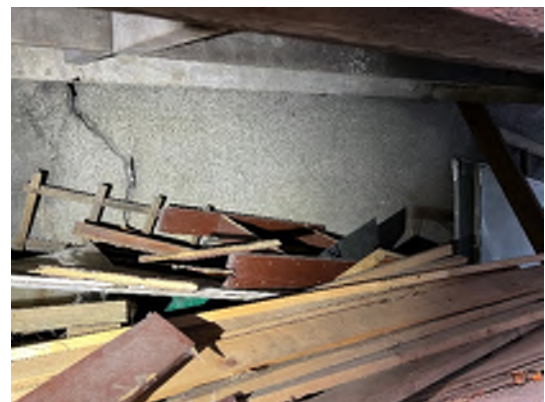
**Figure 1-12.** A Large, Deep Concrete Crack on the North Wall. No reinforcement is observed.

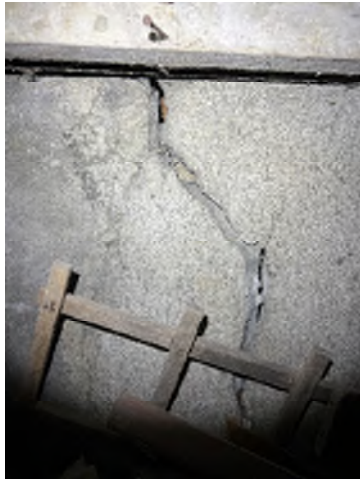
**Figure 1-13.** Visible Wood Framing in the Deep Crack Where Water Infiltrates the Basement.

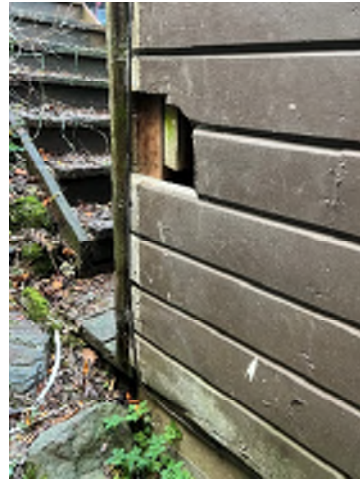
**Figure 1-14.** A Hole in the Siding That Can Allow Water or Animals in the Wall Cavity.

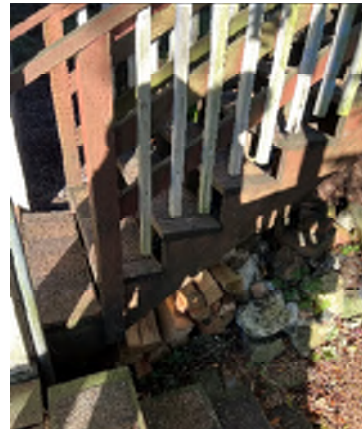
**Figure 1-20.** A Long Crack on the Side of the Stringer.

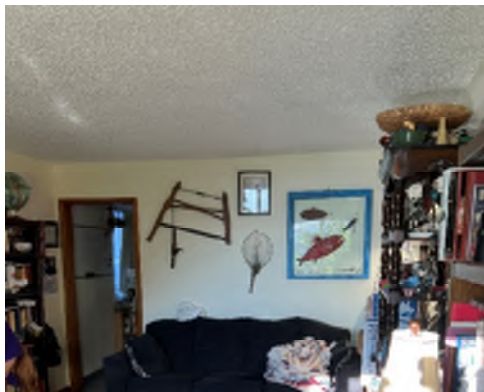
**Figure 1-21.** Very Few Sheetrock Cracks Were Observed on the Main Level.

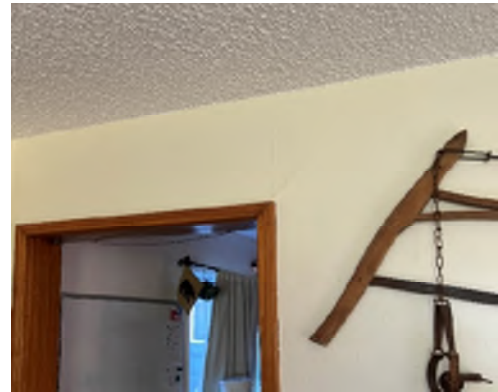
**Figure 1-22.** A Diagonal Crack Above the Door Frame.

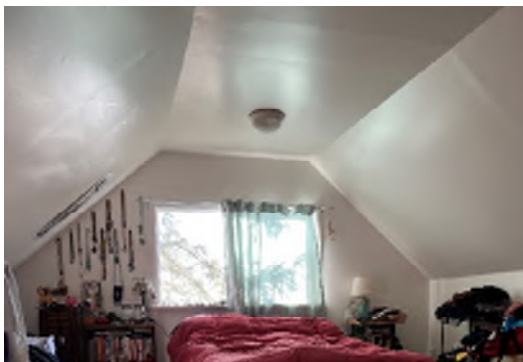
**Figure 1-23.** The Wood Framing Is Not Visible at the Edges Because the Upper Level Is Fully Finished.

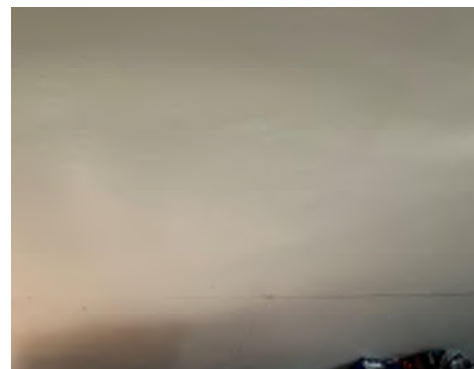
**Figure 1-24.** The Only Cracks Observed Were at the Sheetrock Panel Joints.

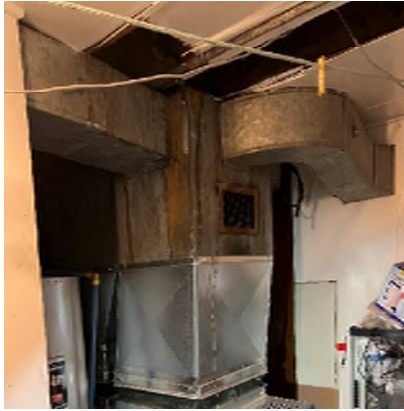
**Figure 1-25.** Staining on the Ducting Indicating Past Leaks.

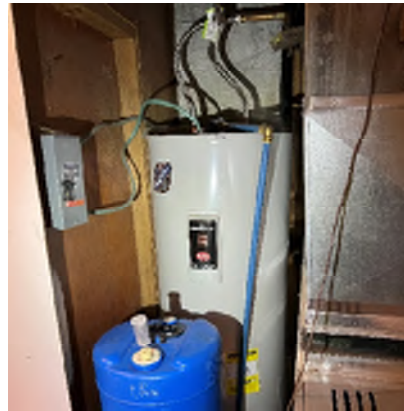
**Figure 1-26.** Water Heater Without Seismic Strapping.

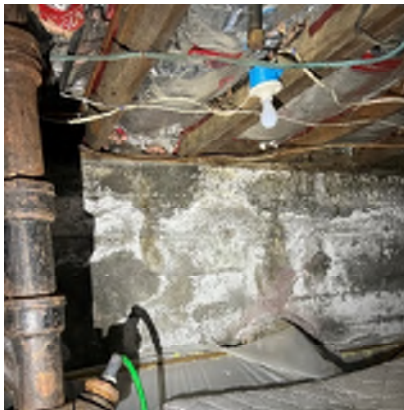
**Figure 1-27.** Many Signs of Water Infiltration Exist on this Concrete Wall From the Discoloration. The sill plate is rotten from the outside.

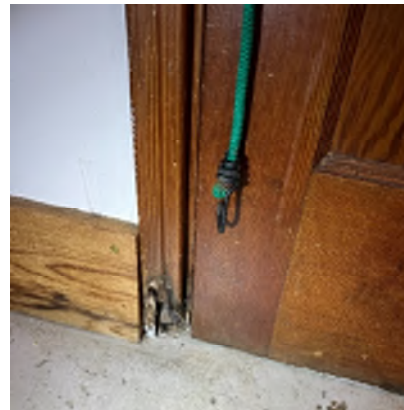
**Figure 1-28.** Bottom of the Door Frame Trim Is Rotten, Indicating Water Damage.

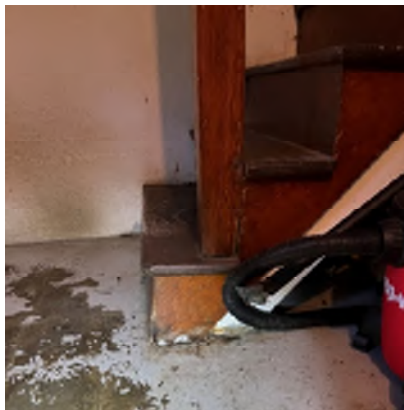
**Figure 1-29.** Wood at the Bottom of the Stairs Has Some Water Damage.

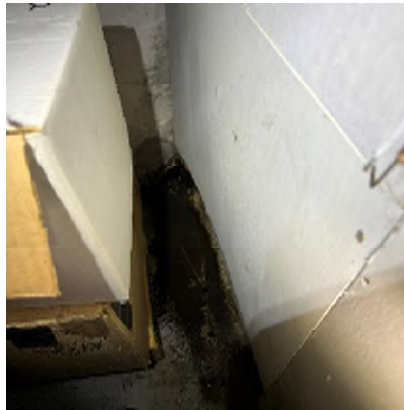
**Figure 1-30.** Channel Under the Stairs Where Water Frequently Flows In. This is the location of the large concrete crack on the north side wall.

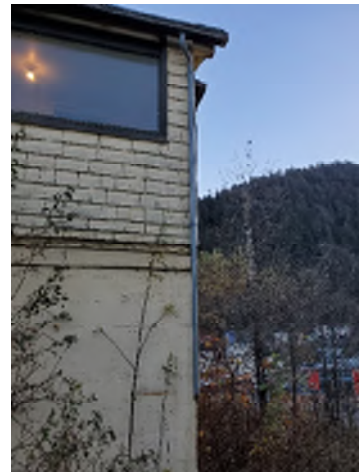
**Figure 2-4.** Drainage Pipe Ends Abruptly Mid-Air and Not Directing Water Away From the Foundation.

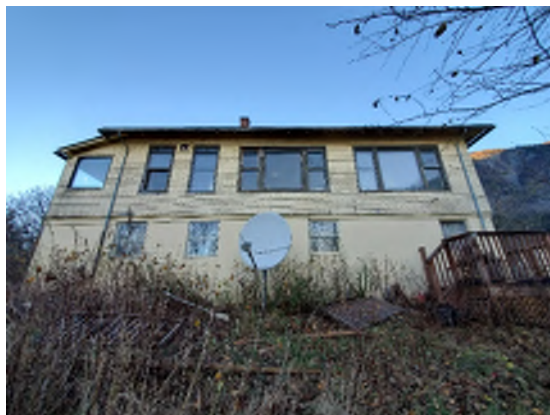
**Figure 2-5.** South Side of the Building.

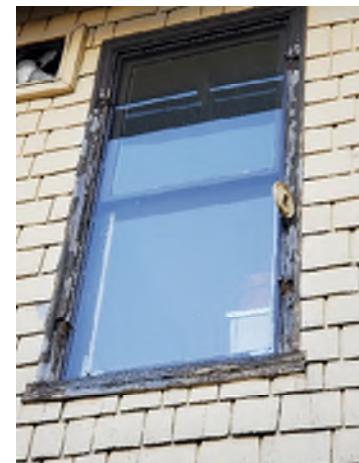
**Figure 2-6.** Window Sill Is Visibly Rotten. The lower cover is missing, which could lead to water infiltration and rot and mold in the wall.

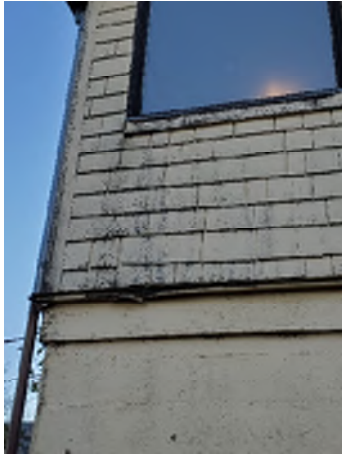
**Figure 2-7.** Black Mold on the Siding at the Southwest Corner.

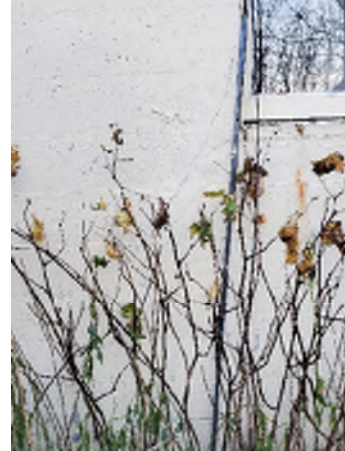
**Figure 2-8.** Cracks in the Concrete Wall. One crack has been patched.

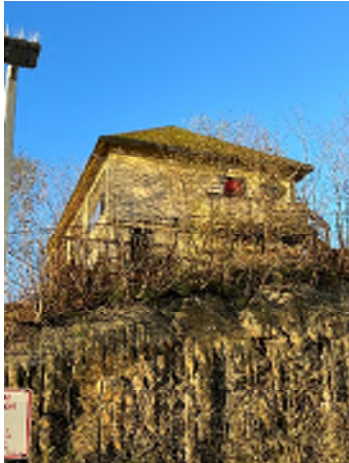
**Figure 2-9.** East Side of Building With Moss on the Roof.

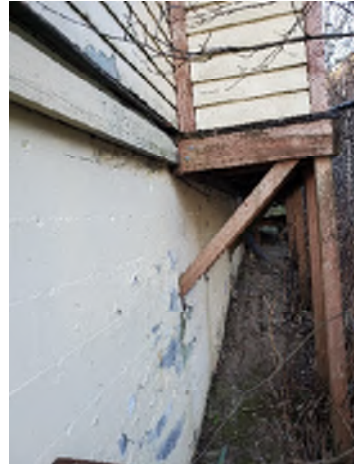
**Figure 2-10.** Paint Flaking Off the Concrete Wall and Spalled Concrete at the Top of the Concrete Wall.

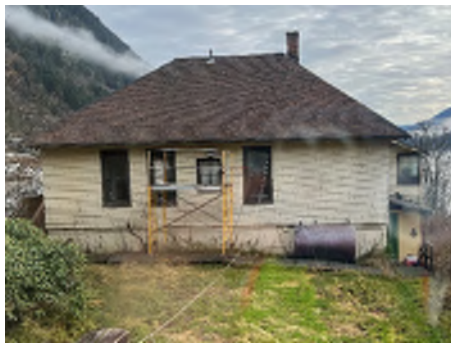
**Figure 2-11.** North Side of the Building.

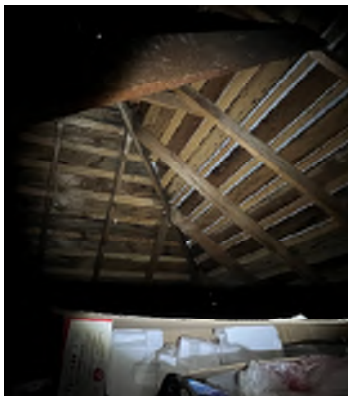
**Figure 2-15.** Daylight Is Visible Through Holes in the Northwest Corner of the Roof, Which Allows Water to Penetrate the Roof. This is the cause of the water damage seen on the ceiling of the second level. A roof replacement is in progress.

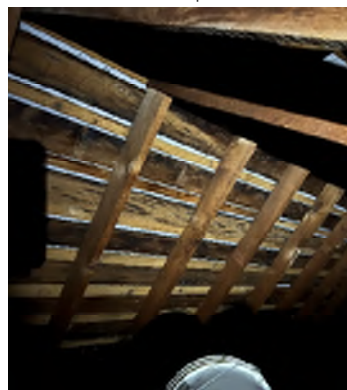
**Figure 2-16.** Indications of Previous Leak Repairs. Water infiltration can cause the structural members to rot. The roof rafters and site built trusses are under sized for current snow loads.

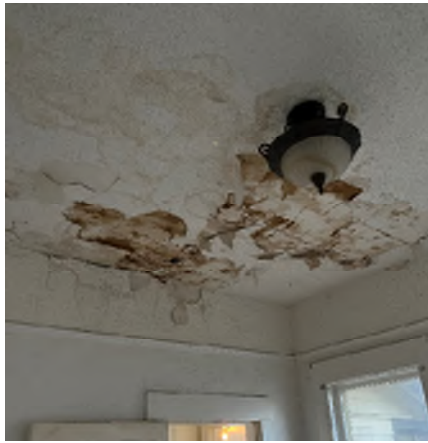
**Figure 2-17.** Significant Water Damage to the Ceiling Below the Roof Leak. The light fixture was not tested because of signs of water infiltration.

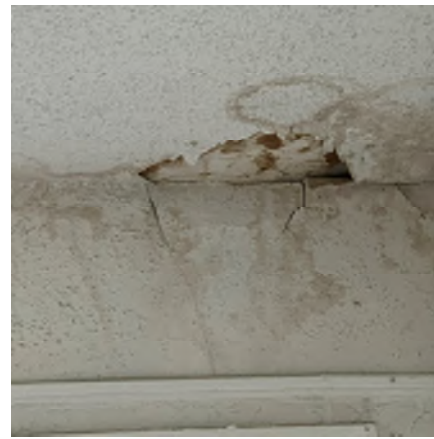
**Figure 2-18.** Ceiling Paint Is Cracked and Falling From the Water Infiltration. How extensive the water damage is or if there is mold is unknown without a destructive investigation.

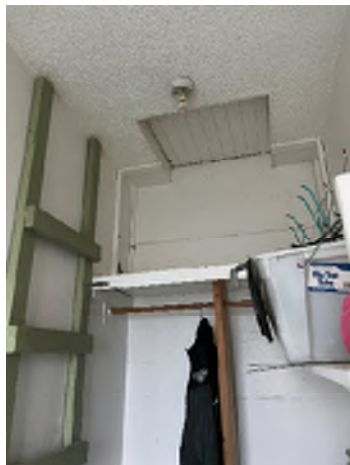
**Figure 2-19.** Inadequate Framing to Support the Closet Used for Attic Access.

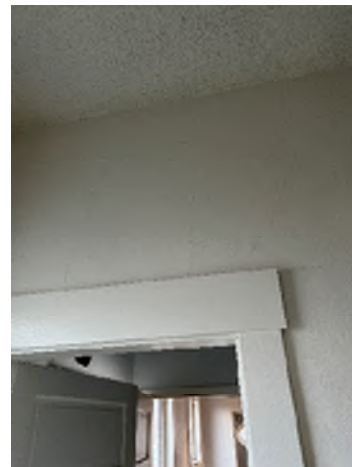
**Figure 2-20.** Sheetrock Cracks on the Wall in the Bathroom.

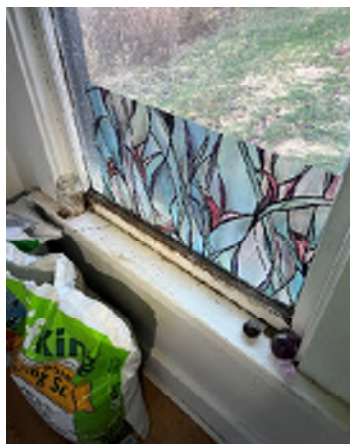
**Figure 2-21.** Rotting Window Frames.

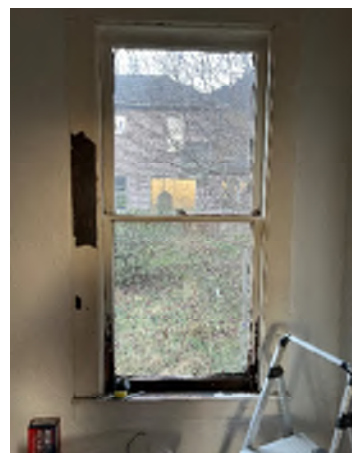
**Figure 2-22.** Rot in the Window Frames.

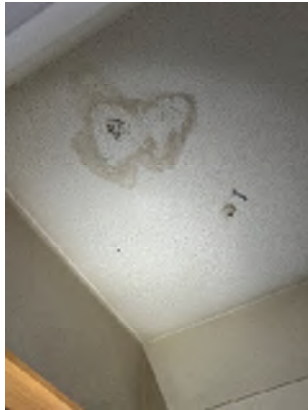
**Figure 2-23.** Water Damage, Cracks, and Exposed Wiring in the Closet on the Northeast Side of the Building.

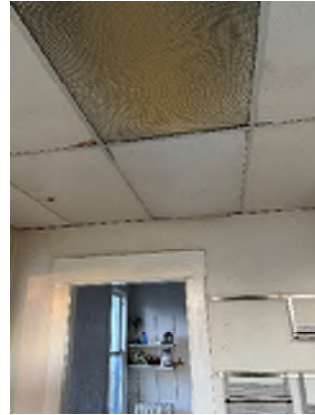
**Figure 2-24.** Sagging Ceiling Panel in the Kitchen From Water Damage.

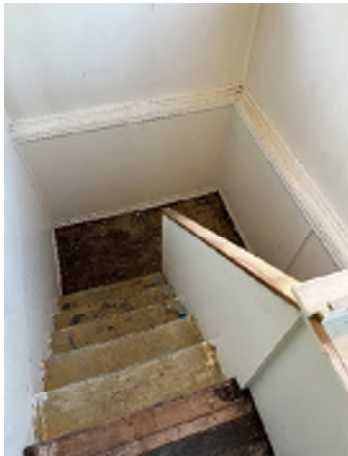
**Figure 2-25.** Much of the Flooring Was Removed, Leaving the Subfloor Unprotected.

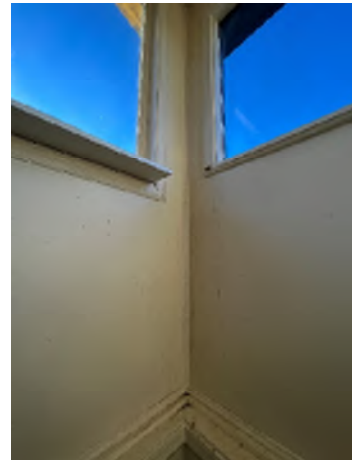
**Figure 2-26.** Water Staining on the Wall Indicating Leaking Windows.

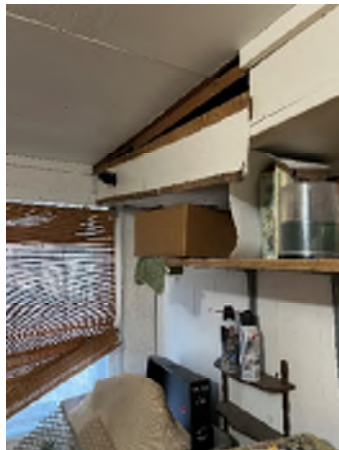
**Figure 2-27.** Wall Finishes Have Detached.

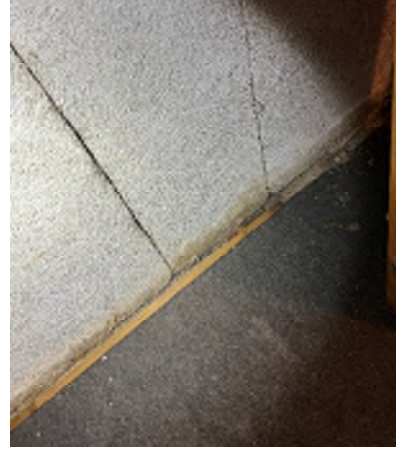
Figure 2-30. Bottom of the Wall Panel Has Water Damage.

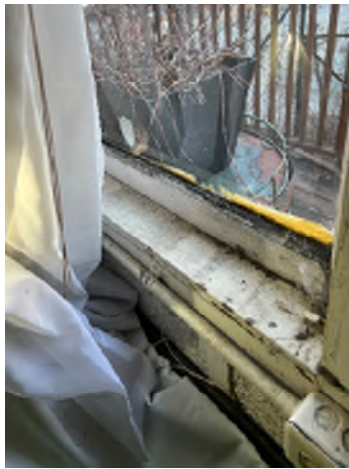
Figure 2-31. Window Sill Is Rotten.

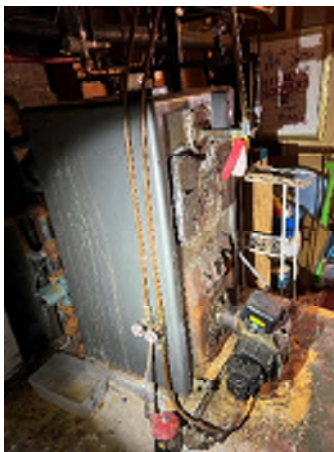
Figure 2-33. Signs of Leaks Exist With the Staining on the Side of the Unit.

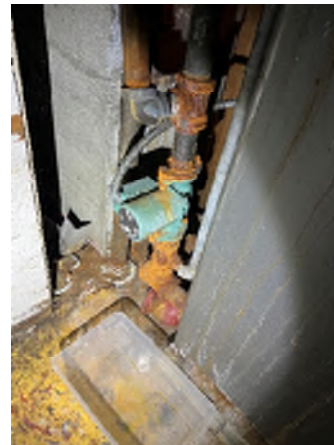
Figure 2-34. Signs of Leaks Exist at the Pipe Connections.

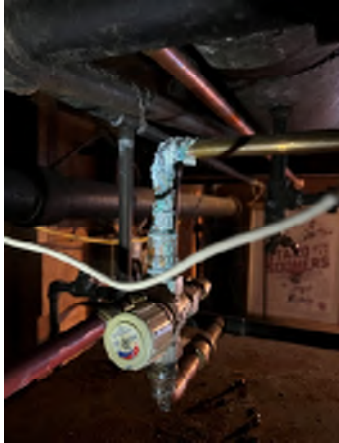
**Figure 2-35.** Signs of Leaks and Corrosion Exist at the Pipe Connections.

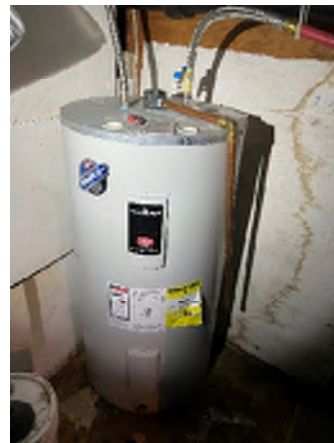
**Figure 2-36.** No Seismic Strapping Around the Water Heater.

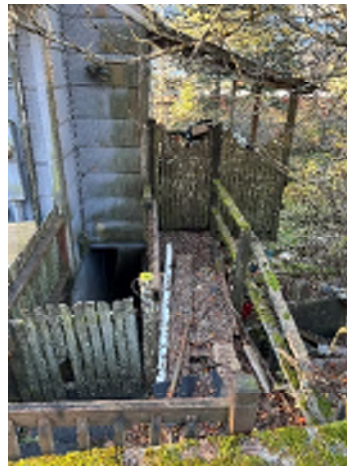
**Figure 3-4.** Rotten Gates, Railings, and Deck Framing Pose a Safety Hazard and Should Not Be Used.

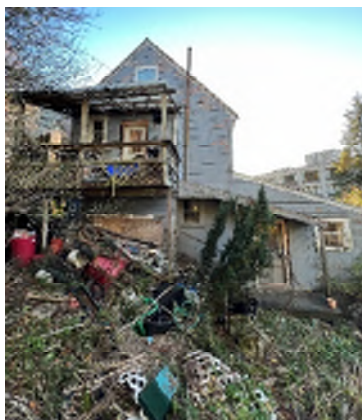
**Figure 3-5.** North Side of the Building.

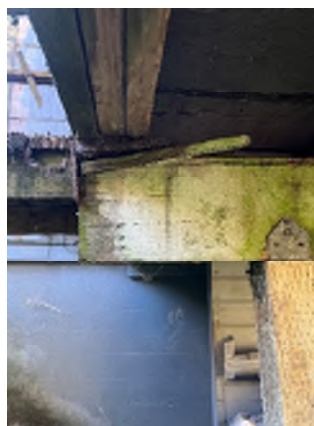
**Figure 3-6.** The Beam Supporting the Deck Is Shimmed Likely Due to Rot. No connection exists between the beam to deck framing.

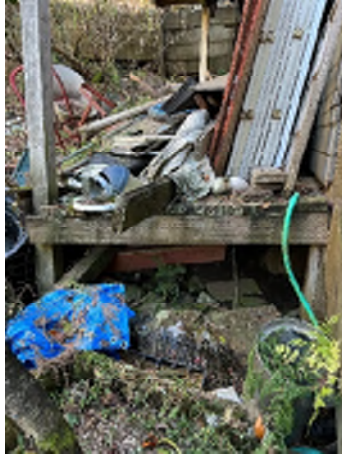
**Figure 3-7.** Moss and Rot on the Deck.

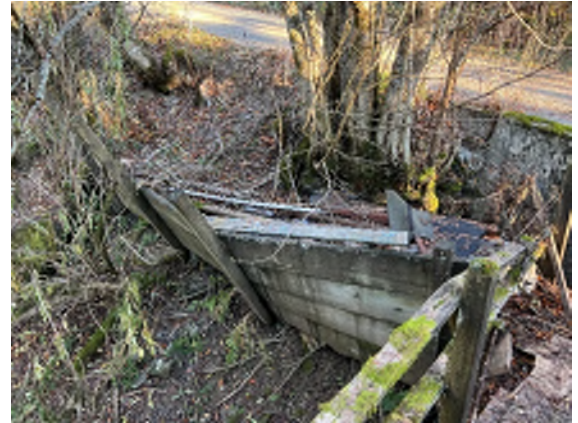
**Figure 3-8.** Failed Wooden Retaining Wall.

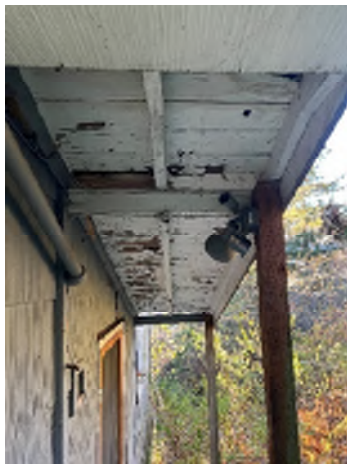
**Figure 3-9.** Peeling Paint and Fixtures Missing Bulbs; Open Fixtures or Exposed Wiring Can Be Hazardous.

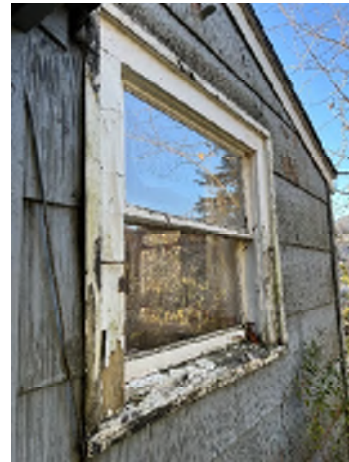
**Figure 3-10.** Rotten Windowsill and Siding in Poor Condition.

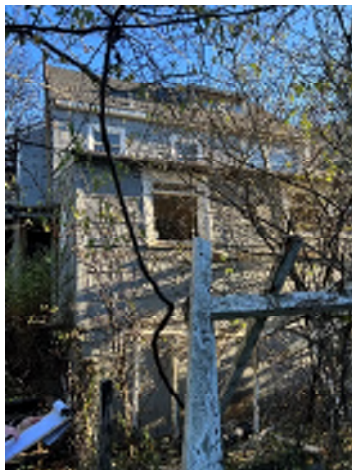
**Figure 3-11.** West Side of the Building.

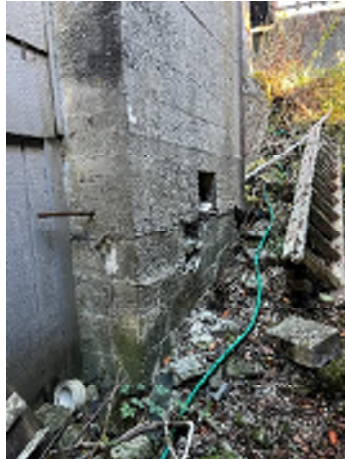
**Figure 3-15.** Failed Chimney Foundation Wall. Collapse Hazard.

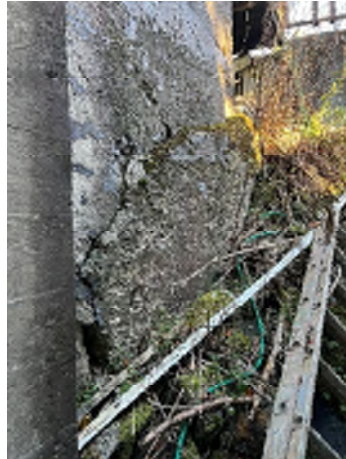
**Figure 3-16.** Cracked Concrete Wall/ Failed Foundation, Possibly From Flexure and Shifting. No reinforcement was observed. Collapse Hazard.

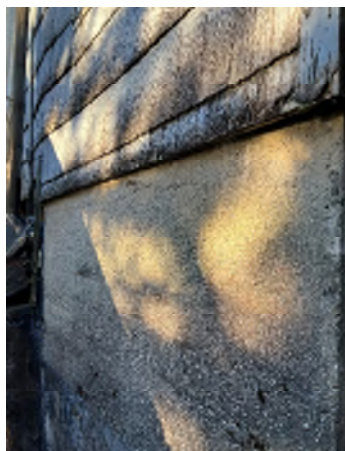
**Figure 3-17.** Long Crack at the Top of the Wall.

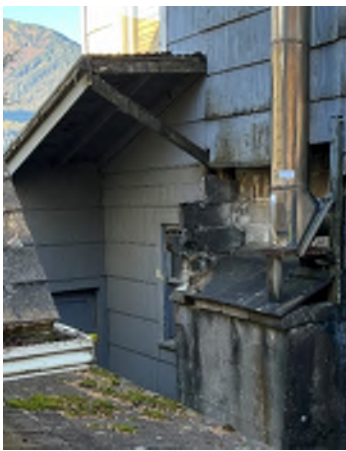
**Figure 3-18.** Concrete Blocks Not Adequately Secured. The new stack is partially supported on a rotten piece of plywood.

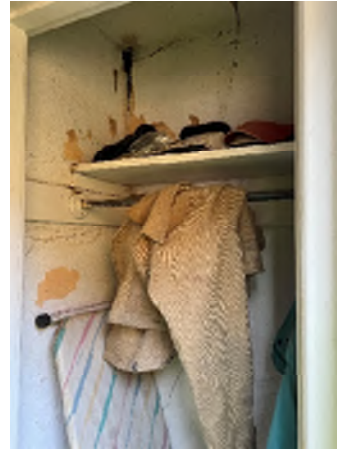
**Figure 3-20.** Significant Sheetrock Damage in the Closet.

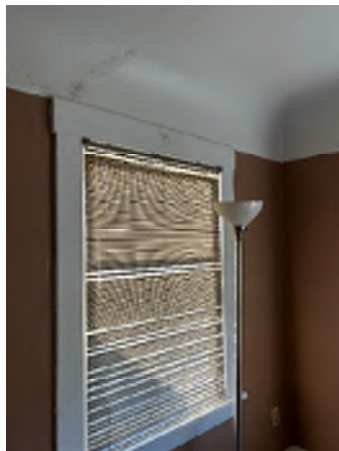
**Figure 3-21.** Sheetrock Cracks in the Ceiling and Walls.

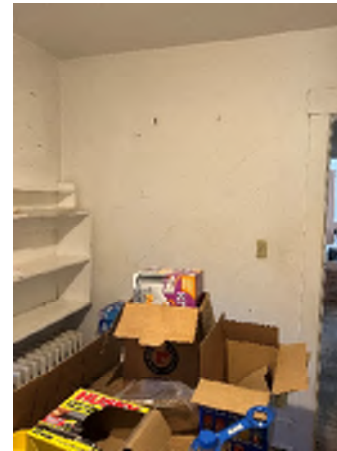
**Figure 3-22.** Wall Cracks Extending Diagonally Across the Entire Wall.

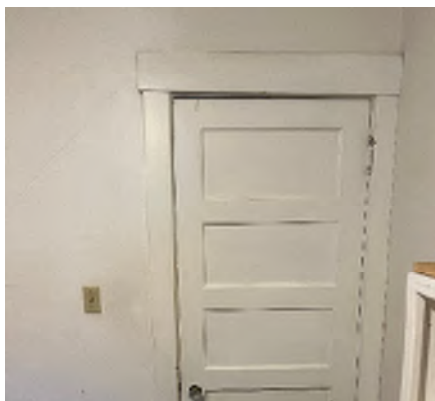
**Figure 3-23.** Door Does Not Sit Square in the Door Frame.

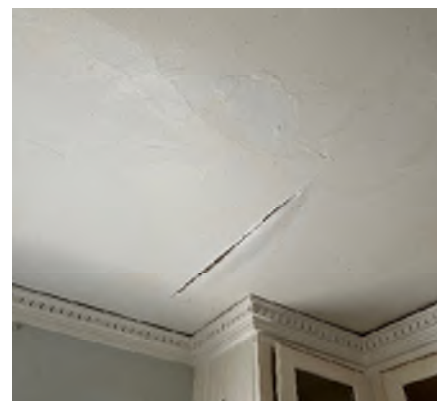
**Figure 3-24.** Sheetrock Cracks and Water Damage on the Ceiling.

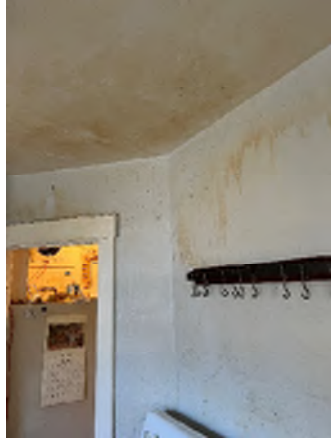
**Figure 3-25.** A Significant Amount of Discoloration on the Sheetrock Above the Stove in the Kitchen, Water Damage.

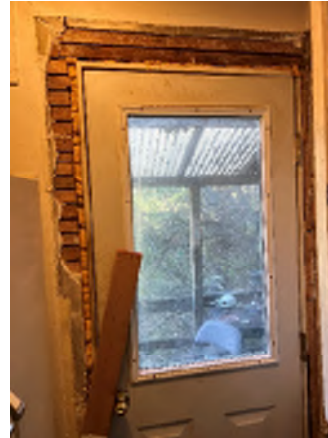
**Figure 3-26.** Damage to Plaster Around the Door because of Missing Trim.

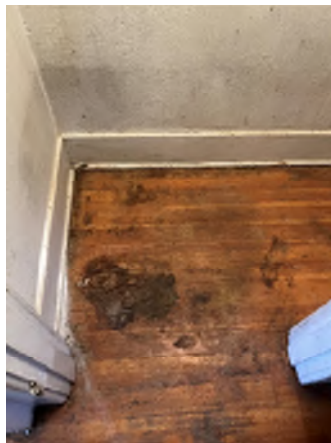
**Figure 3-27.** Floor Damage.

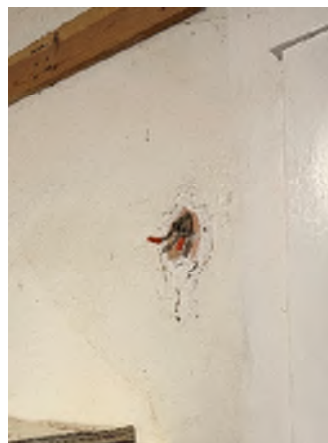
**Figure 3-28.** Exposed Wiring Was Observed in Multiple Locations, Creating a Hazard. One location did not have wires caps.

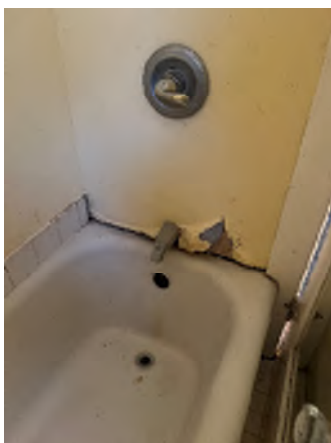
**Figure 3-29.** Wall Finish Damage in the Bathroom. Water could enter the wall cavity. Water has likely been infiltrating the wall cavity and causing damage.

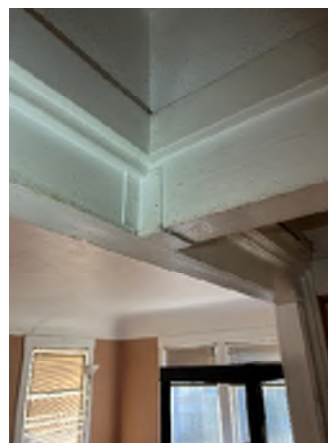
**Figure 3-30.** A Beam Hanger Observed at the Framing Near the Stair Opening.

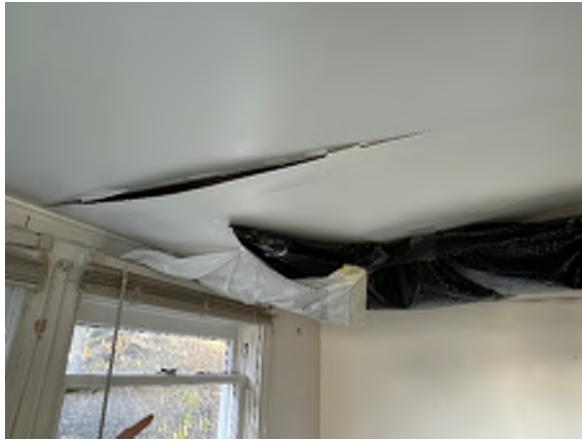
**Figure 3-31.** Ceiling Damage From a Roof Leak.

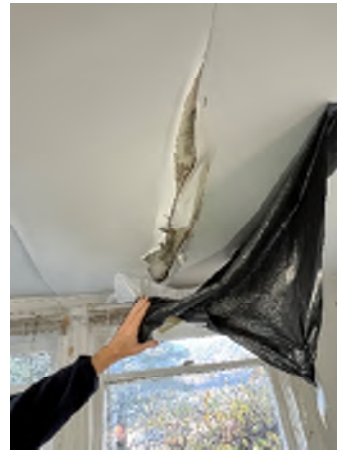
**Figure 3-32.** More Damage From a Roof Leak Under the Bag.

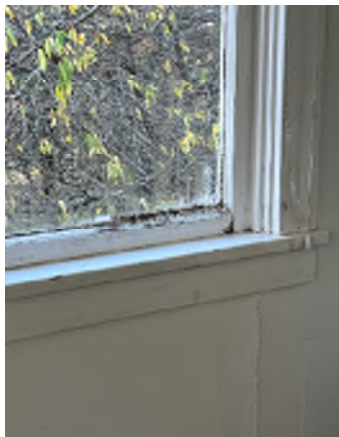
**Figure 3-33.** Mold in the Windowsill.

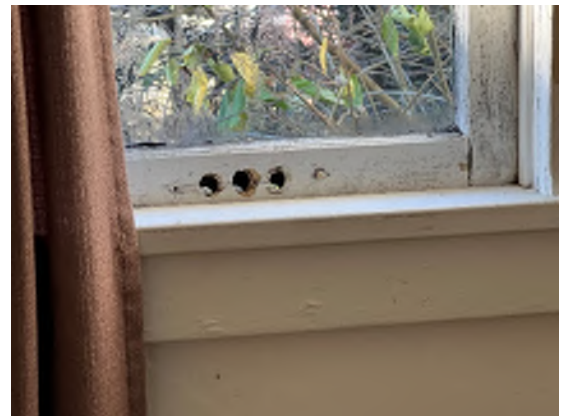
**Figure 3-34.** Mold and Holes in the Windowsill. The holes can lead to water infiltration.

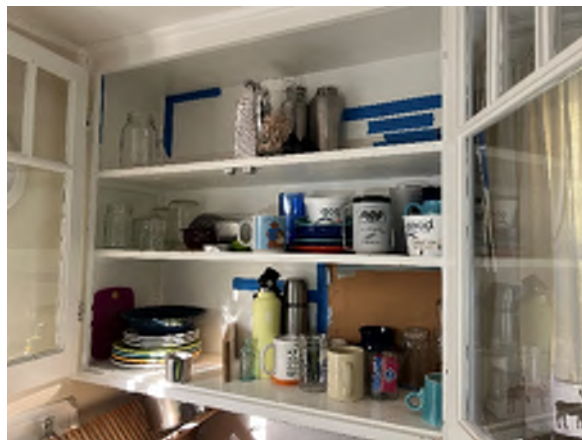
**Figure 3-35.** Blue Tape Where the Tenant Found Cracks.

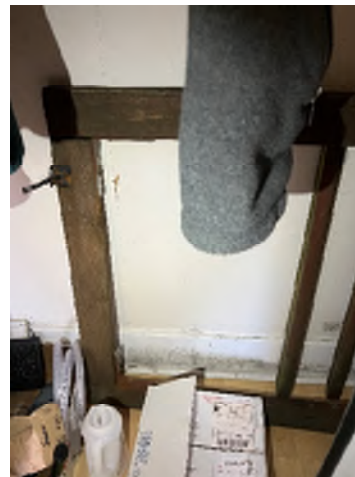
**Figure 3-36.** Sheetrock Crack in the Closet and Mold on the Baseboard.

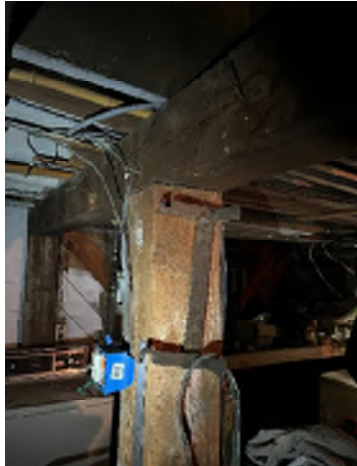
**Figure 3-37.** No Hardware Providing Connections from the Columns to Beam Above.

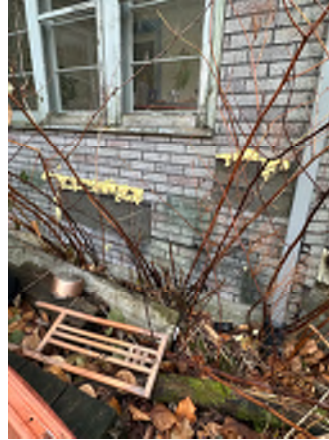
**Figure 4-4.** Siding Replaced With Roof Shingles and Spray Foam.

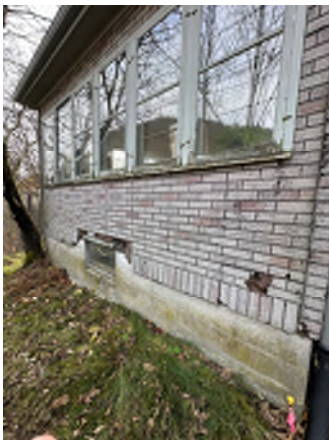
**Figure 4-5.** East Side of the Building.

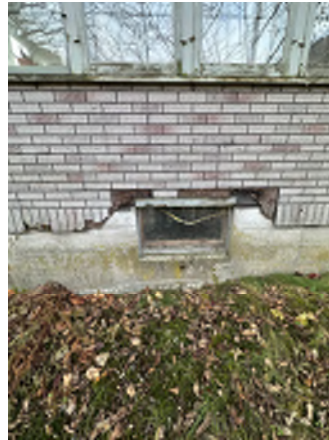
**Figure 4-6.** Deteriorated Siding and Windowsills.

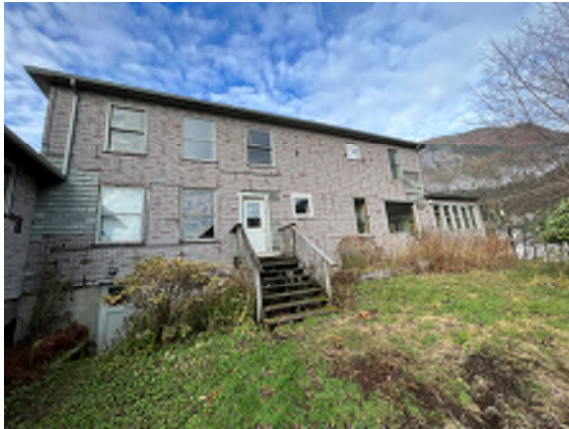
**Figure 4-7.** South Side of Building.

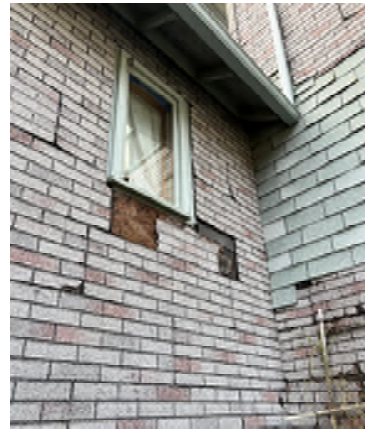
**Figure 4-8.** Deteriorated/Missing Siding.

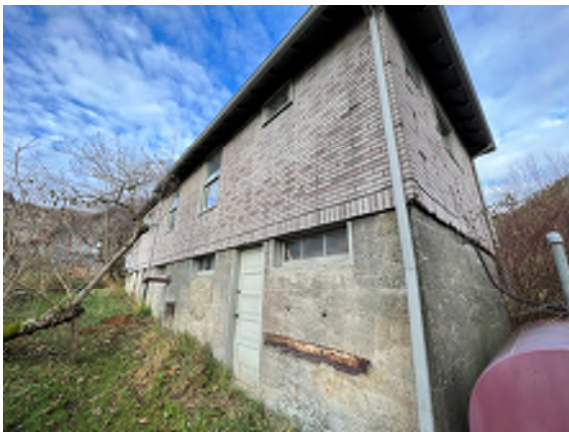
**Figure 4-9.** West Side of Building.

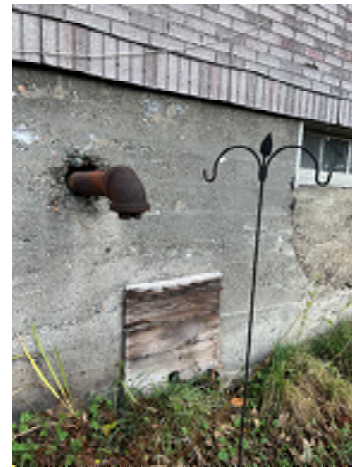
**Figure 4-10.** Large Hole Where Pipe Exits the Basement and Cracking Between the Different Concrete Pours Under Window.

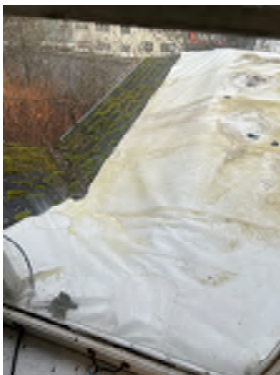
**Figure 4-11.** Tarp Covering the East Roof. There are known leak issues at the interface of the lower roof and wall.

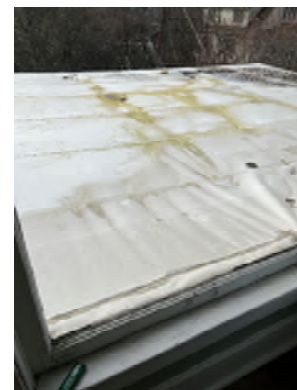
**Figure 4-12.** Tarp Covering the West Roof.

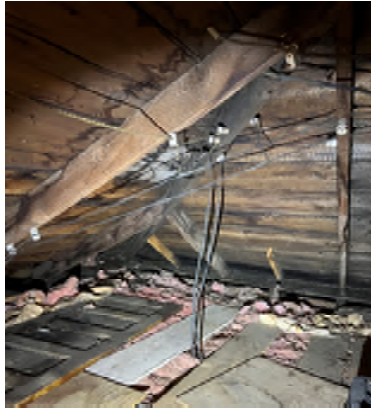
**Figure 4-13.** Cut Rafter Member and Extensive Water Damage From Past Events.

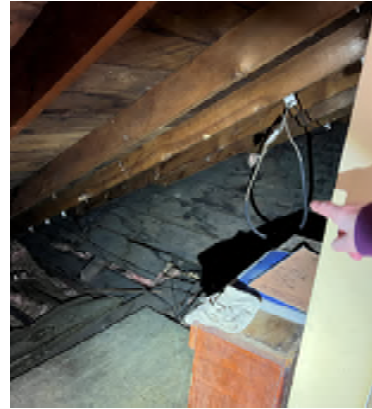
**Figure 4-14.** New Roof Framed Over the Original Roof. Water damage in the insulation and original roof boards.

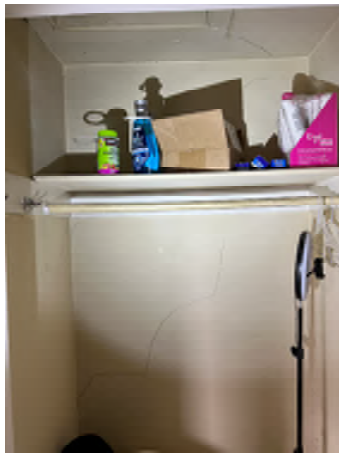
**Figure 4-15.** Crack Going up the Wall Onto the Ceiling.

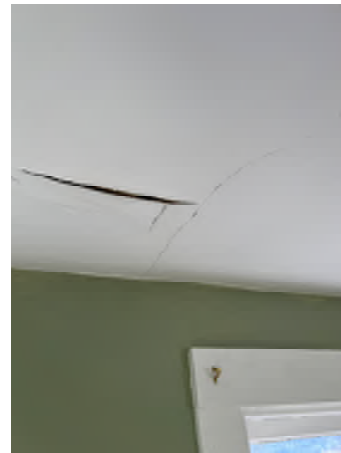
**Figure 4-16.** Cracked Sheetrock and Peeling Paint on the Ceiling.

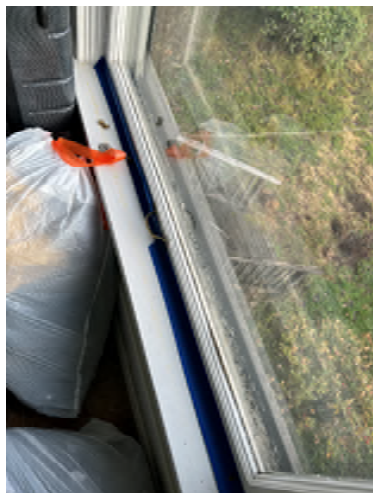
**Figure 4-17.** Deteriorating Windowsill.

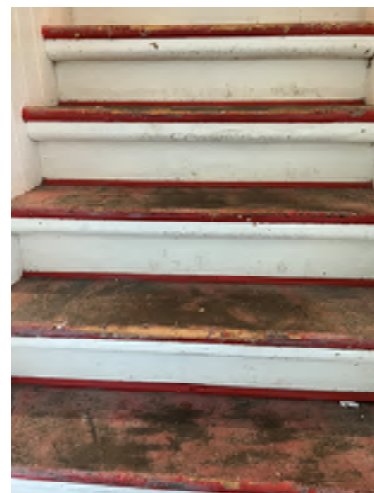
**Figure 4-18.** Steps Leading to the Second Floor Are in Poor Shape.

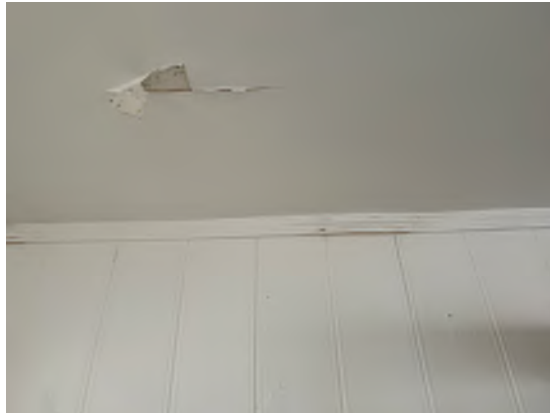
**Figure 4-19.** Peeled Paint With Signs of Water Damage on the Ceiling and Cracking in the Trim and Wallboards.

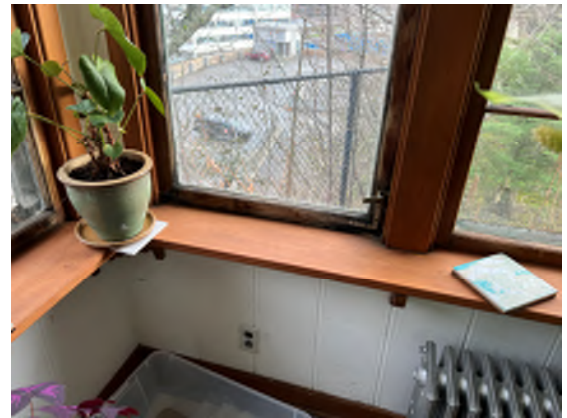
**Figure 4-20.** Rotting Window Frame.

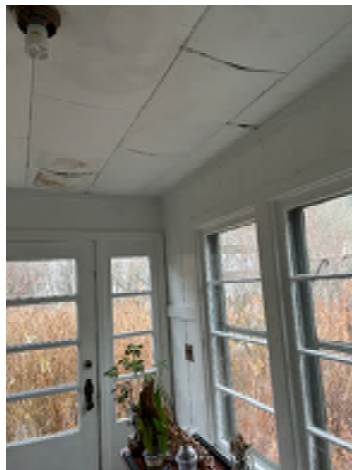
**Figure 4-21.** Sagging Ceiling and Signs of Water Damage in the East Entryway.

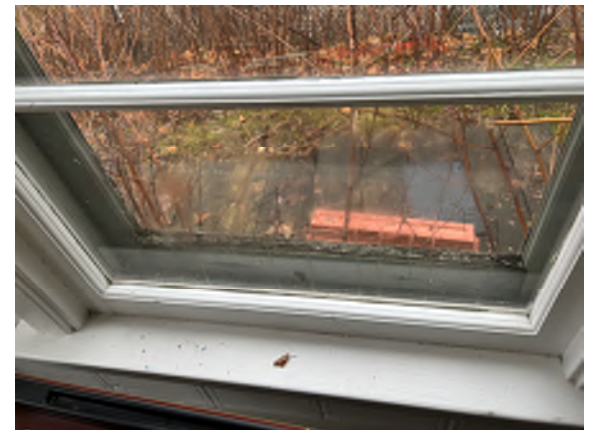
**Figure 4-22.** Rotting Storm Window and Window Frame.

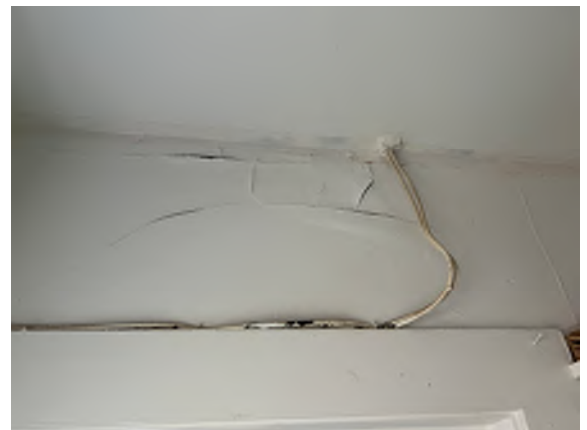
**Figure 4-24.** Cracked and Bubbled Paint likely from Water Infiltration.

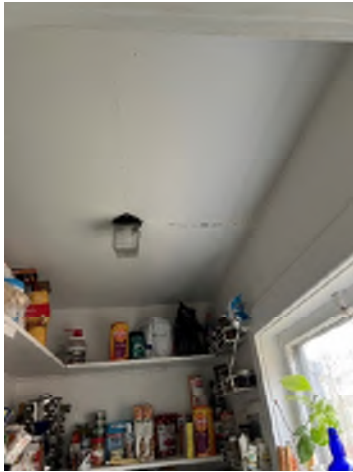
Figure 4-25. Sheetrock Cracks at Panel Edges.

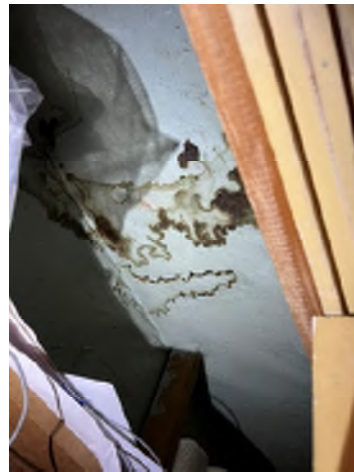
Figure 4-26. Staining on Ceiling.

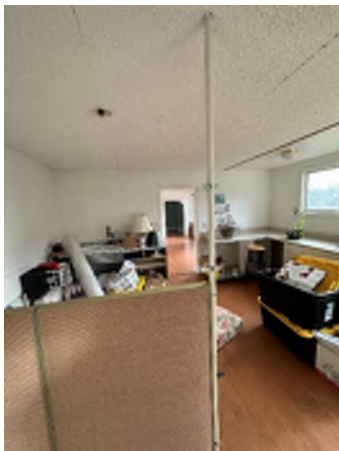
Figure 4-27. Main Room.

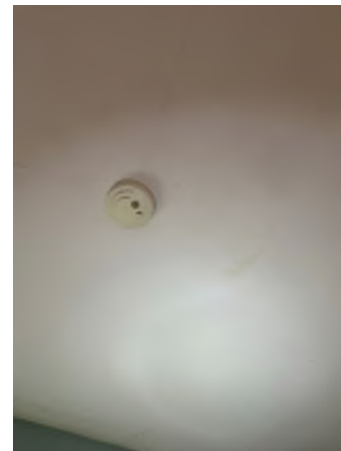
Figure 4-28. Sheetrock Cracks on the Ceiling.

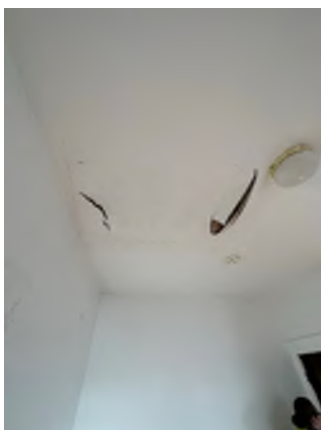
Figure 4-29. Peeled Paint and Cracked Sheetrock on the Ceiling from Water Damage.

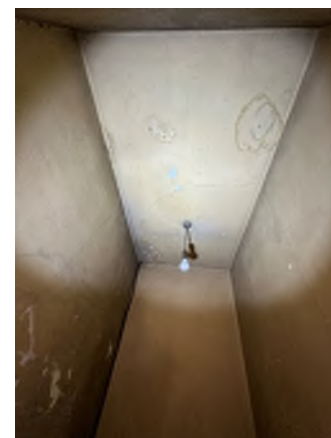
Figure 4-30. Cracking on the Ceilings and Walls and Signs of Water Damage.

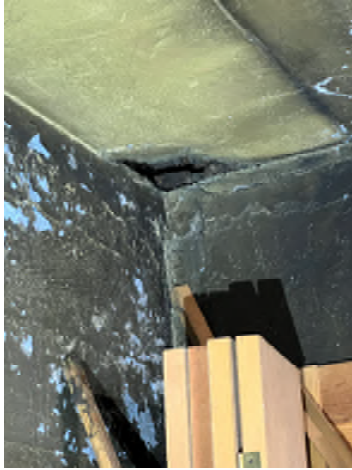
**Figure 4-31.** Deteriorated Ceiling.

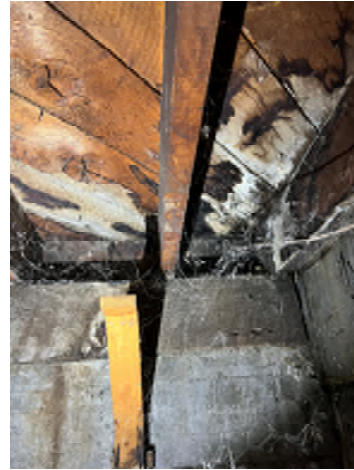
**Figure 4-32.** Rotting Floorboards.

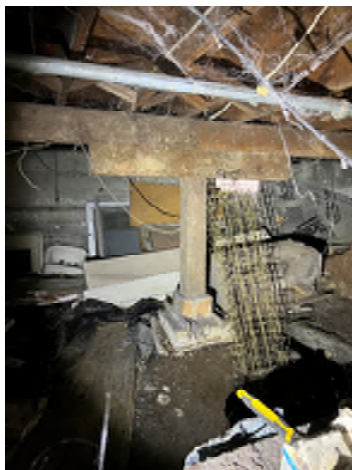
**Figure 4-35.** Column Sitting Directly on the Foundation With No Positive Connection to the Concrete or to the Beam.

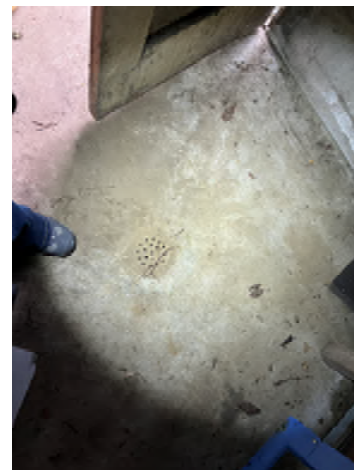
**Figure 4-36.** Drain Leads Directly Under the Foundation, Potentially Undermining the Foundation.

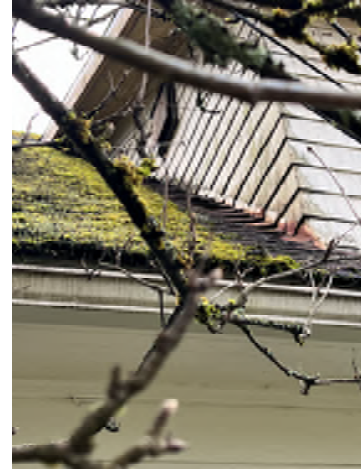
**Figure 5-2.** Moss on the Roof and Deteriorating Shingles and Siding.

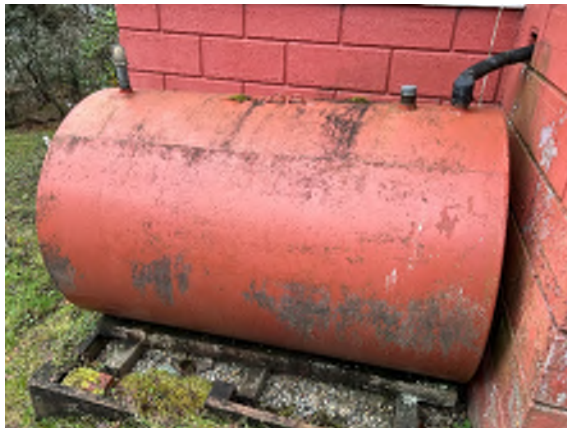
**Figure 5-3.** Cracking in the Concrete Wall. The tank is not seismically anchored and the framing is rotten.

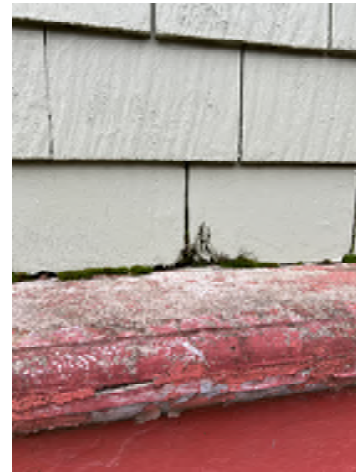
**Figure 5-4.** Deteriorated Siding With Moss Growing in the Gaps.

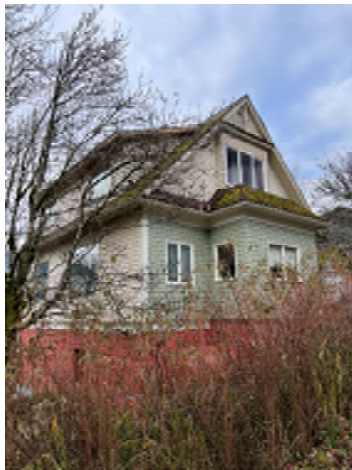
**Figure 5-5.** Southeast Corner of the Building.

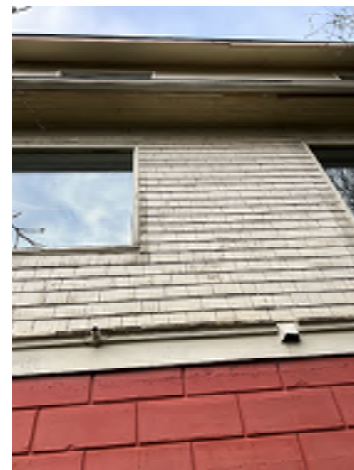
**Figure 5-6.** Deteriorating Siding and Eave.

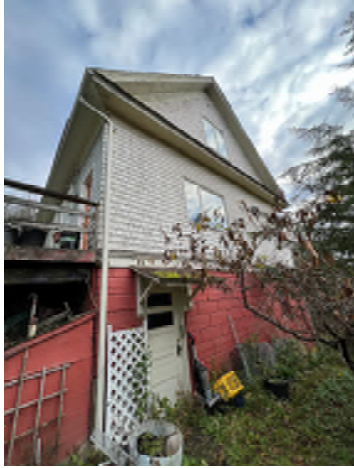
Figure 5-7. Northwest Side of the Building.

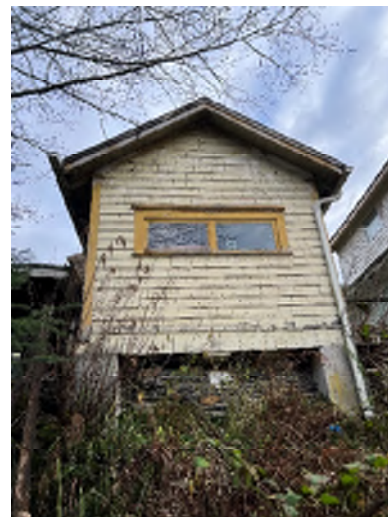
**Figure 5-16.** West Side of Garage. Paint on the siding has significantly deteriorated.

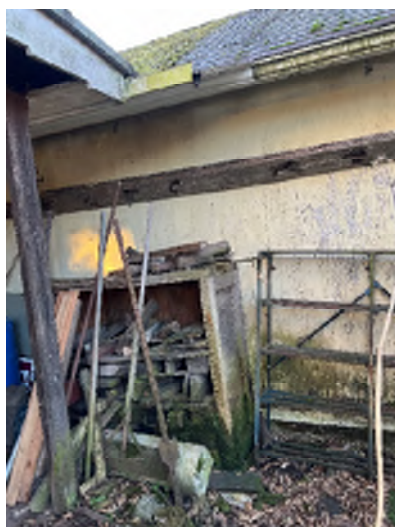
**Figure 5-17.** Gutter Drainage Splashed on the Garage and Caused Significant Moss to Grow and the Plywood to Rot.

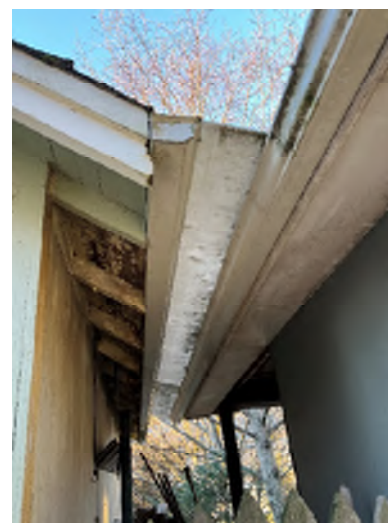
**Figure 5-18.** Deterioration Under the Eave.

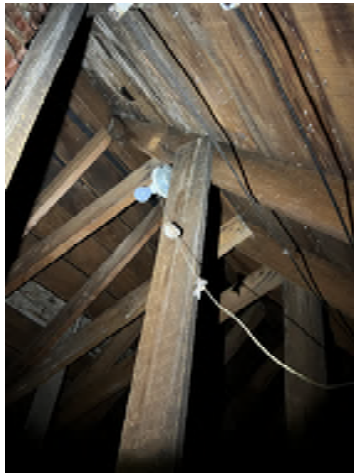
**Figure 5-19.** Indications of Water Damage on the Roof Rafters.
