# STRUCTURAL CONDITION SURVEYS

TELEPHONE HILL, JUNEAU, ALASKA

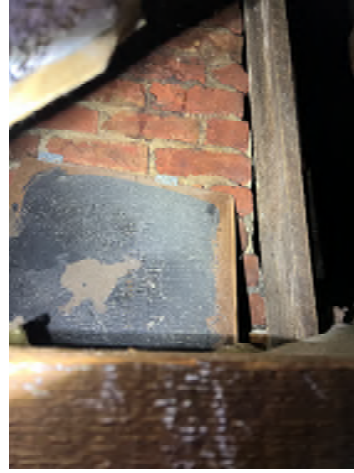
**Figure 5-20.** Deteriorating Chimney.

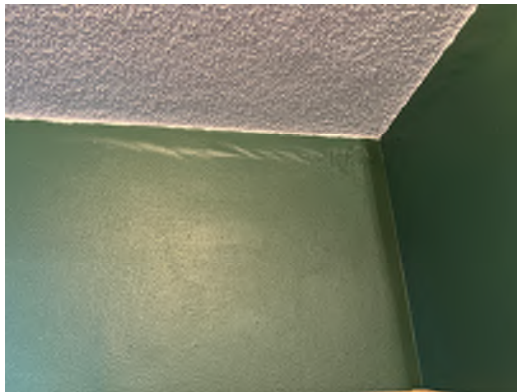
**Figure 5-21.** Bubbled Paint.

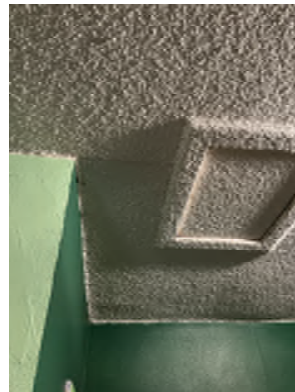
**Figure 5-22.** Cracked Ceiling Drywall.

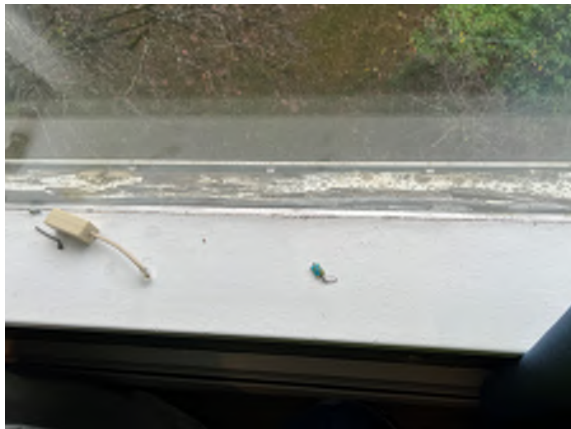
**Figure 5-23.** Deteriorating Windowsill.

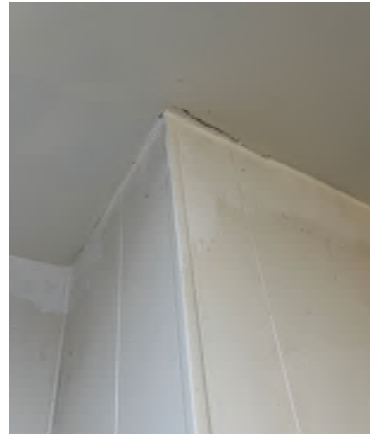
**Figure 5-24.** Continuous Ceiling Crack Around a Corner.

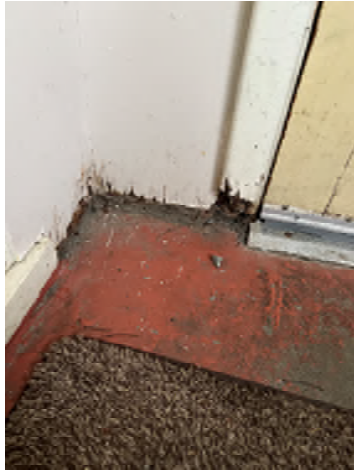
**Figure 5-25.** Rotting Wood Next to the Entryway Door.

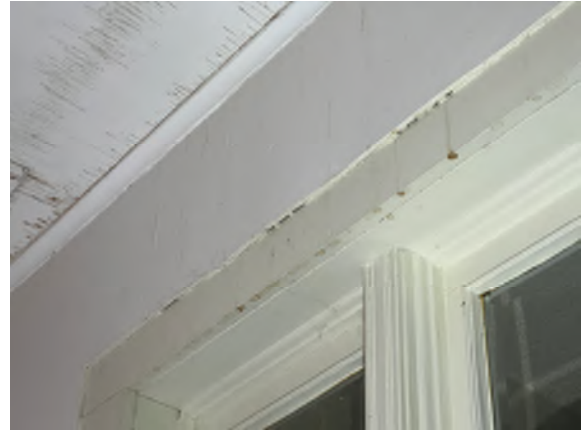
**Figure 5-26.** Indications of Water Damage on Windowsill.

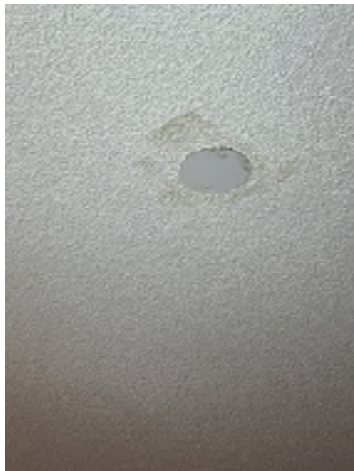
**Figure 5-27.** Water Damage Around Light Wiring Cover.

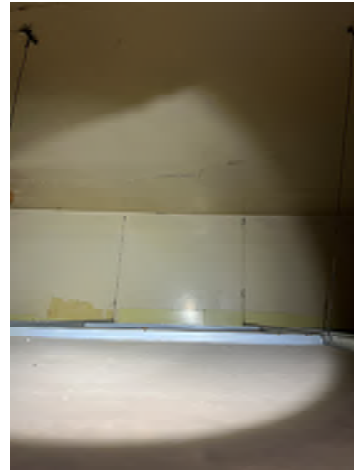
**Figure 5-28.** Cracks in the Ceiling Above the Dropped Ceiling in the Kitchen.

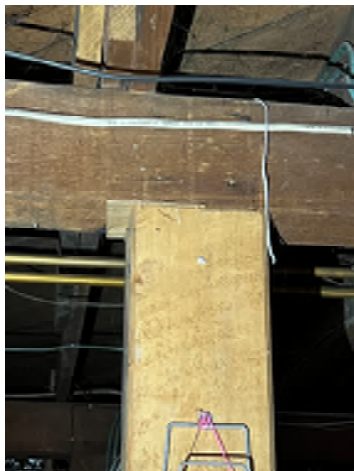
**Figure 5-29.** Shimmed Column With No Positive Connection to the Beam.

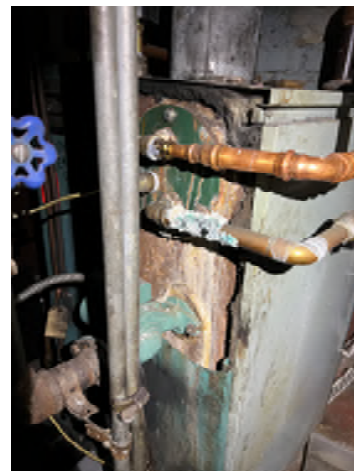
**Figure 5-30.** Significant Corrosion on the Boiler.

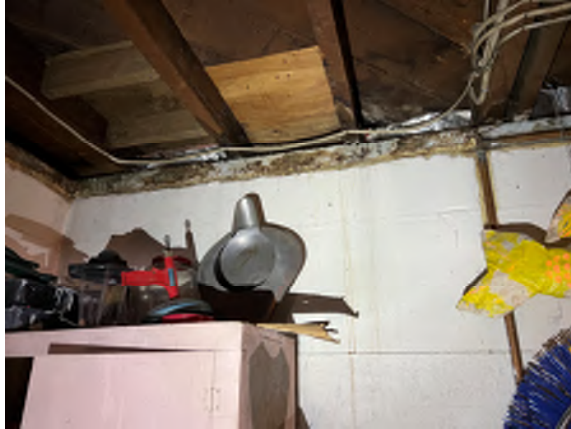
**Figure 5-31.** Water-Damaged Insulation and Water Marks Running Down the Concrete Basement Wall.

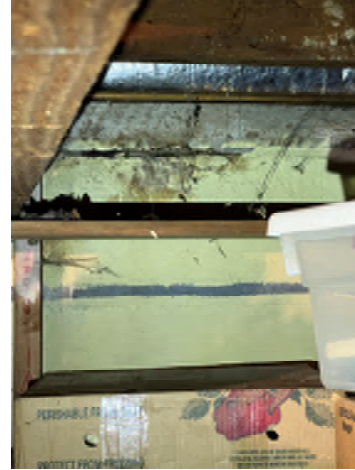
**Figure 5-32.** Large Crack on the Interior of the Concrete Basement Wall.

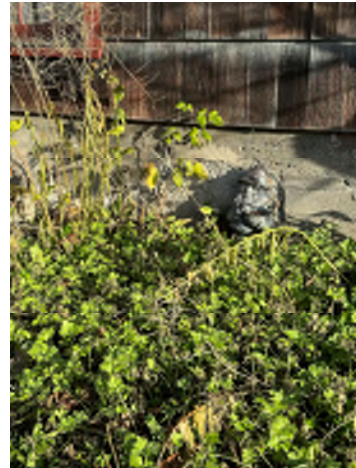
**Figure 6-2.** Cracking in the Concrete Foundation.

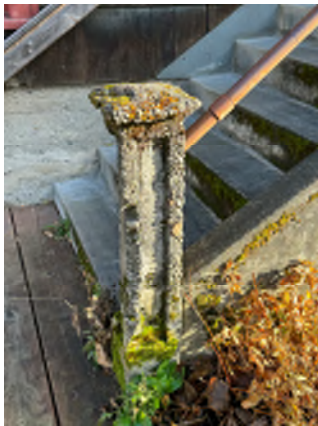
**Figure 6-3.** Damaged Concrete Post.

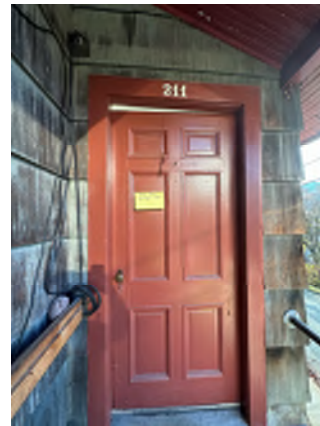
**Figure 6-4.** Large Gap Between the Door and Doorframe.

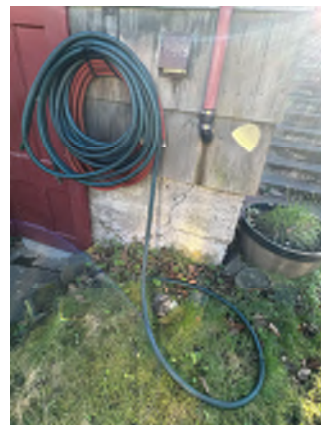
**Figure 6-6.** Cracking in the Concrete Foundation at the Northeast Corner of the Building.

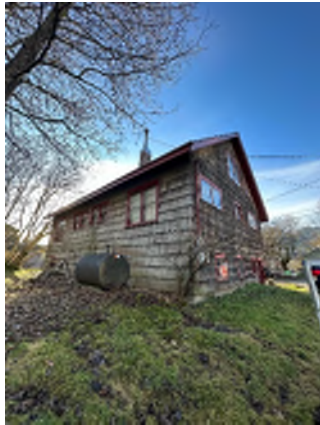
Figure 6-7. East Side of the Building.

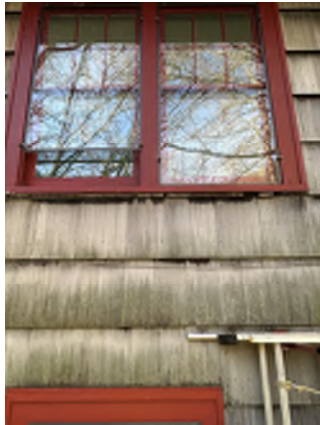
Figure 6-9. Deteriorating Window Sill.

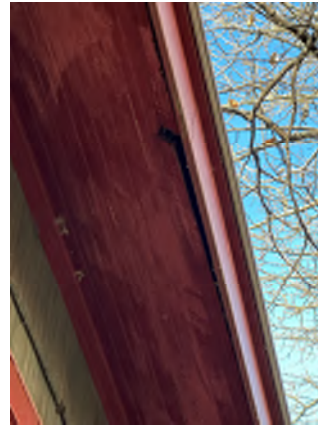
Figure 6-10. Damaged Eave.

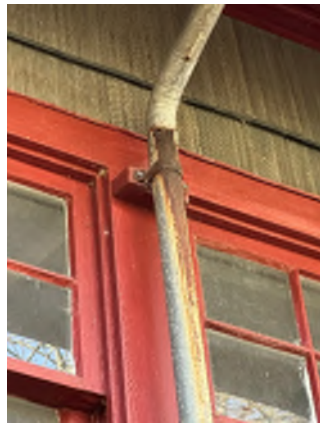
Figure 6-11. Drainpipe Is Rusted.

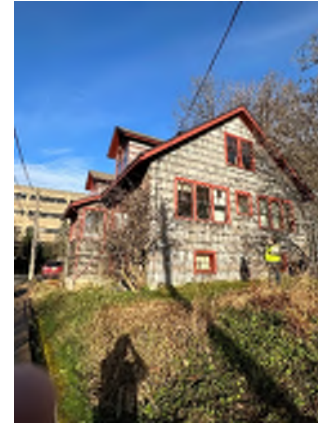
Figure 6-12. South Side of the Building.

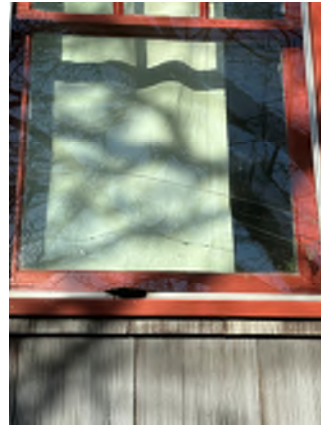
**Figure 6-14.** Crack in the Storm Window.

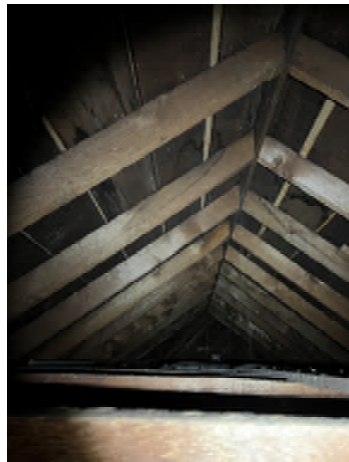
**Figure 6-15.** Signs of Old Water Damage. New roof sheathing exists above the old boards that appears to be in good condition.

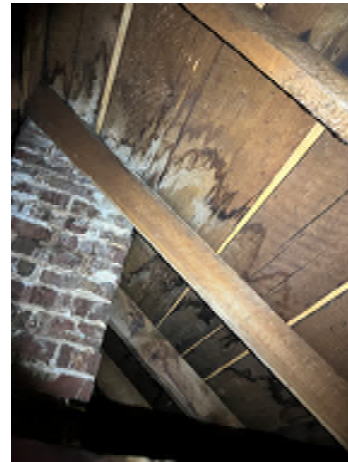
**Figure 6-16.** Significant Amount of Old Water Damage Around the Chimney.

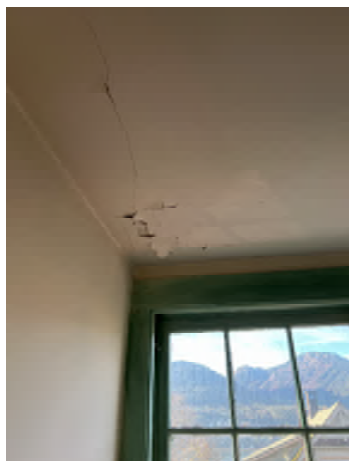
**Figure 6-17.** Cracking and Peeling Paint on the Ceiling.

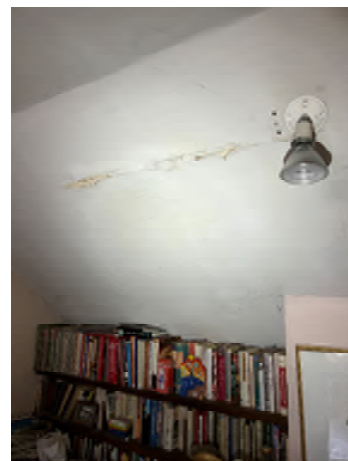
**Figure 6-18.** Cracking and Indications of Water Damage on the Ceiling.

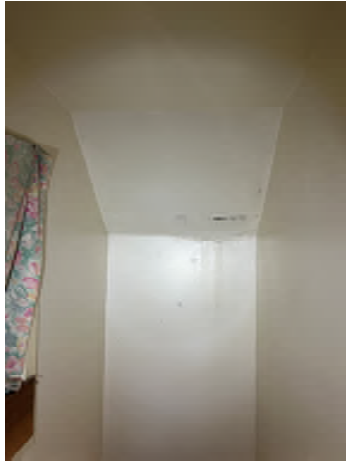
**Figure 6-19.** Cracking and Water Damage Indications Above the Stairs.

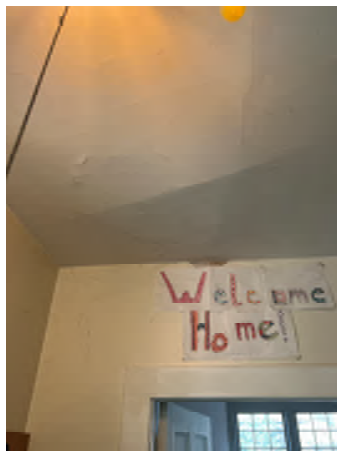
**Figure 6-20.** Cracked Drywall and Drooping Ceiling.

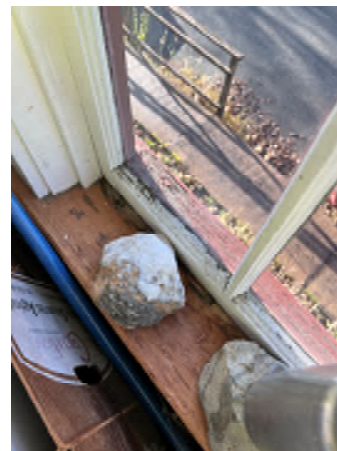
**Figure 6-21.** Indications of Water Damage on the Windowsill.

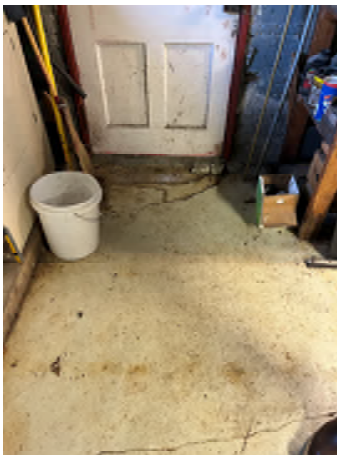
**Figure 6-22.** Cracked Slab-on-Grade at the North Basement Entrance.

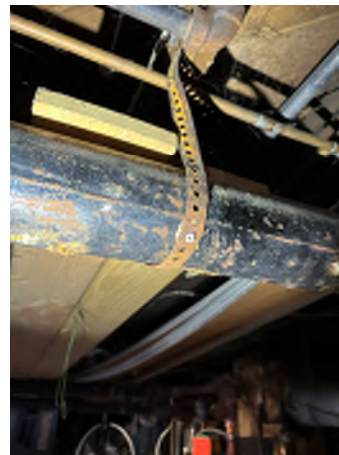
**Figure 6-23.** Rusted Strap.

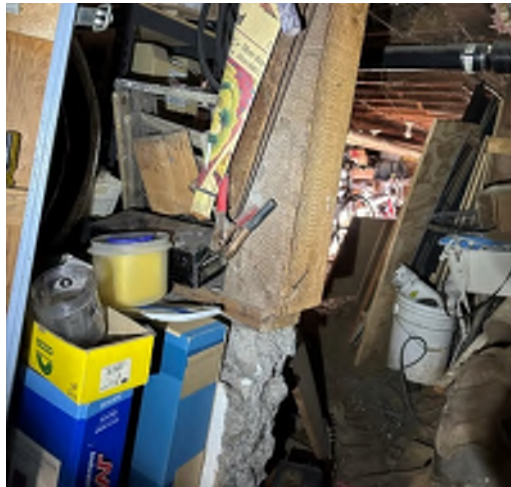
**Figure 6-24.** Wood Post Supported Eccentrically by Stem Wall With a Chunk of Concrete Missing Directly Below the Post.

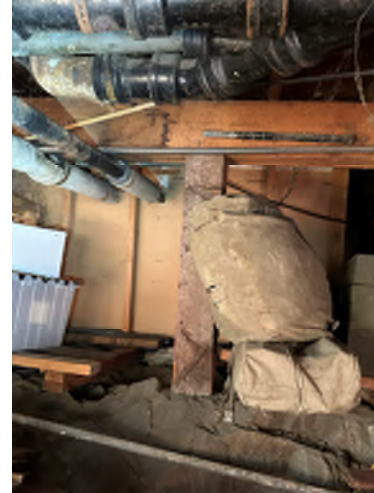
**Figure 6-25.** No Lateral Restraint/Connection From Beam to Column. The wood column is placed directly on top of the rock.

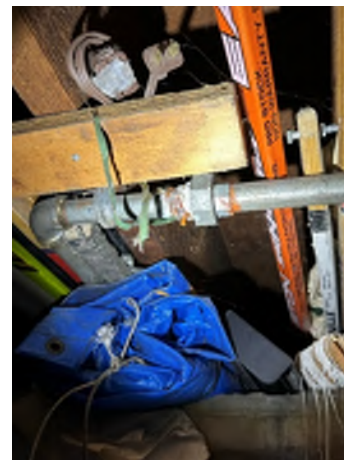
**Figure 6-27.** Pipe Leak Has Stained the Concrete Floor.

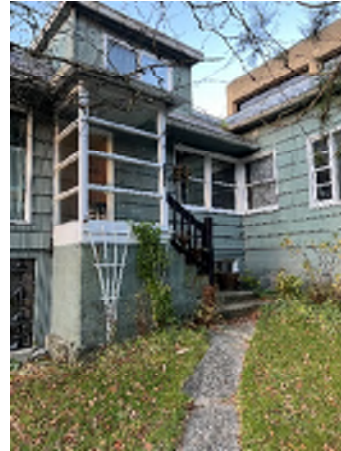
**Figure 7-2.** There Is Some Deterioration to the Exterior, Including a Cracked Window and Spalled Concrete.

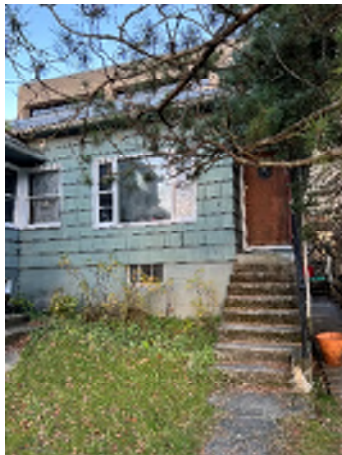
**Figure 7-3.** Moss on the Concrete Stairs.

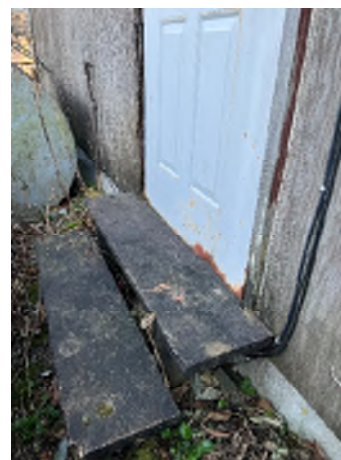
**Figure 7-6.** Unprotected Plywood Sheathing by the Siding and Rust Around the Man Door.

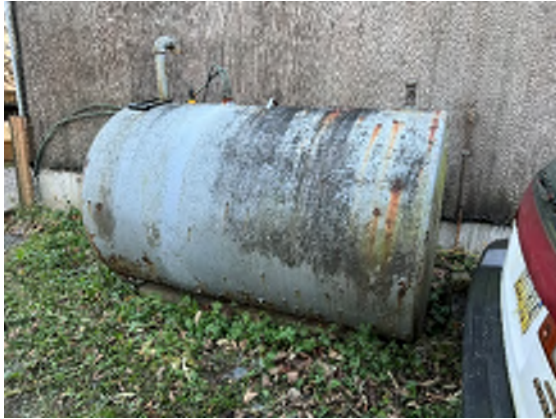
**Figure 7-7.** A Rusted Tank That Is Not Seismically Secured.

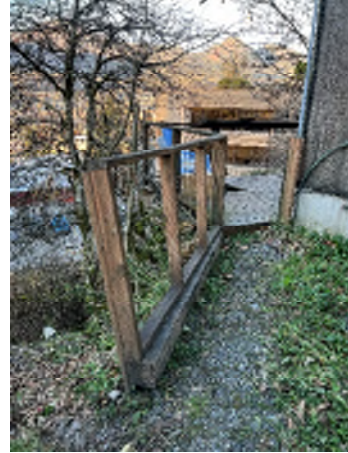
**Figure 7-8.** Leaning Handrails.

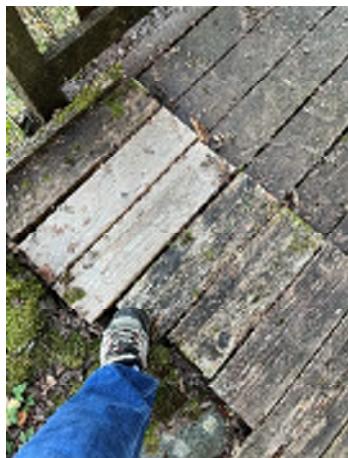
**Figure 7-10.** Rotten Boards on the Deck That Is a Hazard if Someone Steps Wrong and Falls Through.

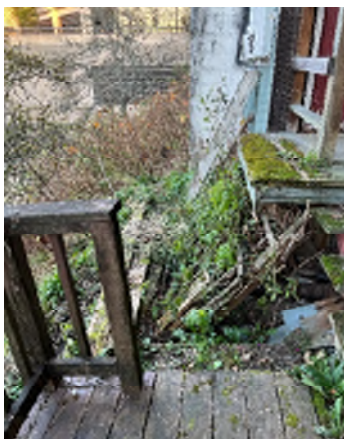
**Figure 7-11.** Moss on the Stair Landing and a Pile of Wood on the Ground.

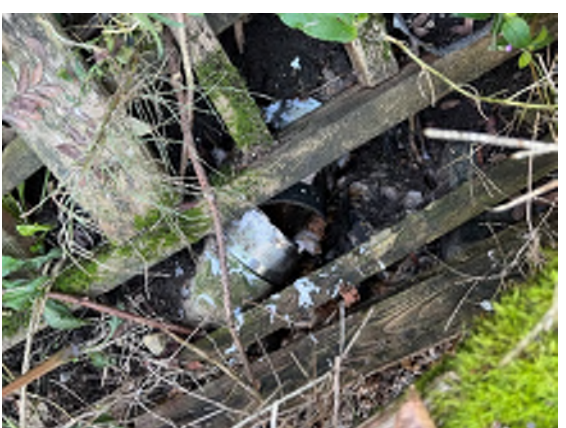
**Figure 7-12.** A Broken Pipe Below the Pile of Wood That May Be a Sewer Pipe.

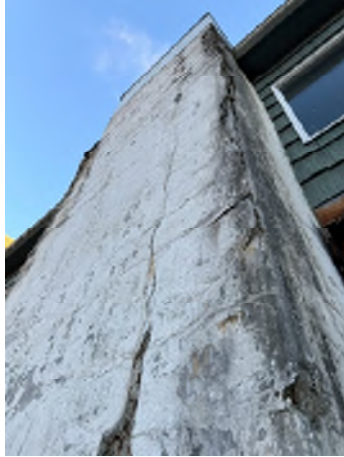
**Figure 7-13.** A Long Crack Up the Side of the Chimney.

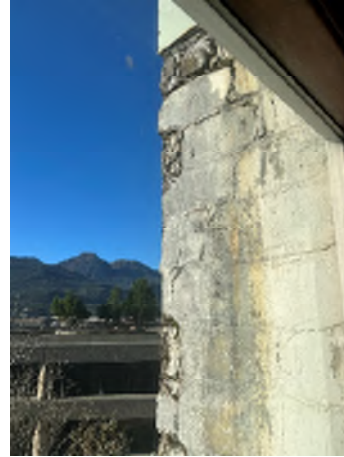
**Figure 7-14.** Concrete Falling Off the Side of the Chimney.

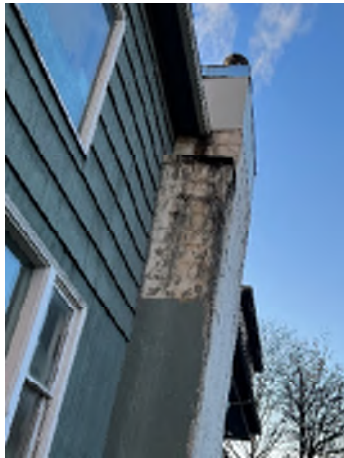
**Figure 7-15.** Water-Stained Chimney With Visible Cracks.

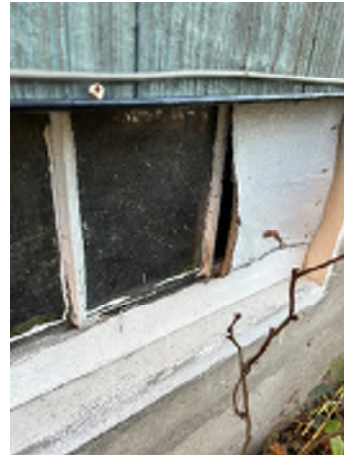
**Figure 7-16.** A Basement Broken Window, Which Is Not Adequately Sealed, That Can Allow Water or Animals Inside.

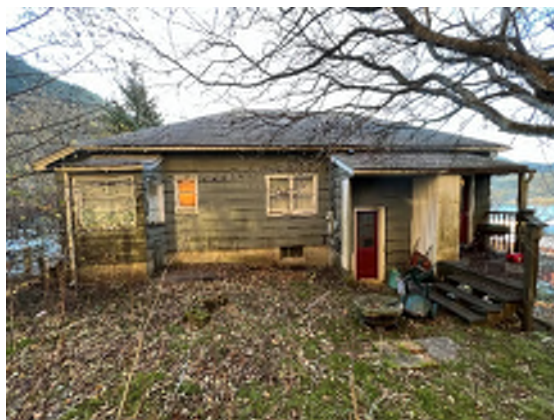
**Figure 7-17.** North Side of the Building.

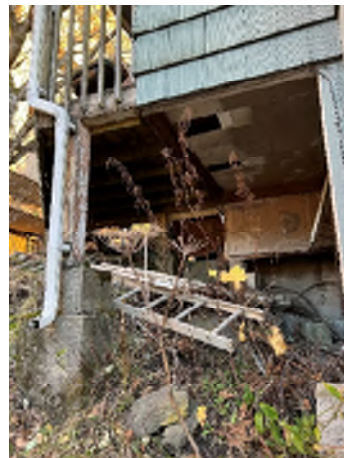
**Figure 7-18.** Missing Soffit Panels. The column is sitting on a concrete pile.

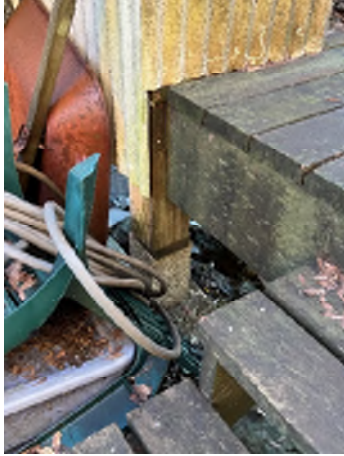
**Figure 7-19.** Moss Growing on the Deck. The column is shimmed and sitting on a concrete pile.

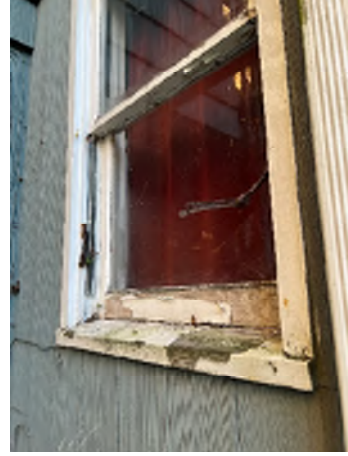
**Figure 7-20.** Rot at the Windowsill.

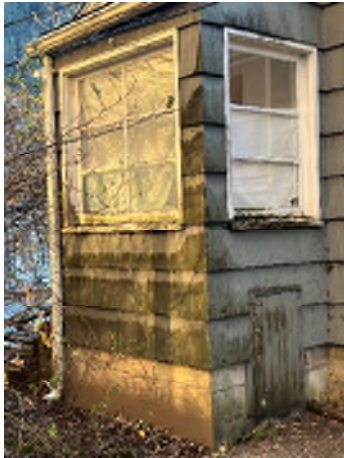
**Figure 7-21.** Moss on the Windowsills and Siding on Unit A's Back Entryway and Rot on the Windowsills.

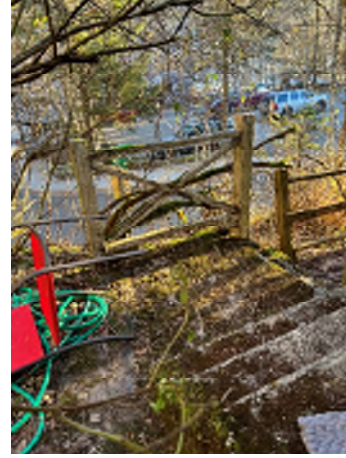
**Figure 7-22.** Deteriorated and Rotted Portions of the Walkway Railings.

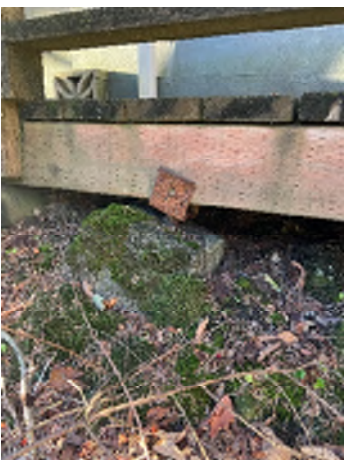
**Figure 7-23.** A Rotated Walkway Support Connector.

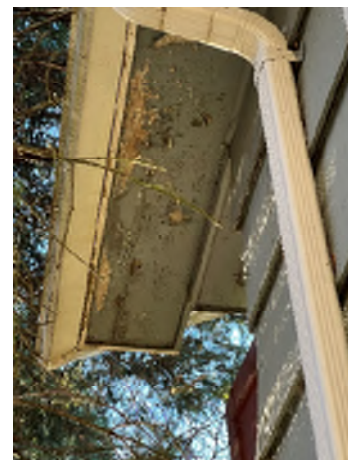
**Figure 7-24.** Deterioration to the Underside of the Eave.

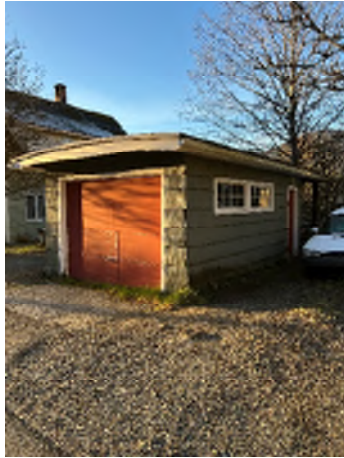
**Figure 7-25.** Garage/Shed on the South Side of the Building. No Lateral System on Front.

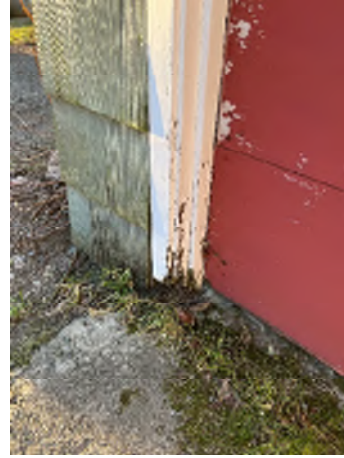
**Figure 7-26.** Rot Near the Ground.

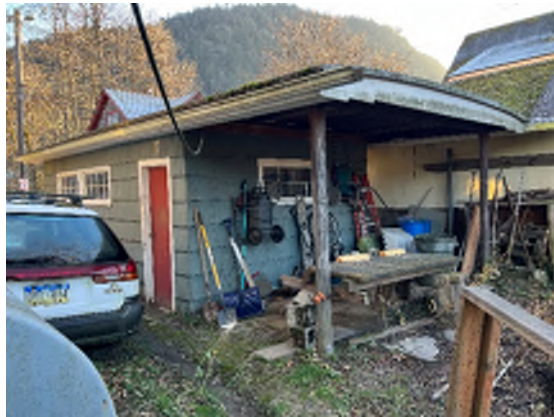
**Figure 7-27.** West Side of the Garage Building.

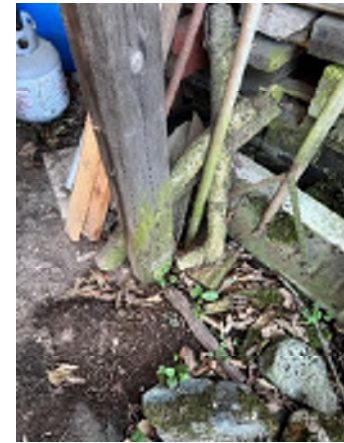
**Figure 7-28.** Moss Growing on Main Column Supports That Are not Pressure Treated. These columns can rot quicker untreated.

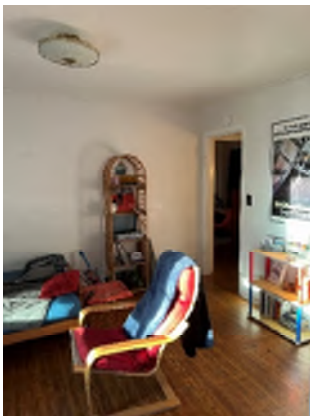
**Figure 7-29.** Small Cracks at the Sheetrock Panel Edges.

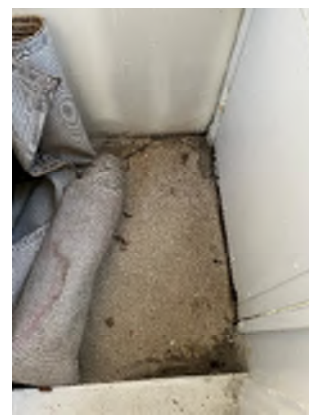
**Figure 7-30.** Moisture Damage and Rot in the Back Entryway.

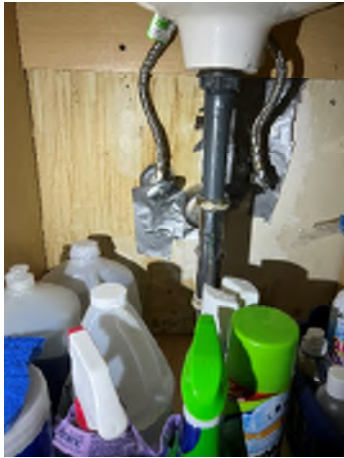
**Figure 7-31.** An Upper-Level Sink Leaked.

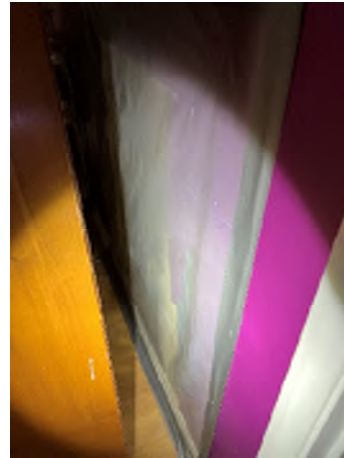
**Figure 7-32.** Back of the Wall That Was Opened to Repair the Leak and Covered With Vapor Barrier.

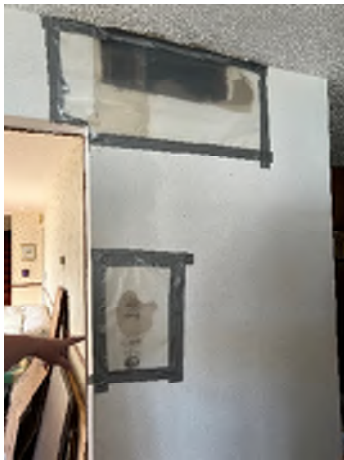
**Figure 7-33.** Damage to the Finishes Caused by the Sink Leak.

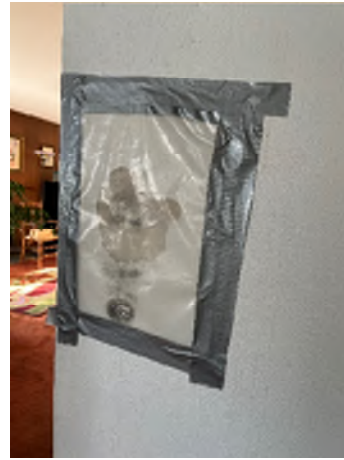
**Figure 7-34.** Mold Is Growing Under the Vapor Barrier. The Extent of Damage in the Wall Cavity Is Unknown.

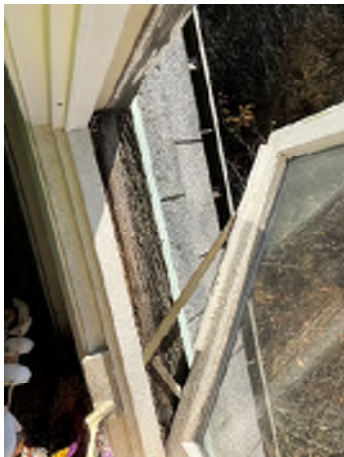
**Figure 7-35.** Rot Under Some Windows.

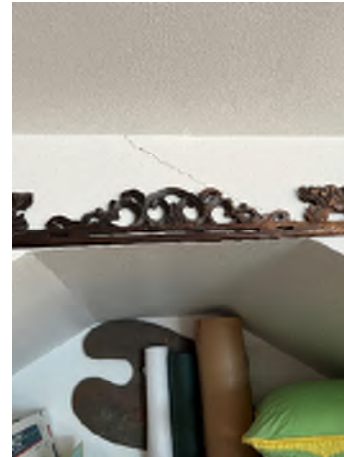
**Figure 7-36.** Sheetrock Cracks Through the Unit.

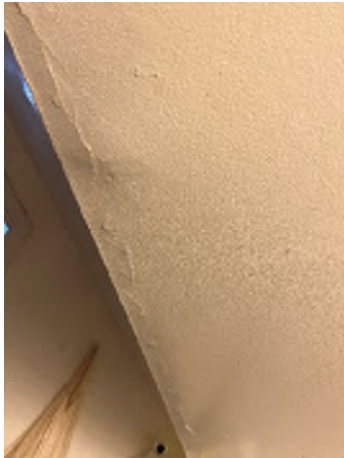
**Figure 7-37.** Paint Is Chipped, and the Sheetrock Fasteners Are Visible in Some Places.

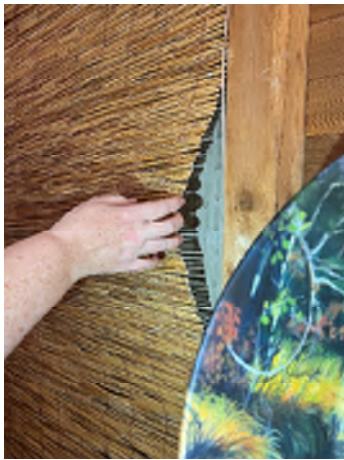
**Figure 7-39.** Tiles Were Found Behind the Old Fireplace Hearth. Approximately one-third of the tiles have fallen off the wall.

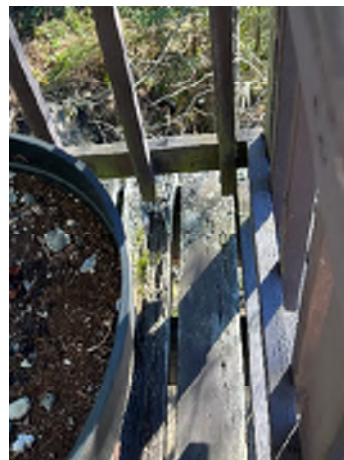
**Figure 7-40.** Rotten Boards on the corner of the Elevated Deck.

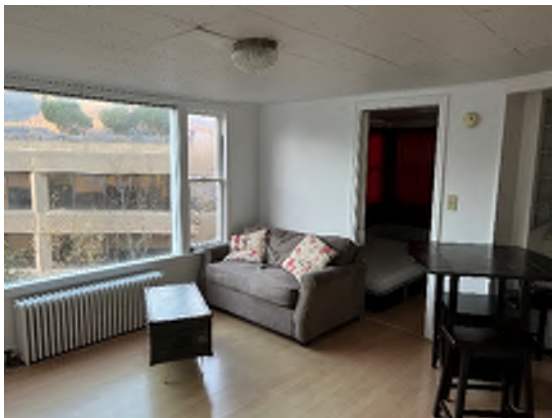
**Figure 7-41.** Finishes Appeared to Be in Good Condition.

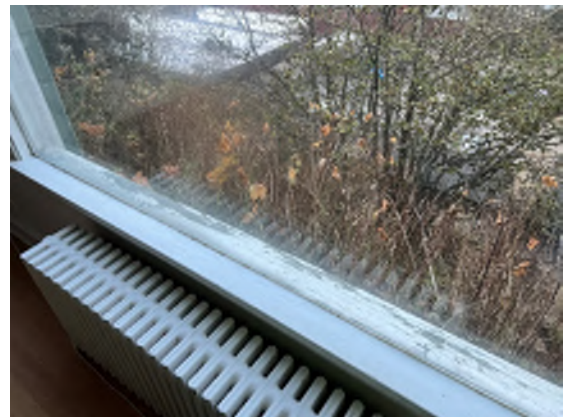
**Figure 7-42.** The Window Frame Has Some Deterioration.

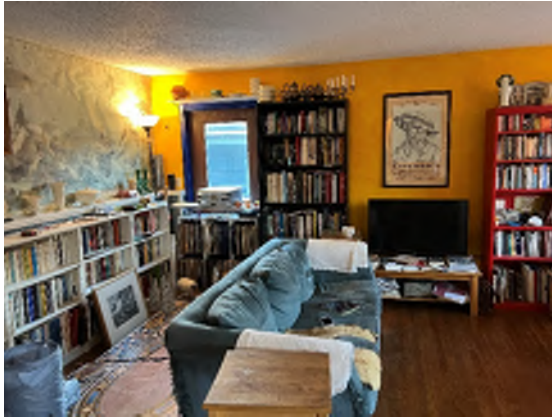
**Figure 7-43.** More Finishes Appeared to Be in Good Condition.

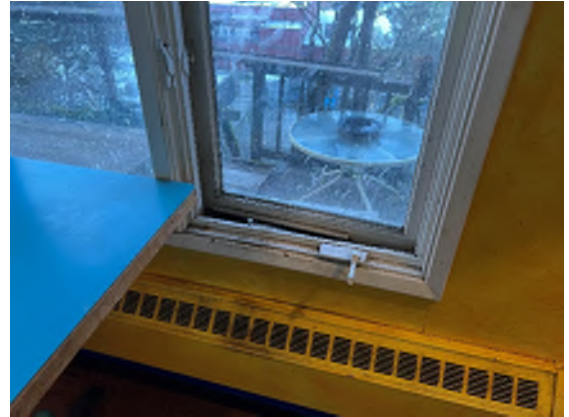
**Figure 7-44.** One Window No Longer Opens Properly.

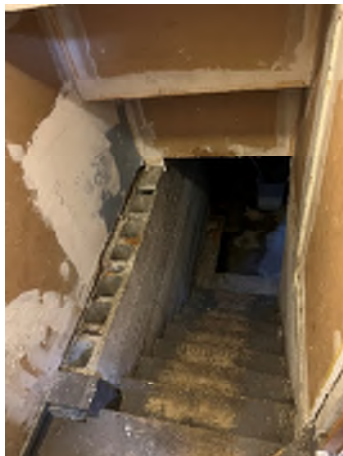
**Figure 7-45.** No Grout Columns Were Observed in the Visible Portion of the Masonry Wall. This wall is likely unreinforced.

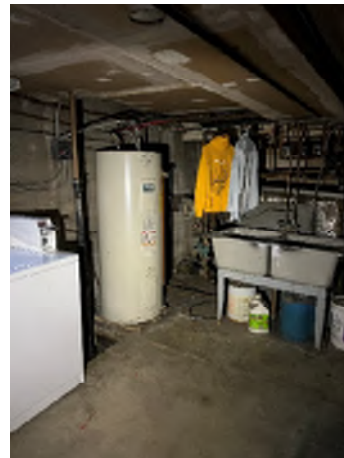
**Figure 7-46.** Water Heater Does Not Have Seismic Straps.
