**JUNEAU AREA MASS-WASTING &
SNOW AVALANCHE HAZARD ANALYSIS**

Prepared For: City & Borough of Juneau, Alaska

Art Mears
Arthur I. Mears, P.E., Inc.
Gunnison, Colorado

February 1992

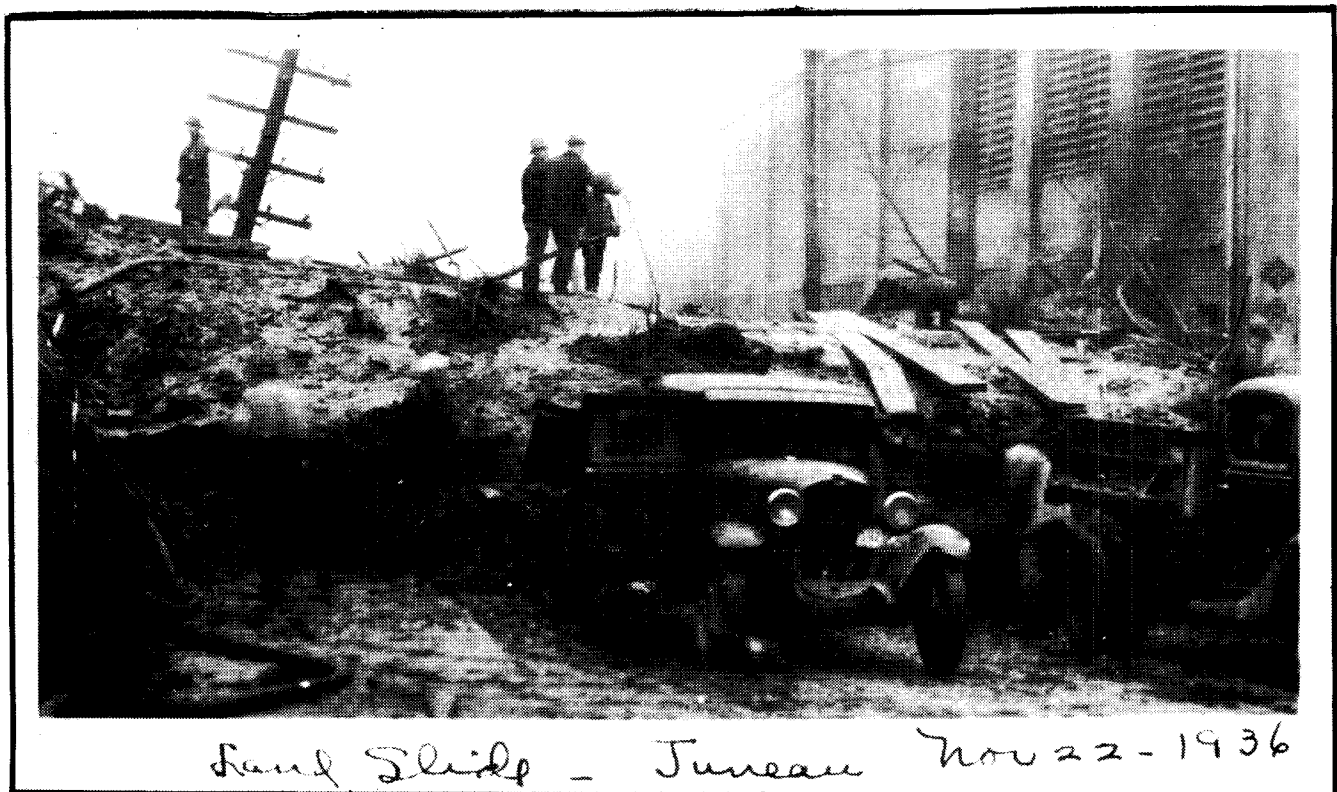
Figure 2. Debris avalanches such as this one on S. Franklin St. (Nov. 22, 1936) exert large thrust pressures against fixed objects while moving and significant depositional forces after movement stops. Flows can be several feet thick and carry rocks and large trees. Source: Alaska Historical Library, Early Prints of Alaska Collection.

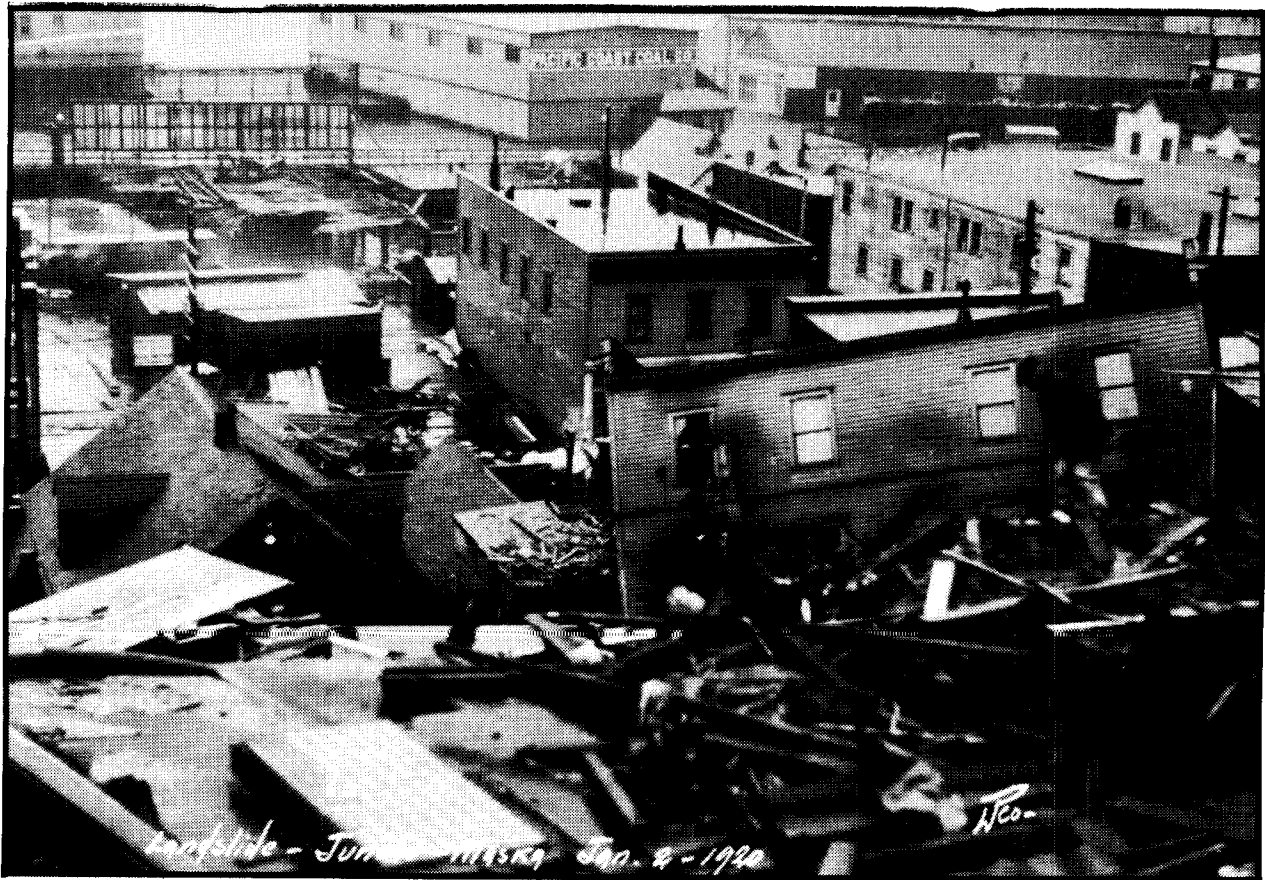
Figure 3. This view of the area between Gastineau Ave. and S. Franklin St. (Jan. 2, 1920) illustrates how buildings were destroyed by a debris avalanches through the processes of impact and relocation. Source: Alaska Historical Library, Early Prints of Alaska Collection.

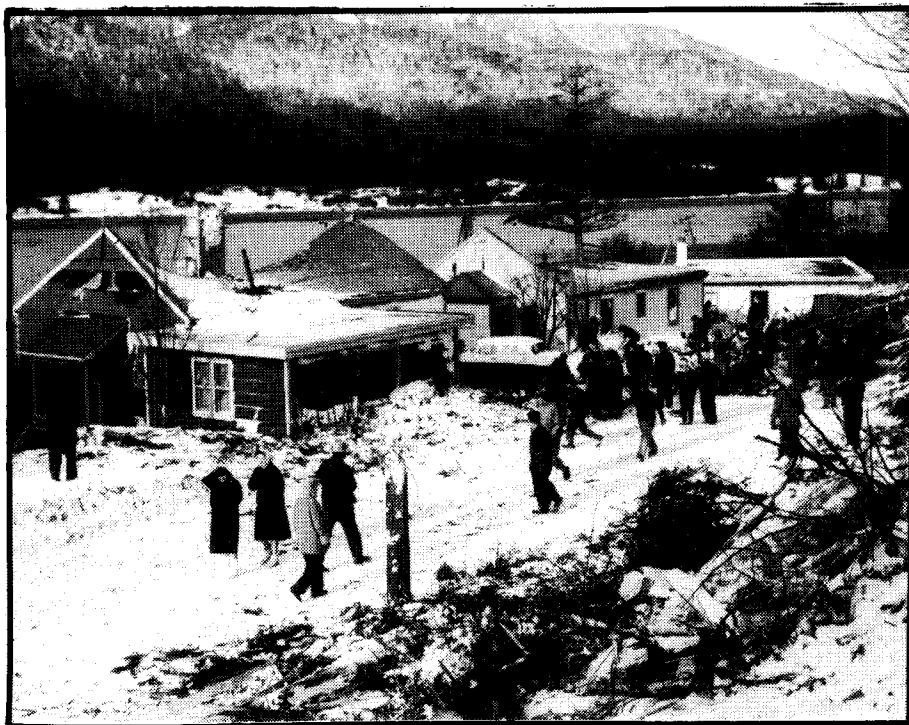
Figure 5: Taken shortly after the March 22, 1962 Behrends Ave. avalanche, this photograph illustrates some of the damage resulting from the powderblast of this fast moving low density avalanche. Thirty five houses were damaged: some were pushed off of foundations, roofs were blown off, walls pushed in, chimneys snapped off, trees broken and hurled through walls and roofs, and windows were blown in or sucked out. Photo source: Alaska Mountain Safety Center, Inc., Hart Collection.

7. 1962, 03-22, 0530: The most destructive avalanche in recent years, this event was precipitated by strong NE winds, cold temperatures, and heavy amounts of new snow and wind-loading which resulted in a major soft slab avalanche with considerable powderblast damage, but very little debris. According to Mr. R.E. (Randy) Randall, who was possibly the only eyewitness, "the airborne-powder avalanche travelled completely across Gastineau Channel terminating near the Treadwell Ditch at elevation 750'" (Source: Hart, 1967, *Report of the Preliminary Evaluation of the Behrends Avenue Avalanche Path*, p 15). In all, approximately 35 residential structures on three streets were damaged. These included:

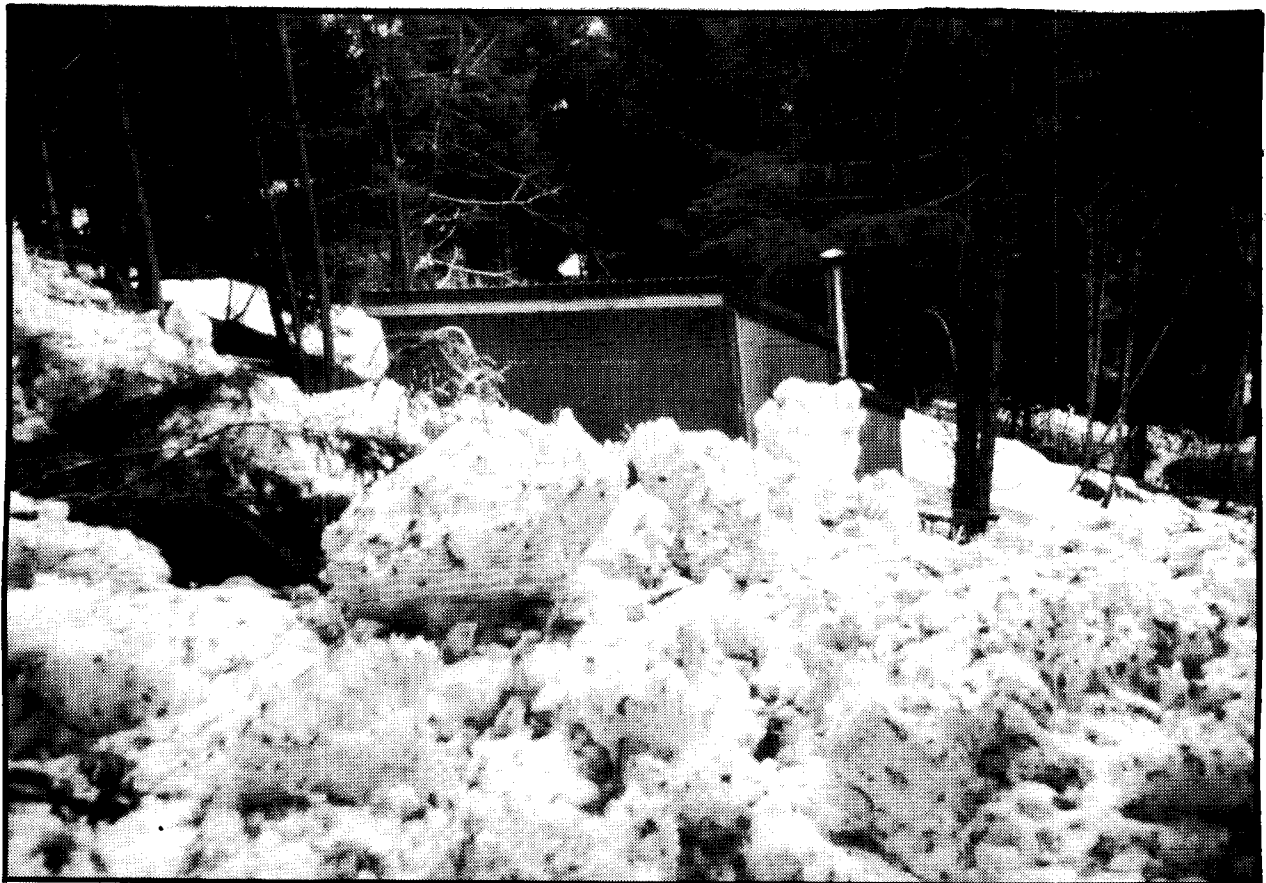
Figure 6: The avalanche which hit and damaged this occupied residence in White Subdivision was the 4th slide of the season in this path and the second one in a month to hit the house. Only the second story is visible above the debris and the garage (immediately to the right of the house) is still buried along with the owner's vehicle which was parked in the driveway. Damage from wet snow avalanches such as this usually results from crushing and dislocation. Photo by Doug Fesler, Feb. 20, 1985.

8. 1985, 02-20, 2150: A large avalanche hit and damaged one residential structure (the Tow residence) and partly buried one vehicle and a cache of building materials, came within 10' of a second house (Kohler residence), stopped approximately 70' above a third structure (on Wickersham Ave.), and 150' above a fourth structure (the grey condominium
-
