## APPENDIX C

### TECHNICAL MEMOS

<b>To:</b>	Teri Camery (CBJ)	<b>Date:</b>	April 27, 2022
<b>c:</b>	Alix Pierce (CBJ)	<b>Memo No.:</b>	1
<b>From:</b>	Rita Kors-Olthof, Vladislav Roujanski, Shirley McCuaig	<b>File:</b>	704-ENG.EARC03168-01 / 704-ENG.EARC03168-02A
<b>Subject:</b>	Landslide Mapping Accuracy and Modelling Downtown Juneau Landslide and Avalanche Hazard Assessment

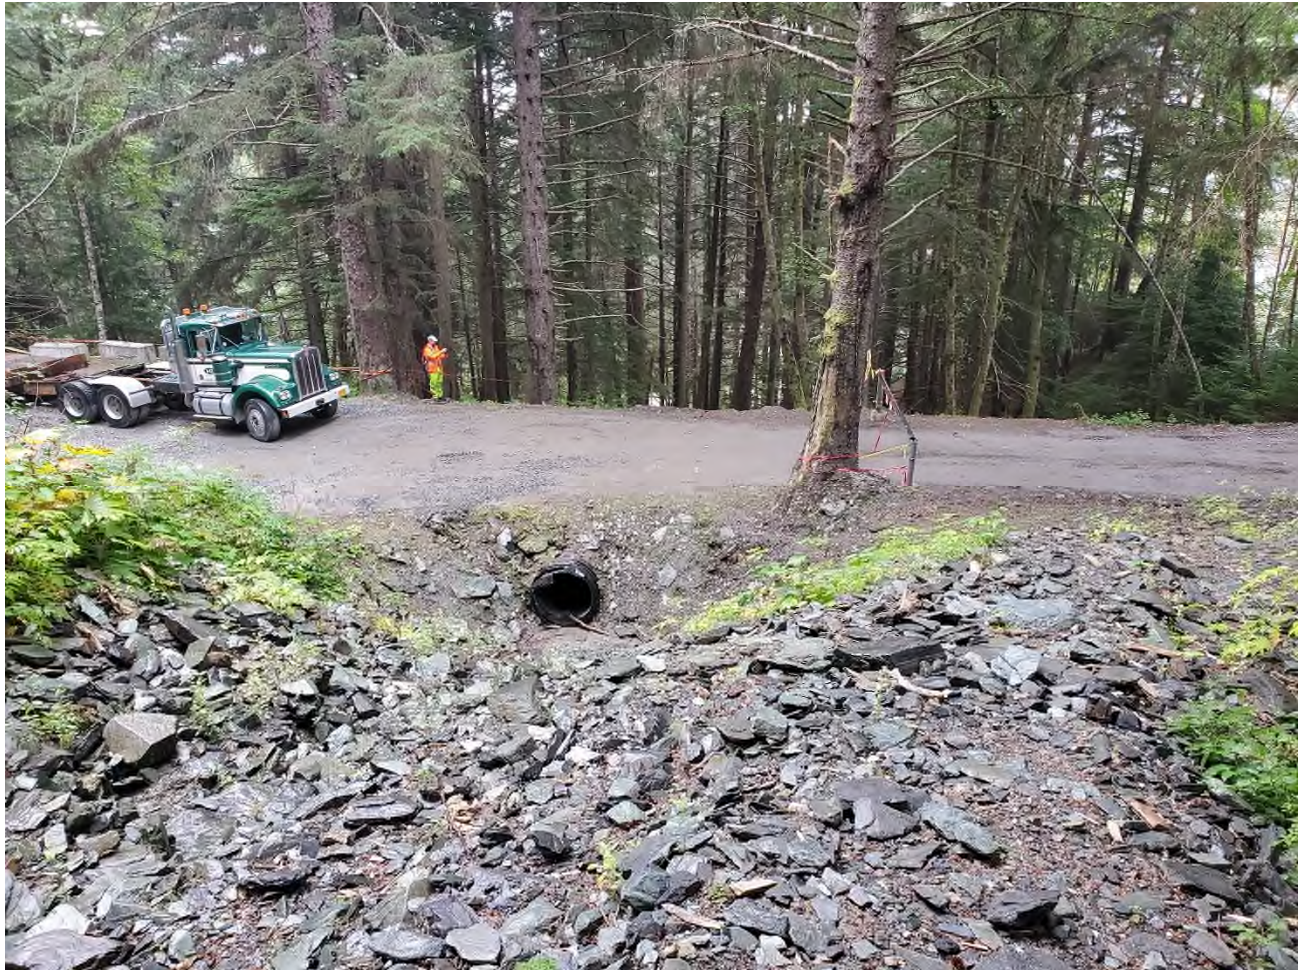
**Figure 4: Looking down towards the Gold Creek Flume Trail from the Bathe Creek debris flow gully. Note the large amount of debris in and alongside the gully, as well as the scarring on the tree beside the road that extends to at least 6 feet above ground surface. This gully is very active, and the debris that is deposited at the road crossing is regularly cleaned up. This road crossing has the potential to divert debris flows into the residential community downslope and to the west, especially if more than one surge of debris occurs before the debris can be cleaned.**

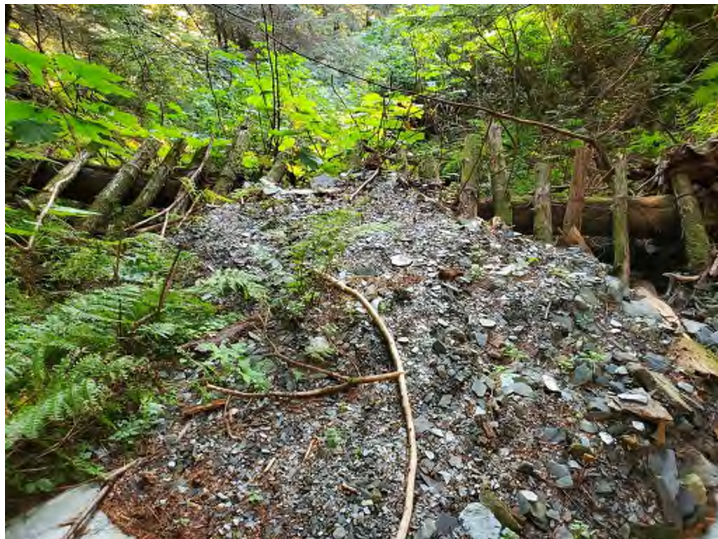
**Figure 16: Photos from the fieldwork in September 2019 showing one of the existing debris-flow mitigation structures that were built by homeowners living below the G000 Park debris flow path above Starr Hill. This structure has captured debris material from one or more mass-wasting events and measured about 8 feet wide by 7 feet long by 2 feet deep.**

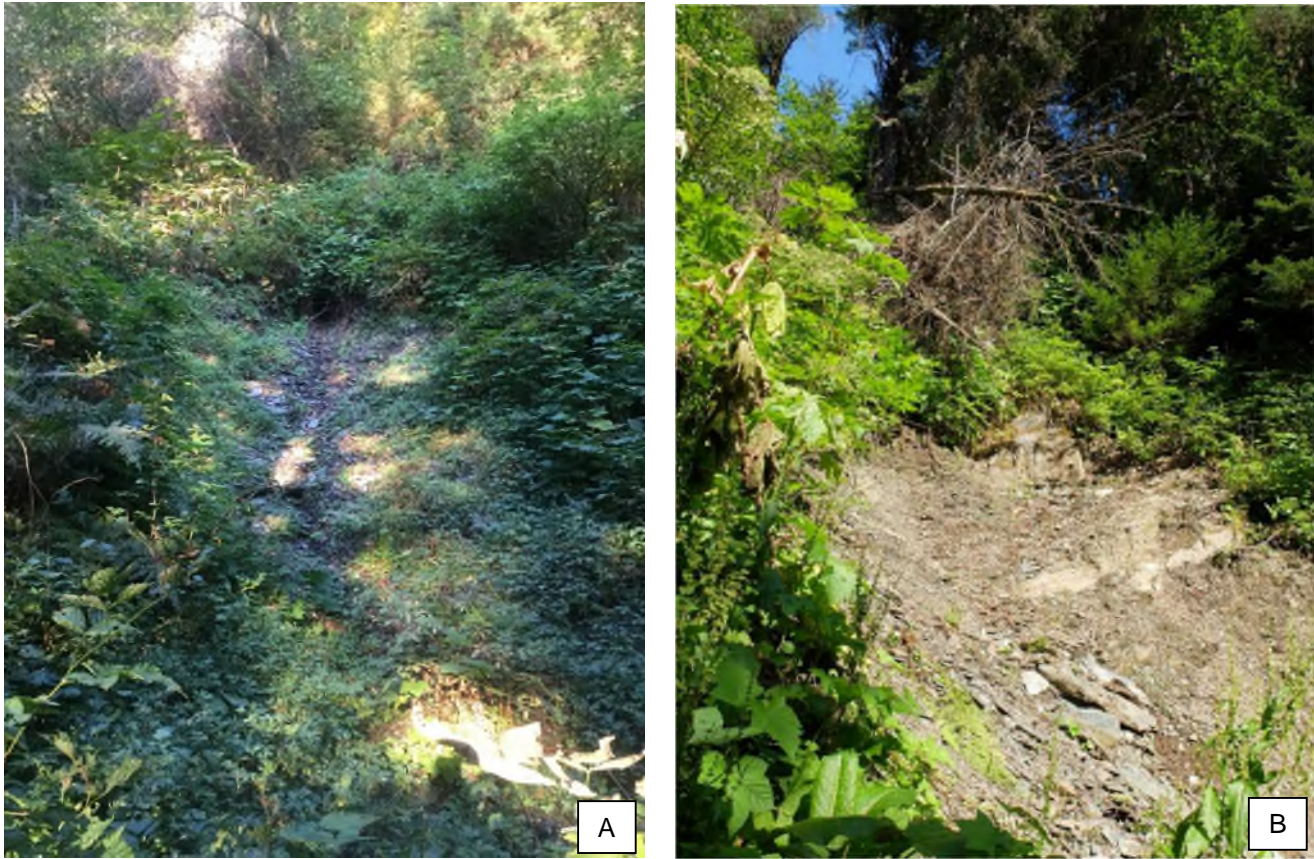
**Figure 18: Compares Tetra Tech’s photo from September 10, 2019 (Figure 18A) with residents’ photo from August 1, 2021 (Figure 18B) at the same location. Slope instabilities appear to be ongoing in the historical slide paths located above Nelson Street on a slope with a landslide hazard designation of Severe. See Technical Memo #3 for more information about the slopes around Starr Hill.**

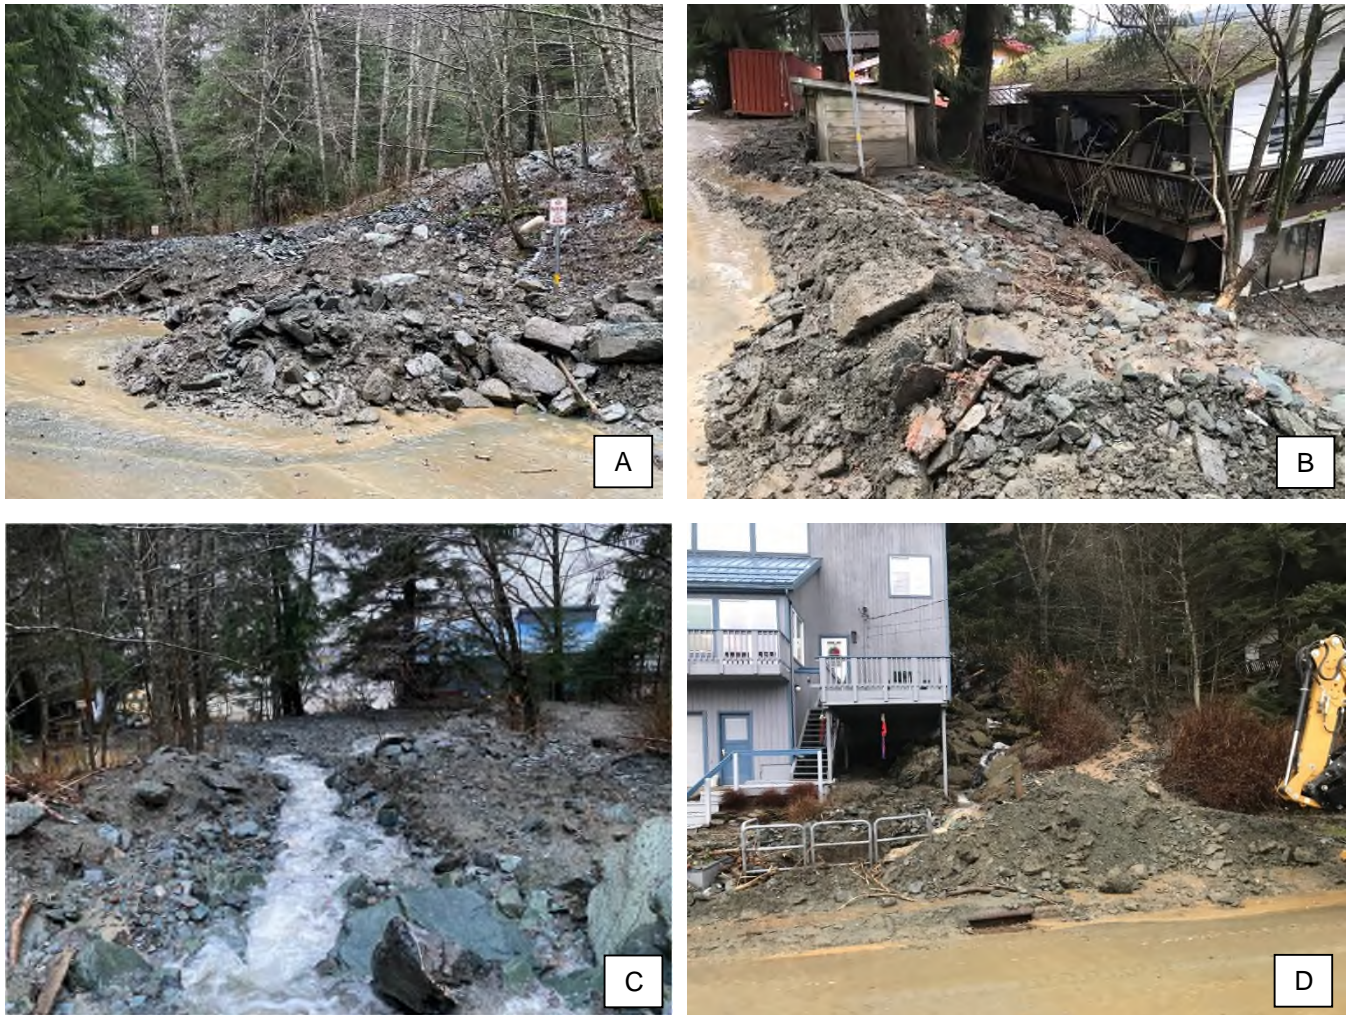
**Figure 20: The Wickersham debris slide in the White Subdivision is an example of a landslide in terrain with a Severe landslide hazard designation. Figure 20A: Part of the debris deposit at the northwest end of Wickersham Avenue on the uphill side; Figure 20B: Debris on the downhill side of Wickersham Avenue; Figure 20C: Debris running down along the swale between Wickersham and Glacier Highway; Figure 20D: Debris deposit at Glacier Highway, filling a concrete sump behind the railing. (Photo credits: CBJ December 4, 2020.)**
