<b>To:</b>	Teri Camery (CBJ)	<b>Date:</b>	April 27, 2022
<b>c:</b>	Scott Ciambor (CBJ)	<b>Memo No.:</b>	4
<b>From:</b>	Rita Kors-Olthof, Alan Jones, Vladislav Roujanski	<b>File:</b>	704-ENG.EARC03168-02A
<b>Subject:</b>	Guide to Avalanche and Landslide Hazard Designations Downtown Juneau Landslide and Avalanche Hazard Assessment

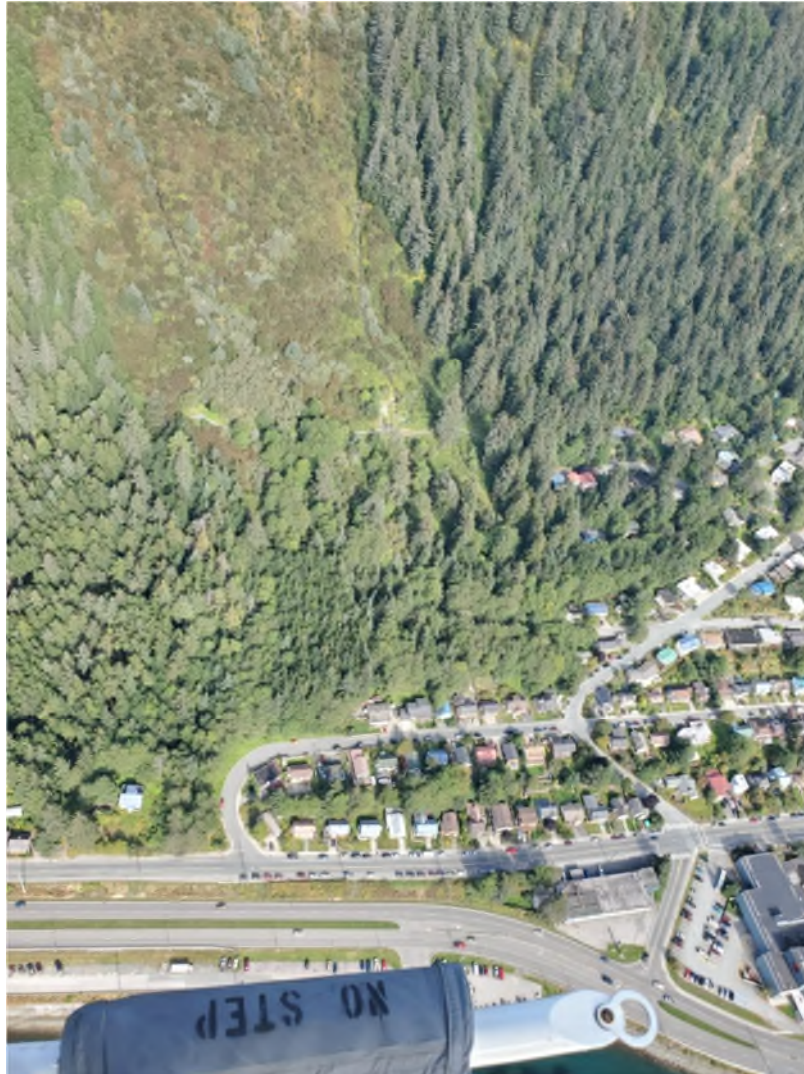
**Figure 6: Looking north-northeast at the lower end of the J010 Behrends Avenue avalanche path. Note the differences in vegetation within the path, beside the path, and below it, mostly due to regular and destructive avalanche activity. The large building in the lower right corner of the photo is the high school at the corner of Glacier Avenue and Highlands Drive. The school is located just outside of the *Moderate* hazard zone. Most of the other areas (with the exception of the densely forested upper right part of the photo) are within either *Severe* or *Moderate* hazard zones.**

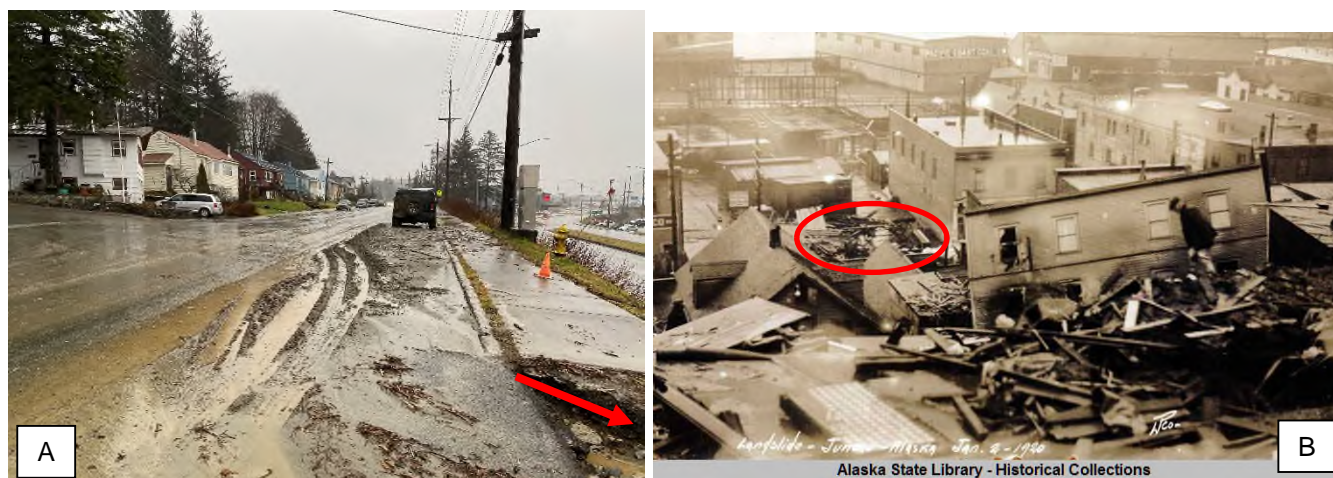
possible, such as erosion (red arrow on Figure 13A), the landslide hazard designation here cannot be considered *Low*. As shown on Figure 11B, no other historical slope movement features were observed on the imagery, and on Figure 11C, the gullies appear not to extend across Behrends Avenue or Glacier Avenue, although the debris may flow onto them. Therefore, a landslide hazard designation of *Moderate* is considered appropriate.

**Figure 13: These photos are of *Moderate* terrain. Figure 13A is looking southeast along Glacier Avenue on December 4, 2020, where Ross Way enters. Ross Way carried debris and water from Behrends Avenue to Glacier Avenue. Debris can also run southeast on Behrends Avenue. Note the apparently eroded and failed section of the sidewalk (at red arrow) where a section of concrete slab was missing. Figure 13B is looking downslope towards South Franklin Street (formerly Front Street) on January 2, 1920, after a major landslide from upslope of Gastineau Avenue. The red circle shows possible landslide debris across the street. (Photo credits: Figure 13A: CBJ December 4, 2020. Figure 13B: Alaska State Library – Historical Collections, [ASL-P109-42](#), Katherine Shaw 1920. ASL 2022b.)**
