City and Borough of Juneau Aurora Harbor

PHASE III - FLOATS H & J MUNICIPAL HARBOR FACILITY GRANT APPLICATION

August 1, 2018

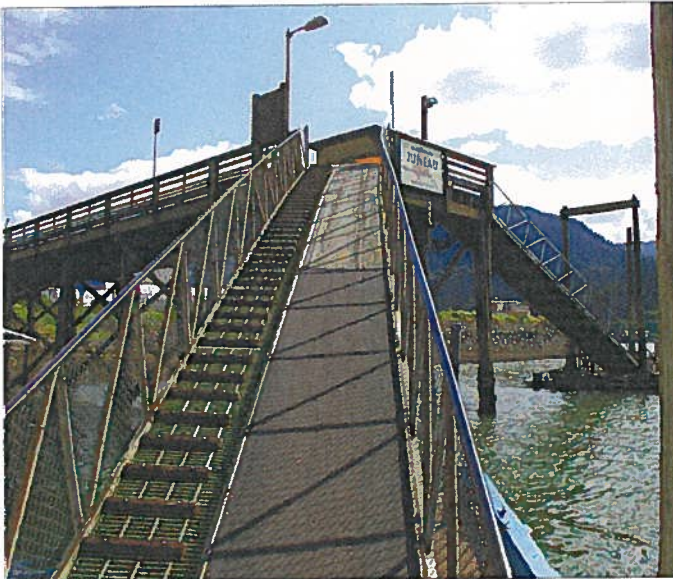
| PHOTO | DESCRIPTION |
|---|--|
| AURORA 007 | "A" GANGWAY DAMAGED FROM VESSEL IMPACT |

AURORA 007.jpg
"A" GANGWAY DAMAGED FROM VESSEL IMPACT

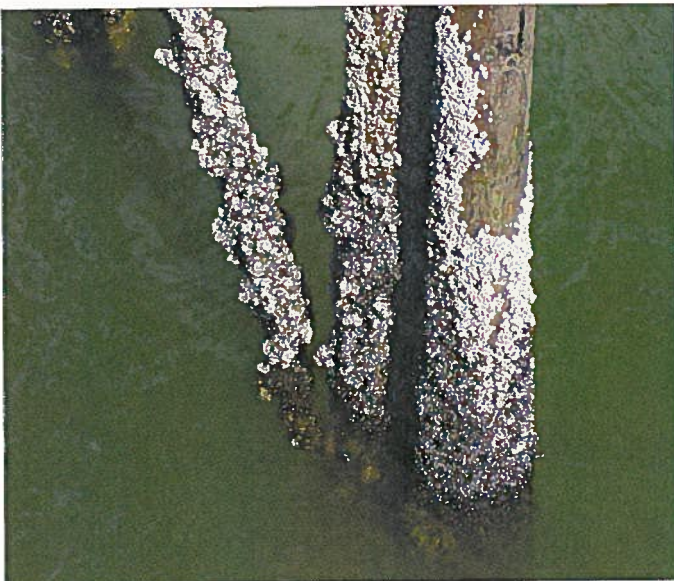
- a) Longitudinal bracing is rotten and broken
- b) Lateral cross-braces are broken and split (4 of 12).
- c) Gangway is excessively steep at low tide.
- d) Gangway skids are not lubricated.

| PHOTO | DESCRIPTION |
|---|--|
| AURORA 009 | BROKEN X-BRACING ON "A" GANGWAY APPROACH DOCK |

AURORA 009.jpg
BROKEN X-BRACING ON "A" GANGWAY APPROACH DOCK

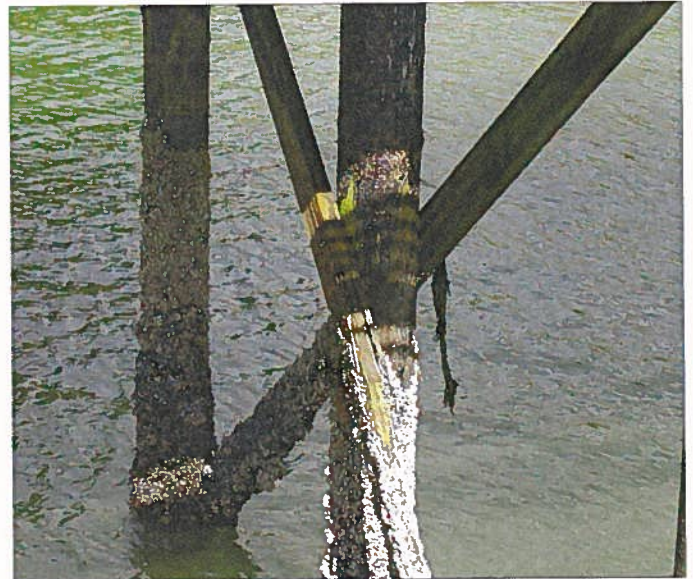
| PHOTO | DESCRIPTION |
|---|--|
| AURORA 010 | BROKEN X-BRACING ON "A" GANGWAY APPROACH DOCK |

AURORA 010.jpg
BROKEN X-BRACING ON "A" GANGWAY APPROACH DOCK

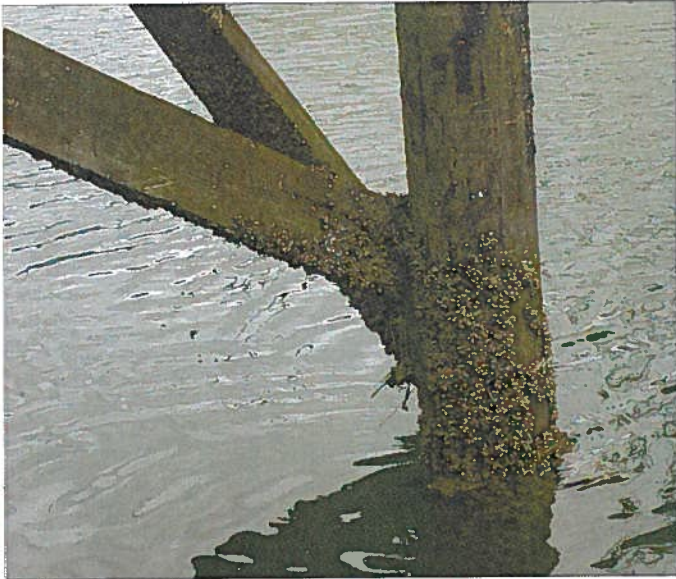
| PHOTO | DESCRIPTION |
|---|--|
| AURORA 019 | BROKEN X-BRACING AT "C" GANGWAY APPROACH DOCK |

AURORA 019.jpg
BROKEN X-BRACING AT "C" GANGWAY APPROACH DOCK

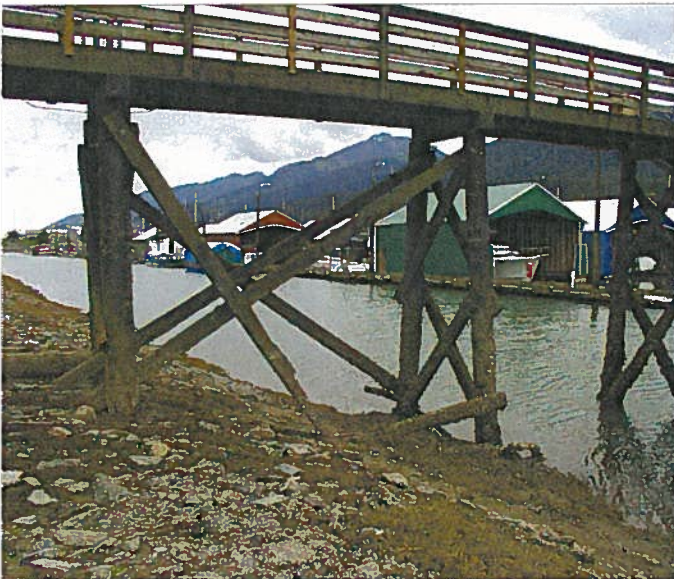
| PHOTO | DESCRIPTION |
|---|--|
| AURORA 033 | DAMAGED BRACING AT "H" APPROACH DOCK |

AURORA 033.jpg
DAMAGED BRACING AT "H" APPROACH DOCK

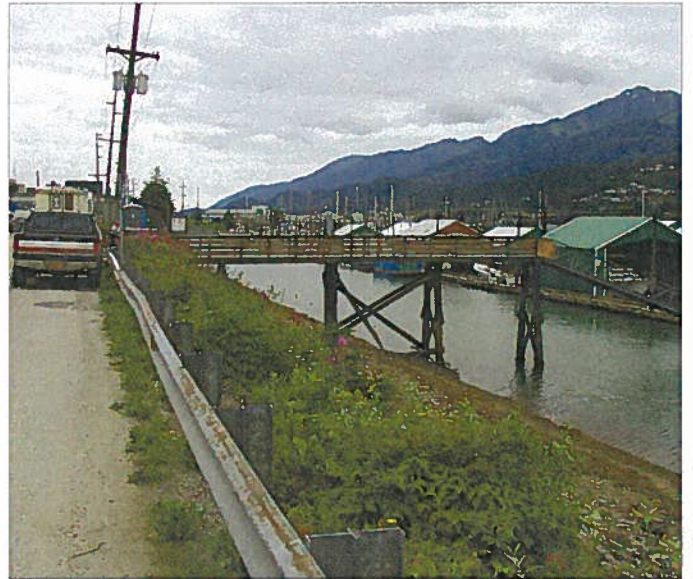
| PHOTO | DESCRIPTION |
|---|--|
| AURORA 034 | DAMAGED BRACING AT "H" APPROACH DOCK |

AURORA 034.jpg
DAMAGED BRACING AT "H" APPROACH DOCK

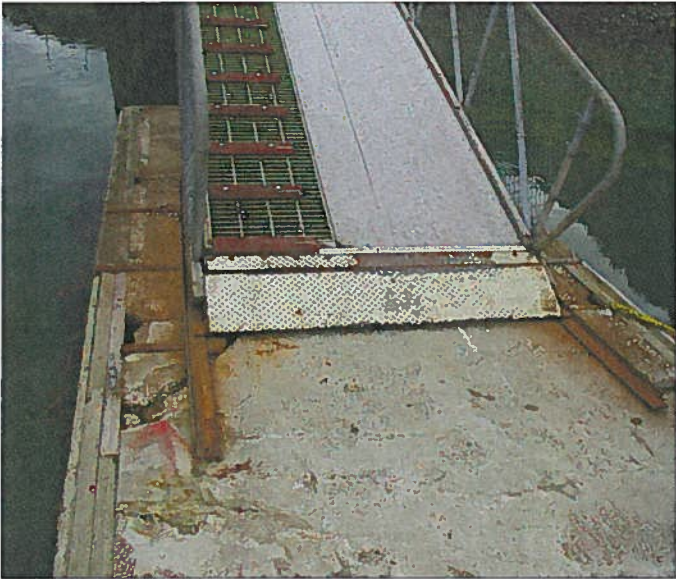
| PHOTO | DESCRIPTION |
|---|--|
| AURORA 057 | "N" GANGWAY/FLOAT TRANSITION, SKIDS, DETERIORATED LANDING FLOAT |

AURORA 057.jpg
**"N" GANGWAY/FLOAT TRANSITION, SKIDS,
DETERIORATED LANDING FLOAT**

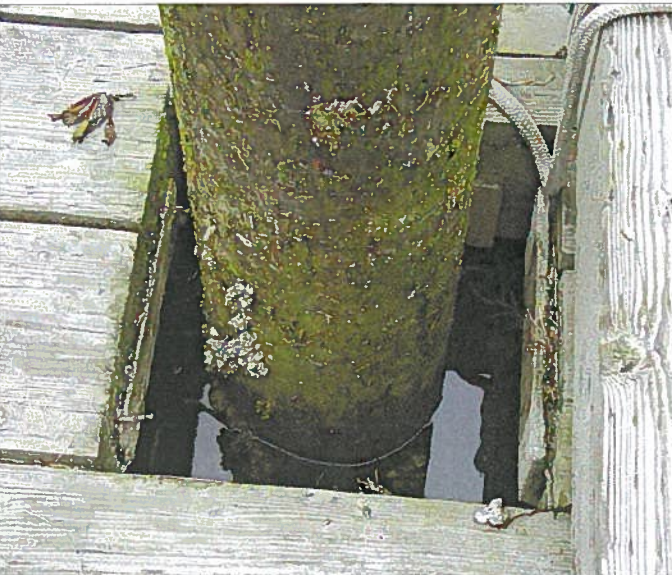
| PHOTO | DESCRIPTION |
|---|--|
| AURORA 071 | "C" FLOAT ABRADED PILE AND WORN RUB STRIPS |

AURORA 071.jpg
"C" FLOAT ABRADED PILE AND WORN RUB STRIPS

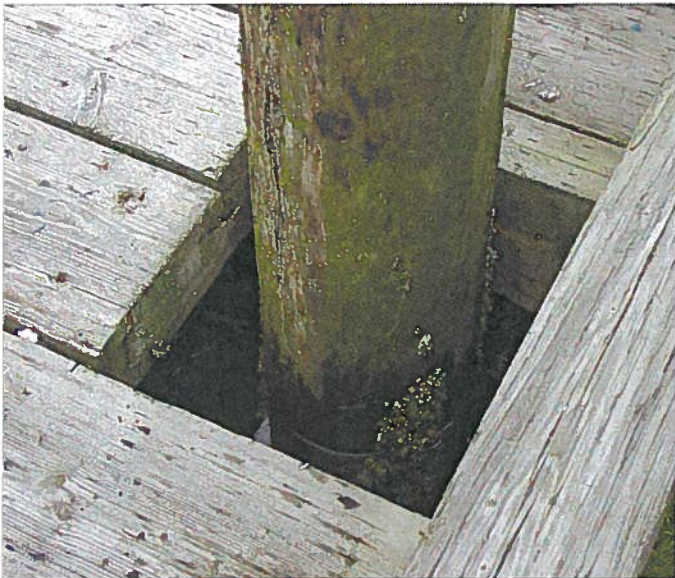
| PHOTO | DESCRIPTION |
|---|--|
| AURORA 073 | "C" FLOAT ABRADED PILE AND WORN RUB STRIPS |

AURORA 073.jpg
"C" FLOAT ABRASED PILE AND WORN RUB STRIPS

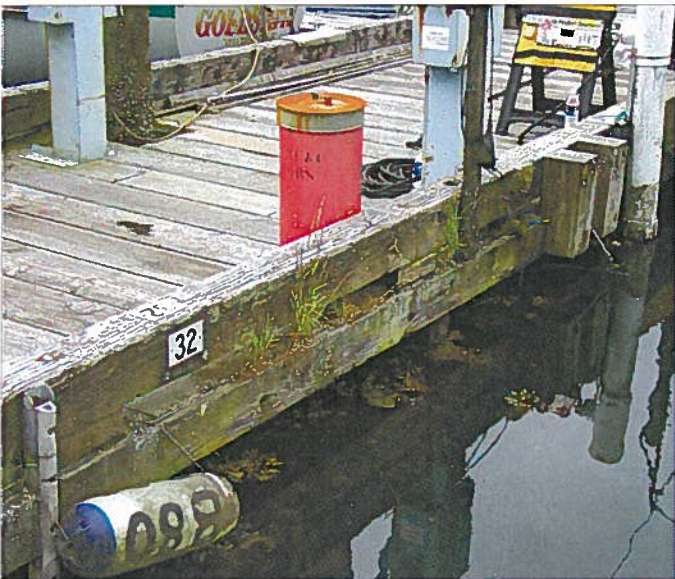
| PHOTO | DESCRIPTION |
|---|--|
| AURORA 075 | ROT AND VEGETATION ON "D" FLOAT |

AURORA 075.jpg
ROT AND VEGETATION ON "D" FLOAT

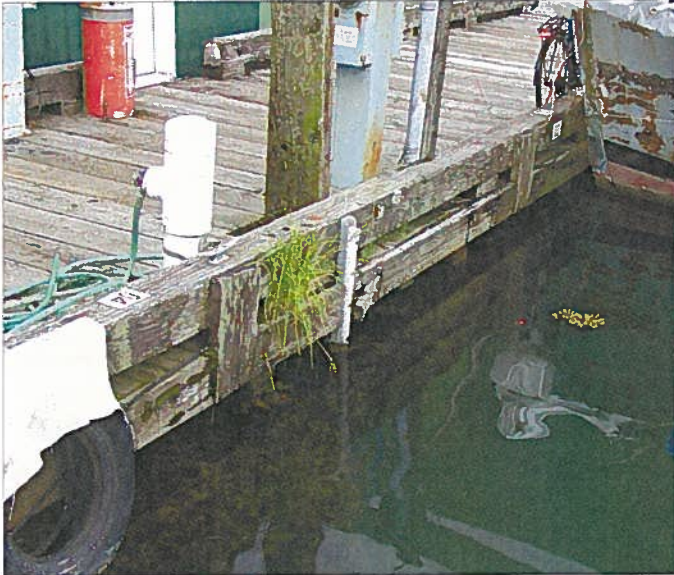
| PHOTO | DESCRIPTION |
|---|--|
| AURORA 079 | ROT, DETERIORATED RUBSTRIP AND VEGETATION ON "E" FLOAT |

AURORA 079.jpg
ROT, DETERIORATED RUBSTRIP AND VEGETATION
ON "E" FLOAT

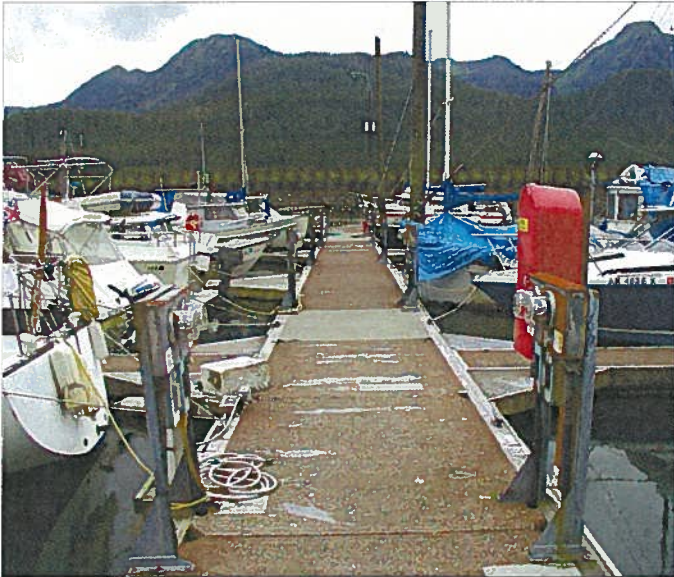
- Main float freeboard = 10" throughout with no listing. End of mainwalk float is sagging with freeboard = 8".
- Little organic growth on timbers.
- Approximately 25% of floats show concrete cracking throughout mainwalk and fingers.
- Piles are in good condition with no mechanical damage.
- Approximately 50% of finger walers are twisted, however none severely.

| PHOTO | DESCRIPTION |
|---|--|
| AURORA 091 | VIEW WEST DOWN "H" FLOAT SHOWING REPAIRED CONCRETE SURFACE |

AURORA 091.jpg
VIEW WEST DOWN "H" FLOAT SHOWING REPAIRED CONCRETE SURFACE

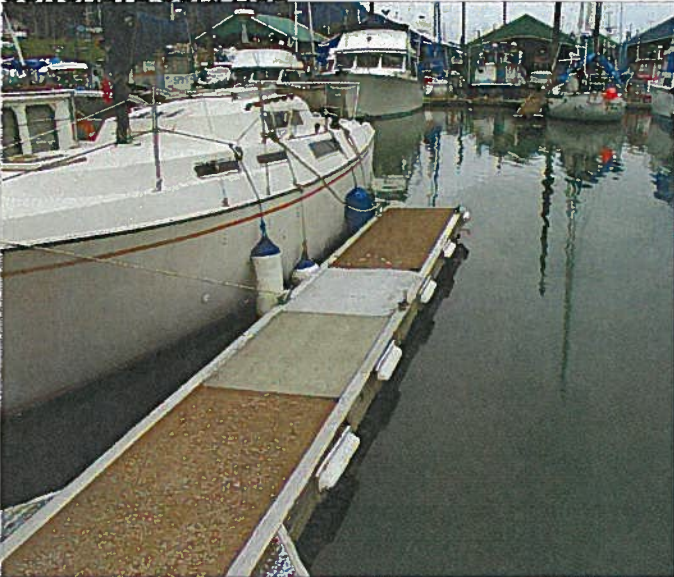
- Cracked and spalling concrete.
- Several float modules have been resurfaced.
- Two (2) finger floats are twisted.
- Structural timbers are weathered and show minor indications of deterioration.

| PHOTO | DESCRIPTION |
|---|--|
| AURORA 093 | REPAIRED SURFACE OF "J" FLOAT FINGER |

AURORA 093.jpg
REPAIRED SURFACE OF "J" FLOAT FINGER

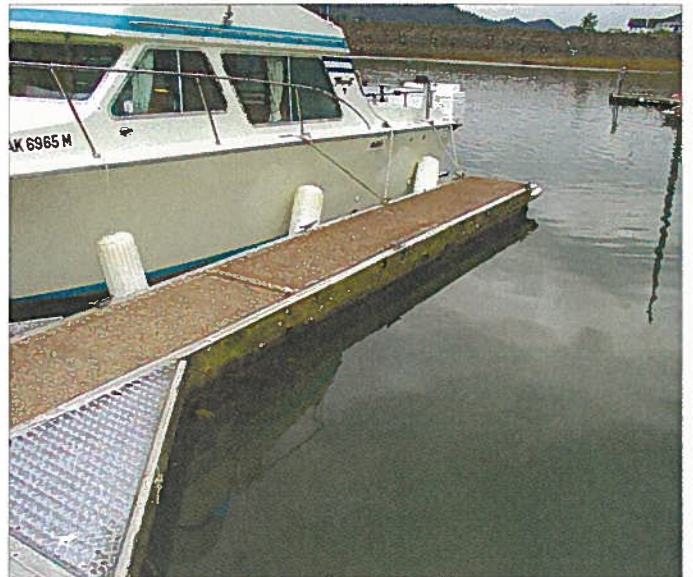
| PHOTO | DESCRIPTION |
|---|--|
| AURORA 096 | DETERIORATED TIMBERS ON FINGER ON "K" FLOAT |

AURORA 096.jpg
DETERIORATED TIMBERS ON FINGER ON "K" FLOAT

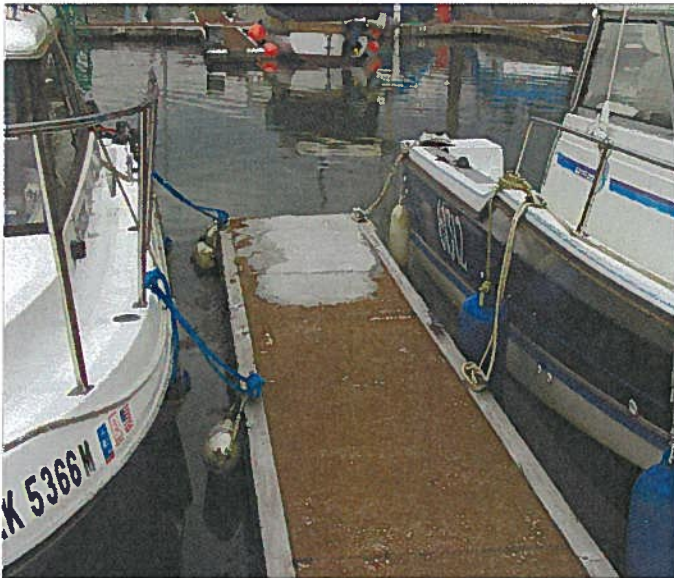
| PHOTO | DESCRIPTION |
|---|--|
| AURORA 097 | REPAIRED CONCRETE ON FINGER OFF OF "K" FLOAT |

AURORA 097.jpg
REPAIRED CONCRETE ON FINGER OFF OF "K" FLOAT

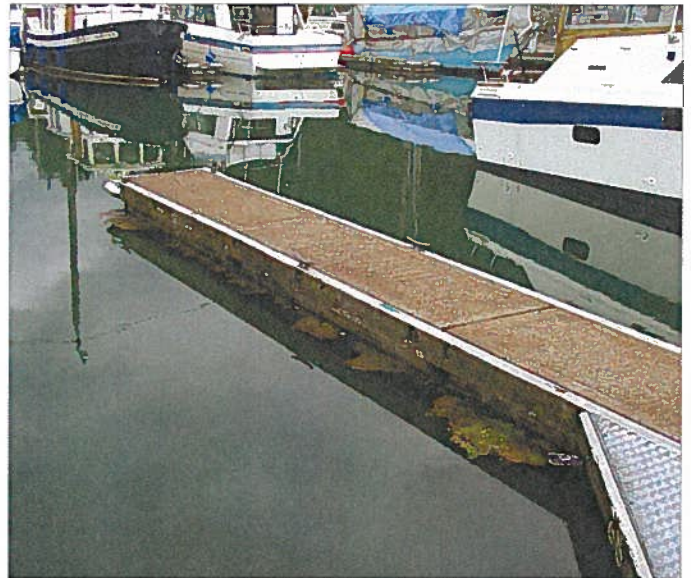
| PHOTO | DESCRIPTION |
|---|--|
| AURORA 098 | DETERIORATED TIMBERS ON FINGER ON "K" FLOAT |

AURORA 098.jpg
DETERIORATED TIMBERS ON FINGER ON "K" FLOAT

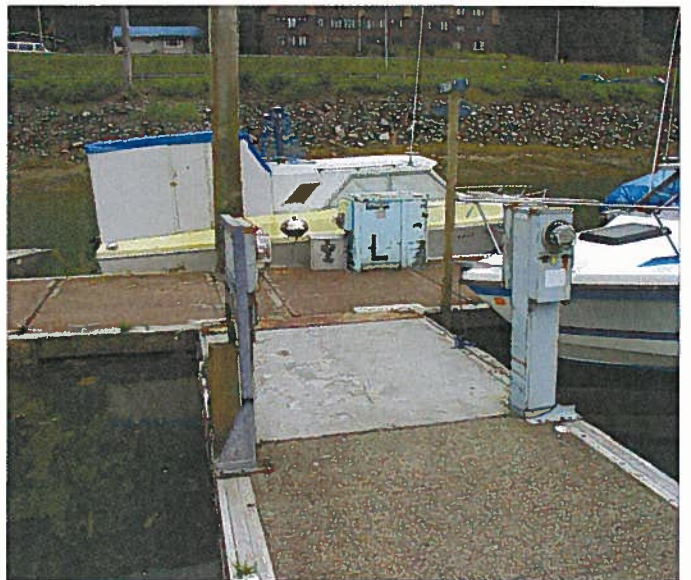
| PHOTO | DESCRIPTION |
|---|--|
| AURORA 100 | REPAIRED CONCRETE ON "L" FLOAT |

AURORA 100.jpg
REPAIRED CONCRETE ON "L" FLOAT

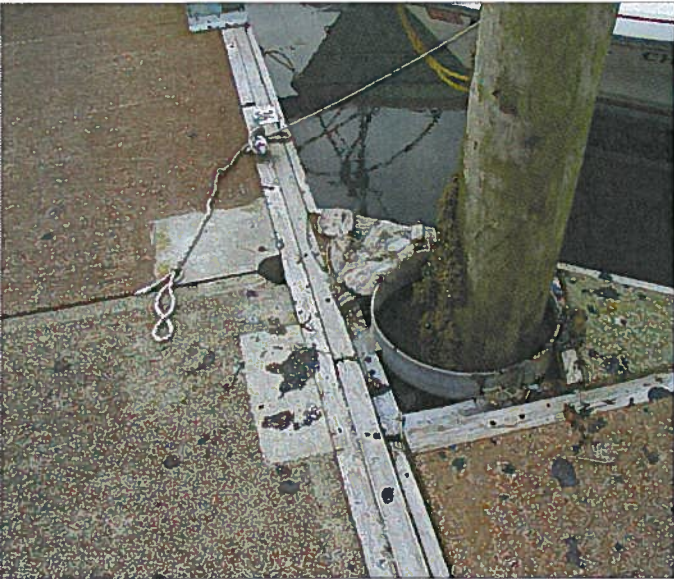
| PHOTO | DESCRIPTION |
|---|--|
| AURORA 105 | BROKEN WALER ON "N" FLOAT |

AURORA 105.jpg
BROKEN WALER ON "N" FLOAT

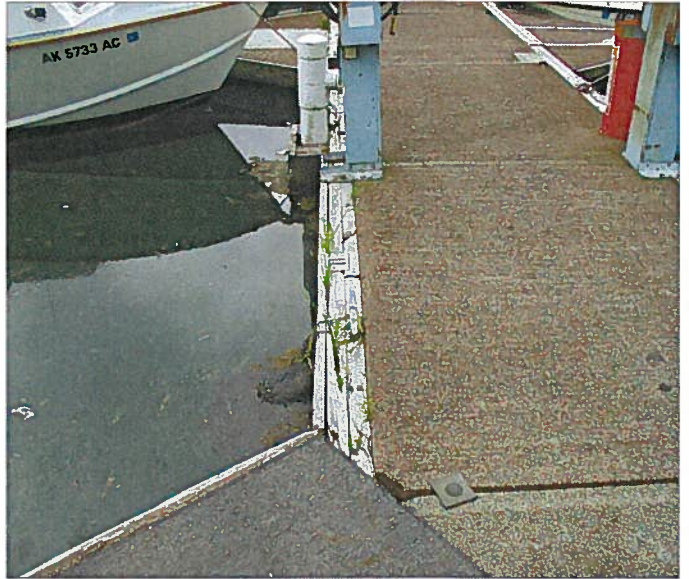
| PHOTO | DESCRIPTION |
|---|--|
| AURORA 106 | VEGETATION/DETERIORATED FLOAT TIMBERS ON "N" FLOAT |

AURORA 106.jpg
VEGETATION/DETERIORATED FLOAT TIMBERS ON "N" FLOAT

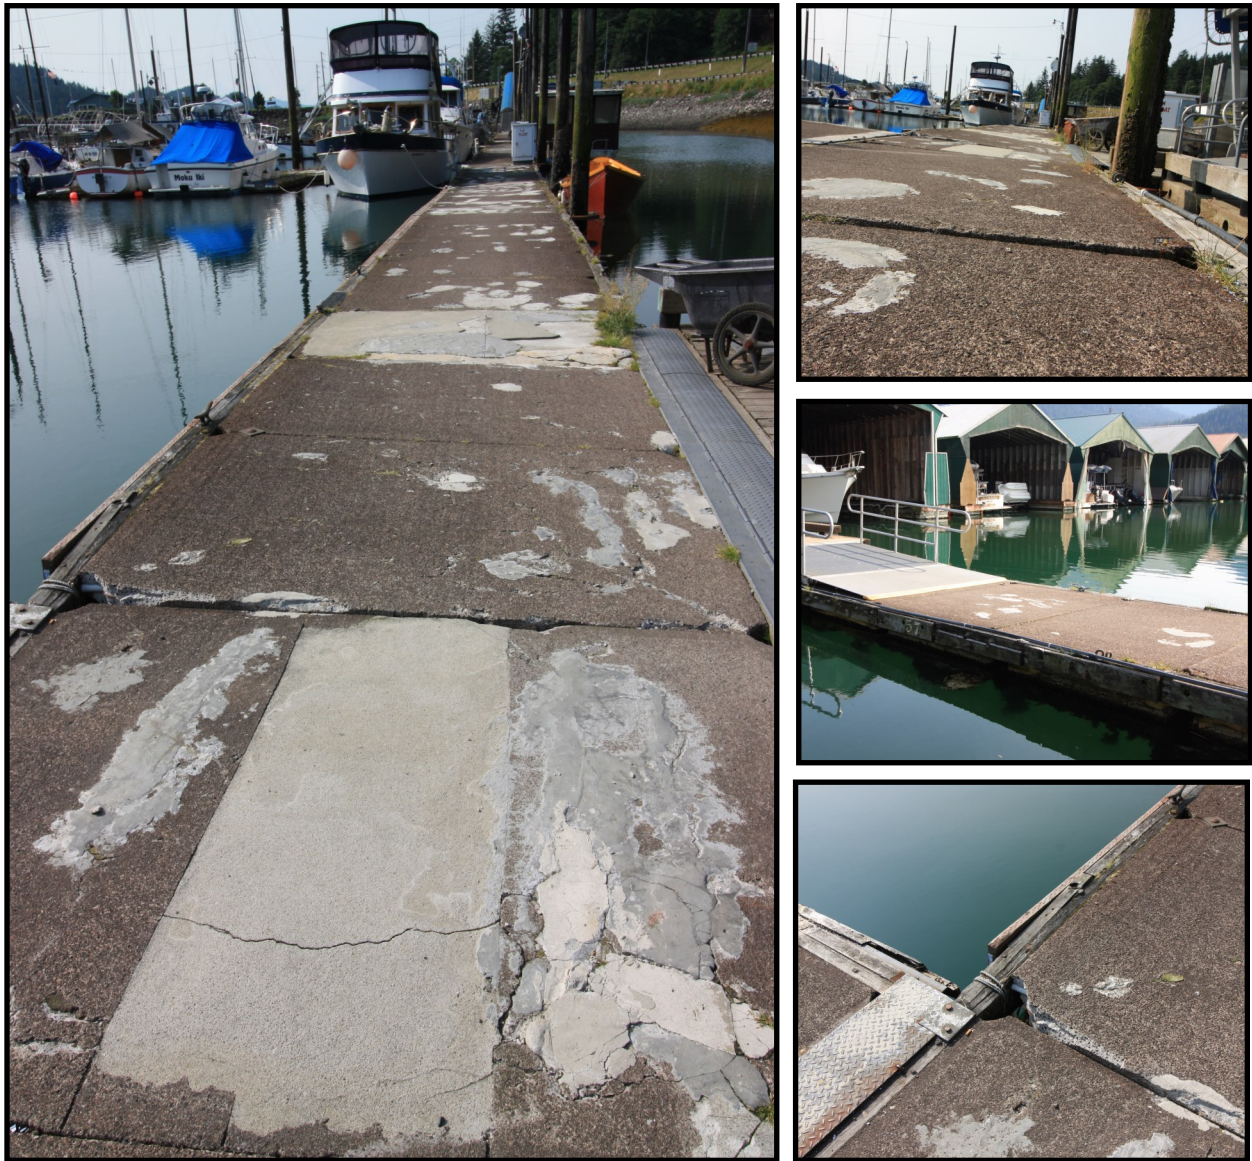
Concrete float wear and uneven float conditions

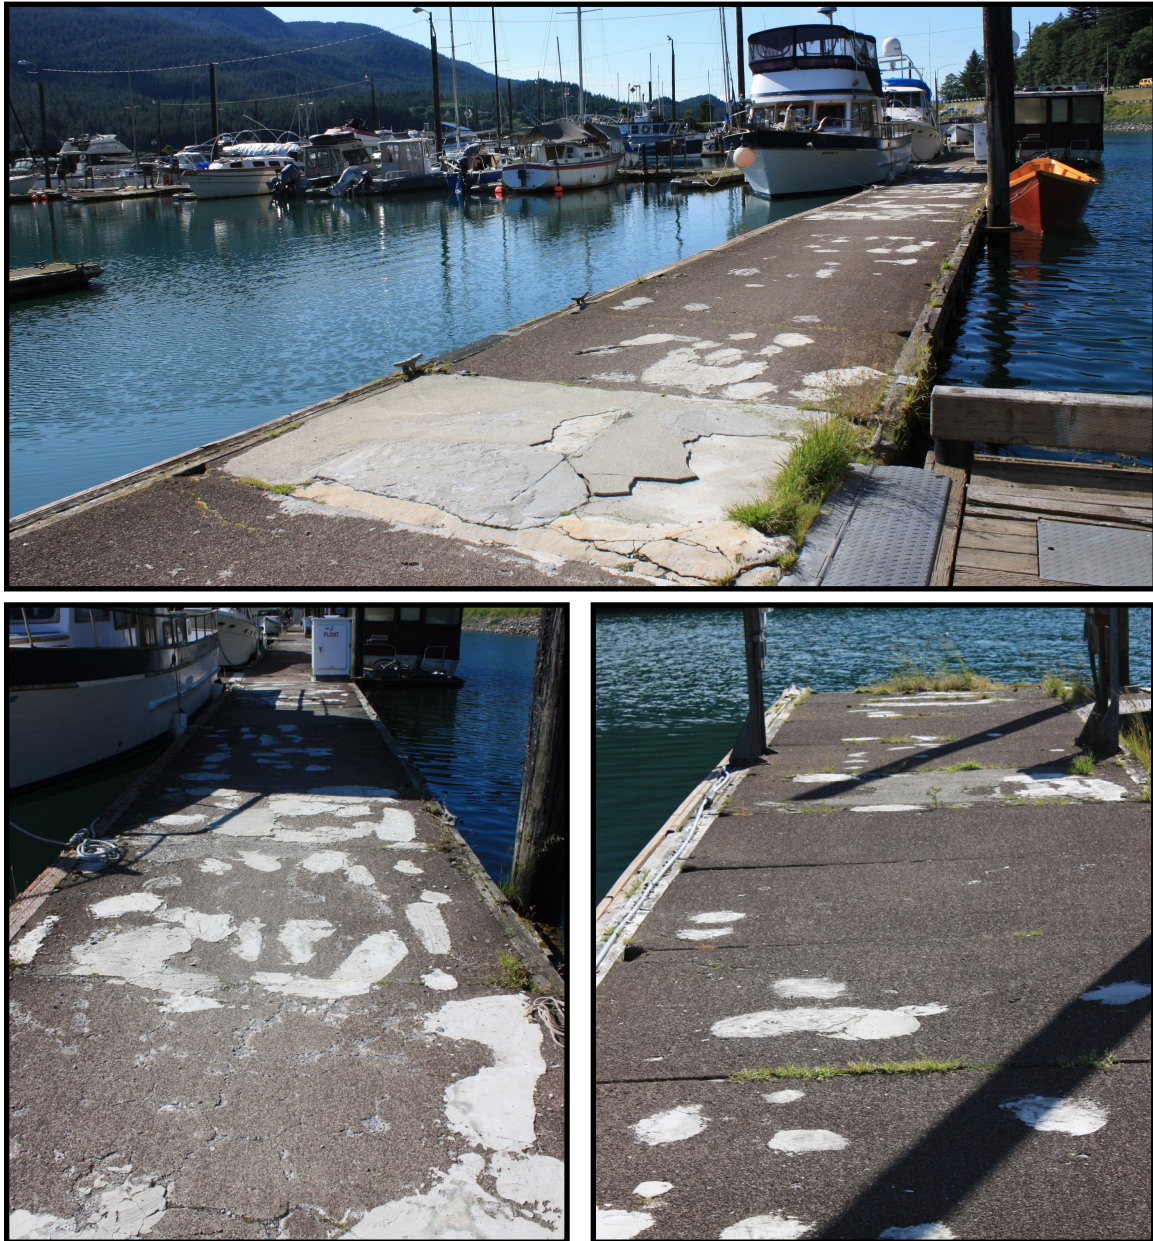
Damaged and patched concrete decking

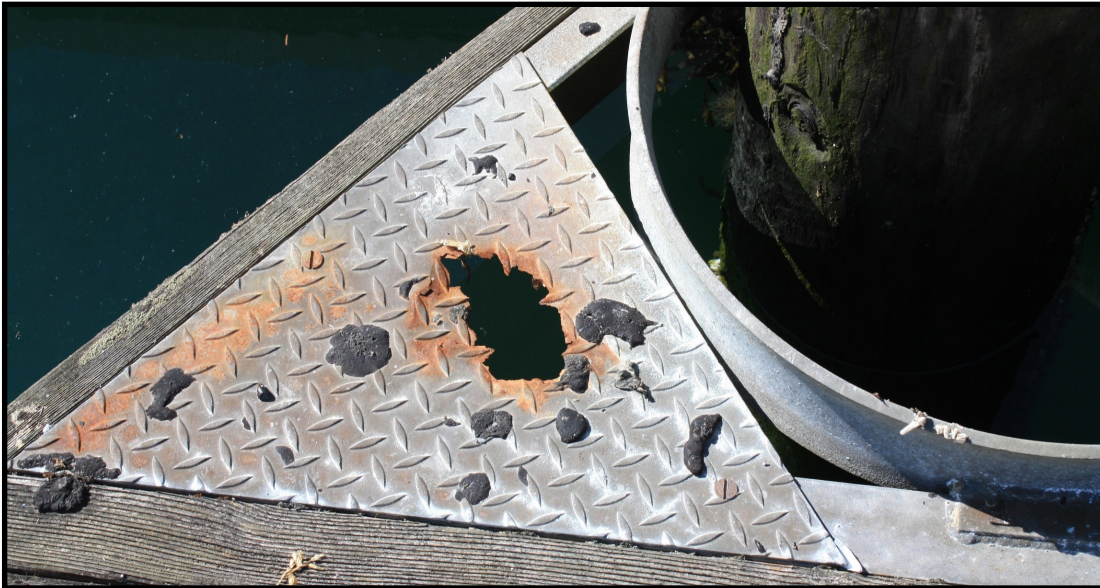
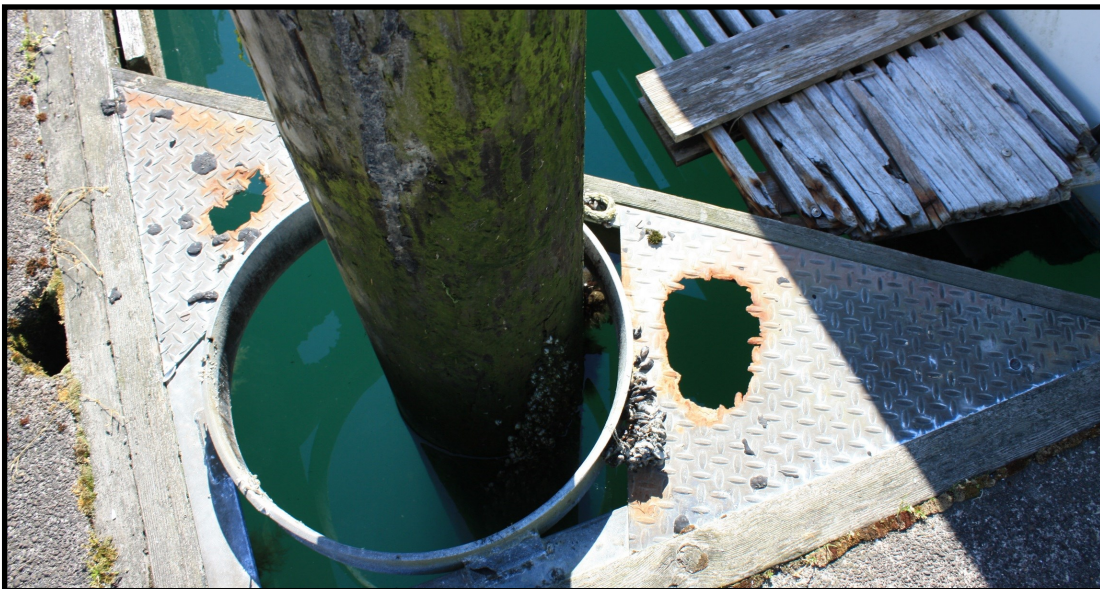
Rusted holes in steel bracing covers

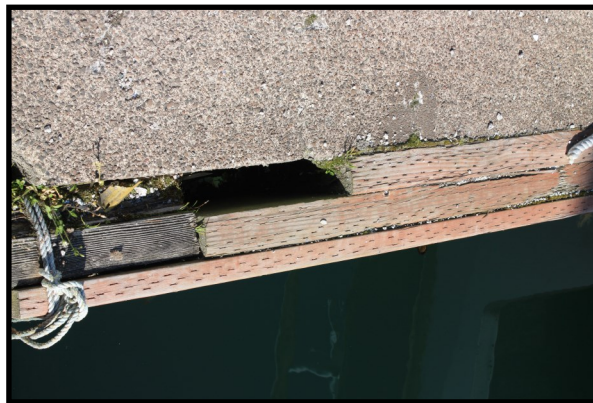
Missing walers on headwalk

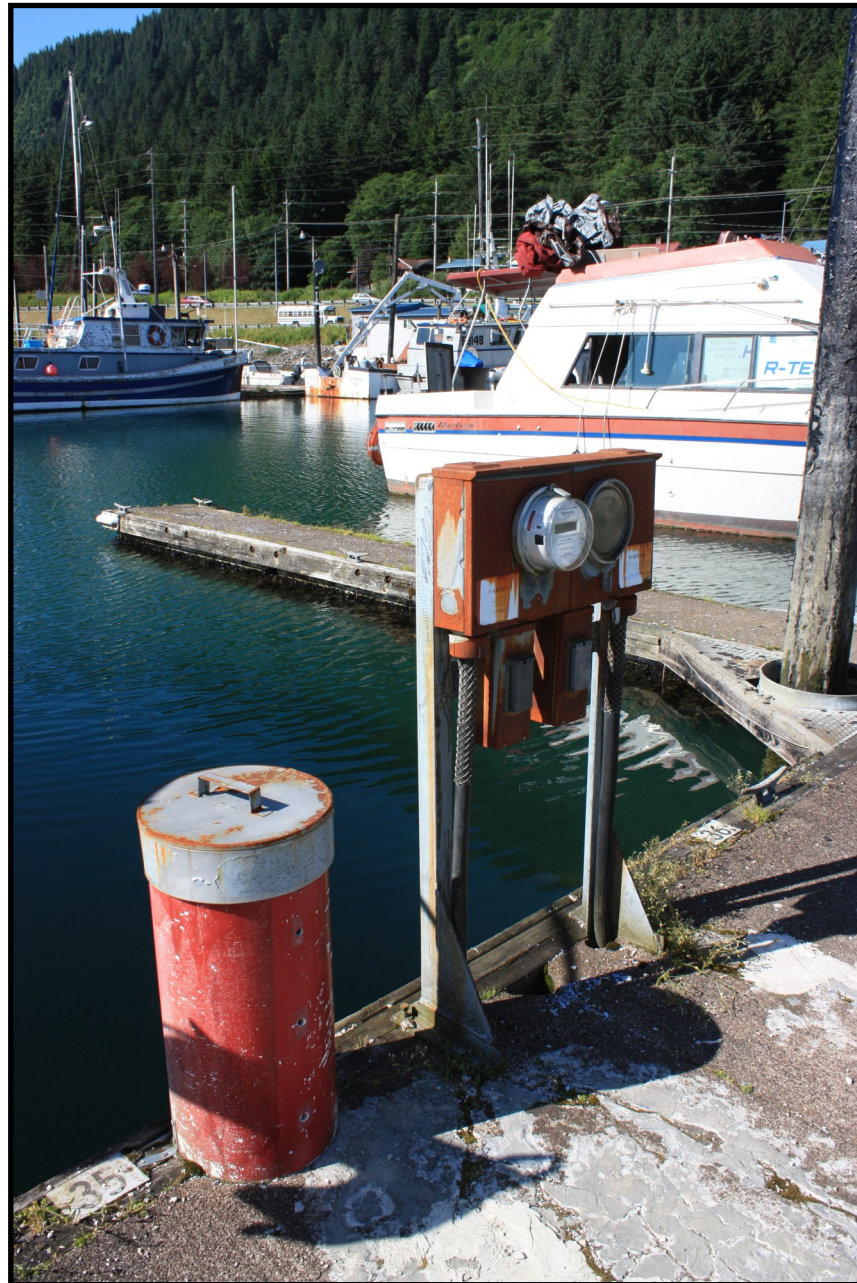
Old and damaged electrical meters
