To:	Teri Camery (CBJ)	Date:	August 10, 2021
c:	Alix Pierce (CBJ)	Memo No.:	2
From:	Rita Kors-Olthof, Vladislav Roujanski, Shirley McCuaig	File:	704-ENG.EARC03168-01
Subject:	Responses to Public Comments Arising from Issued-for-Review Report (3 rd Draft) and Landslide and Avalanche Hazard Public Meeting – July 21, 2021 Downtown Juneau Landslide and Avalanche Assessment

1.0 INTRODUCTION

This technical memo addresses some of the comments and questions that arose from Tetra Tech's Issued-for-Review (3rd Draft) Report, Downtown Juneau Landslide and Avalanche Assessment, dated May 28, 2021, and the Landslide and Avalanche Hazard Public Meeting that took place on July 21, 2021.

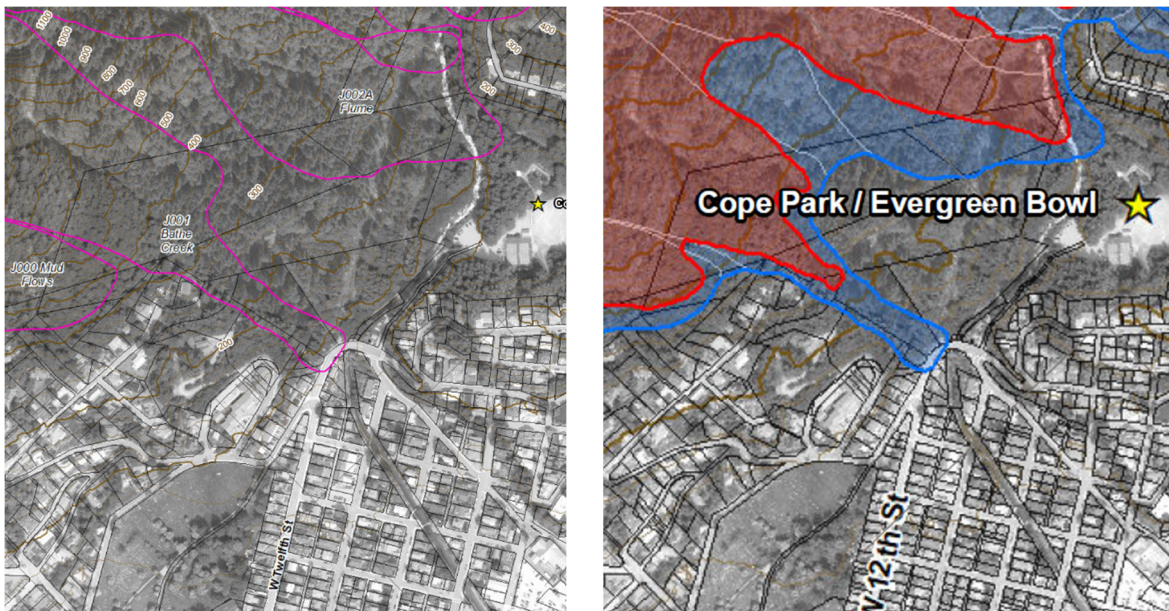
Response: See response to Item 3 above regarding the irregular “curlicues and “projections.” Bathe Creek is an example of where adjacent terrain units affect the shape of this terrain unit. In general, because the processes are not the same, avalanche path boundaries should not be expected to match landslide hazard boundaries. Compare the excerpts from the avalanche path and hazard mapping in Figures 2.2c and 2.3a (Figure 1 below) with the surficial geology and major gully features in Figures 1.3b and 1.5b (Figure 2 below). The boundaries of wet avalanches might sometimes approximate the boundaries of debris flows in the same terrain feature, a resemblance that would necessarily depend on the size and mobility of each event. In this case, they could be similar but not identical.

Figure 1: Excerpts from Figure 2.2c Avalanche Path Mapping Detail (left) and Figure 2.3a Avalanche Hazard Designation Mapping Overview (right).

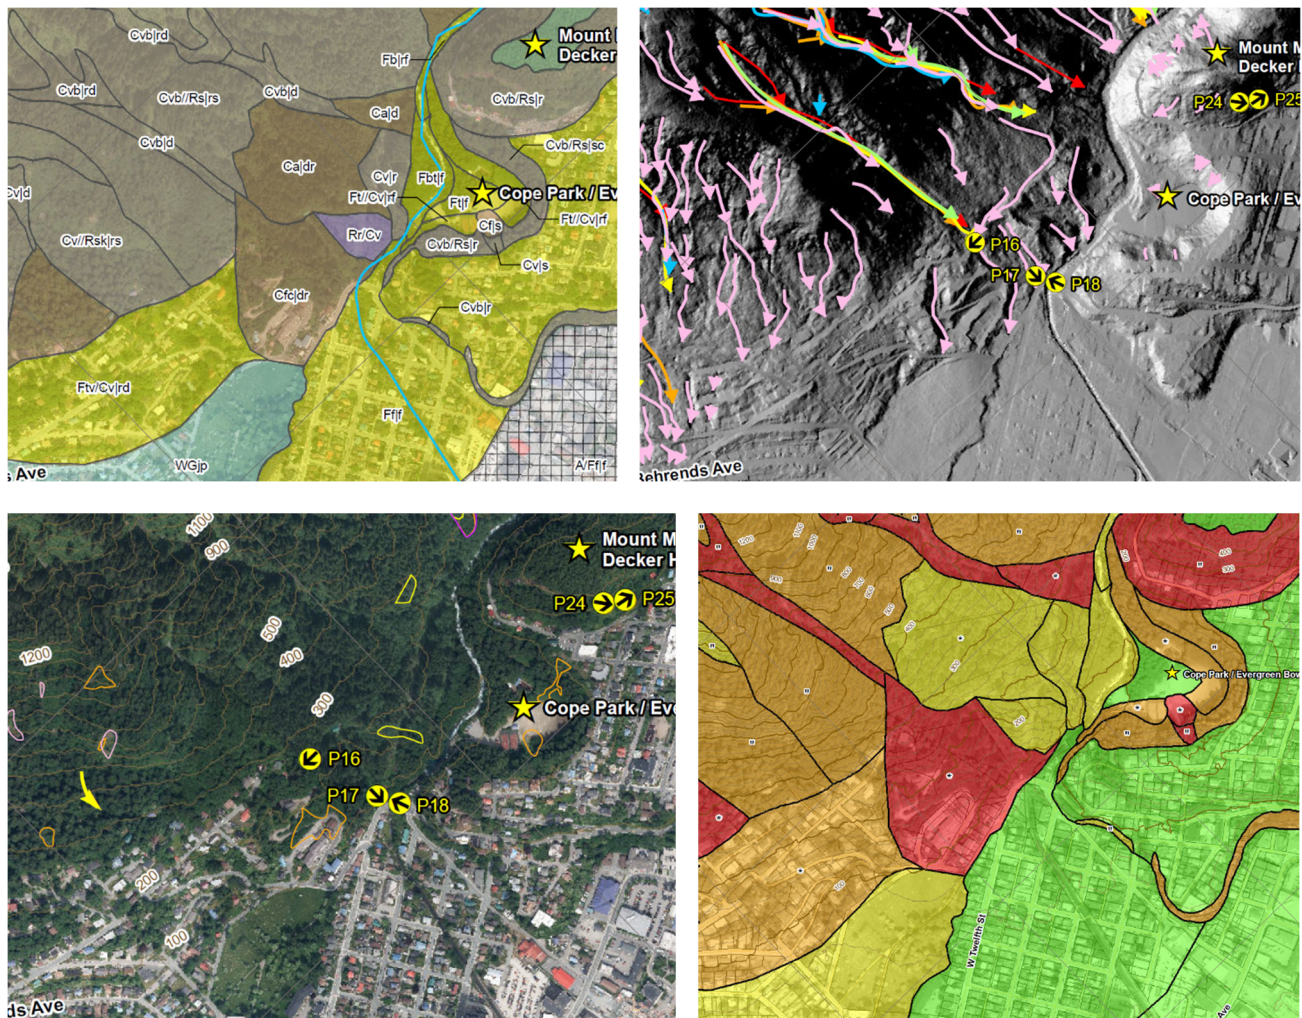
Compare the surficial geology and the major gully features shown in excerpts from Figures 1.3b and 1.5b (top left and top right in Figure 2 below). In the case of Bathe Creek, the shape of the Severe area reflects the shape of the cone/fan and the upslope gully that is the source of the debris, as shown below in the excerpt from Figure 1.6c (bottom right in Figure 2). Finally, even though the fan itself only displays occasional activity (remobilization of old debris flow material), as shown in the excerpt from Figure 1.4b (bottom left in Figure 2), the debris flows originating from upslope govern the hazard designation, as they are what has formed the fan and what will continue to do so in the future.

Figure 2: Excerpts from Figure 1.3b Surficial Geology (top left) and Figure 1.5b Historical Air Photo Record and LiDAR Data Analysis – Gully Erosion Features (1948-2013) (top right), and excerpts from Figure 1.4b Historical Air Photo Record – Slope Movement Features (1948-2020) (bottom left) and Figure 1.6c Landslide Hazard Designation Mapping (bottom right).

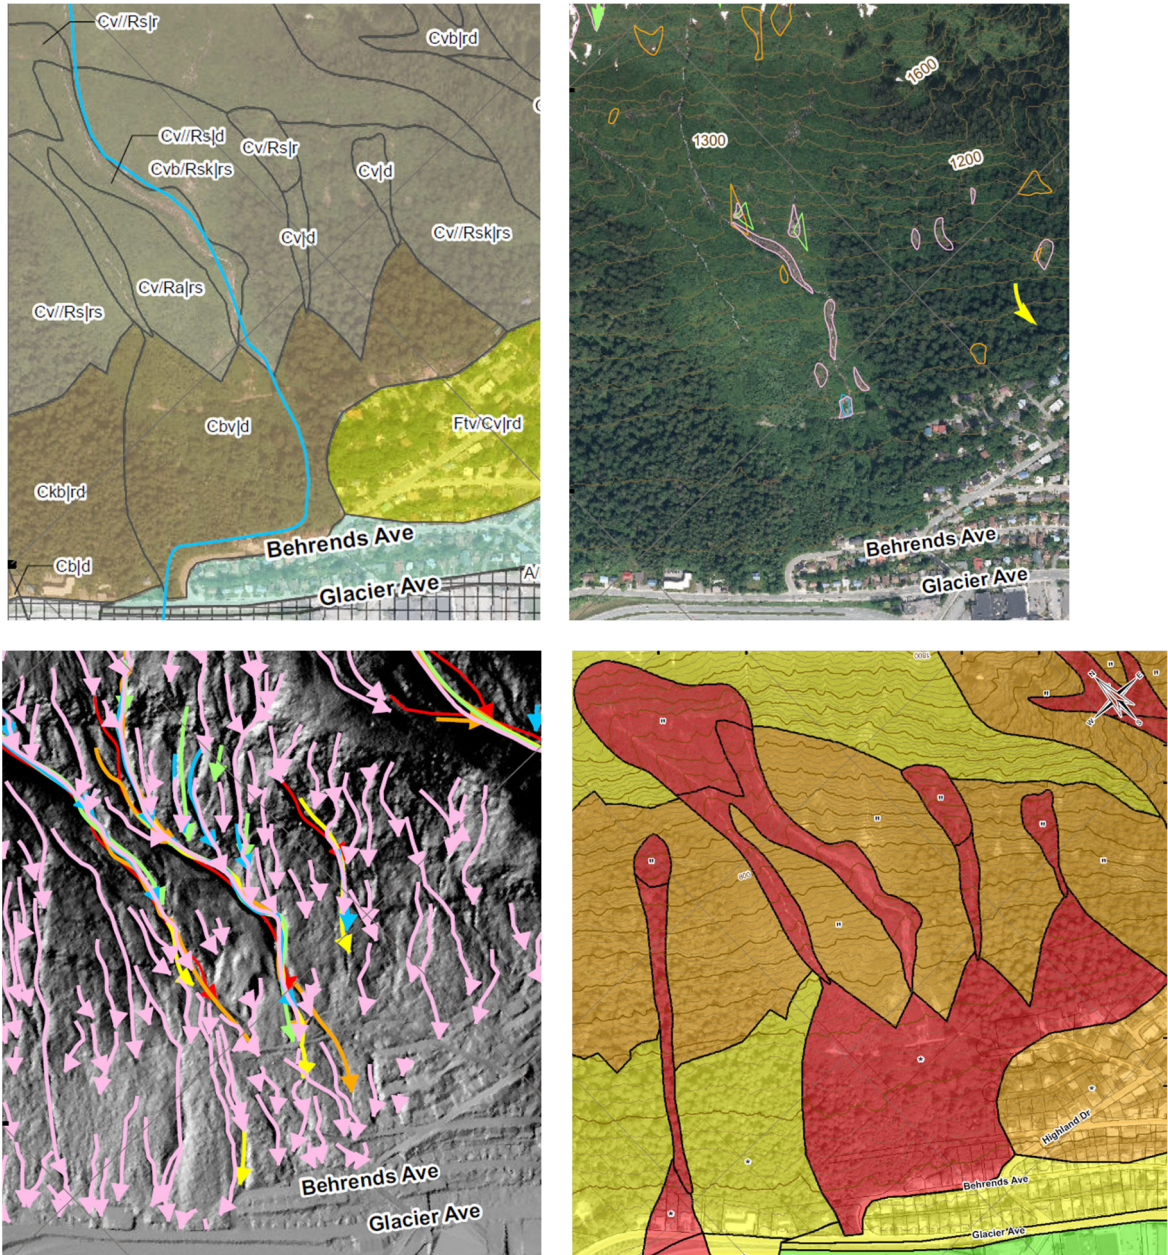
Response: The basis for the Severe hazard designation is not Swanston’s report, but rather Tetra Tech’s independent determination of the characteristics of the terrain units based on surficial geology mapping, historical air photo record analysis of slope movement features and gully erosion features, as well as incident reports and field observations. See also responses to Items 1 and 4 above. Specific to the Severe areas mapped in this part of the study area (Figure 1.6b and 1.6c), these are all colluvial areas (Figure 1.3b) that receive debris from several active gullies upslope (Figure 1.5b), including the previously mentioned Bathe Creek gully (see Figure 2 above), and several active gullies above Behrends Avenue and the west end of Highland Drive (see Figure 3 below). Several of the two dozen debris slides that occurred in various years in the immediate map area (Figure 1.4b) happened within gullies (compare top right and bottom left in Figure 3 below). The excerpt from Figure 1.4b (top right in Figure 3 below) is also a good example of an avalanche track (area with no trees) that does not correspond perfectly with landslide activity and location.

Figure 3: Excerpts from Figure 1.3b Surficial Geology (top left) and Figure 1.4b Historical Air Photo Record – Slope Movement Features (1948-2020) (top right), and excerpts from Figure 1.5b Historical Air Photo Record and LiDAR Data Analysis – Gully Erosion Features (1948-2013) (bottom left) and Figure 1.6c Landslide Hazard Designation Mapping (bottom right).

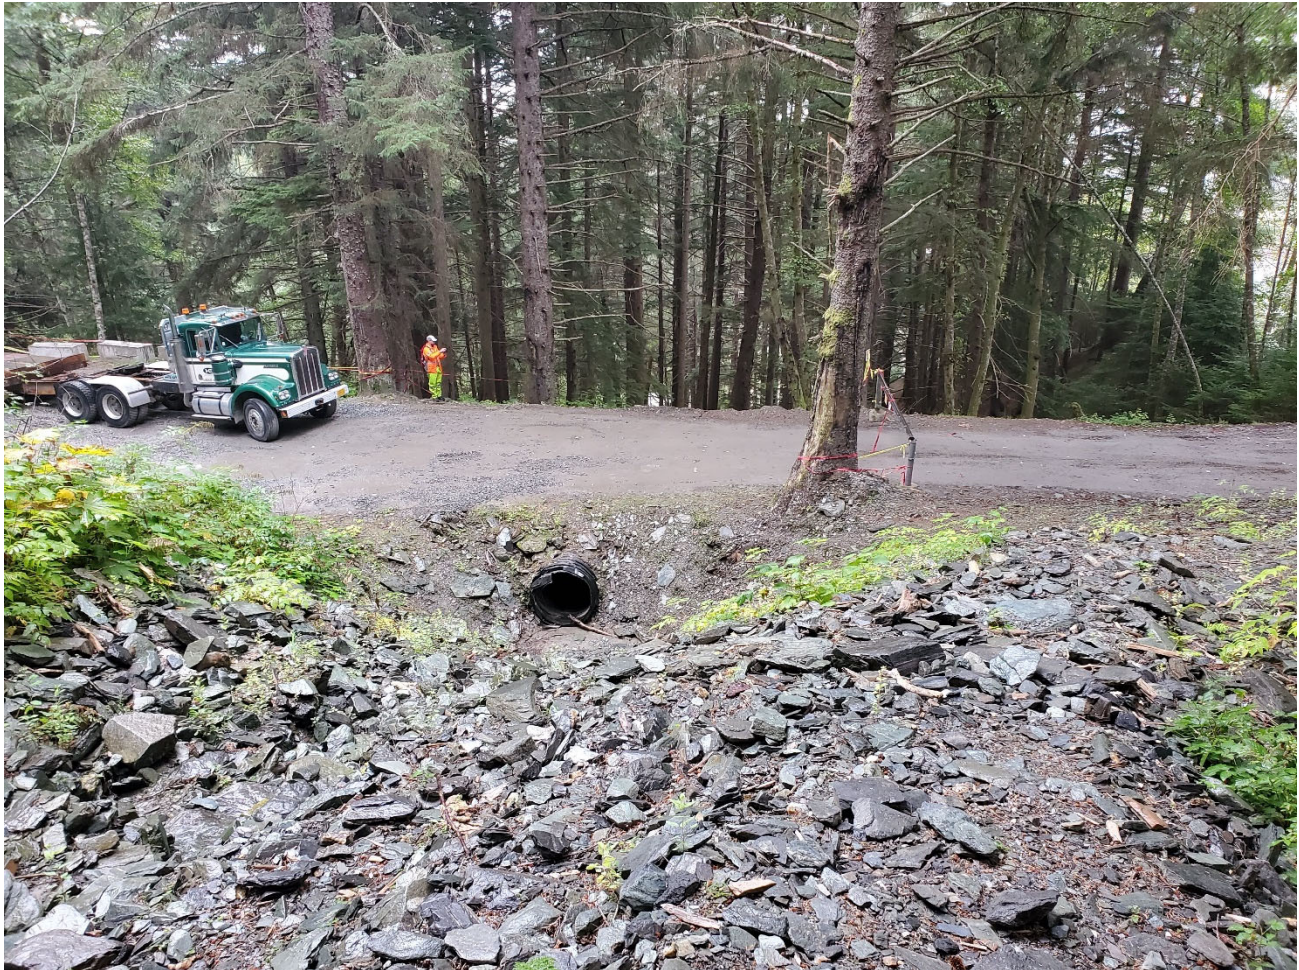
Figure 4: Looking down towards the Gold Creek Flume Trail from the Bathe Creek debris flow gully. Note the large amount of debris in and alongside the gully, as well as the scarring on the tree beside the road that extends to at least 6 feet above ground surface. This gully is very active, and the debris that is deposited at the road crossing is regularly cleaned up. This road crossing has the potential to divert debris flows into the residential community downslope and to the west, especially if more than one surge of debris occurs before the debris can be cleaned.
