Treadwell Mining Complex

HISTORIC RESOURCES AND SITE SURVEY REPORT

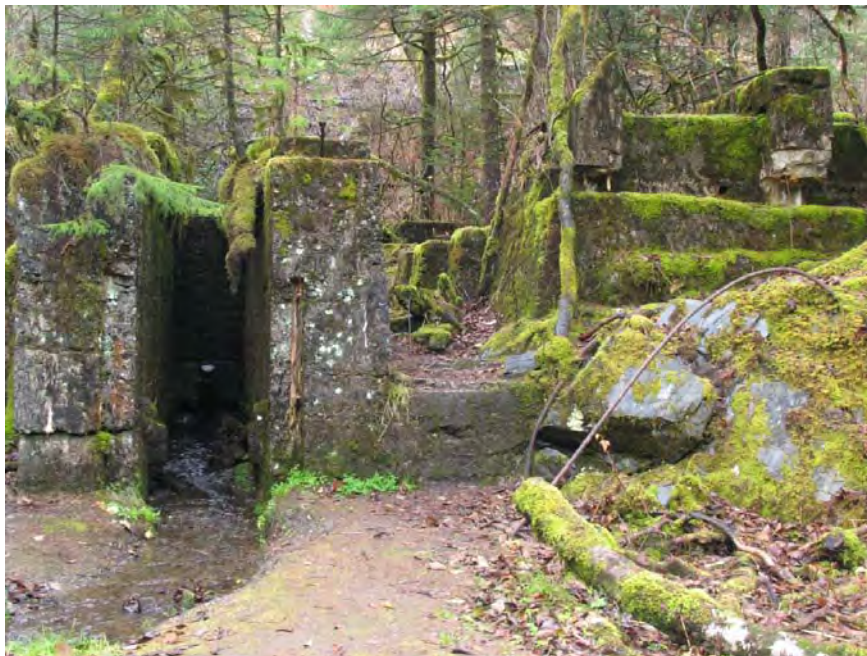
Foundations from the 300 Stamp Mill, November 2009
Photo courtesy of Wayne Jensen

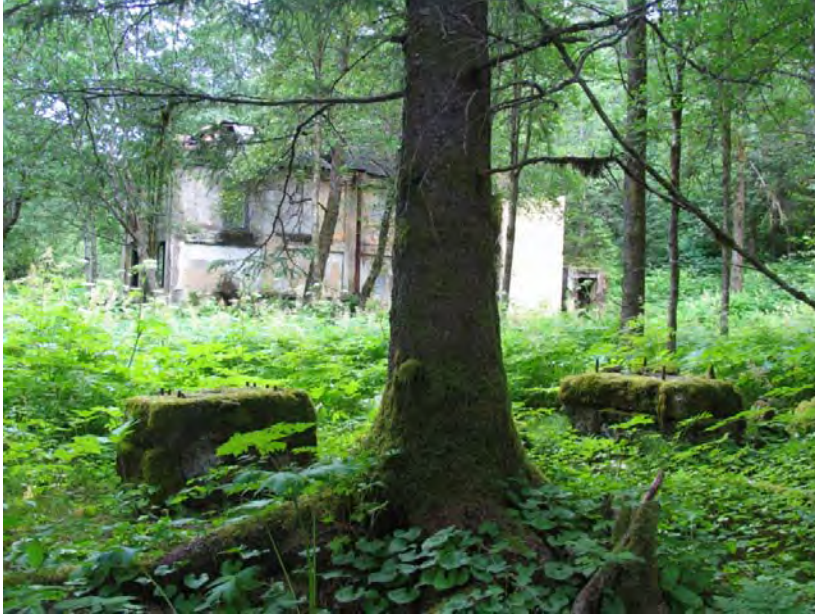
Concrete Foundations in foreground possibly from butcher shop at north side of store. New Office Building in the background.

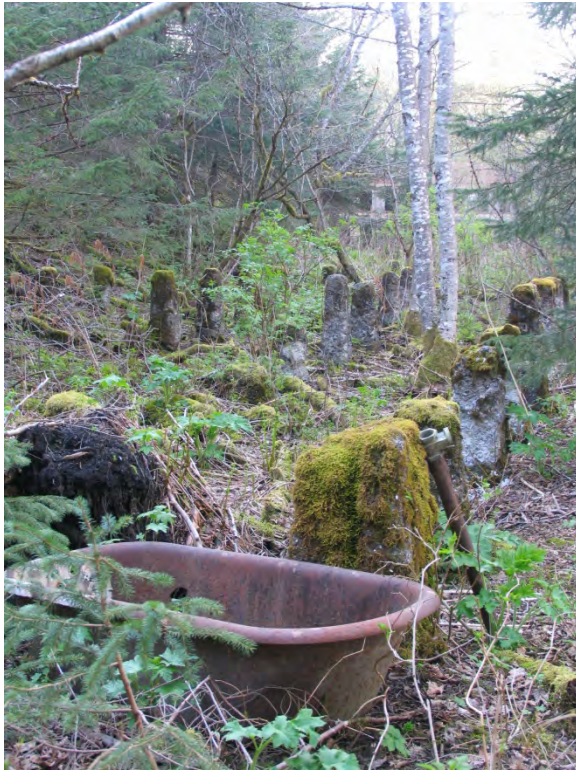
**Foundations & Plumbing Fixtures from
Bunkhouse April 2010**
Photo Courtesy of Wayne Jensen

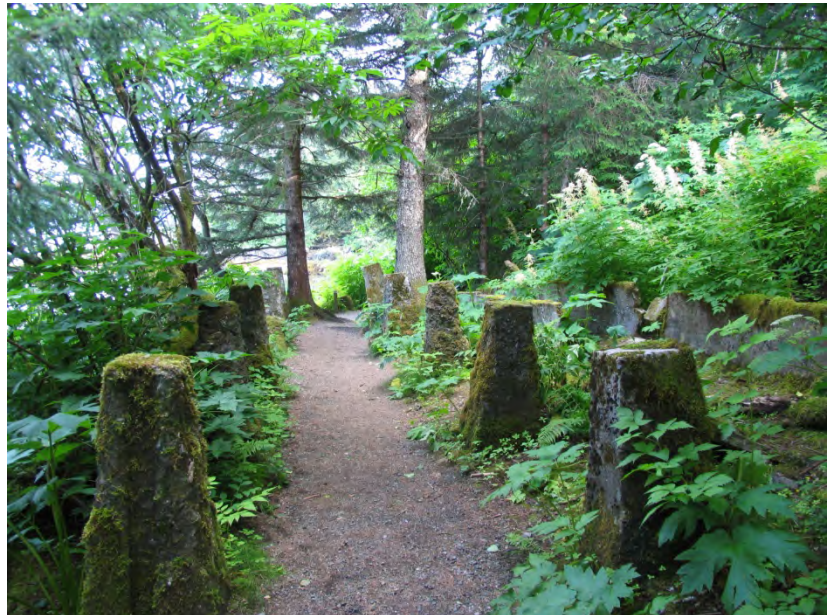
TREADWELL HISTORIC DISTRICT

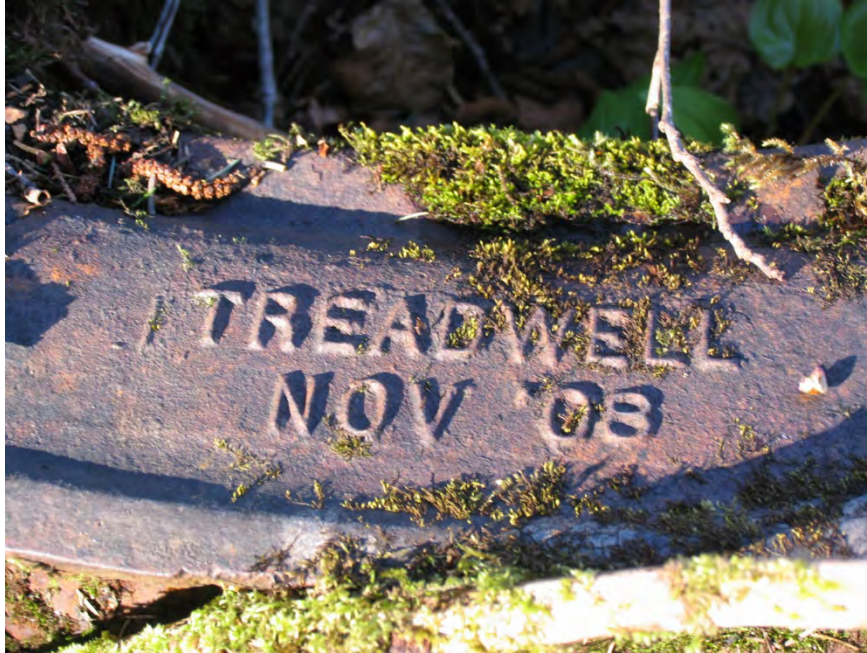
Foundry mark on pulley indicating it was cast at the Treadwell Foundry in 1908
Photo: May 2010 courtesy of Wayne Jensen

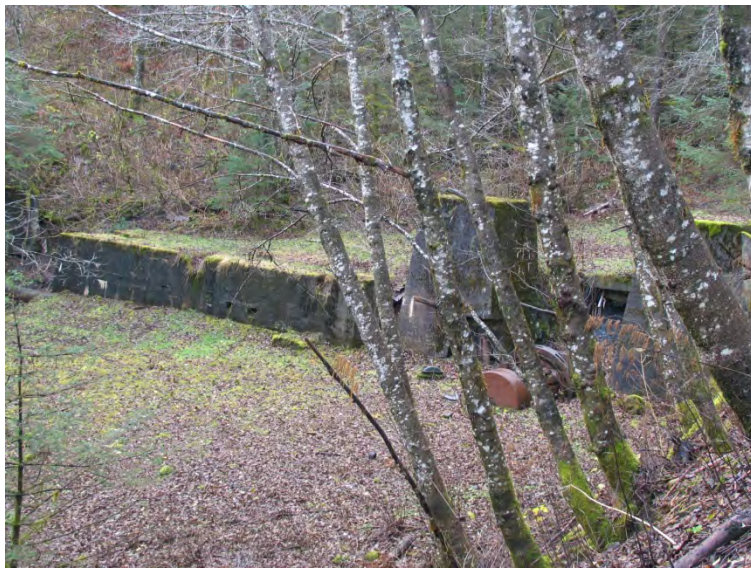
Concrete foundation and electrical generation equipment from 240 Power House, November 2009; photo courtesy of Wayne Jensen.

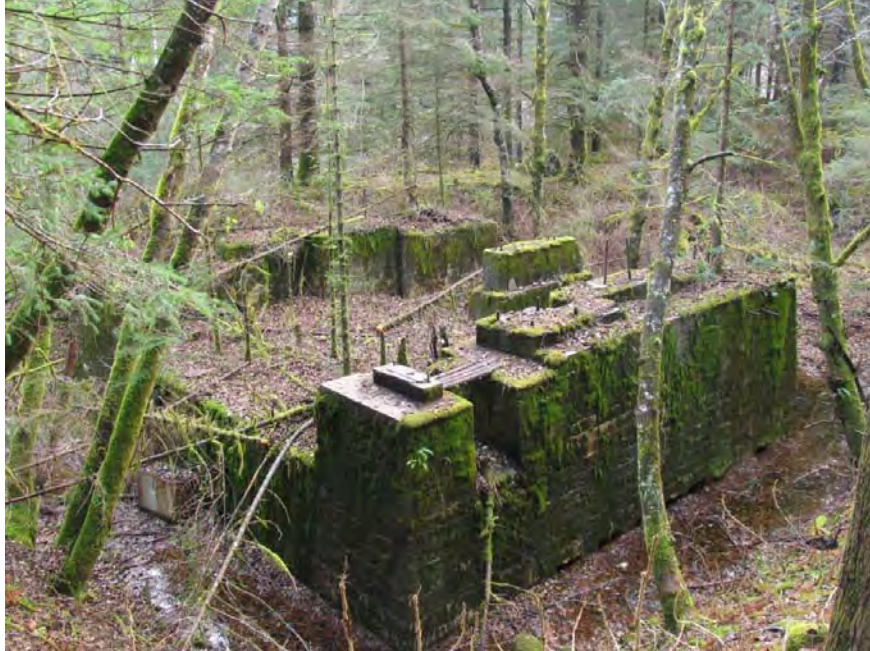
Foundations from Treadwell Hoist, November 2009
Photo Courtesy of Wayne Jensen

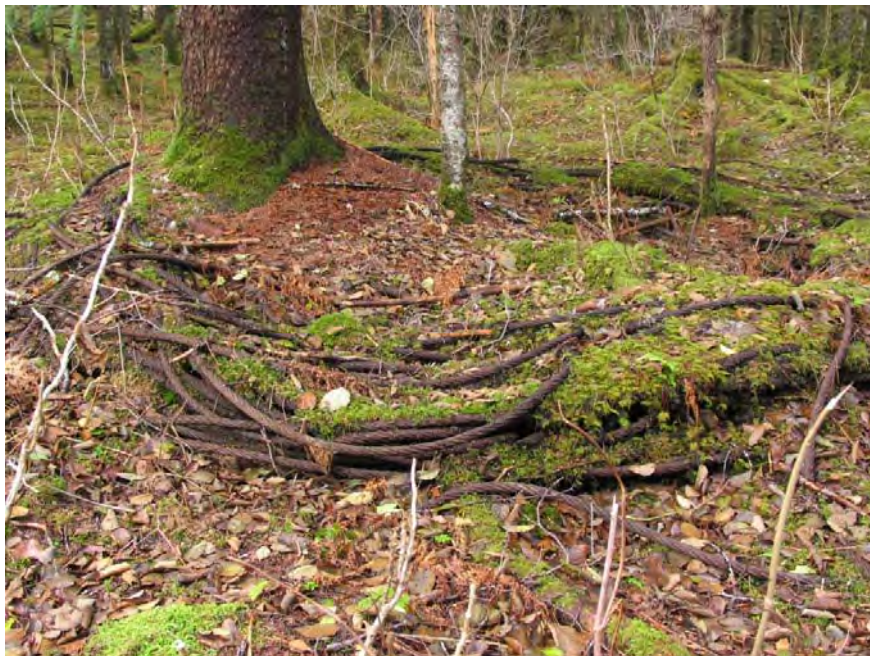
Cable from Treadwell Hoist
Photo courtesy of Wayne Jensen

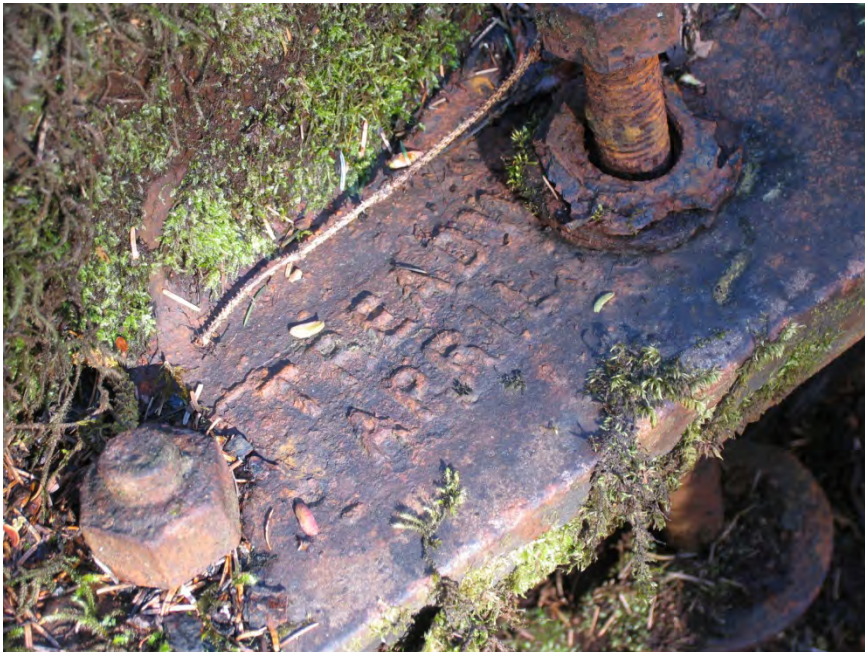
Part of Metal Lathe with foundry mark indicating it was cast at the Treadwell Foundry.
Photo taken in April 2010, courtesy of Wayne Jensen
