<b>To:</b>	Teri Camery (CBJ)	<b>Date:</b>	April 27, 2022
<b>c:</b>	Scott Ciambor (CBJ)	<b>Memo No.:</b>	7
<b>From:</b>	Rita Kors-Olthof, Vladislav Roujanski	<b>File:</b>	704-ENG.EARC03168-02A
<b>Subject:</b>	Considerations for Anthropogenic Terrain at Starr Hill and Gastineau Avenue Downtown Juneau Landslide and Avalanche Hazard Assessment

## JUNEAU LANDSLIDE AND AVALANCHE ASSESSMENT

### Locations of Infrastructure and Landslides on Mt. Roberts (LiDAR)

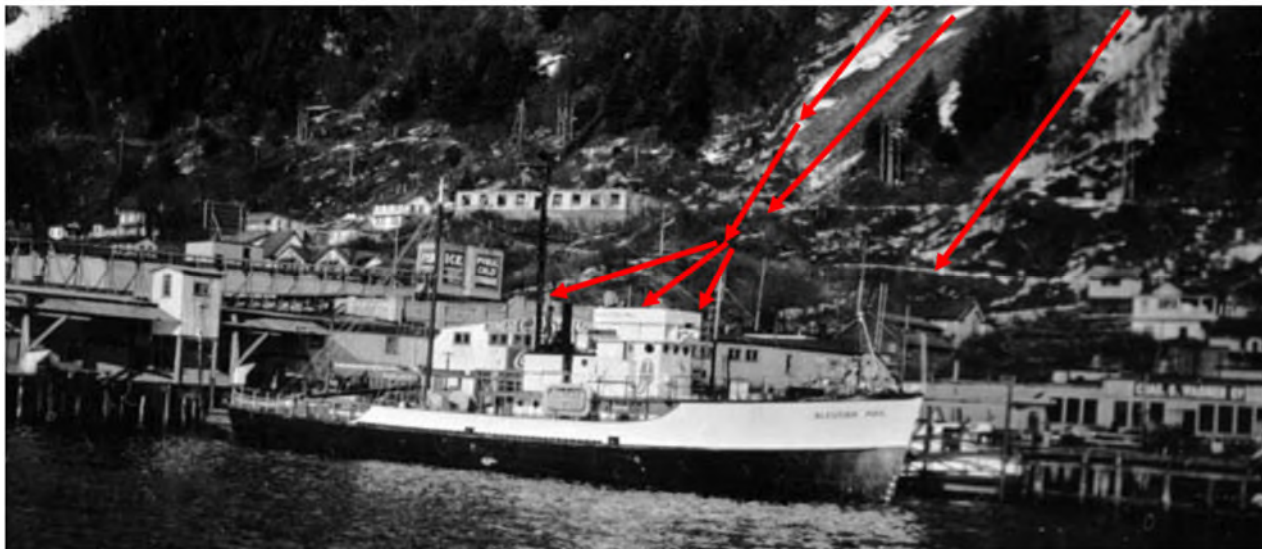
**Figure 6: Two apparent debris paths from November 22, 1936, landslide (red arrows, see also Figure 1a, 1b attached). Structure at center-left was the Juneau Cold Storage Company building, later replaced. Debris ran up against the S. Franklin St. side of Juneau Cold Storage, moved the Madsen Building downslope, destroyed several buildings, and killed 15 people. (Photo credit: Alaska State Library – Historical Collections, [ASL-P134-312-4](#), date uncertain, cropped to fit. ASL 2022d.)**

Figures 4 through 7 below present a few examples of former and/or active linear infrastructure, such as old roads, trails, powerlines, and tramway/railway grades, on the slopes above Gastineau Avenue on Mt. Roberts where landslides have occurred. Figure 1a, 1b, attached, provides some additional interpretation of the current slope conditions, the locations of some of the old mining infrastructure, and the locations of a few of the major slides over the past century. Conceivably, there could be more such features on the slope that have not yet been discovered on the imagery or historical photos. To reduce the likelihood of unexpected contributions from infrastructure to landslide occurrences or severity, more information could be collected on those features, and a decision-making process implemented to decide what to do about them, if anything.
