JUNEAU – DOUGLAS MINING DISTRICT

TREADWELL MINE HISTORIC TRAIL

WALKING TOUR MAP & HISTORIC GUIDE

TREADWELL HISTORIC TRAIL

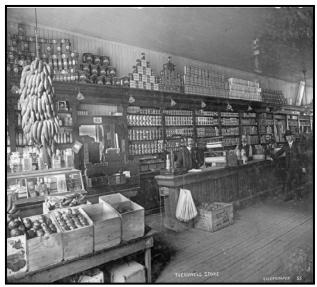
The Treadwell Company Store P39-1142 Case and Draper Collection Alaska State Library

STORE – By 1902, the store carried the largest stock of merchandise in Alaska. The prices were less than in Puget Sound and everything from fancy clothes to the best foods could be purchased.
