Delineation and Function Rating of Jurisdictional Wetlands on Potentially Developable City-owned Parcels In Juneau, Alaska

Community Development Department
Juneau, AK

January 2007

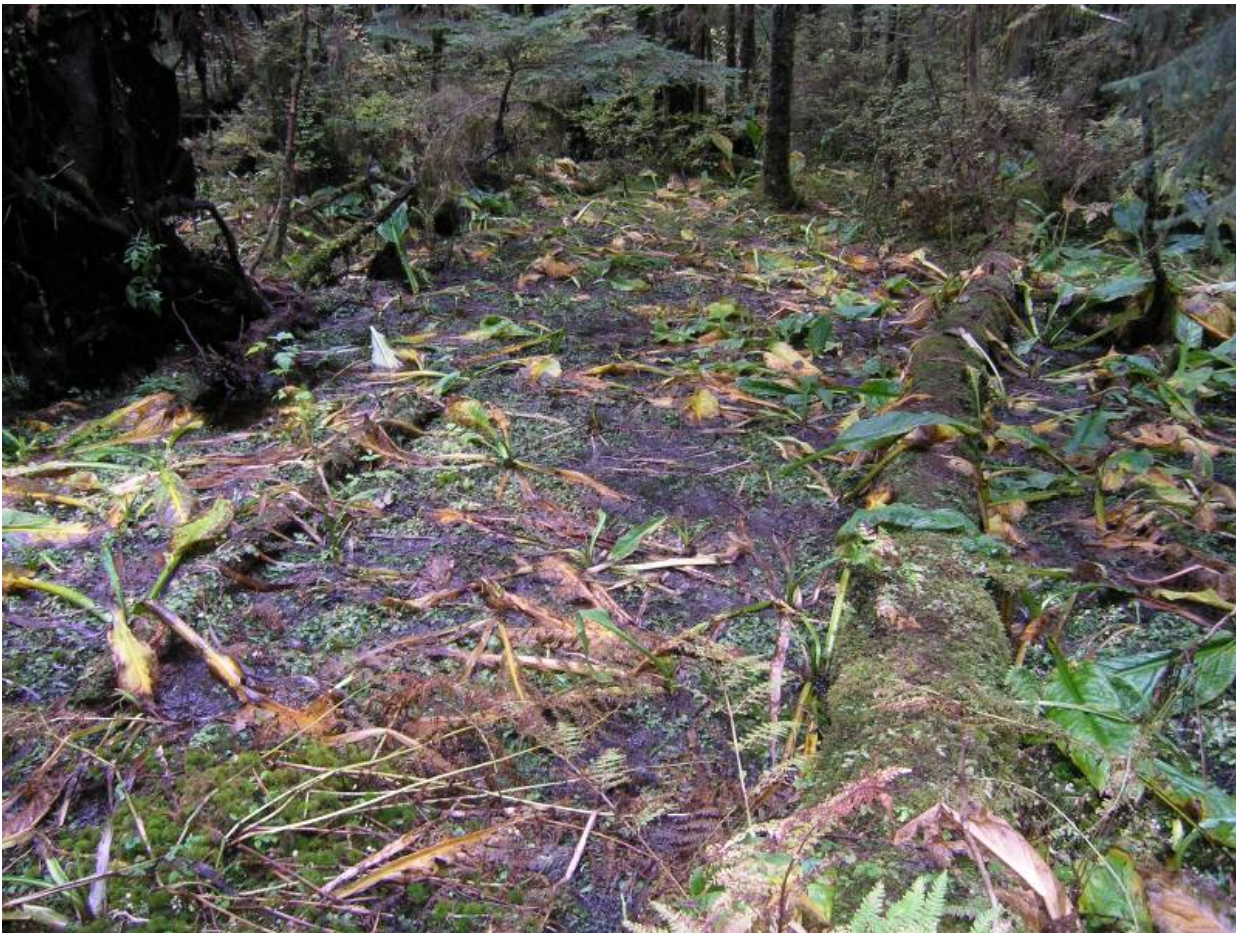
Figure 15 – Site 1 - Wetland #28

Portions of this large wetland are intercepted by upper Switzer Creek. It was assigned to category B based partly on relatively high ratings for Groundwater Discharge, Sediment/Toxicant Retention, Nutrient Export, Salmonid Habitat, Wildlife Habitat, and Recreational Use Potential (Table 2). Ratings were relatively low for Groundwater Recharge and Erosion Sensitivity. This wetland was not assigned to category A partly because of its relatively high PP (lower public preference) and PA (more numerous practicable alternatives) scores based on 1987 information for the closest wetland (L15) assessed at that time. This wetland is a complex of marshy uplifted beach meadow and bog in the southern part (mostly outside the study unit) and scrub-shrub and forested wetland in the northern part. The forested wetland overstory is dominated by large spruce with an understory of young hemlock. The wetter swales were dominated by skunk cabbage, devils club and liverworts and the drier hummocks by spiny wood fern. The scrub-shrub community is dominated by Sitka alder, Sitka willow and high bush cranberry with an understory of skunk cabbage and Sitka sedge. Soils in both communities have been mapped as hydric soils – mostly mucky peats of the Kena and Maybeso Series, and during the time of visit were saturated throughout all of the wetland (except on scattered hummocks).

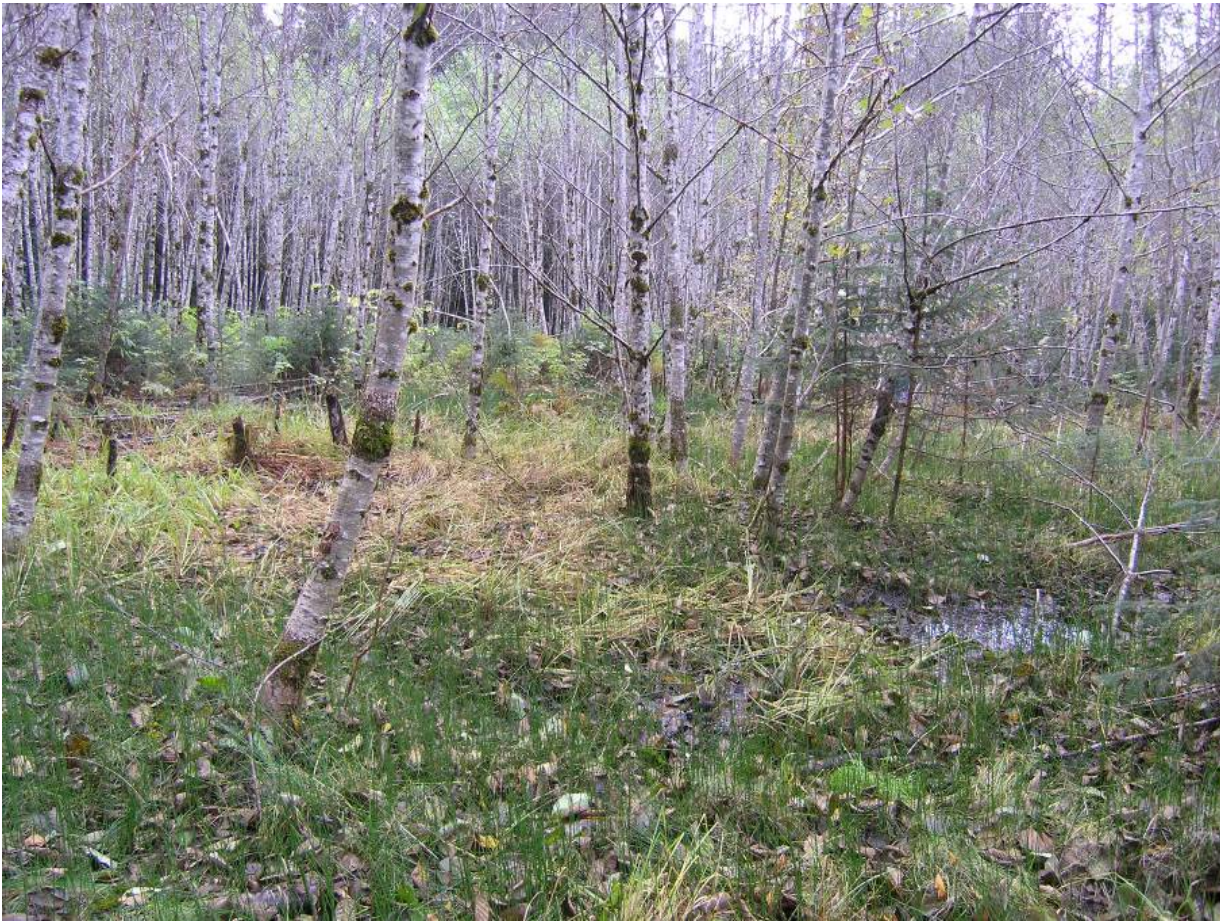
Figure 16 – Site 1 - Wetland #31

This wetland is west of the DZ school and west of wetland #30. It was assigned to category B based partly on relatively high ratings for Groundwater Discharge, Sediment/Toxicant Retention, Riparian Support, Hydrologic Control, and Recreational Use (Table 2). Fish cannot access any part of this wetland, but East Creek flows along the western edge. This wetland was not assigned to category A partly because of its relatively high PP (lower public preference) and PA (more numerous practicable alternatives) scores based on 1987 information for the closest wetland (L15) assessed at that time. This wetland site was formerly a pond created by a small catchment dam on East Creek. The water table is perched in the wetland area by the bedrock that outcrops there. The wetland has an unusual gramimoid understory with a somewhat open overstory of red alder and Sitka willow. Young fast-growing spruce saplings are coming up under the red alder overstory. The soil was a saturated, gleyed soil.

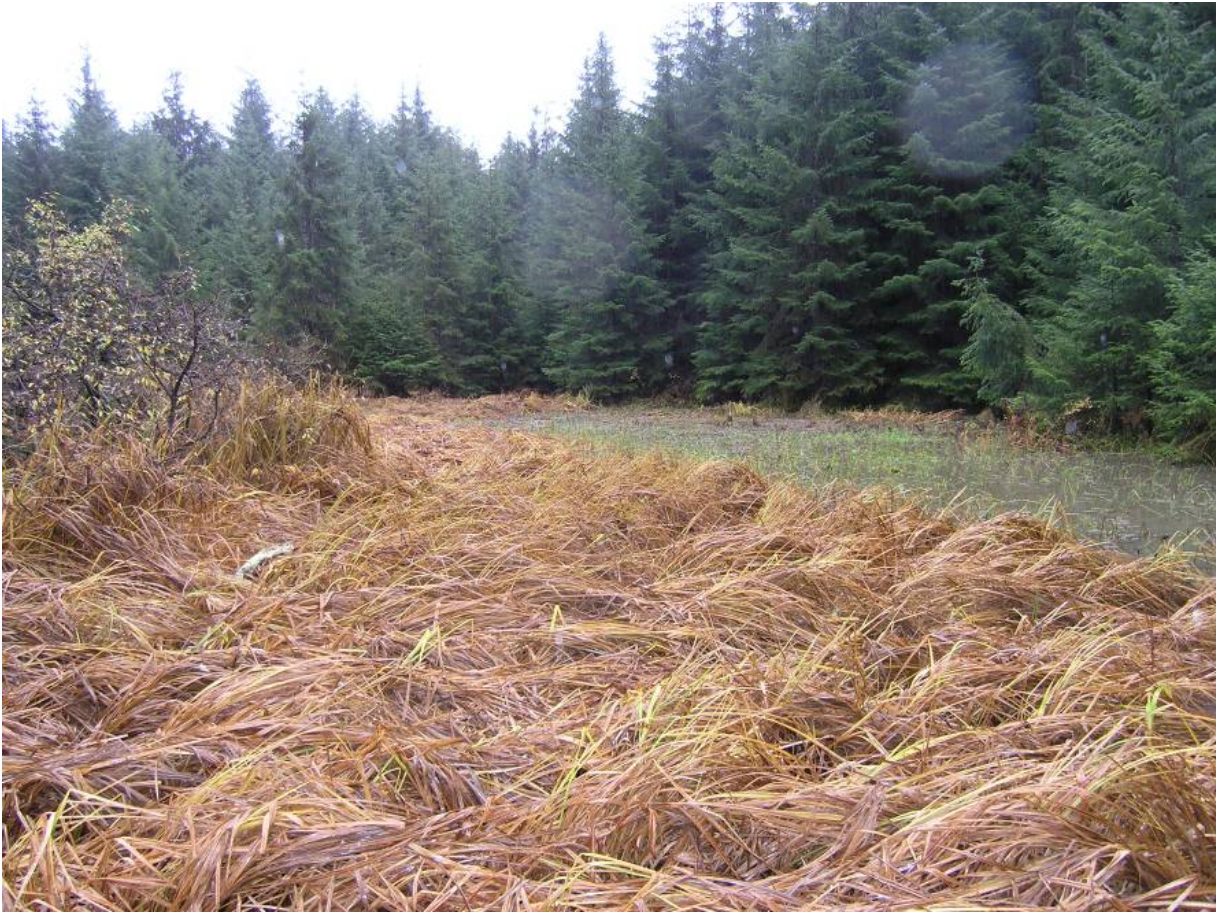
Figure 17 - Site 1 - Wetland #49

This small sedge marsh is upstream from wetland #28, and is intercepted by an ephemeral tributary to Switzer Creek. It was assigned to category C based partly on a relatively low rating for Erosion Sensitivity and moderate ratings for Salmonid Habitat, Recreational use, and Wildlife Habitat (Table 2). A few of the characteristics that contributed to the low ratings for these functions include its relatively flat slope and lack of structurally diverse vegetation. This wetland was not assigned to category B partly because of its relatively high PP (lower public preference) and PA (more numerous practicable alternatives) scores based on 1987 information for the closest wetland (L15) assessed at that time. The wetland is dominated by Sitka sedge and skunk cabbage. The water table over most of the wetland at the time of the visit was 9-10 inches above the surface (i.e, the wetland was flooded) and the soil was a sedge peat of the Kina Series.

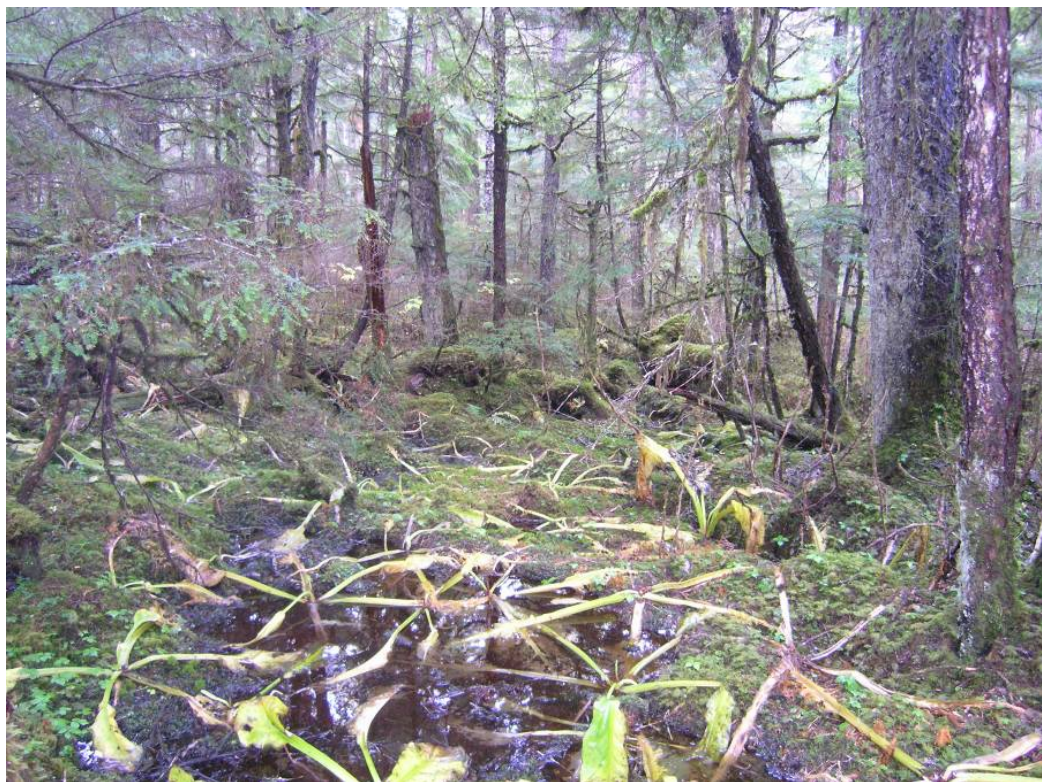
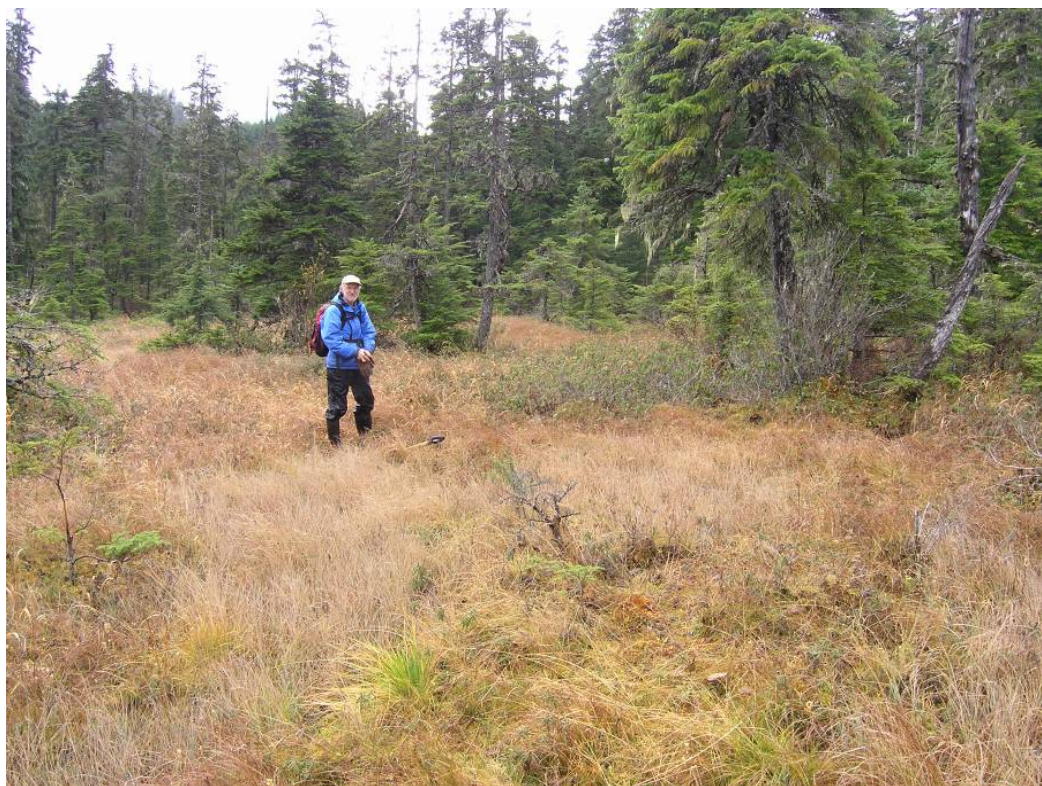
Figure 37 – Site 2 north - Wetland #7 - forested wetland

This wetland is in the northern part of the peninsula. It was assigned to category B based partly on relatively high ratings for Groundwater Discharge and Sediment/Toxicant Retention (Table 2). Small, probably ephemeral, streams flow along the northern and southern edges of this wetland but fish probably cannot access any part of the wetland itself. Part of this wetland overlaps a wetland labeled as MW11 in the 1997 Juneau Wetlands Management Plan, and the Plan also assigned that part to category B. The wetland is a complex of forested wetland and alder fen on the slopes, and sedge fen and ericaceous bog on the flatter benches. The forested wetland is dominated by scrubby hemlock and skunk cabbage and the alder fens by Sitka alder and crabapple. The sedge fen is dominated by Sitka sedge and the ericaceous bog by Labrador tea, stunted shore pine, mountain hemlock, and *Sphagnum* moss. The soils were all hydric and during the time of visit soils in most of the wetland were fully saturated, except on scattered hummocks.

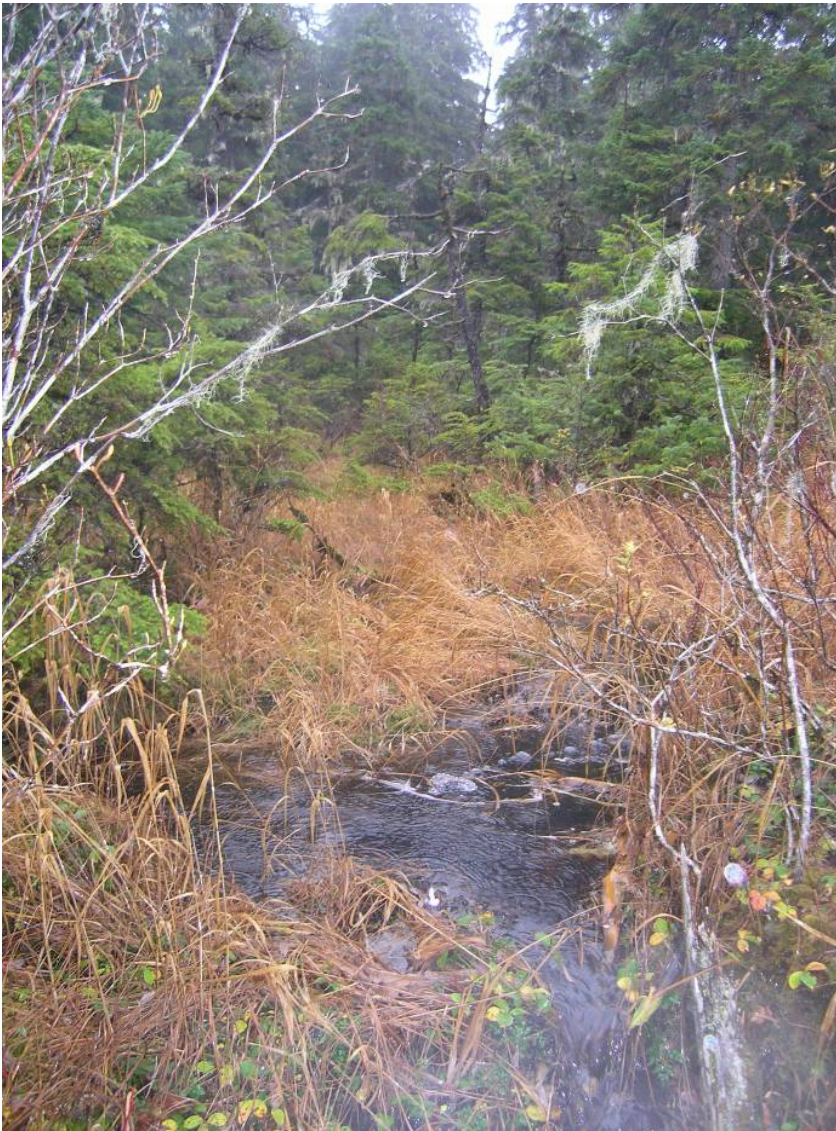
Figure 39 – Site 2 south - Wetland #23

This wetland is in the southern part of the peninsula. It was assigned to category B based partly on relatively high ratings for Groundwater Discharge and Sediment/Toxicant Retention (Table 2). Part of this wetland overlaps a wetland labeled as MW16 in the 1997 Juneau Wetlands Management Plan, and the Plan assigned that part to category C. Fish cannot access any part of this wetland. This wetland is a poor fen/rich bog complex on a narrow bench with a small drainage flowing through it. The wetland is dominated by Sitka alder and Sitka sedge in the fen portions with strong groundwater influence, and Labrador tea, stunted shore pine, mountain hemlock and *Sphagnum* moss on the boggy parts. The soils are all hydric soils, mostly sedge and *Sphagnum* peats of the Kina and Wadleigh series and during the time of visit the water table was at or above the surface of the soil.

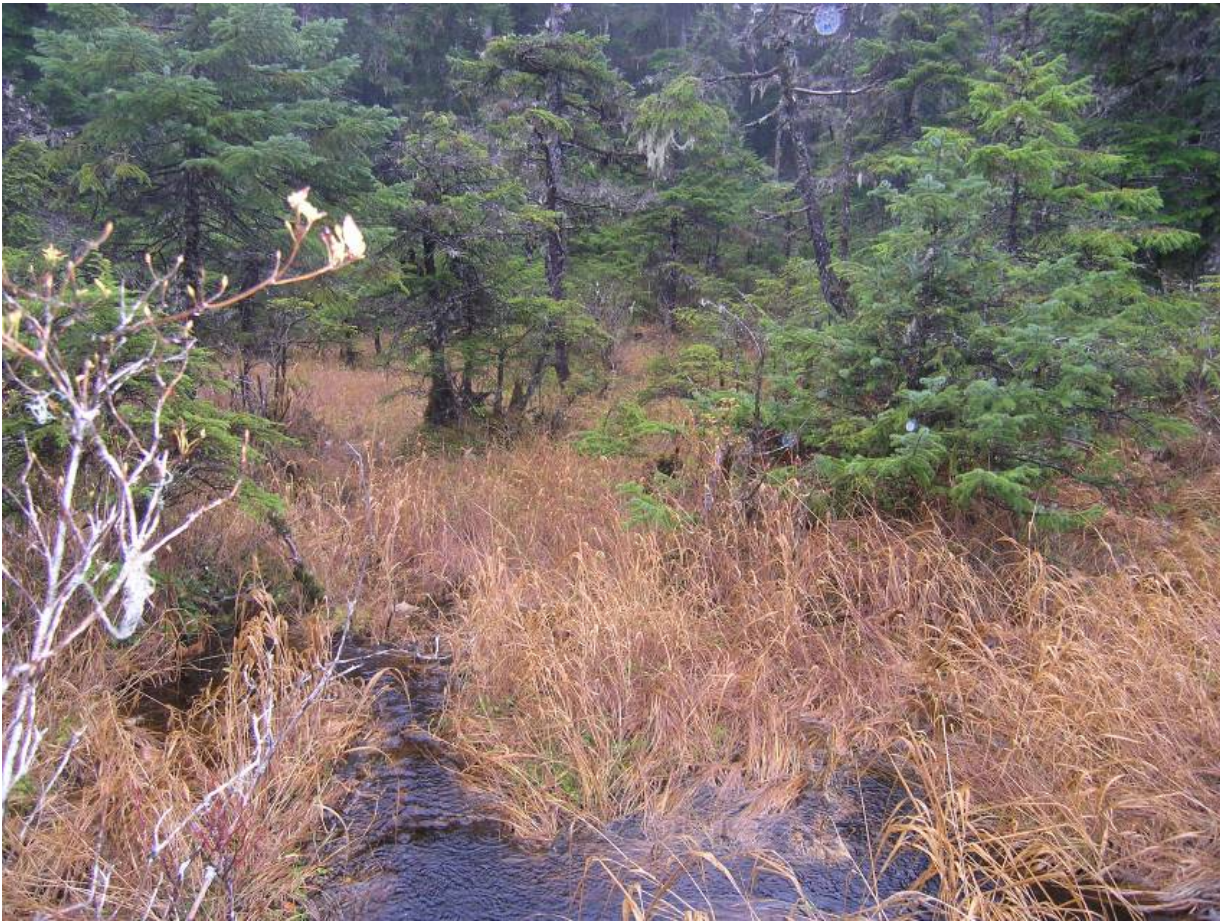
Figure 40 – Site 2 south - Wetland #27

This wetland is in the southern part of the peninsula. It was assigned to category B based partly on moderate to high ratings for Sediment/Toxicant Retention, Wildlife Habitat, and Groundwater Recharge (Table 2). Part of this wetland overlaps wetlands labeled as MW12, MW13, and MW 14 in the 1997 Juneau Wetlands Management Plan, and the Plan assigned those to category C. Fish cannot access any part of this wetland. This wetland is a poor fen/rich bog complex on a flat divide along the ridge that runs north-south down the peninsula. The wetland is dominated by Sitka alder and Sitka sedge in the fen portions with strong groundwater influence, and Labrador tea, stunted shore pine, mountain hemlock and *Sphagnum* moss on the boggy parts. The soils are all hydric soils, mostly sedge and *Sphagnum* peats, of the Kina and Maybeso Series, and during the time of visit the water table was at or above the surface of the soil.

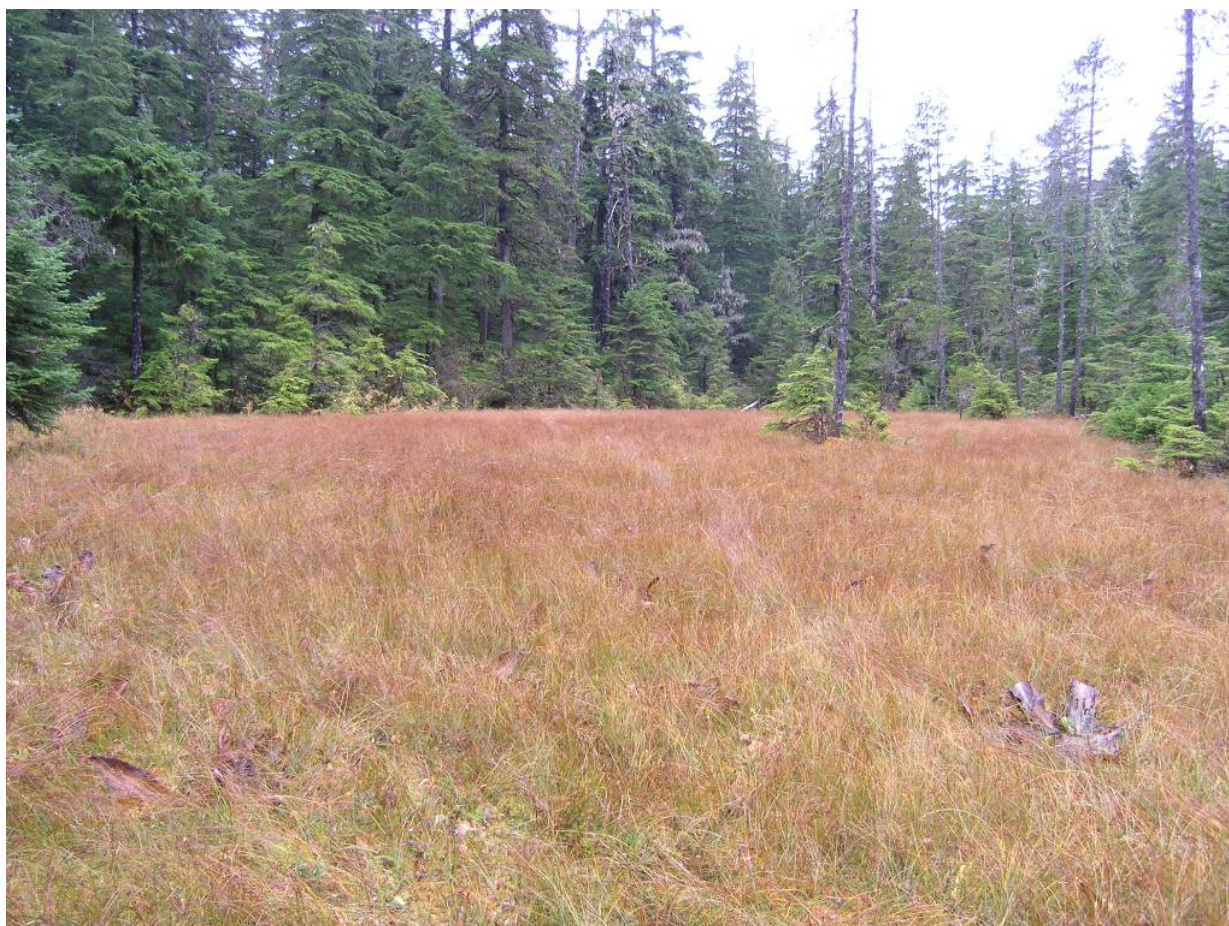
Figure 50 – Site 3 - Wetland #15 - sloping sedge fen

This wetland is on the lower, narrow bench in the northeastern part of the parcel unit. It was assigned to category B based partly on high ratings for Groundwater Discharge and Sediment/Toxicant Retention (Table 2). Fish cannot access any part of this wetland. The northern end of this wetland is a sloping sedge fen dominated by *Trichophorum* and livid sedge with a more ericaceous bog around the edges. The soils are hydric, mostly of the Kina Series. The rest of the wetland is forested wetland dominated by Sitka spruce, western hemlock, blueberries, and skunk cabbage. Those soils are mostly hydric, with mucky peats of the Maybeso Series in the swales and non-hydric soils on the hummocks. At the time of the study the water table was at or near the surface over most of the wetland.

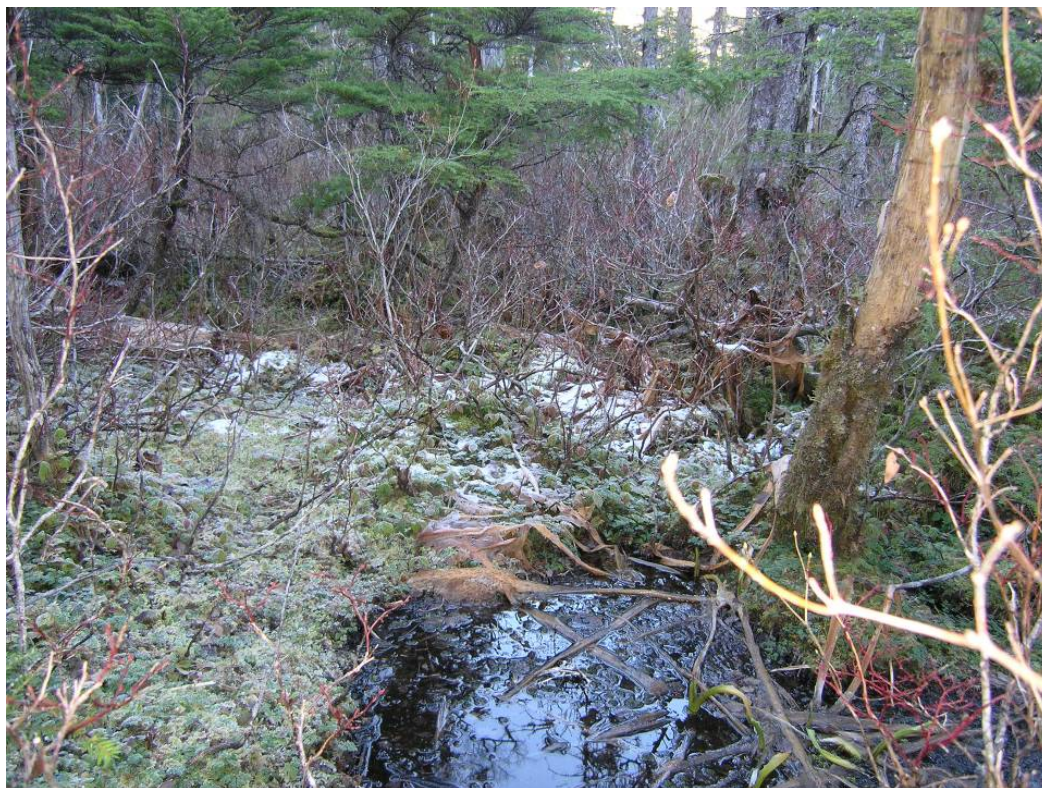
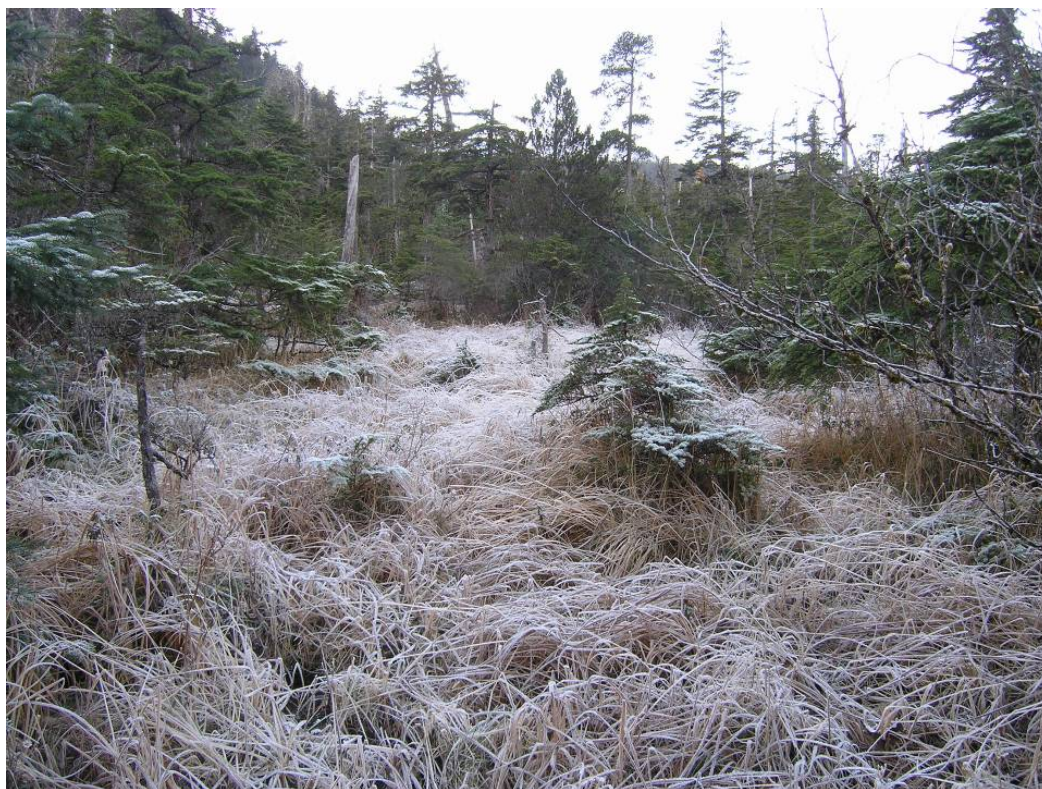
Figure 51 – Site 3 - Wetland #32 - edge of forested wetland/alder fen

This wetland is in the eastern part of the parcel unit. It was assigned to category B based partly on high ratings for Groundwater Discharge and Sediment/Toxicant Retention (Table 2). Fish cannot access any part of this wetland. This wetland is a complex of forested wetland - alder fen – ericaceous bog. The forested wetland is dominated by scrubby hemlock and skunk cabbage, and the alder fens by Sitka alder and crabapple. The alder fen is dominated by Sitka alder and various graminoids and the ericaceous bog by Labrador tea, stunted pine, Sitka spruce, hemlock and *Sphagnum* moss. The soils are all hydric, mostly of the Kina and Maybeso Series. The water table was at or near the surface over all the wetland except for scattered hummocks.

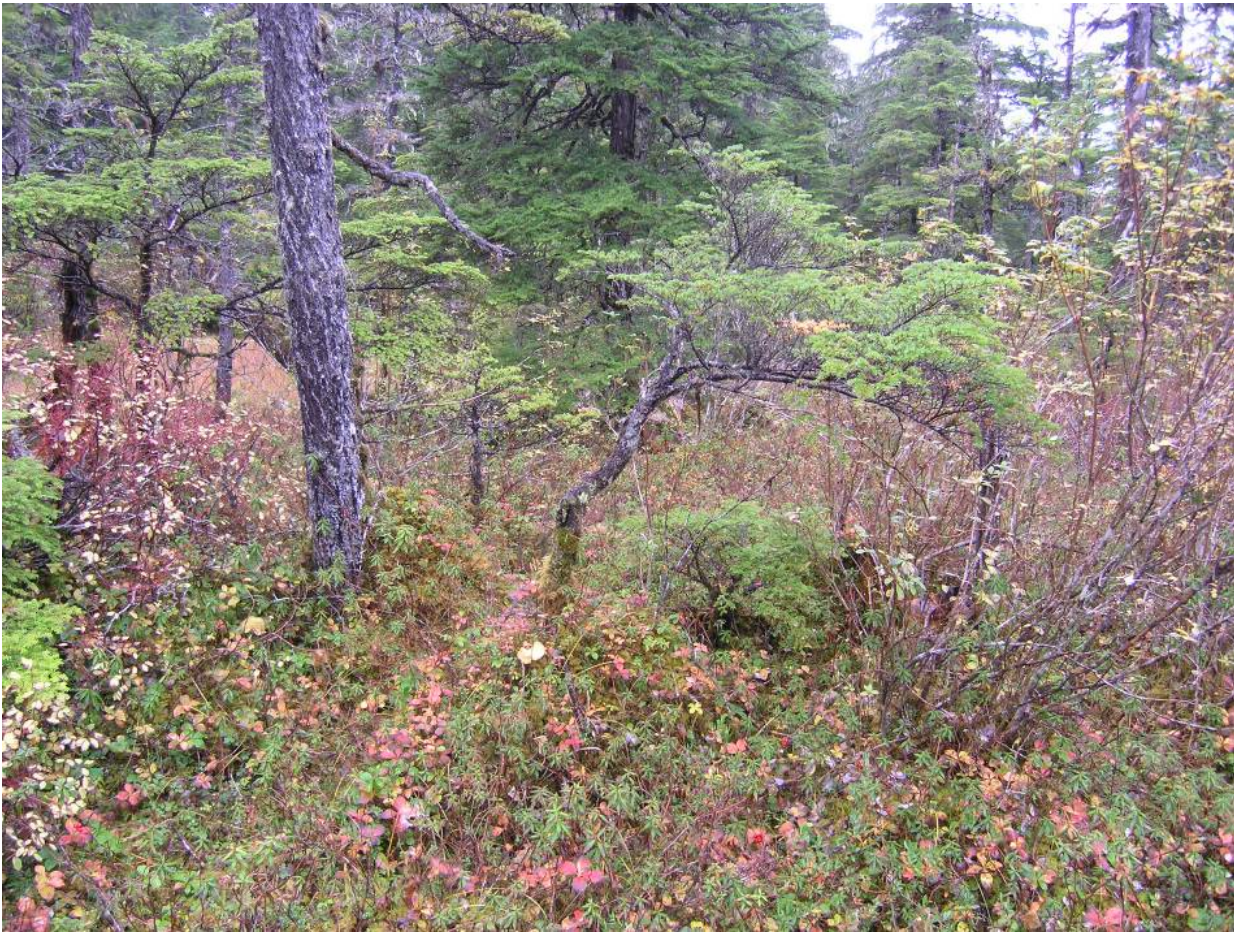
Figure 53 – Site 3 - Wetland #39 - ericaceous bog

This wetland is relatively large and extends beyond the western end of this parcel unit. It was assigned to category B based partly on moderate to high ratings for Riparian Support, Recreational Use, and Wildlife Habitat, but in general this wetland scored lower than wetlands 35 and 36 (Table 2). Fish cannot access any part of this wetland. This wetland is a complex of forested wetland - alder fen – ericaceous bog. The forested wetland is dominated by scrubby hemlock and skunk cabbage and the alder fens by Sitka alder and crabapple. The ericaceous bog is dominated by Labrador tea, stunted pine, spruce, hemlock and *Sphagnum* moss. The soils are all hydric, of the Kina and Maybeso Series, and the water table was at or near the surface over all the wetland except for scattered hummocks.

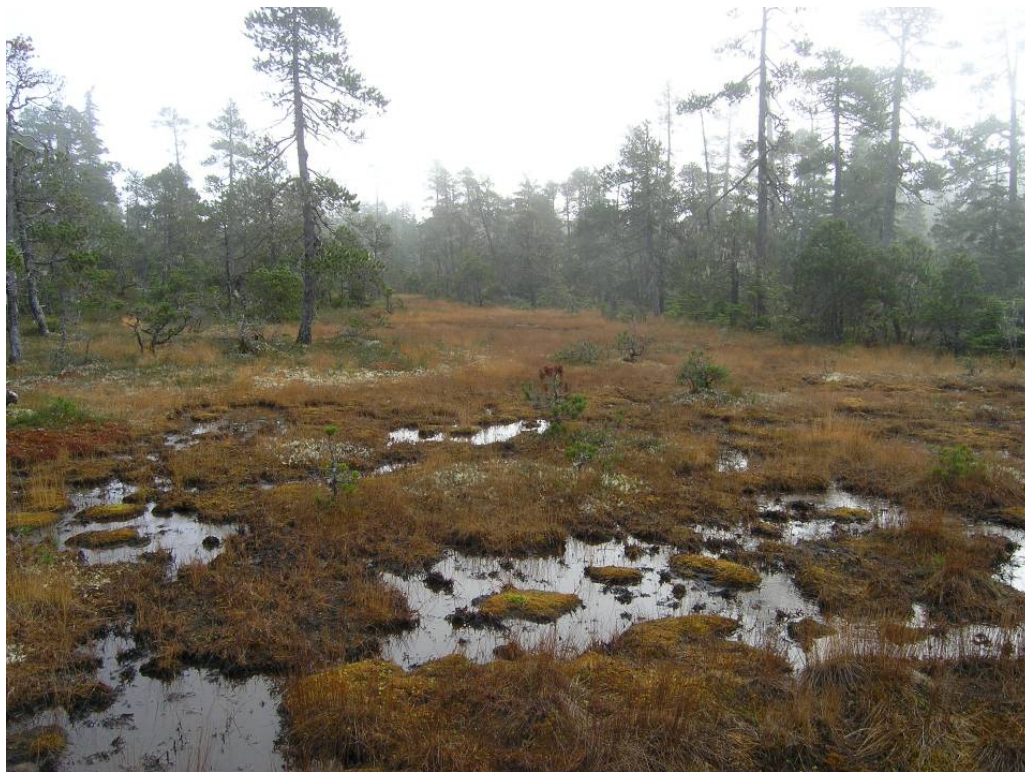
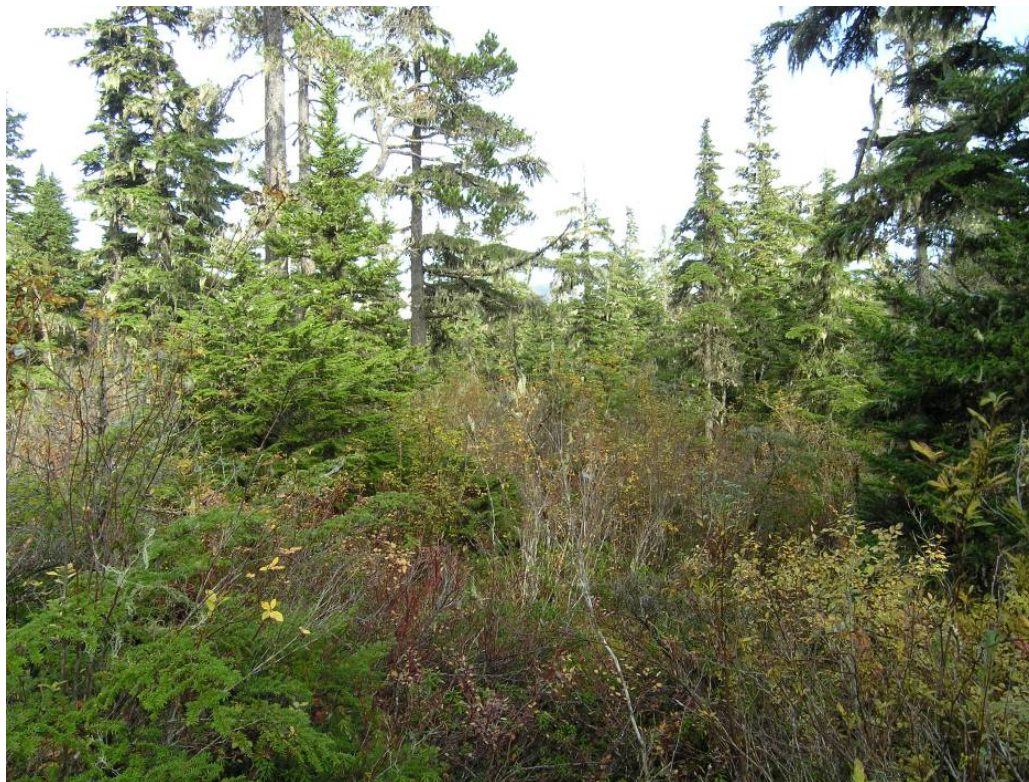
Figure 63 – Site 4 - Wetland #5 - bog with ponds

This very large hilltop wetland is on the western side of the parcel unit. It was assigned to category B based partly on a high rating for Groundwater Recharge and moderate to high ratings for Sediment/Toxicant Retention and Wildlife Habitat (Table 2). Part of this wetland overlaps a wetland labeled as A1 in the 1997 Juneau Wetlands Management Plan, and the Plan assigned that part to category C. Fish cannot access any part of this wetland. The flatter central part of this wetland is an ombrogenous bog with many small ponds. This wetland is dominated by *Sphagnum* moss and stunted shore pine. The more rolling edges of this wetland are parklands dominated by shore pine and ericaceous subshrubs. The spur off the southern end of the wetland is a forested wetland dominated by western hemlock and skunk cabbage. The soils are all hydric, mostly of the Kogish and Wadleigh Series, and the water table was at or within 12 inches of the surface during the study.

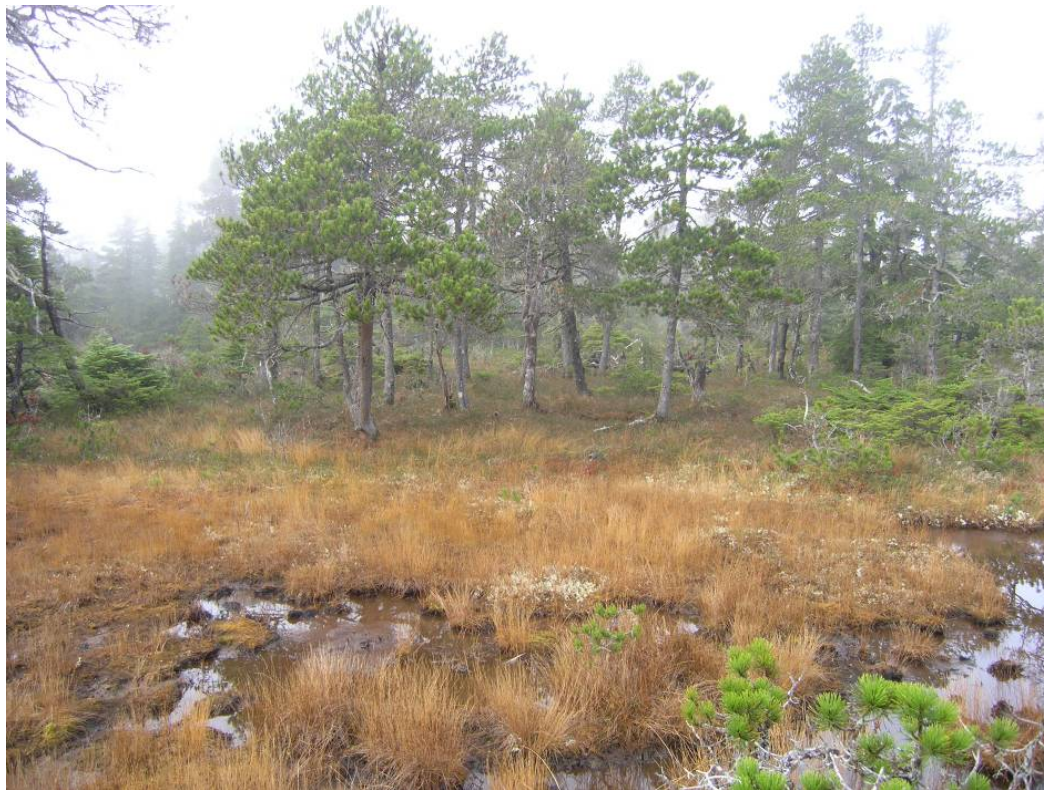
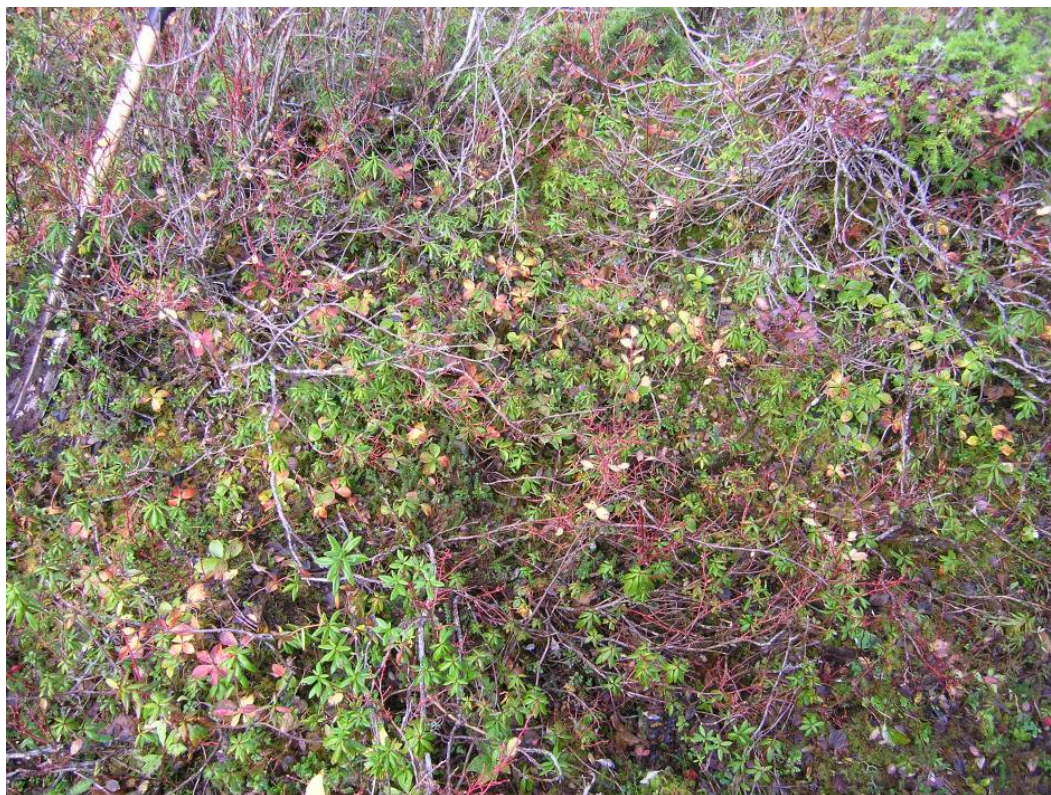
Figure 65 – Site 4 - Wetland #6 - bog with ponds

This very large hilltop wetland is on the eastern side of the parcel unit and is almost contiguous to wetland #5. It was assigned to category B based partly on a high rating for Groundwater Recharge and moderate to high ratings for Sediment/Toxicant Retention and Wildlife Habitat (Table 2). Part of this wetland overlaps a wetland labeled as A1 in the 1997 Juneau Wetlands Management Plan, and the Plan assigned that part to category C. Fish cannot access any part of this wetland. The flatter central part of this wetland is an ombrogenous bog, dominated by *Sphagnum* moss and stunted shore pine. The more rolling edges of this wetland are parklands, dominated by shore pine and ericaceous subshrubs. The soils are all hydric, mostly of the Kogish and Wadleigh Series, and the water table was at or within 12 inches of the surface during the study.

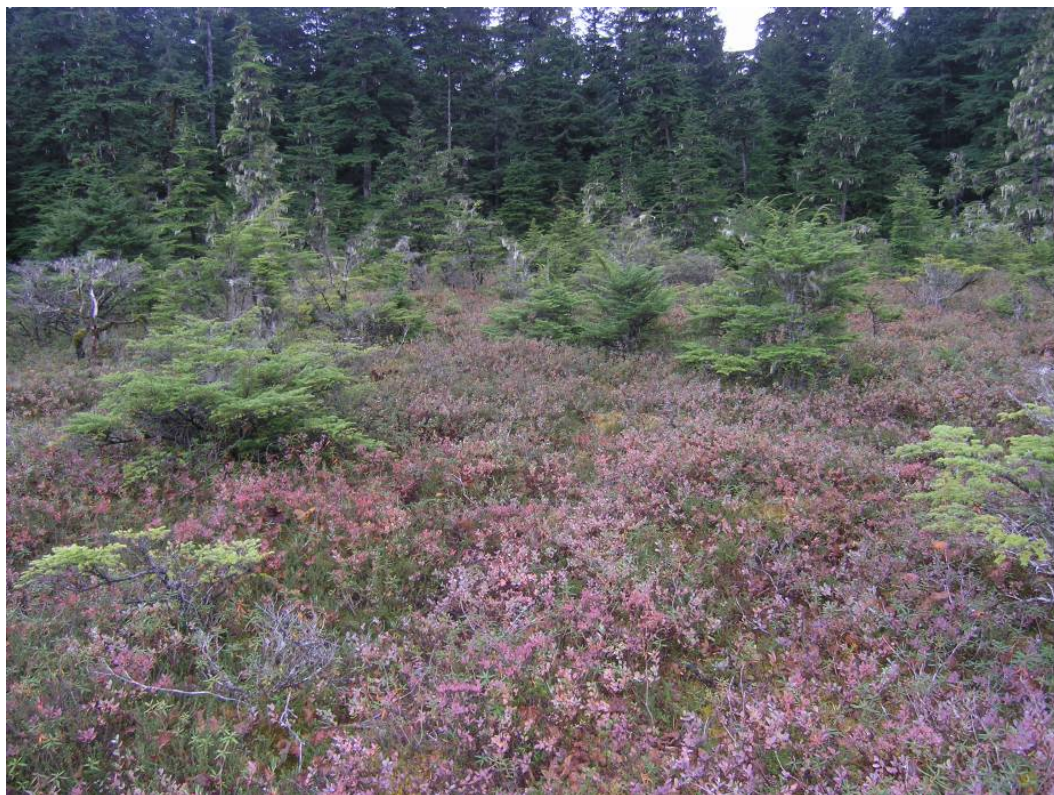
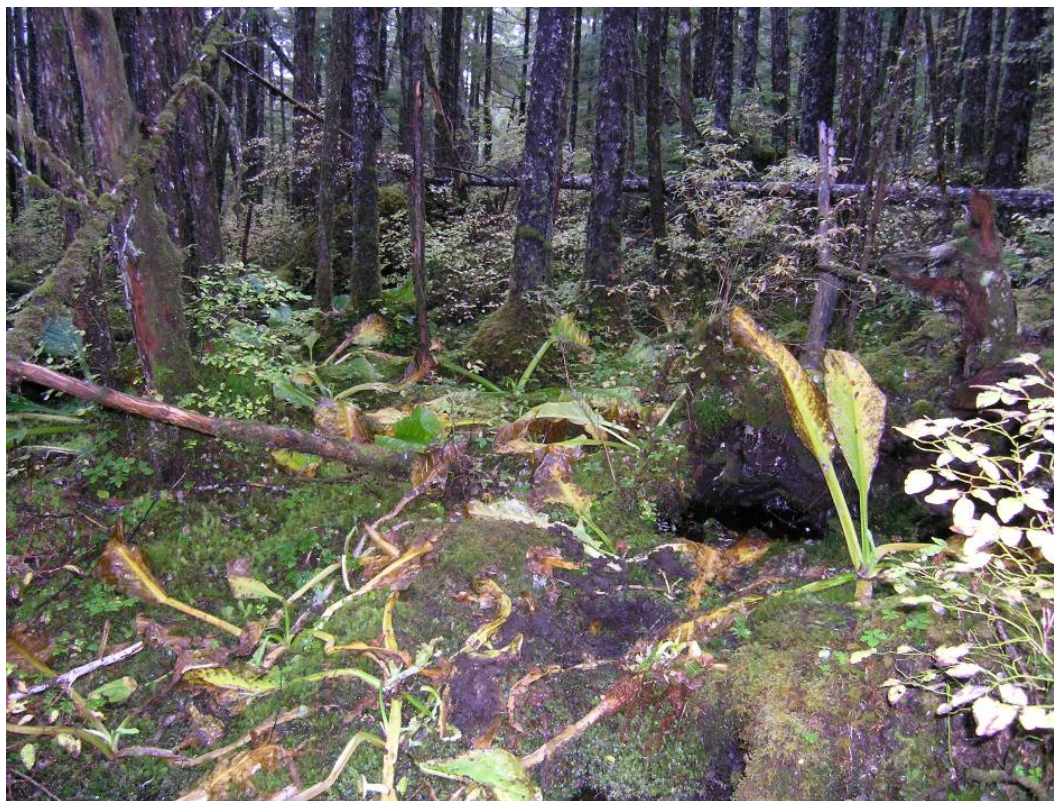
Figure 94 – Site 7 - Wetland #3 - ericaceous bog

This wetland is in the western part of the parcel unit and is mostly bog with forested wetland edges. It was assigned to category B based partly on high ratings for Groundwater Discharge and Erosion Sensitivity (Table 2). Part of this wetland overlaps a wetland labeled as A5 in the 1997 Juneau Wetlands Management Plan, and the Plan assigned that part to category A. Fish cannot access any part of this wetland. This wetland is a complex of forested wetland and ericaceous bog. The forested wetland is dominated by small hemlock, *Sphagnum* moss and skunk cabbage. The ericaceous bog is dominated by Labrador tea, stunted pine, spruce, hemlock and *Sphagnum* moss. The soils are all hydric, of the Kina and Maybeso Series, and the water table was at or near the surface over all the wetland except for scattered hummocks.

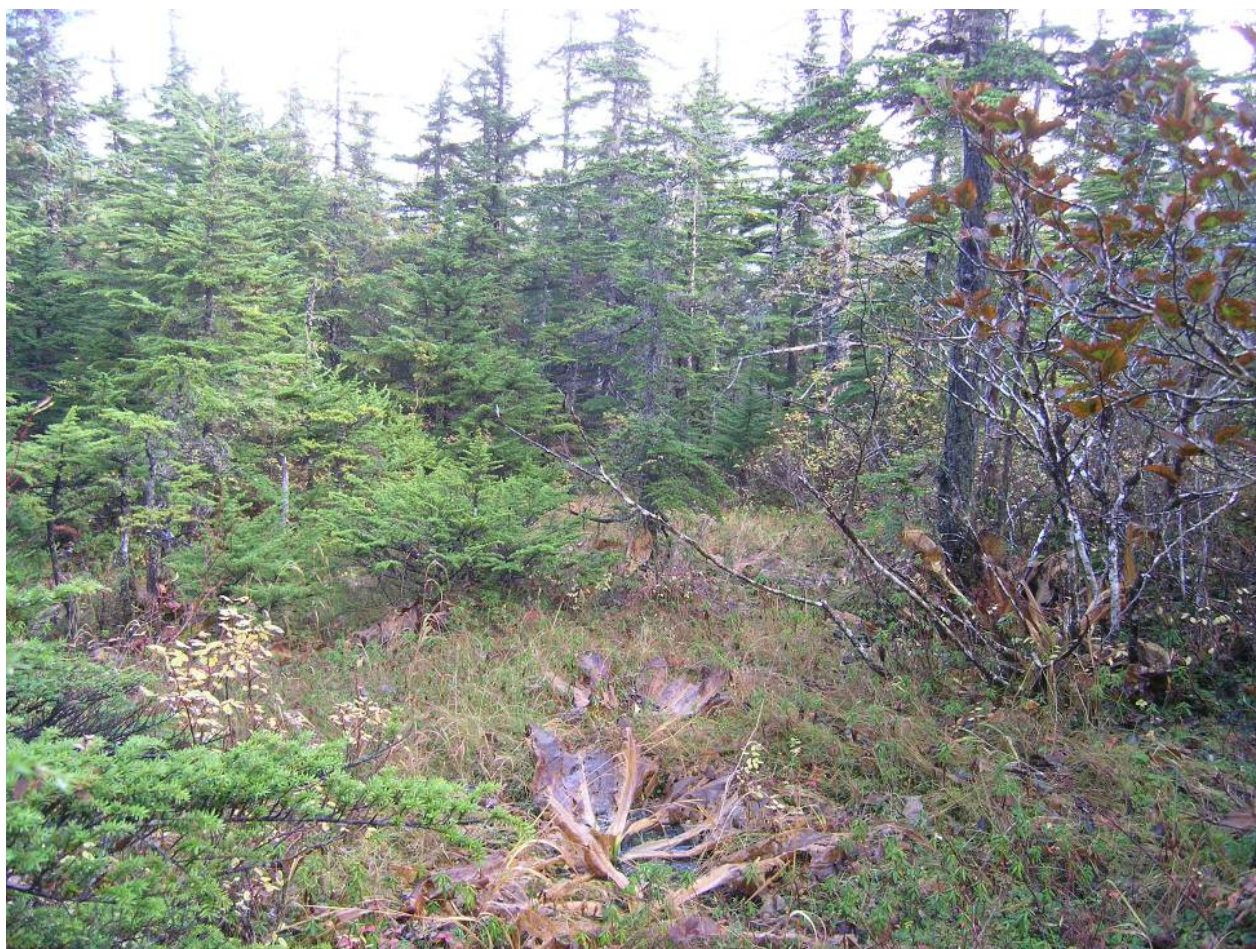
Figure 114 – Site 9 - Wetland #16 - ericaceous bog

This wetland is in the south-central part of the parcel unit and is mostly herbaceous, grading into forested wetland around the edges. It was assigned to category B based partly on high ratings for Groundwater Discharge and Erosion Sensitivity (Table 2). Fish cannot access any part of this wetland. This wetland is a complex of ericaceous bog – alder fen and forested wetland. The forested wetland is dominated by scrubby hemlock and skunk cabbage, the alder fen by Sitka alder and crabapple. The ericaceous bog is dominated by Labrador tea, stunted pine, spruce, hemlock and *Sphagnum* moss. The soils are all hydric, of the Kogish and Maybeso series, and the water table was at or near the surface over all the wetland except for scattered hummocks.

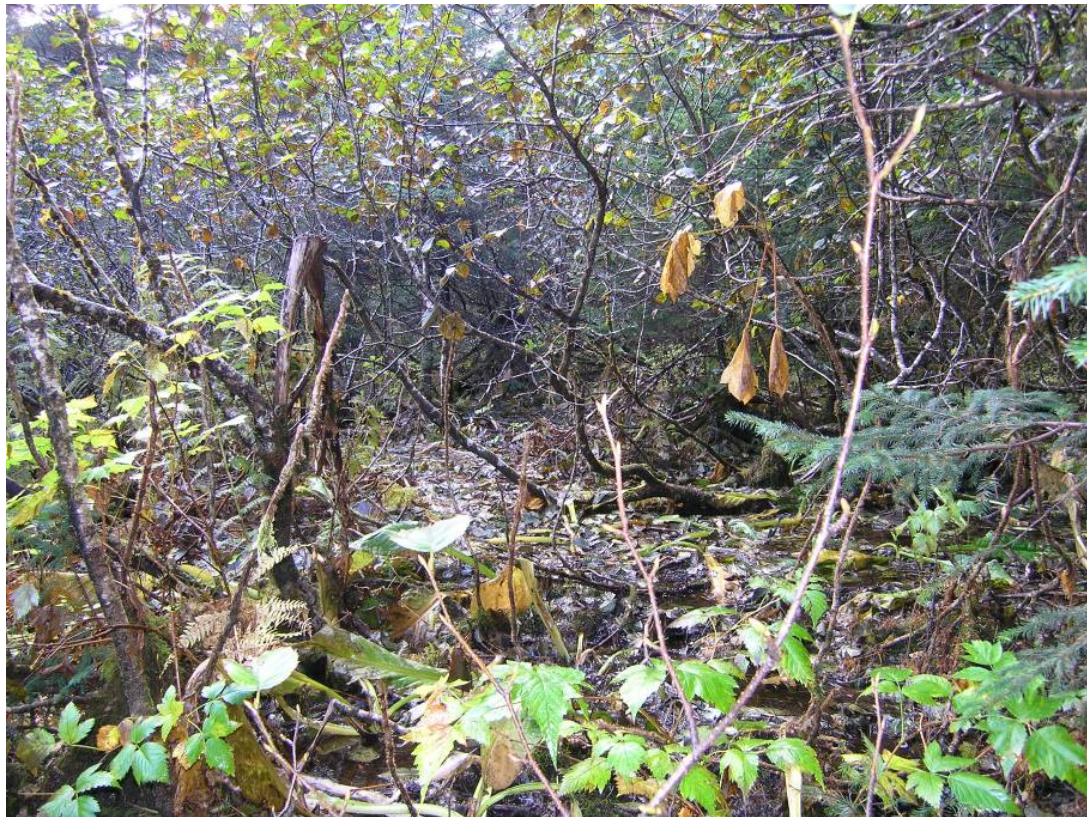
Figure 115 – Site 9 - Wetland #22 - alder fen

This wetland is on a narrow bench at the toe of a slope and just from wetland #16. It was assigned to category A based partly on high ratings for Groundwater Discharge, Sediment/Toxicant Retention, Recreational Use, and Wildlife Habitat (Table 2). Fish cannot access any part of this wetland. The wetland is a narrow strip of alder fen all along the base of the slope that trends northwest-southeast through the unit. The hydrology of the wetland might have been changed by the construction of a dirt access road that runs below it. The alder fen is dominated by Sitka alder, salmonberry and skunk cabbage. The soil is hydric; a mucky peat of the Maybeso Series, and the water table was at the surface at the time of the survey.
