TO:	Kate Kanouse Southeast Regional Supervisor	DATE:	August 5, 2020
		FILE:	FH08-I-0002
		SUBJECT:	Duck Creek JNU Airport Tree Cutting Trip Report
FROM:	Greg Albrecht 6 Habitat Biologist	PHONE NO:	(907) 465-6384

Duck Creek JNU Airport Tree Cutting Trip Report

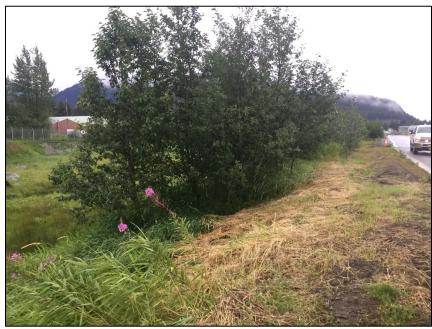
Figure 3.–Alders growing on road shoulder.

The Duck Creek channel was constructed with 3–4 ft tall banks sloped at a 45 degree angle, which along with tall grass provide shade for the creek. Alders on the south side of the creek provide shade as well and are thick at this early stage of colonization. Alders on the shoulder of the roadway and in the field south of the creek presently provide no fish habitat function (Figure 3). Therefore, I recommend considering cutting trees as necessary on the south side of the creek, while leaving a dominant alder every 10–20 ft along the south bank within 10 ft of the creek (Figure 4). The trees left standing could be pruned high enough to see wildlife moving in the creek and along the banks (about 6 ft) and would still maintain shade value and other riparian functions. I also recommend airport staff consult the 2007 Environmental Impact Statement for the airport runway expansion project to ensure there are no environmental commitments that may affect tree cutting, and the City and Borough and Juneau, which regulates riparian vegetation removal.

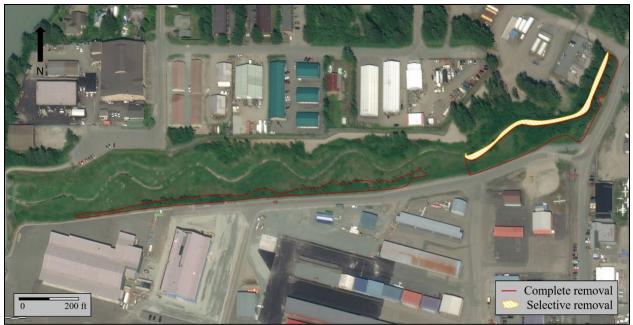
Figure 4.–Aerial map showing recommendations for complete and selective tree removal to maintain fish habitat value.
