(C3) RFP No. MR E21-137
Capital School Park Reconstruction

January 26, 2017

PND 172114.01

Re: Chicken Yard Park and Capital Park
Conceptual Design and Cost Estimate

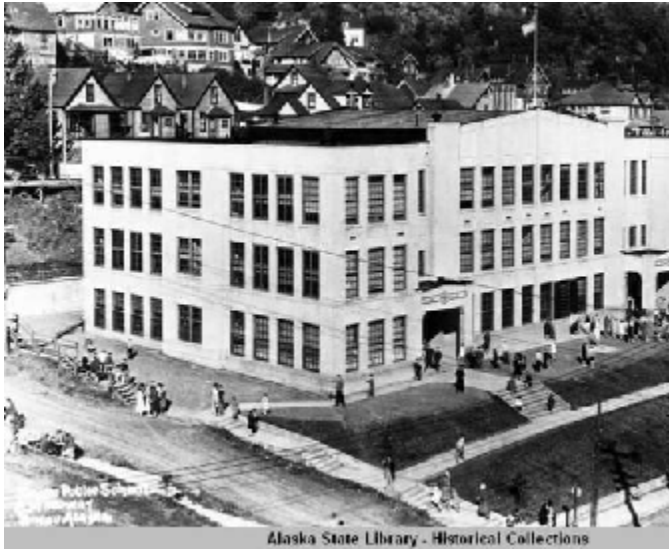
Capital Park is the site of the original Juneau School building that is shown on the site plan of the Juneau High School (later Capital Grade School and currently the Terry Miller Office Building) dated June 1927. The retaining wall that is the subject of this project appears in the 1918 photo of the school. The wall is over 100 years old.

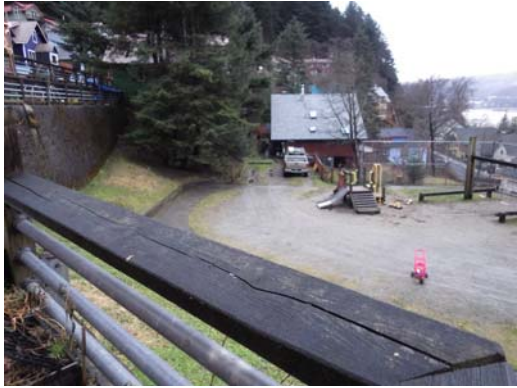
<p>1) The existing house with address 626 Fifth Street uses the park as a driveway. The portion of Fifth Street that this house fronts is a wooden-framed stair and the house and lot have no vehicle access. The CBJ Assessor Data Base indicates that the house was originally constructed in 1937. Traffic in the park appears to be light and the travelled way appears to be away from play equipment. The concrete driveway from Sixth Street is how the vehicles access the park and their home. PND as been told that the CBJ Law department was determining if this house has legal access for vehicles across the park.</p>

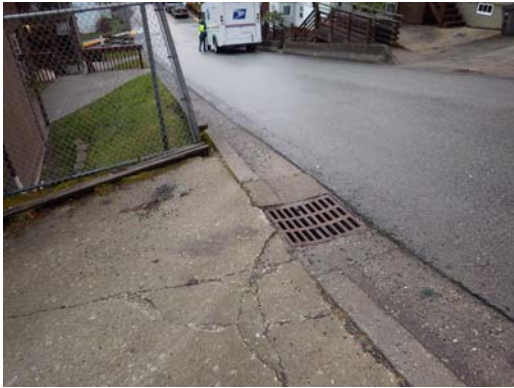
<p>2) The concrete driveway on Sixth Street has cracks but the cracks are not large and the vertical step across the cracks does not appear to be much of a tripping hazard.</p>

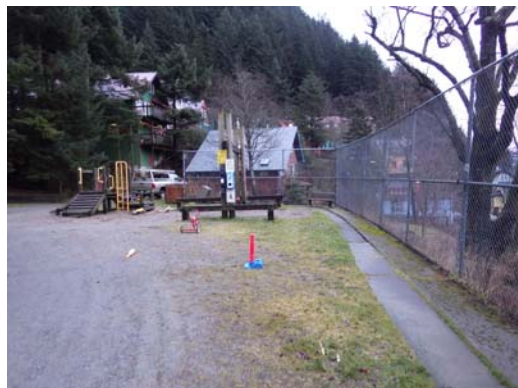
4) The concrete sidewalk next to the fence was placed in two distinct pours. The sidewalk is not level and there is significant drop across the joint. Adjacent to the driveway the sidewalk is narrow. The sidewalk should be replaced.

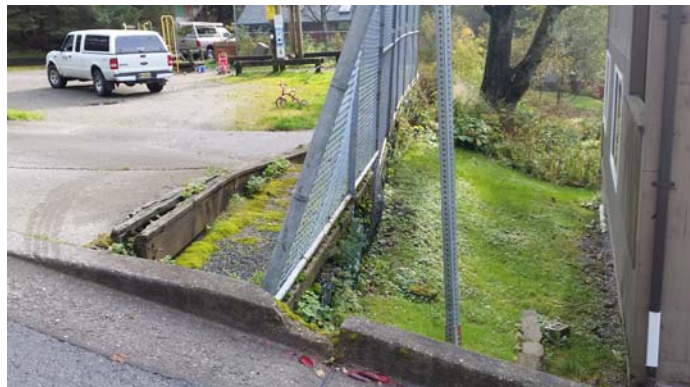
5) The fence on the southwest and southeast edges of the park is not plumb. The fence posts penetrate the sidewalk and are embedded in grout or concrete in plastic pipe in the gabion wall below. The fence other than leaning a little, is in fair to good condition. If the sidewalk is replaced the fence should be removed, new fence post sleeve bases should be secured in a reinforced, concrete replacement sidewalk and the fence re-installed in a plumb condition.

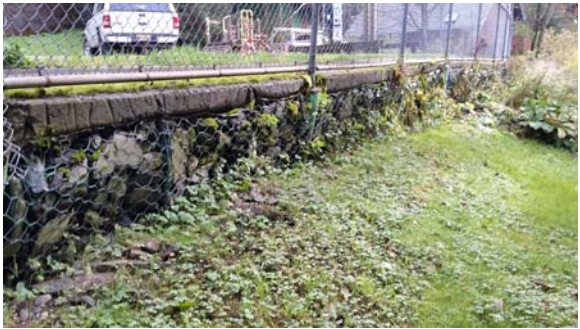
<p>6) The gabion wall under the perimeter sidewalk and fence appears to be in fair to good condition. Wires are not corroded. The vertical face of the wall is not straight or smooth, but such is the nature of gabion walls. If this wall was built in 1981 it likely has 10 to 20 more years of life in it. If this project improvements are to last longer than 20 years, it is recommended that the wall be removed and replaced by a large concrete block retaining wall, whose life will be between 50 and 100 years.</p>

This alternative involves removing the fence and concrete on the gabion wall and leaving the gabion wall in place. The replacement wall cap/sidewalk will be thicker than the existing, reinforced, and capable of supporting the fence. This alternate also includes removing and replacing the existing steps at Sixth Street and the wood curb.

This alternate includes the work in Alternate 1 and removing and replacing the gabion wall with a large concrete block wall.

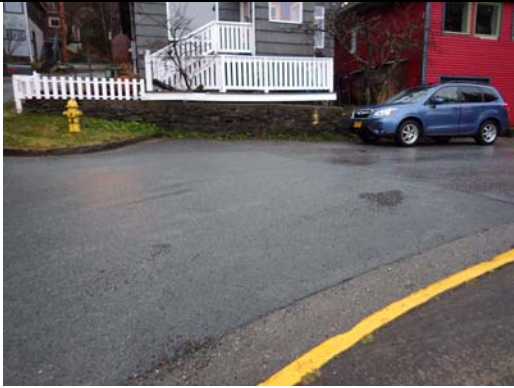
<p>7) Hydrant on east side of Kennedy Street. Main is in middle of street per as-builts. Community Garden is on west side of street. Pavement is in good condition. Water service will require pavement cut. An alternative is to create rain catchment on a pavilion or other shelter that could be built on site.</p>

This alternate includes the construction of a yard hydrant with connection to the existing waterline under Kennedy Street. Work will include cutting pavement, excavating a trench, tapping into the existing line with a service saddle, installing a copper line to the new hydrant, installing a curb valve and box, installing the hydrant, bedding the line, backfilling, testing and disinfection and patching the pavement.

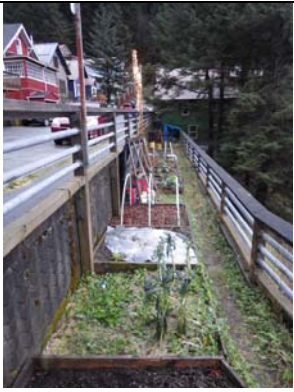
<p>8. Community Garden- along Kennedy Street</p>

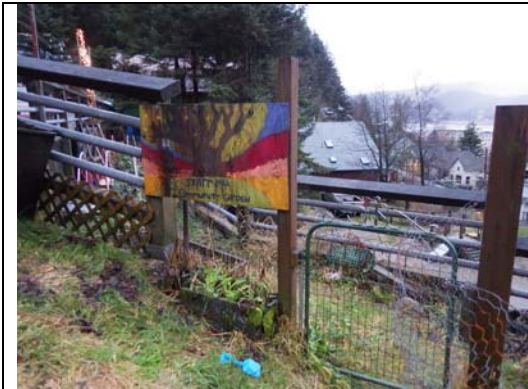
- 9. Entrance to Community Garden.
 Potential location for small pavilion over gate. Rain catchment consisting of a roof with gutters and multiple large plastic barrels could provide some unchlorinated water for users.

This alternate involves removing the existing gate structure and possibly several planters and constructing a pavilion with metal or polycarbonate roofing with gutters and downspouts into several rain barrels. The barrels would allow garden users to have access to water.

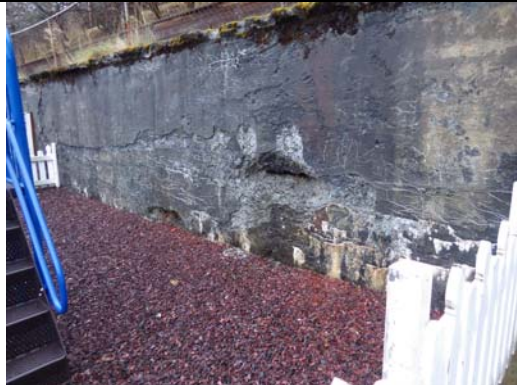
The approximately 8 foot high concrete wall on the northwest edge of the play area is deteriorating and beyond its useful life. There are large voids and reinforcing is exposed. There are large sections with cracking and efflorescence. The concrete was likely not air entrained to protect it from deterioration during freeze-thaw cycles. It will continue to deteriorate and likely fail in the next 5 to 10 years. Due to the low amount of reinforcement in the wall it will likely fail quickly rather than in a slow ductile fashion.

<p>Large surface void in the “Tot Play” area</p>

Replacement of the wall in the near future should be considered.

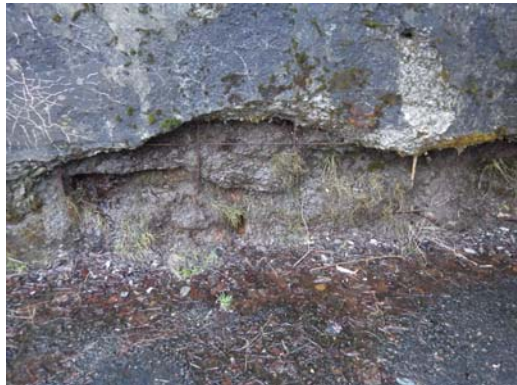
<p>Large void at base of wall at the basketball court – Reinforcing in this is present but is less frequent than would be present in current designs.</p>

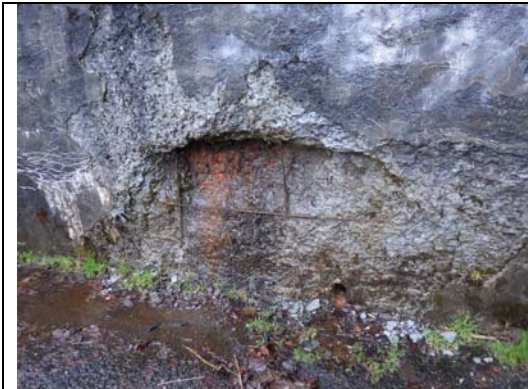
The gravel path above the retaining wall does not drain freely. There is standing water. The soils behind the wall do no freely drain indicating that there is a high amount of water that the wall supports. This water moves through the retaining wall as concrete is not impervious. The water in the wall expands when frozen

and causes cracking and delamination. If the wall is replaced there should be free-draining backfill and a continuous perforated drain pipe so that water will not build up behind the wall.

Void at base of wall at basketball court. Reinforcing exposed. Weep hole visible – Other weep holes not visible

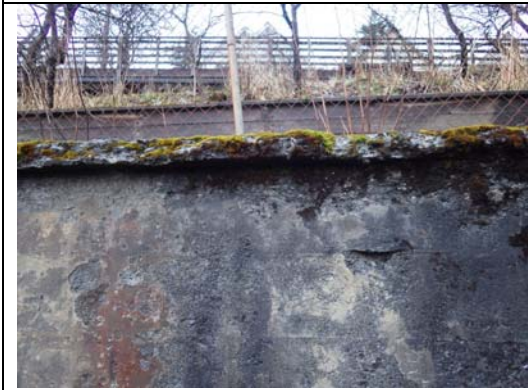
Deterioration at top of wall

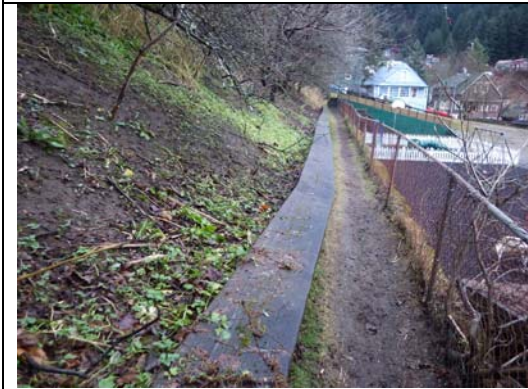
The demolition of the existing wall will undermine the timber framed retaining wall on the uphill side of the gravel path above the retaining wall. This wall appears to be similar to those specified in the 1979 plans. It is not plumb and does not appear to have been designed for earth at rest lateral pressures. Other timber walls that are in the nearby Seward Street right-of-way show signs of rot and fungus. Fungal growth on the surface of timber retaining walls indicate that the wall has been saturated for a considerable amount of time and is likely rotten.

The chain link fence above the retaining wall is old and in fair to poor condition. Metal coatings on the posts, top rail and fence fabric are beyond their useful life. It should be replace in the near future.

Timber wall and fence on the concrete wall. Timber wall is not plumb and the fence is corroding.

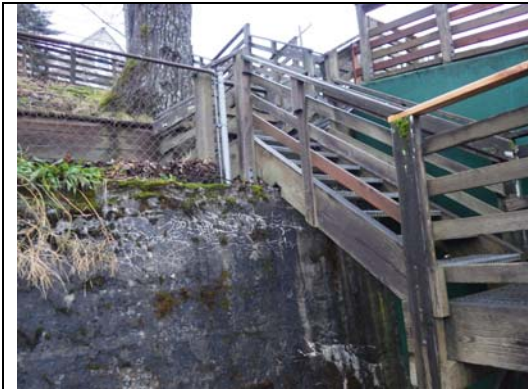
At the east end of the wall there is a timber-framed stair. This stair will need to be removed for wall demolition and reconstruction. The stair is adjacent to the basketball court. Some thought should be given to removing the stair and reconstructing it above the existing east end retaining wall that is in good condition and to remain. A relocated stair may be in the sledding area but could be made of reinforced concrete and be much more durable than a timber framed stair.

Demolition of the existing wall will require removal of two large cottonwood trees at the east end of the wall. These are on the fill behind the timber wall just above the concrete wall. During demolition excavators will undermine the support for these trees.

Stairs at east end of retaining wall. Note large cotton wood above wall.

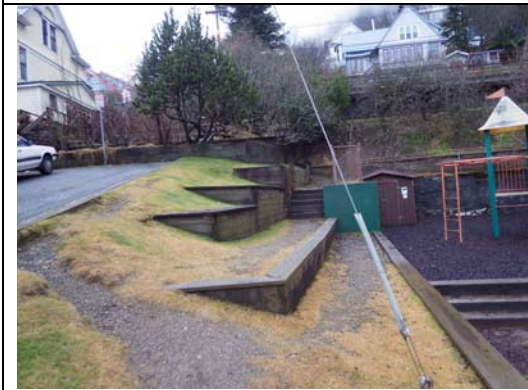
Replacement will require moving the small shed at the west end of the wall. This 8' x 8' light framed timber structure appears to be on a minimal foundation and may be removed and reset as needed.

West end of wall- Note shed in corner and play equipment. Green concrete wall is newer and in good condition and need not be replaced. Timber walls in fore-ground are in the Seward Street right-of-way and not part of this project.
