## ATTACHMENT #5

**From:** Mike Wilson <[mwilson@coastalhelicopters.com](mailto:mwilson@coastalhelicopters.com)>  
**Sent:** Tuesday, September 28, 2021 8:46 AM  
**To:** Patty Wahto <[Patty.Wahto@jnuairport.com](mailto:Patty.Wahto@jnuairport.com)>; Scott Rinkenberger <[scottr@jnuairport.com](mailto:scottr@jnuairport.com)>  
**Subject:** SW corner wall

**ATTACHMENT #5****Report Title: Coastal Safety Reporting Form Lite****Header Information****Event Date/Time** 11/06/2019 03:46 GMT **Name (Optional)****Detailed description of the Hazard / Incident / Event / Concern**

Hangar wall damage

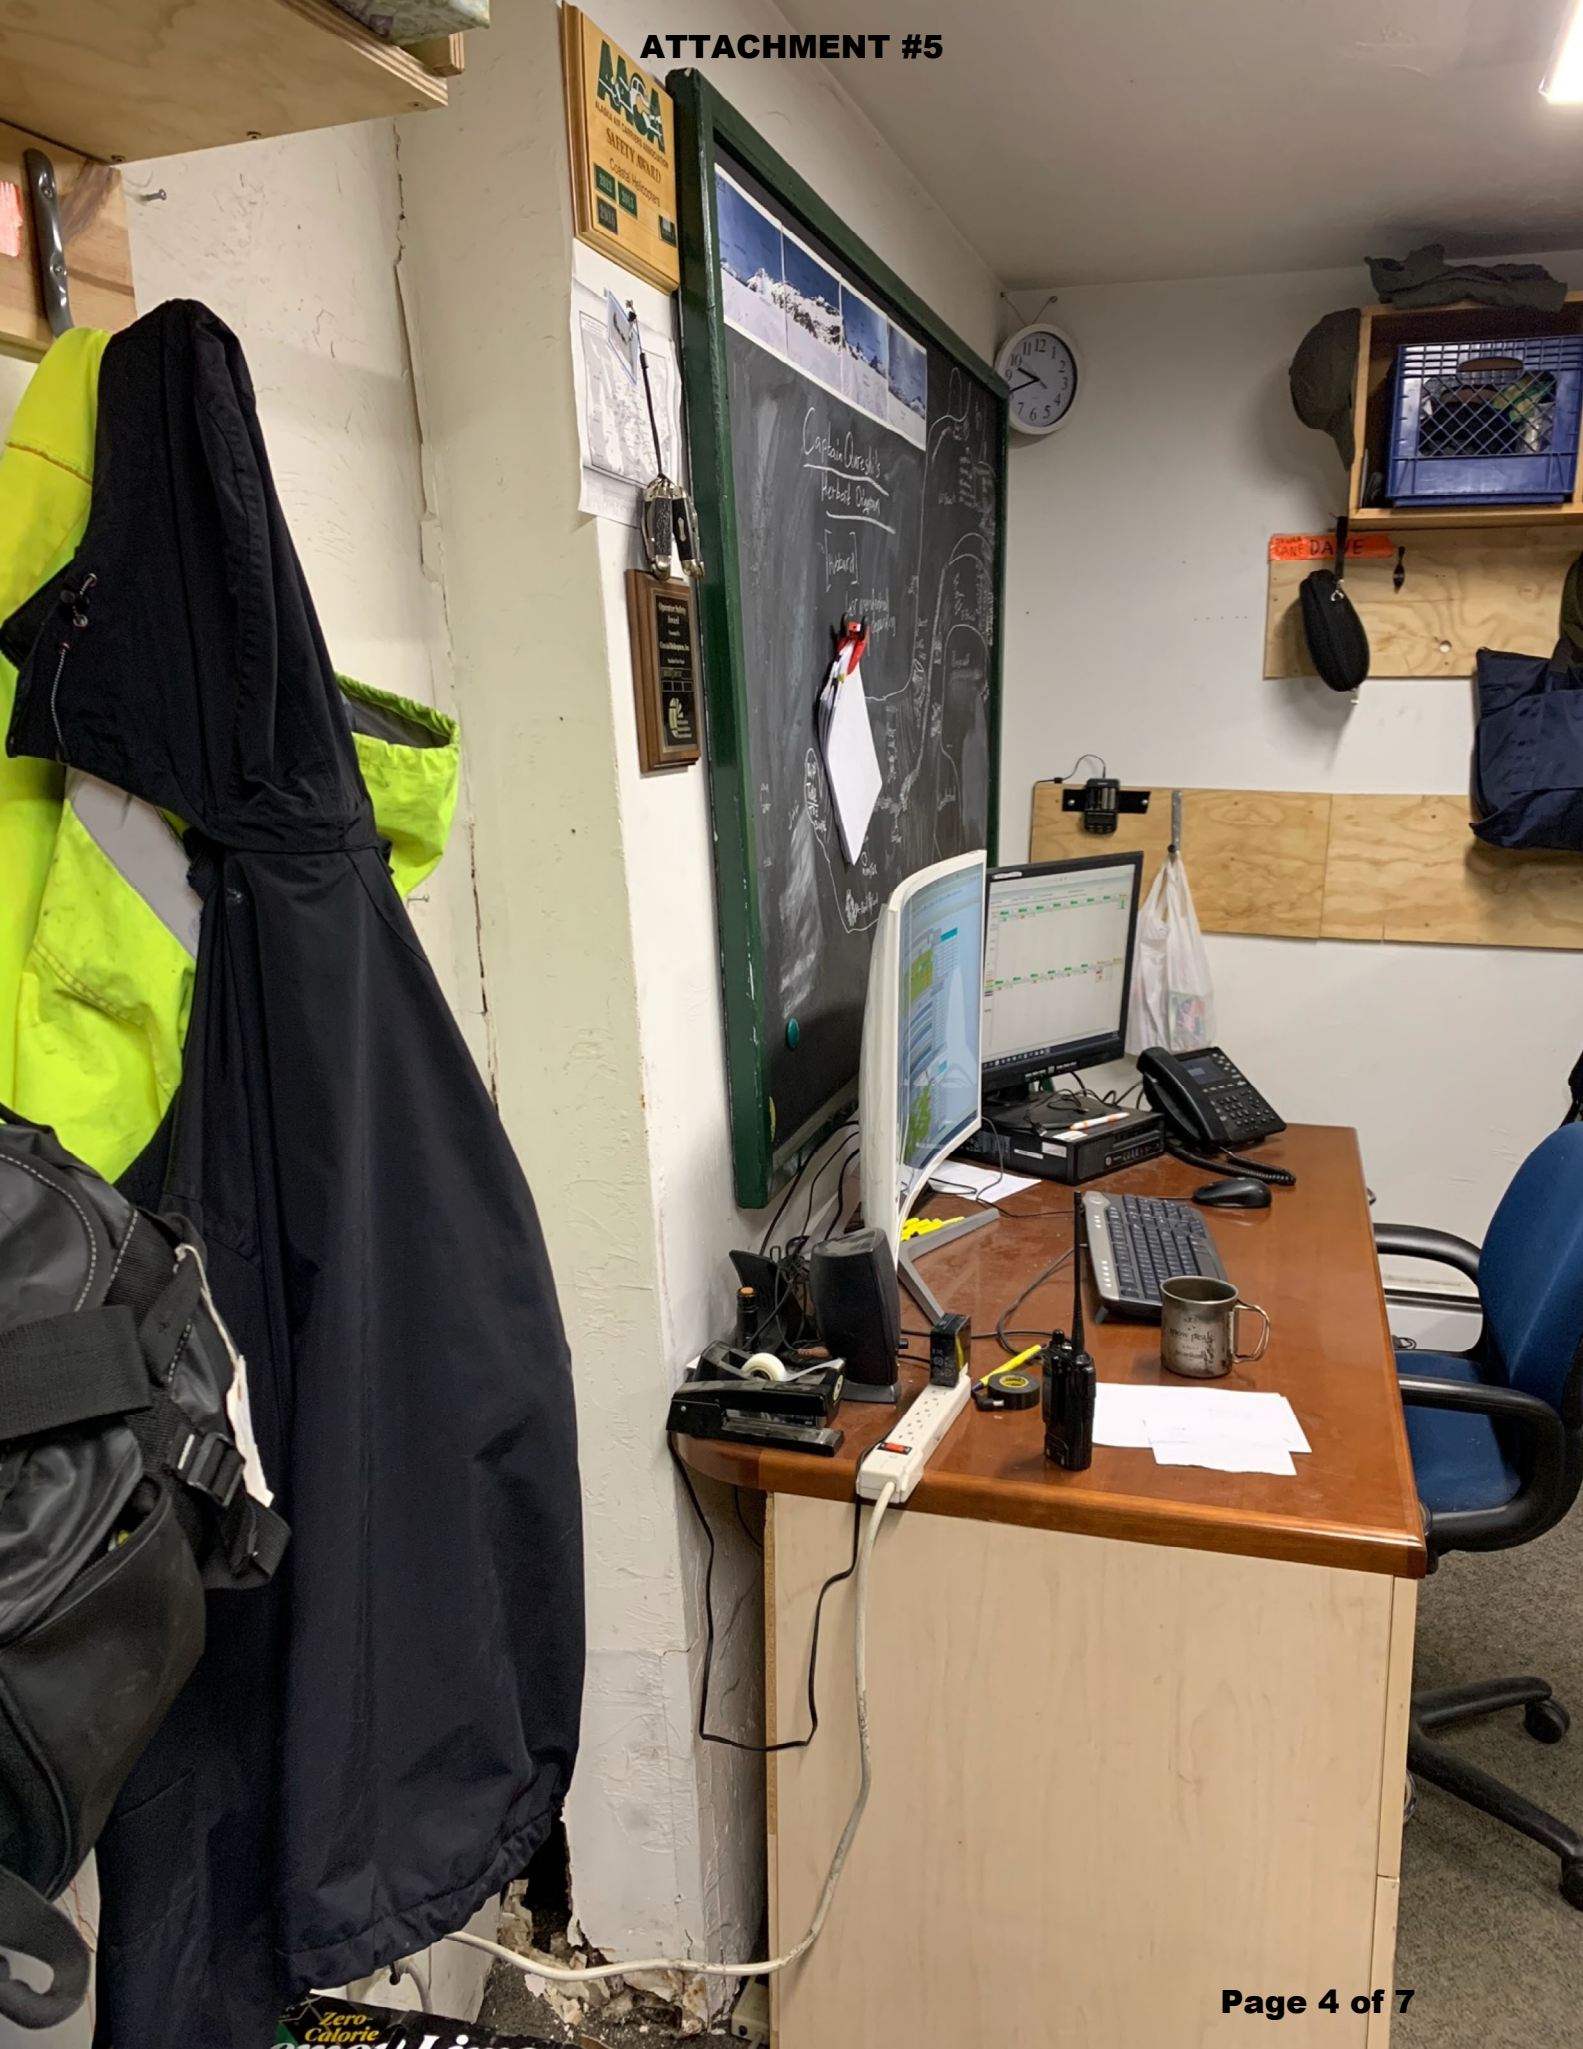
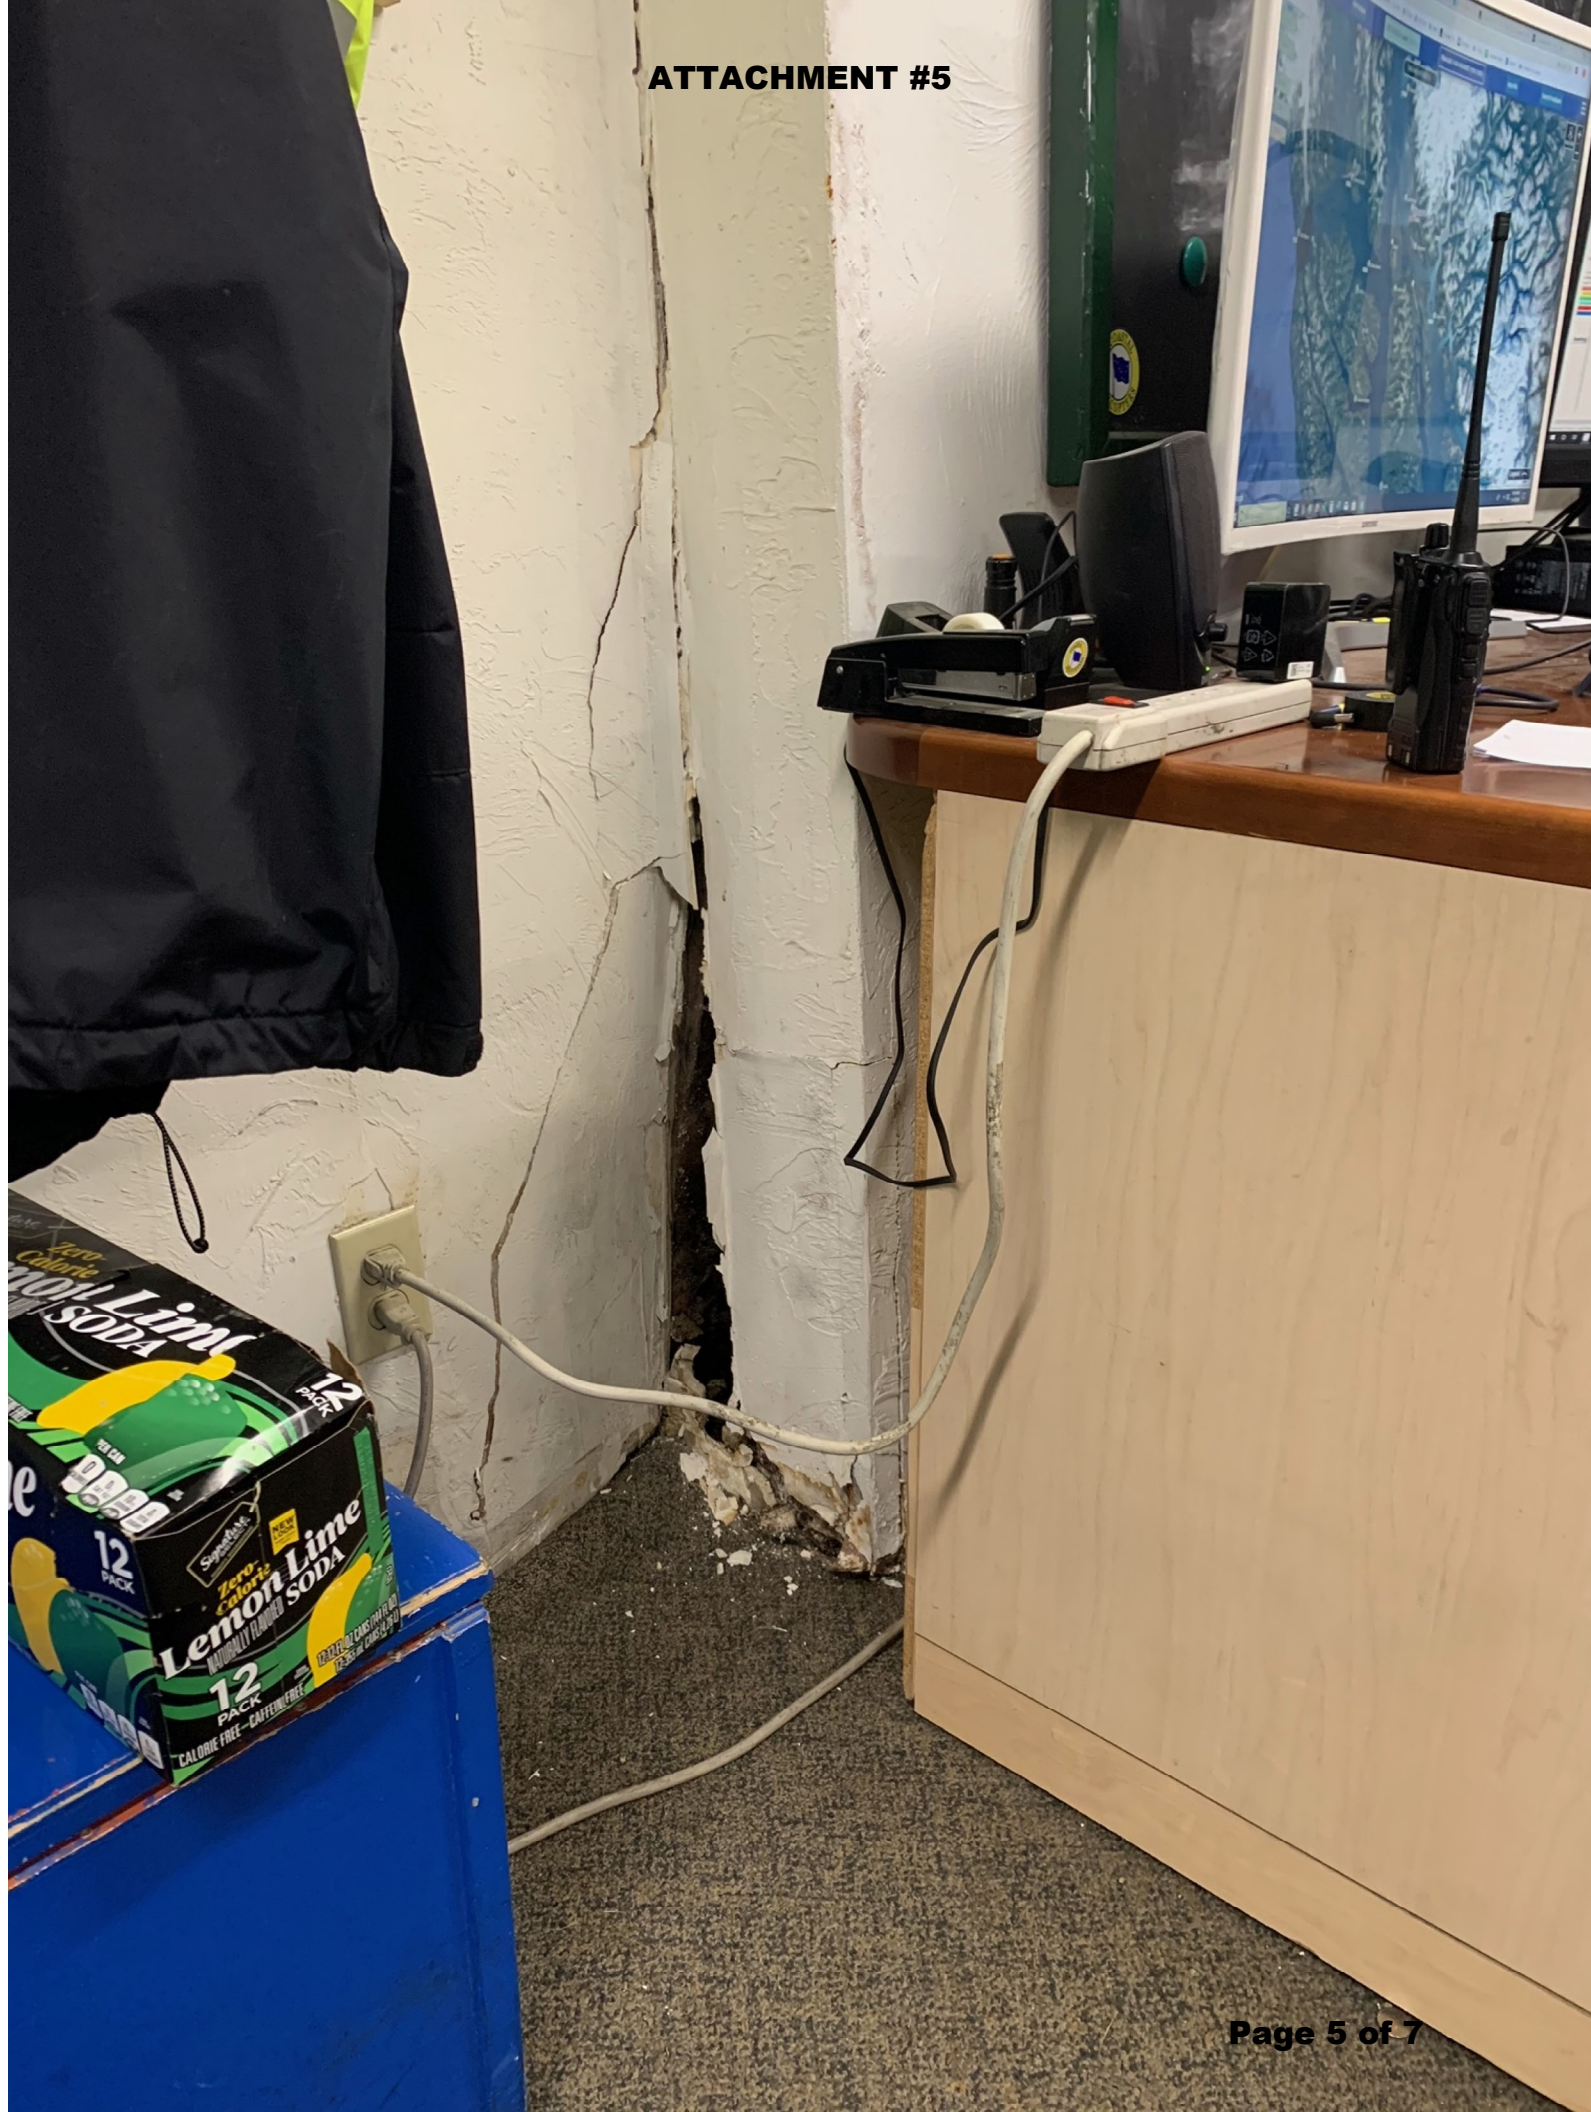
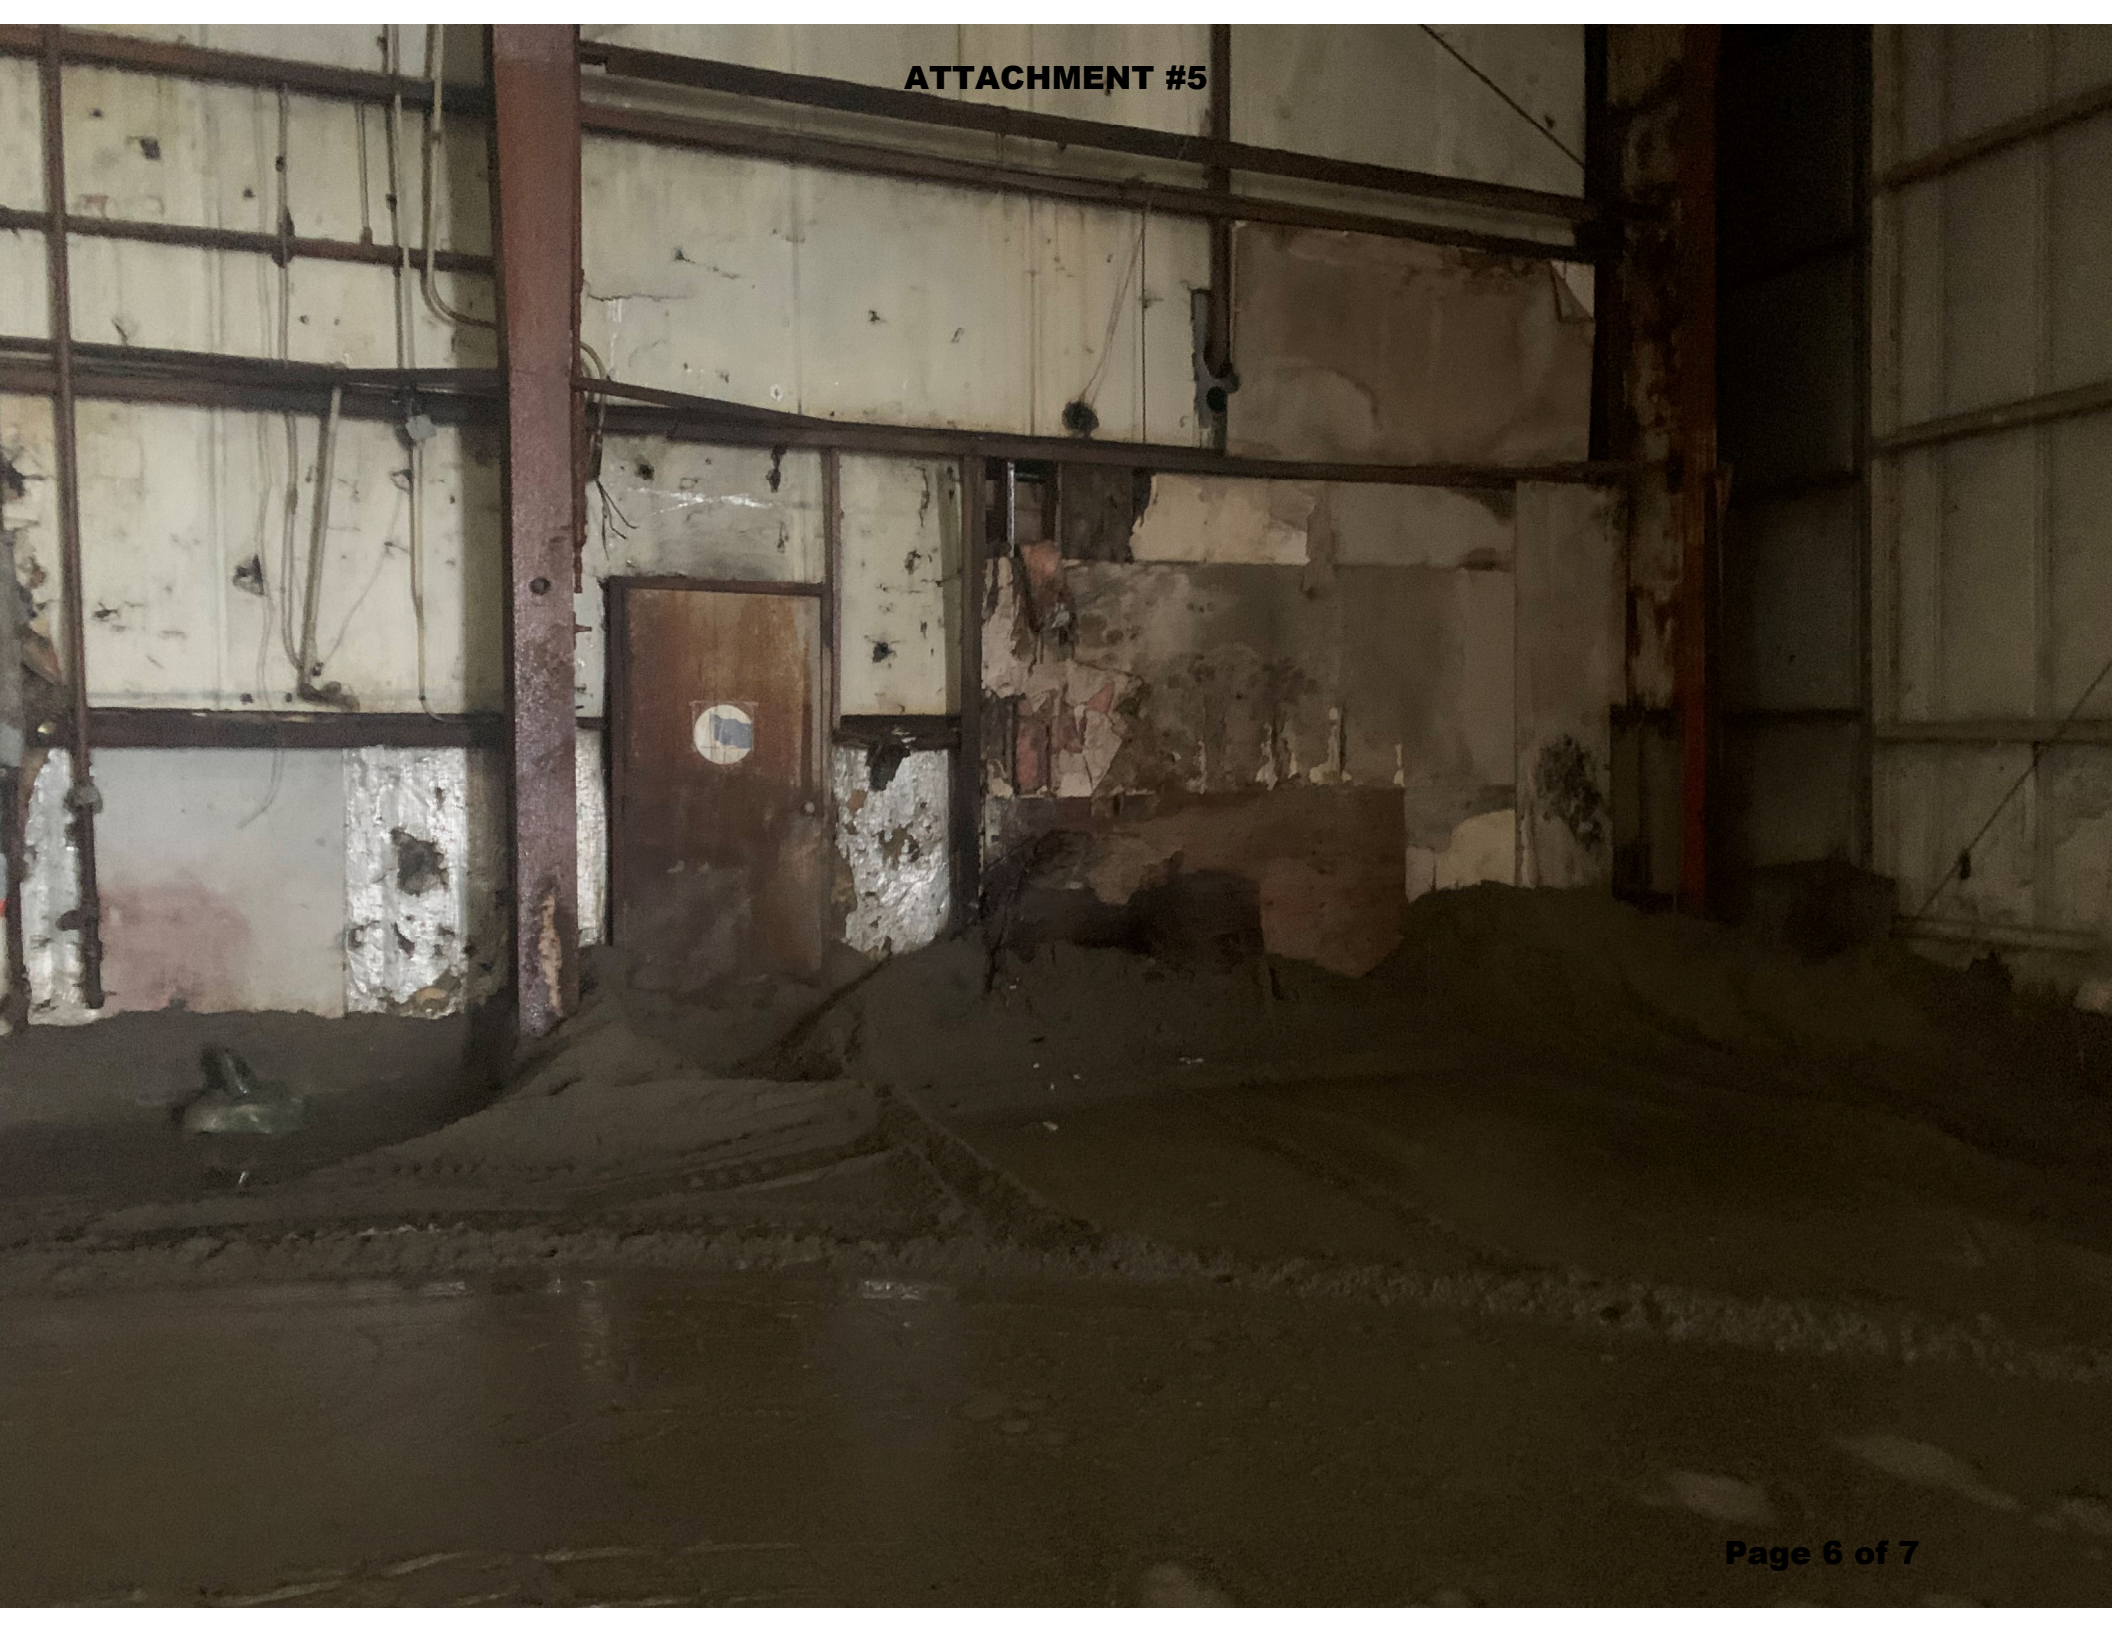
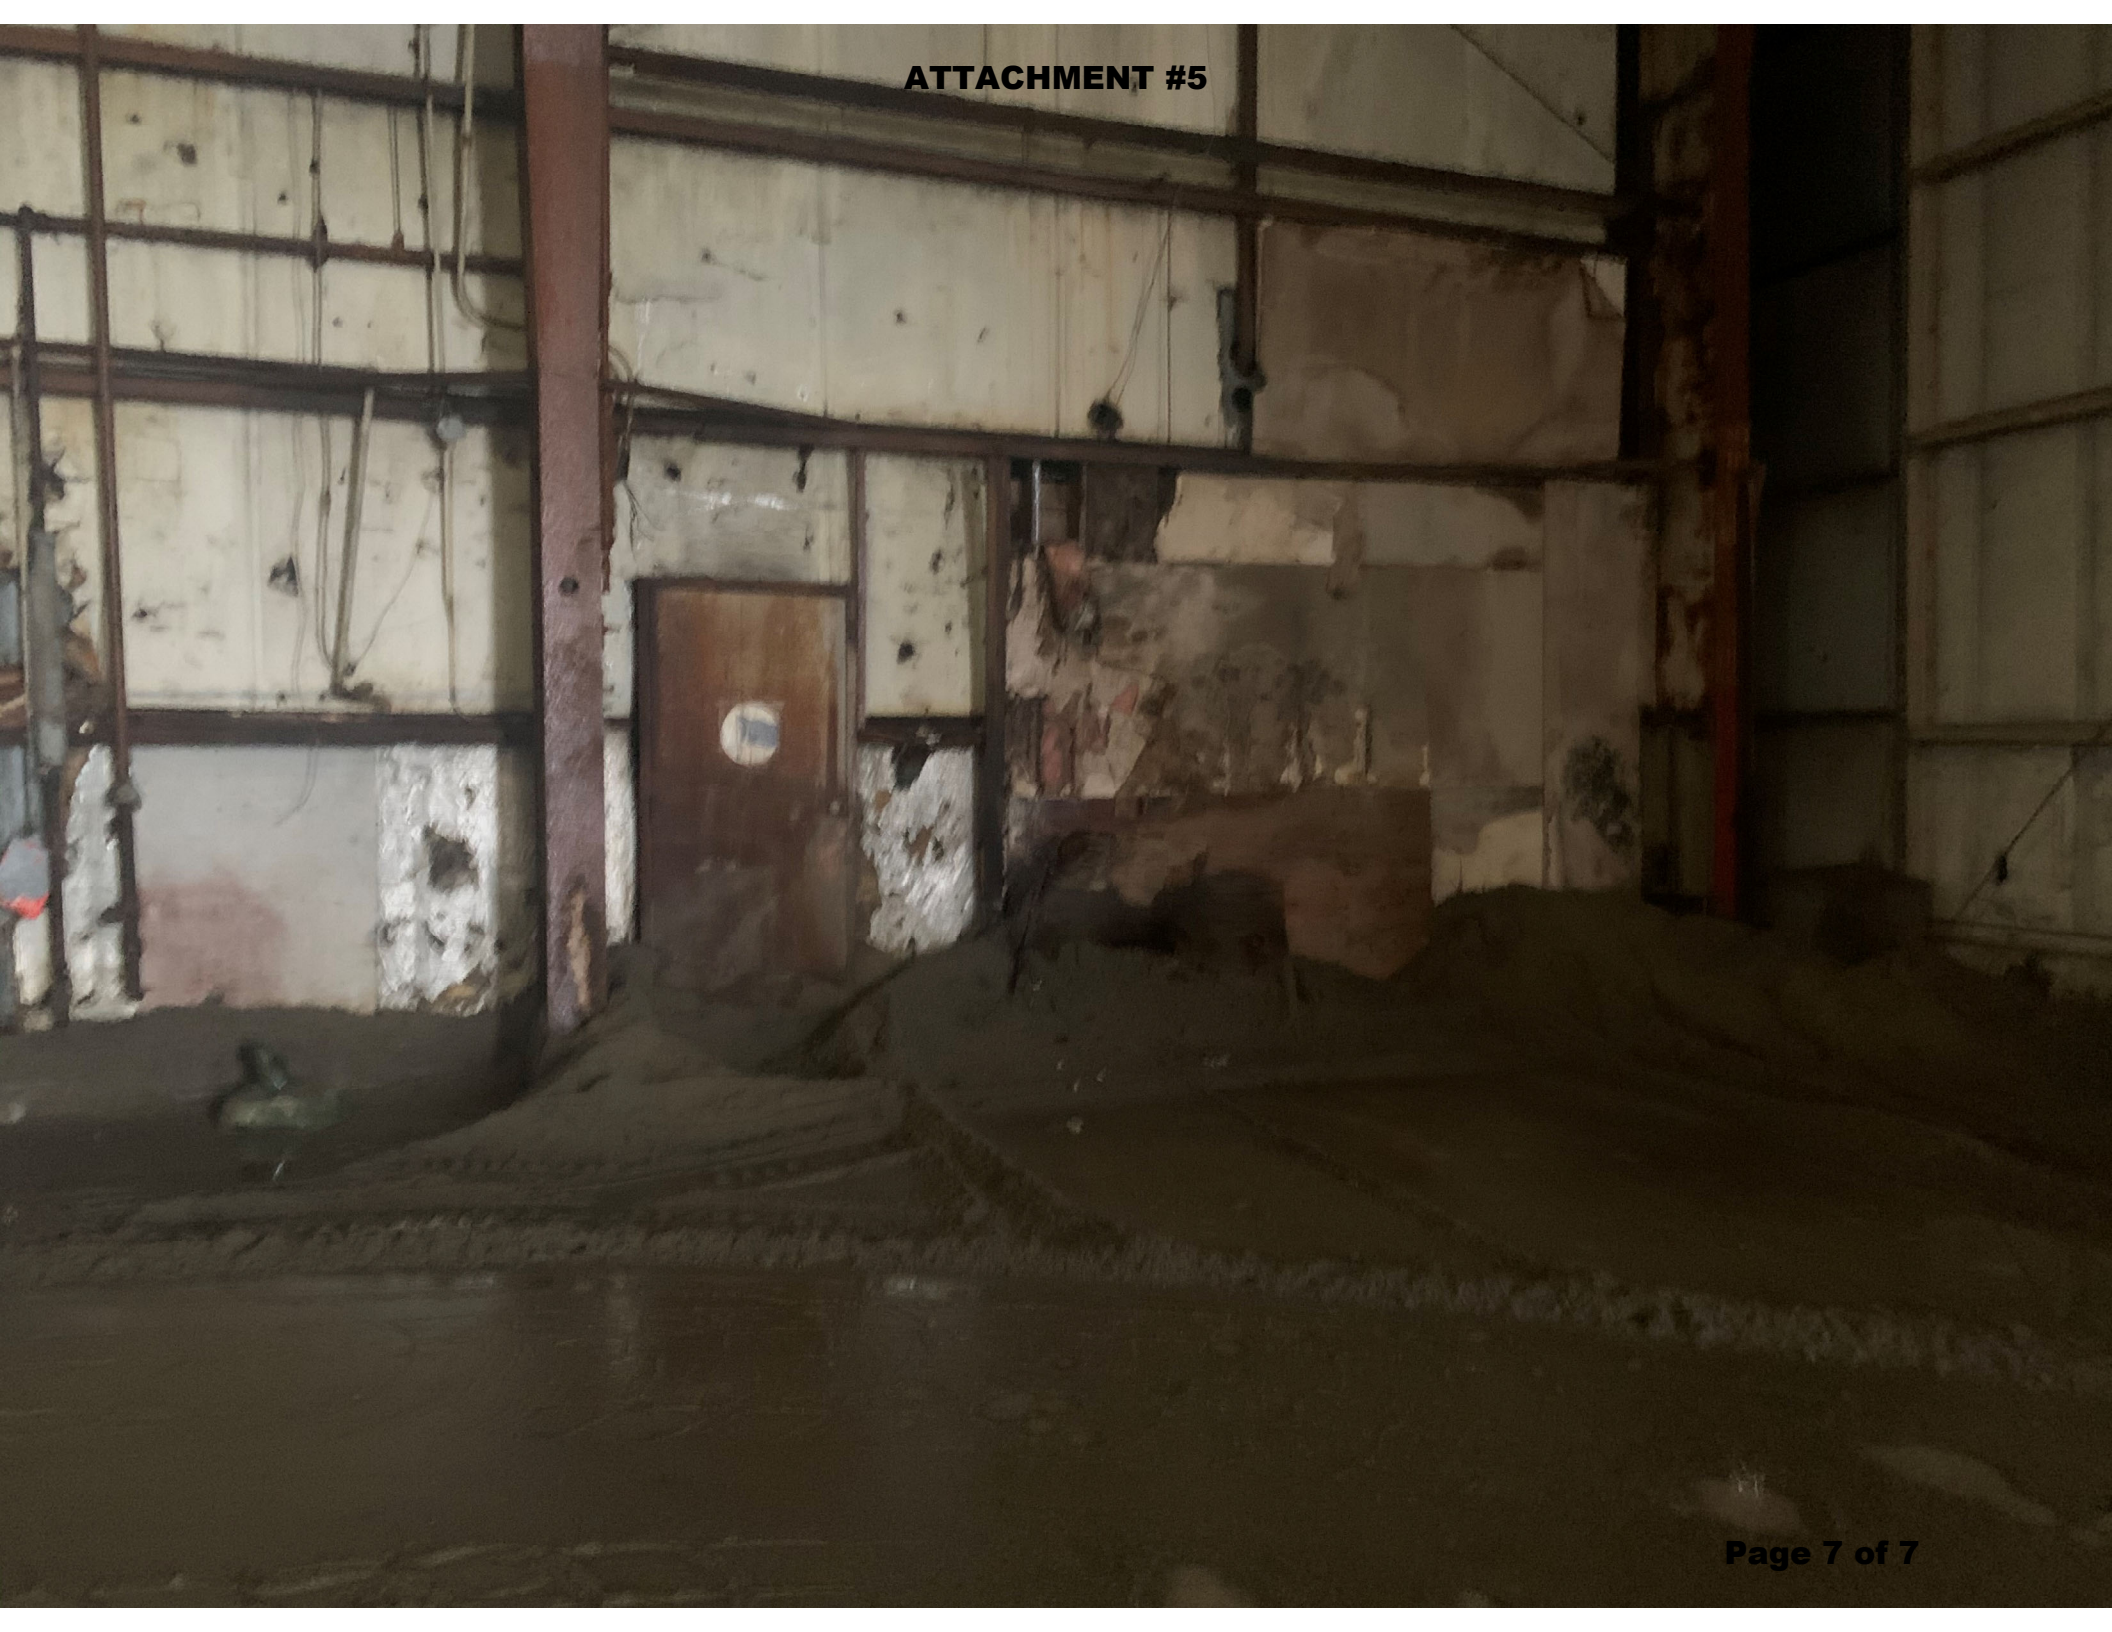
A portion of the west wall the borders the old sand hangar is structurally failing and pushing into the back room of the Coastal hangar.

The wall on the CBJ side has been impacted by something large (Loader most likely), Aral Loken (Channel Flying) and Mike Greene (CBJ) viewed and agreed this damage was done during the operation to remove from the CBJ hangar. The wall has a lumber structure built into it, not sure when it was done, most likely after 1974 but before 1989, the wood is rotten. There is a large impact area visible on the CBJ hangar wall and portions of the wall have come off. ...mw 11/4/19

JNU Airfield maintenance will close the holes in the wall to keep further damage from occurring from the CBJ side. Channel Flying (CHI) will use temporary repair methods to keep further damage from occurring through the winter. Spring (March or April) 2020 JNU will begin the process of removing the CBJ hangar, at that time full and proper repair to the wall will be completed....mw 11/4/19

CBJ hangar removed fall/winter/spring 2020/2021, interior walls repaired, still waiting for final repair of room in SW corner of hangar 9/13/2021...mw
