ATTACHMENT #1**Report Title: Coastal Safety Reporting Form Lite****Header Information****Event Date/Time** 11/06/2019 03:46 GMT **Name (Optional)****Detailed description of the Hazard / Incident / Event / Concern**

Hangar wall damage

A portion of the west wall the borders the old sand hangar is structurally failing and pushing into the back room of the Coastal hangar.

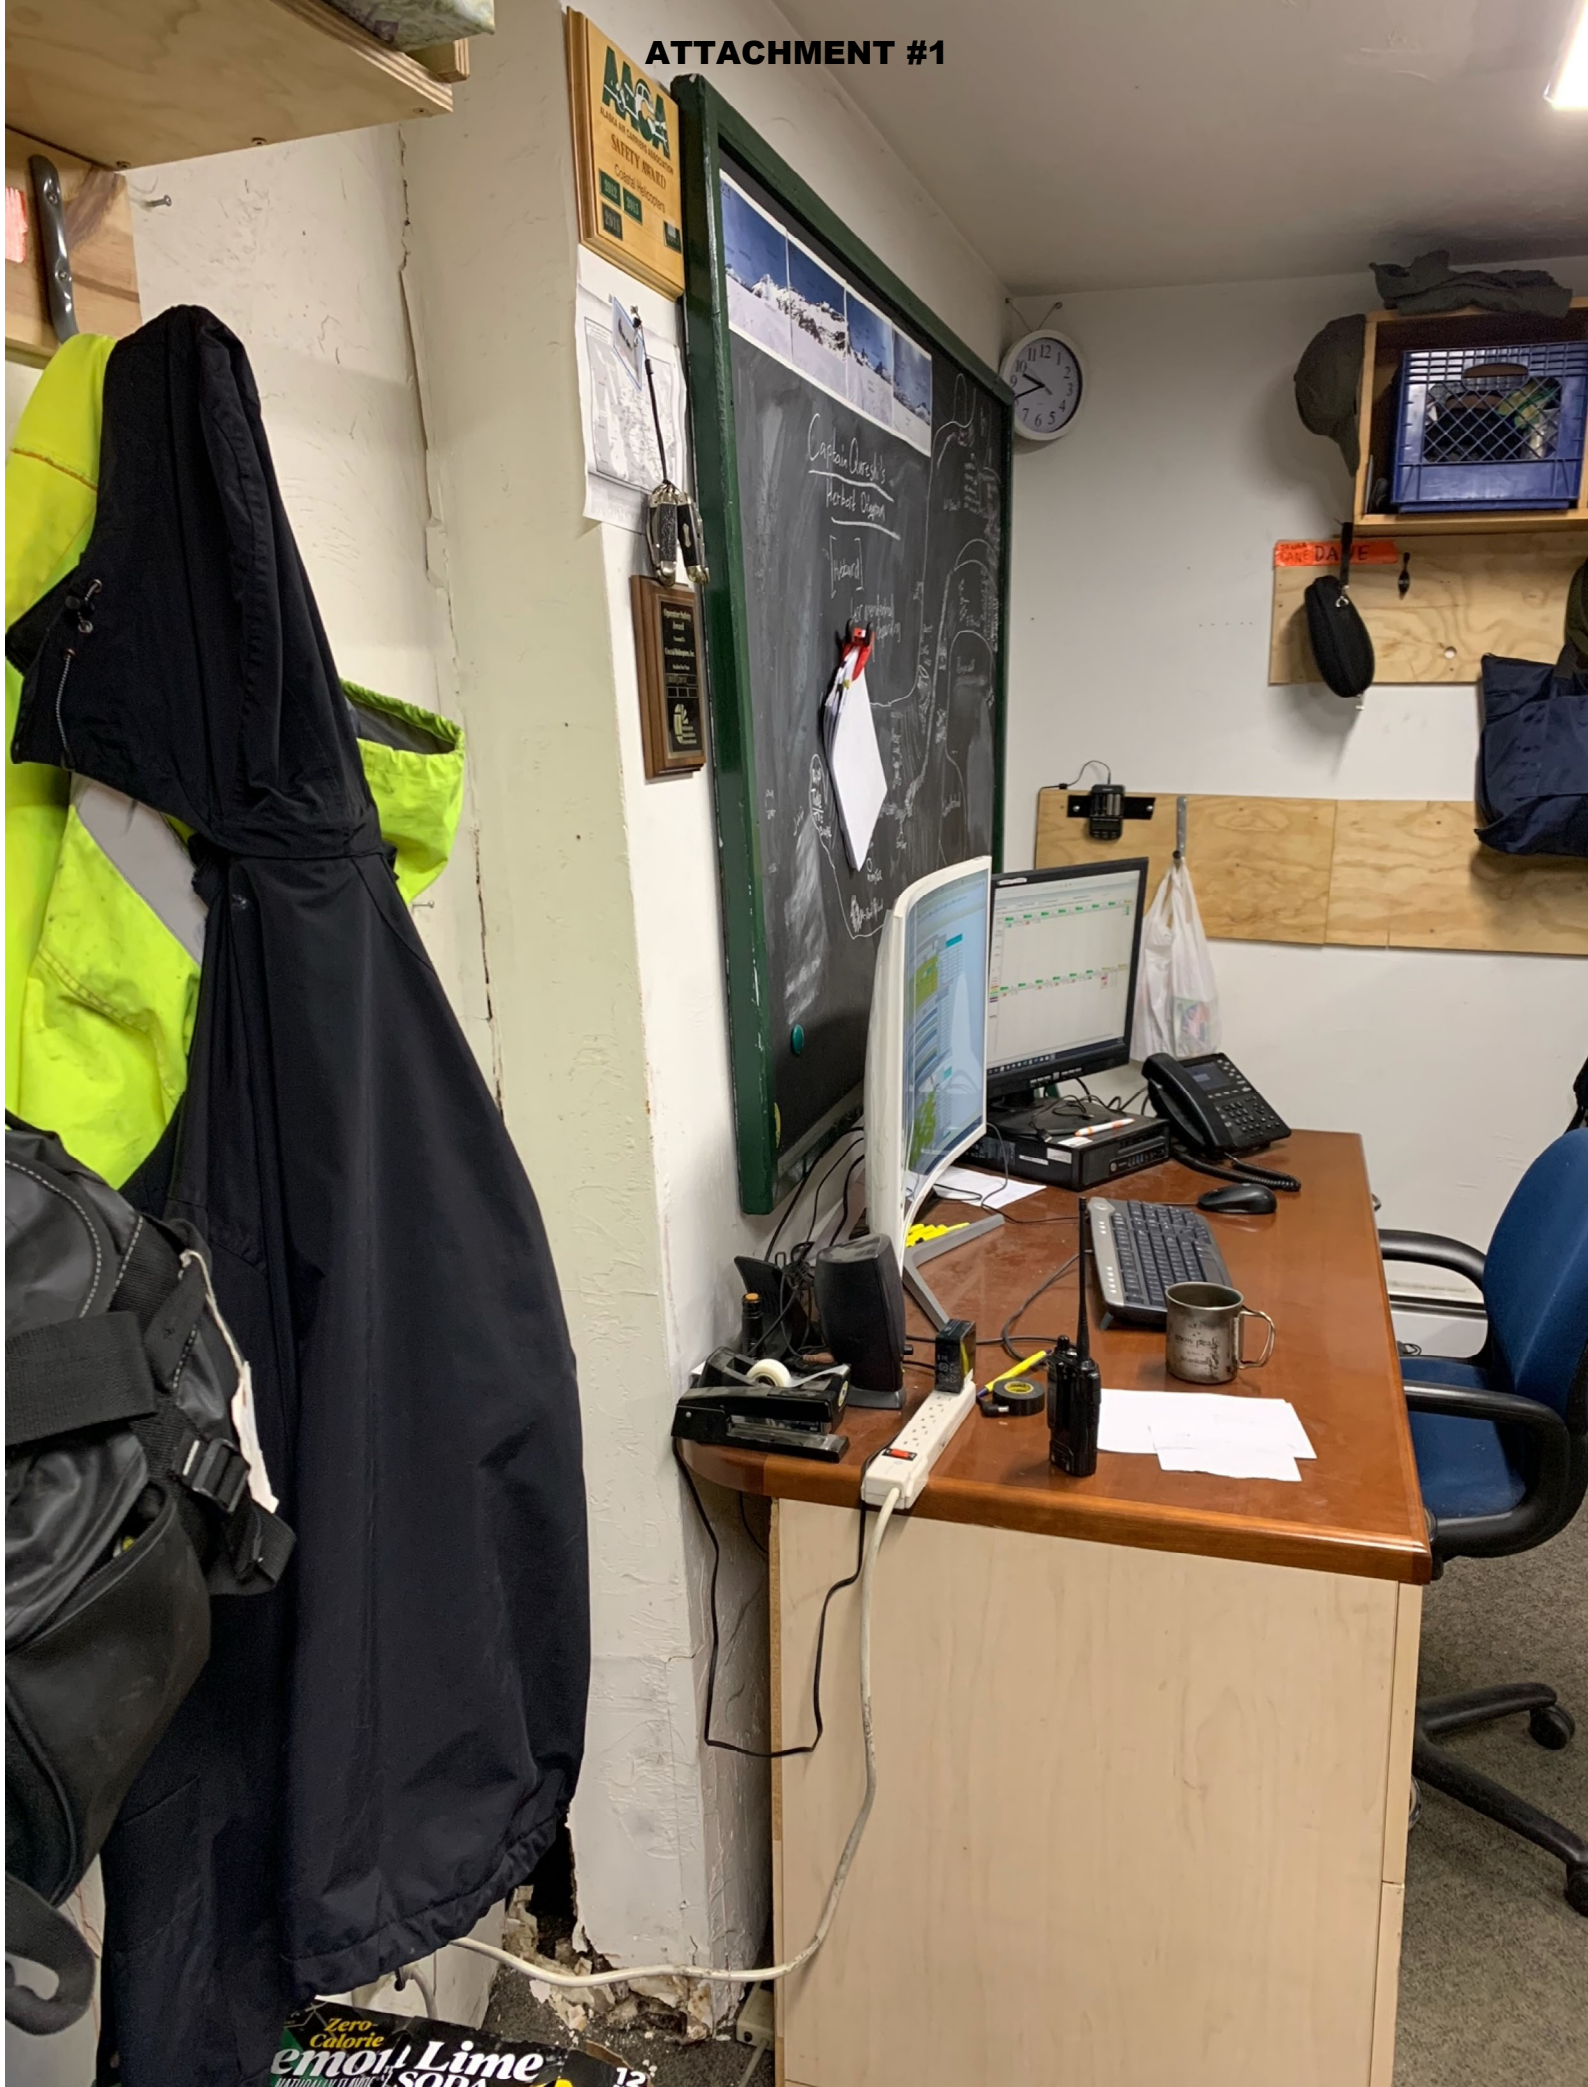
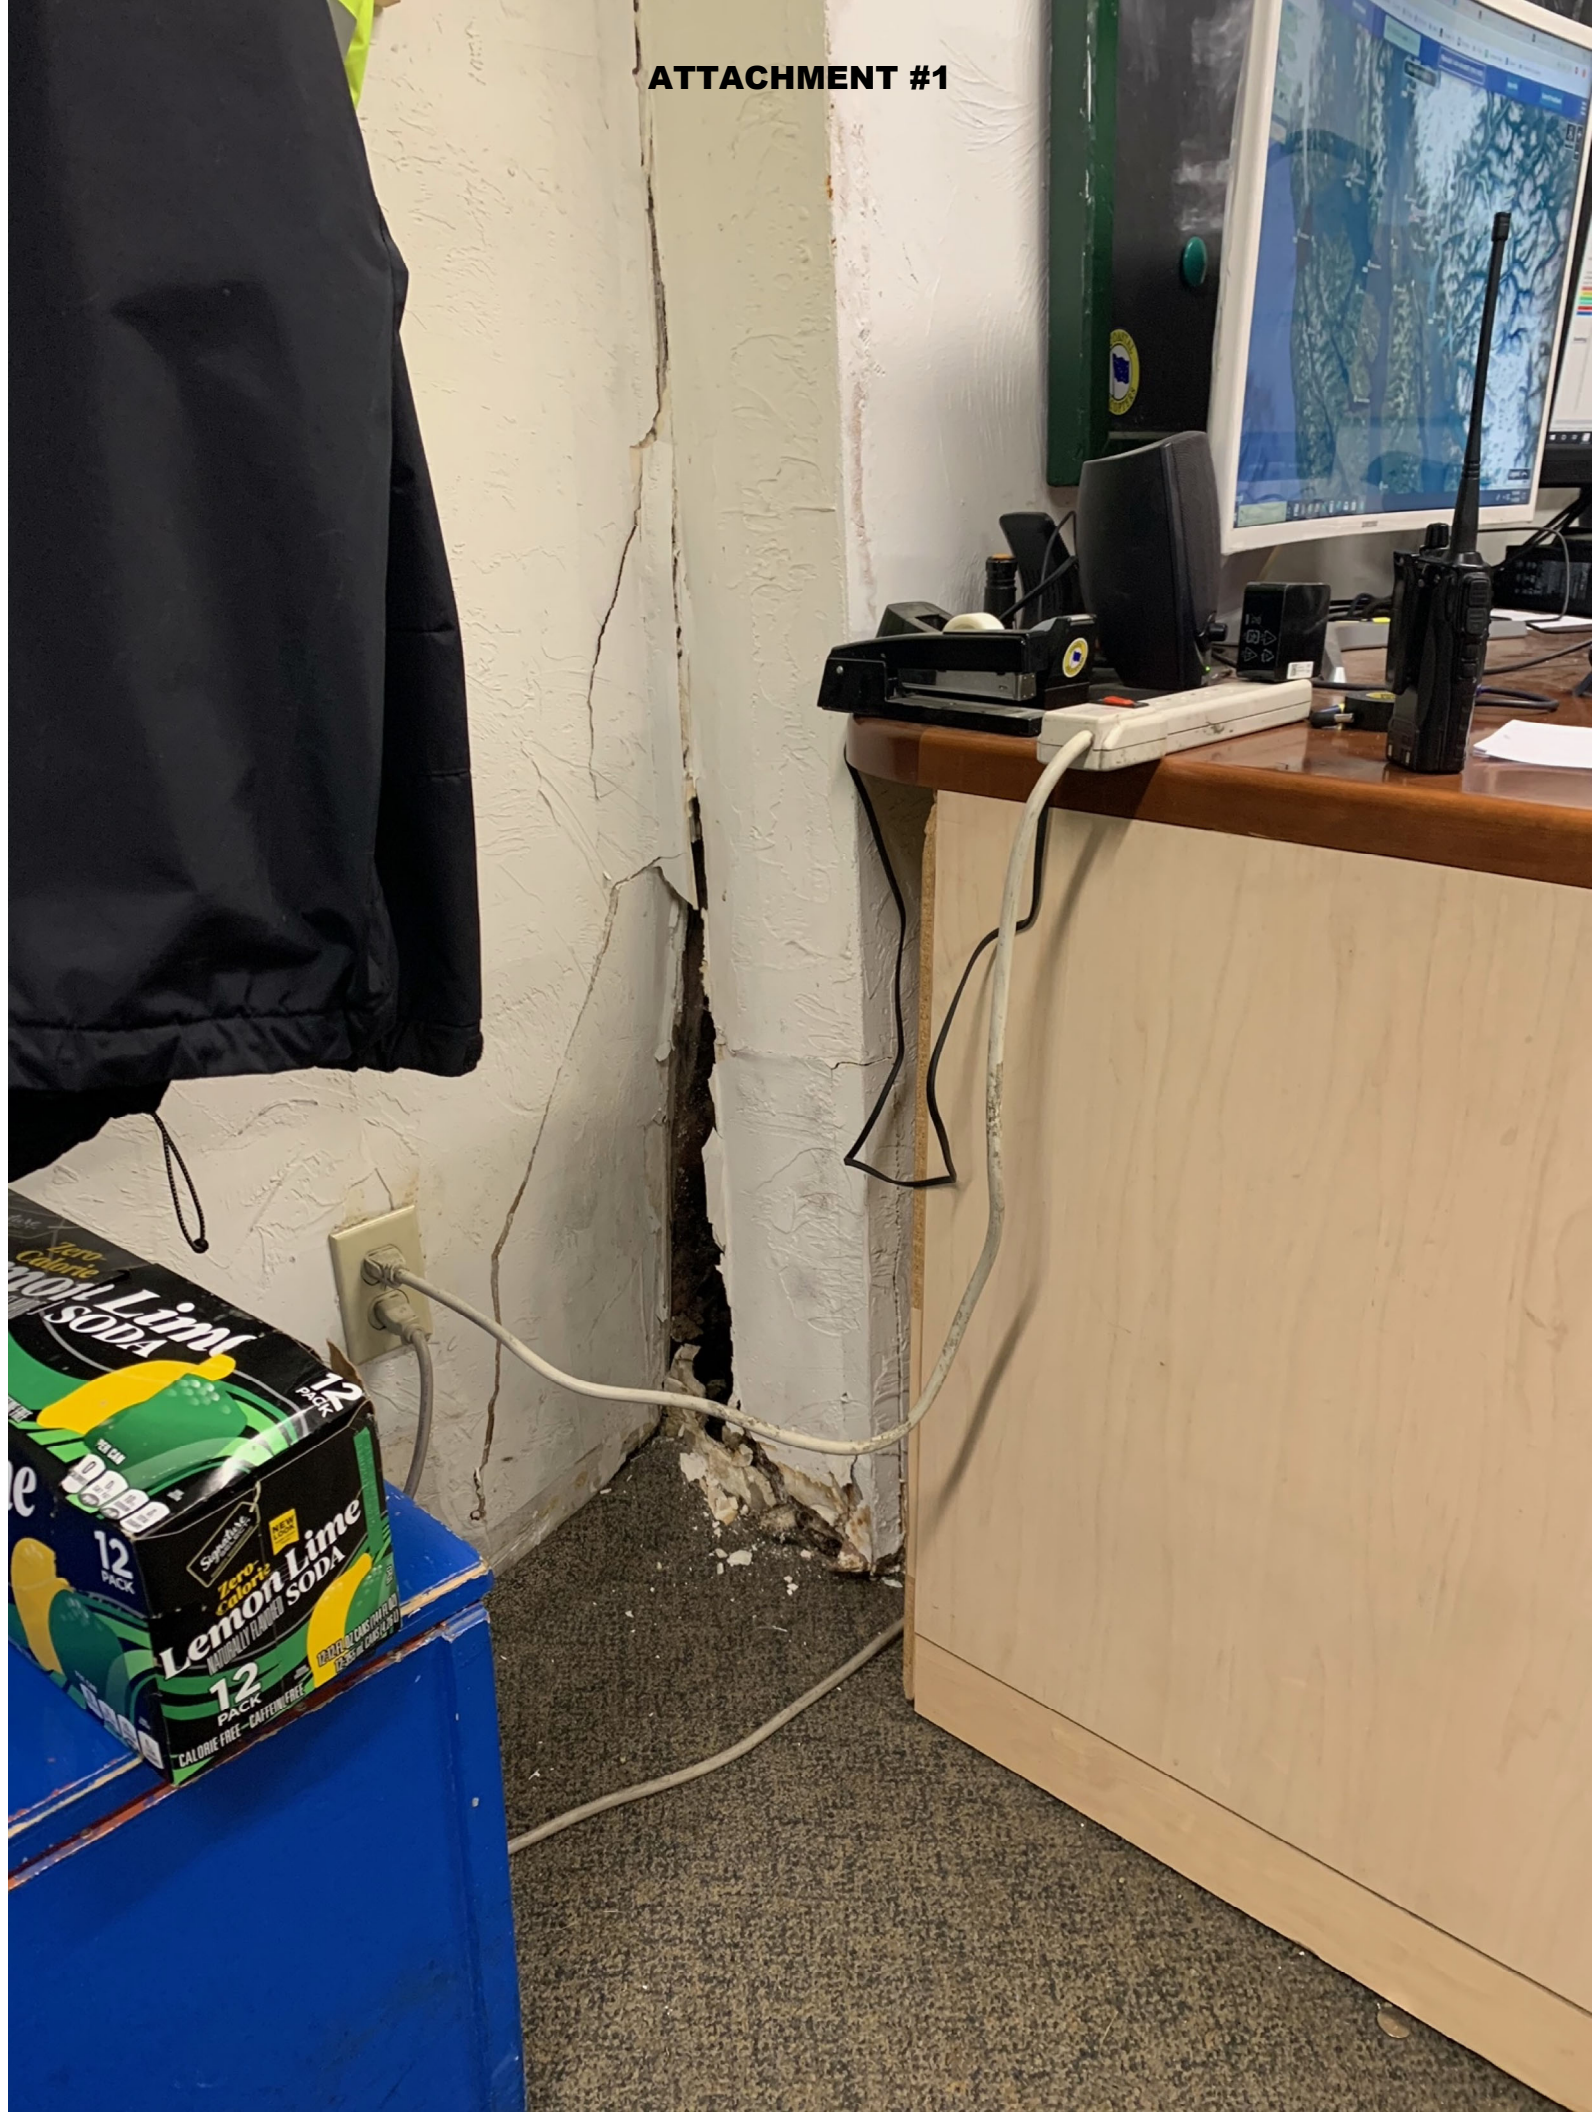
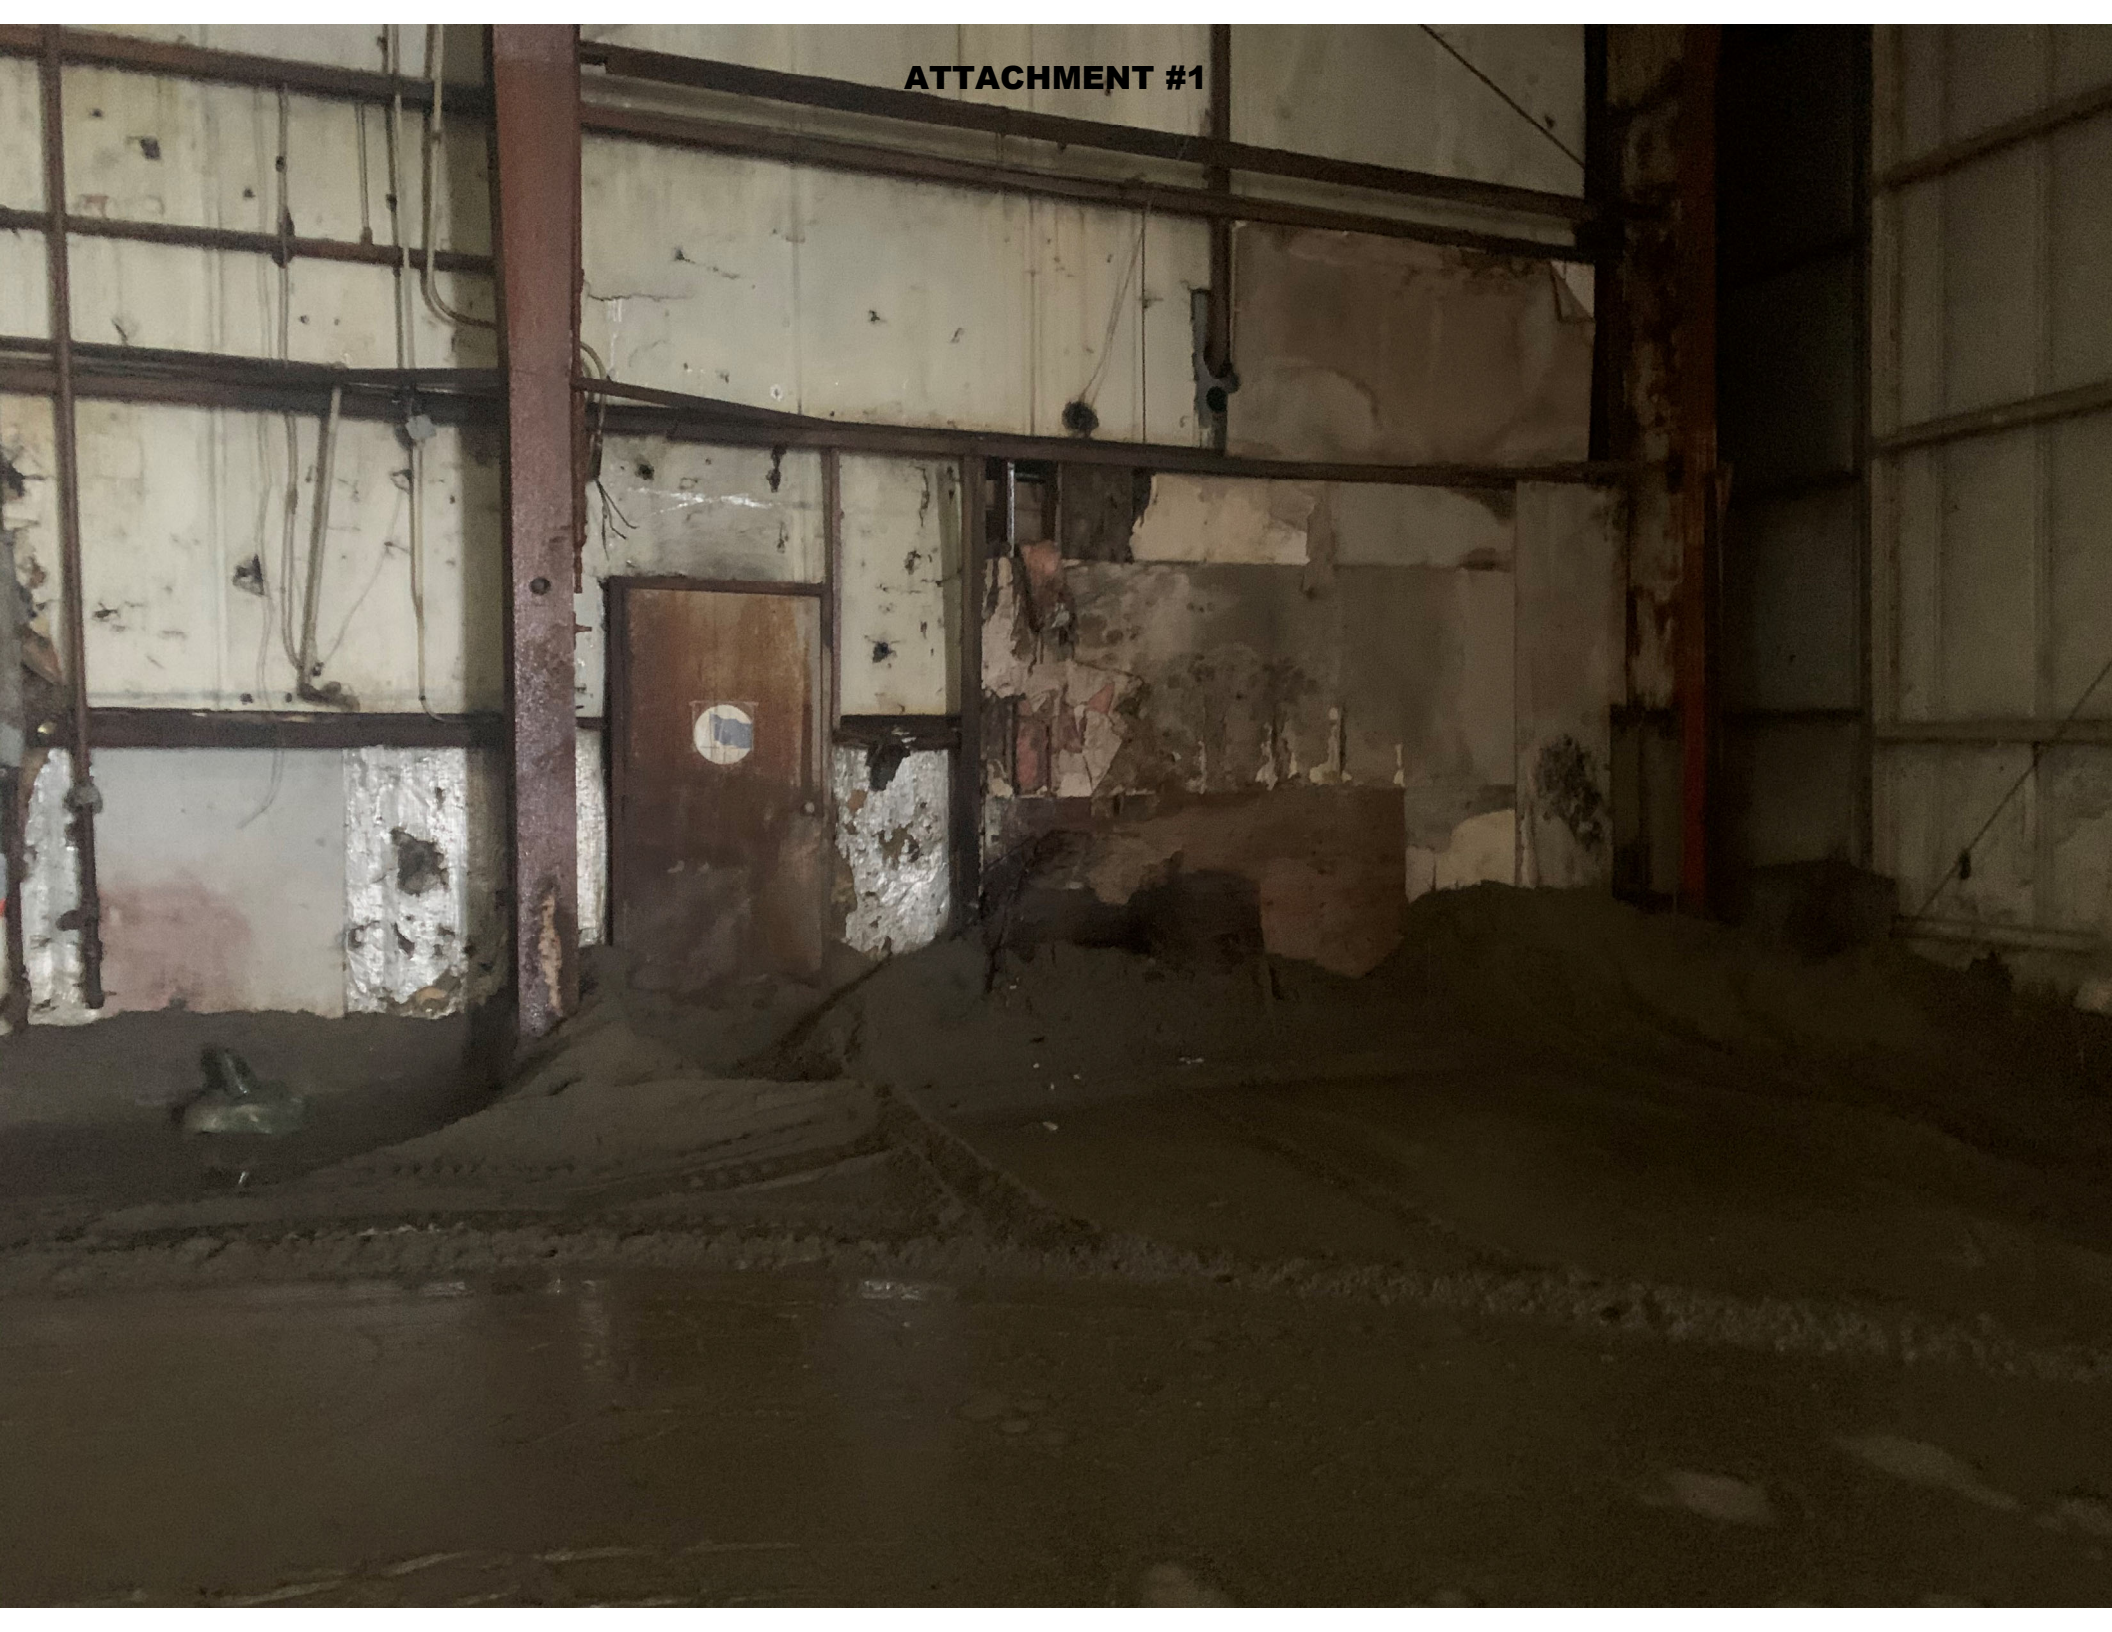
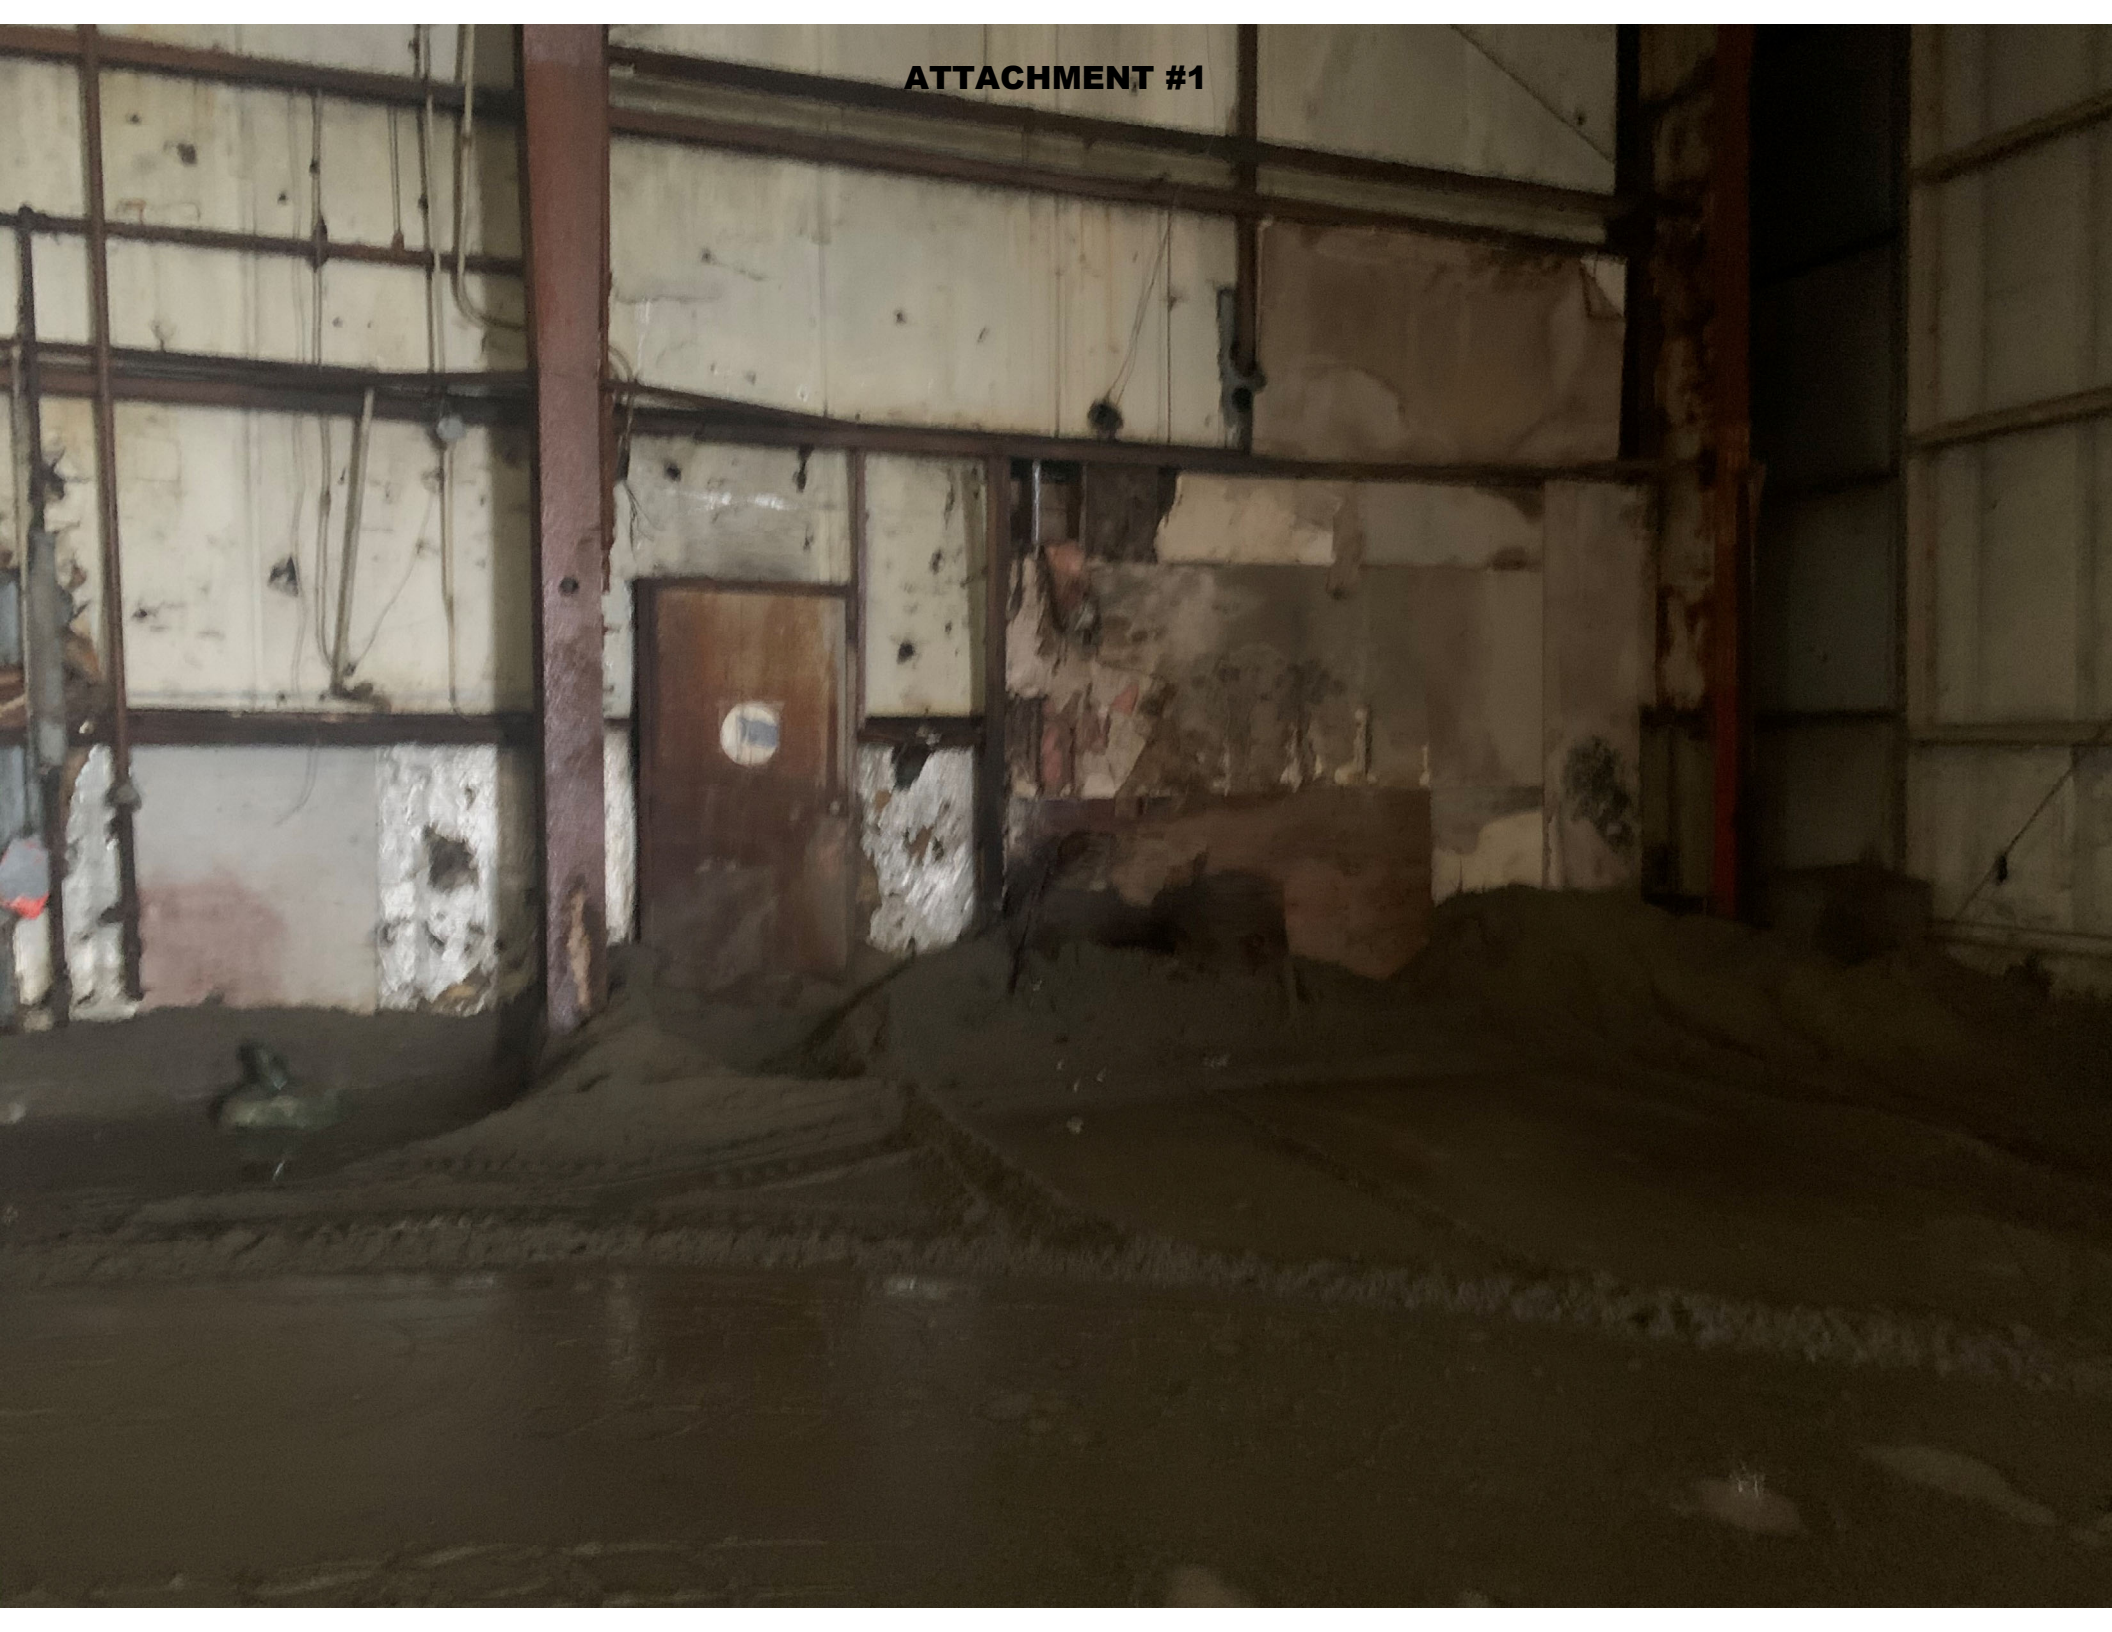
The wall on the CBJ side has been impacted by something large (Loader most likely), Aral Loken (Channel Flying) and Mike Greene (CBJ) viewed and agreed this damage was done during the operation to remove from the CBJ hangar. The wall has a lumber structure built into it, not sure when it was done, most likely after 1974 but before 1989, the wood is rotten. There is a large impact area visible on the CBJ hangar wall and portions of the wall have come off. ...mw 11/4/19

JNU Airfield maintenance will close the holes in the wall to keep further damage from occurring from the CBJ side. Channel Flying (CHI) will use temporary repair methods to keep further damage from occurring through the winter. Spring (March or April) 2020 JNU will begin the process of removing the CBJ hangar, at that time full and proper repair to the wall will be completed....mw 11/4/19

CBJ hangar removed fall/winter/spring 2020/2021, interior walls repaired, still waiting for final repair of room in SW corner of hangar 9/13/2021...mw
