## ATTACHMENT #2

To: Jeannie Johnson, JNU Manager August 2, 2012  
From: Thomas G. Carson, JNU Engineer File: 1603.13  
Re: JNU RSA Improvements Project Update

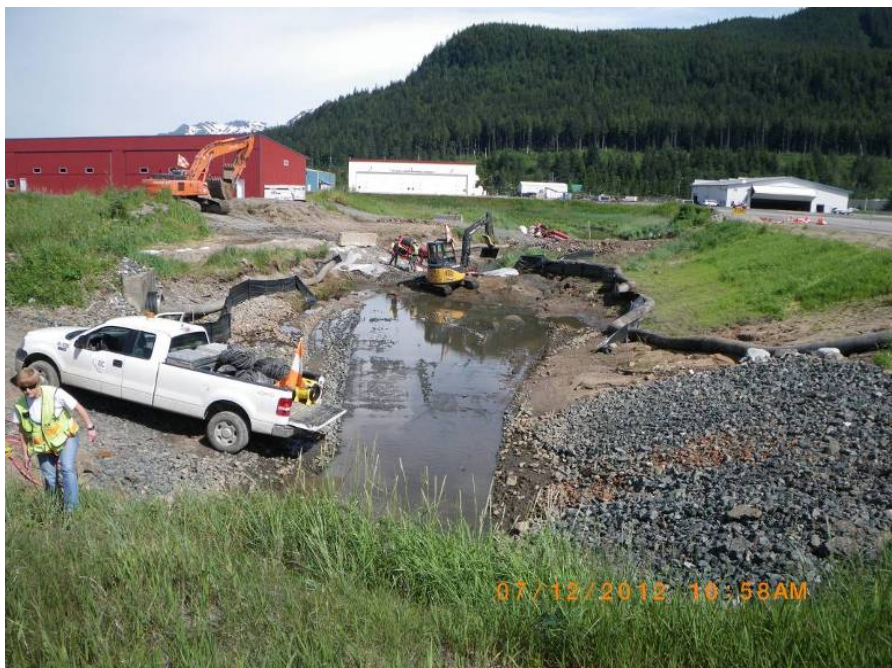
**This image, taken on July 12, shows the successful water control approach for allowing work inside the Jordan Creek culvert.**

- Water elevation in the pond ranged from 16' to 17' during July, with no need to pump water from the Mendenhall River.
- During the first part of July, AIC focused on punch list work, finishing the majority of the identified items.
- Throughout July, AIC worked on the Jordan Creek culvert repair. By the end of the month, they had successfully maintained control of Jordan Creek, cleaned the old culvert, installed the new 7' diameter sleeve, and installed the annular "bulkheads" at each end of the new culvert to seal the space between the old and new pipes. Grouting began on July 31 and is anticipated to be complete by August 3.

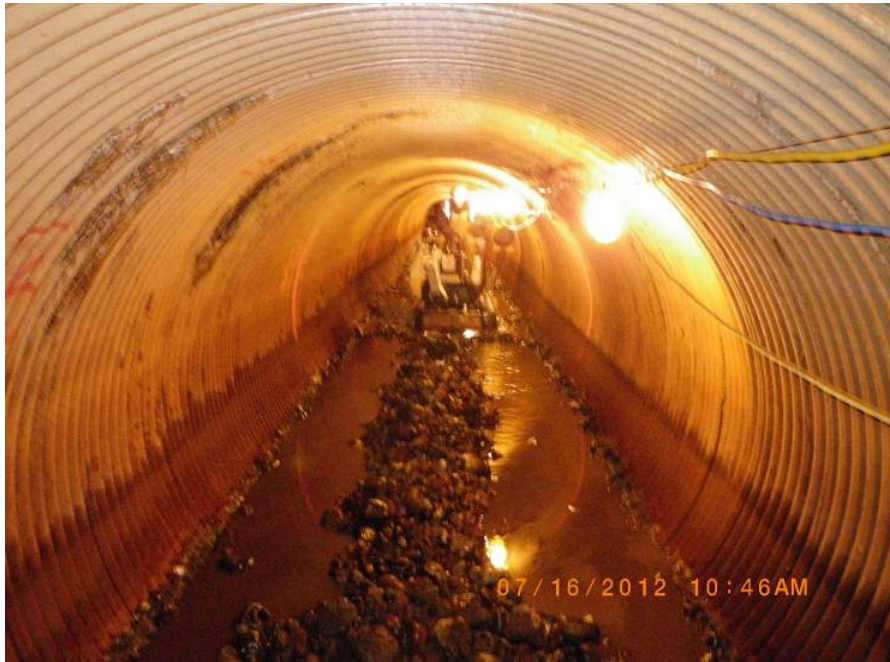
**This image, taken on July 16, shows the operation undertaken inside the old culvert to remove gravel and sediment using a mini-excavator and a mini-track dump truck.**

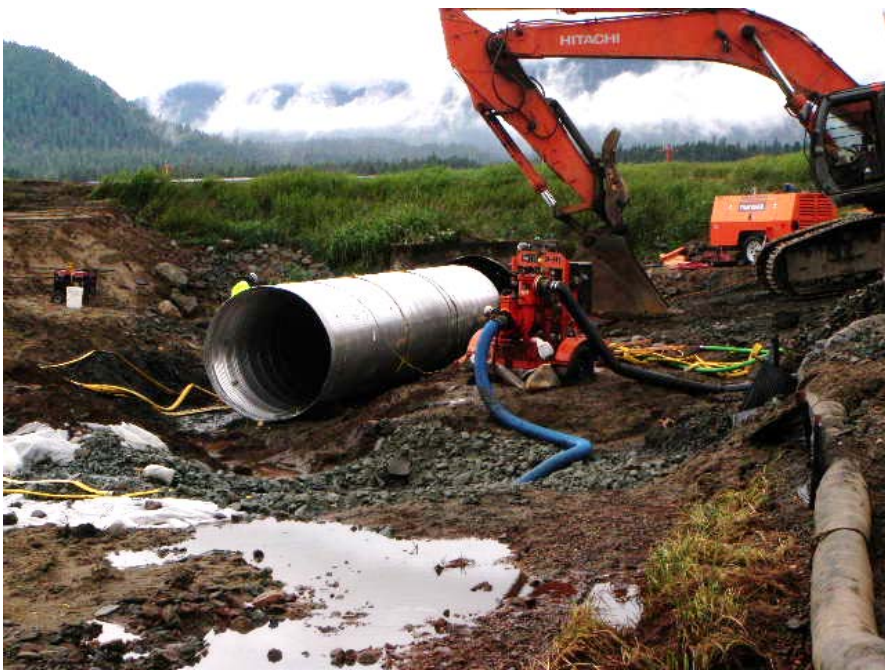
**This image, taken on July 27, shows the first 40' section of culvert being positioned for installation into the existing Jordan Creek culvert. By July 29, all three sections were successfully installed. Grouting began on July 31.**
