# MEMORANDUM

**State of Alaska**  
Department of Fish and Game  
Division of Habitat

SUBJECT: Jordan Creek greenbelt  
Trip Report  
August 21, 2015

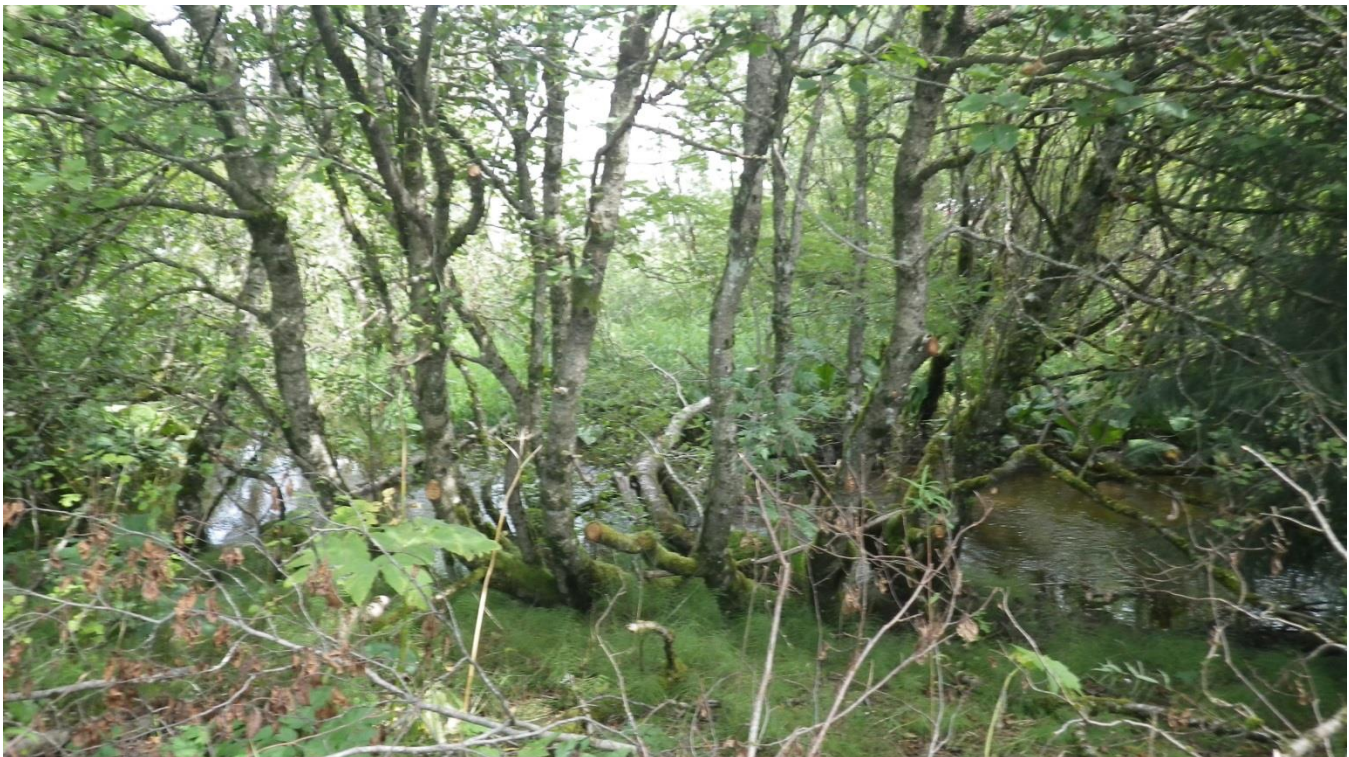
Figure 1.–Streamside alder limbing along the main channel.

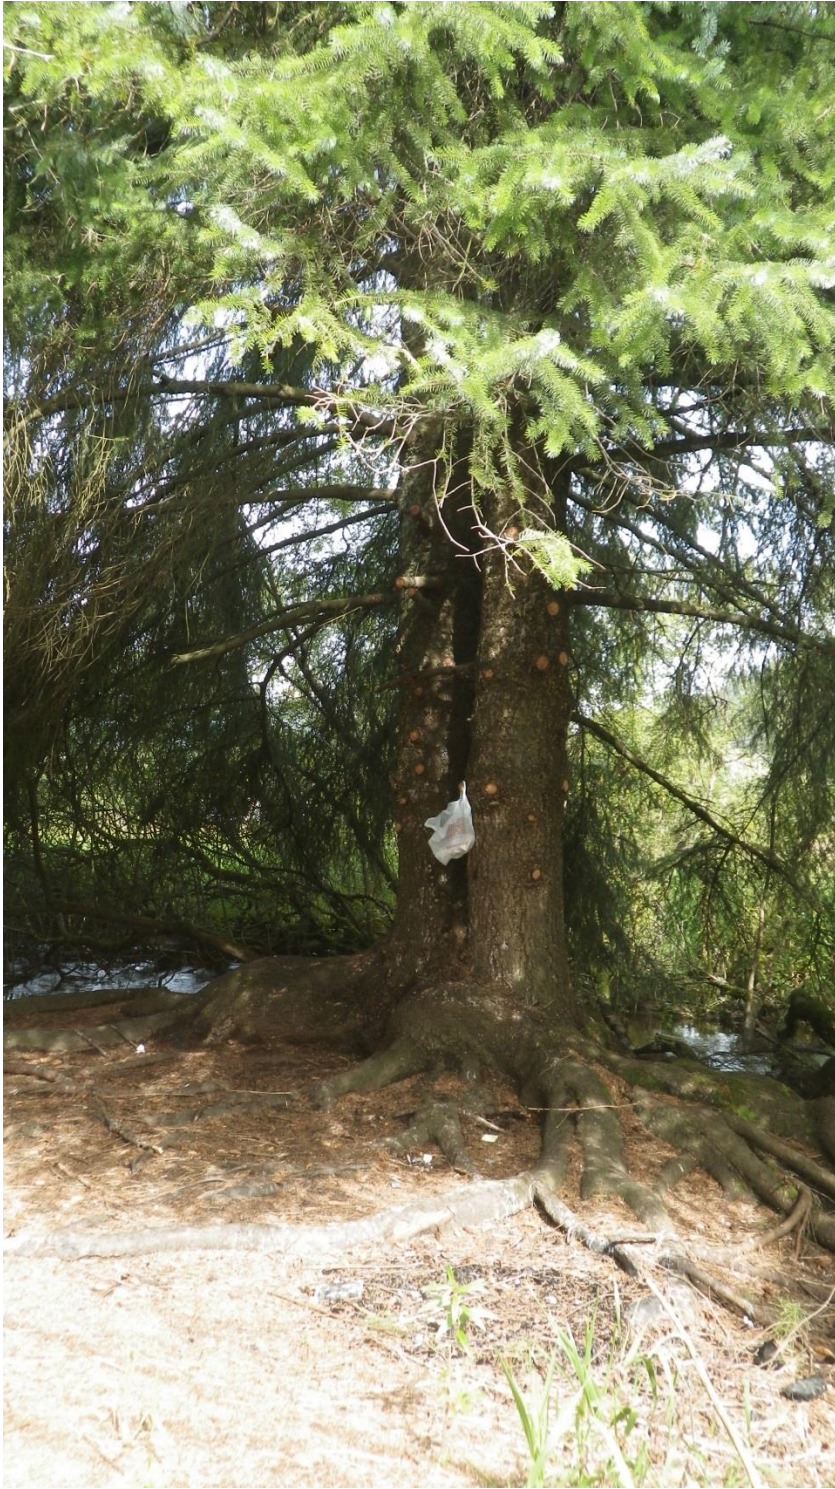
Figure 2.—Limbs from this tree previously overhung the trail and concealed a campsite. Creek remains shaded in the background.

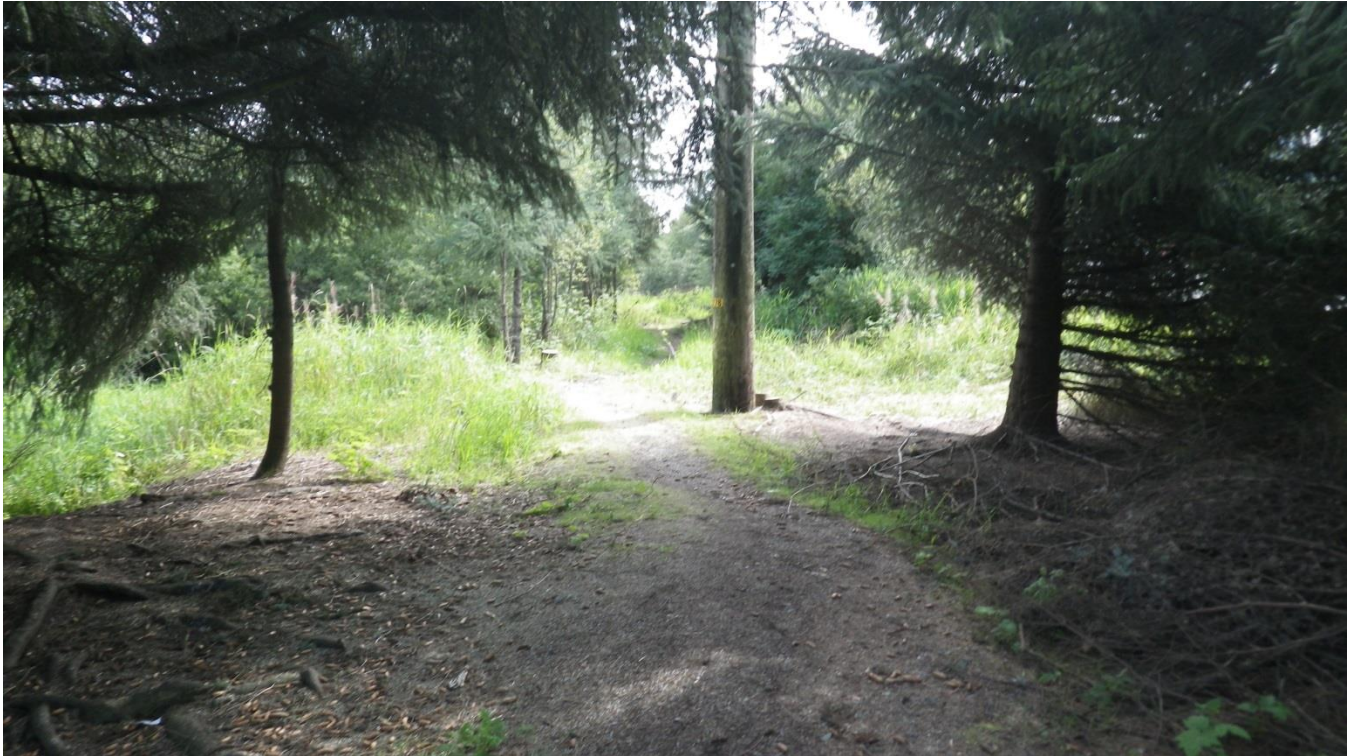
Figure 3.–Picture showing trail limbing (foreground) and the removal of three spruce trees by Alaska Energy, Light, and Power to maintain power line easement. Creek is immediately to the left.

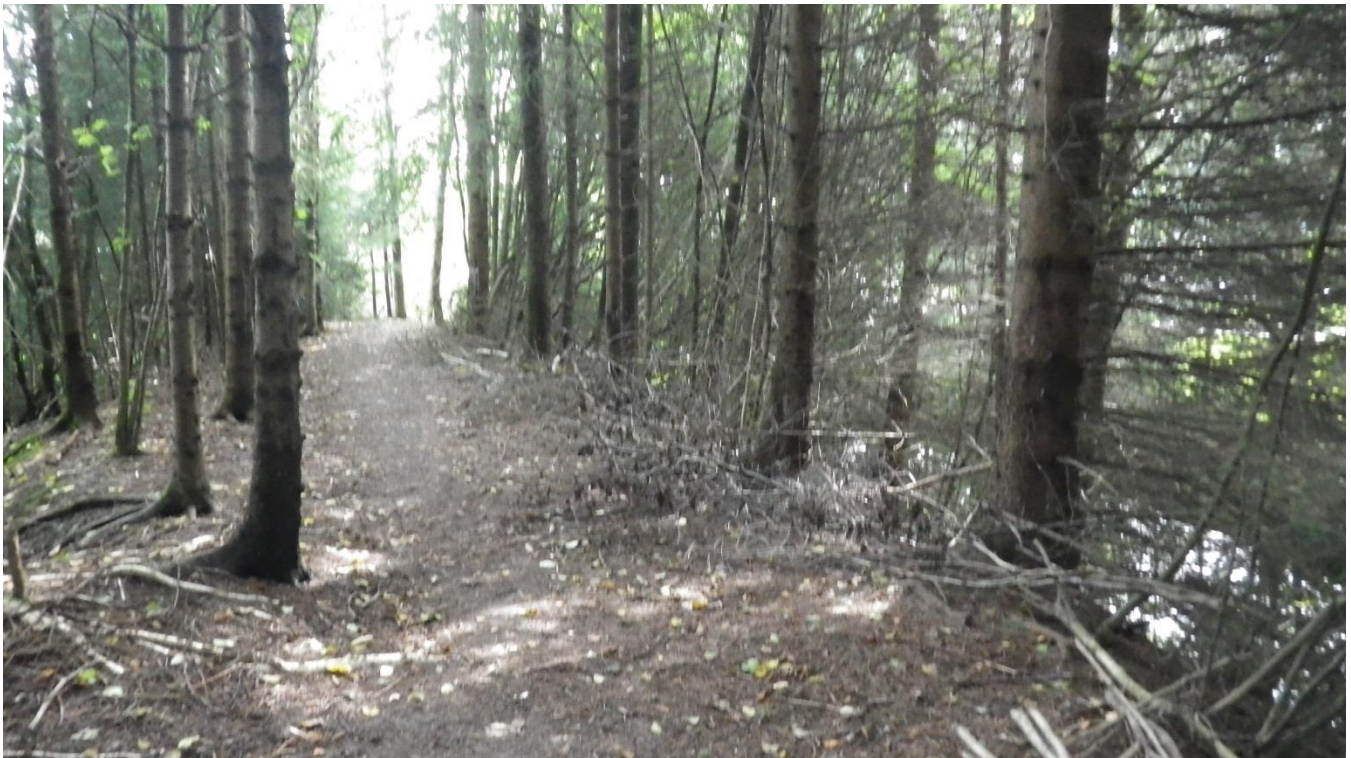
Figure 4.–Limbing along the dense second growth stand on the elevated portion of the trail at the north end. Main channel is below the path at photo right.

On the north end of the trail, I recommend thinning the stand to promote growth of the strongest spruce trees and return the corridor to a characteristic old growth state, a commonly used stream restoration technique on the Tongass National Forest. Selecting dominant spruce and removing all trees within an 8 ft radius will accelerate growth, reduce the number of trees to be limbed and maintained in the future, and increase low growing forbs and shrubs. At the southern end of the trail and downstream from the trail end, replacing reed canary grass infestations with native grass and alders staked along the banks would benefit the stream.
