3.11 CULTURAL RESOURCES

3.11.1 AREA OF POTENTIAL EFFECT

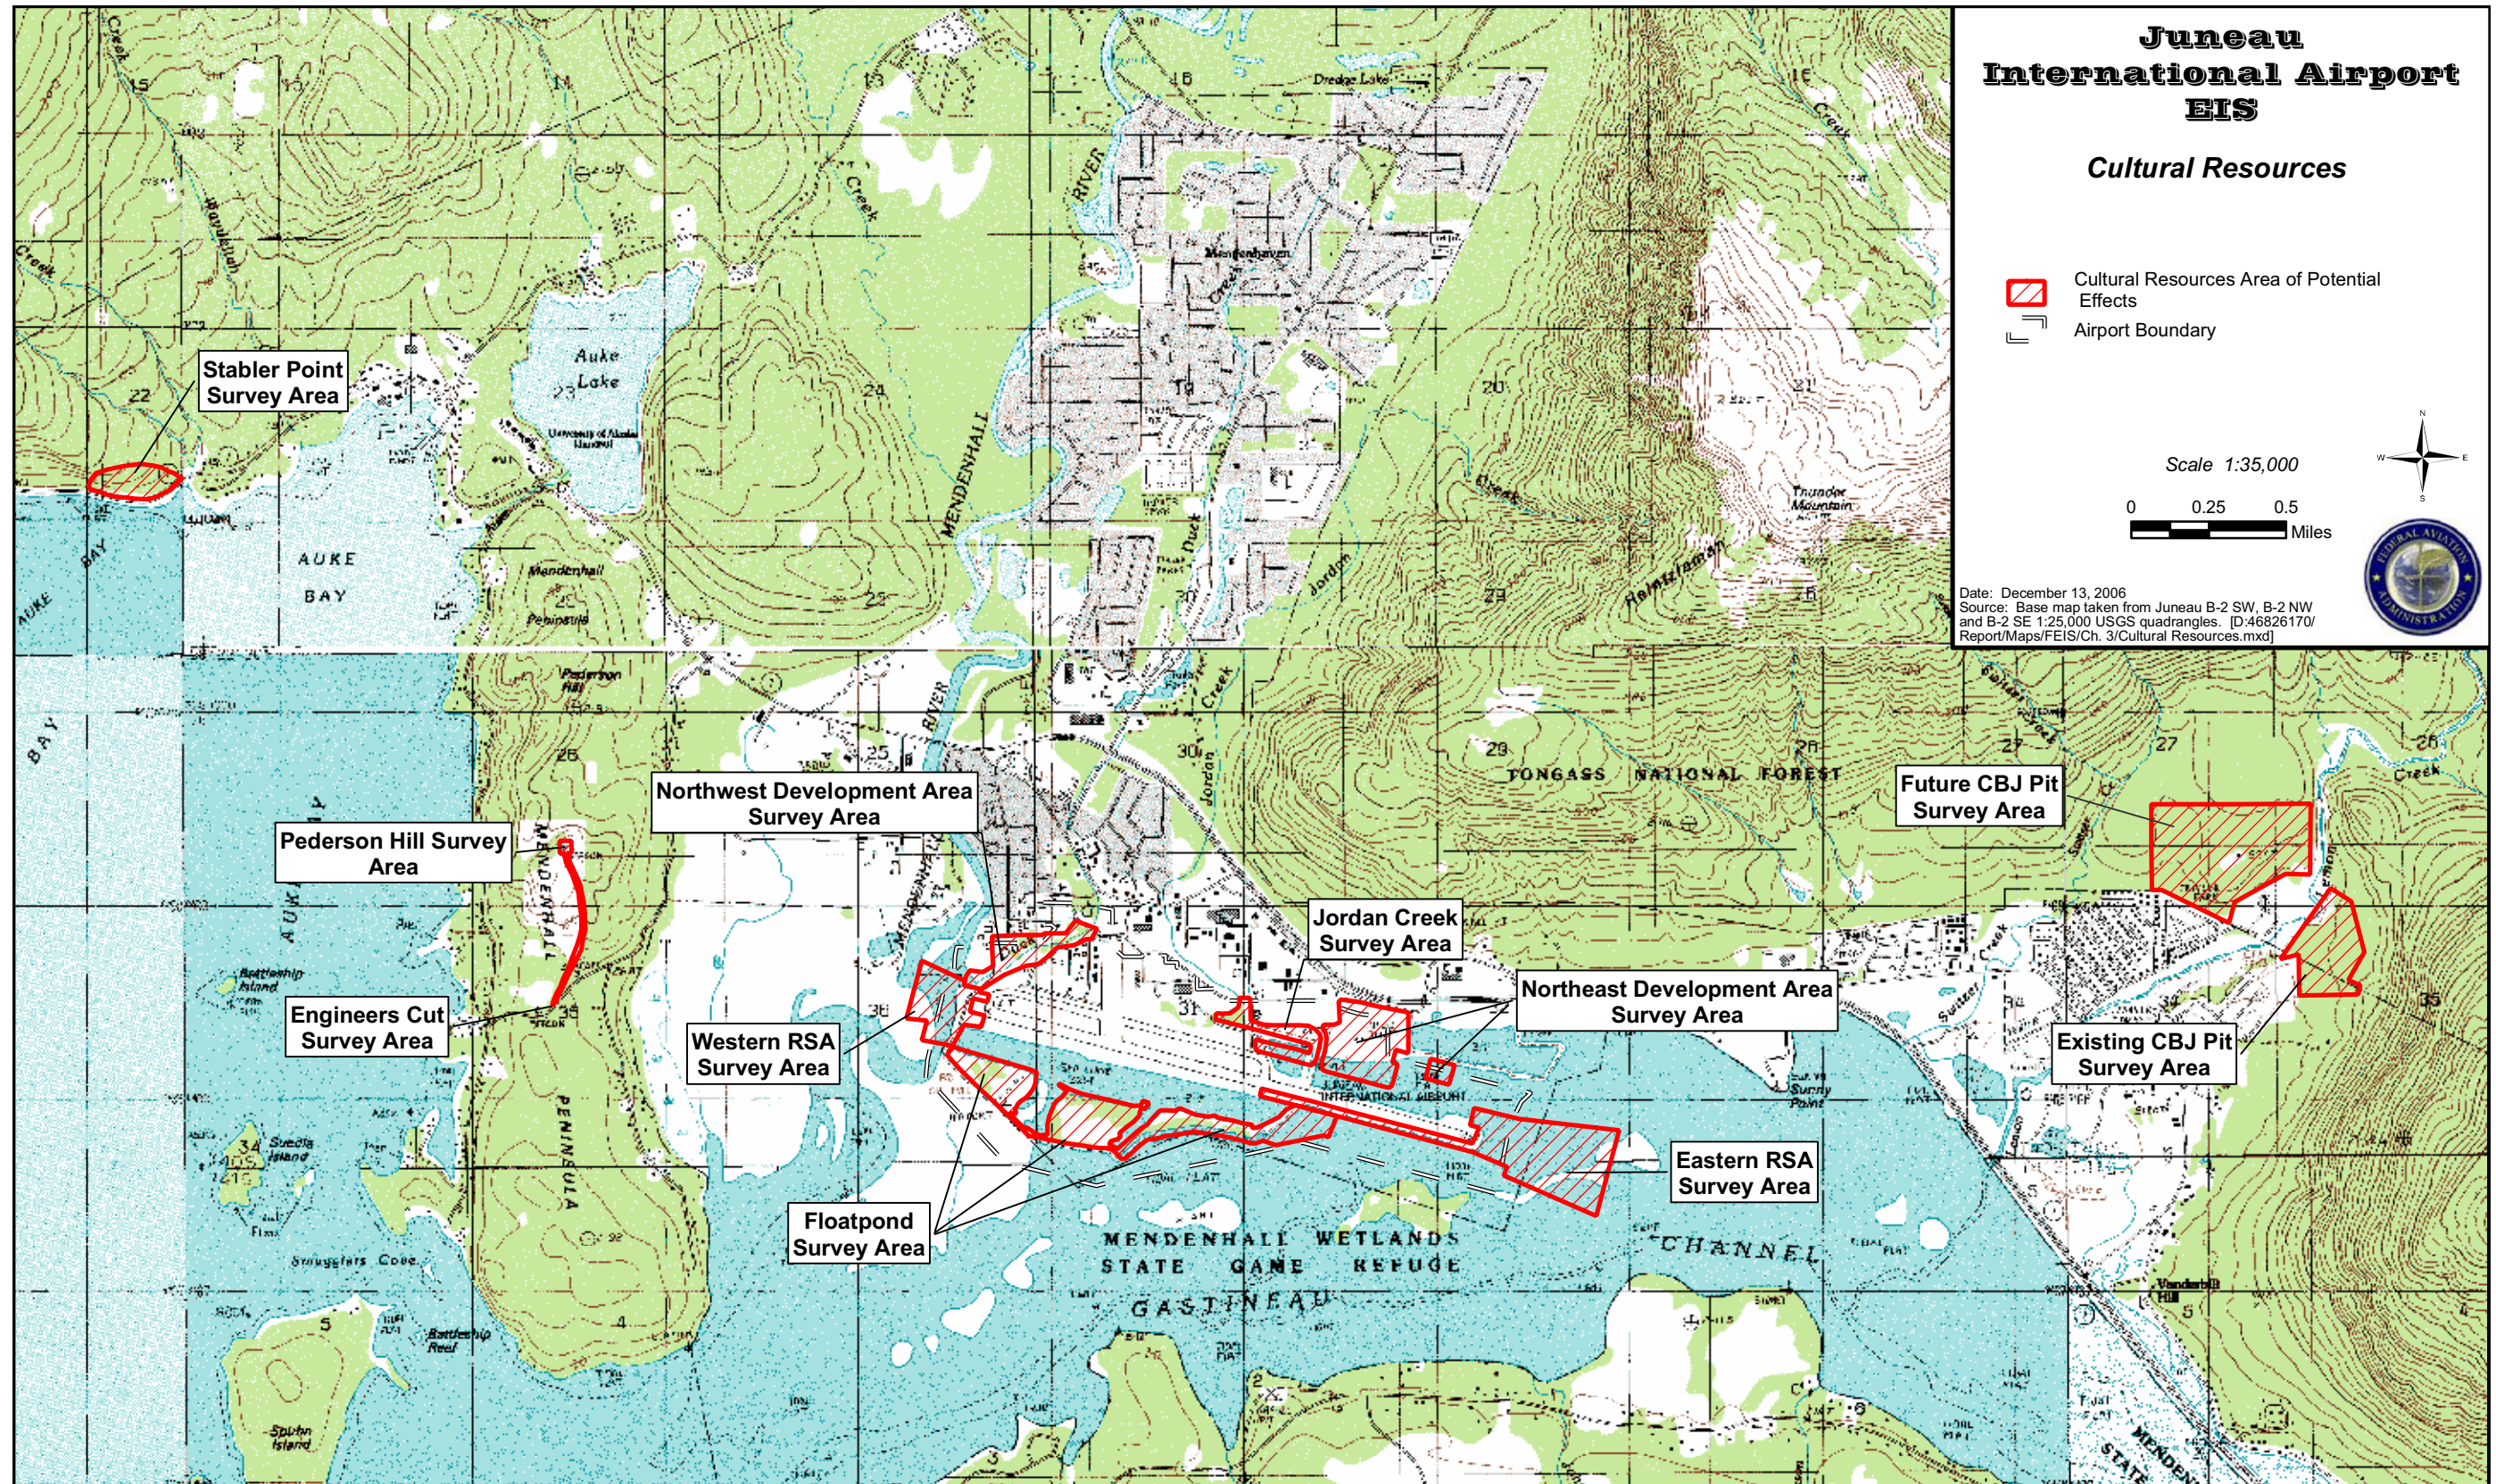
Figure 3-34. Areas of potential effect for cultural resources.

The area of potential effects (APE) for cultural resources was defined as all previously undisturbed and unsubmerged locations that are being considered for development or alteration in relation to the proposed project, including those on and off Airport property. Figure 3-34 shows these locations. For the purpose of this EIS, the APE for cultural resource investigations was limited to those areas that could be physically disturbed as a result of project implementation. While cultural resource APEs may also include broader areas that could be subject to visual and auditory impacts, such broad designation was unnecessary for this EIS as none of the projects would cause appreciable changes in the visual nature of the Airport or in aircraft approach or departure patterns. The APE for cultural resources was approved of by the Alaska SHPO as part of granting the permit to conduct the cultural resources inventory for the EIS.

The on-Airport study area included the Northwest Development Area (around Duck Creek), two parcels of land in the Northeast Development Area near the existing TEMSCO facility, two parcels of land in the Jordan Creek Area, the proposed RSAs east and west of the existing runway and taxiway, and the area between the Airport float plane pond and the Dike Trail. The float plane pond, which may be dredged to provide fill material for Airport projects or to remove vegetation attracting waterfowl, was excluded from the cultural resource APE. The exclusion of the pond from the cultural resource inventory was decided as part of the pre-inventory consultation with the Alaska SHPO, due to the inundated nature of the area, the magnitude of historical dredging activities that would have likely removed or significantly altered cultural resources that may have been present, and the resulting low probability of this area to yield intact cultural resources of scientific, religious, or traditional significance.

Off-Airport cultural resource study areas included a small parcel and access route on Pedersen Hill, the existing CBJ gravel pit, the future CBJ gravel pit, and the Stabler Point Quarry. The gravel pits and quarry were evaluated because of the potential for riprap and fill materials to be imported from CBJ-owned borrow sites. Pedersen Hill was evaluated because it had been considered a candidate site for relocation of the RCO.
