TETRA TECH

Downtown Juneau Landslide and Avalanche Assessment

Presentation for Public Meeting July 21, 2021

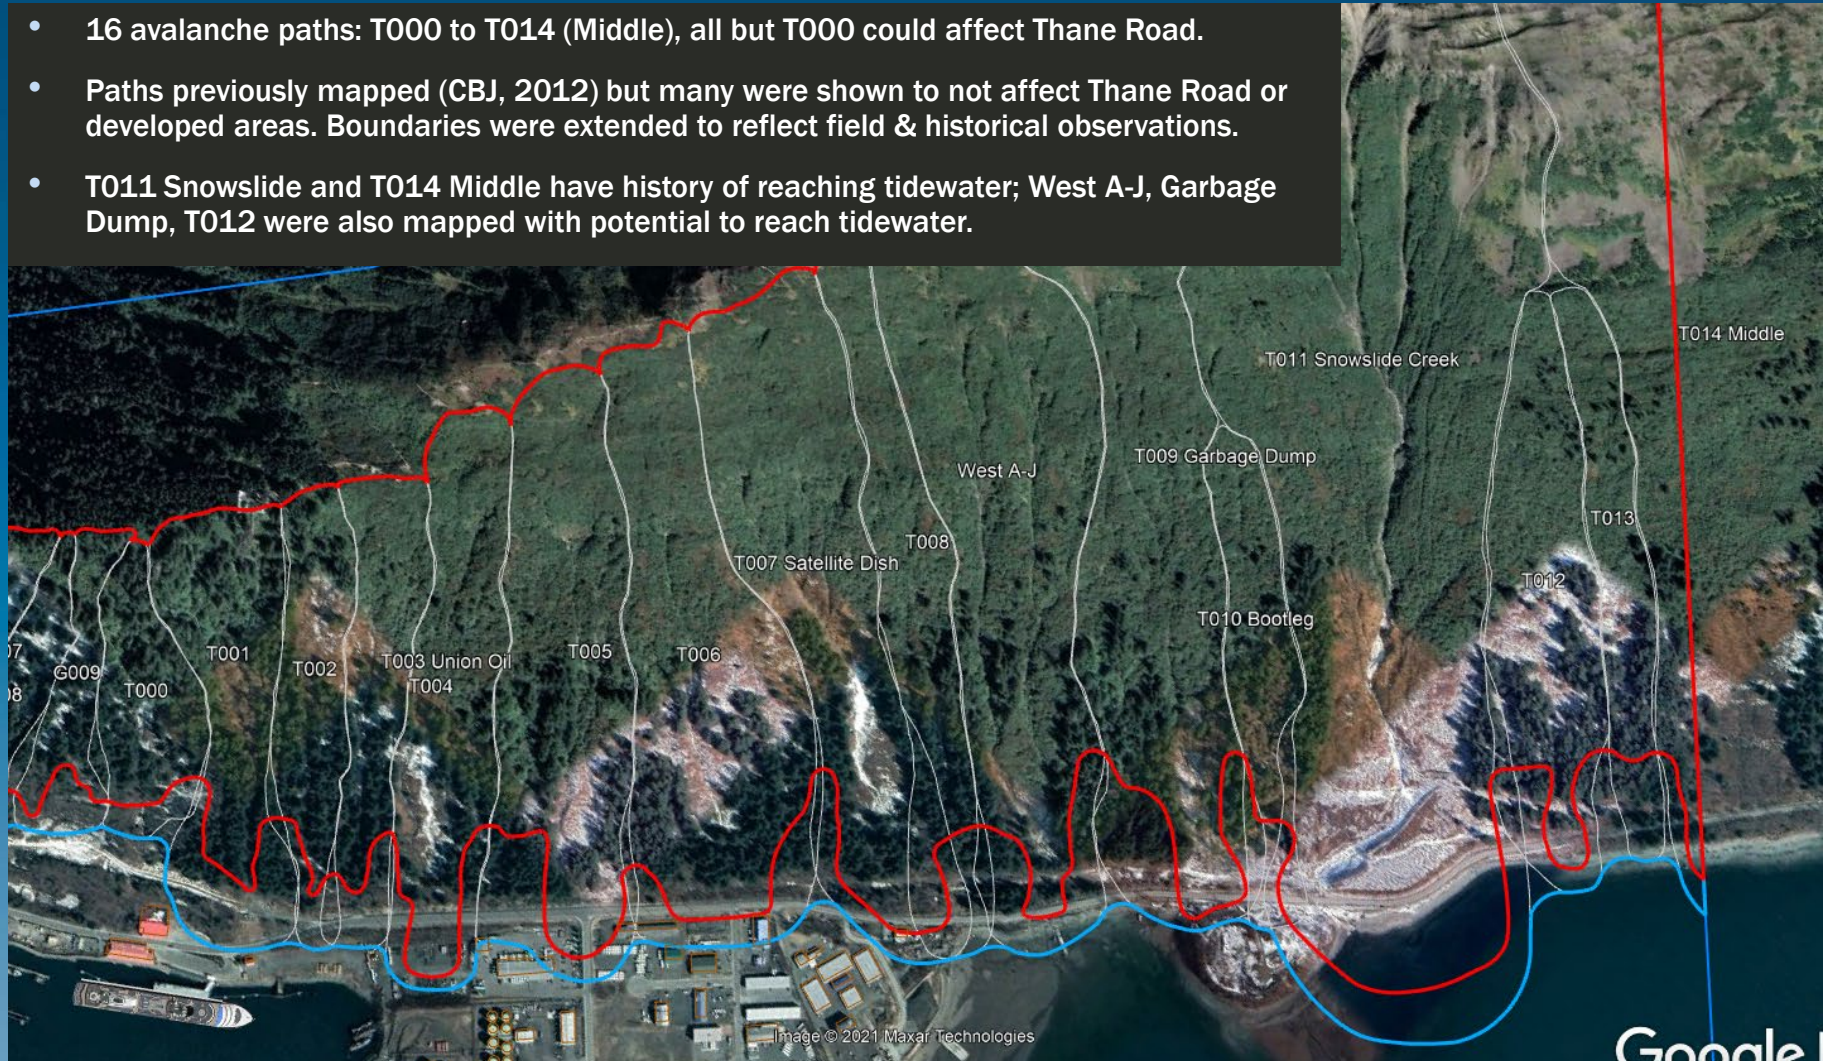
Avalanche Mapping Results – Thane Road

- 16 avalanche paths: T000 to T014 (Middle), all but T000 could affect Thane Road.
- Paths previously mapped (CBJ, 2012) but many were shown to not affect Thane Road or developed areas. Boundaries were extended to reflect field & historical observations.
- T011 Snowslide and T014 Middle have history of reaching tidewater; West A-J, Garbage Dump, T012 were also mapped with potential to reach tidewater.
