Downtown Juneau Landslide and Avalanche Assessment

Presentation for Planning Commission – August 10, 2021

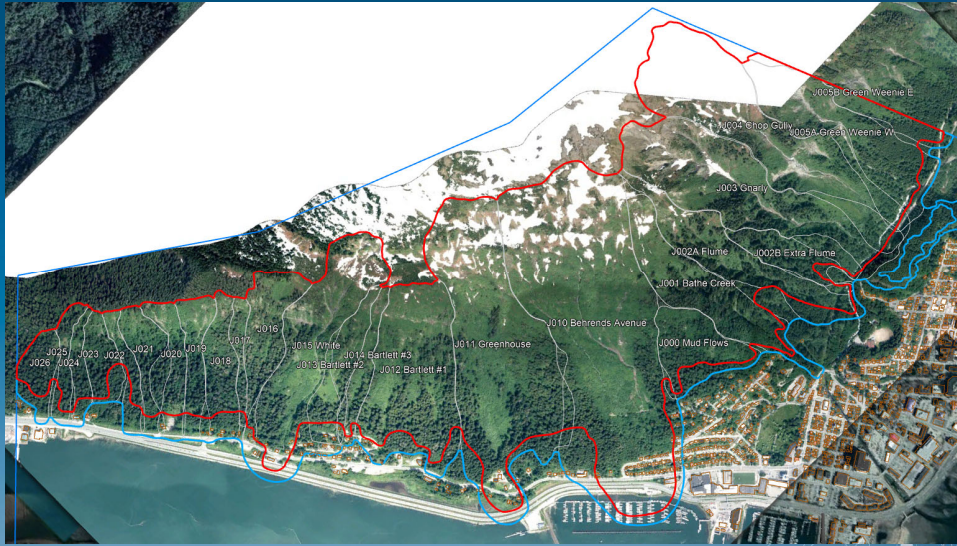
Example: Avalanche Mapping Results – Mt. Juneau

- Identified 52 unique avalanche paths, each was assigned *Severe, Moderate* and *Low* hazard areas.
- Paths identified in 3 areas: Mt. Juneau (25 paths), Gastineau Ave. (11 paths), Thane Road (16 paths).
- Paths mapped to delineate a 300-year hazard boundary for destructive flow (dense and/or powder)

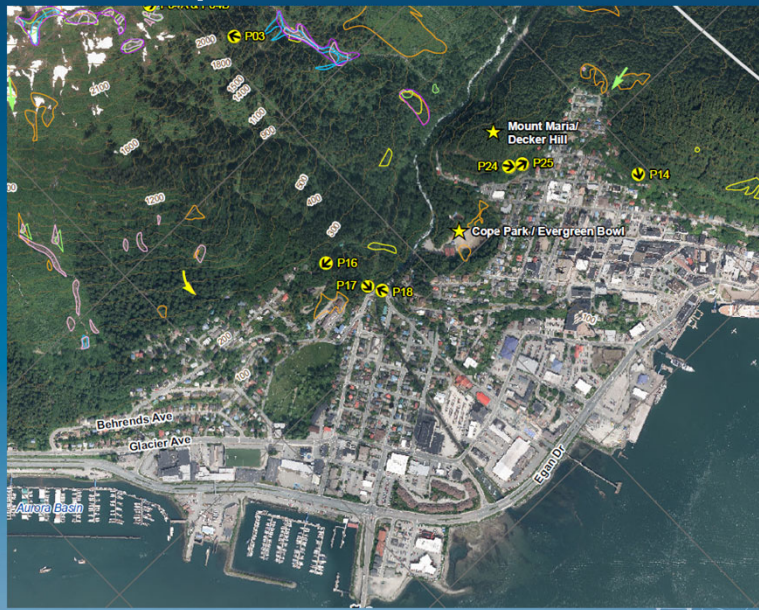
Historical Slope Movements - Downtown

Next, let's see what the historical records can tell us about where the slope has been moving, with evidence from the air photos, satellite imagery, site investigations, and the incident reports. The arrows and outlines that represent debris slides or rockslides are coded by colour to show which air photo year they were identified on. Now let's look at the gullies.

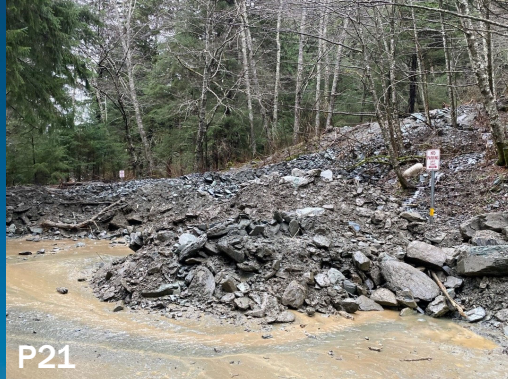
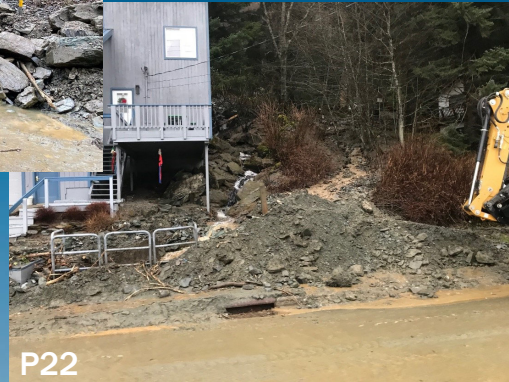
2020 Wickersham Debris Slide

Here's an example of what gullies can do – dump a lot of debris and water where nobody wants it. CBJ told us about this one and sent us their photos.

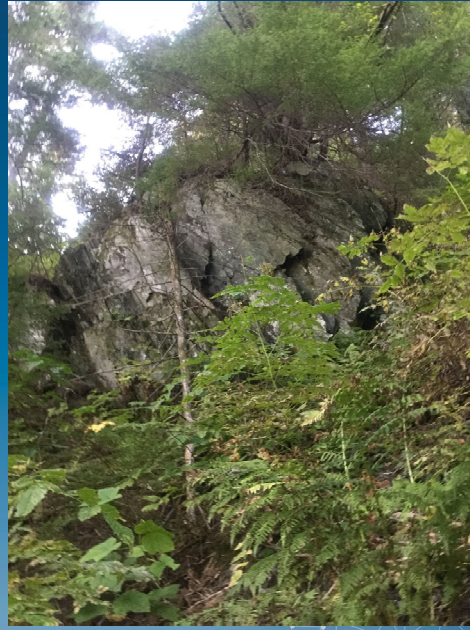
Starr Hill - Rockfall

Sometimes, we discover exactly what we expected from the maps. Other times, especially where there is a lot of thick forest, we discover that there are even *more* landslide features that couldn't be seen on the air photos, like rockfall that doesn't destroy the trees, or very narrow gullies or slide paths that hidden by the trees, such as the slopes above parts of Starr Hill. In the field, we try to collect enough information to confirm or correct the mapping. Sometimes information is also available from incident reports, or news reports.

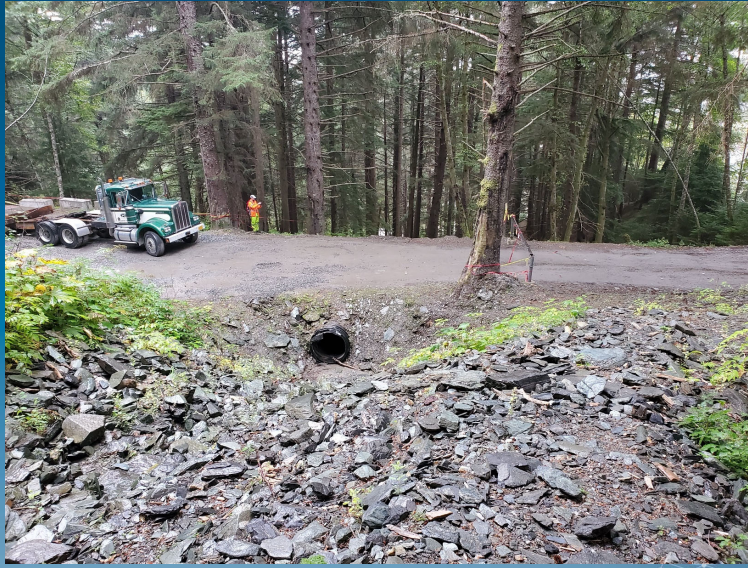
2019 Gold Creek Flume Trail

Here's another gully – this photo is looking down towards the Gold Creek Flume Trail from the Bathe Creek debris flow gully. Notice the large amount of debris in and alongside the gully, as well as the scarring on the tree beside the road that extends to at least 6 feet above ground surface. This gully is very active, and the debris that is deposited at the road crossing, and that plugs the culvert, is regularly cleaned up. This road crossing has the potential to divert debris flows into the residential community downslope and to the west, especially if more than one surge of debris happens before the debris can be cleaned up. The LiDAR shows two major gullies alongside the subdivision that are otherwise hidden by trees on the air photos.

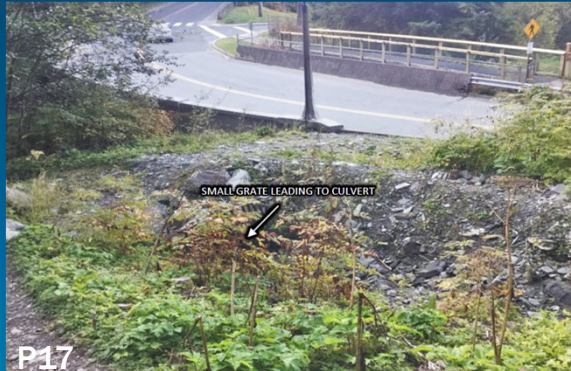
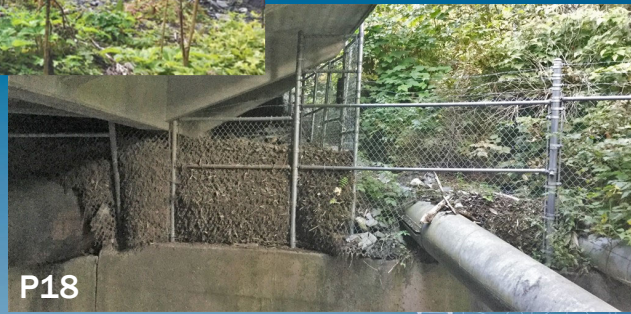
Irwin Street Bridge

Debris flow deposits are seen at the Irwin Street bridge over Gold Creek, which receives a lot of that debris from the Bathe Creek feature. Here are a couple of photos, one looking south at the debris deposited near the bridge, and the other looking north at the debris deposited under the bridge. The debris flow gully at Bathe Creek has created two big gullies on either of the residential area, with the east end of Evergreen Avenue at the top, and Irwin Street at the bottom. Smaller gullies are also visible above Hermit Street. Any diversion of the debris at Evergreen or the Gold Creek Flume Trailhead could result in debris flowing through the subdivision.

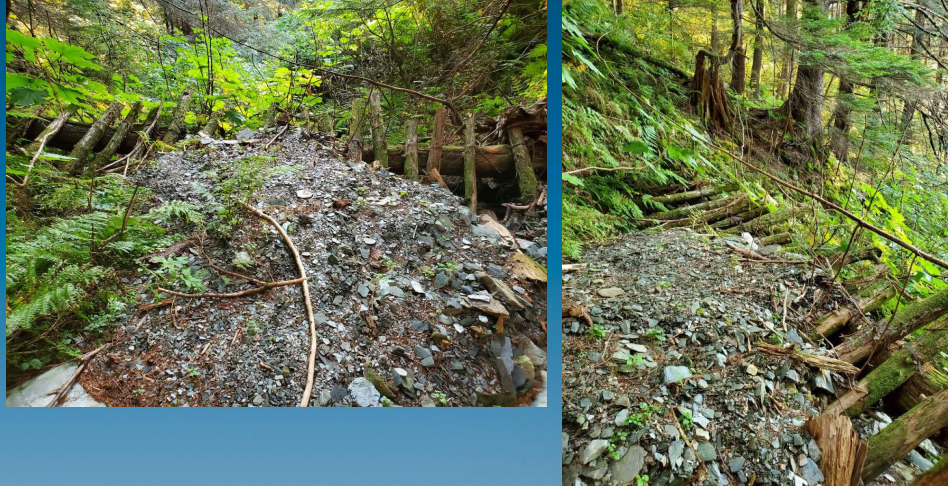
G000 Park Path – Starr Hill

Here are a couple of different views of one of the debris-flow mitigation structures that were built by homeowners living below the G000 Park debris flow path above Starr Hill. This structure has captured debris material from one or possibly two events. Depending on the size of the next debris flow, maybe it'll retain a little more debris, or collapse, or be overrun by debris, or even be completely scoured out by a larger debris flow originating further up the gully. The homeowners currently living below this debris flow path report that some of the structures need repair or replacement.
