## Risk Engineering Services

**December 18, 2024**

**Ms. Patty Wahto, Airport Manager**  
**Juneau International Airport (JNU)**  
**City & Borough of Juneau**  
1873 Shell Simmons Drive  
Juneau, AK 99801  
[Patty.Wahto@jnuairport.com](mailto:Patty.Wahto@jnuairport.com)

<b>Purpose:</b>	<b>AIRPORT LIABILITY RISK ENGINEERING SURVEY</b>
<b>Client:</b>	<b>City and Borough of Juneau</b>
<b>Location:</b>	<b>Juneau International Airport (JNU)</b>
<b>Dates of Survey:</b>	<b>September 25-26, 2024</b>
<b>Policy Number:</b>	<b>AAP N14308118 (7/1/2023-7/1/2025)</b>
<b>Broker:</b>	<b>Alliant Insurance Services, Inc.</b>

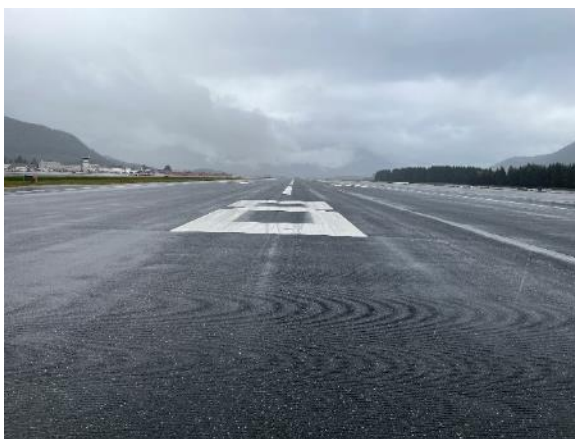
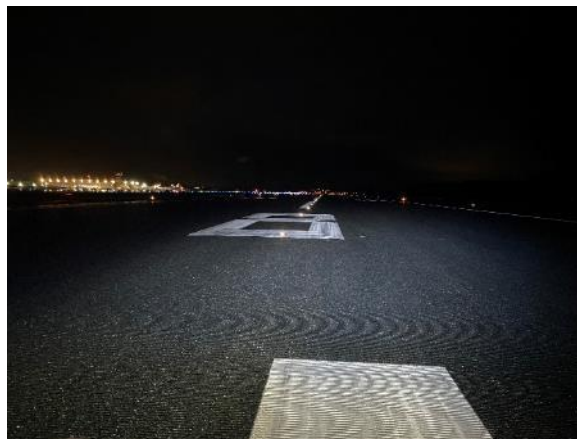
Runway 8 designator and in-pavement center line lighting

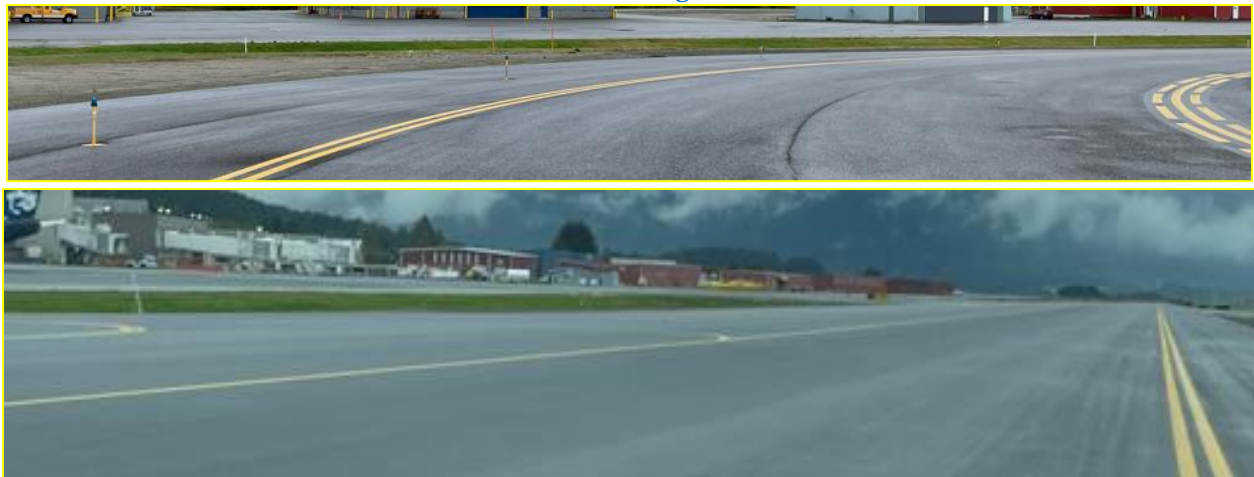
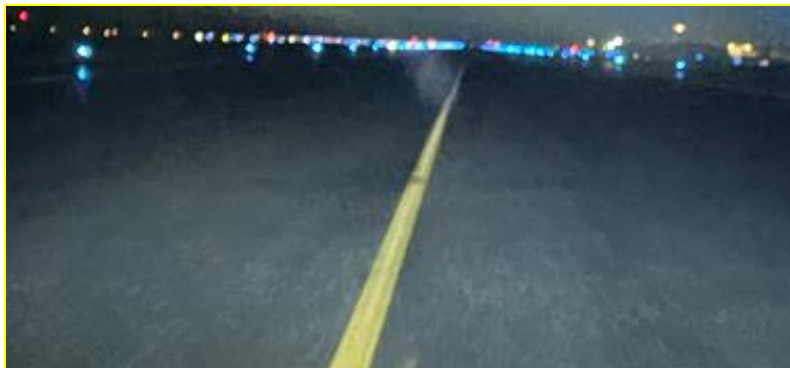
Movement area markings in good condition

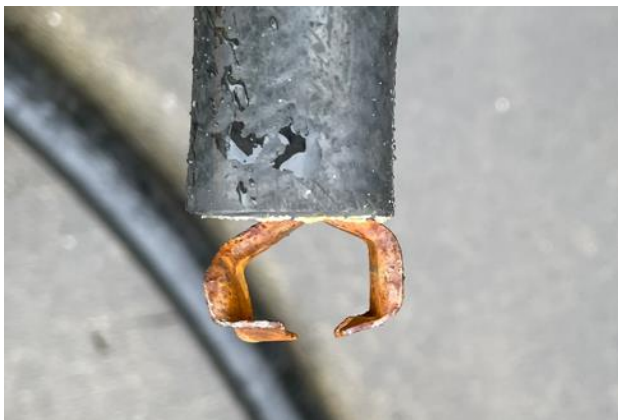
Ward Air Bonding cable clip does not close, the exact condition observed in 2022 and 2023

The prior recommendation will be resubmitted.

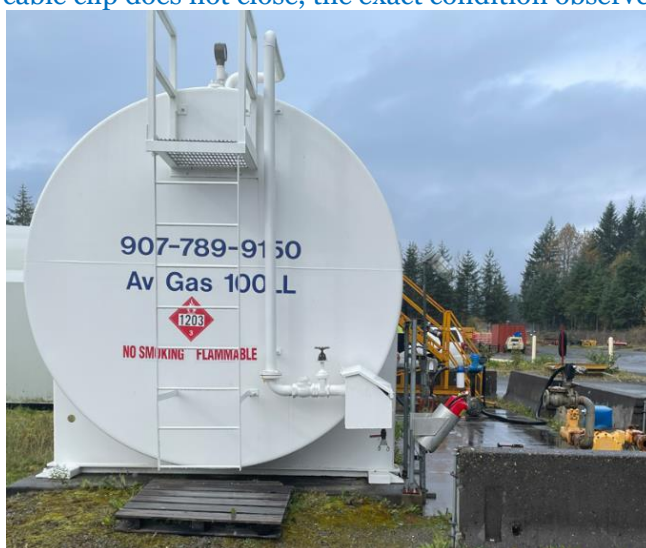
Ward Air supply tank intake for filling, no deadman or overfill controls

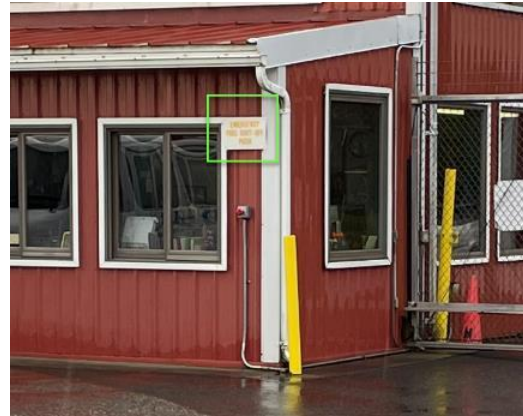
Ward Air emergency shut off valve is located outside of the “probable spill area”, but the placard is faded and should be replaced

As recommended in 2023, the placard for the emergency fuel shut off valve at their main office is faded and should be replaced.

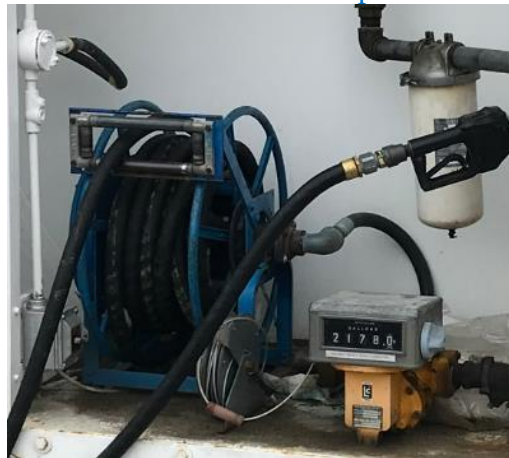
The fuel tank filling equipment contains safety features include bonding cable and deadman control

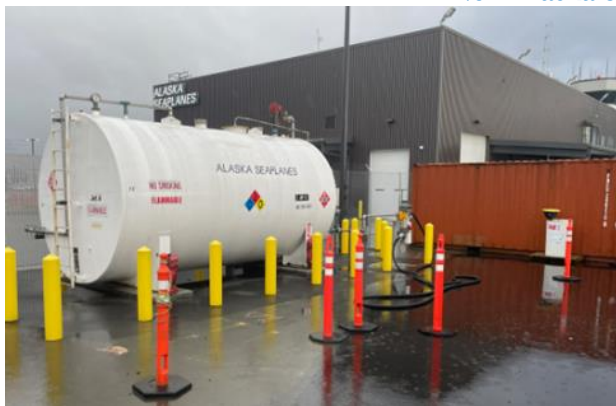
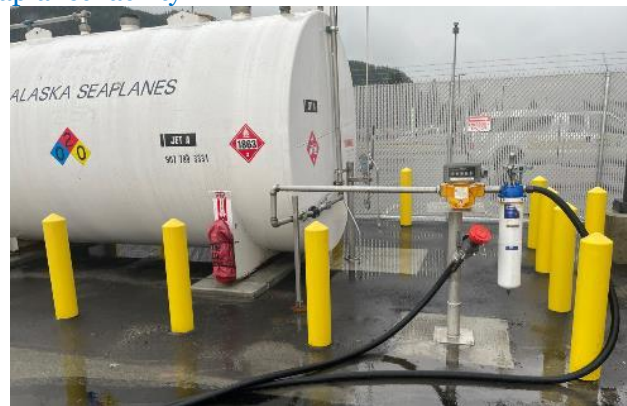
Alaska Seaplanes newly relocated Jet A fuel tank for supplying mobile fuelers

The fuel tank is properly protected with impact bollards, but otherwise is missing several import safety features. It is recommended that the following missing safety features be installed: bonding cable, deadman control, emergency fuel shut-off, and overfill protection.

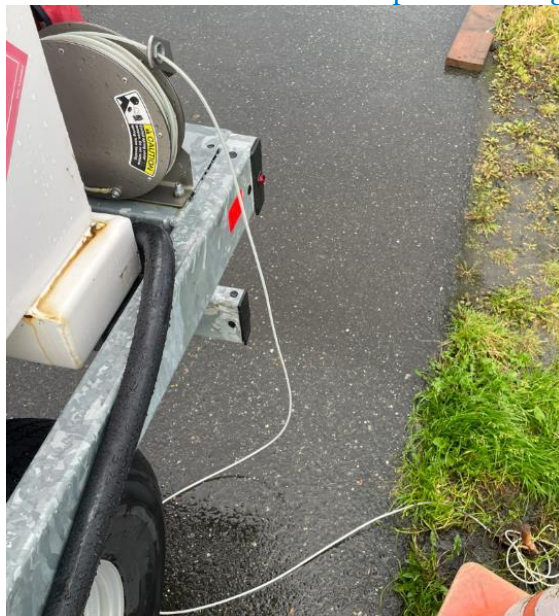
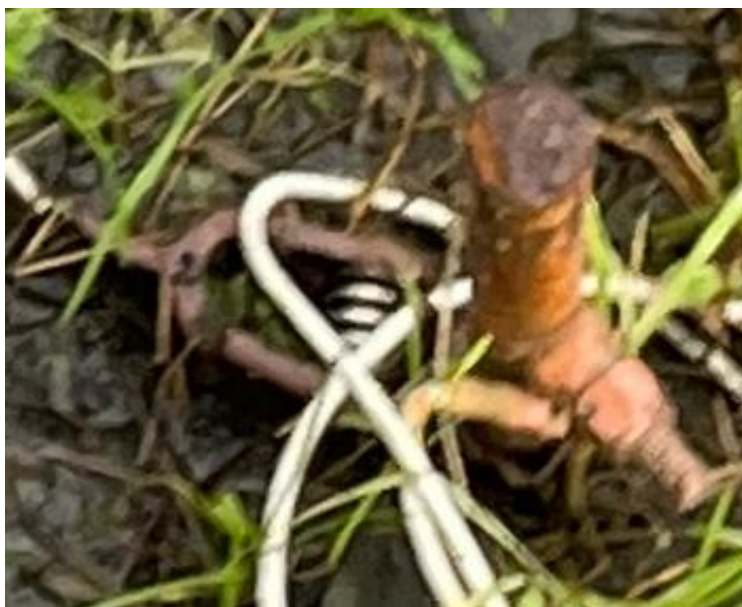
The bonding cable was clipped to a ground post

The ARFF Programs Manager participated in a tour the float pond fueling operations. He did not understand the bonding cable configuration and generally not comfortable with the permanently uncoiled fuel hose sitting on the dock. He will address CCFR concerns along with our resubmitted recommendation with Alaska Seaplanes.

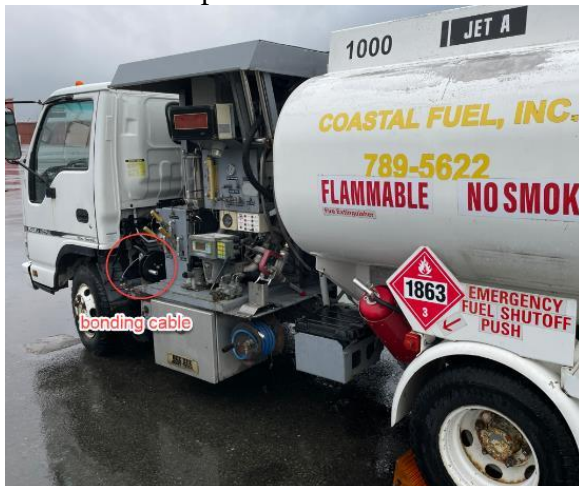
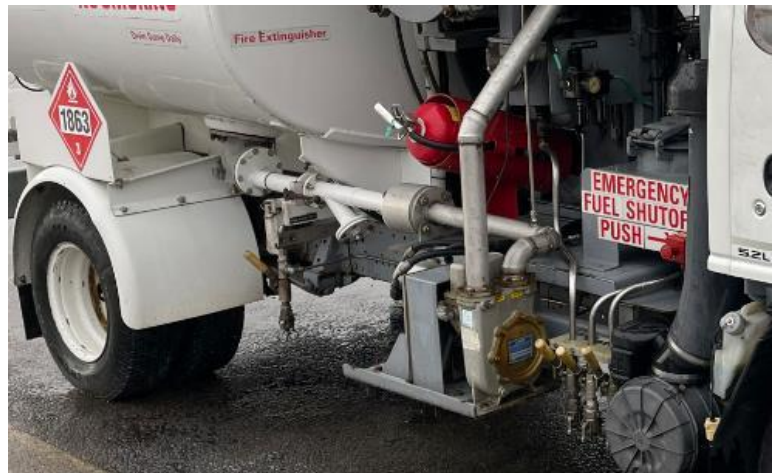
The mobile fuelers were outfitted with functioning bonding cables and deadman controls. Placards were generally in good condition, although one of the “No Smoking” signs was partially obstructed, so it would be better to move that placard to the bumper.

Coastal mobile fueler outfitted with bonding cable, chocked wheels, and emergency fuel shut-off

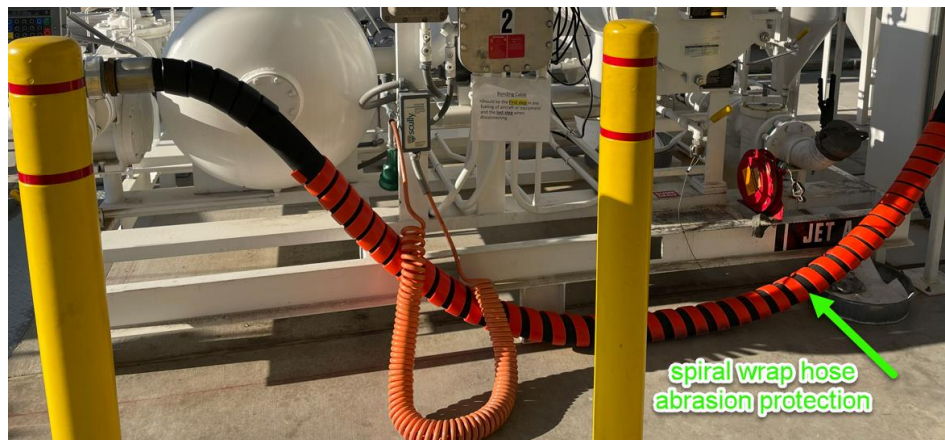
Example of a hose protected in plastic spiral wrap to mitigate degradation from surface abrasion

One final observation and suggestion is to have the various fueling operators protect fuel hoses from wear and tear by installing protective spiral wrapping on fuel hoses that are not mounted on supports or reels. This would apply to fuel tanks mounted on concrete pads operated by Ward Air, Alaska Seaplanes, and Coastal Fuel.

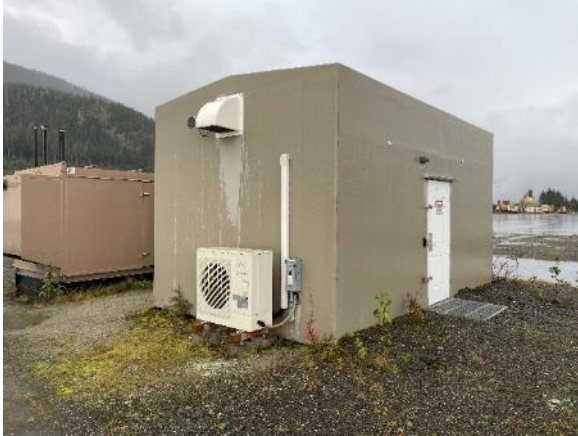
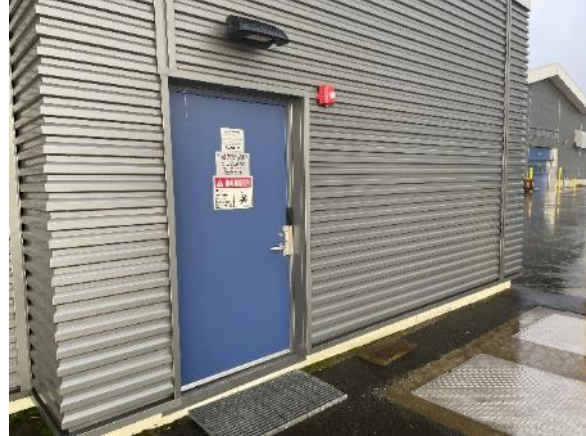
The are two airfield lighting electrical vaults. The primary vault continues to be the older one of the two, which is a freestanding building on apron east of the ARFF station. The newer vault located in the SRE building will be the reserve facility for now. Both vaults were observed to be well maintained with good housekeeping and no accumulation of combustibles. Both have newly installed “Danger - High Voltage” warning signs posted on all exterior doors.

The older vault remains as the primary airfield lighting vault (left) and door to new backup vault in the Maintenance & SRE shop (right)

The regulators in both vaults have placards identifying the circuit numbers under their control, however the actual names of the lighting or signs powered by the regulators are not identified, such as Runway 8/26 or Taxiway A. It is recommended that more descriptive placards be mounted on each regulator, to include clearly stated descriptions of the exact circuits controlled.

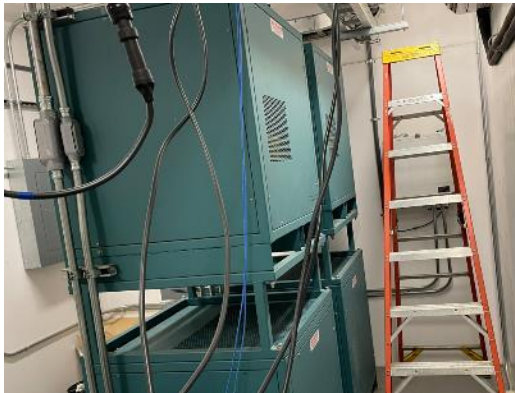
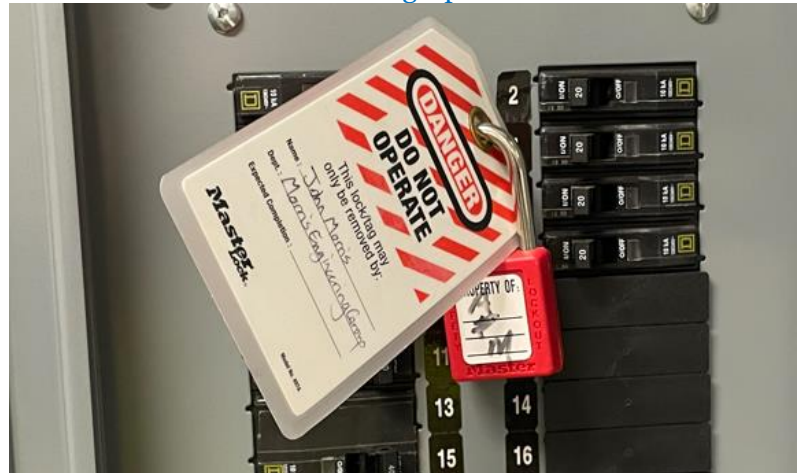
Older vault electrical work being conducted (not a lighting regulator) that was properly locked out

It is also recommended that the LOTO written program be printed and posted on the wall inside both airfield lighting electrical vault.

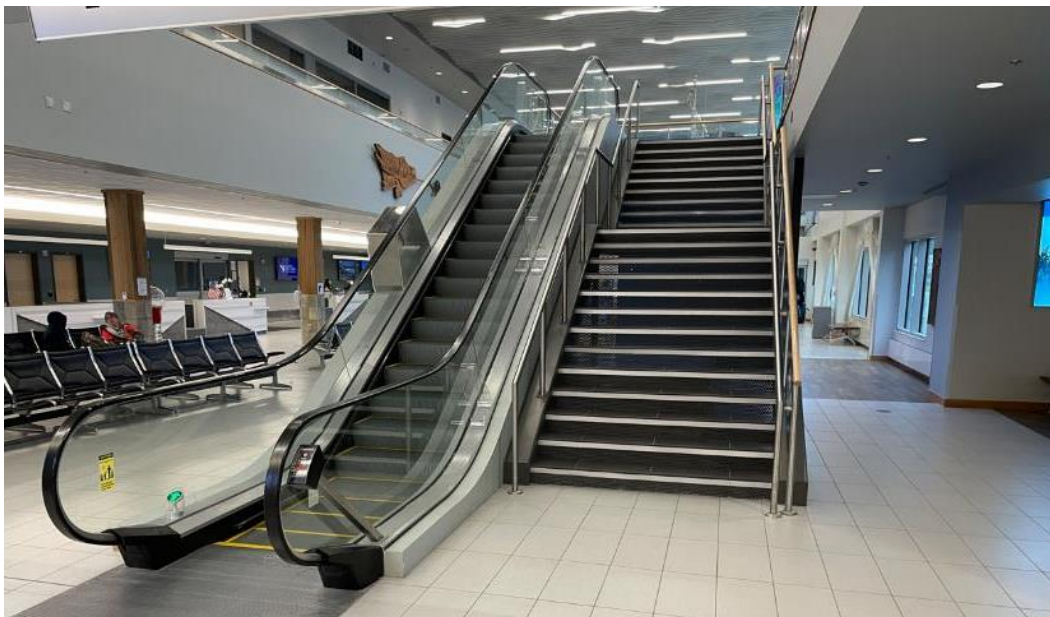
The second level of the terminal is accessed via two escalators at the north and east ends, open staircases next to each escalator, or by one bank of elevators at the center of the terminal. Both escalators have posted placards instructing riders to hold the handrail and supervise children. It is being recommended that signs be posted in the vicinity of both escalators with directions to the elevators. These signs will provide an alternative option for patrons with mobility challenges, excessive luggage, and/or with children that might help prevent an accident. The re-direction signs away from malfunctioning escalators will also reduce confusion, also mitigating potential accidents.

North end up escalator and stairs, lacks a sign for redirecting to the elevators

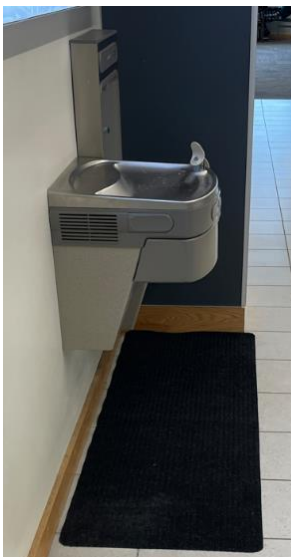
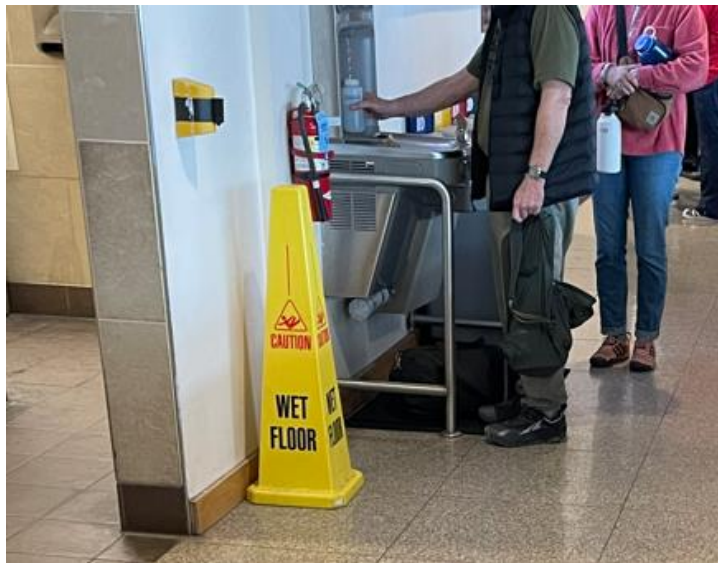
Non-secured area drinking water fountain (left) and secured area (right) with bottle filling station with newly installed walk off mats (which should be pulled further away from the wall to catch spills/drips)

Walk off mats were installed below the drinking water fountains as recommended in prior surveys. It is being recommended that the mats be repositioned slightly further away from the wall, so that any water drips will be collected as persons are walking away from the water fountain or bottle filling station. The custodians should be alerted to regularly inspect the condition of the mats. Mats should remain flat on the floor and that none of the edges are rolled or folded over which would result in a trip hazard. For those mats in high foot traffic corridors, there should be a plan to replace them on a regular basis, including a stock of replacement mats.

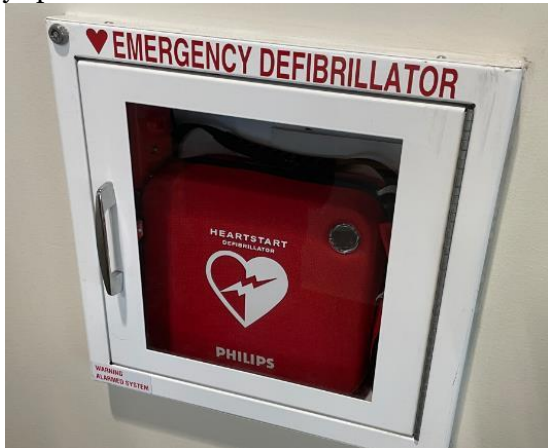
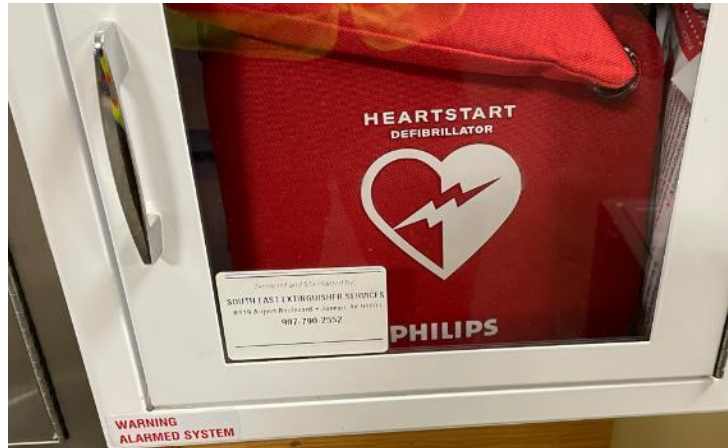
The terminal is equipped with automatic external defibrillator (AED) devices and portable fire extinguishers. It was not evident from the cabinets when the last equipment and inspection took place. AED devices should be inspected and maintained in accordance with manufacturer specifications. Some features, such as the electrodes that are attached to the skin have a limited useful product life and should be replaced. It is recommended that a qualified vendor inspect all AED equipment present in the terminal and update all contents in accordance with original factory specifications.

AED cabinets located throughout the terminal, no label indicating date of last service

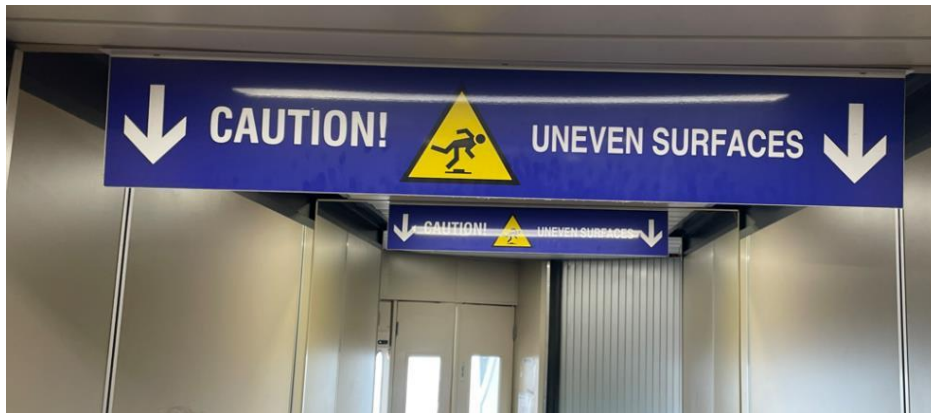
Gate 2 jetbridge overhead warning sign, which should be replicated for the new Gate 5 jetbridge

The Gate 5 jetbridge was replaced this year with all new equipment. It is recommended that additional warning signs be installed, identical to what is installed in Gate 2, including floor markings of uneven edge surfaces and an overhead sign indicating “Caution - Uneven Surfaces”.

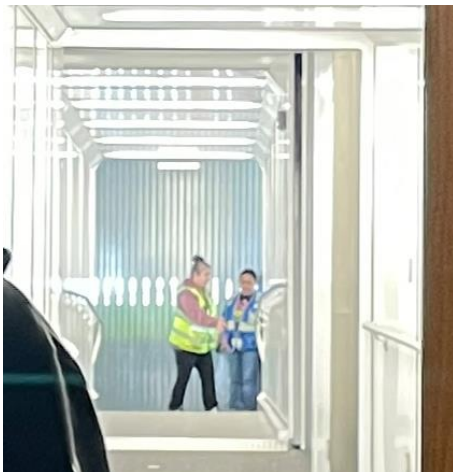
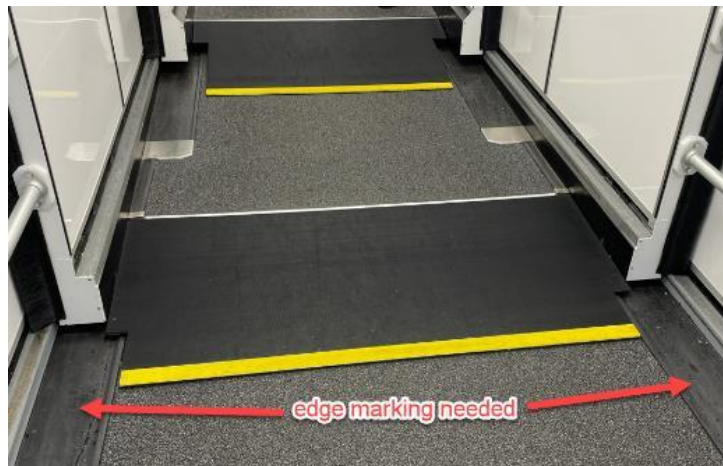
New Gate 5 Jetbridge needs overhead and edge markings for uneven surfaces

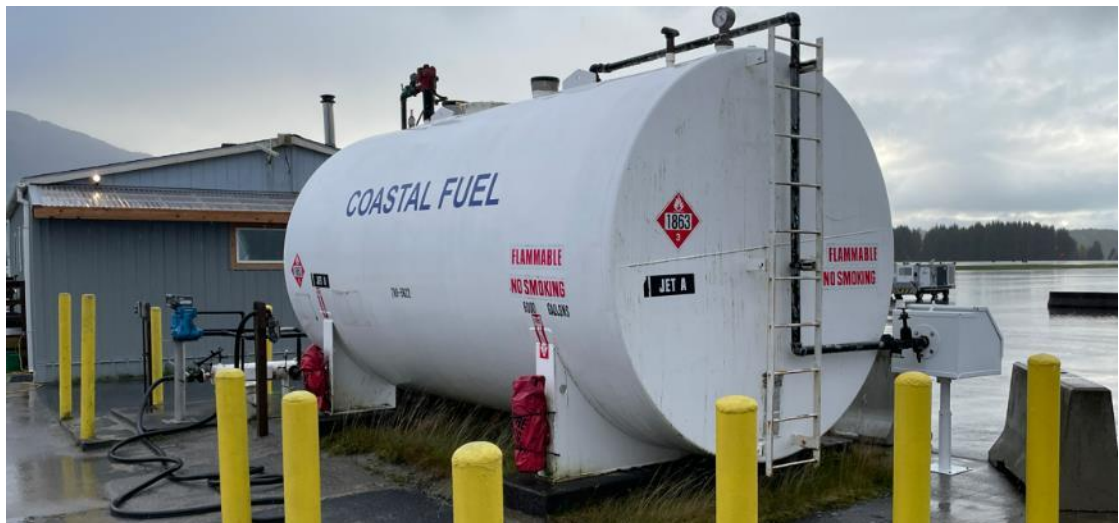
Coastal Fuel supplies Jet A aircraft fuel their mobile fuel trucks from one above ground tank. To reduce the risk of leaks and possible resulting fires, damage, and injuries, it is recommended that their Jet A fuel station be outfitted with overfill protection and deadman control as per NFPA 407 (Standard for Aircraft Fuel Servicing). There is no bonding cable, so it is highly suggested that the airport and/or the ARFF Programs Manager confirm that bonding cables from the mobile fuelers and the incoming supply trucks are connected to effectively bond and ground electrostatic energy. Otherwise bonding cable reels should be installed at the fuel station.

Coastal Fuel airfield based Jet A supply tank

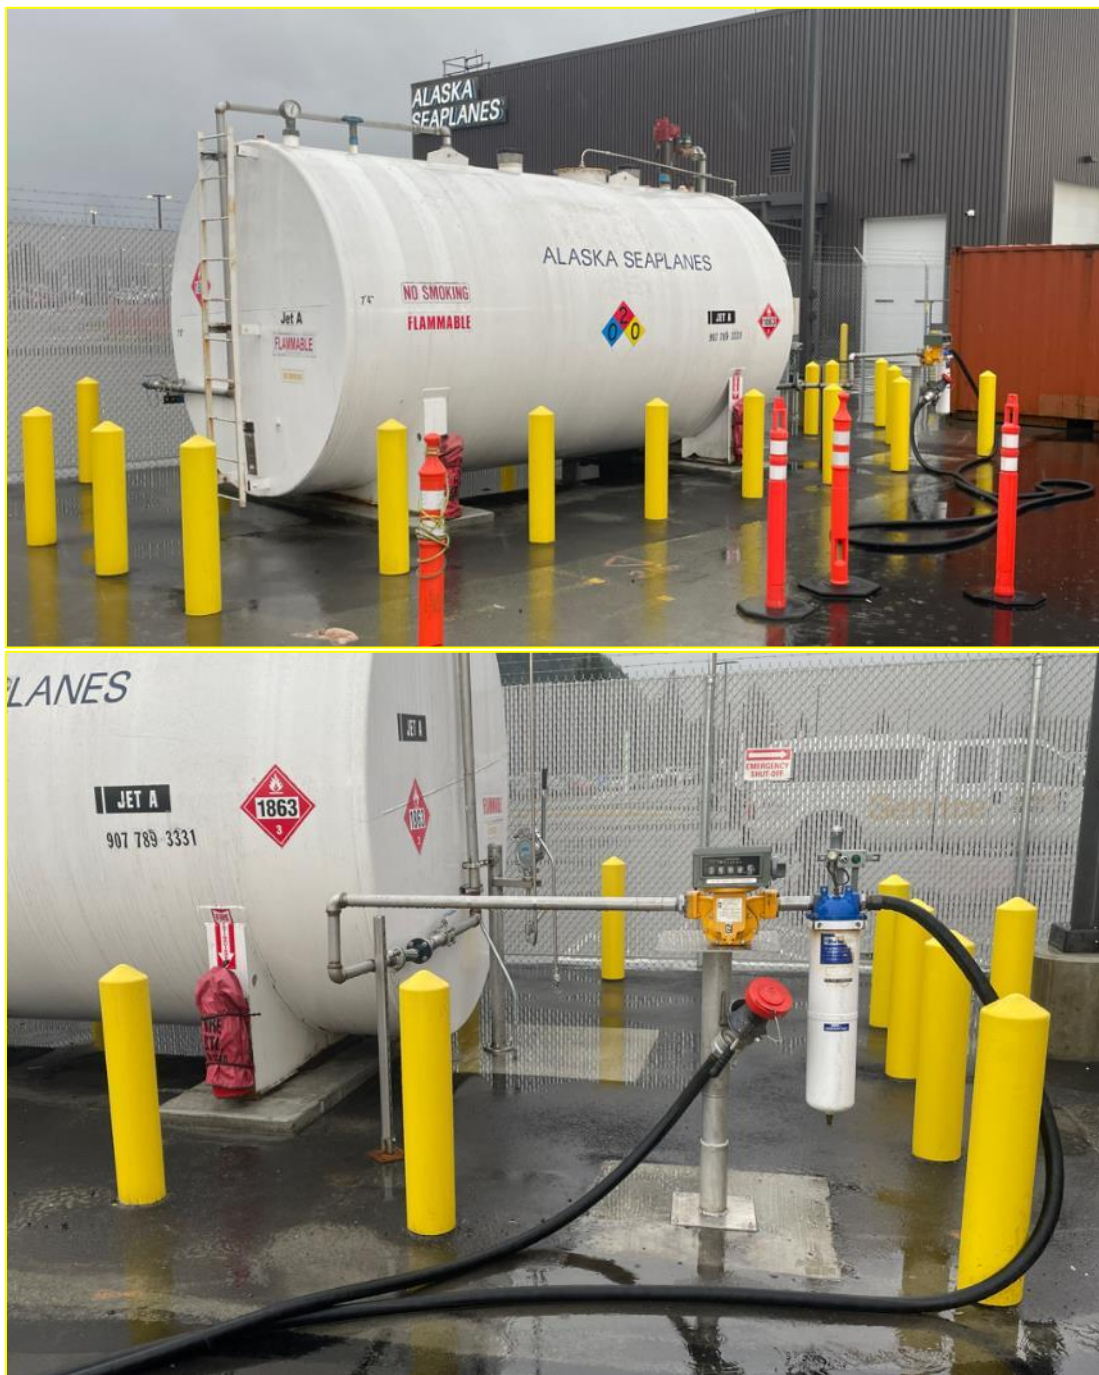
There is no bonding cable, so it is suggested that the airport and/or the ARFF Programs Manager confirm that bonding cables from the mobile fuelers and the incoming supply trucks are connected to effectively bond and ground electrostatic energy. Otherwise a bonding cable reel should be installed at the fuel station.

Alaska Seaplanes newly relocated Jet A fuel supply tank on the airfield

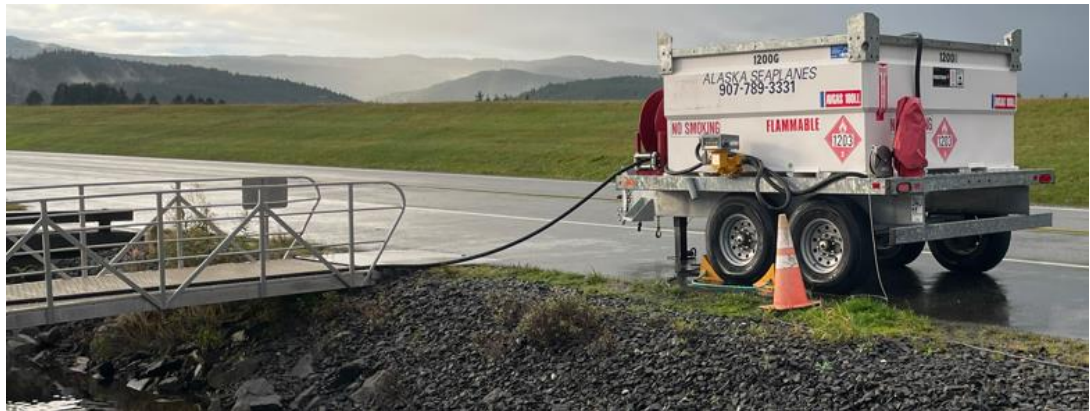
Alaska Seaplanes float pond based Av Gas fuel trailer

To assure that bonding is conducted when fueling, it is recommended that a hardwired bonding cable be installed on the dock to allow the fuel operator to safely bond the aircraft during fueling operations without having to pull from the trailer to the aircraft. It is also recommended that the airport and/or the ARFF Programs Manager conduct periodic observations to confirm that fueling operations are in compliance with NFPA 407.

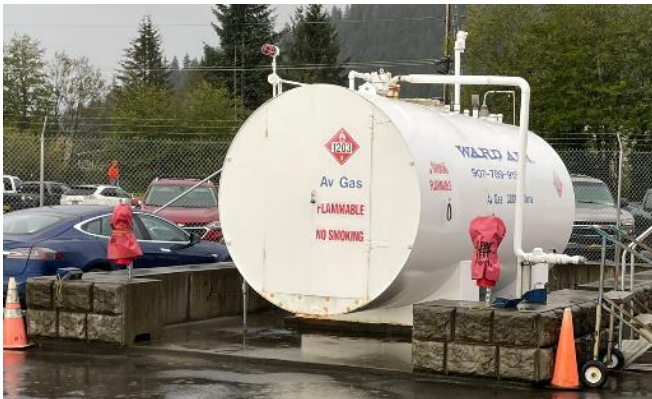
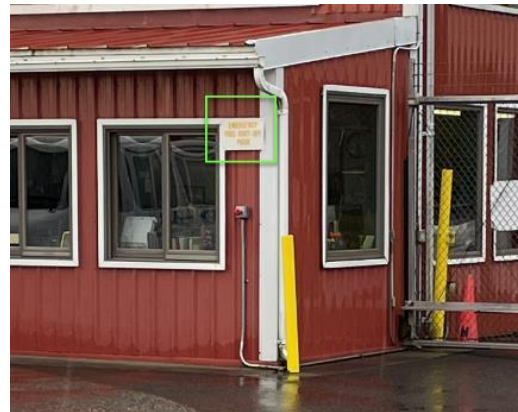
Ward Air airfield based Av Gas supply tank (left) and faded and illegible emergency fuel shut-off sign (right)

It is recommended that these be addressed during the next round of quarterly fuel inspections and noted on the respective forms to track compliance. To help reduce the potential for leaks and risk of fire, damage, or injuries, it is further recommended that their Av Gas fuel station be outfitted with overfill protection system as per NFPA 407 (Standard for Aircraft Fuel Servicing).

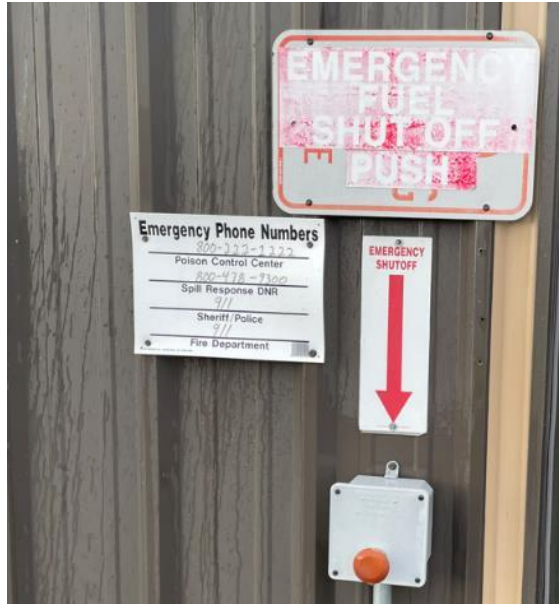
Faded placard to be replaced and installed at seven feet above ground

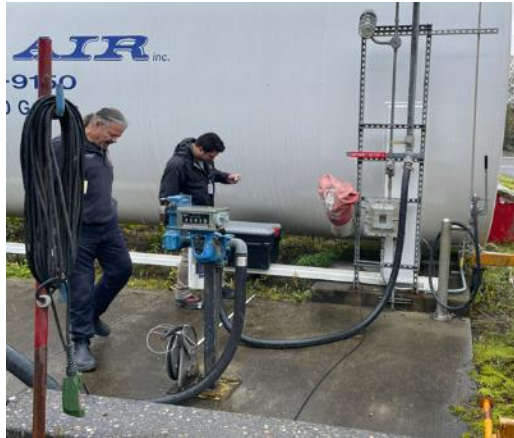
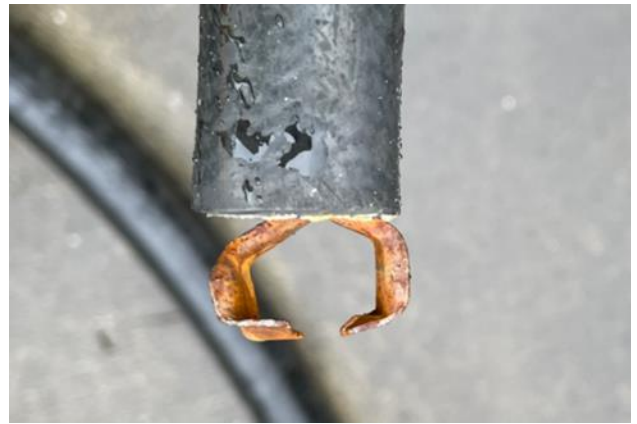
Ward Air emergency fuel shut-off well within the probable spill area (left) and defective bonding cable clip (right)

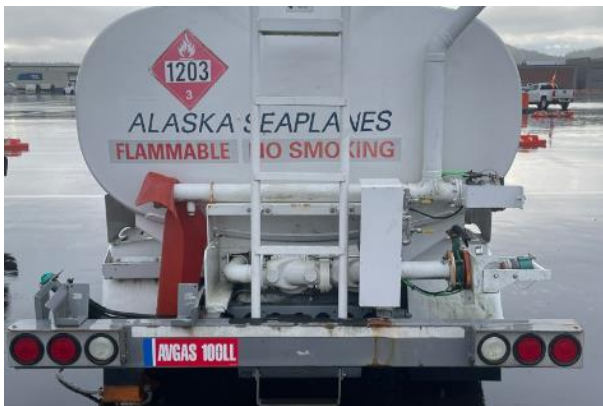
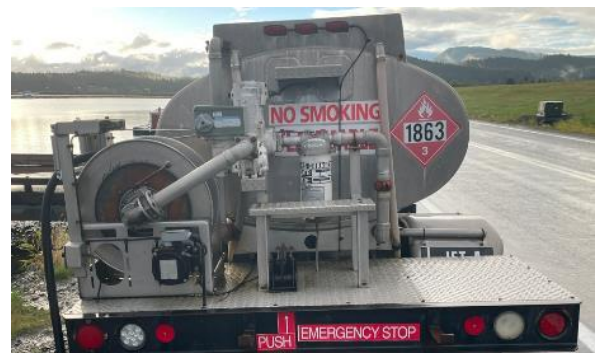
Faded & obstructed placards, Alaska Seaplanes (left) and Ward Air (right)

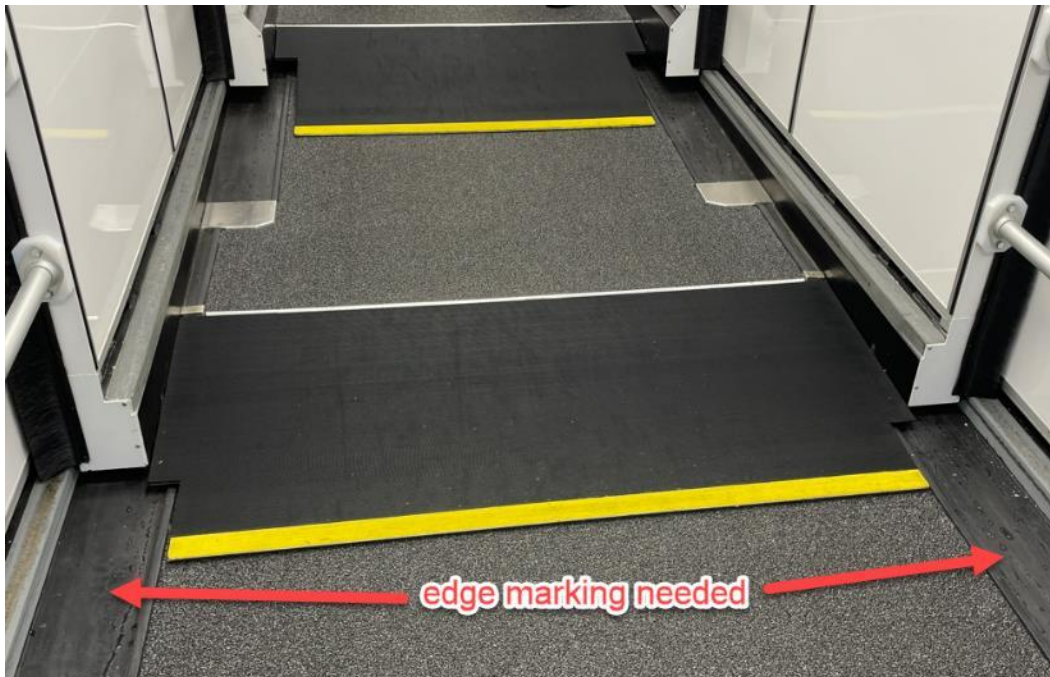
New Gate 5 Jetbridge needs edge markings for uneven surfaces

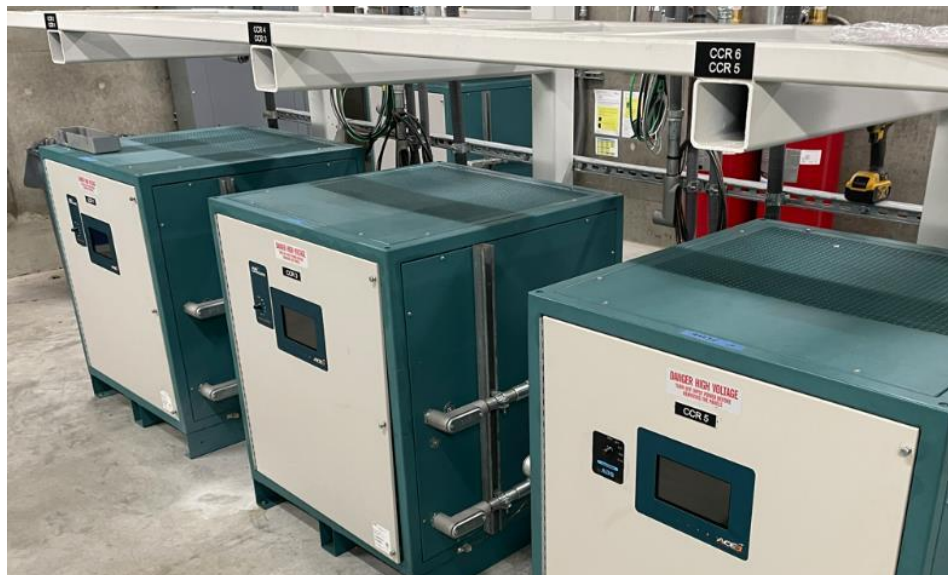
Primary vault regulators with circuit names (CCR 5, CCR 6, etc) on black placards, but with no other references

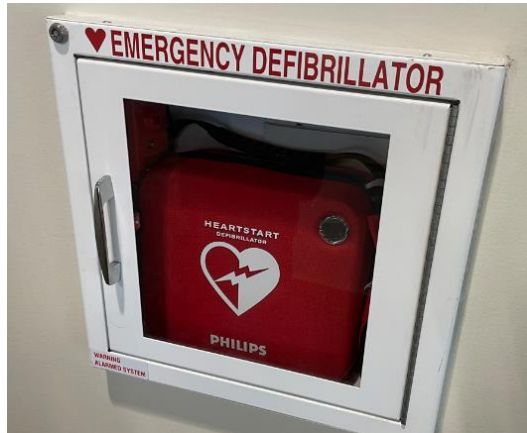
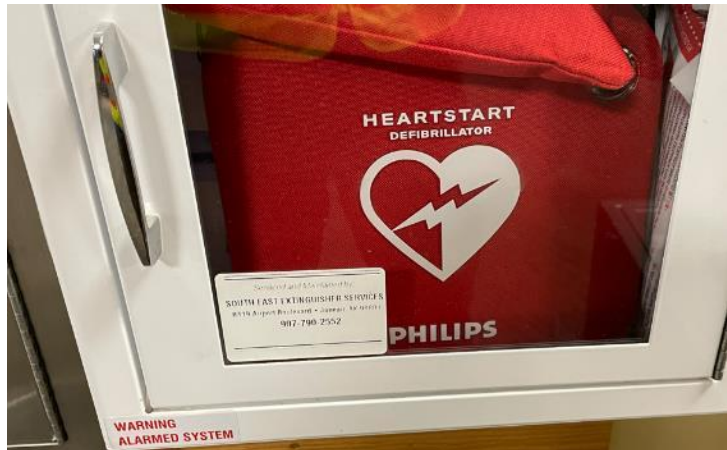
AED cabinets located throughout the terminal, no label indicating date of last service

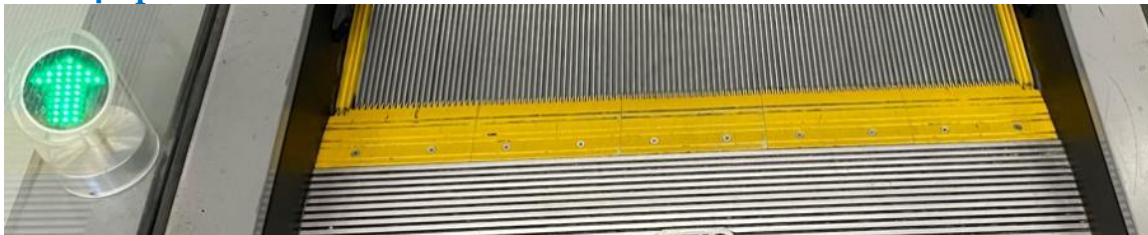
All escalator comb plates are now full width solid yellow
