## APPENDIX C

### TECHNICAL MEMOS

<b>To:</b>	Teri Camery (CBJ)	<b>Date:</b>	April 27, 2022
<b>c:</b>	Alix Pierce (CBJ)	<b>Memo No.:</b>	1
<b>From:</b>	Rita Kors-Olthof, Vladislav Roujanski, Shirley McCuaig	<b>File:</b>	704-ENG.EARC03168-01 / 704-ENG.EARC03168-02A
<b>Subject:</b>	Landslide Mapping Accuracy and Modelling Downtown Juneau Landslide and Avalanche Hazard Assessment

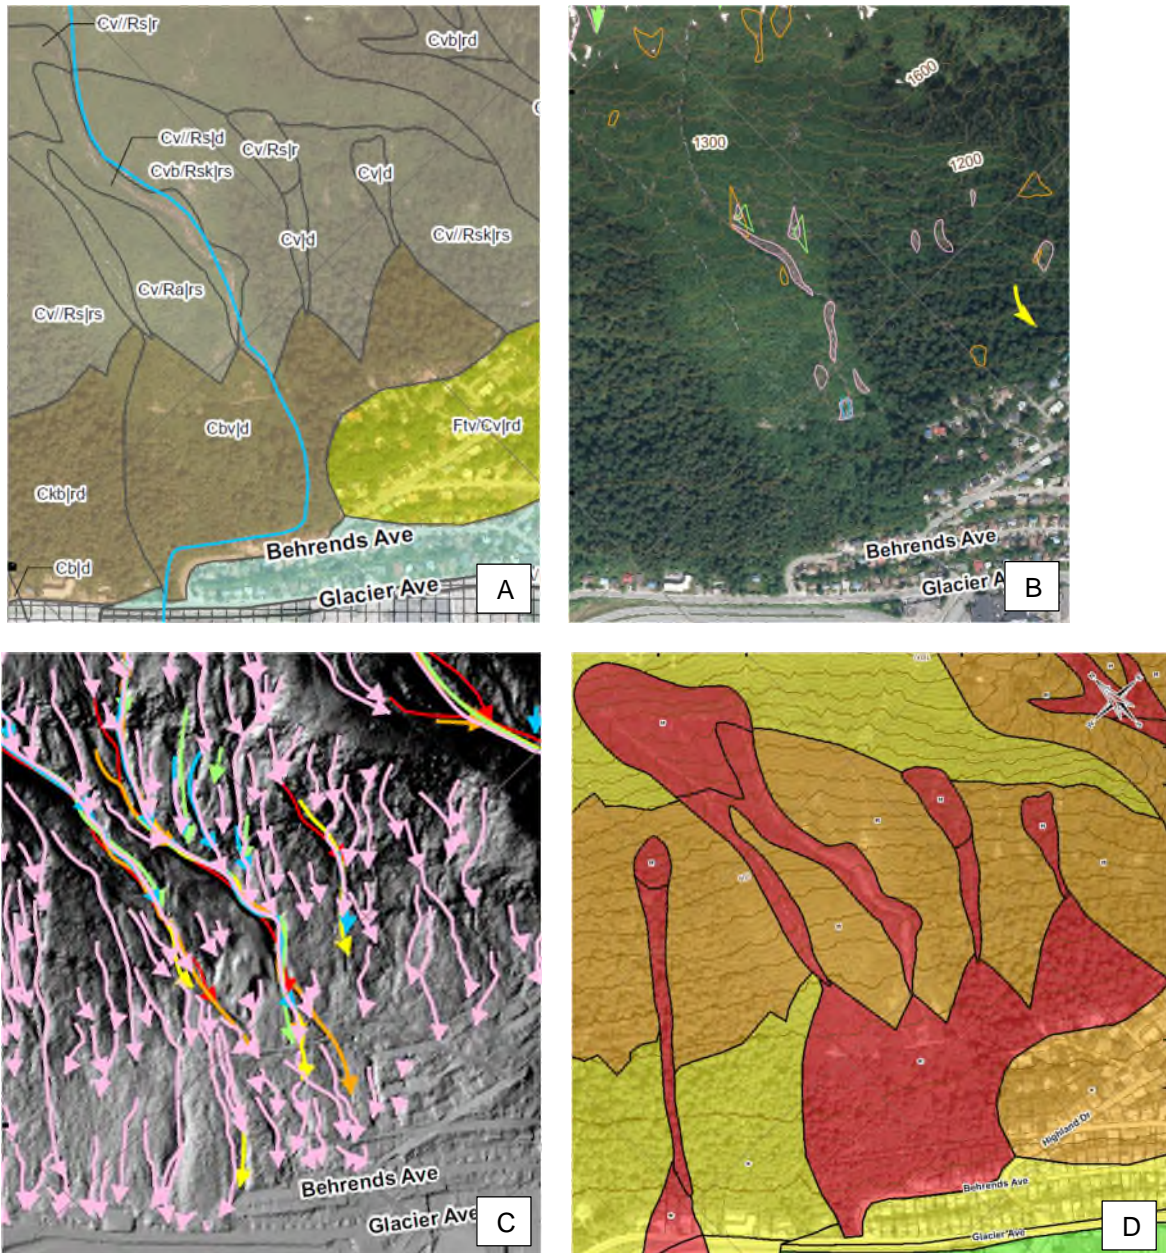
**Response:** The basis for the *Severe* hazard designation is not Swanston’s report, but rather Tetra Tech’s independent determination of the characteristics of the terrain units based on surficial geology mapping, historical air photo record analysis of slope movement features and gully erosion features, as well as incident reports and field observations. See also responses to Items 1 and 4 above. Specific to the *Severe* areas mapped in this part of the study area (Figure 1.6b and 1.6c), these are all colluvial areas (Figure 1.3b) that receive debris from several active gullies upslope (Figure 1.5b), including the previously mentioned Bathe Creek gully (see Figure 2 above), and several active gullies above Behrends Avenue and the west end of Highland Drive (see Figure 3 below). Several of the two dozen debris slides that occurred in various years in the immediate map area (Figure 1.4b) happened within gullies (compare Figures 3B and 3C below). The excerpt from Figure 1.4b (Figure 3B below) is also a good example of an avalanche track (area with no trees) that does not correspond perfectly with landslide activity and location.

**Figure 3: Excerpts from Figure 1.3b Surficial Geology (Figure 3A) and Figure 1.4b Historical Air Photo Record – Slope Movement Features (1948-2020) (Figure 3B), and excerpts from Figure 1.5b Historical Air Photo Record and LiDAR Data Analysis – Gully Erosion Features (1948-2013) (Figure 3C) and Figure 1.6c Landslide Hazard Designation Mapping (Figure 3D).**

While it is possible that houses have stood in one location for many years without being affected by a landslide, it does not mean there is nothing going on above them on the slope. If that activity has not reached a particular house yet, the resident may just have been lucky so far.

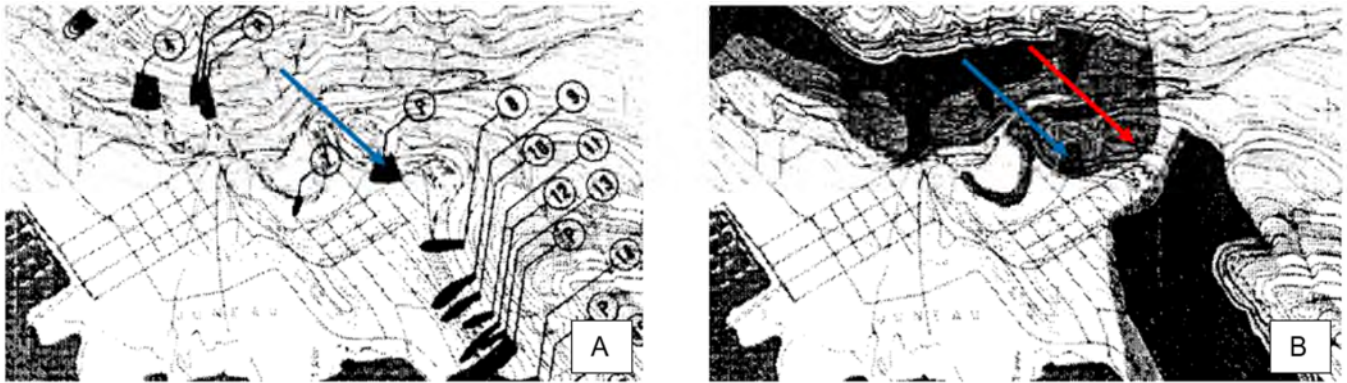
**Figure 2: Excerpts from Swanston (1972) – Figure 5 – Historic Landslide Deposits (Figure 2A) and Figure 6 – Mass Wasting Hazard Areas (Figure 2B).**

In Swanston’s Figure 5, “P” means “Prehistoric” (before 1880). A prehistoric slide area was noted on the south side of Mt. Maria (blue arrow in Figure 2A). In Swanston’s Figure 6 (Figure 2B), hazards for mass wasting (landslide) hazard areas are shown, with *Potential* Hazards marked in gray, and *High* Hazards marked in black. The prehistoric slide is shown as a *High* Hazard area (blue arrow in Figure 2B). A small cliff with a talus deposit above the corner of 6<sup>th</sup> and Nelson Streets was also designated as being in a *High* Hazard area (red arrow in Figure 2B).

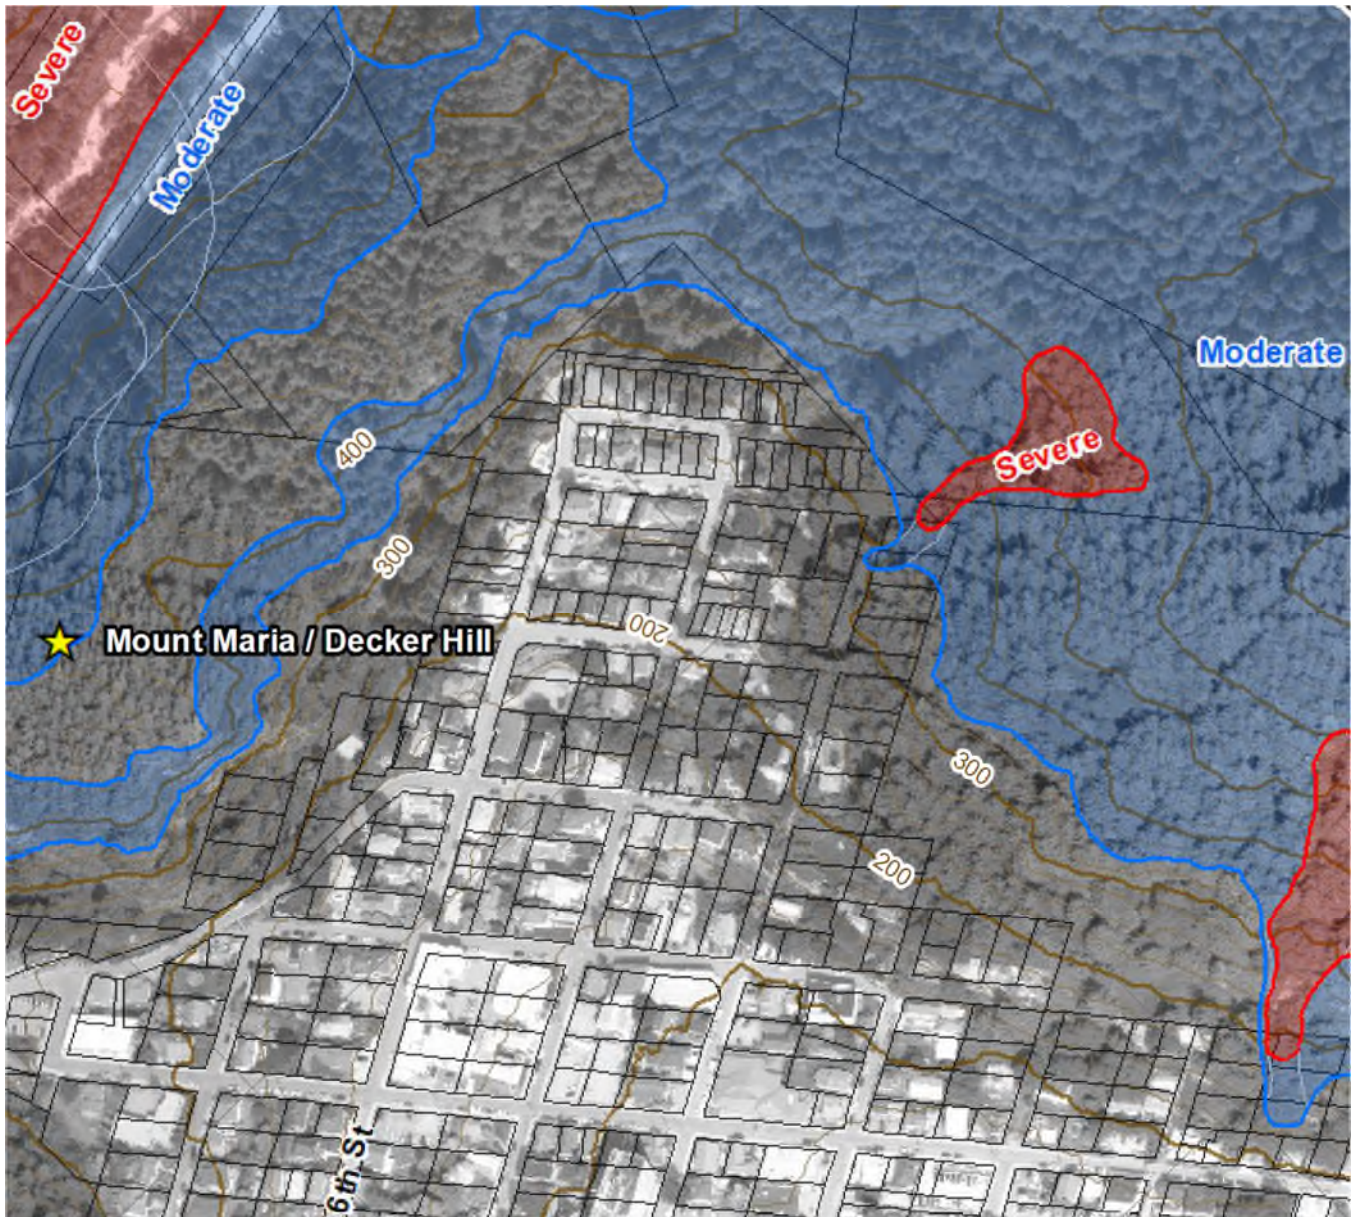
One example of terrain with an avalanche hazard designation of *Low* is most of the Starr Hill subdivision, as shown in Figure 1. Figure 2 shows a view of Starr Hill from the helicopter.

Figure 1: Excerpt from Figures 2.4c and 2.4h in the main report, showing the northeast end of the Starr Hill subdivision. Almost all of the lots are mapped with an avalanche hazard designation of *Low* (i.e., not colored as red or blue), with the only encroachment being the G000 (Park) avalanche path on the right (marked *Severe*, with *Moderate* terrain below). All the existing houses are currently located in areas designated as *Low*.

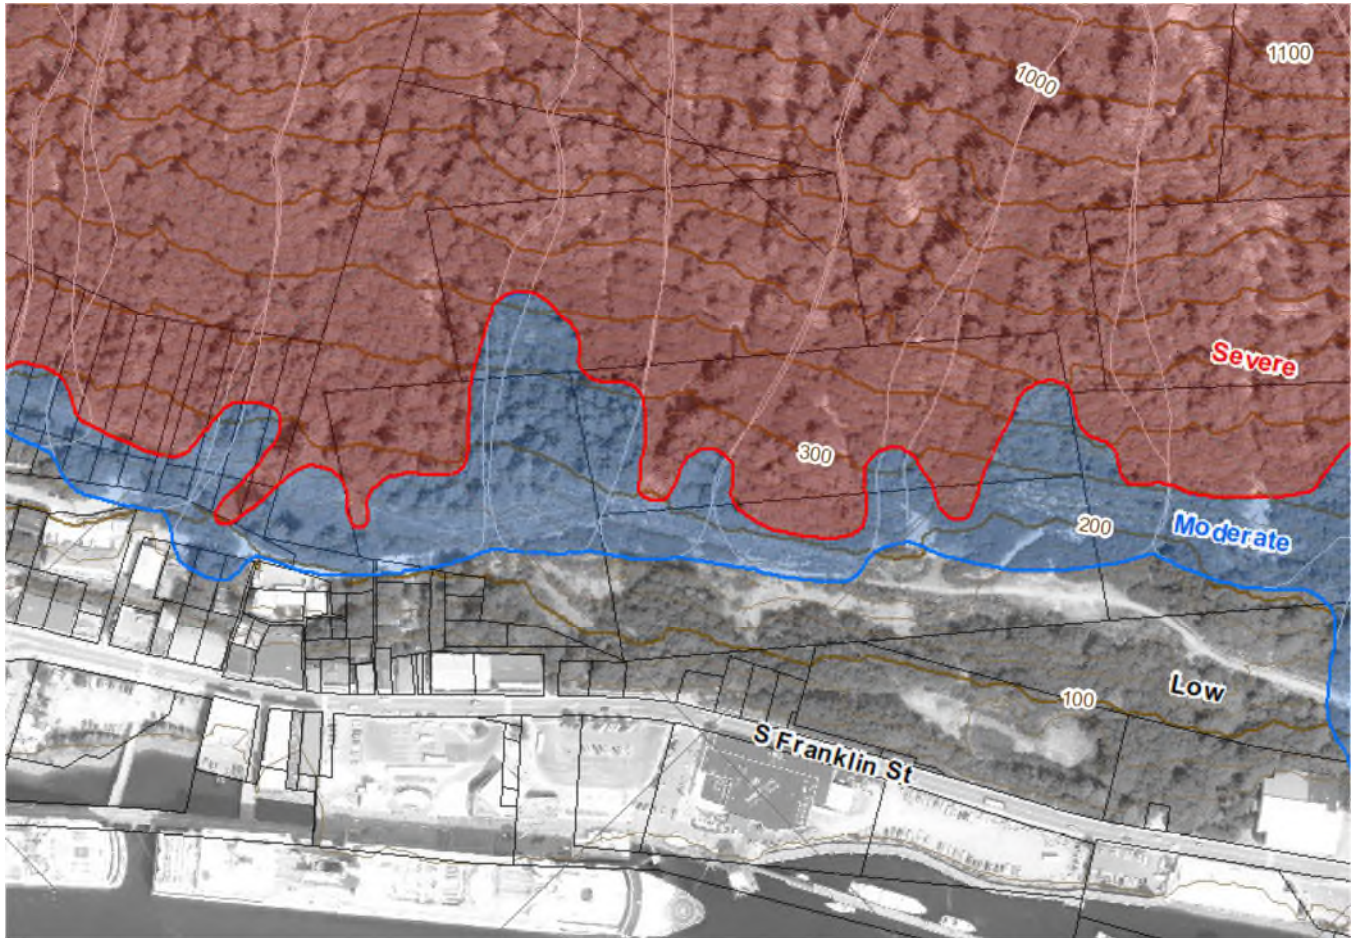
Avalanche areas mapped with a hazard designation of *Moderate* are shown in blue on the mapping. Typically, the *Moderate* zone on the larger mountain slopes forms a fringe downslope and alongside the main avalanche paths (mapped in red) that is less likely to experience an avalanche, and if an avalanche does reach *Moderate* terrain, the impact pressures are expected to be lower, and are impacted less frequently. Figure 3 is an example of this type of avalanche terrain adjacent to the southern section of Gastineau Avenue and upslope of South Franklin Street.

**Figure 3: Excerpt from Figure 2.4d in the main report, showing avalanche paths G003 to G009 and T000 (from left to right). The blue fringe shows terrain designated as having *Moderate* avalanche hazard along the toe of Mt. Roberts. In this area, the *Moderate* hazard does not reach South Franklin Street, but it does reach Gastineau Avenue in several locations. Further southeast (off the right-hand side of this map excerpt), the slopes of Mt. Roberts become higher and are affected by unforested alpine terrain, and the *Moderate* avalanche terrain reaches further downslope, past Thane Road, and sometimes into Gastineau Channel.**

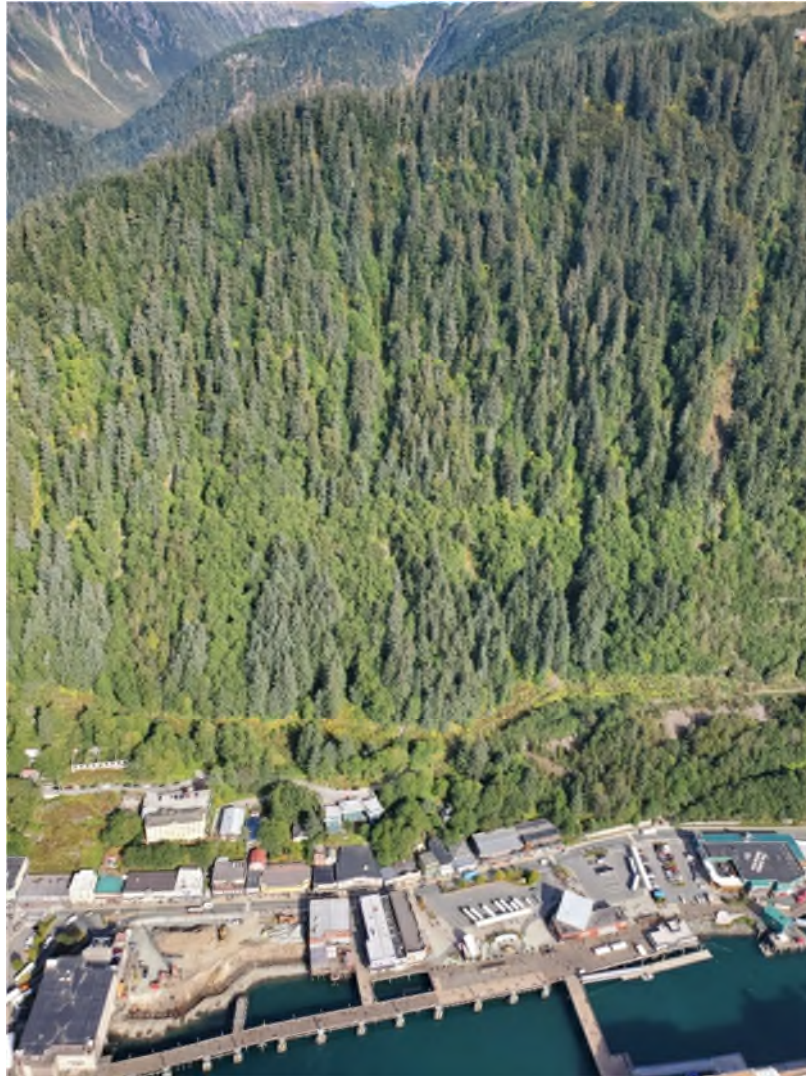
Figure 4a below shows the slope from the helicopter, which is vegetated with a relatively dense forest cover in this area. Avalanche hazards are present within the gullied parts of the slopes, and have historically affected areas close to Gastineau Avenue. Figure 4b provides a view from Google Earth that shows distinct avalanche paths and start zones within the gullies that are easily seen on the winter imagery, which highlights the differences in coniferous versus deciduous forests.

**Figure 4a: View of Mt. Roberts from the helicopter showing part of the slope mapped in Figure 3. Note the increasing height of slope from left to right (northwest to southeast). The slope is fairly well-treed but is still prone to avalanching. Gullies tend to increase avalanche runouts. See also Figure 4b.**

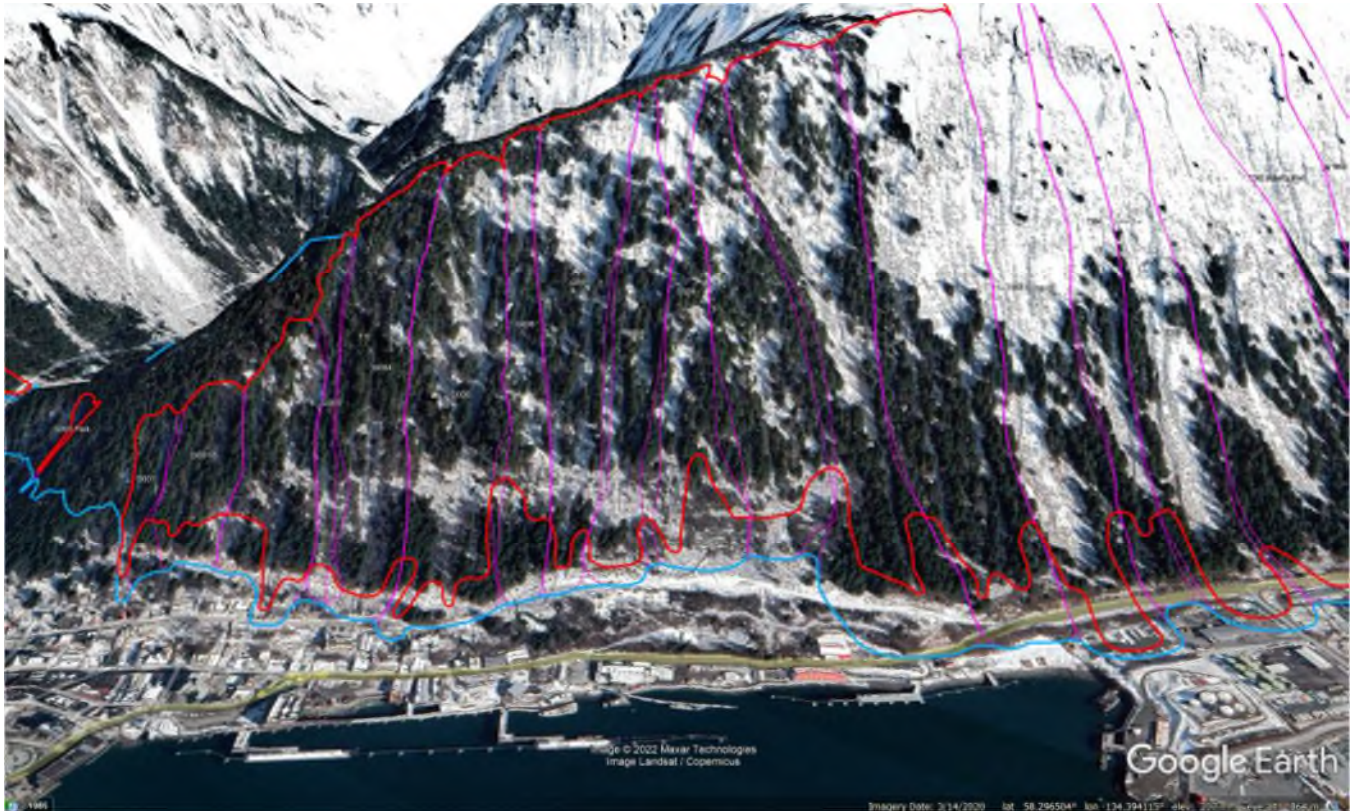
**Figure 4b: View of the northern part of Mount Roberts along Gastineau Avenue and South Franklin Street, with avalanche paths and *Moderate/Severe* hazard boundaries shown. Note the increasing height (and length) of slope from left to right (northwest to southeast), which increases the runout distance and hazard to lower elevation areas towards the industrial park. Although the Gastineau Avenue area is forested, distinct avalanche paths and start zones within the gullies can be observed on the winter imagery, which highlights the forest cover differences (coniferous versus deciduous forests). (Image credit: Google Earth 2022.)**

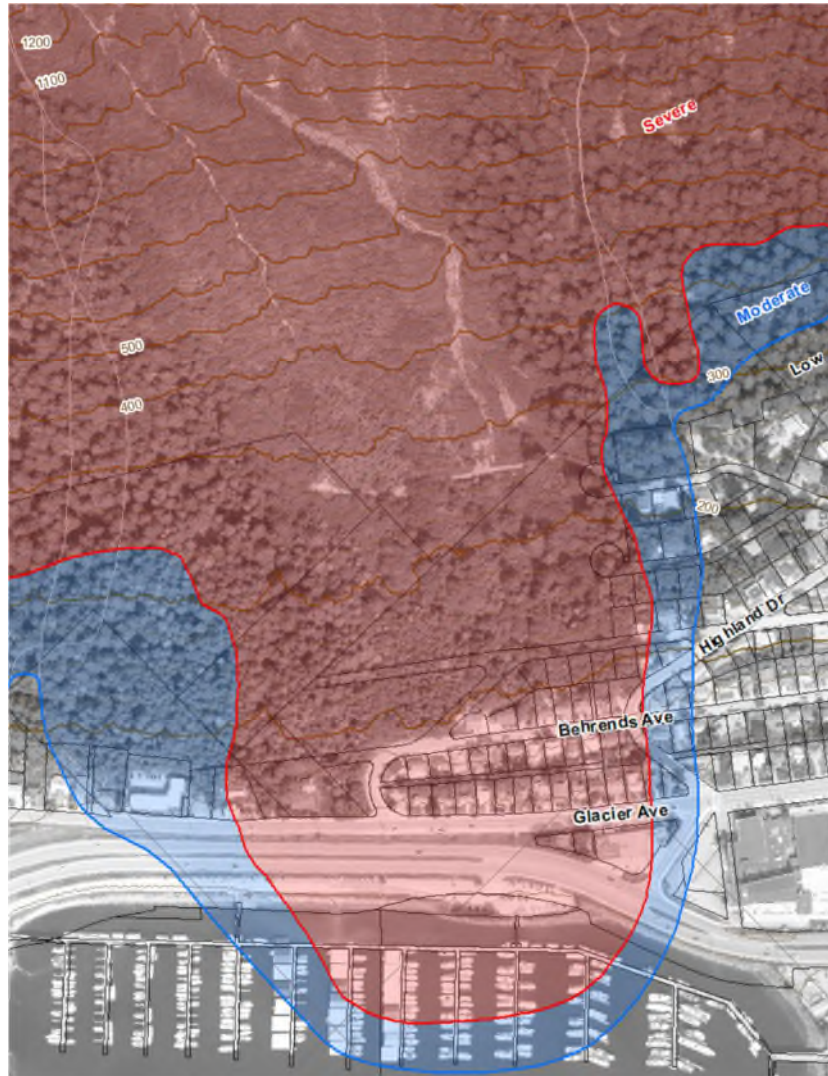
most likely to experience an avalanche (i.e., higher frequency), and experience the highest impact pressures. In many cases within the Juneau area, this occurs within distinct gullies. Figure 5 is an example of this type of avalanche terrain in the Behrends avalanche path and subdivision. Figure 6 shows the slope from the helicopter. Figure 7 shows the lower part of the slope after a very large avalanche in 1985.

**Figure 5: Excerpt from Figure 2.4b showing the major avalanche path at J010 Behrends. Note the distinct trimlines that define the edges of this path, indicating regular avalanche activity within the central part of the path and less frequent avalanche activity on the outside (lateral boundaries) of the path.**

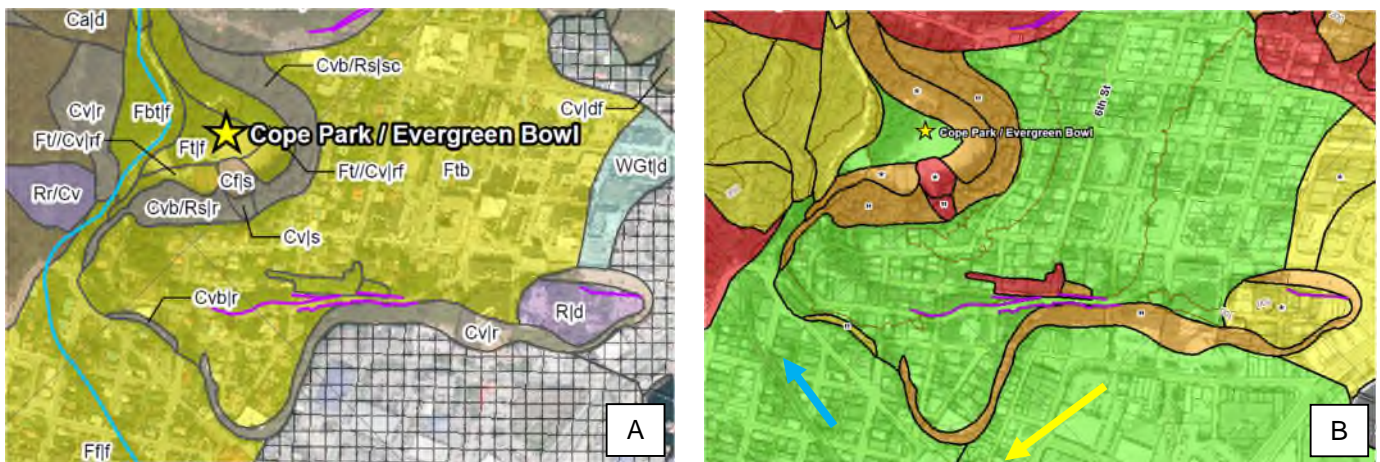
Figure 9 shows the surficial geology and the landslide hazard mapping for two areas of Downtown Juneau that are designated as having a *Low* landslide hazard. Figure 10 shows a photo for each of those areas.

**Figure 9:** These two map excerpts are from the mapping across the approximate middle of the downtown area. Figure 79A shows the surficial geology, and Figure 9B shows the landslide hazard mapping. Gold Creek is marked as a blue stream along the left side of Figure 9A. Willoughby Avenue is in the cross-hatched area on Figure 9A, where fill was placed to extend the land area of the city. The yellow arrow on Figure 9B shows the direction of look in Figure 10A. The blue arrow on Figure 9B shows the direction of look in Figure 10B.

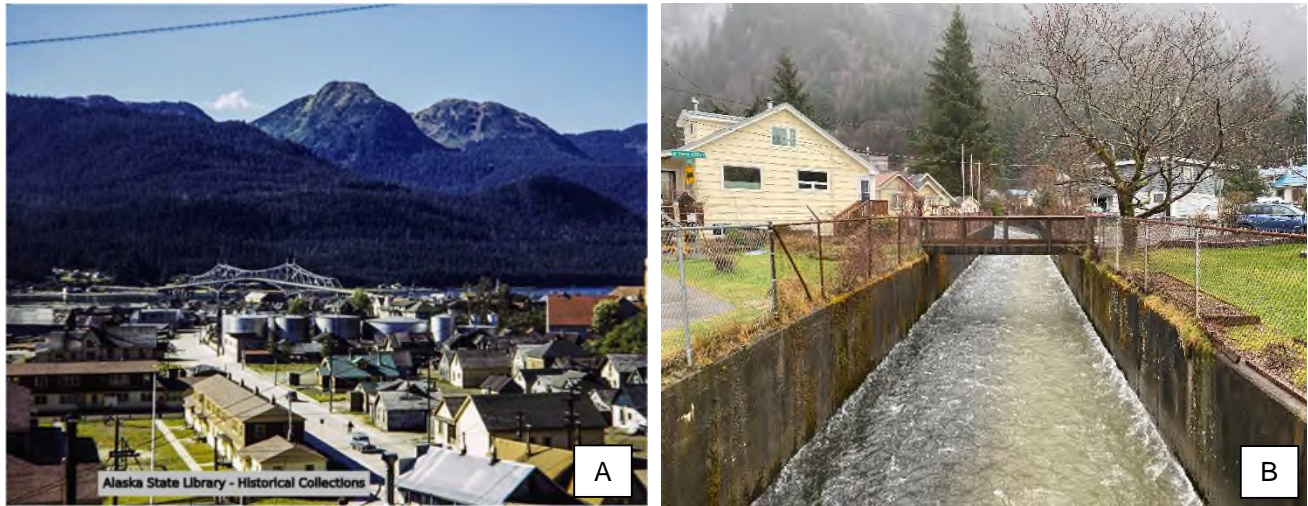
**Figure 10: Views of Juneau in terrain mapped with landslide hazard designation of *Low*.**

**Figure 10A: Looking west from Telephone Hill at the east-west leg of Willowby Avenue. Figure 10B: Looking upstream at the Gold Creek flume, with terrain mapped in *Low* on both sides of the creek. (Photo credits: Figure 10A: Alaska State Library – Historical Collections, [ASL-P417-040](#), Caroline Jensen 1948. ASL 2022a. Figure 10B: CBJ December 4, 2020.)**

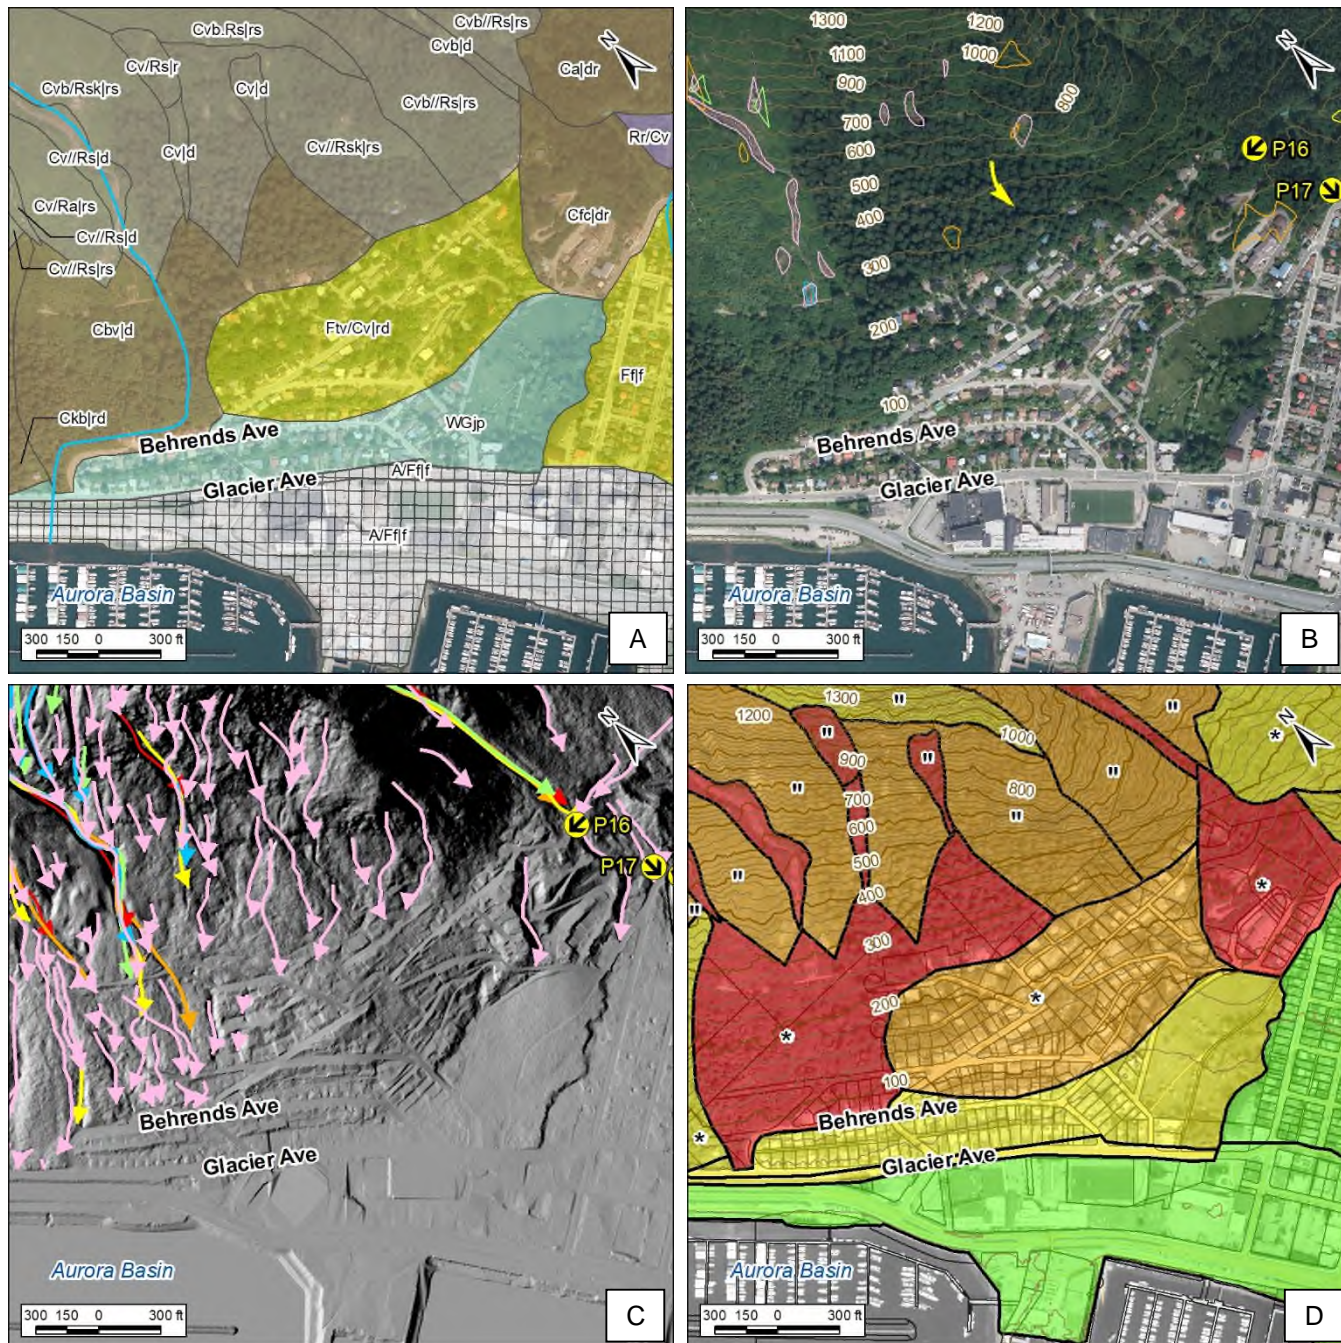
**Figure 11: These mapping excerpts show *Moderate* hazard terrain from part of the Juneau Study Area. Figures 11A through 11D. The terrain mapped as glaciomarine (WG) in Figure 11A reveals no slope movement features in Figure 11B, and no gully erosion features in Figure 11C. That results in a landslide hazard designation of *Moderate*, as shown on Figure 11D. See also Figure 13 for examples of *Moderate* terrain. Events that affect mainly roads (e.g., Figure 13A) tend to be cleaned up promptly and are generally not seen on the air photos.**

As shown on Figure 11D, Glacier Avenue at Ross Way is just below the *Severe* landslide designation zone at the Behrends Subdivision, at the northwest end of Behrends Avenue (left side of figure). That means Glacier Avenue could receive some smaller water-borne debris and muddy water that runs down the road, but it should not experience the more serious impacts generally seen further upslope. However, because some effects are still

possible, such as erosion (red arrow on Figure 13A), the landslide hazard designation here cannot be considered *Low*. As shown on Figure 11B, no other historical slope movement features were observed on the imagery, and on Figure 11C, the gullies appear not to extend across Behrends Avenue or Glacier Avenue, although the debris may flow onto them. Therefore, a landslide hazard designation of *Moderate* is considered appropriate.

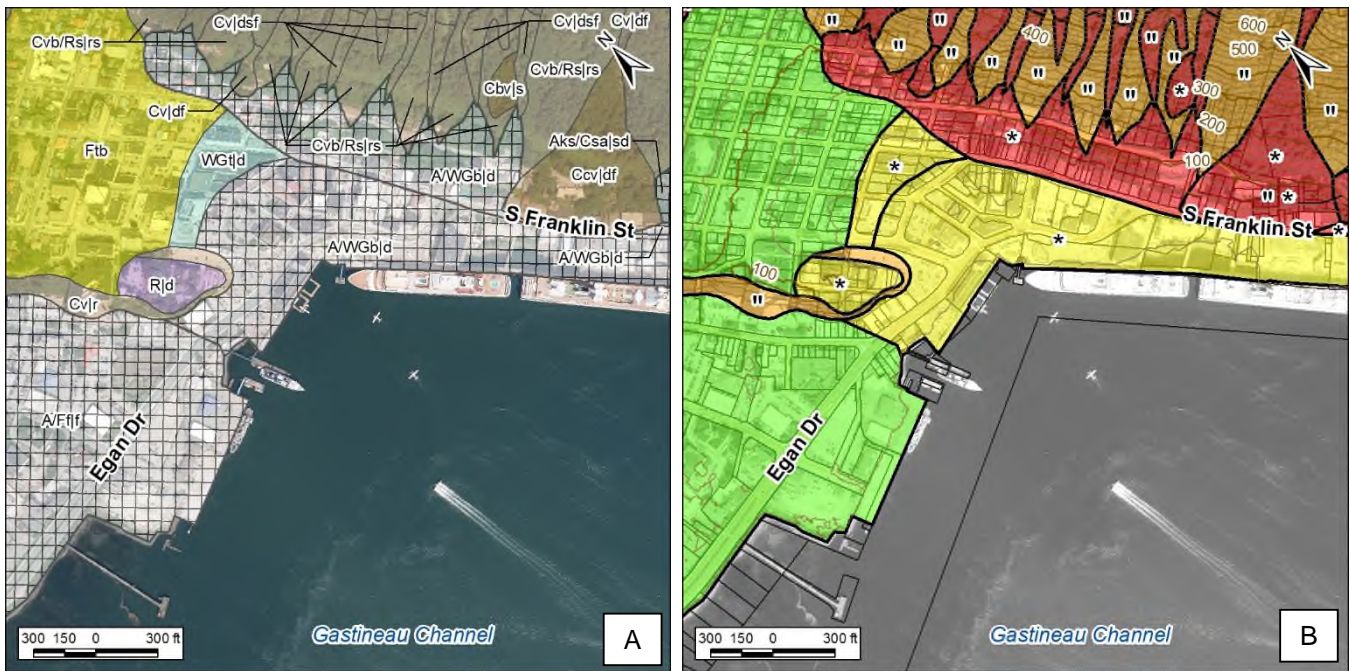
Similar conditions apply downslope of South Franklin Street. The runouts of the several landslides on this slope are represented by surficial geology shown in Figure 12A and the *Severe* landslide hazard designations shown in Figure 12B.

**Figure 12:** These mapping excerpts show *Moderate* hazard terrain from another part of the Downtown Juneau Study Area. Figures 12A and 12B are from the Downtown Historic District, the east leg of Tideland, and the top of Telephone Hill. At center-left of Figure 12A, there is glaciomarine terrain (WG), and a rock outcrop (R) at Telephone Hill. Southeast of these two upslope areas, the terrain has been extensively human-modified (A). In this case, new ground was made from fill to create more space for the townsite development. These three areas together (except for the steep colluvial sideslopes of Telephone Hill) result in a *Moderate* hazard designation along the shoreline. In this case, a large landslide originating from the *Severe* terrain upslope of South Franklin Street (including the apparently mining-related events of 1920 and 1936) could have the potential to affect the *Moderate* terrain, but no obvious signs remain below South Franklin Street.

No mass movement events appear to have crossed South Franklin Street recently, and it is possible that the drainage and retaining structures erected along Gastineau Avenue could mitigate the extent of future landslides, at least at the 1920 landslide location. Nevertheless, the lower edge of the *Severe* terrain has been adjusted to be located downslope of South Franklin Street to account for the possibility of debris having been cleaned up and not seen on the imagery (Figure 12B). See Technical Memos #3, #6, and #7 (Appendix C in the main report; Tetra Tech 2022c, 2022f, 2022g) for more information about the slopes on Mt. Roberts.

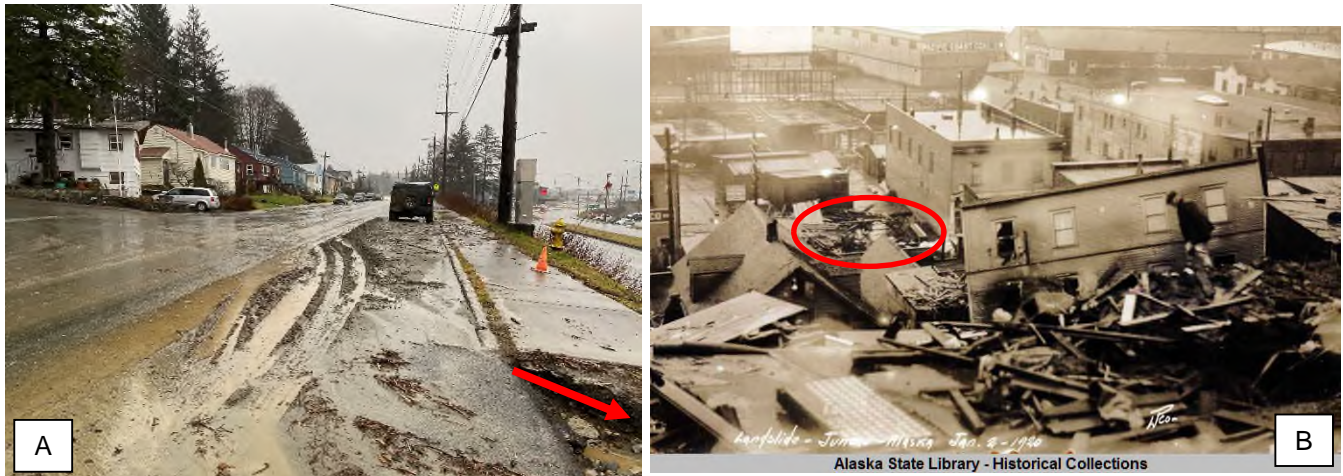
**Figure 13: These photos are of *Moderate* terrain. Figure 13A is looking southeast along Glacier Avenue on December 4, 2020, where Ross Way enters. Ross Way carried debris and water from Behrends Avenue to Glacier Avenue. Debris can also run southeast on Behrends Avenue. Note the apparently eroded and failed section of the sidewalk (at red arrow) where a section of concrete slab was missing. Figure 13B is looking downslope towards South Franklin Street (formerly Front Street) on January 2, 1920, after a major landslide from upslope of Gastineau Avenue. The red circle shows possible landslide debris across the street. (Photo credits: Figure 13A: CBJ December 4, 2020. Figure 13B: Alaska State Library – Historical Collections, [ASL-P109-42](#), Katherine Shaw 1920. ASL 2022b.)**

On South Franklin Street (formerly Front Street), debris has sometimes crossed the road, for example, during the November 22, 1936 major landslide when debris reached the Juneau Cold Storage building, or as seems to have happened during the January 2, 1920 landslide, based on the photo in Figure 3B. However, these appear to be relatively rare events and, in the case of the 1920 landslide, seem to have been aggravated by a leaky flume from the Alaska Juneau Gold Mining Company (AJGMC) and, in 1936, was possibly aggravated by an oversteepened fill/spoil slope, also mining-related. The October 1, 1952 landslide resulted in debris blocking South Franklin Street.

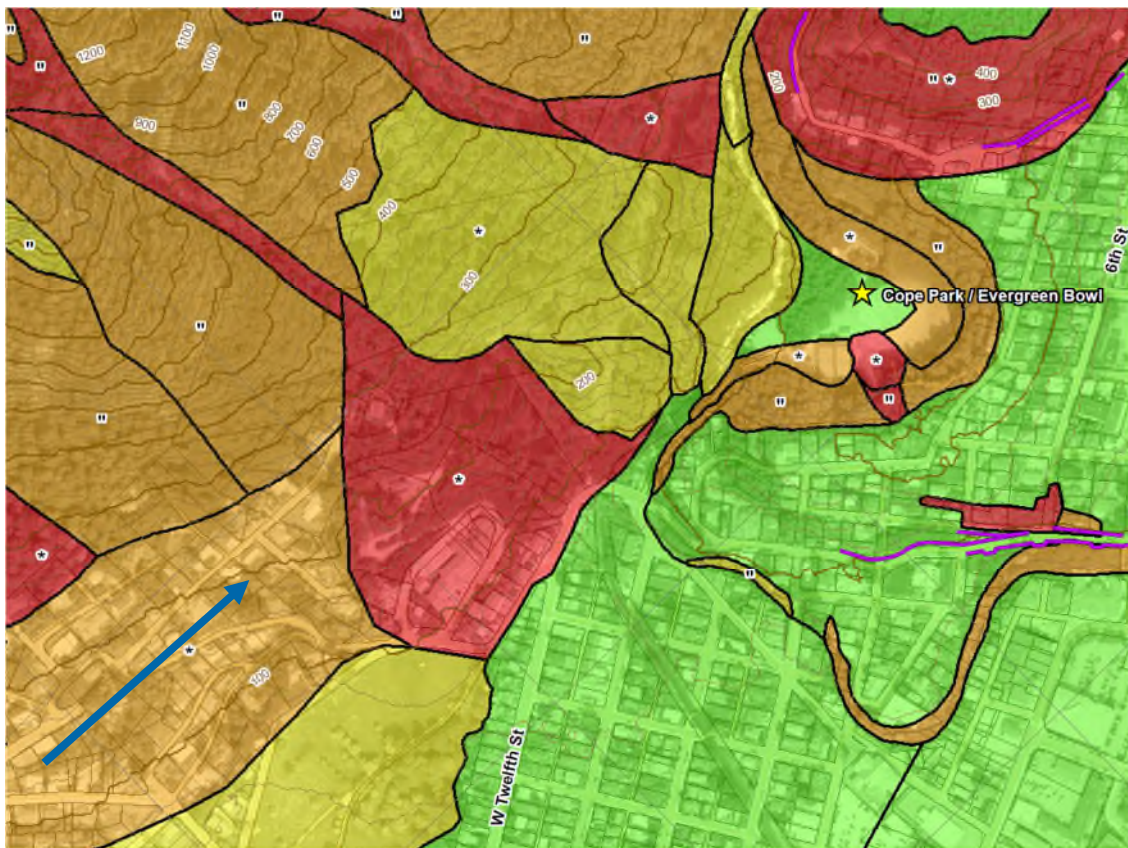
Two example areas are provided for terrain designated with a *High* landslide hazard in the vicinity of Evergreen Avenue and around the slopes of Cope Park (Figures 14, 15, and 16).

**Figure 14: Excerpt from the landslide hazard mapping. Blue arrow on Figure 14 is direction of look on Figure 15, and back end of arrow is lower edge of photo in Figure 15. (See also Figures 9 and 11 for connecting map areas.)**

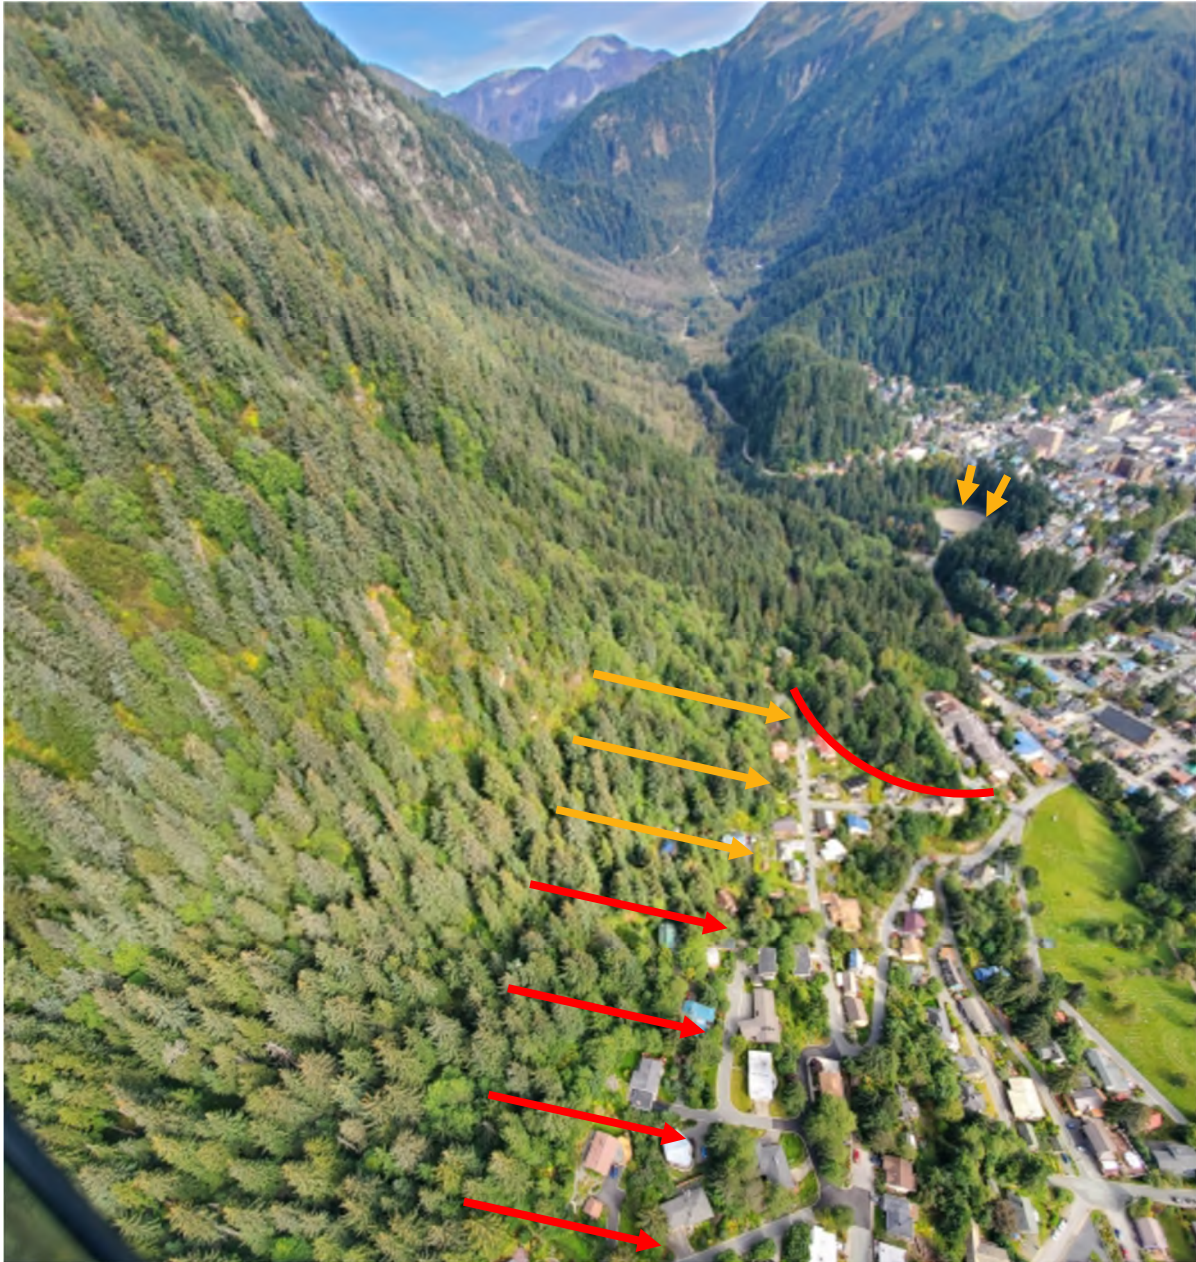
**Figure 15: View from the helicopter looking east towards Last Chance Basin (see direction of look on Figure 14). Upper Evergreen Avenue is approximately in line with direction of look.**

Most of the residential area in the foreground of Figure 15 is in *High* hazard zone. The upper ends of the road stubs in the foreground are mapped as *Severe* hazard (red arrows). Moving further east of the hairpin turn of Evergreen Avenue (further away from the camera), the upslope terrain is in *High* hazard zone (orange arrows) until the Bathe Creek fan/cone, where trees obscure the east end of Evergreen Avenue along the west edge of a large gully (near side outlined in red). The cemetery, which is the verdant green space at the lower right edge of the photo, is in *Moderate* hazard zone. The orange arrows at Cope Park (in the middle distance) show that most of the slope around the park is mapped as *High* hazard. See Figure 14 for more hazard mapping details. See Figure 16 for a close-up view of the slopes at Cope Park. See Technical Memo #2 (Appendix C in the main report; Tetra Tech 2022b) for more information about the Bathe Creek area.

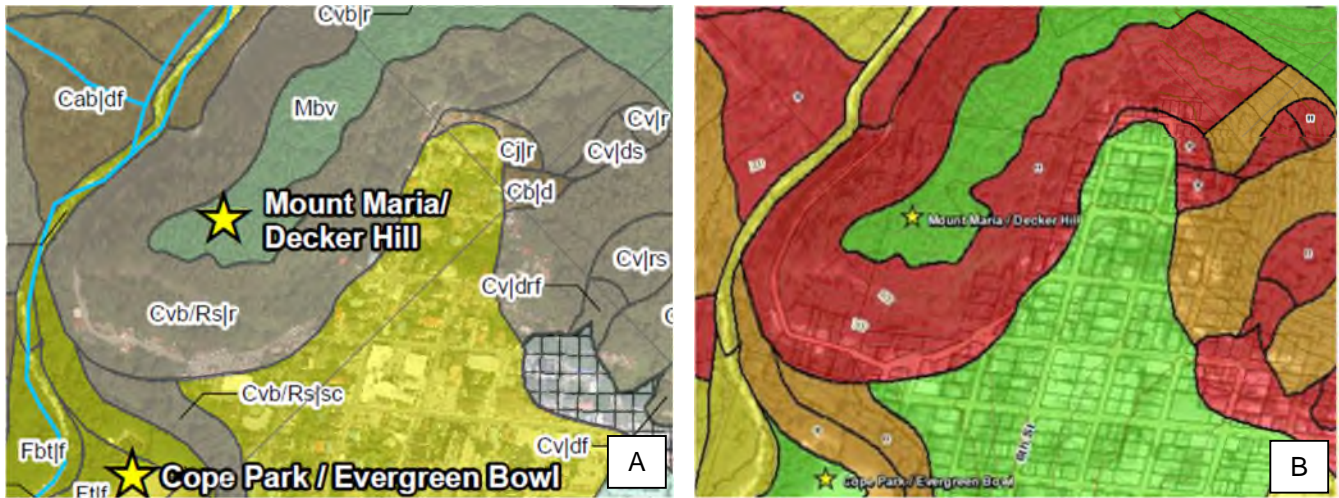
**Figure 17: These two map excerpts are from the mapping slopes above Starr Hill. Figure 17A shows the surficial geology, and Figure 17B shows the landslide hazard designation mapping. Around Starr Hill, the green signifies *Low* hazard, the orange is *High* hazard, and the red is *Severe* hazard. See Figure 18 for the landslide seen in the *Severe* hazard area above Nelson Street. More information about this area is available in Technical Memo #3.**

Figures 17B and 19D are hazard maps, which indicate areas that are potentially hazardous. If there was a lot of potentially hazardous geomorphic process activity on a slope, or if new activity was identified in the field, that area was mapped as having a *Severe* hazard. For instance, debris could be building up on the slope directly above a house (Figure 18), or in a location where debris can potentially run towards a house, and where it could become a more serious hazard in the future (Figures 20B and 20D). Smaller debris slides and debris flows tend to accumulate debris material in wedges within gullies. Eventually, when a critical level of debris accumulation is reached, or a significant precipitation event occurs, all that stored debris is scoured out of the gully, potentially resulting in a very large debris flow event. Similar events can occur on open slopes where slide debris piles up in lobes over days, months, or years, sometimes separated by channels of faster-flowing loose material. These debris lobes can slowly be creeping downslope, until the critical moment when there is enough mass and enough water to trigger the debris flow rapidly downslope. See also Technical Memo #2 for more mapping examples (Appendix C in the main report; Tetra Tech 2022b).

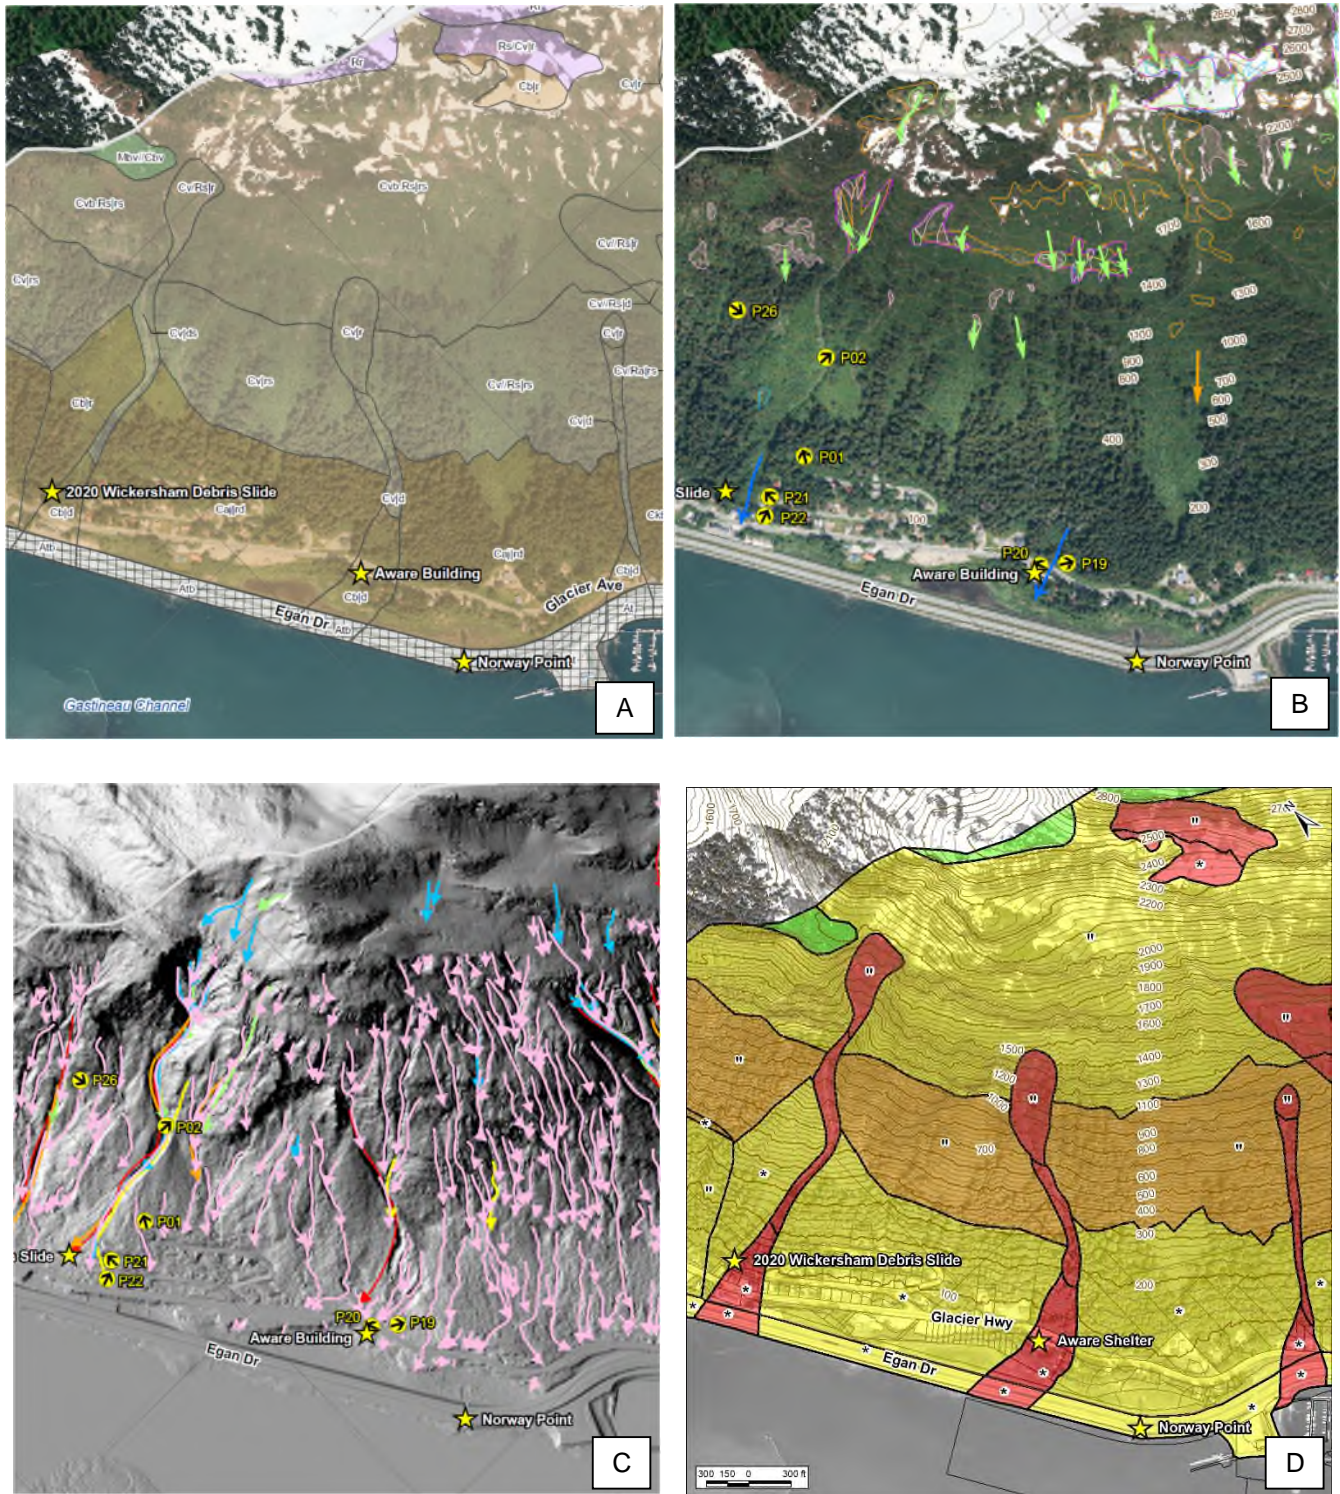
**Figure 19: These excerpts are from the mapping at the slopes at the White Subdivision. Figure 19A shows the surficial geology, Figure 19B shows the slope movement features, Figure 19C shows the gully erosion features, and Figure 19D shows the landslide hazard mapping. The Wickersham slide (Figure 20) is related to a very active gully erosion feature in Severe hazard.**
