## APPENDIX C

### TECHNICAL MEMOS

<b>To:</b>	Teri Camery (CBJ)	<b>Date:</b>	April 27, 2022
<b>c:</b>	Alix Pierce (CBJ)	<b>Memo No.:</b>	1
<b>From:</b>	Rita Kors-Olthof, Vladislav Roujanski, Shirley McCuaig	<b>File:</b>	704-ENG.EARC03168-01 / 704-ENG.EARC03168-02A
<b>Subject:</b>	Landslide Mapping Accuracy and Modelling Downtown Juneau Landslide and Avalanche Hazard Assessment

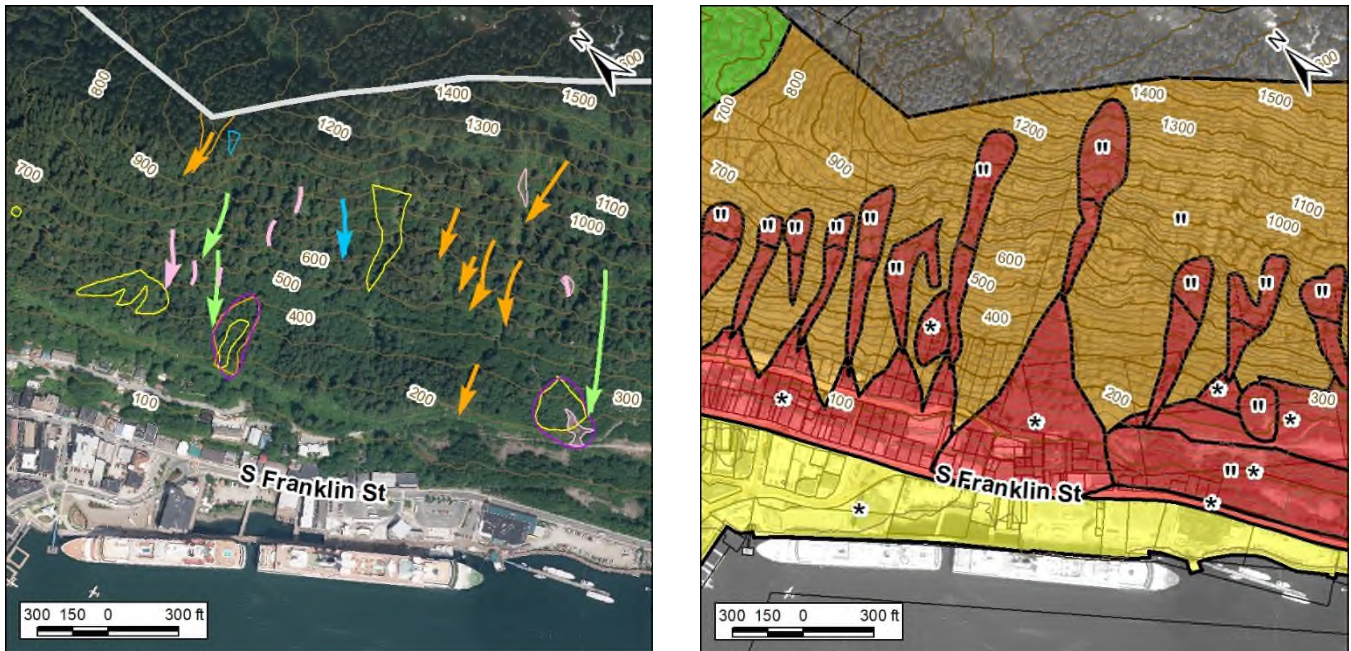
**Landslides of November 22, 1936:** The tension crack reported below the AJGMC tramline (presumably within the fill/spoil slope) seems suspicious, suggesting initiation of the slope failure in *High*. However, the slide seems to have entered the runout in *Severe* along the southeast edge of the runout cone encompassing the former AJGMC office (for 1936B), and the adjacent slide (1936A) seems to have been entirely within *Severe* (Figures 1a, 1b in Technical Memo #7). Several debris slides were mapped in this area thereafter, apparently on the fill/spoil slope, in 1962, 1977 (confirming the 1971 air photo mosaic map from the State of Alaska, Department of Highways (ASL 2022)), and in 2013 and 2019 (Figure 8; Tetra Tech 2021a, Figure 1.4b). All but one of these later debris slides ran out to approximately the upper edge of the cleared powerline right-of-way, and the 2019 debris slide ran out to the lower edge of the right-of-way (Figure 8). Another debris slide or flow was mapped on the 1977 air photos, originating from upslope of the tramline, apparently flowing along the northwestern edge of the 1936B debris slide path, but running out well above the powerline right-of-way (Figure 8).

**Figure 8: Excerpts from Figure 1.4b Slope Movement Features (left) and Figures 1.6c and 1.6h Landslide Hazard Designation Mapping (right) near the northwest end of Mt. Roberts. Note outlines of several colours at center-left, indicating several years of landslide events at the same location, just upslope of the powerline right-of-way.**

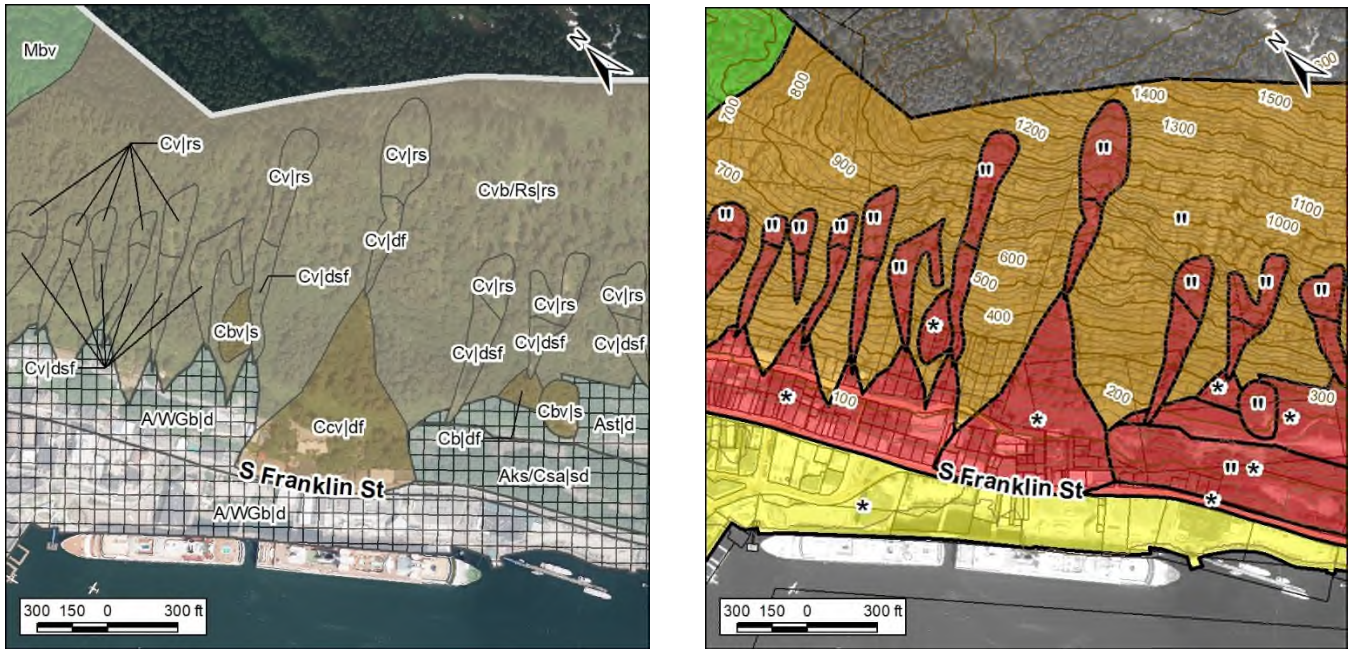
A summary of Tetra Tech's mapping near the northwest end of Mt. Roberts is shown in Figure 1, and the southeast end of the Study Area along Mt. Roberts is shown below in Figure 2, both with surficial geology on the left and landslide hazard designation mapping on the right. There is a clear correlation between the type and shapes of the surficial geology units and the landslide hazard designations.

**Figure 1: Excerpts from Figure 1.3b Surficial Geology (left) and Figures 1.6c and 1.6h Landslide Hazard Designation Mapping (right).**

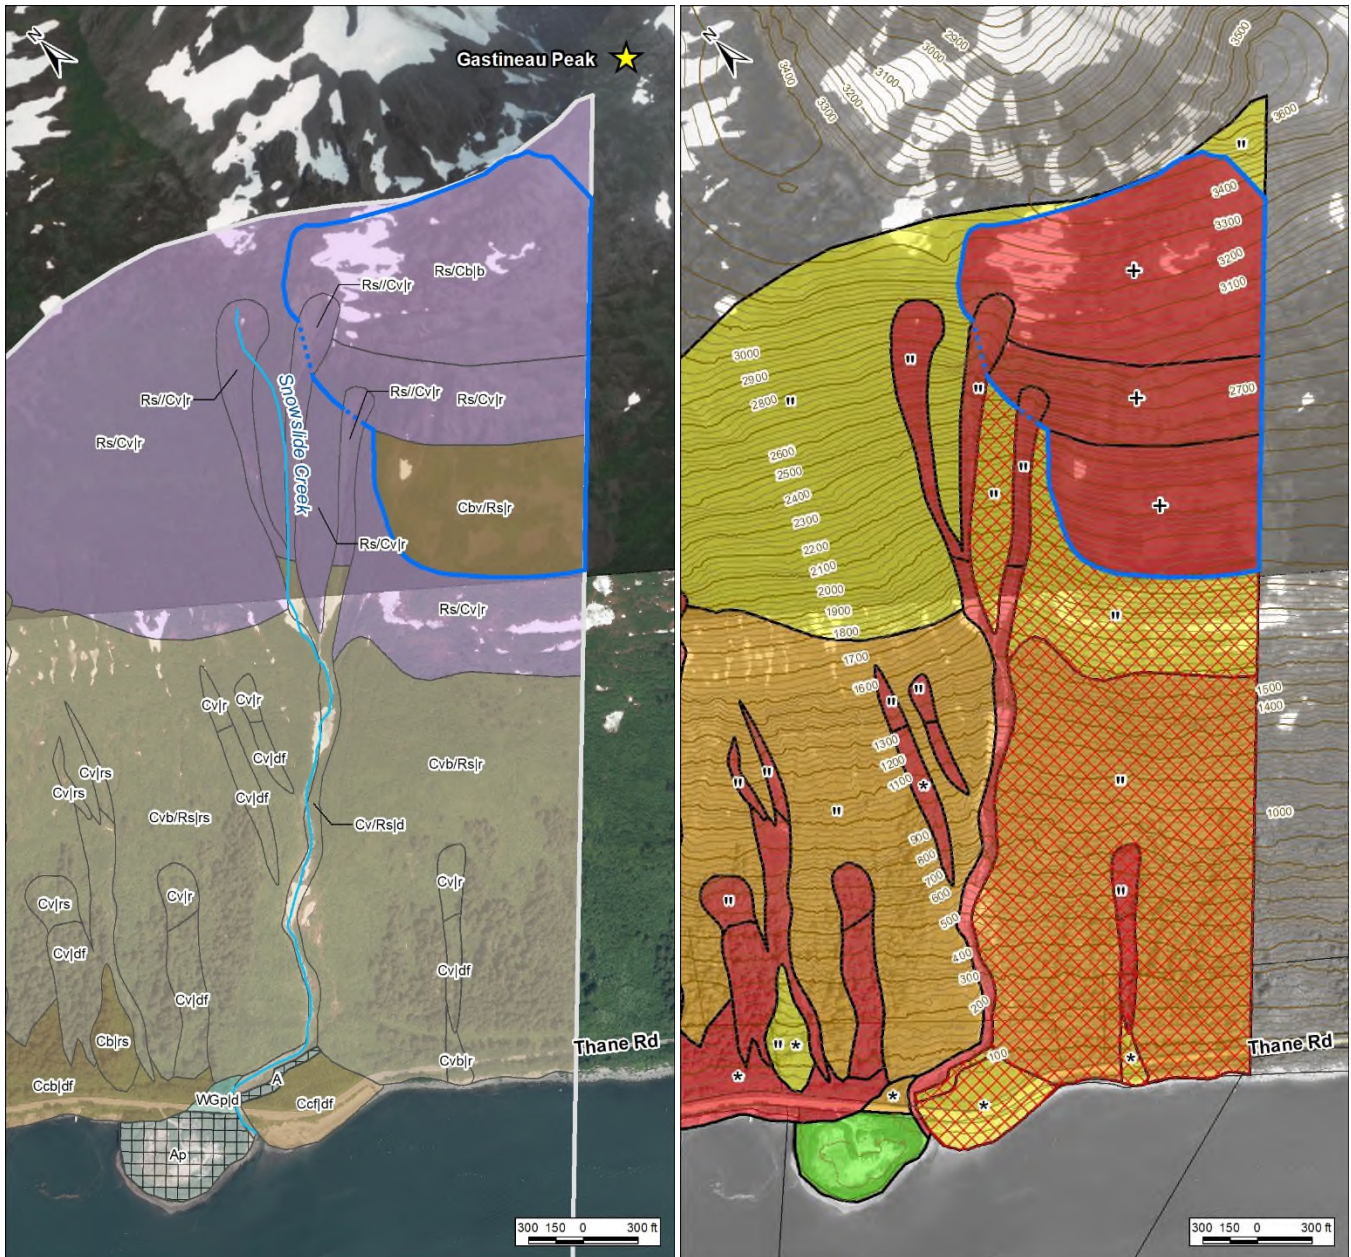
The processes described for Starr Hill are the same as on Mt. Roberts, though the slope length is greater on Mt. Roberts, and although debris slides on open slopes are often similar in size to those above Starr Hill, larger events are possible, particularly for debris flows or debris slides within gullies (see Figures 1.4b, 1.4c, 1.5b, and 1.5c in Tetra Tech 2021a). In general, however, along the upper slopes of Mt. Roberts, where bedrock is more common at ground surface than colluvium (60% to 75% bedrock), or *much* more common than colluvium (80% to 95% bedrock), the slopes are considered more stable (rated *Moderate*) than the lower slopes that have more colluvium than bedrock (rated *High* or *Severe*). The only places where that rule-of thumb does not apply on Mt. Roberts is the potential very large deep-seated bedrock slide southeast of Snowslide Creek, and the three very large debris-flow initiation zones leading into Snowslide Creek itself (all rated *Severe*).

Figure 2: Excerpts from Figure 1.3c Surficial Geology (left) and Figures 1.6e and 1.6f Landslide Hazard Designation Mapping (right).

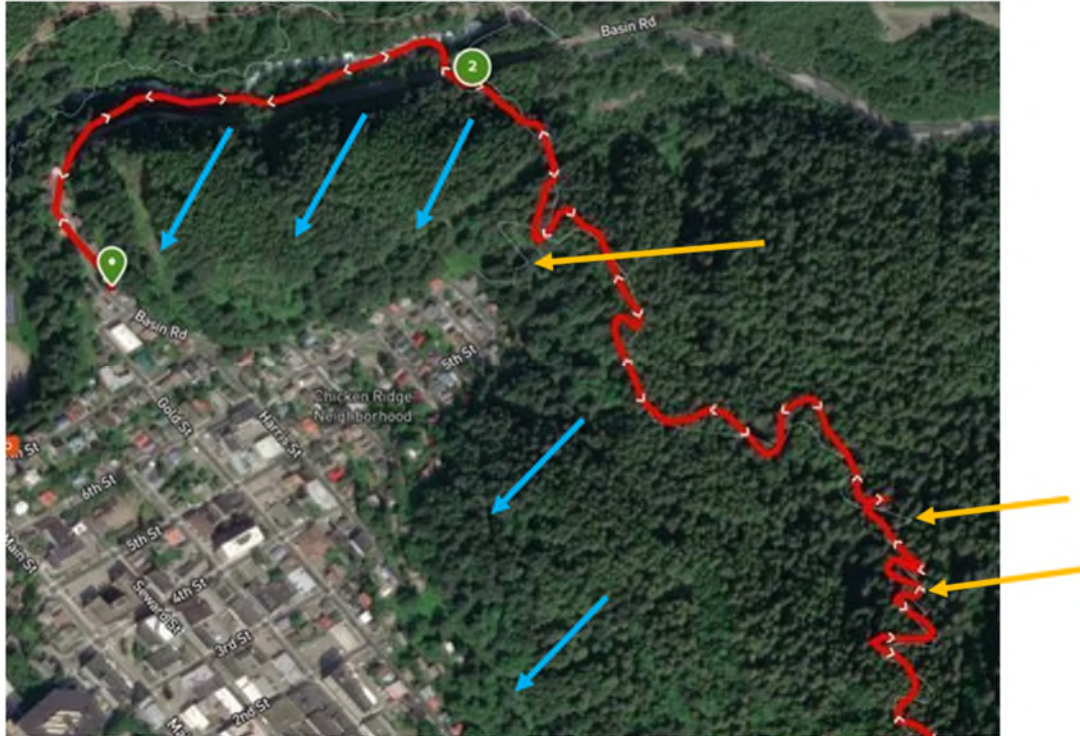
**Figure 1: Current Mt. Roberts hiking trail (red) and former hiking trail (pale gray). Switchbacks along new and old trails (orange arrows). Powerline cutlines are also visible (blue arrows). (Image credit: AllTrails 2021.)**

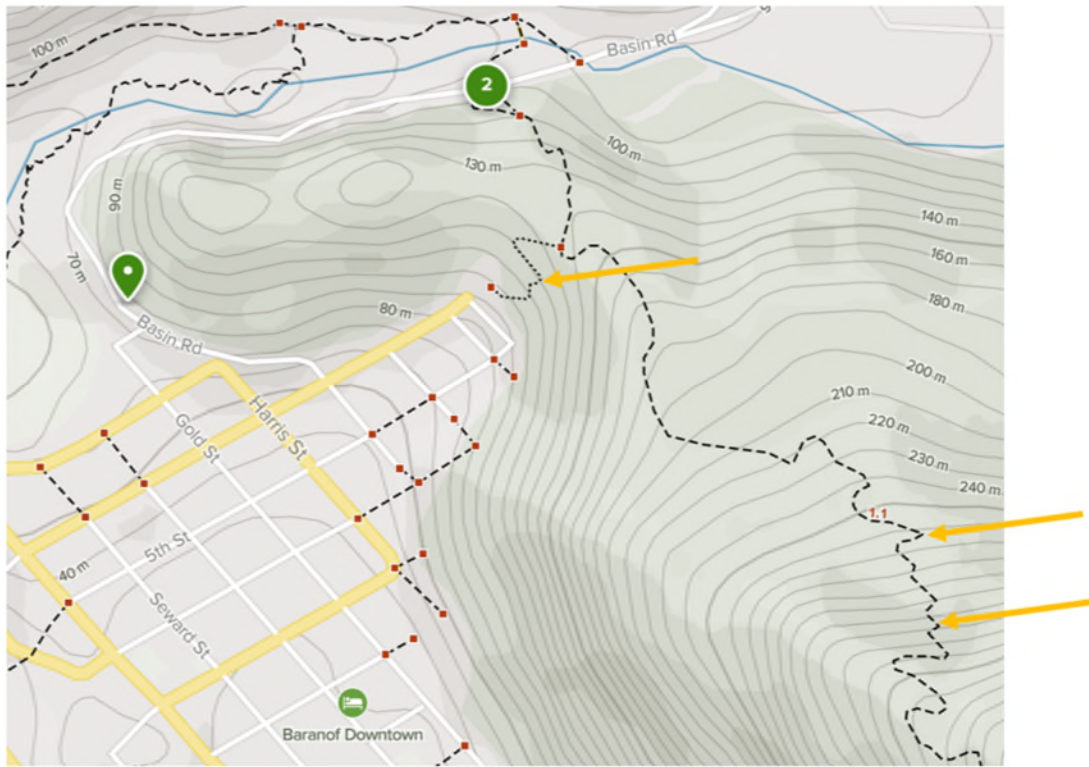
**Figure 2: Topographic map, showing the same trail alignments as the pale gray lines on Figure 1. Dotted trail above Nelson Street is the trail section officially no longer used. Note switchbacks. (Image credit: AllTrails 2022).**

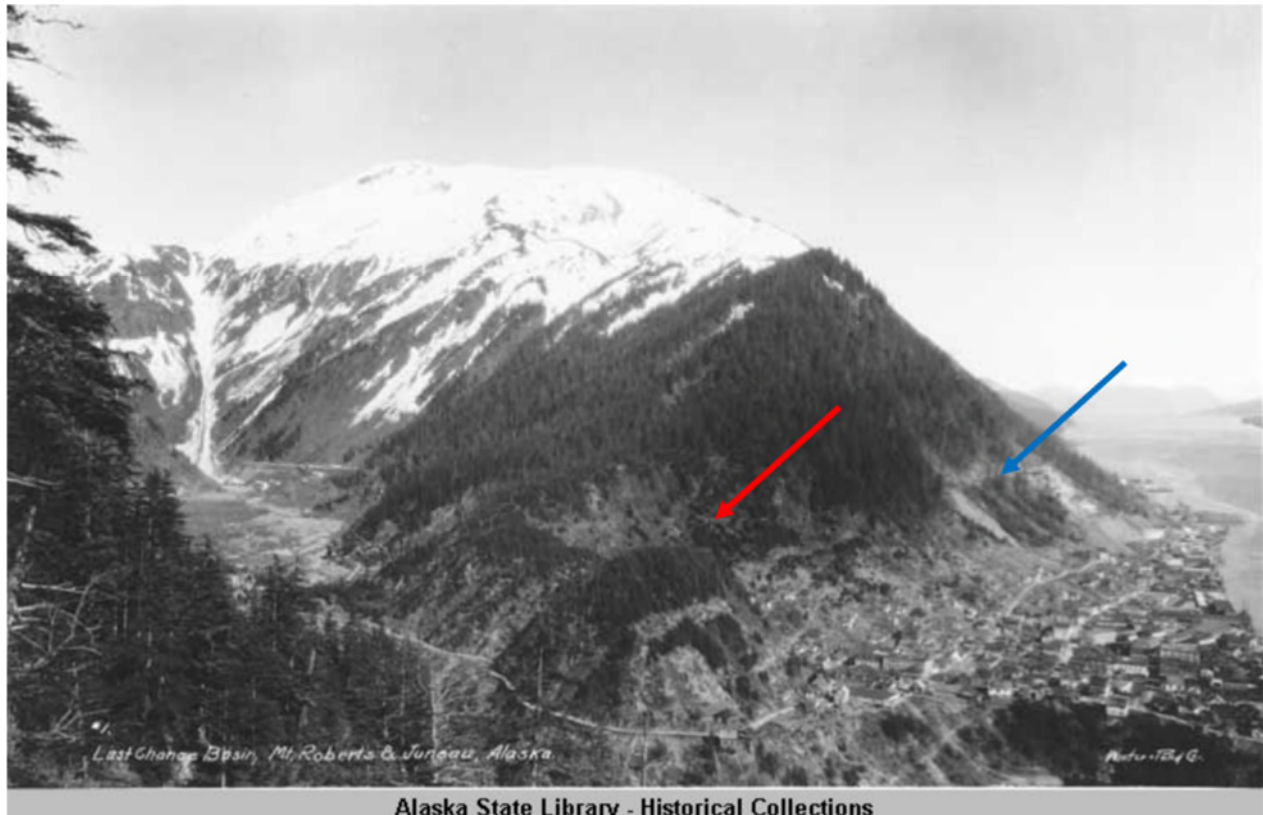
**Figure 3: View of Mt. Maria and Mt. Roberts from Mt. Juneau, circa 1935. Note possible old forestry trail on the slopes above Starr Hill (red arrow) and the former Alaska Juneau Gold Mining Company (AJGMC) tramway (blue arrow). (Photo credit: Alaska State Library – Historical Collections, [ASL-P87-0542](#), Winter & Pond. ASL 2022a.)**

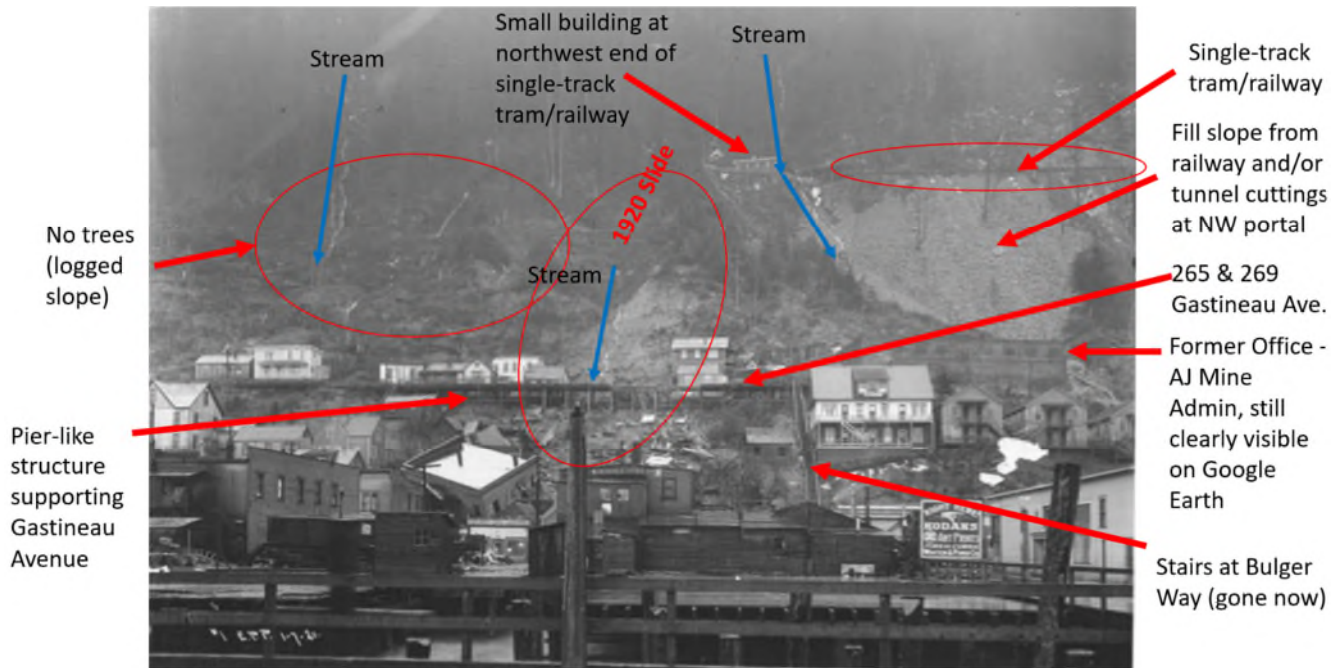
**Figure 5: Compare to Figure 4 and note numerous missing, destroyed and/or shifted structures. Slope right of small building failed in November 22, 1936 landslide. (Photo credit: Alaska State Library – Historical Collections, [ASL-P87-1223](#), Winter & Pond, January 7, 1920; cropped to fit page, markups from CBJ and Tetra Tech. ASL 2022c.)**

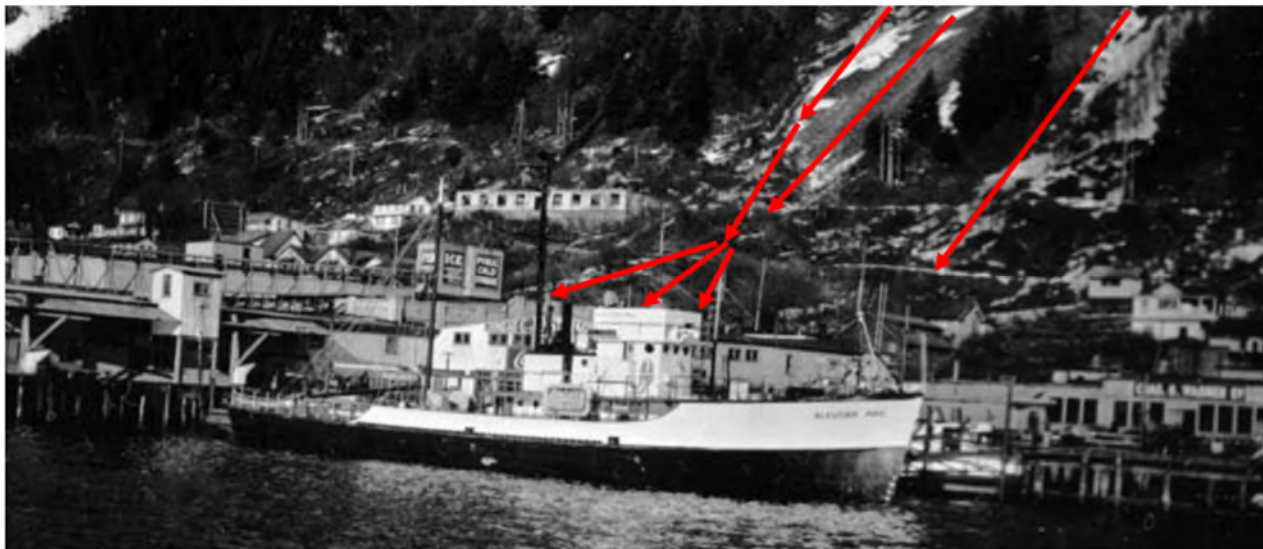
**Figure 6: Two apparent debris paths from November 22, 1936, landslide (red arrows, see also Figure 1a, 1b attached). Structure at center-left was the Juneau Cold Storage Company building, later replaced. Debris ran up against the S. Franklin St. side of Juneau Cold Storage, moved the Madsen Building downslope, destroyed several buildings, and killed 15 people. (Photo credit: Alaska State Library – Historical Collections, [ASL-P134-312-4](#), date uncertain, cropped to fit. ASL 2022d.)**

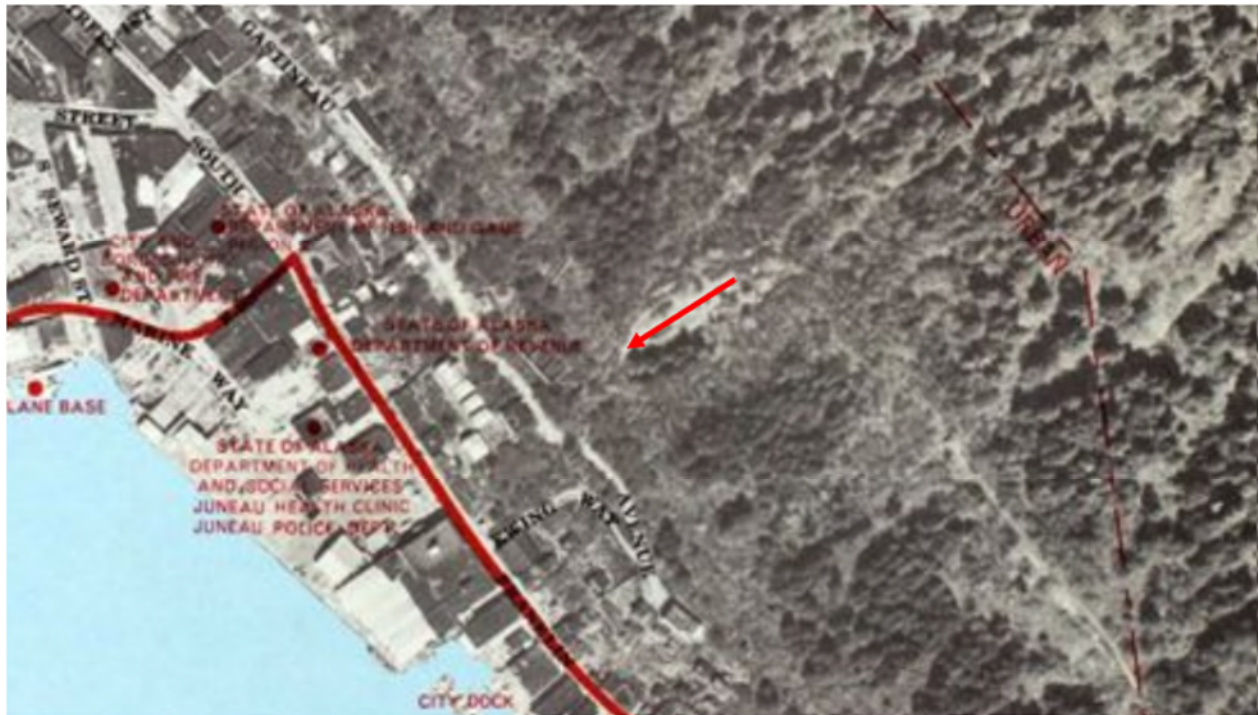
Figure 7: Excerpt from 1971 air photo mosaic showing a reactivated slope failure at the site of the 1936 landslide (red arrow). Since the 1968 air photo mosaic showed little exposed soil at this location, this slope might continue to slough and ravel periodically over time, confirmed by Tetra Tech’s mapping of mass movement features (Tetra Tech 2021a). (Image credit: Alaska State Library – Historical Collections, [ASL- Map Case Juneau 1971](#), ALS 2022e.)
