## **Downtown Juneau Landslide and Avalanche Hazard Assessment**

PRESENTED TO  
**City and Borough of Juneau**

APRIL 27, 2022  
ISSUED FOR USE  
FILE: ENG.EARC03168-01

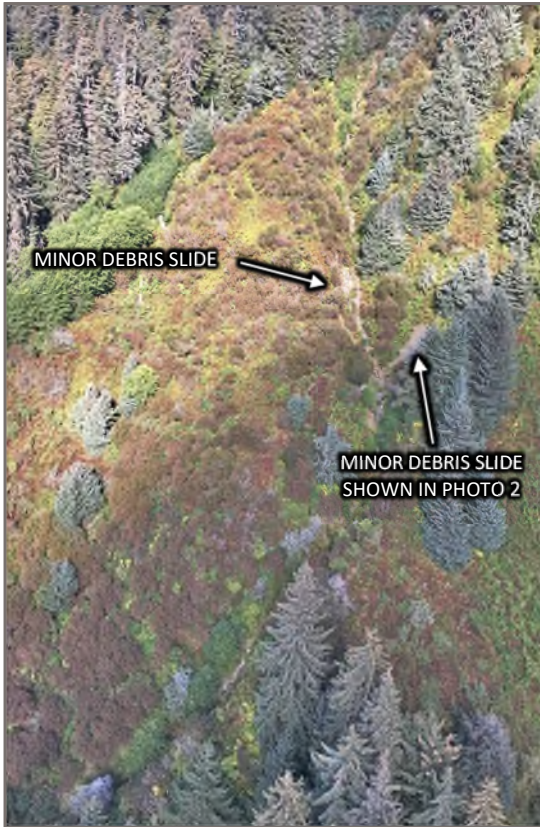
**Photo 1:** Looking northeast at part of the White avalanche path showing two minor debris slides in existing slope colluvium. The debris slide pictured in Photo 2 is indicated (Date of Photo: September 15, 2019; The photo location is shown on Figures 1.4 and 1.5).

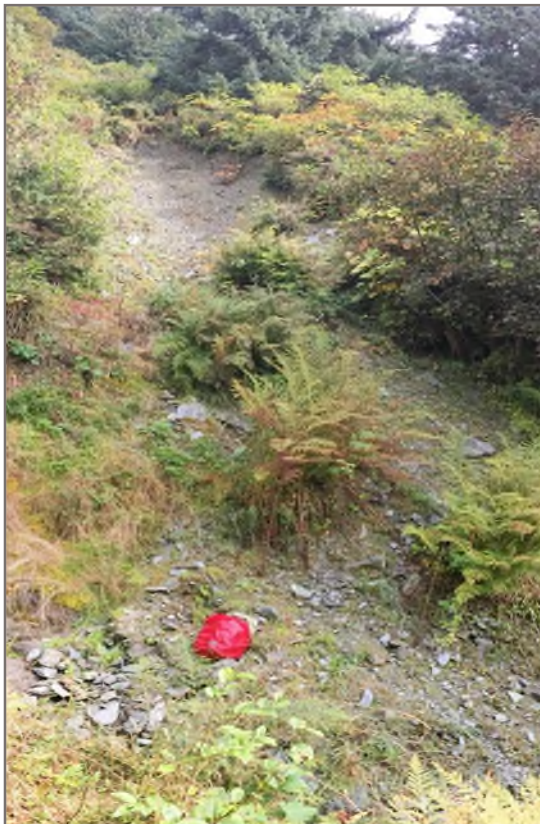
**Photo 2:** Looking east at a small debris slide within the White avalanche path. The bare ground near the top of the photo represents the initiation zone. The red backpack is resting on the deposited material consisting of platy schist cobbles/pebbles, sand, and silt (Date of Photo: September 11, 2019; The photo location is shown on Figures 1.4 and 1.5).

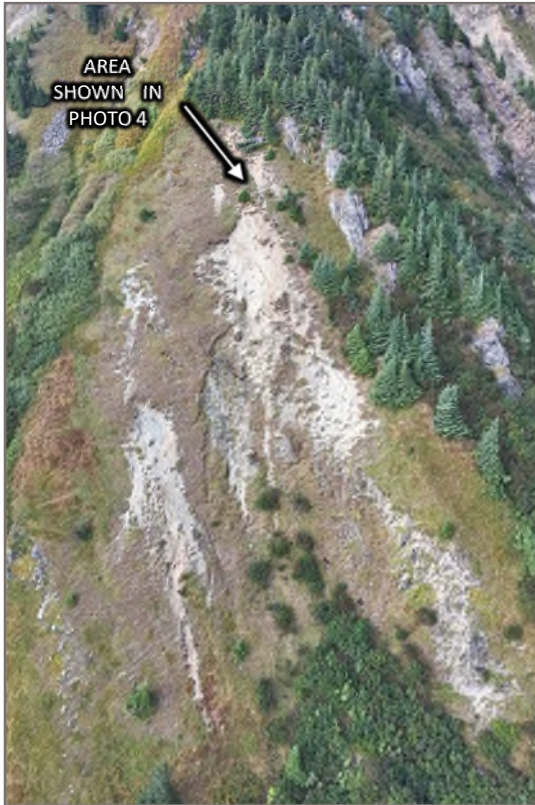
**Photo 3:** Looking northwest at an area of debris sliding near the top eastern side of the Gnarly avalanche path. These debris slides mainly affect the overlying vegetation mat but also involve downslope movement of some of the completely weathered bedrock underlying the vegetation cover (Date of Photo: September 9, 2019; The photo location is shown on Figures 1.4 and 1.5).

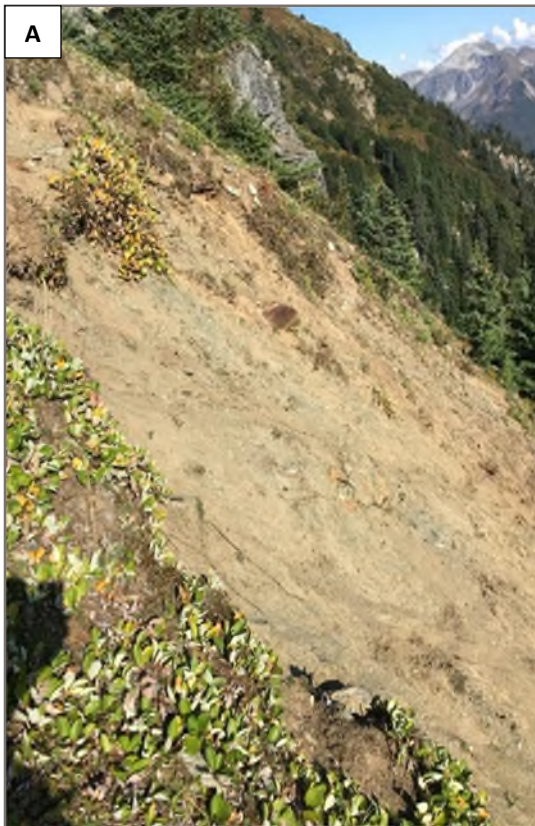
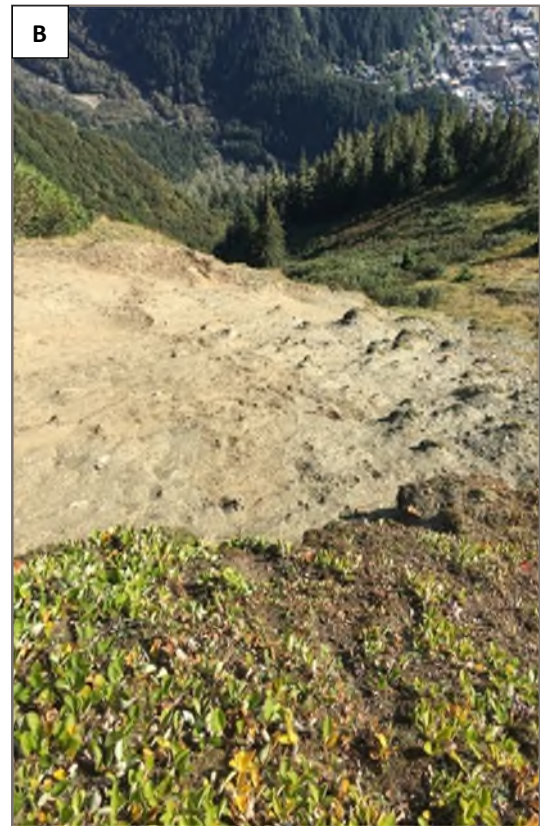
**Photo 4:** A) Looking northeast across slope at the upper portion of a debris slide. B) Looking southeast and downslope at the same area shown in A (Date of Photo: September 10, 2019; The photo location is shown on Figures 1.4 and 1.5).

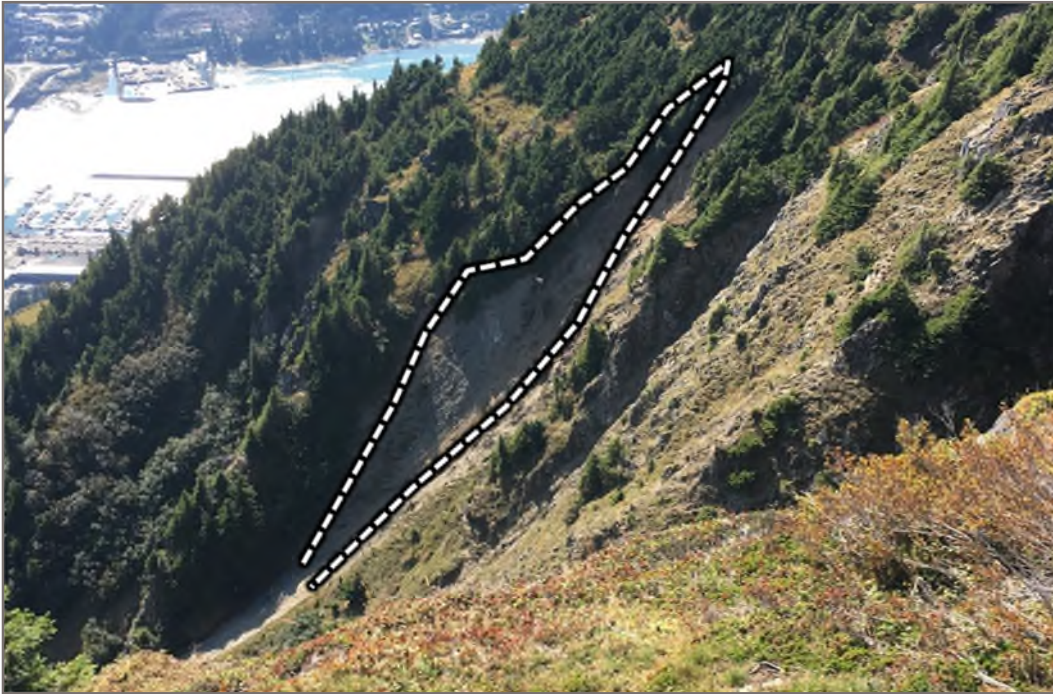
**Photo 5:** Looking south across slope to an area of debris sliding (outlined in dashed white line) near the top of the Gnarly avalanche path (Date of Photo: September 10, 2019; The photo location is shown on Figures 1.4 and 1.5).

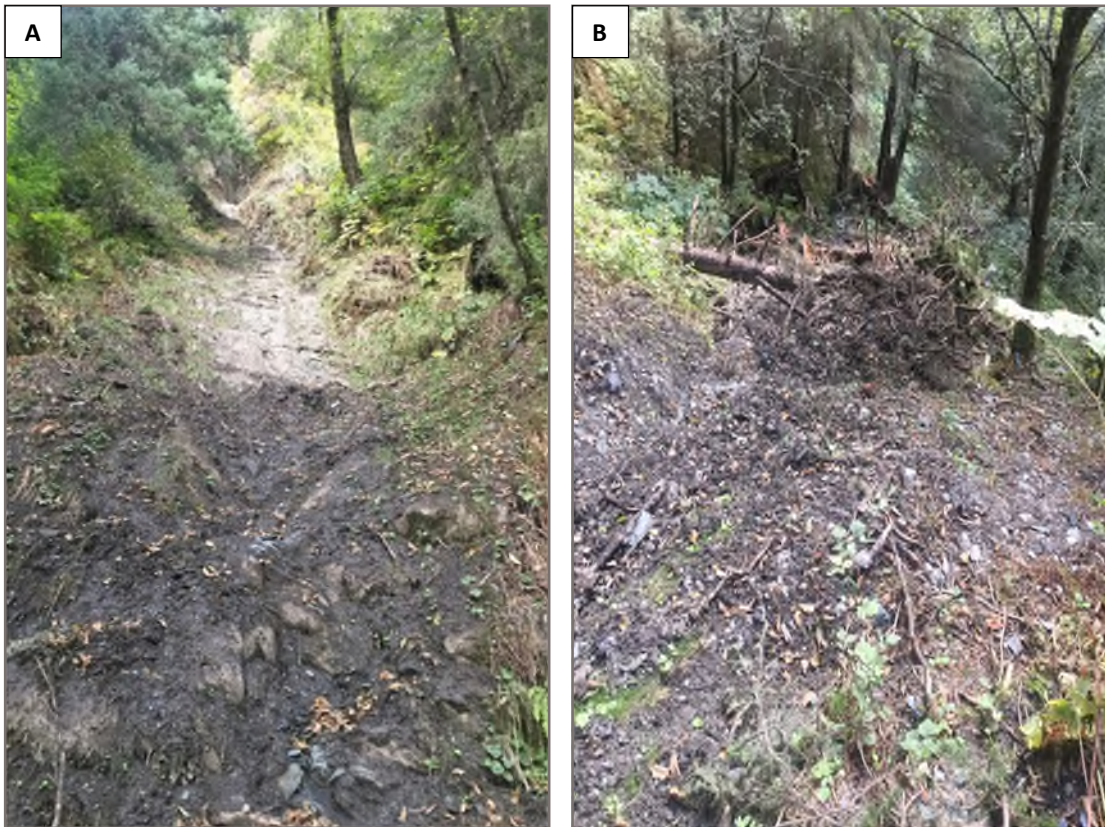
**Photo 6:** A) Looking northeast and upslope at the gullied path of a debris slide near the northern extent of the study area. B) Looking downslope from the same point as A showing deposited debris (Date of Photos: September 11, 2019; The photo location is shown on Figures 1.4 and 1.5).

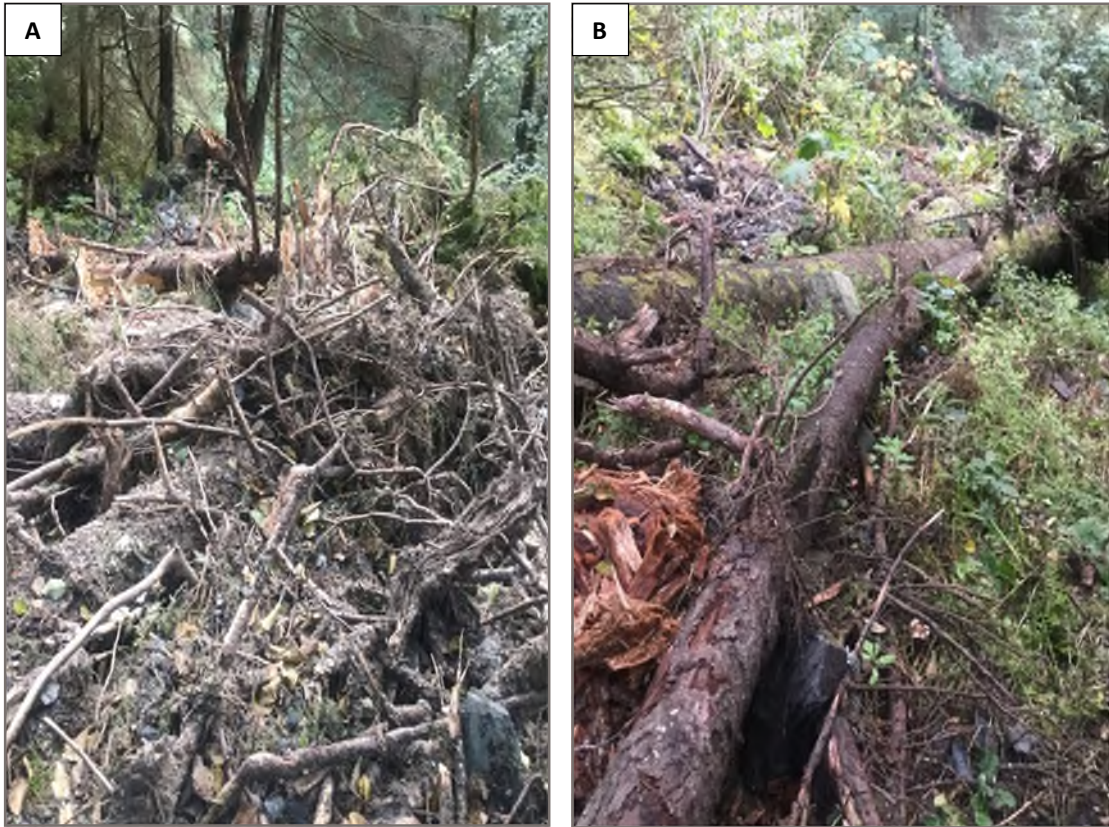
- Photo 7 A) Looking southwest and downslope at more deposited slide material and vegetation from the same small slide shown in Photo 6
- Photo 8 Looking northeast across slope at an area of minor debris accumulation below the gully pictured in Photos 6 and 7. This debris likely accumulated before the slide event shown in Photos 6 and 7, as it is partially revegetated. Red backpack for scale

**Photo 7:** A) Looking southwest and downslope at more deposited slide material and vegetation from the same small slide shown in Photo 6 (Date of Photos: September 11, 2019; The photo location is shown on Figures 1.4 and 1.5).

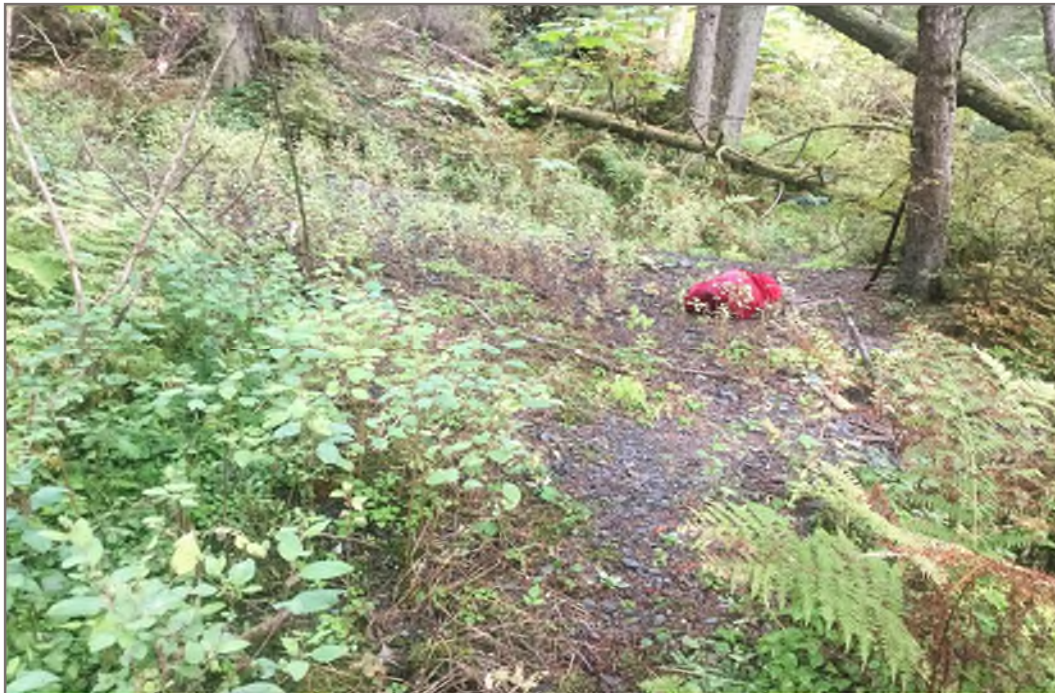
**Photo 8:** Looking northeast across slope at an area of minor debris accumulation below the gully pictured in Photos 6 and 7. This debris likely accumulated before the slide event shown in Photos 6 and 7, as it is partially revegetated. Red backpack for scale. (Date of Photo: September 11, 2019; The photo location is shown on Figures 1.4 and 1.5).

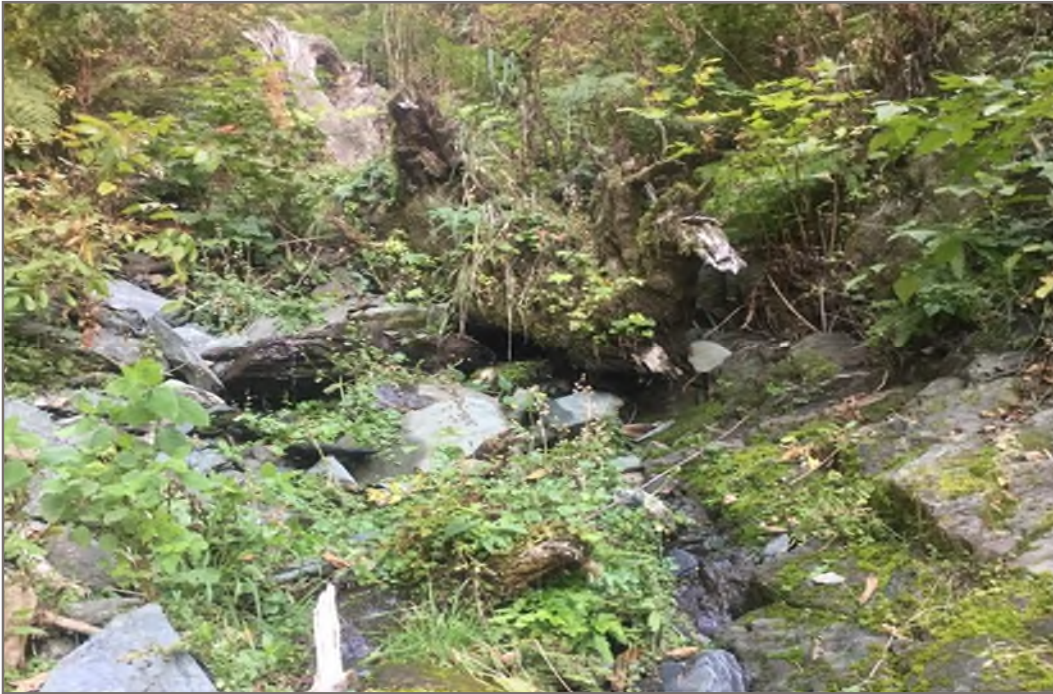
**Photo 9:** Looking northeast and upslope at an example of a relatively minor channel blockage about 680 ft. above the intersection of Mill Street and Thane Road. Path blockage by the tree is trapping a significant amount of debris, as shown in Photos 10 and 11. Bedrock is visible in the lower right corner of the photo (Date of Photo: September 9, 2019; The photo location is shown on Figures 1.4 and 1.5).

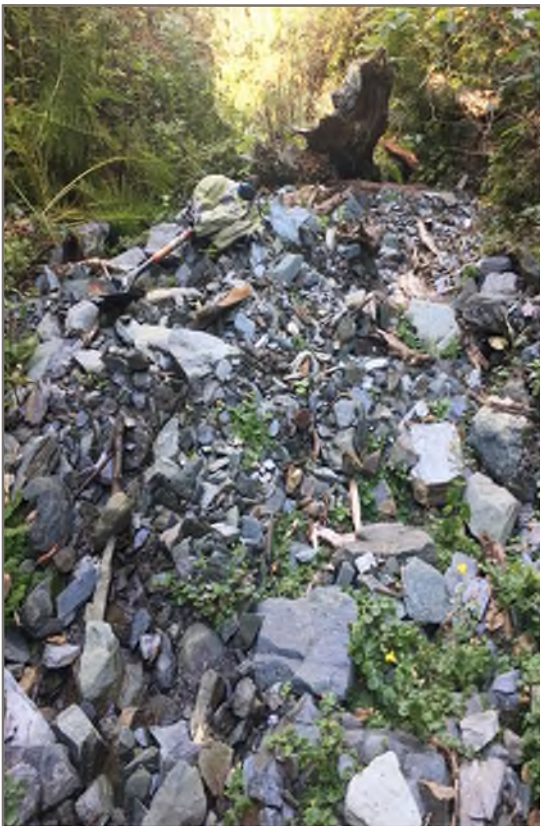
**Photo 10:** Looking southwest and downslope at an example of debris accumulated behind a tree blocking the debris slide path shown in Photo 9. When the tree rots or debris accumulation overcomes the retaining force of the dead tree, debris will likely release rapidly, forming a debris flow (Date of Photo: September 9, 2019; The photo location is shown on Figures 1.4 and 1.5).

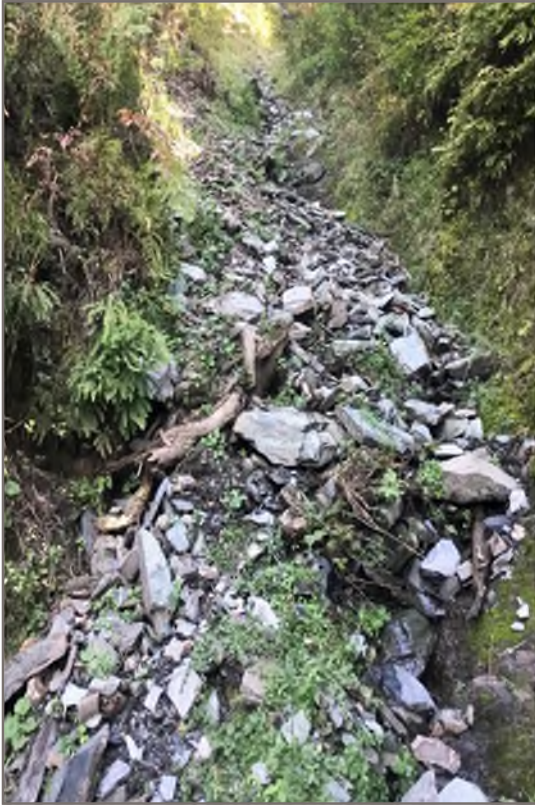
- Photo 11 Looking northeast and upslope at debris accumulated within the gully/debris flow path behind the dead tree shown in Photo 9
- Photo 12 A) Looking upslope at an example of debris accumulated just above Thane Road below the blocked gully shown in Photos 9 to 11. B) Looking across slope from the same location as A

**Photo 11:** Looking northeast and upslope at debris accumulated within the gully/debris flow path behind the dead tree shown in Photo 9 (Date of Photo: September 9, 2019; The photo location is shown on Figures 1.4 and 1.5).

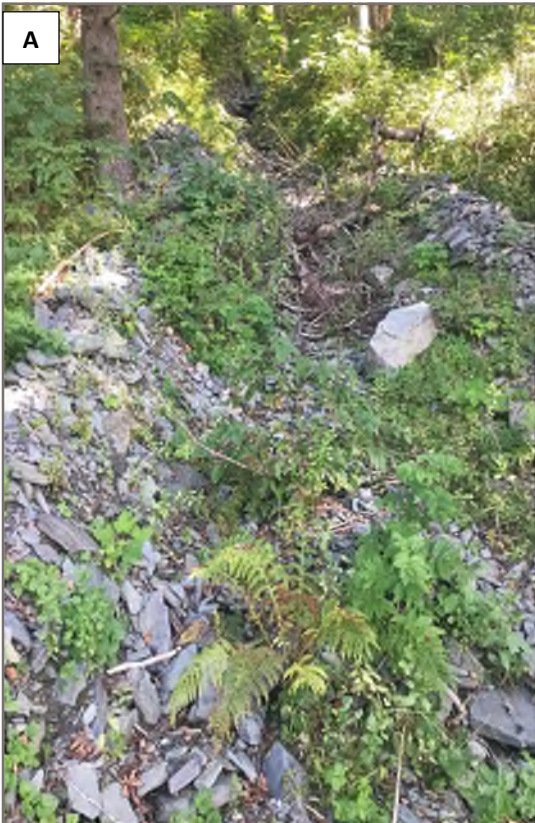
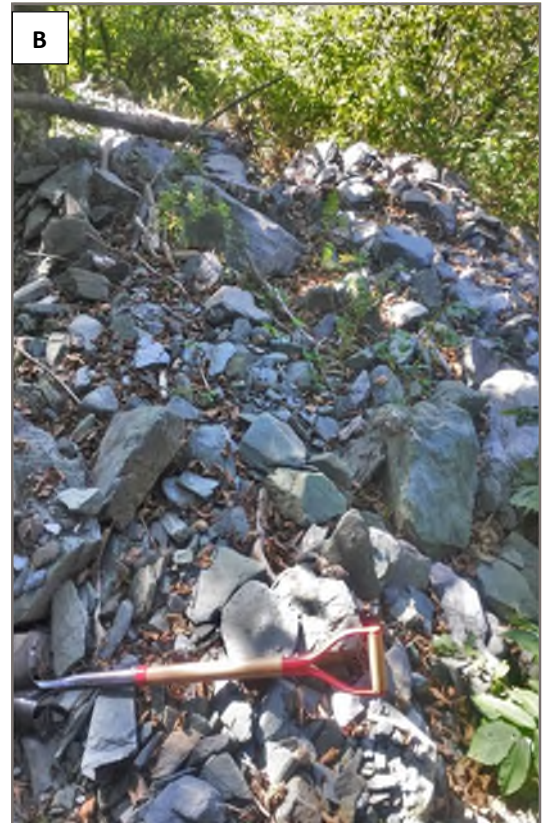
**Photo 12:** A) Looking upslope at an example of debris accumulated just above Thane Road below the blocked gully shown in Photos 9 to 11. B) Looking across slope from the same location as A (Date of Photos: September 9, 2019; The photo location is shown on Figures 1.4 and 1.5).

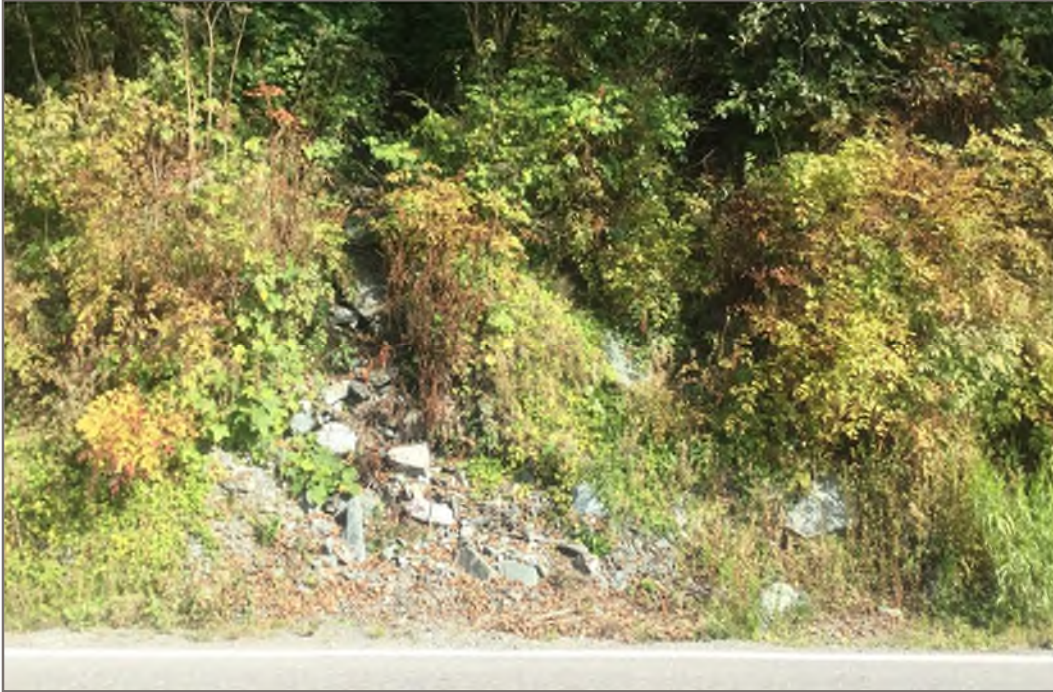
- Photo 13 Looking northeast across Thane Road. This is an example of a debris flow that has essentially stopped at the upslope edge of Thane Road. Material transited through the same gully pictured in Photos 9 to 12

**Photo 13:** Looking northeast across Thane Road. This is an example of a debris flow that has essentially stopped at the upslope edge of Thane Road. Material transited through the same gully pictured in Photos 9 to 12. (Date of Photo: September 9, 2019; The photo location is shown on Figure 2). , 2019; The photo location is shown on Figures 1.4 and 1.5).

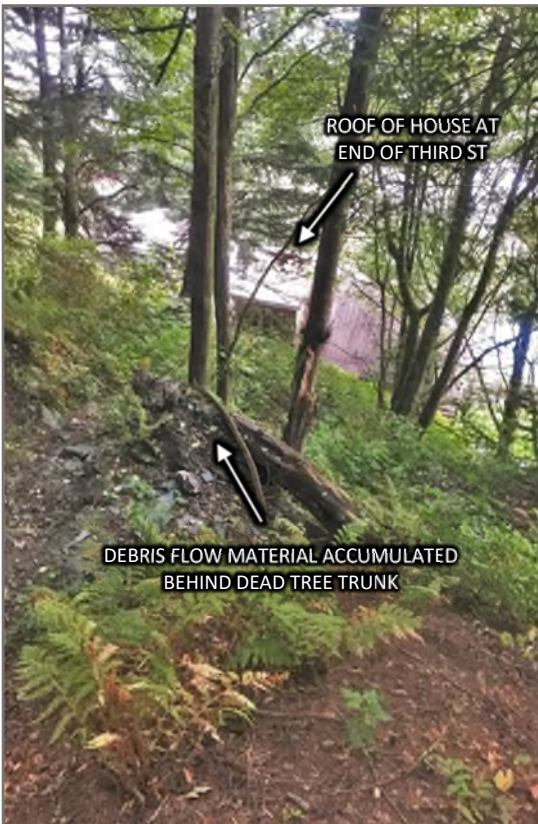
- Photo 14 Looking southwest toward debris flow material accumulation directly above a residence at the end of 3<sup>rd</sup> Street
- Photo 15 Looking northeast and upslope and an example of debris flow material deposited approximately 200 ft. above Thane Road near its intersection with Mt. Roberts Street. Red backpack for scale

**Photo 14:** Looking southwest toward debris flow material accumulation directly above a residence at the end of 3rd Street (Date of Photo: September 12, 2019; The photo location is shown on Figures 1.4 and 1.5).

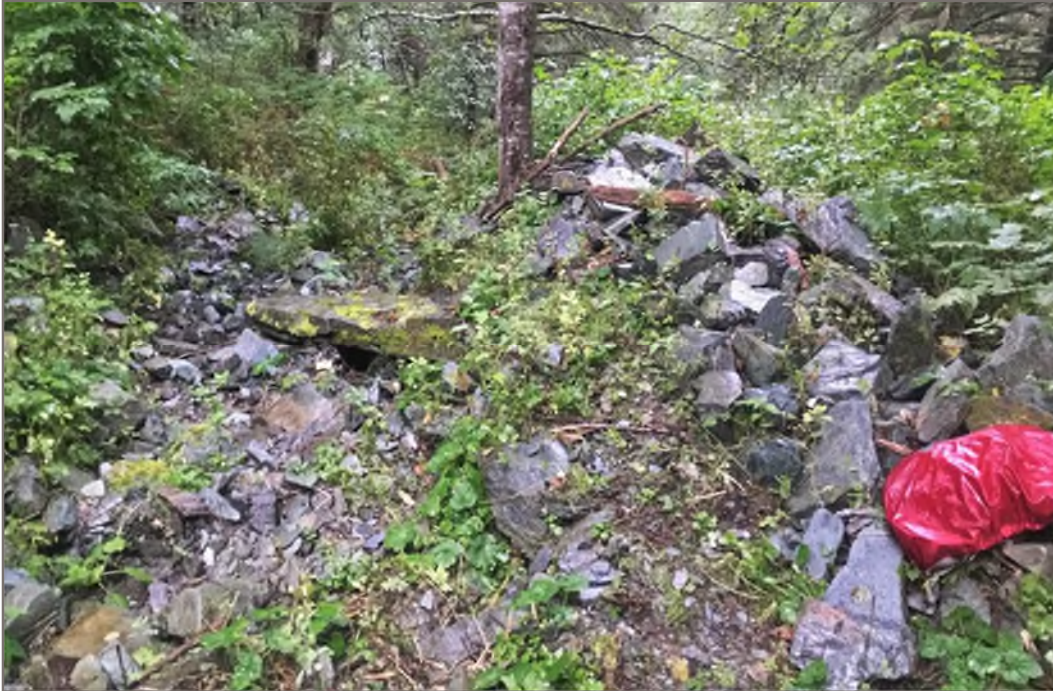
**Photo 15:** Looking northeast and upslope and an example of debris flow material deposited approximately 200 ft. above Thane Road near its intersection with Mt. Roberts Street. Red backpack for scale. (Date of Photo: September 12, 2019; The photo location is shown on Figures 1.4 and 1.5).

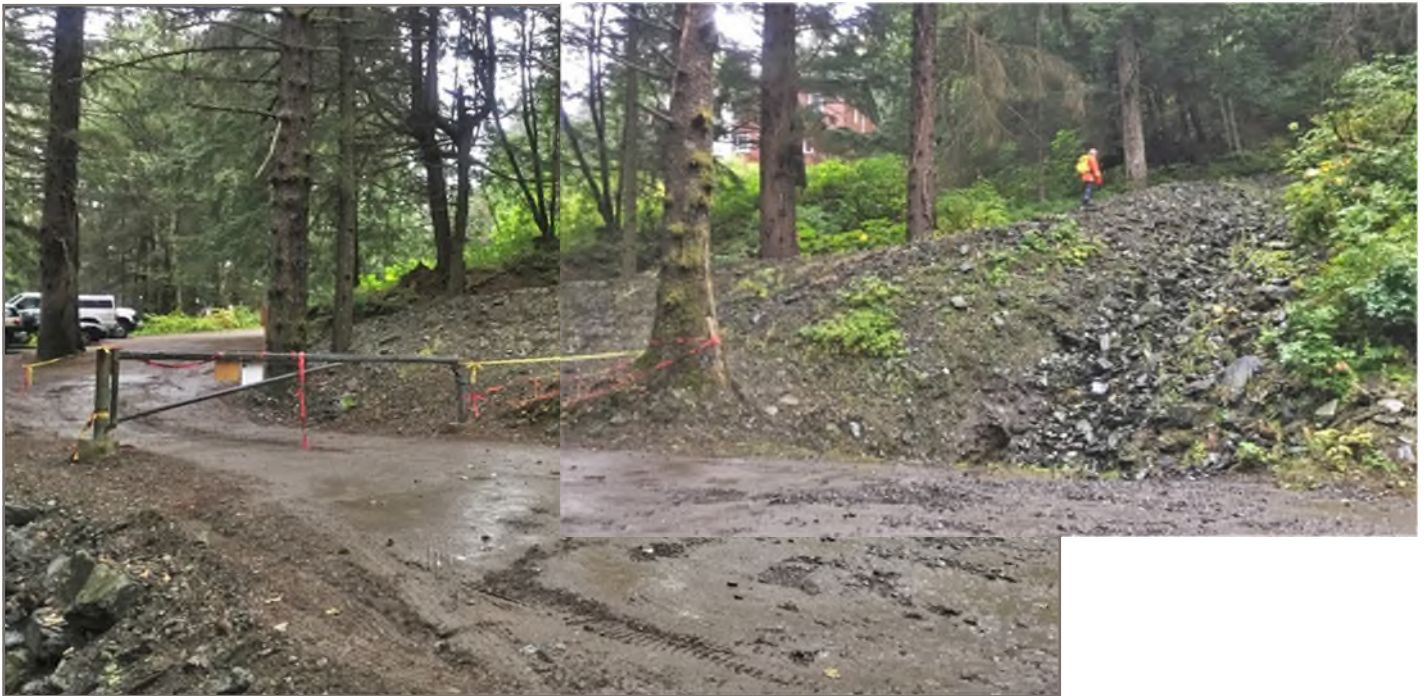
- Photo 16 Looking west and across slope at debris flow material deposited near the end of Evergreen Avenue. A recent debris flow has partially buried some of the tree trunks

**Photo 16:** Looking west and across slope at debris flow material deposited near the end of Evergreen Avenue. A recent debris flow has partially buried some of the tree trunks. (Date of Photo: September 11, 2019; The photo location is shown on Figures 1.4 and 1.5).

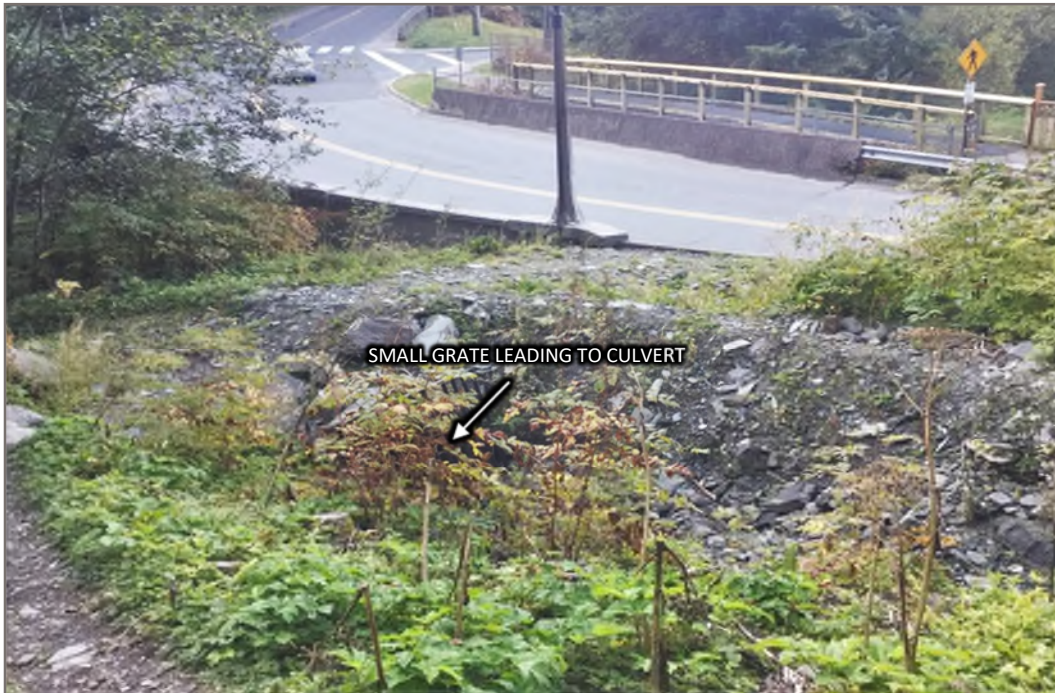
- Photo 17 Looking south at debris flow material deposited near the Gold Creek Calhoun bridge. The small grate leading to a drainage culvert indicated and the drainage channel to the grate likely had to be dug out after the event

**Photo 17:** Looking south at debris flow material deposited near the Gold Creek Calhoun bridge. The small grate leading to a drainage culvert indicated and the drainage channel to the grate likely had to be dug out after the event. (Date of Photo: September 10, 2019; The photo location is shown on Figures 1.4 and 1.5).

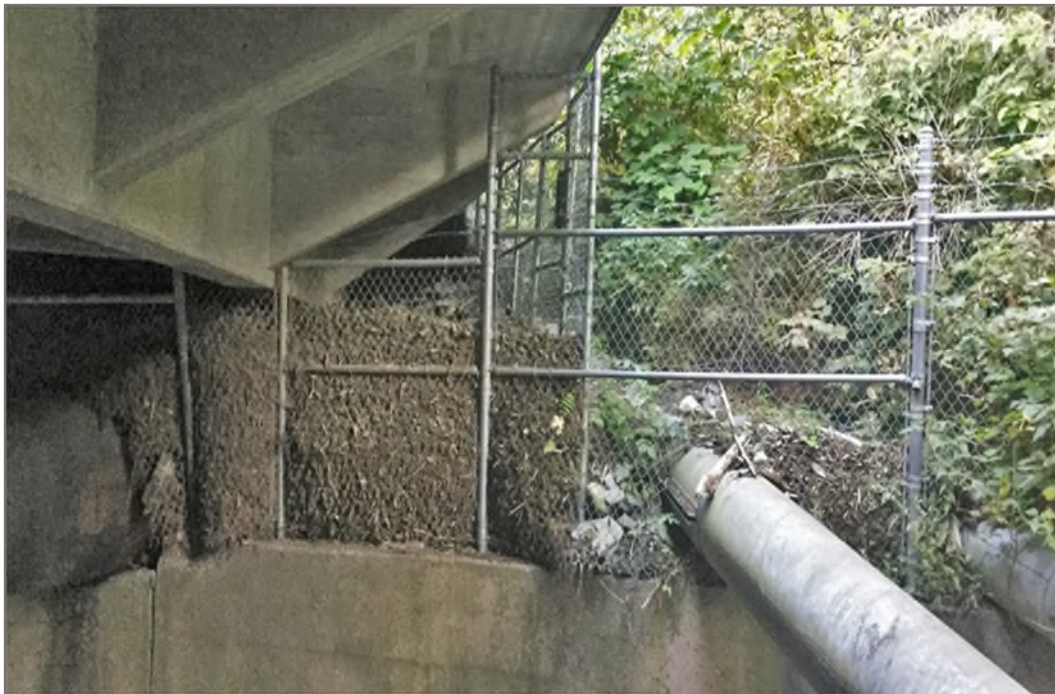
- Photo 18 Looking north at debris flow material deposited beneath the Gold Creek Calhoun bridge
- Photo 19 Looking southeast and upslope at debris flow material depositing on Glacier Highway above the AWARE shelter

**Photo 18:** Looking north at debris flow material deposited beneath the Gold Creek Calhoun bridge (Date of Photo: September 10, 2019; The location is shown on Figures 1.4 and 1.5).

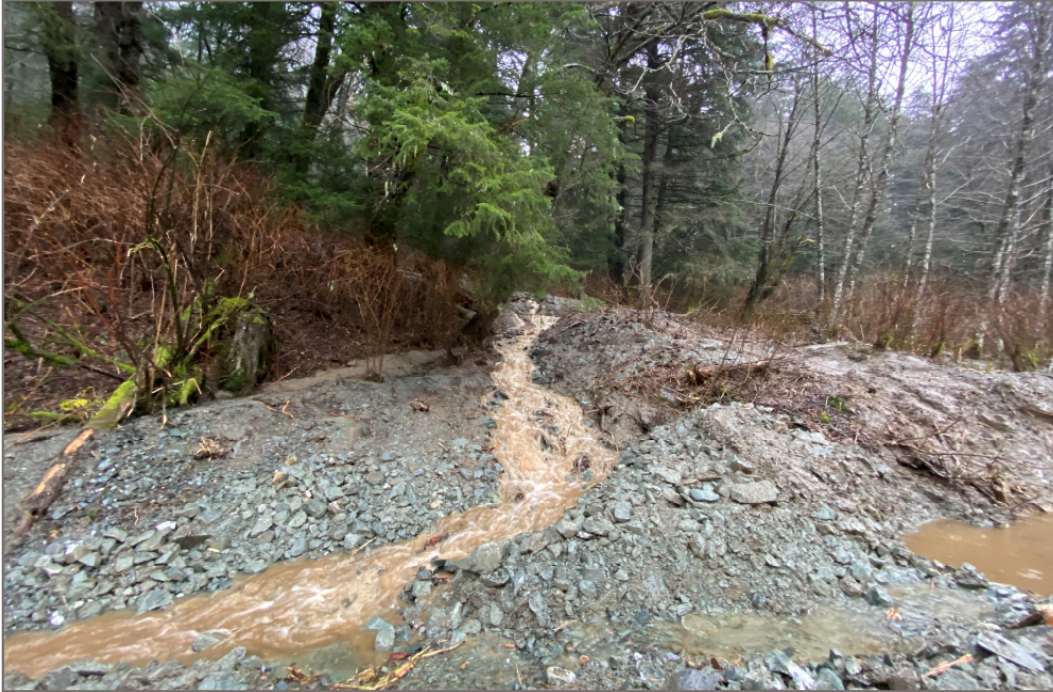
**Photo 19:** Looking southeast and upslope at debris flow material depositing on Glacier Highway above the AWARE shelter (Photo Credit: CBJ Dec 4, 2020; The photo location is shown on Figures 1.4 and 1.5).

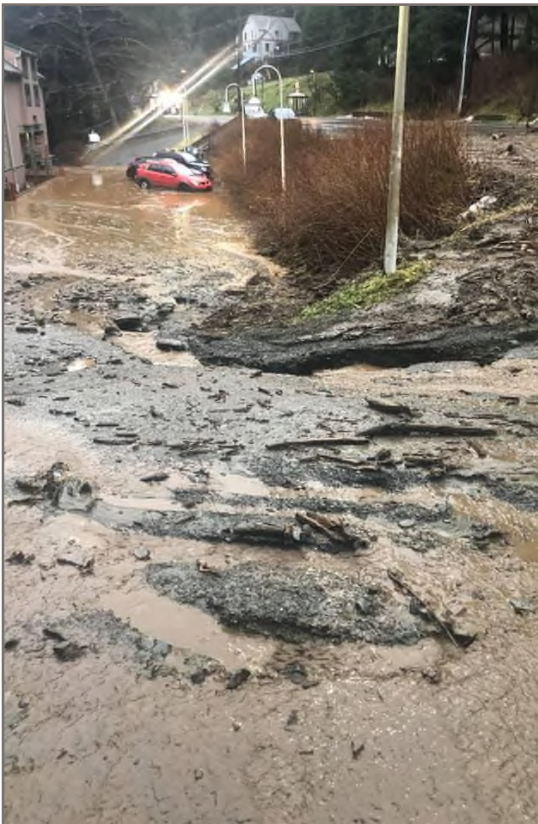
- Photo 20 Looking northwest below Glacier Highway at the parking lot of the AWARE shelter, at debris and water originating from the debris flow on the opposite side of Glacier Highway

**Photo 20:** Looking northwest below Glacier Highway at the parking lot of the AWARE shelter, at debris and water originating from the debris flow on the opposite side of Glacier Highway (Photo Credit: CBJ Dec 4, 2020; The photo location is shown on Figures 1.4 and 1.5).

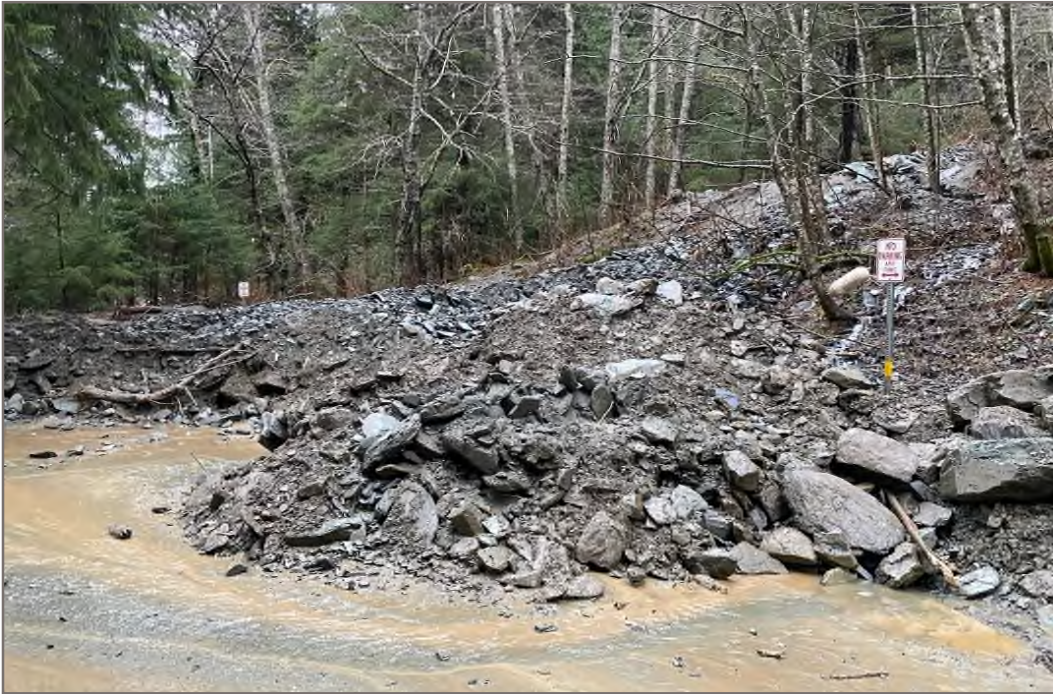
- Photo 21 Looking northwest at the Wickersham debris slide, located just past the intersection of Sutherland Drive at the cul-de-sac at the northwest end of Wickersham Avenue

**Photo 21:** Looking northwest at the Wickersham debris slide, located just past the intersection of Sutherland Drive at the cul-de-sac at the northwest end of Wickersham Avenue (Photo Credit: CBJ Dec 4, 2020; The photo location is shown on Figures 1.4 and 1.5).

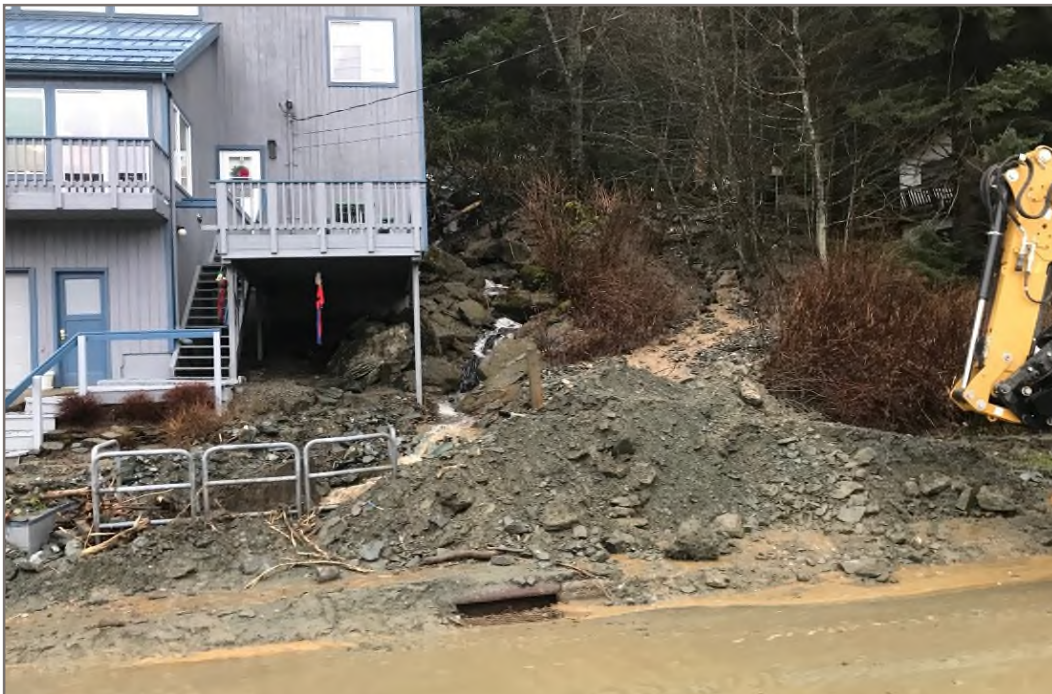
- Photo 22 Looking upslope (northeast) at 2020 Glacier Highway at the debris running out onto the road from the Wickersham slide. The guard rail is located at the drainage under the road, which appeared to have been largely plugged by debris

**Photo 22:** Looking upslope (northeast) at 2020 Glacier Highway at the debris running out onto the road from the Wickersham slide. The guard rail is located at the drainage under the road, which appeared to have been largely plugged by debris (Photo Credit: CBJ Dec 4, 2020; The photo location is shown on Figures 1.4 and 1.5).

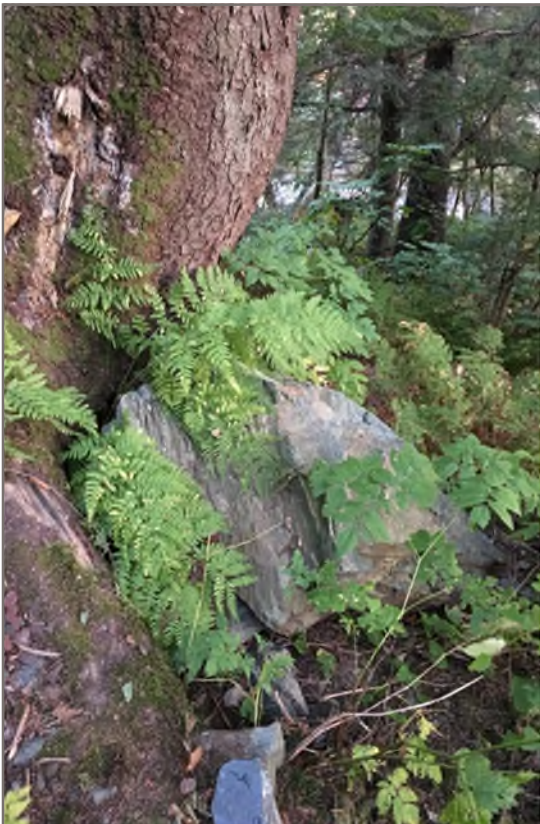
- Photo 23 Looking upslope (northeast) from Thane Road into the Snowslide Creek (T011) avalanche path
- Photo 24 An example of relatively recent rock fall and associated tree damage (estimated to have occurred within the last five years) just above Basin Road

**Photo 24:** An example of relatively recent rock fall and associated tree damage (estimated to have occurred within the last five years) just above Basin Road (Date of Photo: September 10, 2019; The photo location is shown on Figures 1.4 and 1.5).

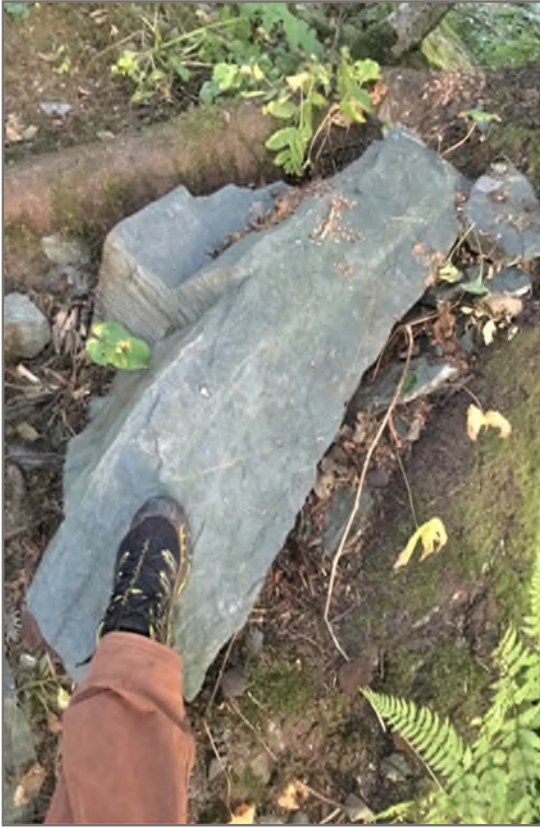
- Photo 25 An example of a relatively recent rock fall (estimated to have occurred within the last five years) just above Basin Road
- Photo 26 Rock fall in the forested areas immediately north of the White avalanche path

**Photo 25:** An example of a relatively recent rock fall (estimated to have occurred within the last five years) just above Basin Road (Date of Photo: September 10, 2019; The photo location is shown on Figures 1.4 and 1.5).

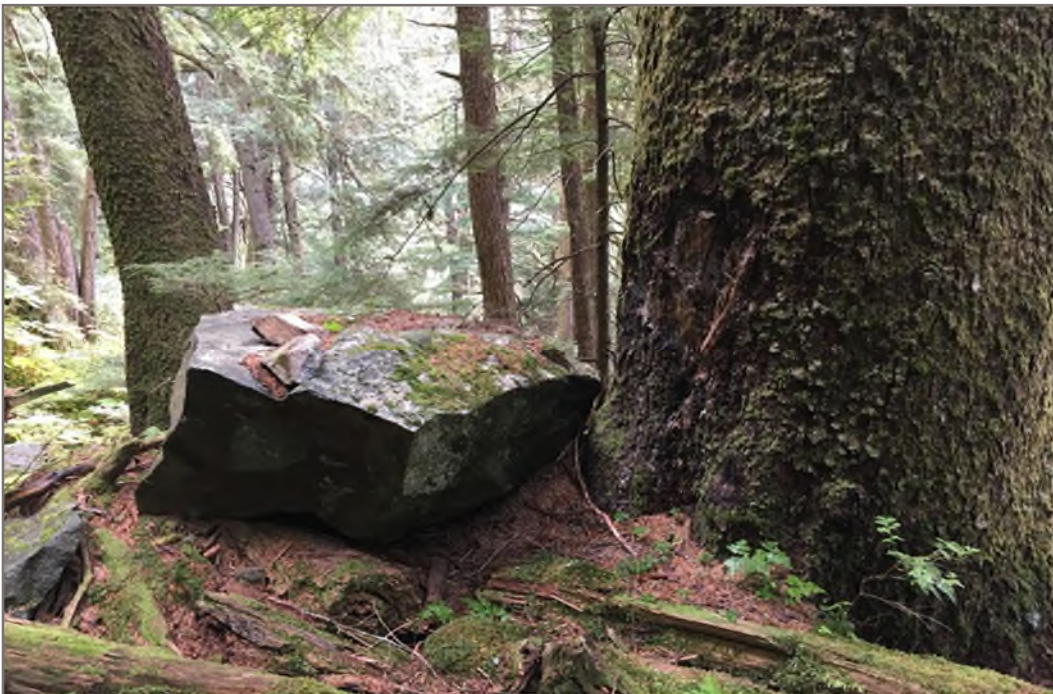
**Photo 26:** Rock fall in the forested areas immediately north of the White avalanche path (Date of Photo: September 11, 2019; The photo location is shown on Figures 1.4 and 1.5).

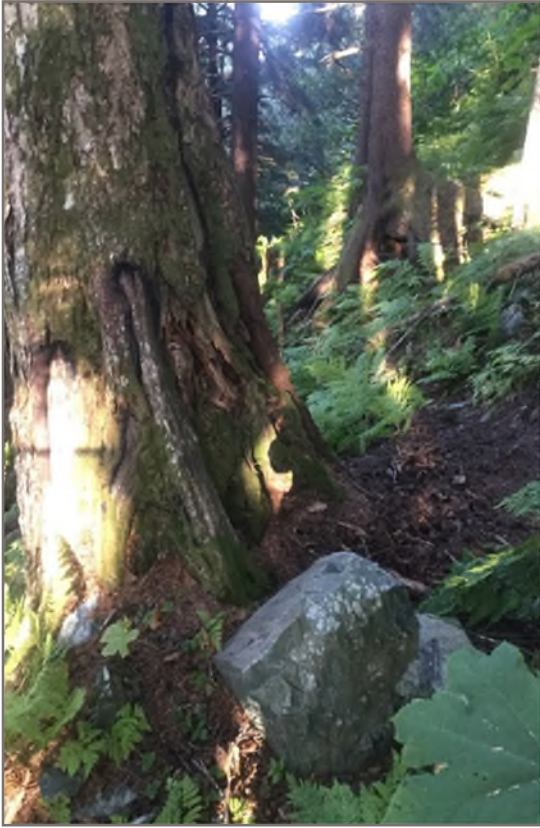
- Photo 27 Looking northwest across slope at an example of rock fall and associated tree trunk damage within the Bootleg avalanche path
- Photo 28 Looking southwest and downslope over a significant rock fall source area above the head of Snowslide Creek. Ongoing rock fall at high elevations such as this accumulates in the gullies below and over time increases the chance of a debris flow forming within the gully during high rainfall events

**Photo 27:** Looking northwest across slope at an example of rock fall and associated tree trunk damage within the Bootleg avalanche path (Date of Photo: September 9, 2019; The photo location is shown on Figures 1.4 and 1.5).

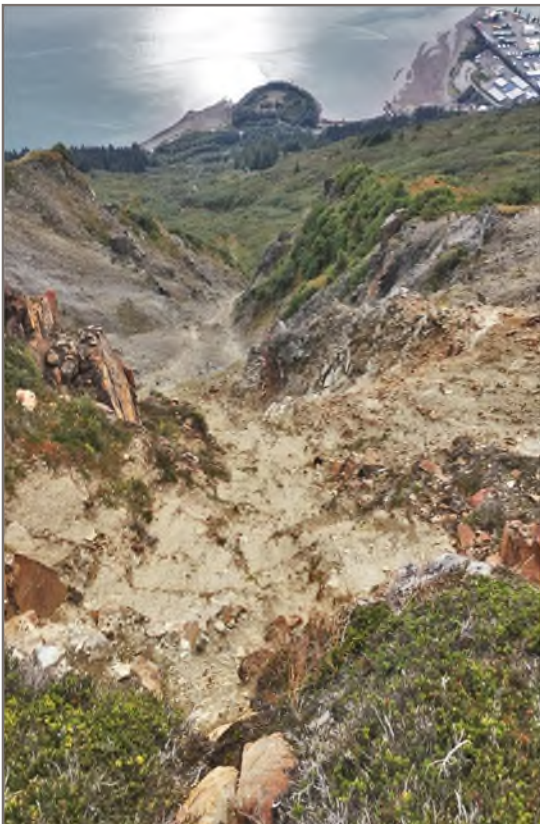
**Photo 28:** Looking southwest and downslope over a significant rock fall source area above the head of Snowslide Creek. Ongoing rock fall at high elevations such as this accumulates in the gullies below and over time increases the chance of a debris flow forming within the gully during high rainfall events (Date of Photo: September 9, 2019; The photo location is shown on Figures 1.4 and 1.5).

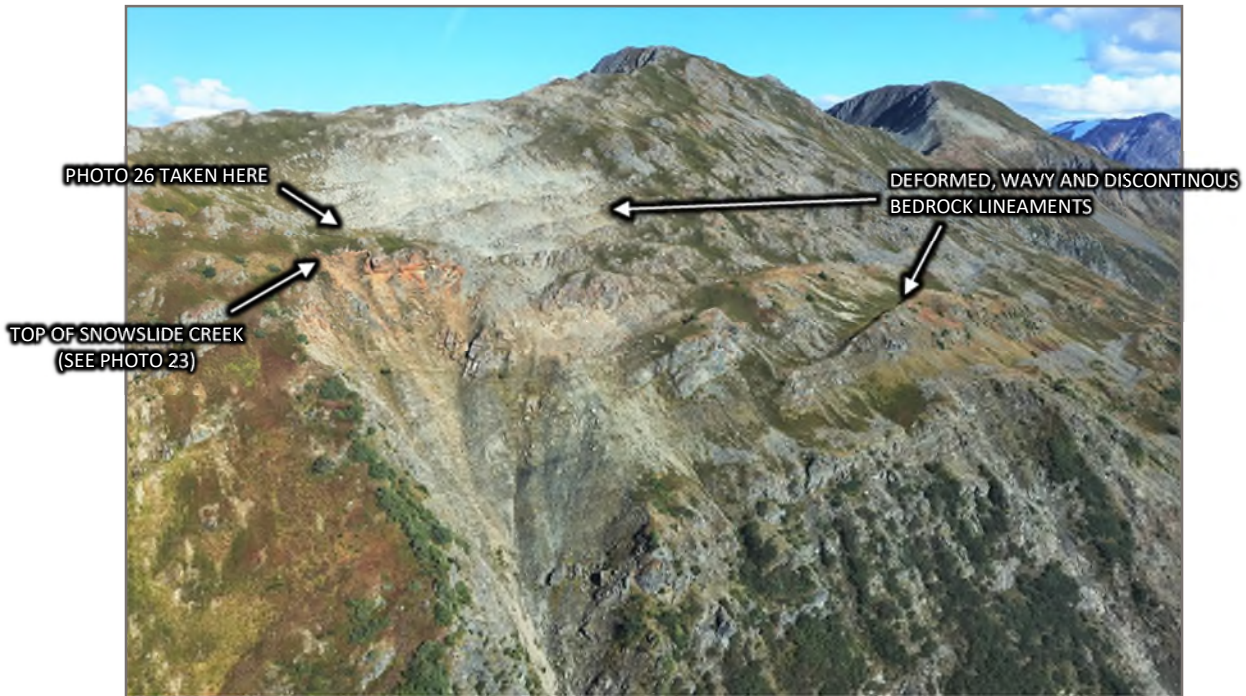
- Photo 29 Looking east at the top of Snowslide Creek and the headscarp of its rock fall/debris flow path. Deep-seated bedrock creep is evident above and east of it. Evidence of deep-seated movement, i.e., developing bedrock slide, includes multiple graben and horst type structures and deformed bedrock lineaments suggesting creep of the rock mass

**Photo 29:** Looking east at the top of Snowslide Creek and the headscarp of its rock fall/debris flow path. Deep-seated bedrock creep is evident above and east of it. Evidence of deep-seated movement, i.e., developing bedrock slide, includes multiple **graben** and **horst** type structures and deformed bedrock lineaments suggesting creep of the rock mass (Date of Photo: September 15, 2019; The photo location is shown on Figures 1.4 and 1.5).

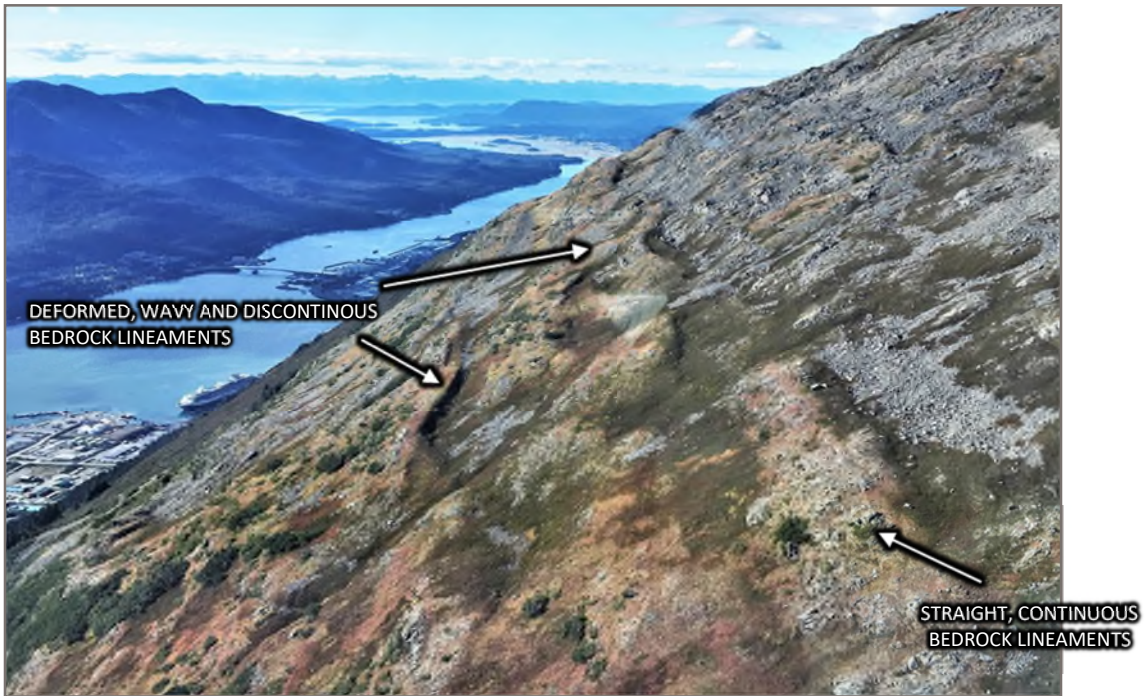
- Photo 30 Looking west toward the area showing evidence of deep-seated bedrock creep that is, in turn, indicative of developing bedrock slide. A stable area showing straight and continuous bedrock lineaments is visible in the foreground, while deformed and discontinuous bedrock lineaments in the potentially unstable area are visible in the middle ground

**Photo 30:** Looking west toward the area showing evidence of deep-seated bedrock creep that is, in turn, indicative of developing bedrock slide. A stable area showing straight and continuous bedrock lineaments is visible in the foreground, while deformed and discontinuous bedrock lineaments in the potentially unstable area are visible in the middle ground (Date of Photo: September 15, 2019; The photo shoot location is not shown on Figures 1.4 and 1.5 because it is outside the extent of the map (approximately 1,500 ft. southeast of the southeastern boundary of the Study Area)).
