## **Downtown Juneau Landslide and Avalanche Hazard Assessment**

PRESENTED TO  
**City and Borough of Juneau**

APRIL 27, 2022  
ISSUED FOR USE  
FILE: ENG.EARC03168-01

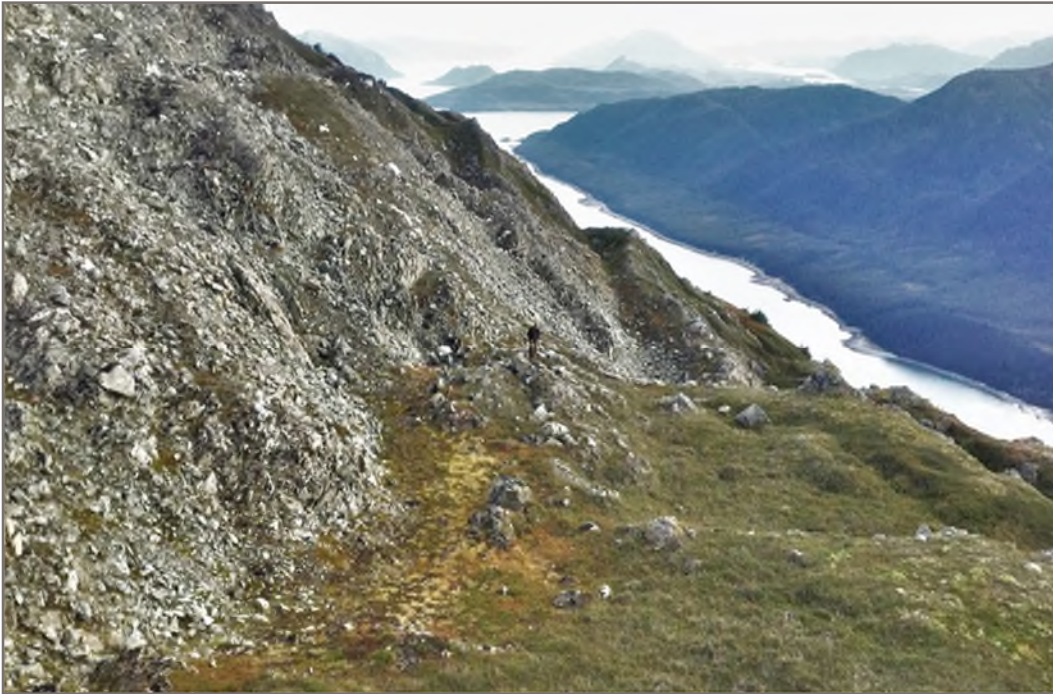
- Photo 31 Looking southeast toward the area showing evidence of deep-seated bedrock creep that, in turn, is indicative of developing bedrock slide. Potentially ploughed bedrock is visible on the left and the graben and horst structures are visible in the middle of the photo

**Photo 31:** Looking southeast toward the area showing evidence of deep-seated bedrock creep that, in turn, is indicative of developing bedrock slide. Potentially ploughed bedrock is visible on the left and the graben and horst structures are visible in the middle of the photo (Date of Photo: September 9, 2019; The photo location is shown on Figures 1.4 and 1.5).

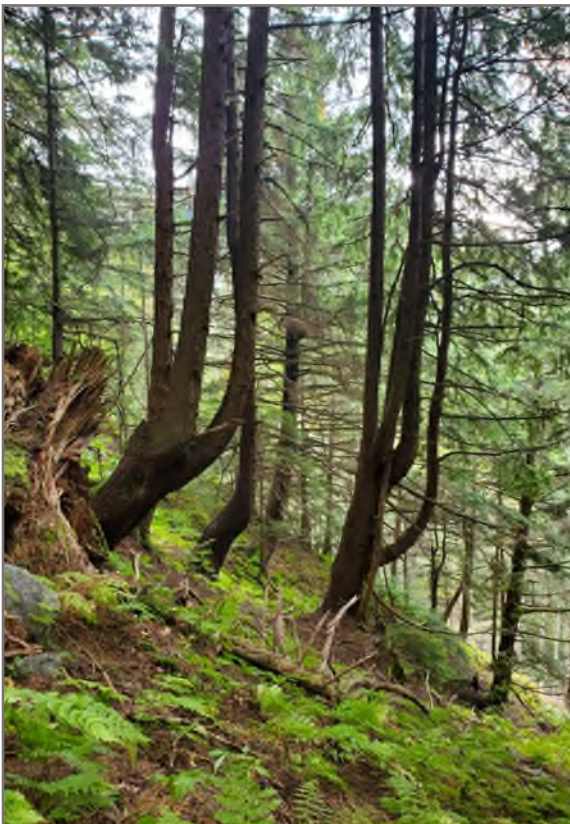
- Photo 32 A snapped stem approximately 2 m to 3 m high provides evidence of historical avalanche activity, J002B Extra Flume path. The tree was snapped at that height by an avalanche and then regrew starting at that point. Trees also show flagging (uphill branches are missing while downhill branches are present) which provides additional evidence of recent historical activity, including at least two significant, damaging events in the tree's lifespan

**Photo 32:** A snapped stem approximately 2-3 m high provides evidence of historical avalanche activity, J002B Extra Flume path. The tree was snapped at that height by an avalanche and then regrew starting at that point. Trees also show flagging (uphill branches are missing while downhill branches are present) which provides additional evidence of recent historical activity, including at least 2 significant, damaging events in the tree's lifespan.

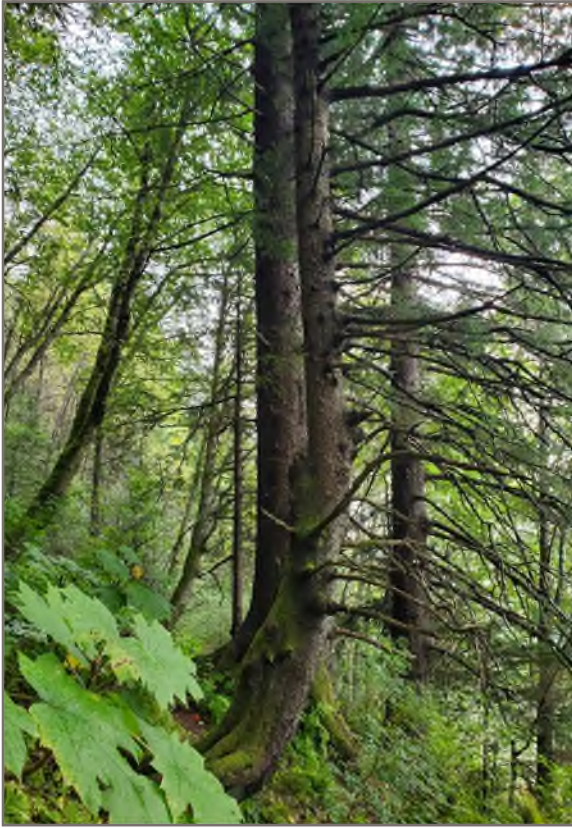
- Photo 33 This photo depicts a variety of evidence supporting historical avalanche activity. The bend at the base of the stem (sometimes called pistol butt) is evidence of either historical avalanche activity, or slope movement. Either way, the tree was displaced in its early years, and then corrected by again growing vertically. Second, a snapped stem is visible on the left side of the tree in the foreground a few meters up. Flagging is obvious, with large branches on the downslope side and no branches facing upslope. There are also two distinct age classes in this area, including the conifers in the photo center and foreground, and the deciduous trees on the left, which grow faster and are a younger age class. In combination, this is evidence of up to three different avalanche events. Magnitude-frequency estimates can be derived with this high-quality vegetation evidence

**Photo 33:** This photo depicts a variety of evidence supporting historical avalanche activity. The bend at the base of the stem (sometimes called pistol butt) is evidence of either historical avalanche activity, or slope movement. Either way, the tree was displaced in its early years, and then corrected by again growing vertically. Second, a snapped stem is visible on the left side of the tree in the foreground a few meters up. Flagging is obvious, with large branches on the downslope side and no branches facing upslope. There are also two distinct age classes in this area, including the conifers in the photo center and foreground, and the deciduous trees on the left, which grow faster and are a younger age class. In combination, this is evidence of up to three different avalanche events. Magnitude-frequency estimates can be derived with this high-quality vegetation evidence.

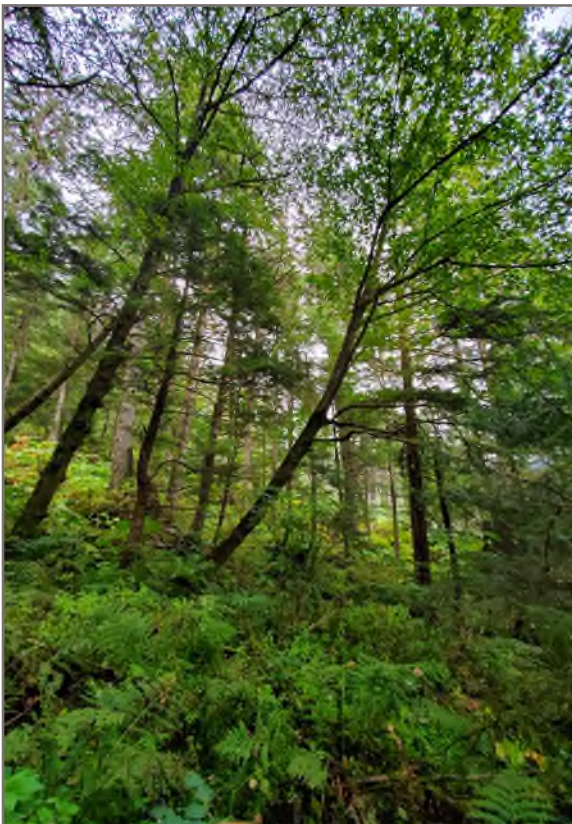
- Photo 34 This photo demonstrates a sweeping tree in the J021 avalanche path, which is similar to pistol butt; however, the tree retains a gradual bend at the base due to repeated and frequent impacts

**Photo 34:** This photo demonstrates a sweeping tree in the J021 avalanche path, which is similar to pistol butt, however the tree retains a gradual bend at the base due to repeated and frequent impacts.

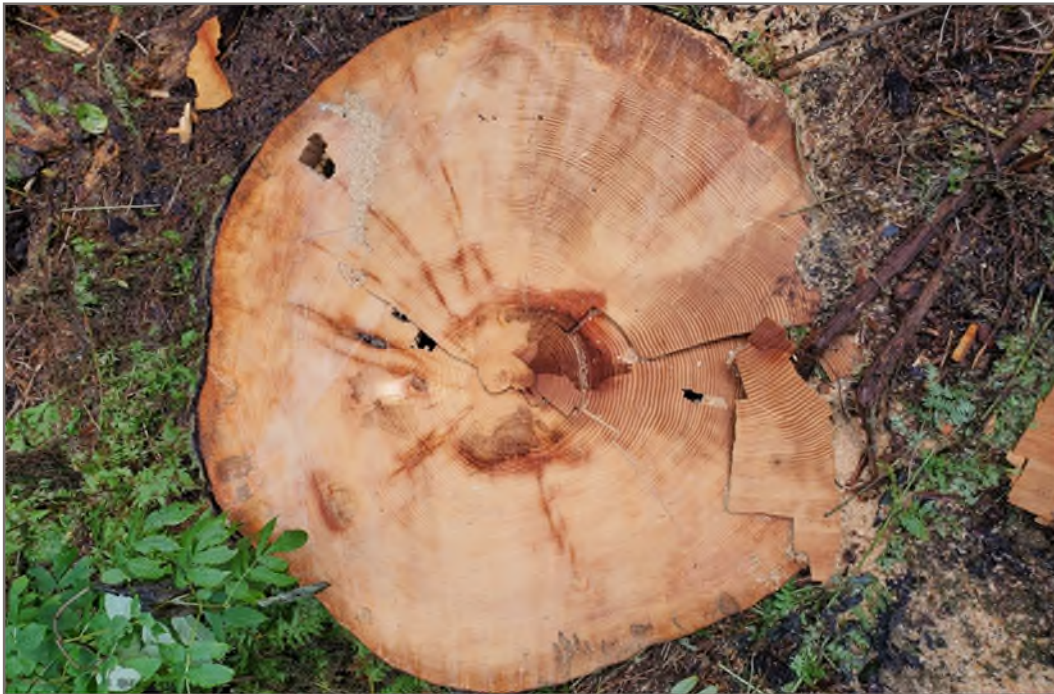
- Photo 38 Tree section showing growth rings. Alternating dark (winter) and light (summer) rings combine to indicate a year of growth, which can be used to age the tree. Sometimes reaction wood can be observed which can indicate significant avalanche events in the tree's life

**Photo 38:** Tree section showing growth rings. Alternating dark (winter) and light (summer) rings combine to indicate a year of growth, which can be used to age the tree. Sometimes reaction wood can be observed which can indicate significant avalanche events in the tree's life.

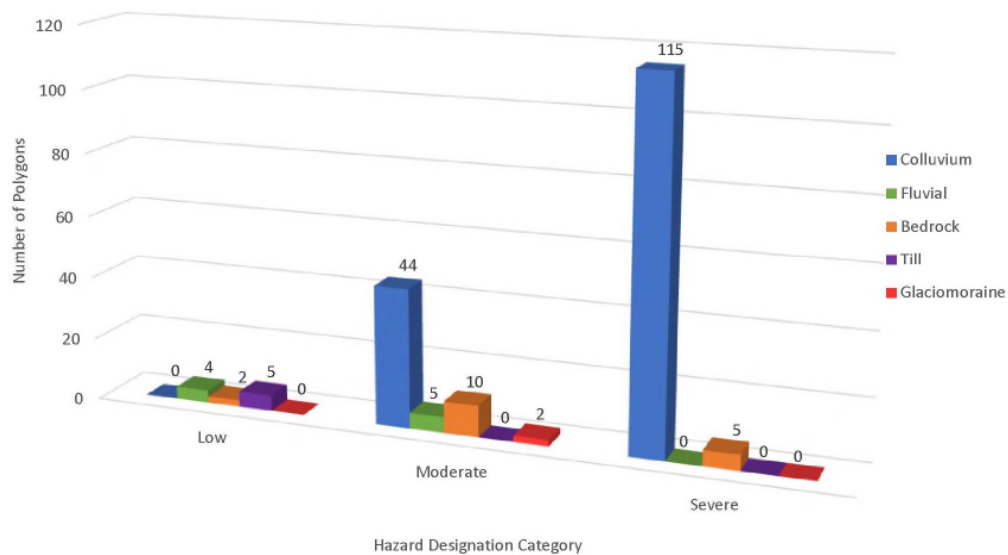
**Figure B.1: Number of Polygons vs. Hazard Designation Categories for Surficial Geology Descriptions.**

First, the updated surficial geology was compared to the hazard designation and, as expected, polygons mapped as mainly colluvial strongly dominated the *Severe* hazard designation category. However, colluvial deposits were also the main constituent of the *Moderate* category (Figure B.1). To further elucidate the relationship between colluvium and hazard designation, thin colluvium (colluvial veneer) was distinguished from thick colluvium (all other colluvial deposits) using GIS analysis. Figure B.2 shows that almost three times as many colluvial veneer polygons were related to *Severe* hazards as were related to *Moderate* hazards. Conversely, polygons containing thicker colluvium had a *Severe* designation almost twice as often as a *Moderate* one. Colluvial veneer, therefore, appeared to be more strongly correlated with a hazard designation of *Severe* than thicker colluvial deposits were.

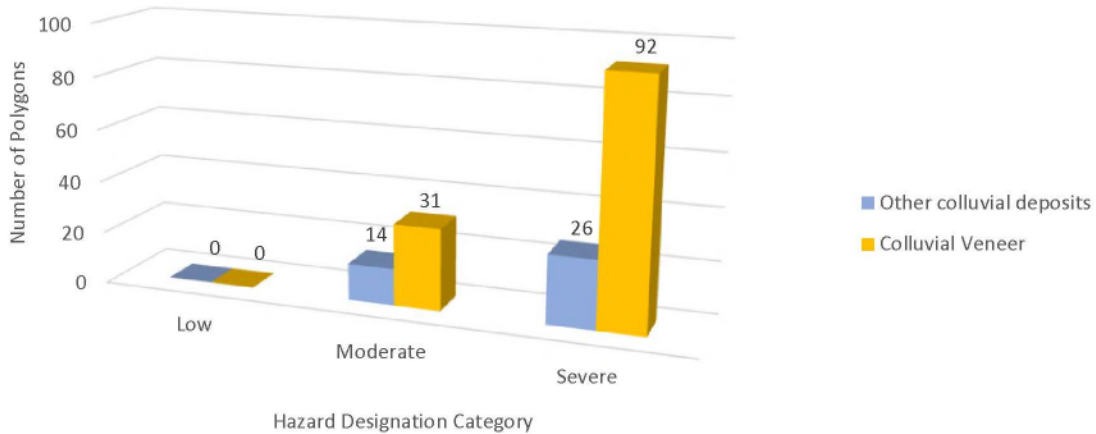
**Figure B.2: Type of Colluvial Deposit vs. Hazard Designation Categories.**

Figure B.2 also shows that in *Moderate* hazard category terrain, the hazard was 2.2 times as likely to be related to a colluvial veneer than other types of colluvium, while for *Severe* hazard terrain, the ratio was 3.5:1. This suggests that slope angle may be an important factor to consider.

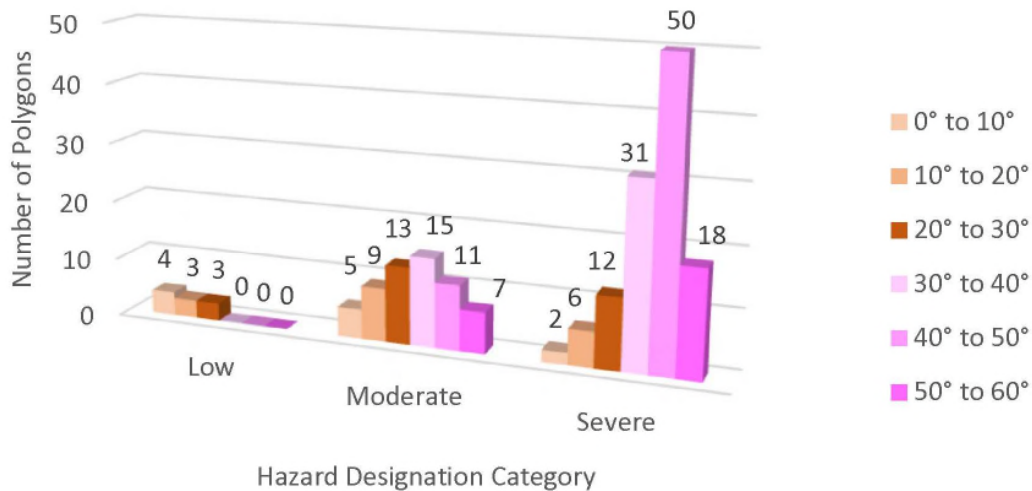
**Figure B.3: Mean Slope Angle vs. Hazard Designation Categories.**

Next, polygon slope angle was compared to hazard designation, using slope categories divided into 10° increments. The mean slope of each polygon vs. its hazard designation is shown in Figure B.3. Two important factors can be identified from this figure:

1. Most of the slopes in the Study Area were steeper than 30°; and
2. Slopes of 30° or more dominated the *Severe* hazard designation, outnumbering those in the *Moderate* category by approximately 3:1. In particular, slopes of 40° to 50° in the *Severe* category outnumbered the slopes of 40° to 50° in the *Moderate* category by almost 5:1.

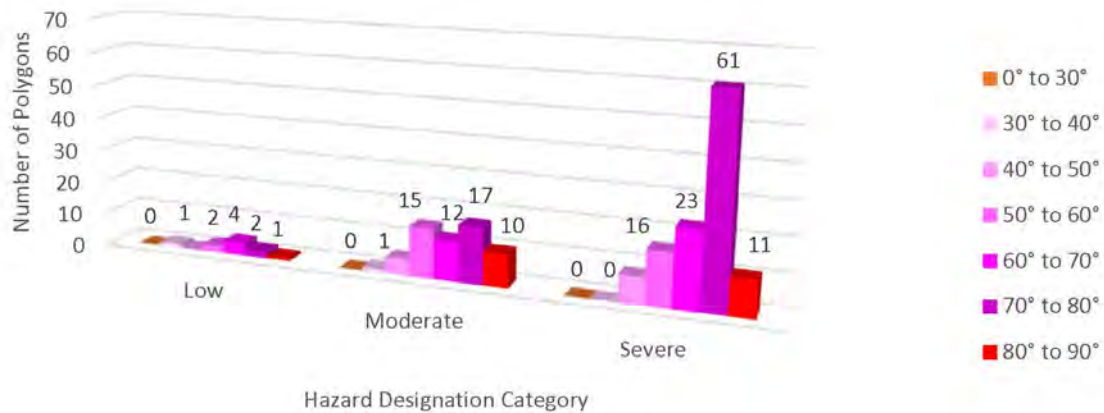
**Figure B.4: Maximum Slope Angle vs. Hazard Designation Categories.**

A similar relationship was observed for the maximum slope angle in each polygon vs. hazard designation (Figure B.4), but with a 2.4:1 ratio for the three highest slope ranges combined. In particular, maximum slopes of 70° to 80° in the *Severe* category outnumbered maximum slopes of 70° to 80° in the *Moderate* category by 3.6:1. The minimum slope angles for each polygon were not analyzed as they were considered unlikely to relate to slide susceptibility.

Additionally, the number of polygons with 80° to 90° maximum slope angles was very similar in the *Moderate* and *Severe* categories. This suggested that competent, near-vertical bedrock cliffs were equally likely to pose *Moderate* and *Severe* hazards. This relationship could be due to local variations in the bedrock, such as number and direction of joints and faults.

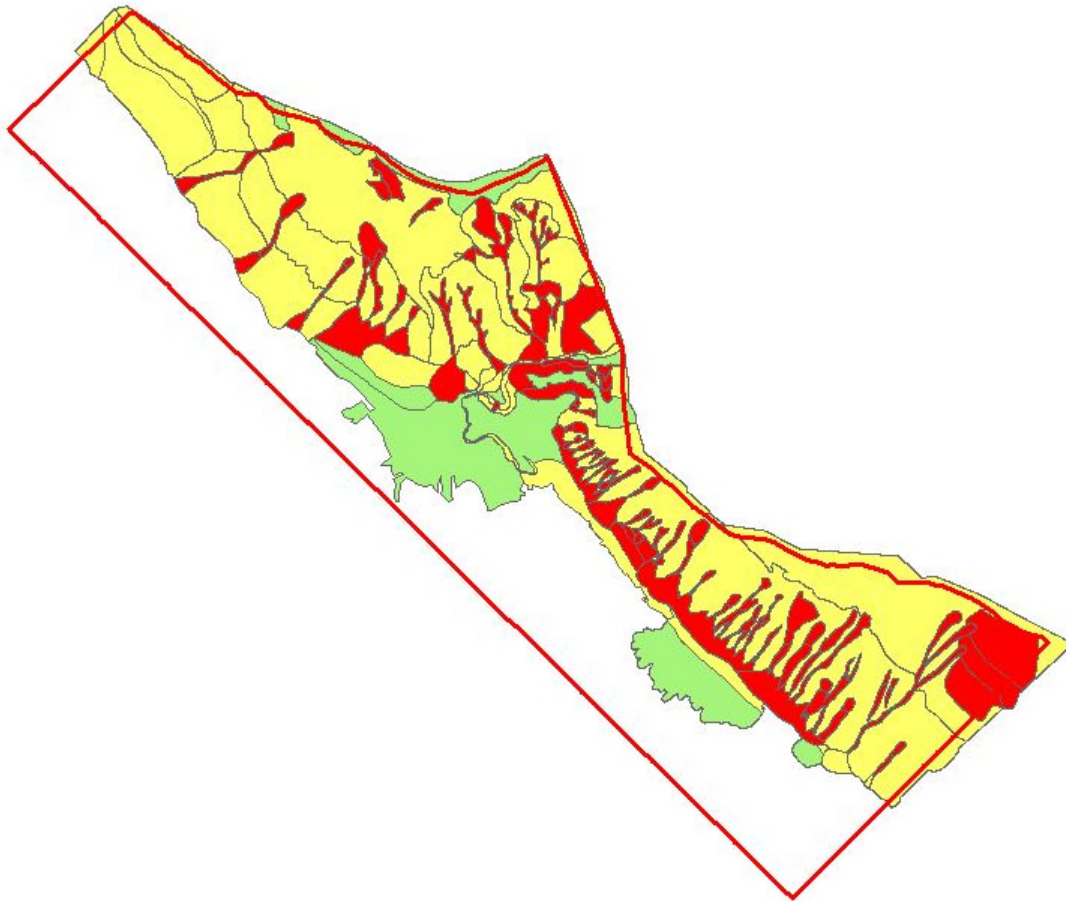
**Figure B.5: Initial Landslide Hazard Designation Map.**  
**(Red = Severe, Yellow = Moderate, and Green = Low hazard)**

An algorithm was run in ArcGIS to convert any non-*Severe* designated polygons to a designation of *High* if at least two of the three semi-quantitative criteria were met (Figure B.6). The result was that most of the areas that were initially of concern, i.e., those initially mapped with a *Moderate* hazard category, plus a few more, are now mapped as having a *High* hazard designation (Figures B.5 and B.6).

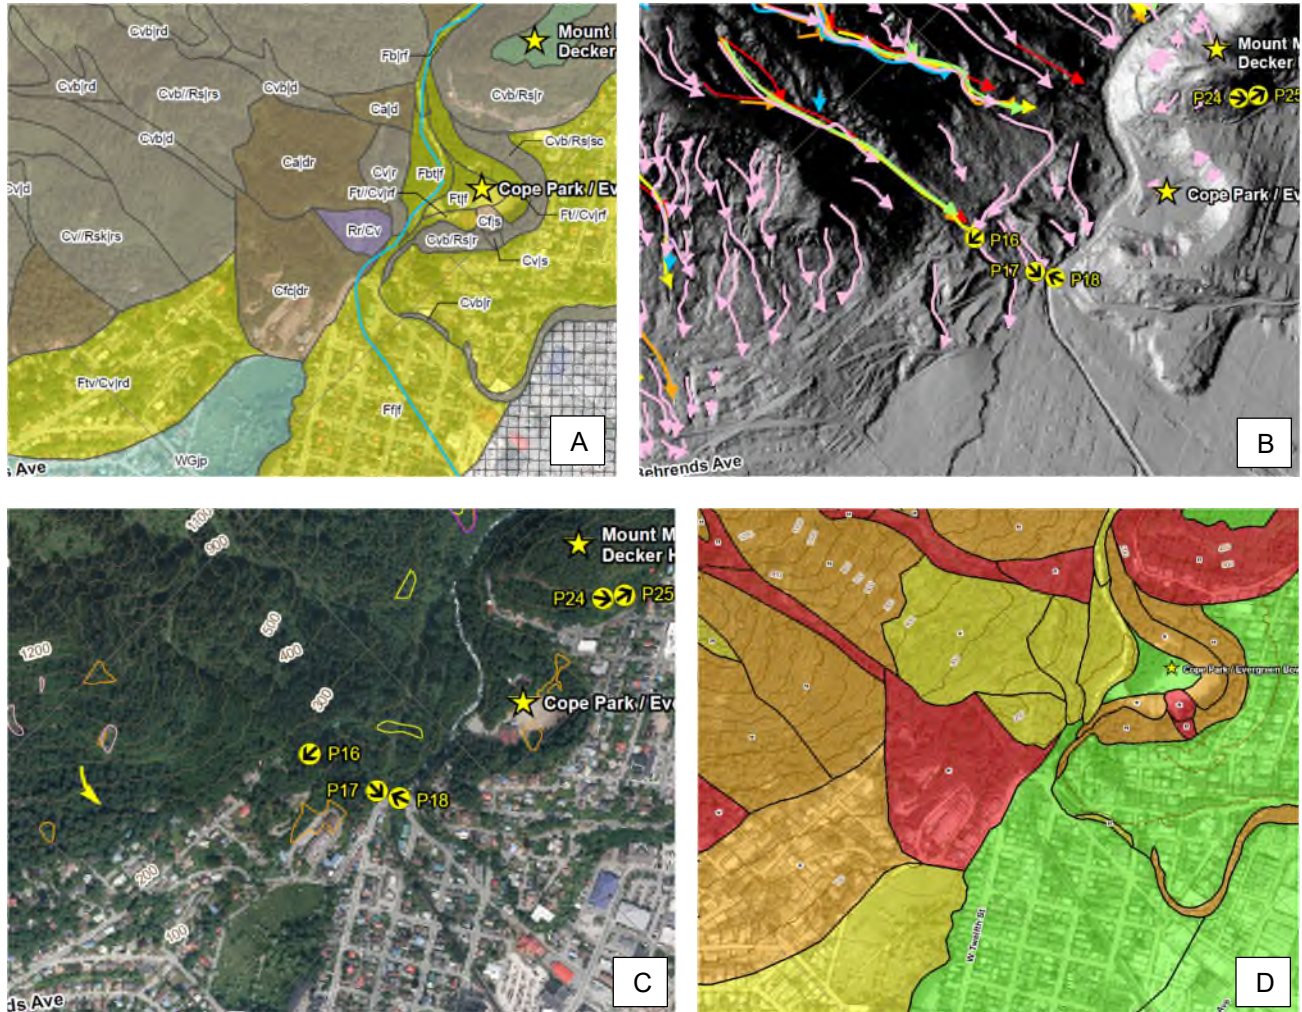
Compare the surficial geology and the major gully features shown in excerpts from Figures 1.3b and 1.5b (Figures 2A and 2B below). In the case of Bathe Creek, the shape of the *Severe* area reflects the shape of the cone/fan and the upslope gully that is the source of the debris, as shown below in the excerpt from Figure 1.6c (Figure 2D). Finally, even though the fan itself only displays occasional activity (remobilization of old debris flow material), as shown in the excerpt from Figure 1.4b (Figure 2C), the debris flows originating from upslope govern the hazard designation, as they are what has formed the fan and what will continue to do so in the future.

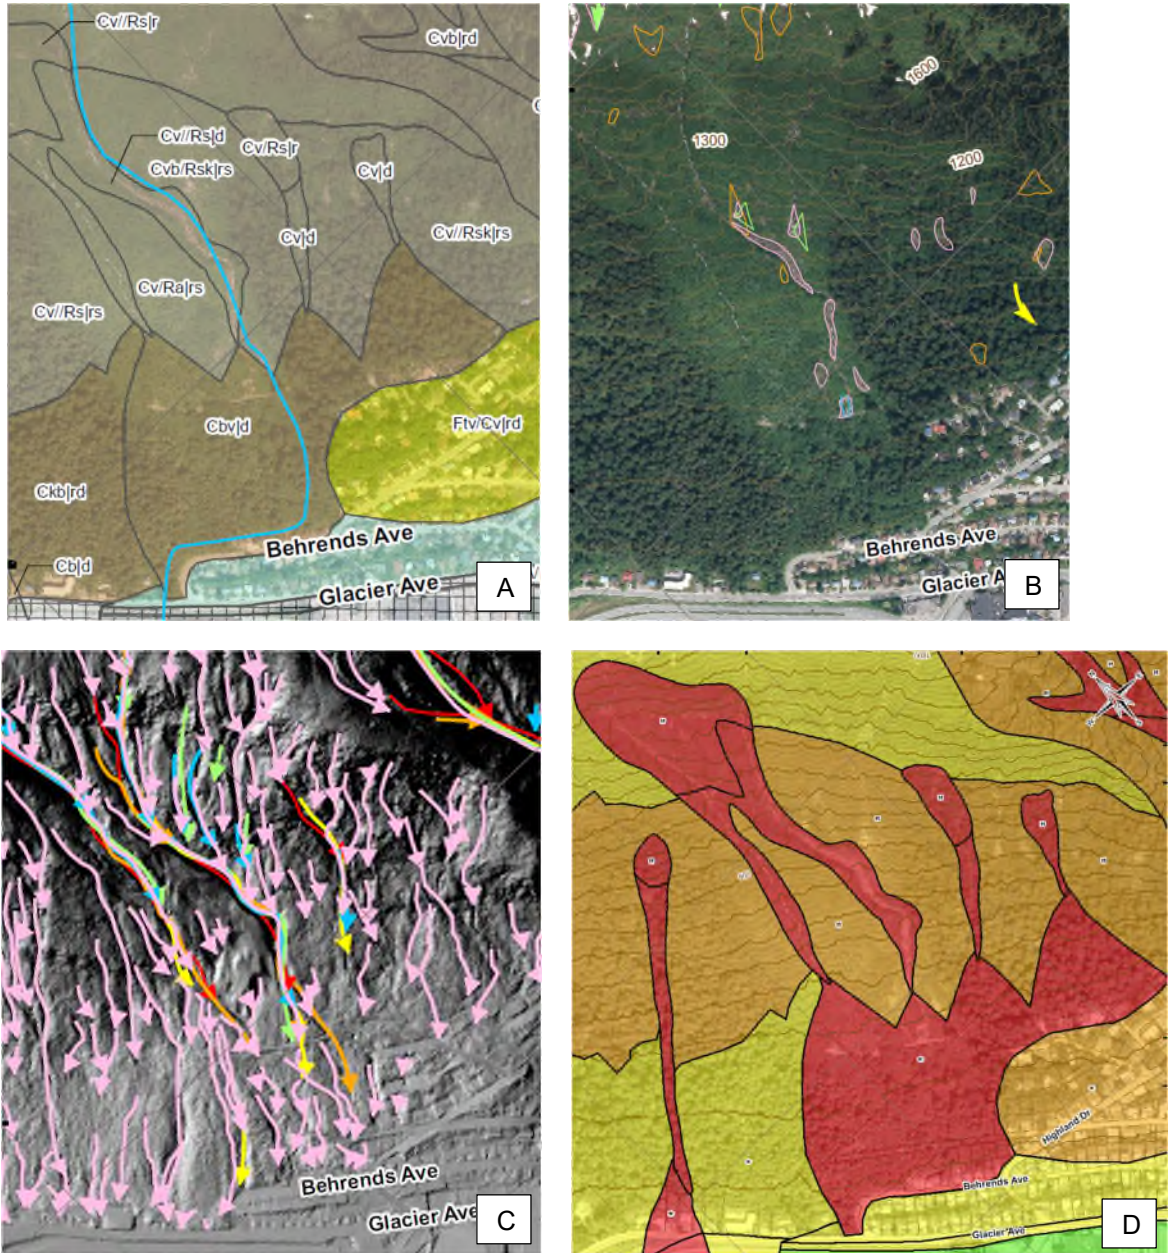
**Response:** The basis for the *Severe* hazard designation is not Swanston’s report, but rather Tetra Tech’s independent determination of the characteristics of the terrain units based on surficial geology mapping, historical air photo record analysis of slope movement features and gully erosion features, as well as incident reports and field observations. See also responses to Items 1 and 4 above. Specific to the *Severe* areas mapped in this part of the study area (Figure 1.6b and 1.6c), these are all colluvial areas (Figure 1.3b) that receive debris from several active gullies upslope (Figure 1.5b), including the previously mentioned Bathe Creek gully (see Figure 2 above), and several active gullies above Behrends Avenue and the west end of Highland Drive (see Figure 3 below). Several of the two dozen debris slides that occurred in various years in the immediate map area (Figure 1.4b) happened within gullies (compare Figures 3B and 3C below). The excerpt from Figure 1.4b (Figure 3B below) is also a good example of an avalanche track (area with no trees) that does not correspond perfectly with landslide activity and location.

While it is possible that houses have stood in one location for many years without being affected by a landslide, it does not mean there is nothing going on above them on the slope. If that activity has not reached a particular house yet, the resident may just have been lucky so far.

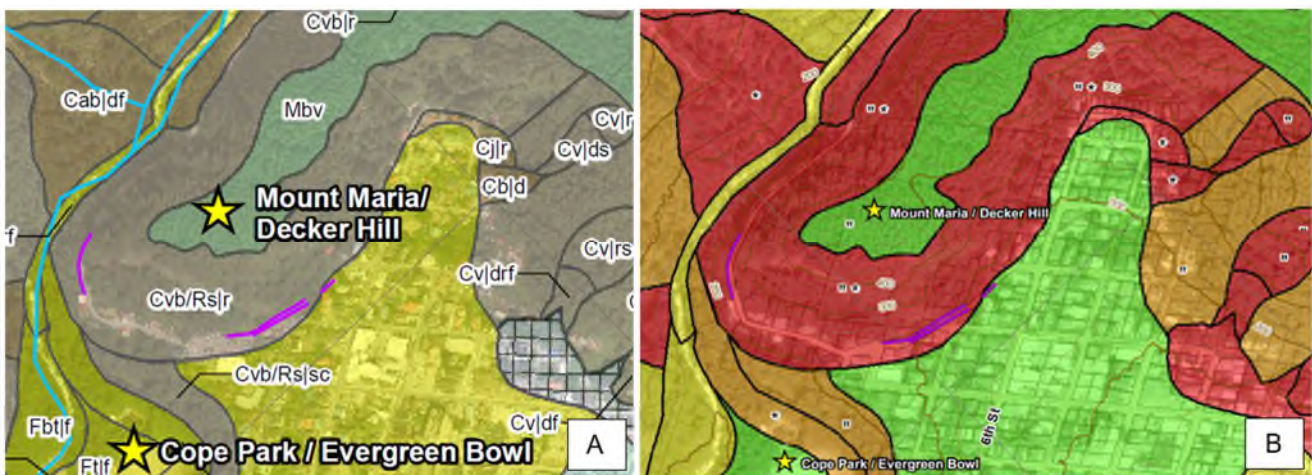
A summary of Tetra Tech’s mapping of the Starr Hill area and the adjacent portion of Basin Road is shown below in Figure 3, with surficial geology in Figure 3A and landslide hazard designation mapping in Figure 3B. There is a clear correlation between the shapes of the surficial geology units and the associated landslide hazard designations.

**Figure 3: Excerpts from Tetra Tech Figure 1.3b Surficial Geology (Figure 3A), and Figures 1.6c and 1.6h Landslide Hazard Designation Mapping (Figure 3B).**

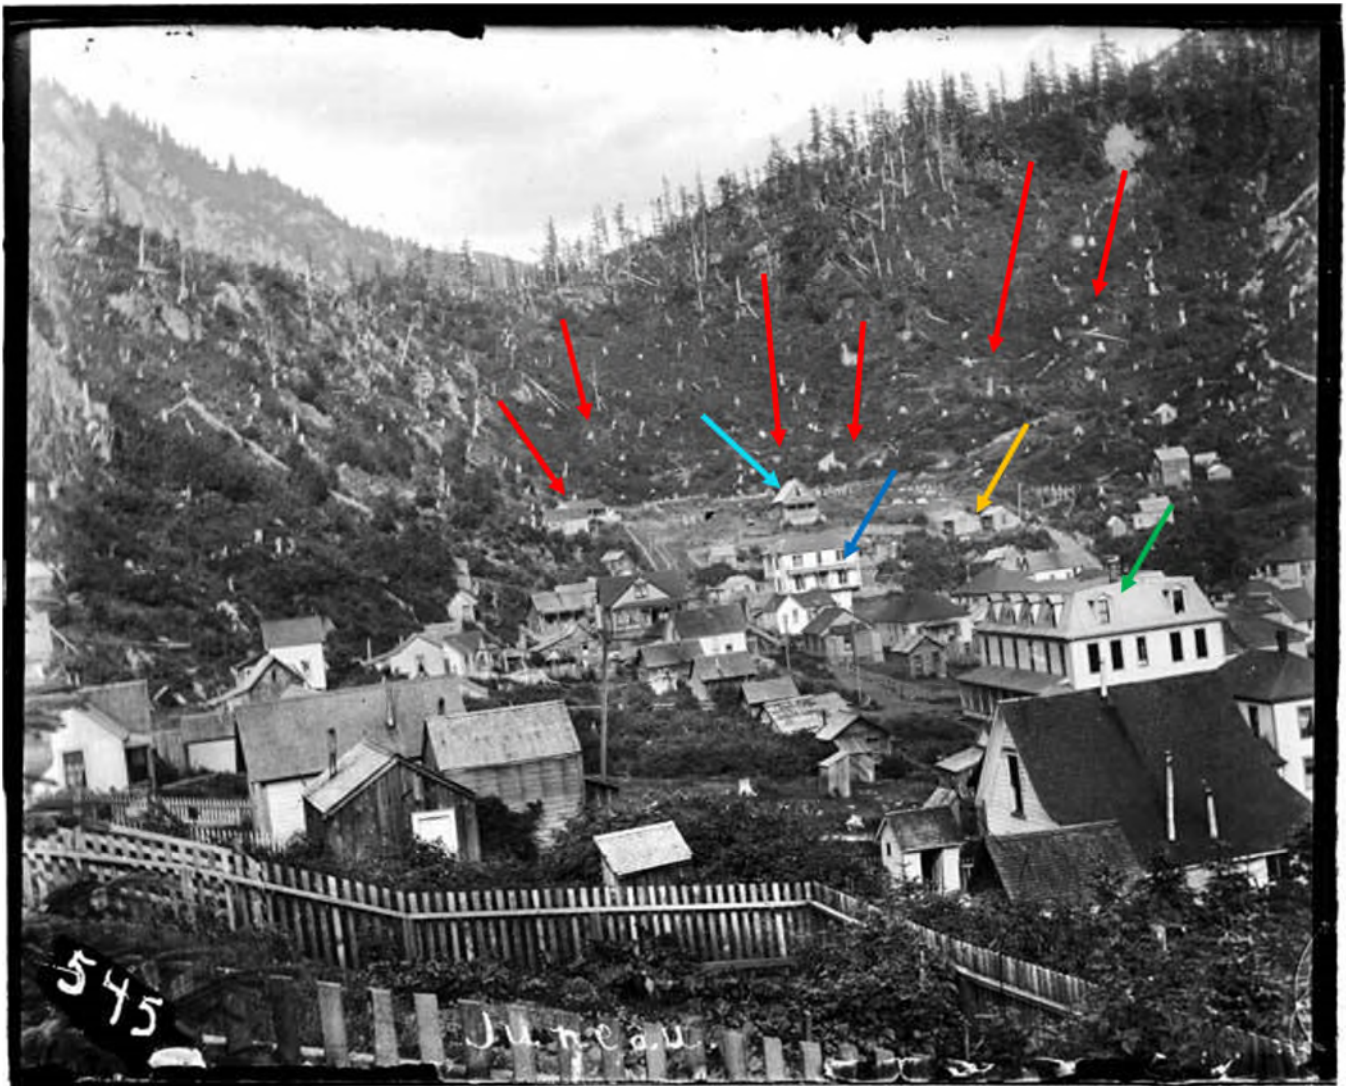
**Figure 10: Looking east-northeast toward Starr Hill from top of Chicken Ridge, 7<sup>th</sup> and Franklin Streets, July 1901. Slopes appear to have been recently clearcut (within the previous few years) with numerous stumps visible. There are some swales and slope sections with few or no stumps, indicating that this slope was not uniformly forested prior to clearcutting (red arrows). At least two recent soil debris slides are visible above what appears to have been Park Street in 1901. (Photo credit: Alaska State Library – Historical Collections, [ASL-P1-506](#), Vincent Soboleff Photograph Collection, ca. July 1901.)**

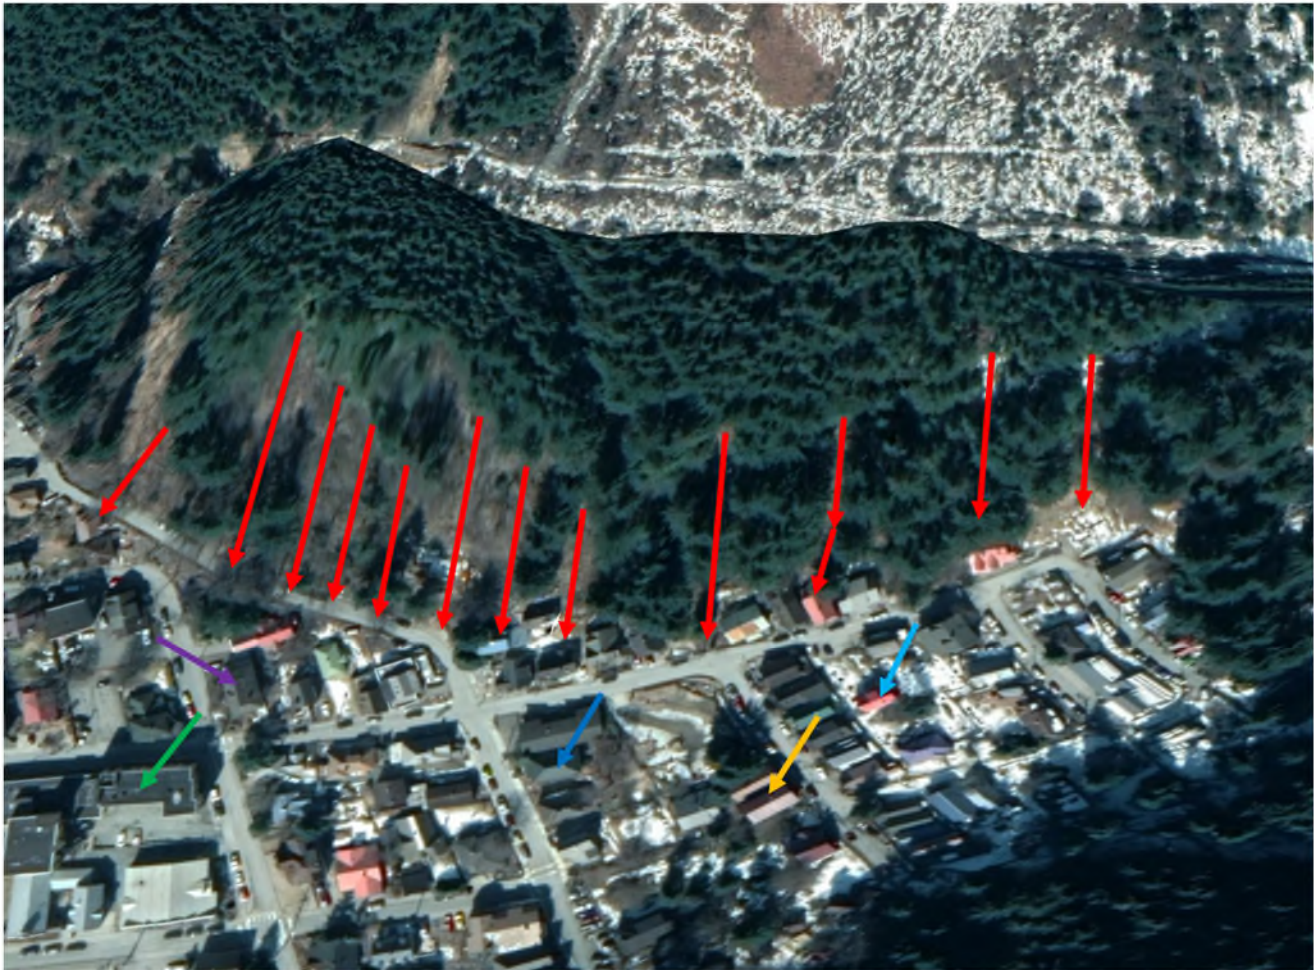
**Figure 14: Looking north-northwest, this Google Earth view is from an eye elevation of about 1,100 feet in early spring (April 2020), so that the slopes currently lacking coniferous trees can be seen more easily. Several of the swales and slope sections lacking tree cover that were seen in the 1902 photo (Figure 13) are still visible in 2020, along with a few more slide paths (red arrows). The apparent alignment of the paths lacking trees is slightly different in Figures 13 and 14, due to the different perspectives of the images. The landmarks in Figure 14 are the same as those in Figure 12. (Image credit: Google Earth 2022.)**

At the top ends of all the paths are rock bluffs or cliffs (Figure 14), which are the source of the rockfalls and rockslides that periodically scour out lower-growing vegetation along the paths, or damage mature trees alongside the paths if the debris is large enough. A couple of the paths seen in 1902 between Kennedy and Park Streets are obscured by trees in 2020 but are likely still present under the tree canopy. Some of the swales that seem to end mid-slope in this image likely continue further downslope under the tree canopy. In some areas of the slope, there are still some trees below rock bluffs, but they tend to be smaller than the trees on slopes not regularly affected by rockfall or rockslide debris (Figure 7). On the far left, the path shown crossing Basin Road represents the rock debris that impacted 712 Basin Road about 12 years ago (CBJ 2020).

Three cutlines are visible in Figure 14: on the left, the powerline above Basin Road; in the middle, where an old cutline crosses over to the north side of Mt. Maria; and, on the right, parallel to 6<sup>th</sup> Street, another old cutline crosses above the corner of 6<sup>th</sup> and Nelson Streets into Last Chance Basin. The latter two cutlines may be related to old mining infrastructure, and/or powerlines.

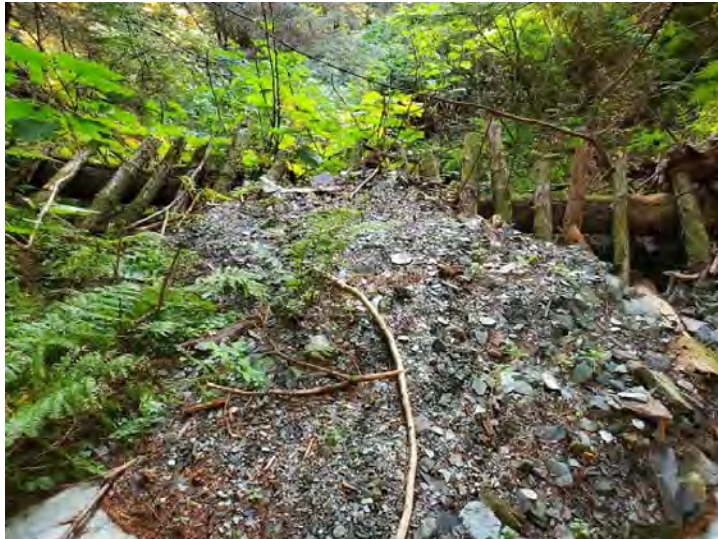
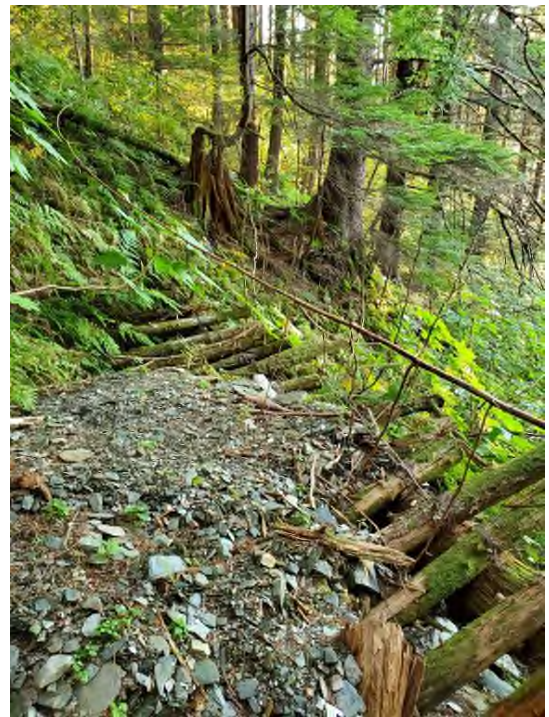
**Figure 16: Photos from the fieldwork in September 2019 showing one of the existing debris-flow mitigation structures that were built by homeowners living below the G000 Park debris flow path above Starr Hill. This structure has captured debris material from one or more mass-wasting events and measured about 8 feet wide by 7 feet long by 2 feet deep.**

Depending on the size of the next debris flow, the structure shown in Figure 16 could retain a little more debris or, instead, it could collapse, be overrun by debris, or even be completely scoured out by a larger debris flow that could originate from further up the gully. The same applies to the other structures documented by residents. Debris can incorporate both large and small woody debris, as seen in these photos and the photos supplied by residents of the mid and upper reaches of the gully. The upslope portion of this debris flow feature is bowl-shaped, indicating the potential for small debris slides from the side slopes to fail and entrain debris in the gully, of which there is a significant amount. The particle size of the material that can be moved by a debris flow is

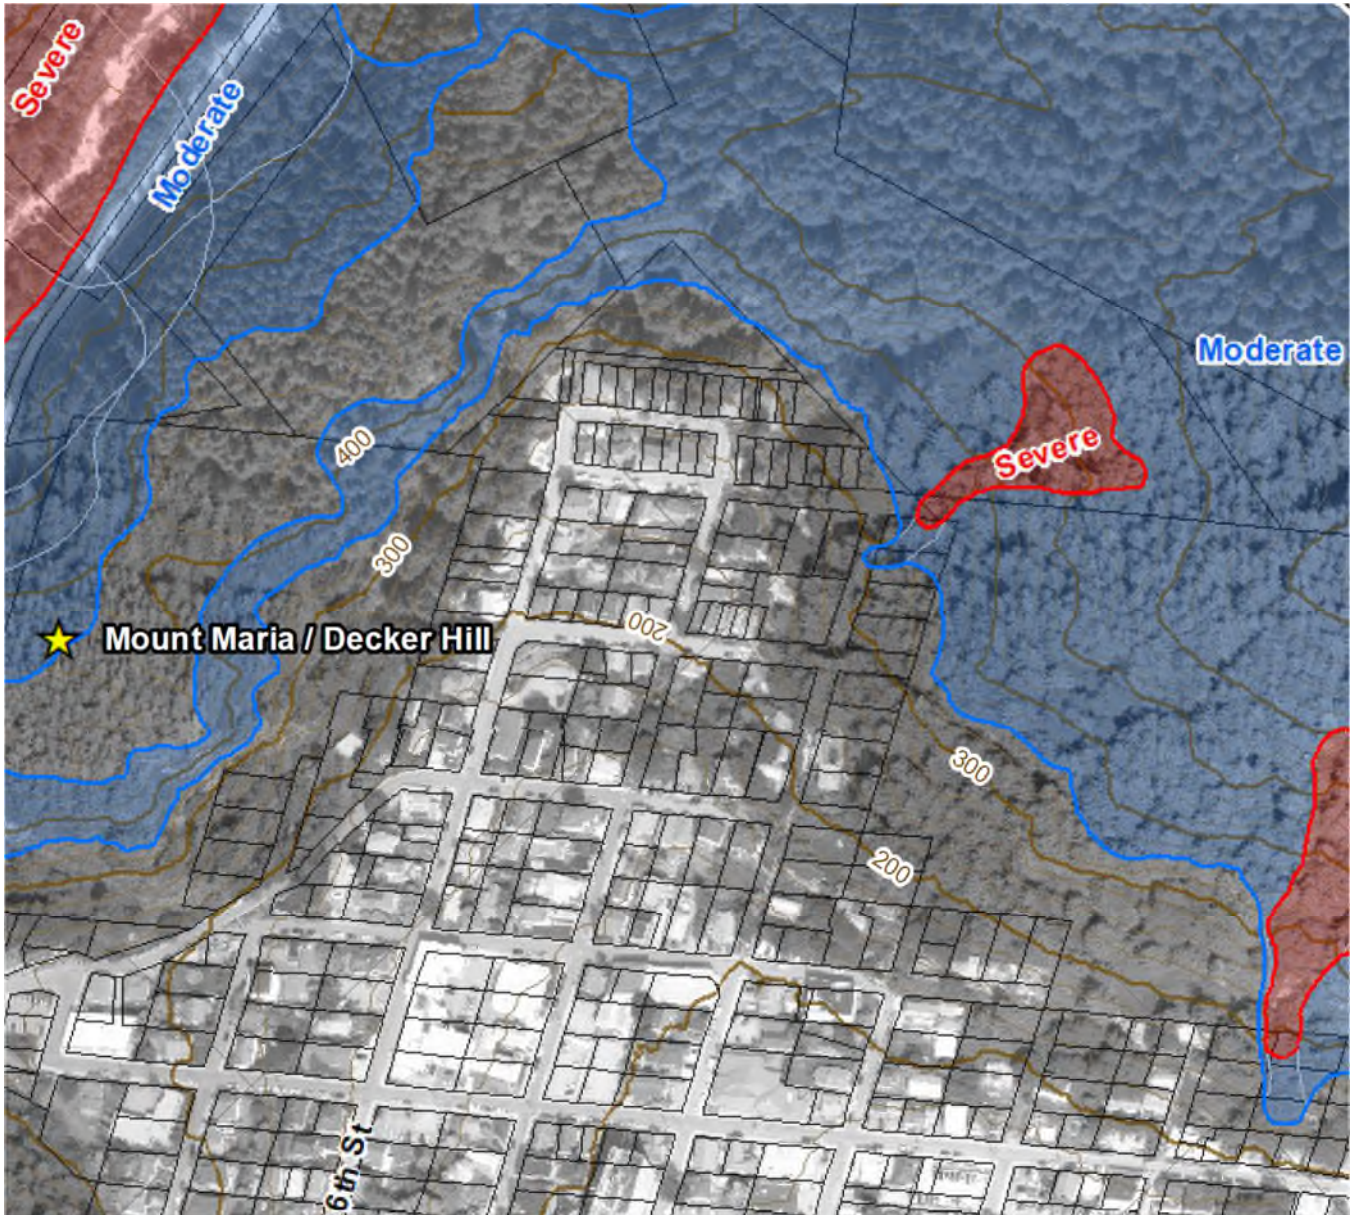
**Figure 1: Excerpt from Figures 2.4c and 2.4h in the main report, showing the northeast end of the Starr Hill subdivision. Almost all of the lots are mapped with an avalanche hazard designation of *Low* (i.e., not colored as red or blue), with the only encroachment being the G000 (Park) avalanche path on the right (marked *Severe*, with *Moderate* terrain below). All the existing houses are currently located in areas designated as *Low*.**

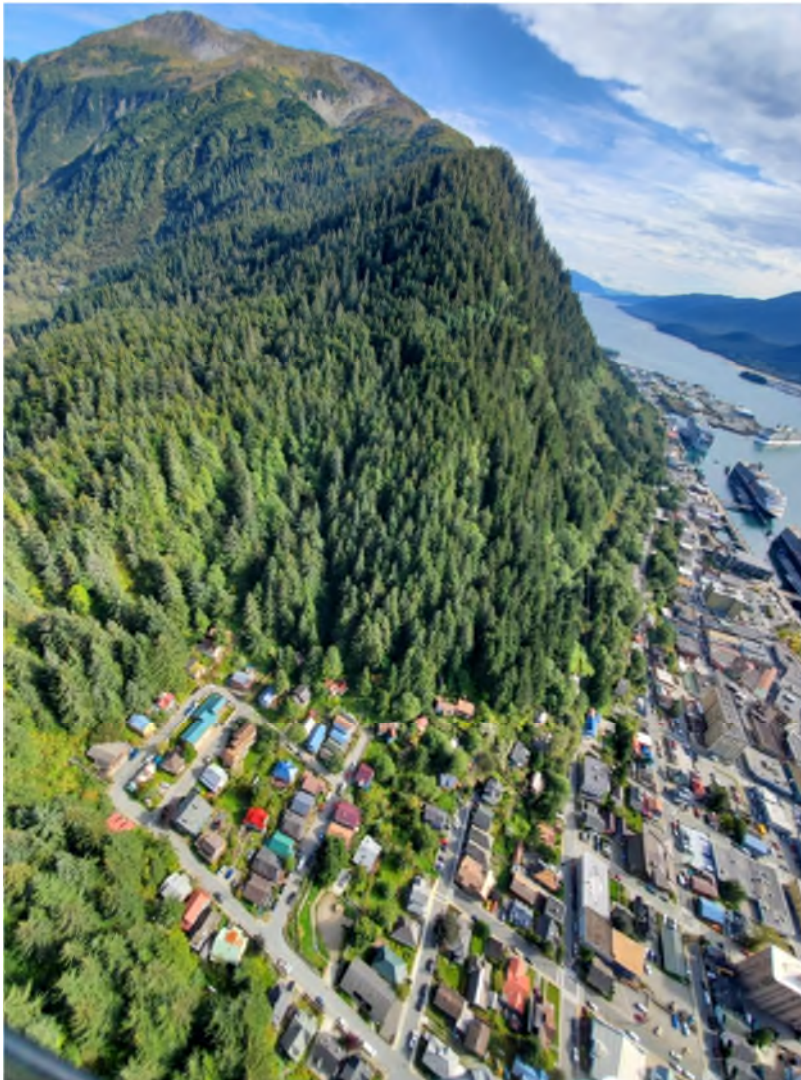
**Figure 2: Looking southeast at the Starr Hill subdivision. Nelson Street is near the top left of the photo, East Street is near the photo center, Gold St. is near the photo right edge. 6<sup>th</sup> Street is in the foreground left, and the next road to the southeast is 5<sup>th</sup> Street.**

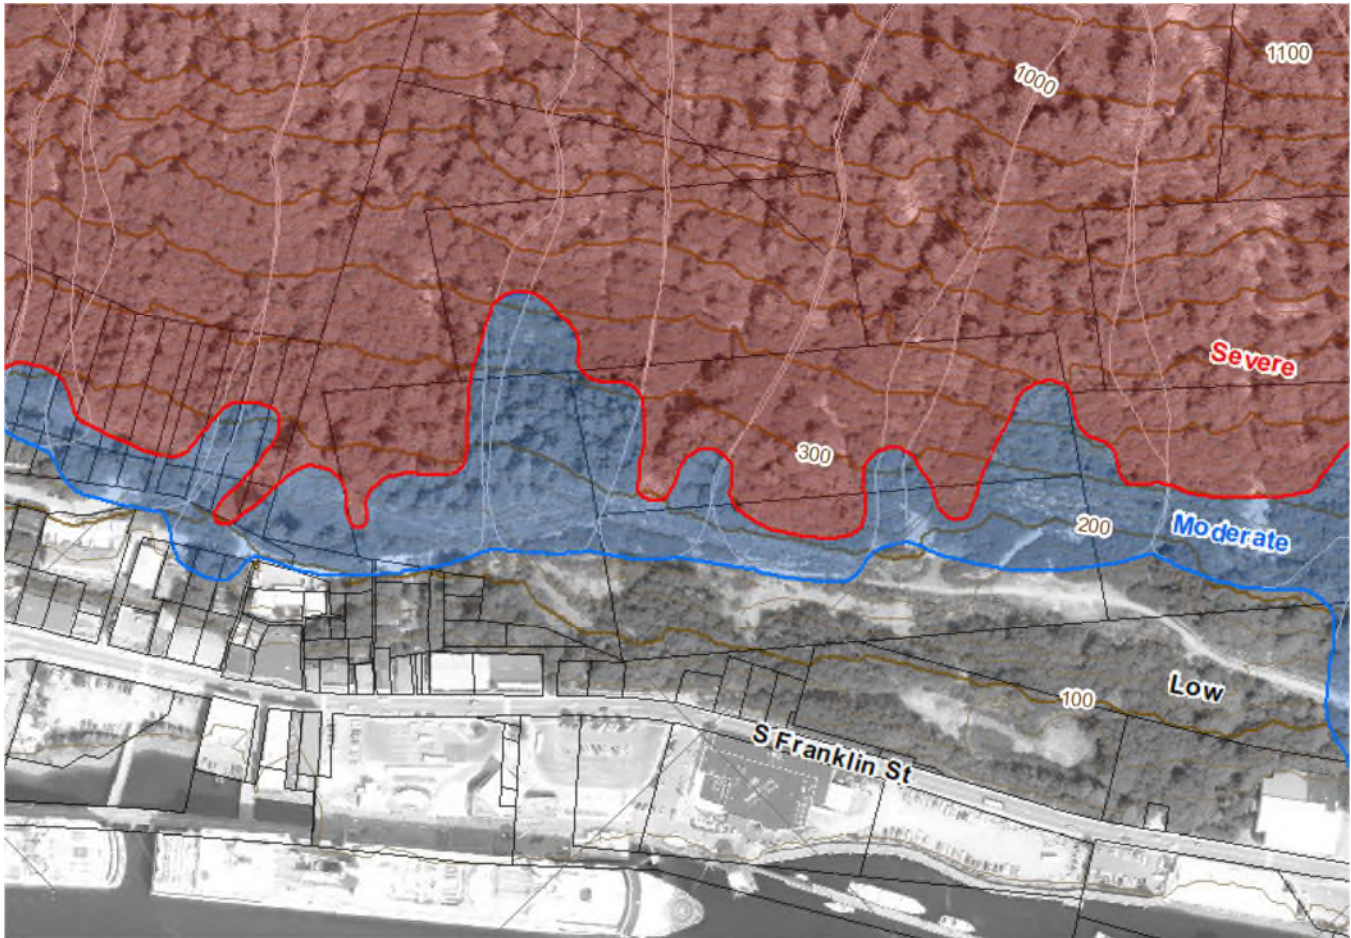
**Figure 3: Excerpt from Figure 2.4d in the main report, showing avalanche paths G003 to G009 and T000 (from left to right). The blue fringe shows terrain designated as having *Moderate* avalanche hazard along the toe of Mt. Roberts. In this area, the *Moderate* hazard does not reach South Franklin Street, but it does reach Gastineau Avenue in several locations. Further southeast (off the right-hand side of this map excerpt), the slopes of Mt. Roberts become higher and are affected by unforested alpine terrain, and the *Moderate* avalanche terrain reaches further downslope, past Thane Road, and sometimes into Gastineau Channel.**

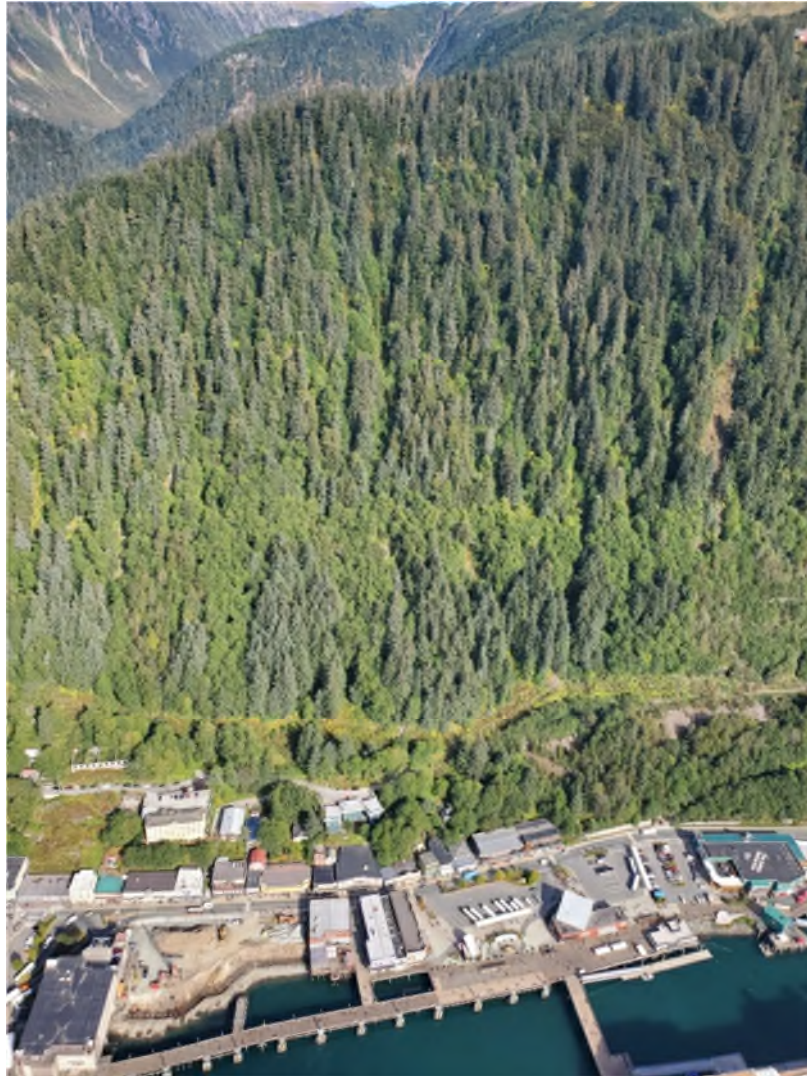
**Figure 4a: View of Mt. Roberts from the helicopter showing part of the slope mapped in Figure 3. Note the increasing height of slope from left to right (northwest to southeast). The slope is fairly well-treed but is still prone to avalanching. Gullies tend to increase avalanche runouts. See also Figure 4b.**

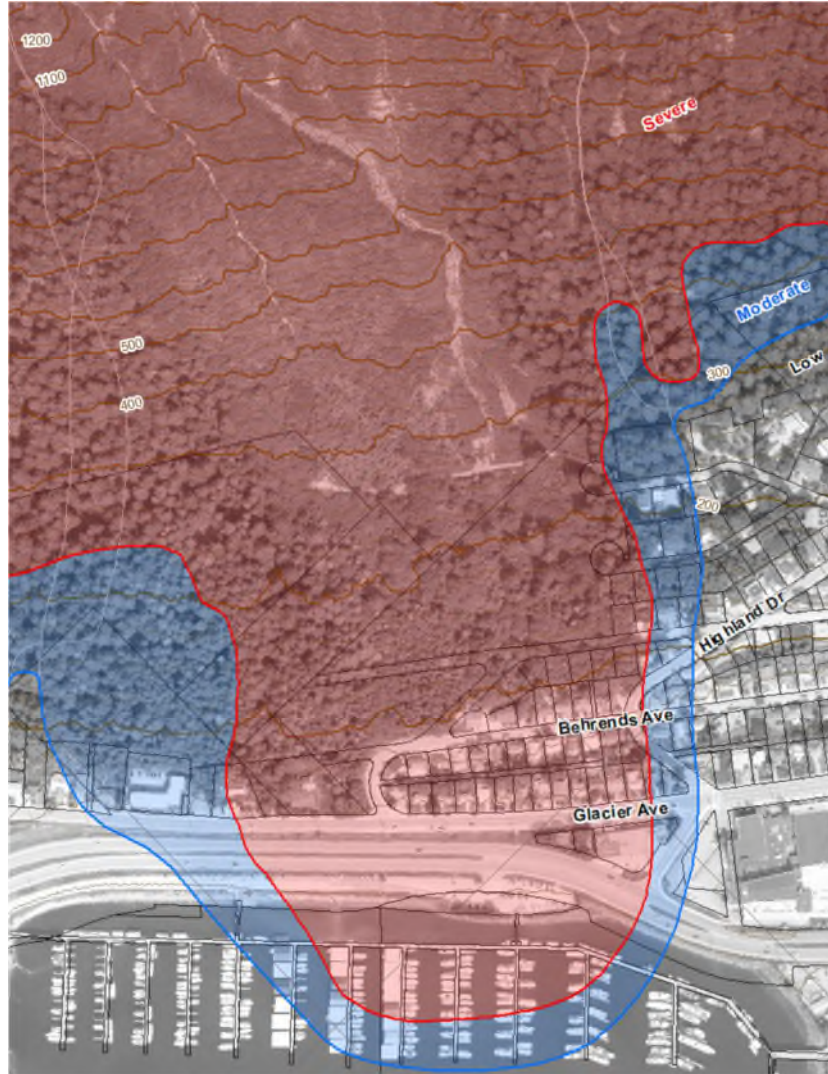
**Figure 5: Excerpt from Figure 2.4b showing the major avalanche path at J010 Behrends. Note the distinct trimlines that define the edges of this path, indicating regular avalanche activity within the central part of the path and less frequent avalanche activity on the outside (lateral boundaries) of the path.**
