## **Downtown Juneau Landslide and Avalanche Hazard Assessment**

PRESENTED TO  
**City and Borough of Juneau**

APRIL 27, 2022  
ISSUED FOR USE  
FILE: ENG.EARC03168-01

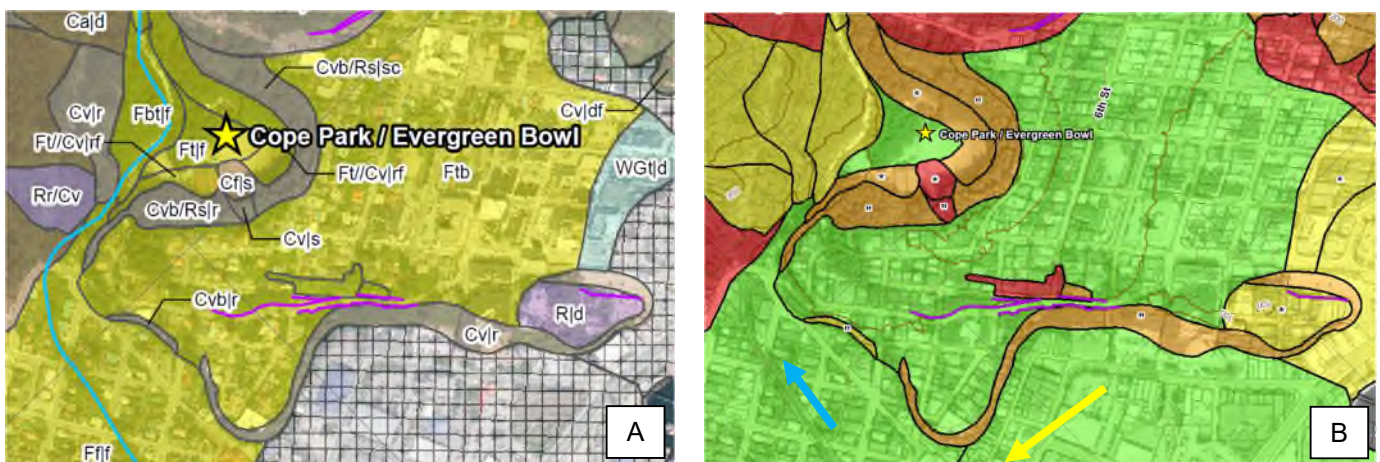
**Figure 9:** These two map excerpts are from the mapping across the approximate middle of the downtown area. Figure 79A shows the surficial geology, and Figure 9B shows the landslide hazard mapping. Gold Creek is marked as a blue stream along the left side of Figure 9A. Willoughby Avenue is in the cross-hatched area on Figure 9A, where fill was placed to extend the land area of the city. The yellow arrow on Figure 9B shows the direction of look in Figure 10A. The blue arrow on Figure 9B shows the direction of look in Figure 10B.

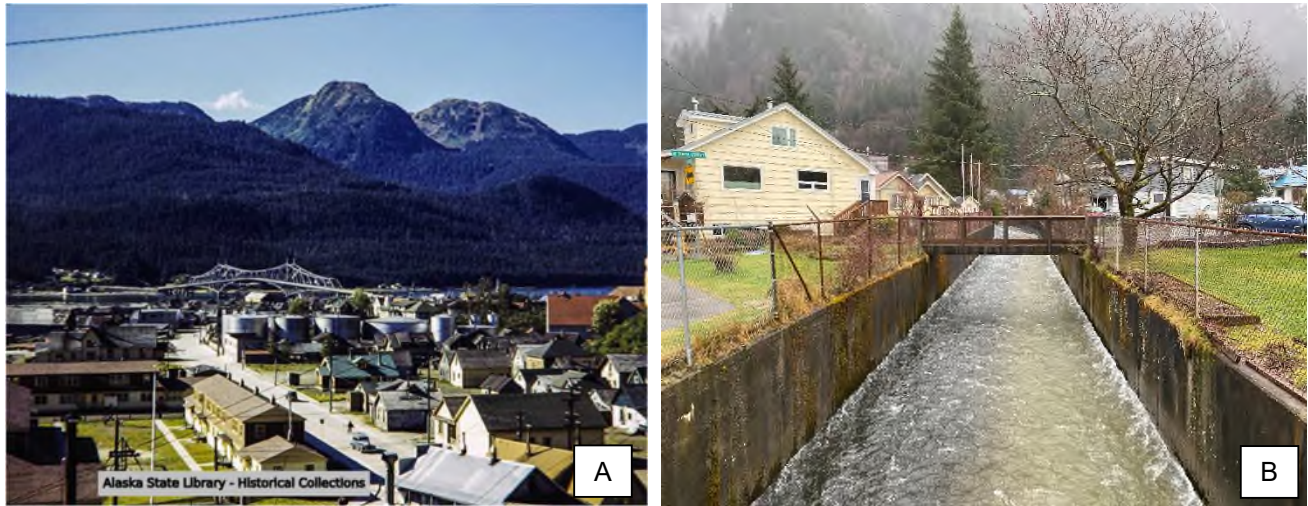
**Figure 10: Views of Juneau in terrain mapped with landslide hazard designation of *Low*.**

**Figure 10A: Looking west from Telephone Hill at the east-west leg of Willowby Avenue. Figure 10B: Looking upstream at the Gold Creek flume, with terrain mapped in *Low* on both sides of the creek. (Photo credits: Figure 10A: Alaska State Library – Historical Collections, [ASL-P417-040](#), Caroline Jensen 1948. ASL 2022a. Figure 10B: CBJ December 4, 2020.)**

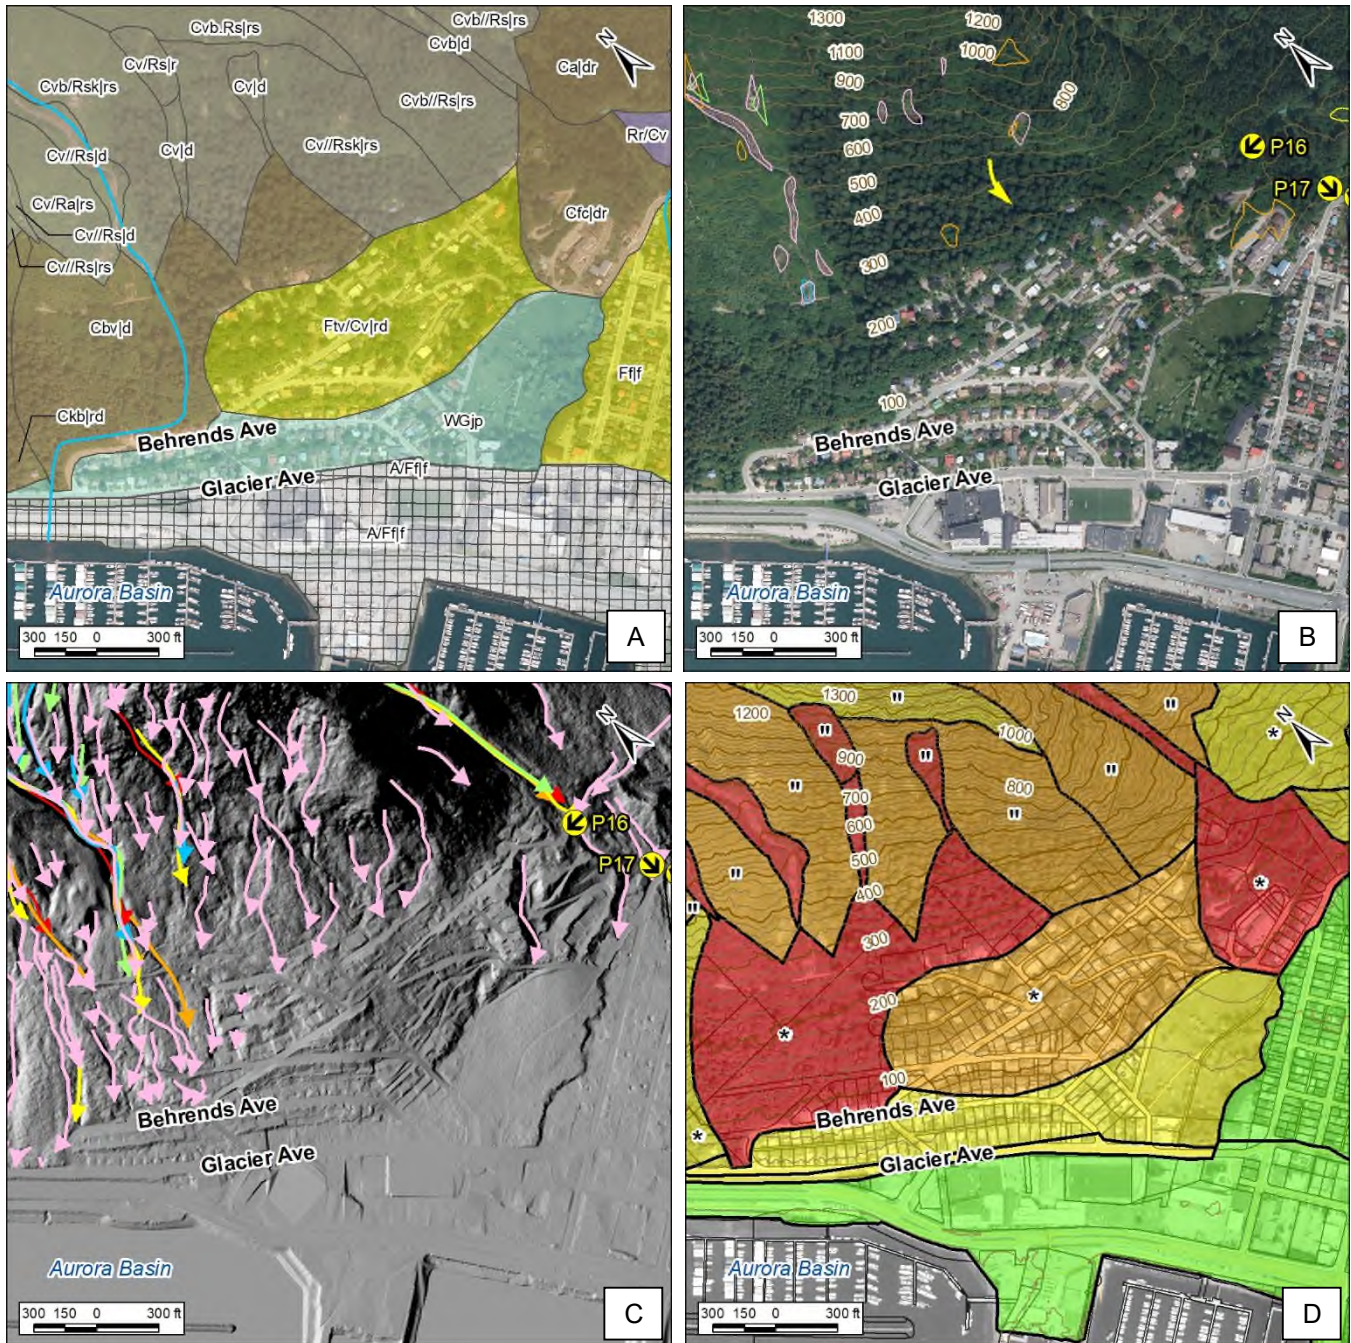
**Figure 11: These mapping excerpts show *Moderate* hazard terrain from part of the Juneau Study Area. Figures 11A through 11D. The terrain mapped as glaciomarine (WG) in Figure 11A reveals no slope movement features in Figure 11B, and no gully erosion features in Figure 11C. That results in a landslide hazard designation of *Moderate*, as shown on Figure 11D. See also Figure 13 for examples of *Moderate* terrain. Events that affect mainly roads (e.g., Figure 13A) tend to be cleaned up promptly and are generally not seen on the air photos.**

As shown on Figure 11D, Glacier Avenue at Ross Way is just below the *Severe* landslide designation zone at the Behrends Subdivision, at the northwest end of Behrends Avenue (left side of figure). That means Glacier Avenue could receive some smaller water-borne debris and muddy water that runs down the road, but it should not experience the more serious impacts generally seen further upslope. However, because some effects are still

possible, such as erosion (red arrow on Figure 13A), the landslide hazard designation here cannot be considered *Low*. As shown on Figure 11B, no other historical slope movement features were observed on the imagery, and on Figure 11C, the gullies appear not to extend across Behrends Avenue or Glacier Avenue, although the debris may flow onto them. Therefore, a landslide hazard designation of *Moderate* is considered appropriate.

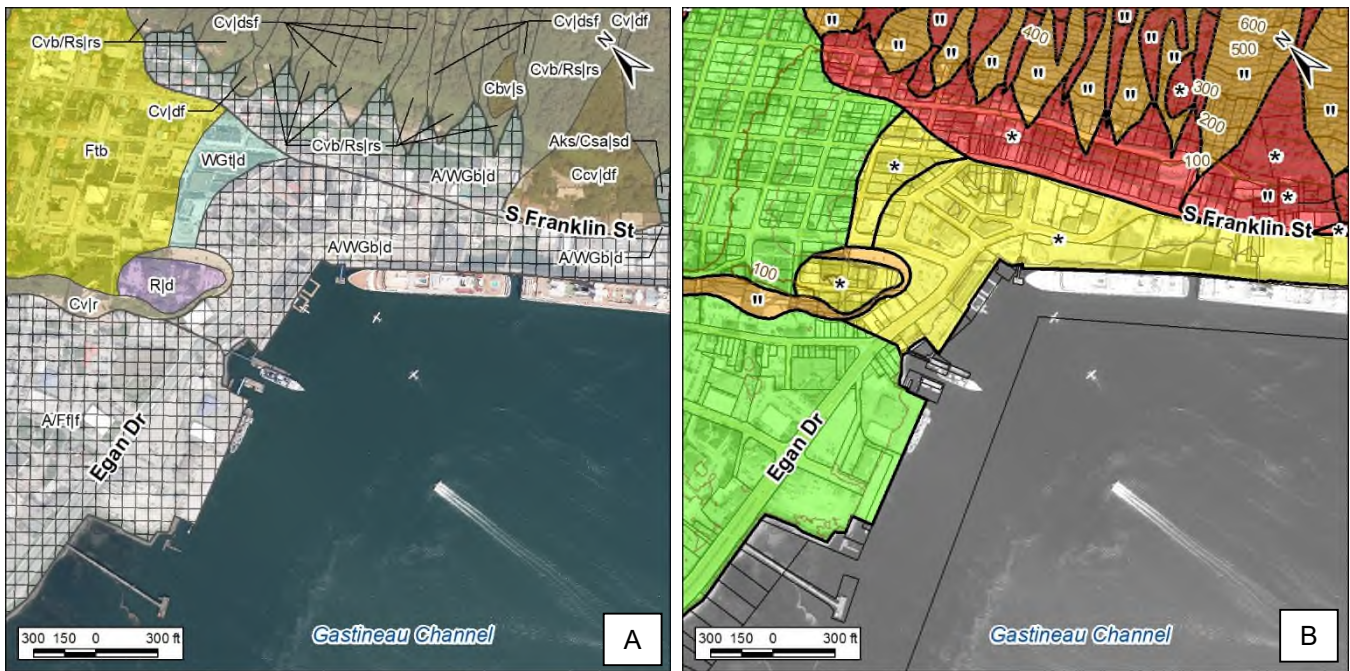
**Figure 12:** These mapping excerpts show *Moderate* hazard terrain from another part of the Downtown Juneau Study Area. Figures 12A and 12B are from the Downtown Historic District, the east leg of Tidelands, and the top of Telephone Hill. At center-left of Figure 12A, there is glaciomarine terrain (WG), and a rock outcrop (R) at Telephone Hill. Southeast of these two upslope areas, the terrain has been extensively human-modified (A). In this case, new ground was made from fill to create more space for the townsite development. These three areas together (except for the steep colluvial sideslopes of Telephone Hill) result in a *Moderate* hazard designation along the shoreline. In this case, a large landslide originating from the *Severe* terrain upslope of South Franklin Street (including the apparently mining-related events of 1920 and 1936) could have the potential to affect the *Moderate* terrain, but no obvious signs remain below South Franklin Street.

No mass movement events appear to have crossed South Franklin Street recently, and it is possible that the drainage and retaining structures erected along Gastineau Avenue could mitigate the extent of future landslides, at least at the 1920 landslide location. Nevertheless, the lower edge of the *Severe* terrain has been adjusted to be located downslope of South Franklin Street to account for the possibility of debris having been cleaned up and not seen on the imagery (Figure 12B). See Technical Memos #3, #6, and #7 (Appendix C in the main report; Tetra Tech 2022c, 2022f, 2022g) for more information about the slopes on Mt. Roberts.

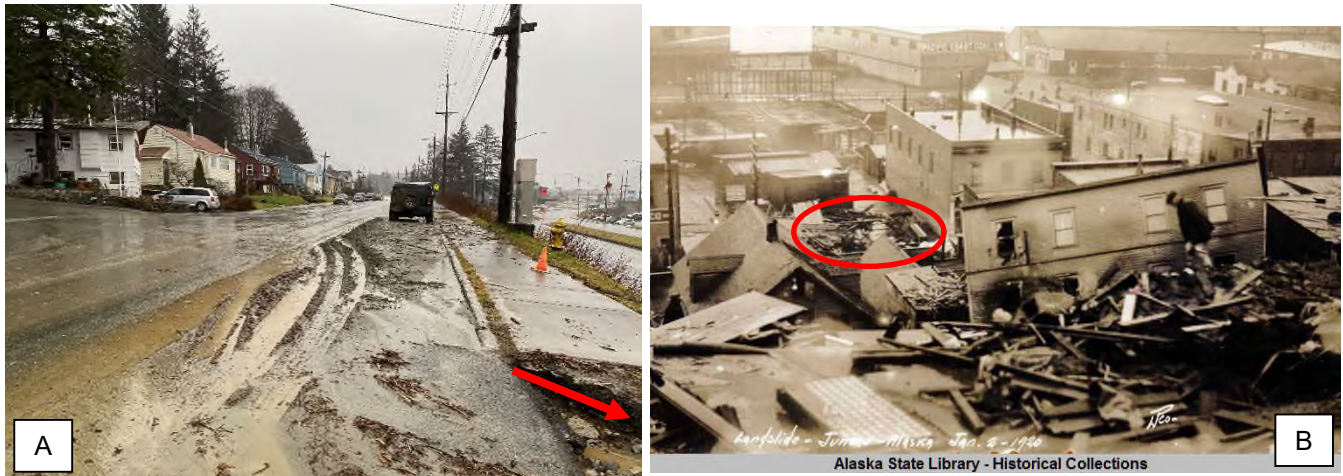
**Figure 13: These photos are of *Moderate* terrain. Figure 13A is looking southeast along Glacier Avenue on December 4, 2020, where Ross Way enters. Ross Way carried debris and water from Behrends Avenue to Glacier Avenue. Debris can also run southeast on Behrends Avenue. Note the apparently eroded and failed section of the sidewalk (at red arrow) where a section of concrete slab was missing. Figure 13B is looking downslope towards South Franklin Street (formerly Front Street) on January 2, 1920, after a major landslide from upslope of Gastineau Avenue. The red circle shows possible landslide debris across the street. (Photo credits: Figure 13A: CBJ December 4, 2020. Figure 13B: Alaska State Library – Historical Collections, [ASL-P109-42](#), Katherine Shaw 1920. ASL 2022b.)**

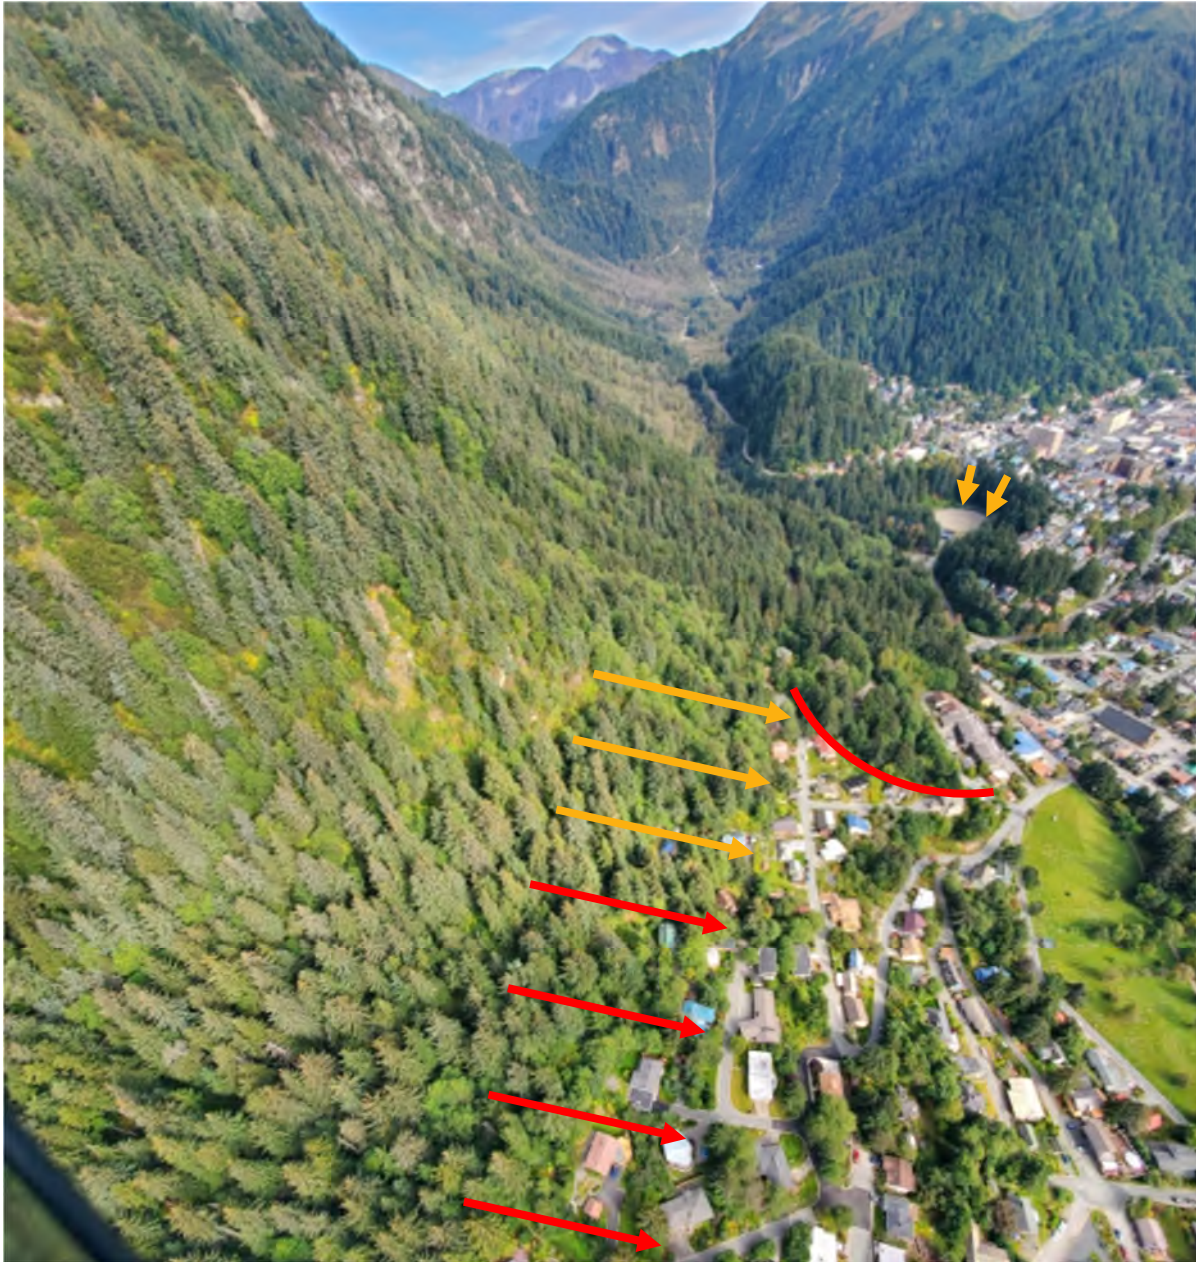
**Figure 15: View from the helicopter looking east towards Last Chance Basin (see direction of look on Figure 14). Upper Evergreen Avenue is approximately in line with direction of look.**

Most of the residential area in the foreground of Figure 15 is in *High* hazard zone. The upper ends of the road stubs in the foreground are mapped as *Severe* hazard (red arrows). Moving further east of the hairpin turn of Evergreen Avenue (further away from the camera), the upslope terrain is in *High* hazard zone (orange arrows) until the Bathe Creek fan/cone, where trees obscure the east end of Evergreen Avenue along the west edge of a large gully (near side outlined in red). The cemetery, which is the verdant green space at the lower right edge of the photo, is in *Moderate* hazard zone. The orange arrows at Cope Park (in the middle distance) show that most of the slope around the park is mapped as *High* hazard. See Figure 14 for more hazard mapping details. See Figure 16 for a close-up view of the slopes at Cope Park. See Technical Memo #2 (Appendix C in the main report; Tetra Tech 2022b) for more information about the Bathe Creek area.

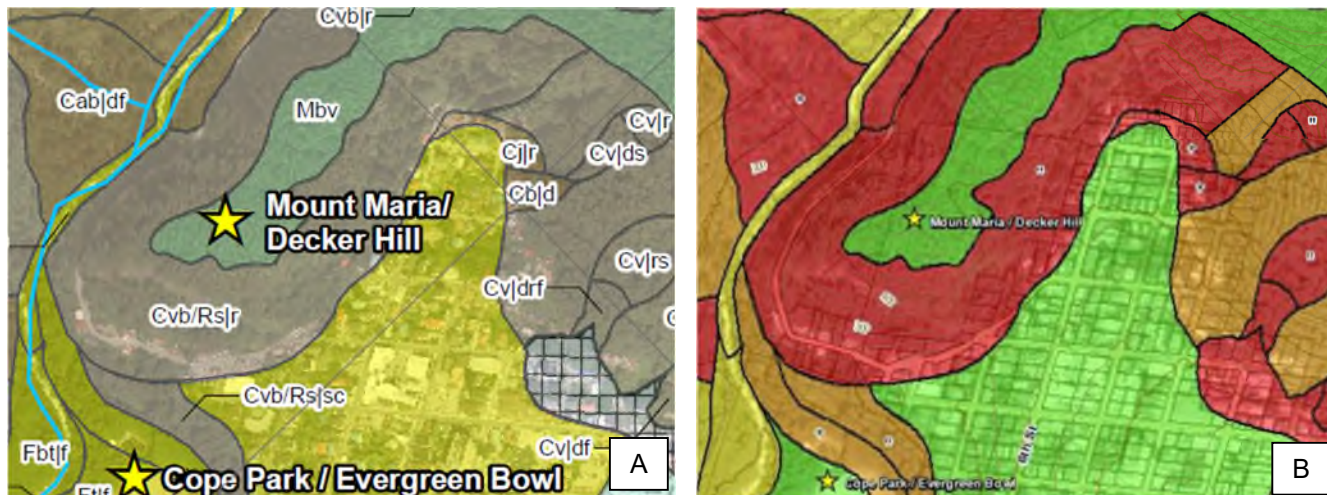
**Figure 17: These two map excerpts are from the mapping slopes above Starr Hill. Figure 17A shows the surficial geology, and Figure 17B shows the landslide hazard designation mapping. Around Starr Hill, the green signifies *Low* hazard, the orange is *High* hazard, and the red is *Severe* hazard. See Figure 18 for the landslide seen in the *Severe* hazard area above Nelson Street. More information about this area is available in Technical Memo #3.**

Figures 17B and 19D are hazard maps, which indicate areas that are potentially hazardous. If there was a lot of potentially hazardous geomorphic process activity on a slope, or if new activity was identified in the field, that area was mapped as having a *Severe* hazard. For instance, debris could be building up on the slope directly above a house (Figure 18), or in a location where debris can potentially run towards a house, and where it could become a more serious hazard in the future (Figures 20B and 20D). Smaller debris slides and debris flows tend to accumulate debris material in wedges within gullies. Eventually, when a critical level of debris accumulation is reached, or a significant precipitation event occurs, all that stored debris is scoured out of the gully, potentially resulting in a very large debris flow event. Similar events can occur on open slopes where slide debris piles up in lobes over days, months, or years, sometimes separated by channels of faster-flowing loose material. These debris lobes can slowly be creeping downslope, until the critical moment when there is enough mass and enough water to trigger the debris flow rapidly downslope. See also Technical Memo #2 for more mapping examples (Appendix C in the main report; Tetra Tech 2022b).

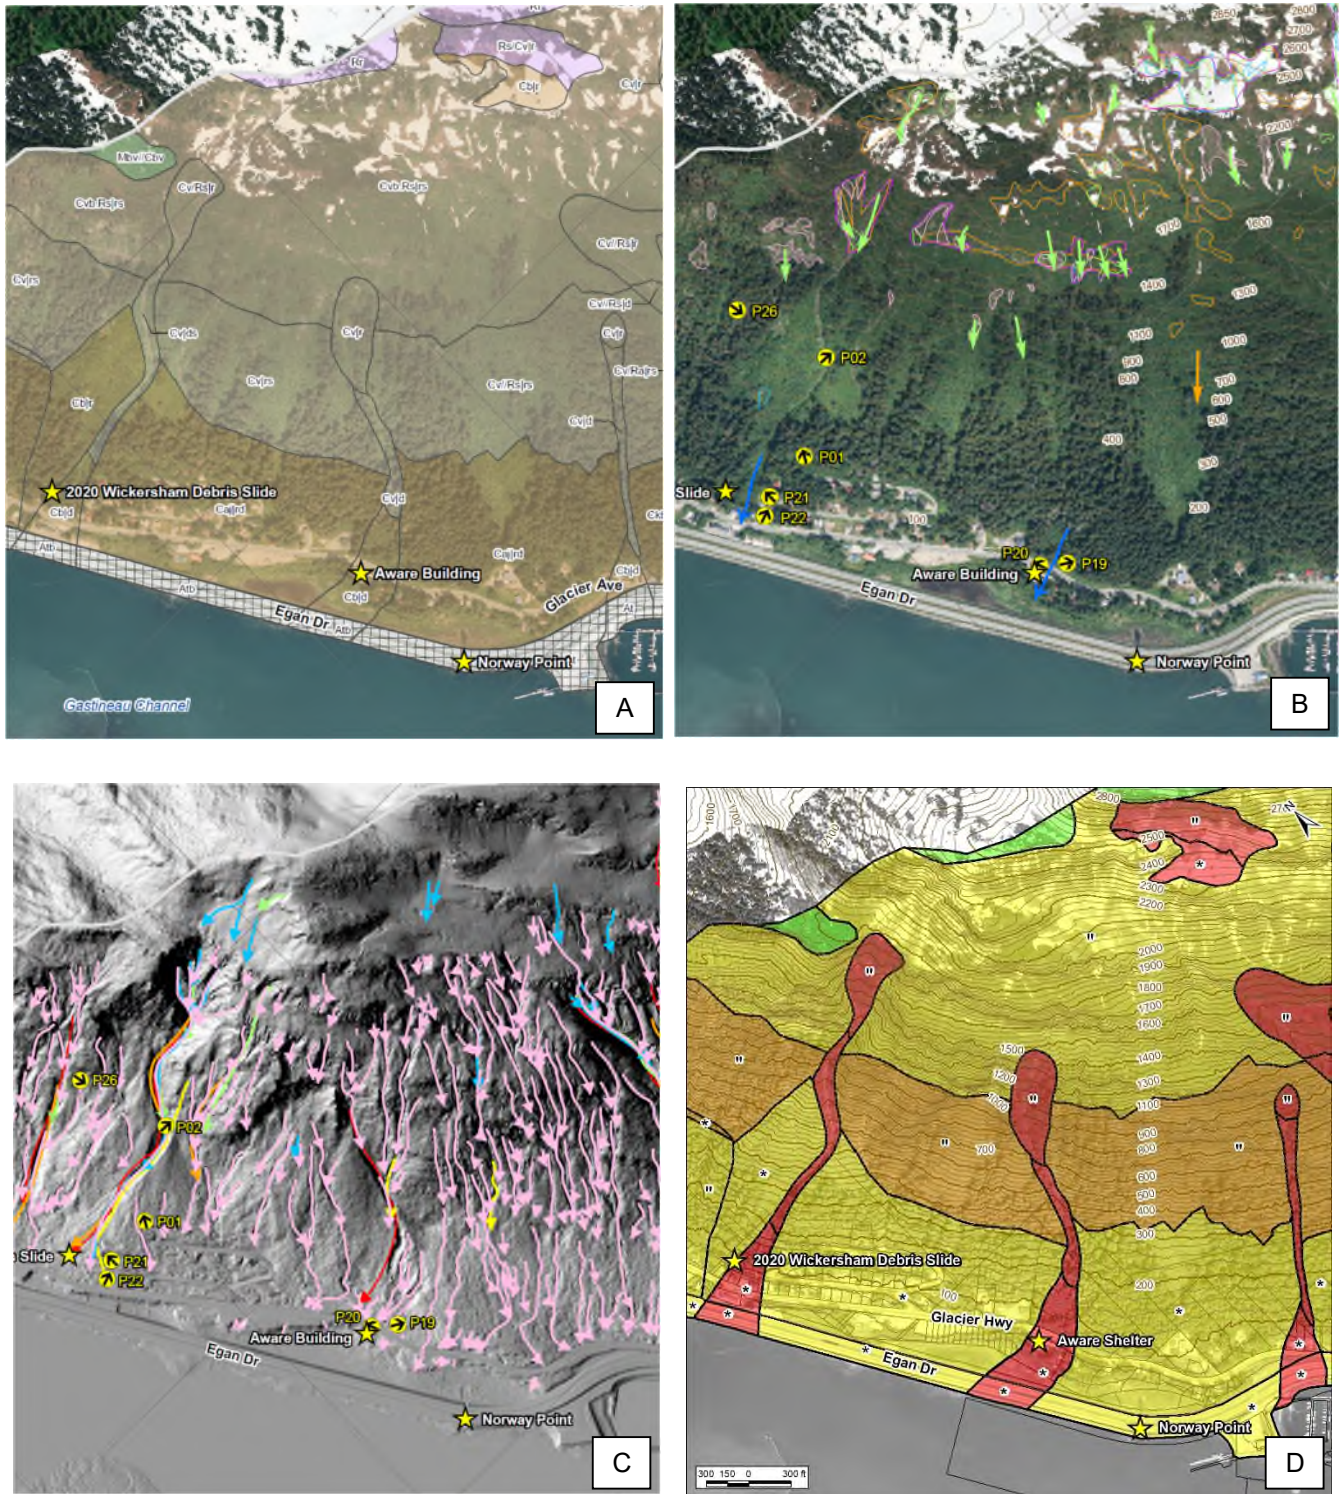
**Figure 19: These excerpts are from the mapping at the slopes at the White Subdivision. Figure 19A shows the surficial geology, Figure 19B shows the slope movement features, Figure 19C shows the gully erosion features, and Figure 19D shows the landslide hazard mapping. The Wickersham slide (Figure 20) is related to a very active gully erosion feature in Severe hazard.**

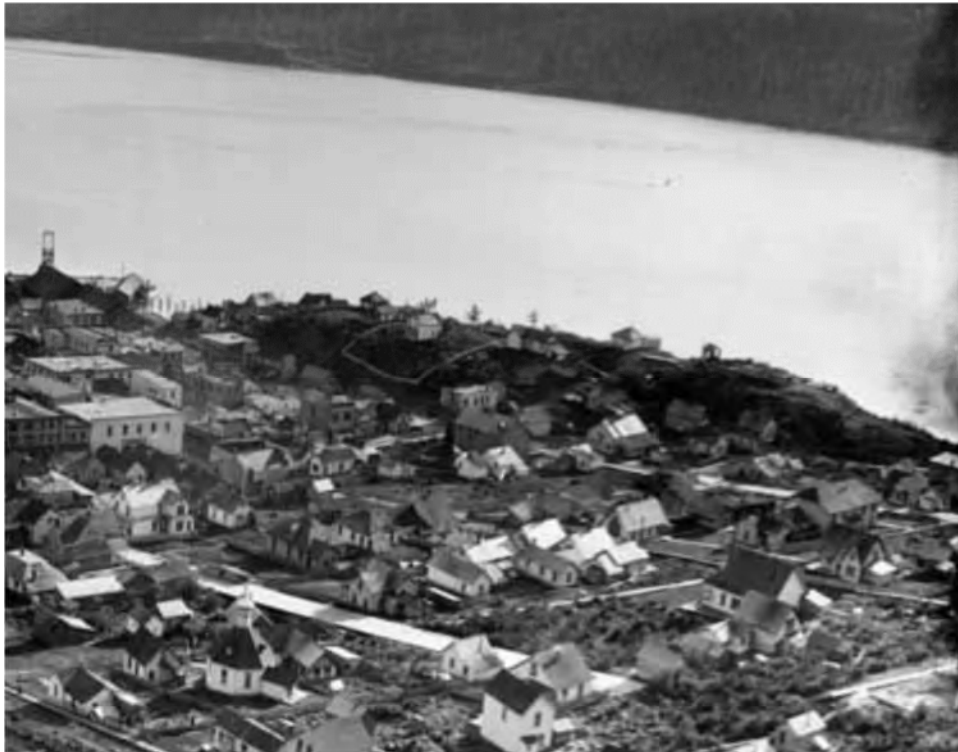
It is useful to first consider a view of Telephone Hill from Mt. Maria in the historical photo taken in about 1896, prior to the Juneau development that has gradually obscured the slopes (Figure 1). The prominent bedrock ridge seen in this photo was mapped by Miller (1975) as undifferentiated Tertiary or upper Mesozoic rock with an unconformity, suggesting that some material was scoured off at some point in geological history, and the bottom of the upper layers does not match the top of the lower layers. Although the top of the ridge is gently sloped, the sides of the ridge are quite steep. In locations where a thin veneer of colluvium covers the bedrock, this material could be more prone to mass movement than other materials such as a blanket of colluvium or glacial till (Tetra Tech 2021a).

**Figure 1: Looking south towards Telephone Hill and Gastineau Channel from Mt. Maria, circa 1896, early in the development of Juneau, when structures along the toe of slope at Willoughby Avenue were supported on wharfs, and before fill began to be placed along the shoreline to extend the useable land area. (Photo credit: Excerpted from Alaska State Library – Historical Collections, [ASL-P87-0753](#), Winter & Pond, ca. 1896.)**

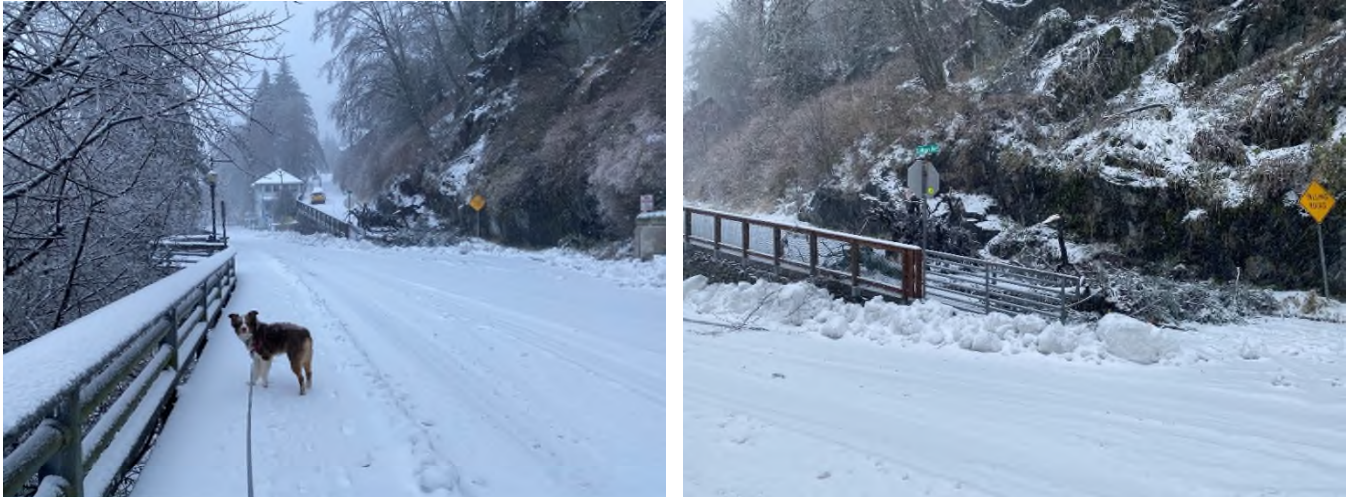
CBJ has reported that debris slides occur regularly at the fork between Dixon Street and Calhoun Avenue, between the northwest end of the retaining wall on Calhoun, and just downslope of the West 6<sup>th</sup> Street cul-de-sac. This location overlaps the southwest corner of Chicken Ridge, and the northwest corner of the Juneau Townsite in CBJ’s [Historic Neighborhoods](#) (CBJ 2022) mapping, and its location is shown in Figure 2. Rocks on the road have been reported after large storm events in at least the past two years. Trees or pieces of large woody debris are less frequent, occurring at roughly five-year intervals (email communications: July 20, 2021; A. Pierce, T. Camery, Q. Tracy, V. Roujanski, and R. Kors-Olthof). Google Street View suggests that debris appears to originate at a

bedrock bluff partway upslope towards West 6<sup>th</sup> Street, and could consist of soil, rocks, trees, or other large woody debris, and other organic debris that typically lands on Dixon Street, requiring cleanup to restore road access, as seen in Figure 3. Part of the slope, between Dixon Street and Main Street upslope, is occupied by a building, but some debris seems to originate from the lower slope below the building too.

**Figure 3: Typical debris slide deposit at the fork between Dixon Street and Calhoun Avenue. In the left-hand photo, note the fork in the road at center-right, and the northwest end of the retaining wall at the right edge of the photo. The downslope edge of Calhoun at the railing is supported by another retaining wall. In the right-hand photo, note the presence of a steep cutslope into apparent weathered bedrock, with a thin veneer of colluvium. The debris from this landslide event extends an estimated 40 feet northwest of the end of the metal railing. The distance along the toe of slope along Dixon/Calhoun is about 110 feet between the northwest edge of the debris and the northwest corner of the upslope retaining wall. (Photo credits: CBJ, provided July 16, 2021.)**

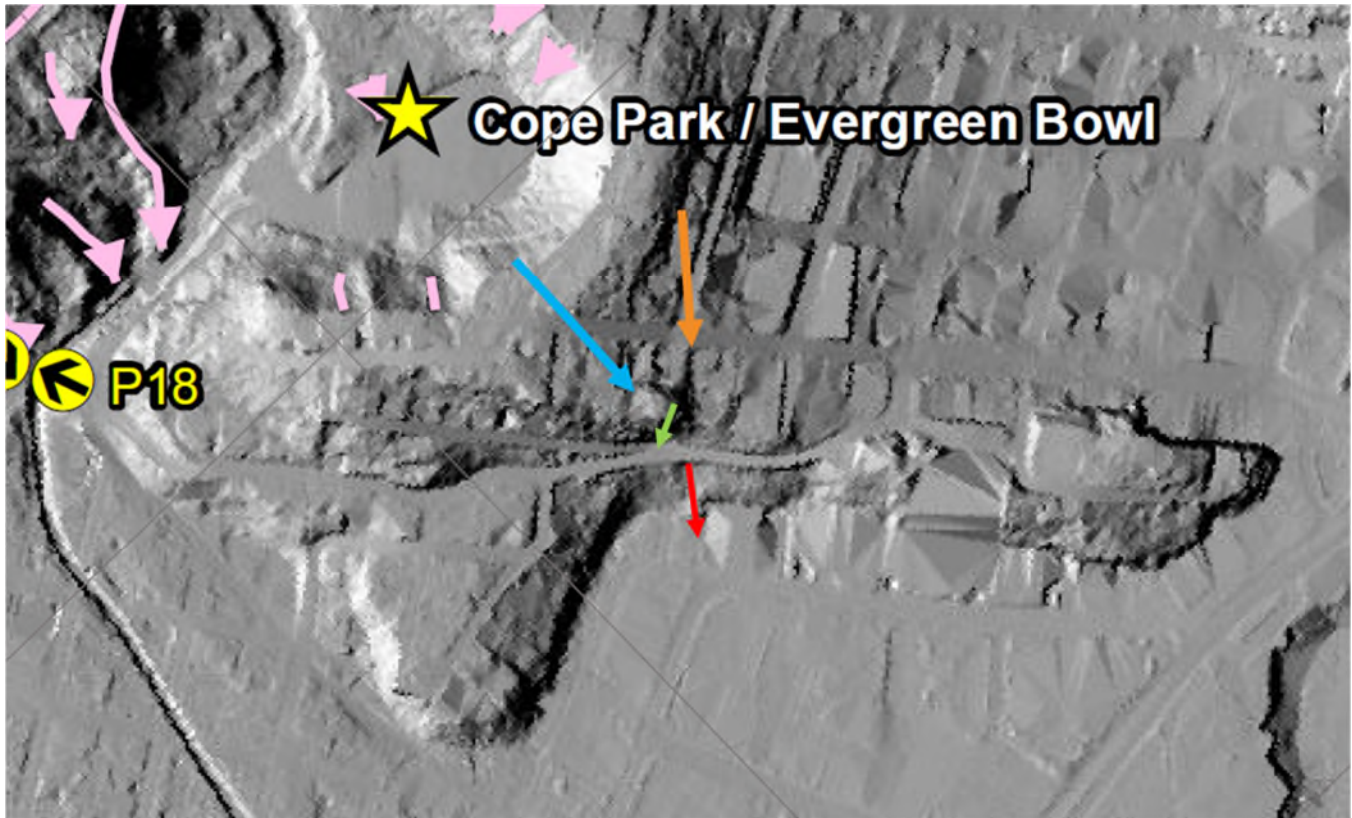
There are a great many retaining walls visible on Dixon Street, Calhoun Avenue, Goldbelt Avenue, parts of Main Street, and connecting streets. Some of these retaining walls were apparently used to construct houses and associated landscaping to make more efficient use of the slope, but numerous retaining walls along roads appear to be necessary to create or maintain access to properties, or to reduce landsliding along steep slopes. In adjacent locations that lack retaining walls, many slope sections have either deciduous trees or grasses, suggesting that shallow debris slides might be fairly common. However, the specific location shown in Figure 3, and the landslide downslope in 1923 at almost this exact location, do suggest that there is something particular about this site that causes it to be exceptionally prone to slope failure. An excerpt of the LiDAR in this area provides a possible explanation (Figure 4).

**Figure 4: Just off the southwest end of West 6<sup>th</sup> Street, there is a prominent bedrock knoll (blue arrow), and an adjacent gully (downslope of the orange arrow) that both potentially contribute to repeated debris slides at this location that regularly run out onto Dixon Street (green arrow). The gully is also directly in line with what appears to be a scar from the 1923 landslide that moved from Calhoun Avenue down to Willoughby Avenue (red arrow). See also Figure 2.**

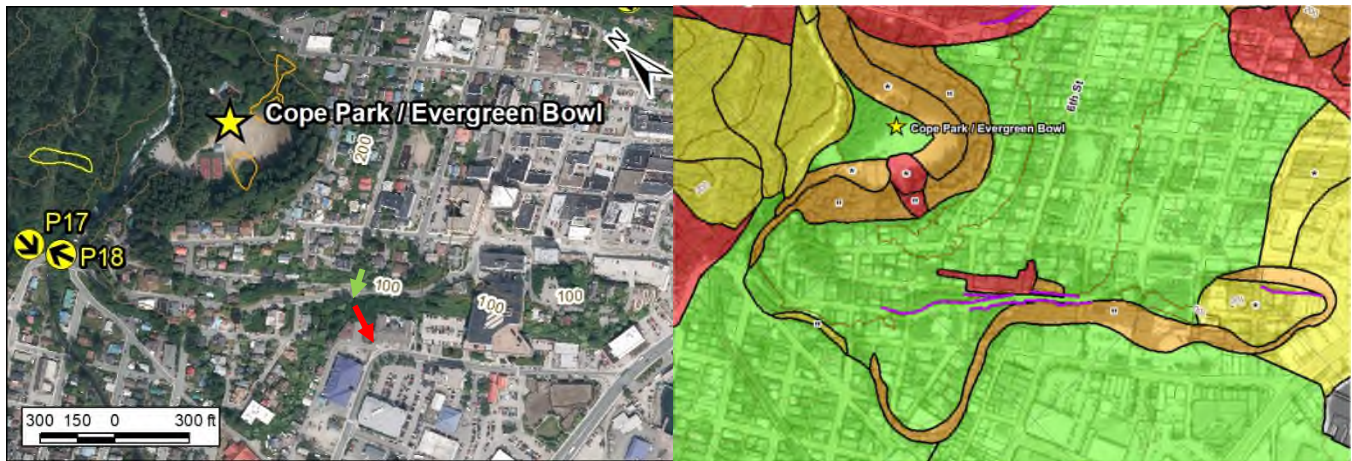
**Figure 6: Excerpts from Figure 1.4b Slope Movement Features and Figure 1.6c Landslide Hazard Designation Mapping. On the left-hand image, the 1923 landslide is shown running downslope from Calhoun Avenue and the southeast end of Dixon Street to a little above the present-day Willoughby Avenue (red arrow). Landslides still occur at Calhoun Avenue, originating upslope of Dixon Street (green arrow). On the right-hand image, the hazard mapping from 1987 has been restored and updated above Calhoun Avenue, based on the debris slides reported by CBJ.**

Depending on the date of construction of the Calhoun Avenue upslope retaining wall, the area currently shown as *High* in Figure 6 could be downgraded to *Moderate*, but the area shown as *Severe* should remain as is due to the high frequency of debris slides at that location.

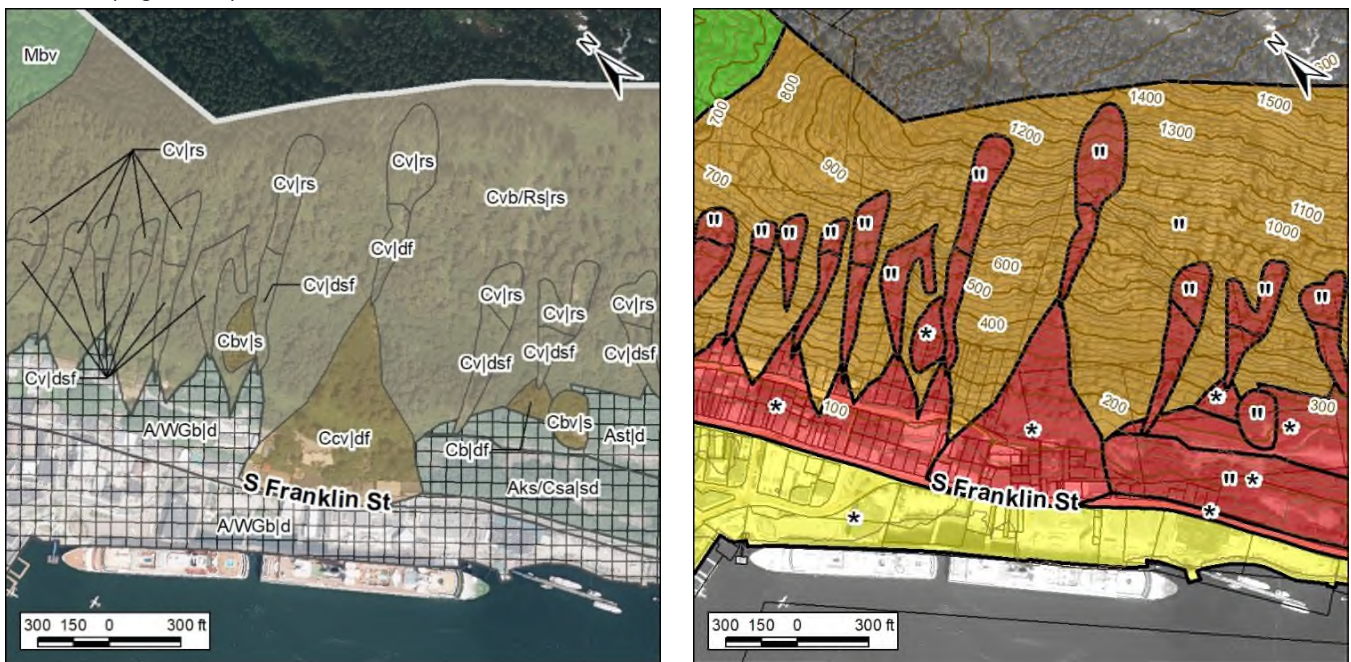
A summary of Tetra Tech’s mapping near the northwest end of Mt. Roberts is shown in Figure 7, with surficial geology on the left and landslide hazard designation mapping on the right. There is a clear correlation between the types and shapes of the surficial geology units and the landslide hazard designations at that location. The same correlations can be seen in the side-by-side comparisons of slope movement features (Figure 9) and gully erosion features (Figure 10).

**Figure 7: Excerpts from Figure 1.3b Surficial Geology (left) and Figures 1.6c and 1.6h Landslide Hazard Designation Mapping (right) near the northwest end of Mt. Roberts. Surficial geology corresponds closely to landslide hazard designations.**

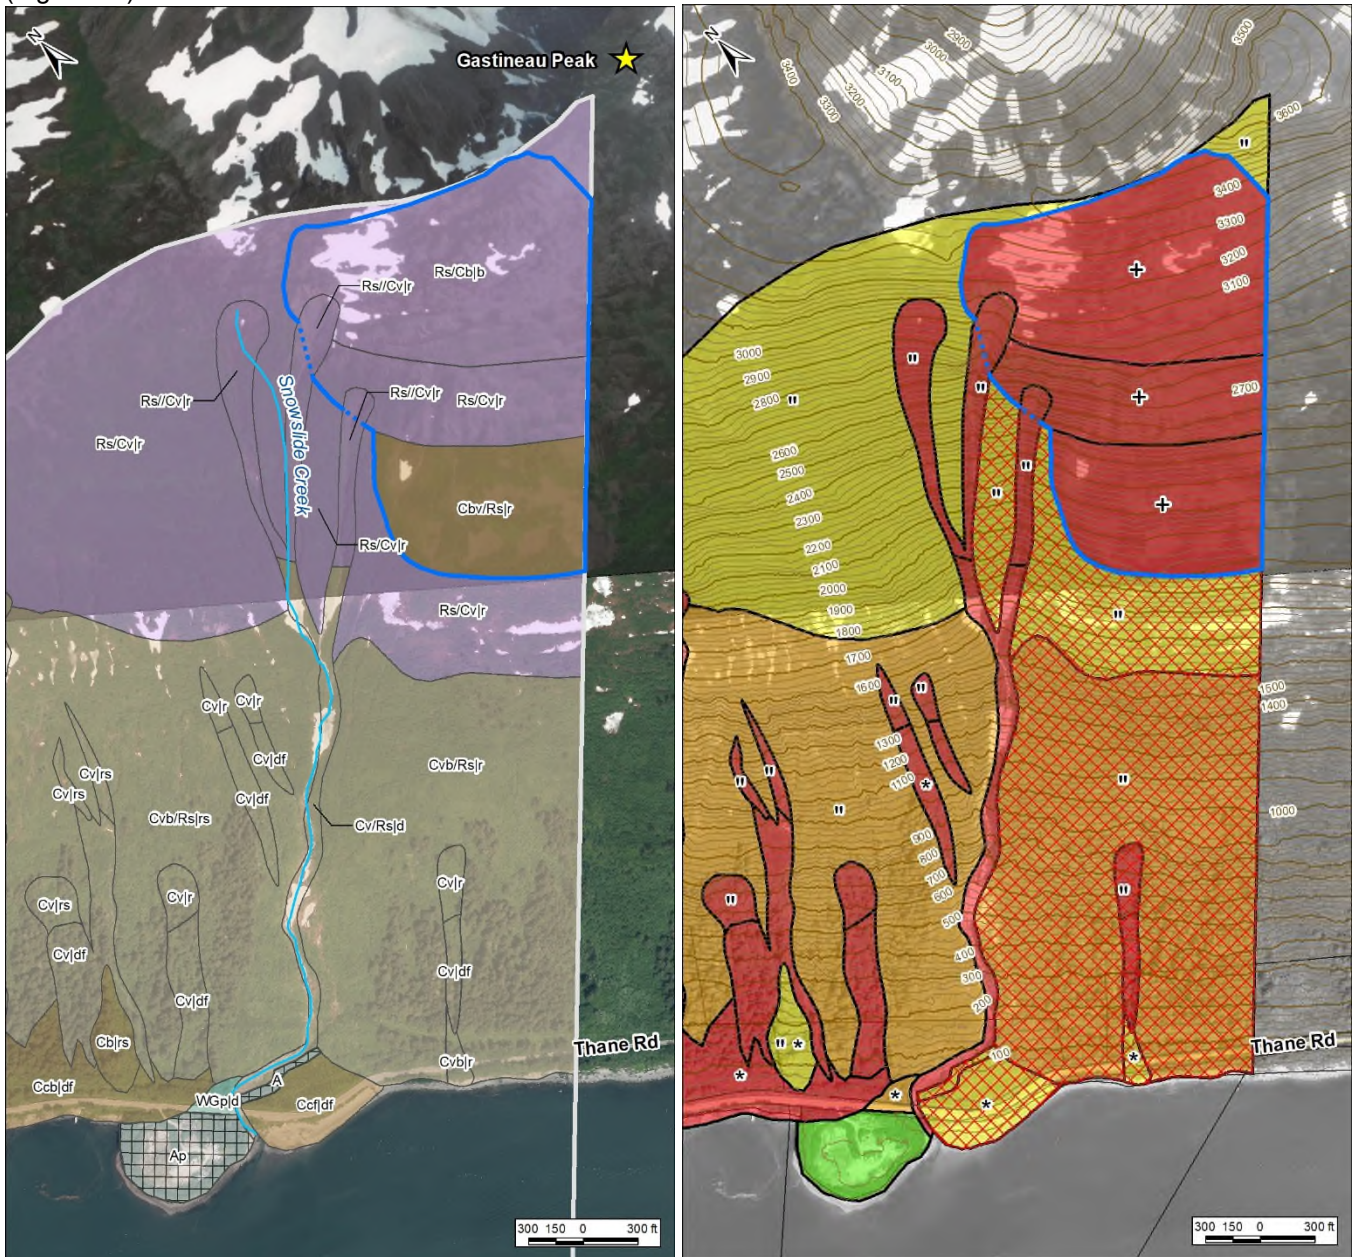
The same comparisons can be made further southeast along the slope, for example, for the terrain at Snowslide Creek, with surficial geology on the left and landslide hazard designation mapping on the right (Figure 10). Once again, there is a clear correlation between the shapes of the surficial geology units and the associated landslide

**Figure 10: Excerpts from Figure 1.3c Surficial Geology (left) and Figures 1.6e and 1.6f Landslide Hazard Designation Mapping (right) at Snowslide Creek at the southeast end of the Study Area. Again, surficial geology corresponds closely to landslide hazard designations.**

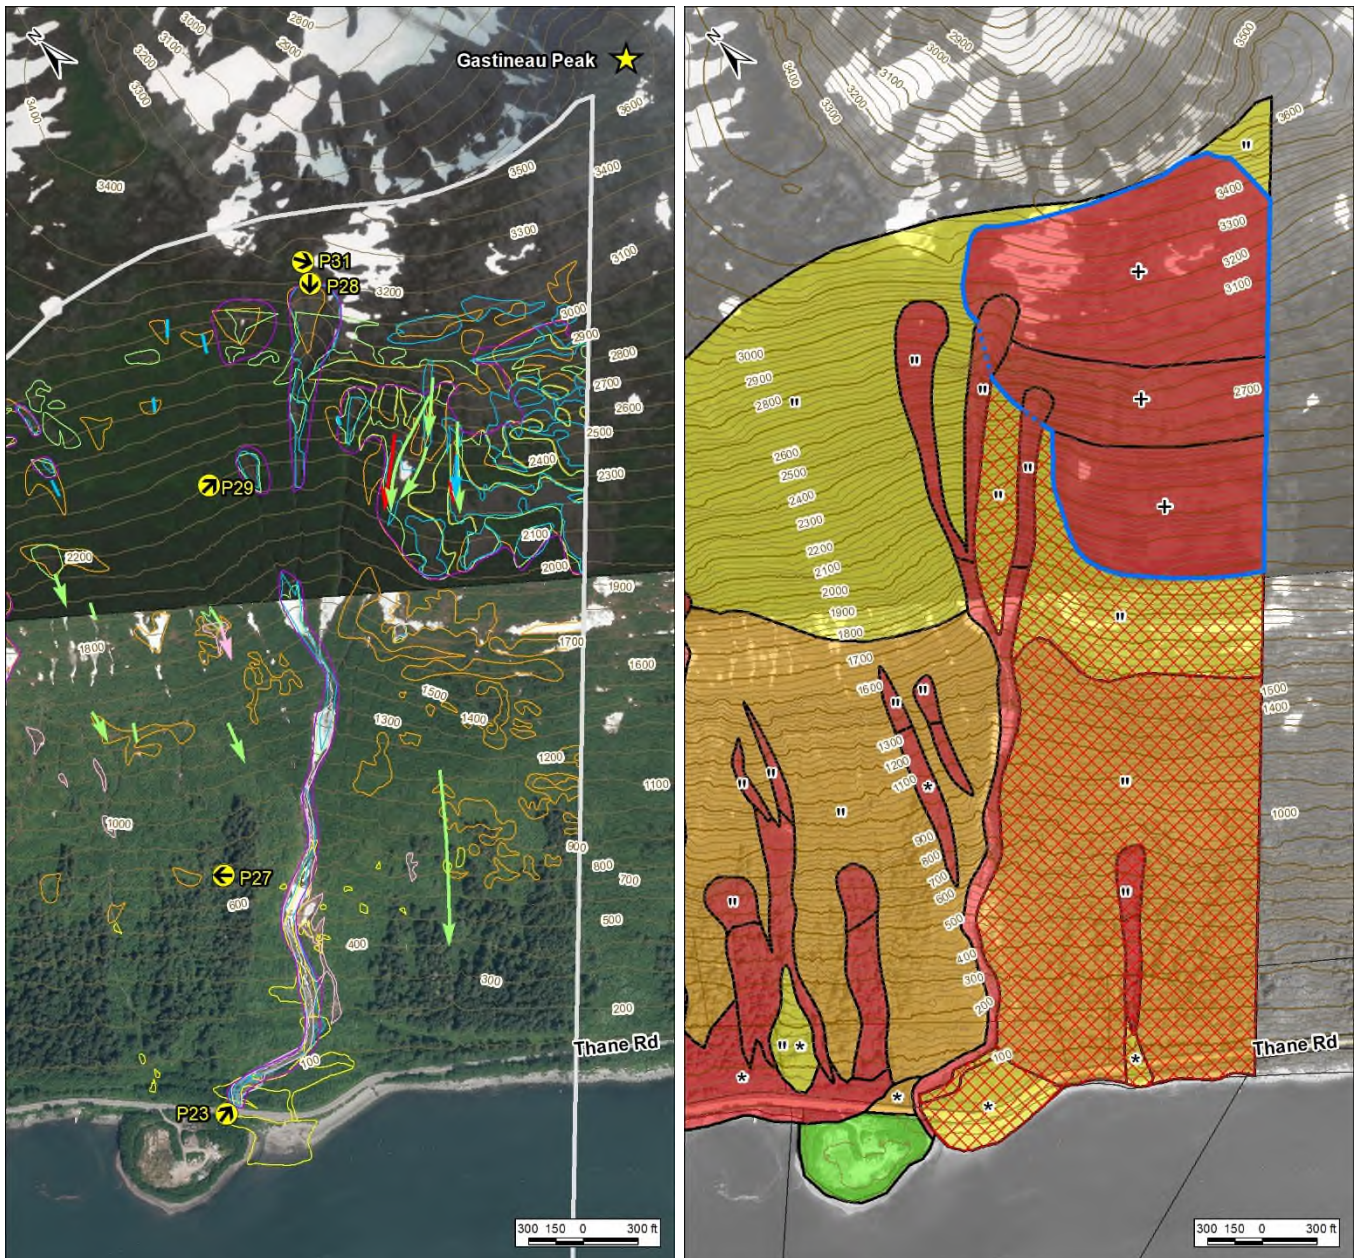
**Figure 11: Excerpts from Figure 1.4c Slope Movement Features (left) and Figures 1.6e and 1.6f Landslide Hazard Designation Mapping (right) at Snowslide Creek at the southeast end of the Study Area. This comparison shows that many slope movement features, such as debris slides, are located on open slopes that typically have a *Moderate* or *High* landslide hazard designation. The exception in this part of the Study Area is the suspected deep-seated bedrock slide on the open slope at the top right of each image, with lots of slope movement features and a *Severe* landslide hazard designation. Slope movement features that take place within gullies contribute to a *Severe* landslide hazard designation, shown dramatically here at Snowslide Creek.**

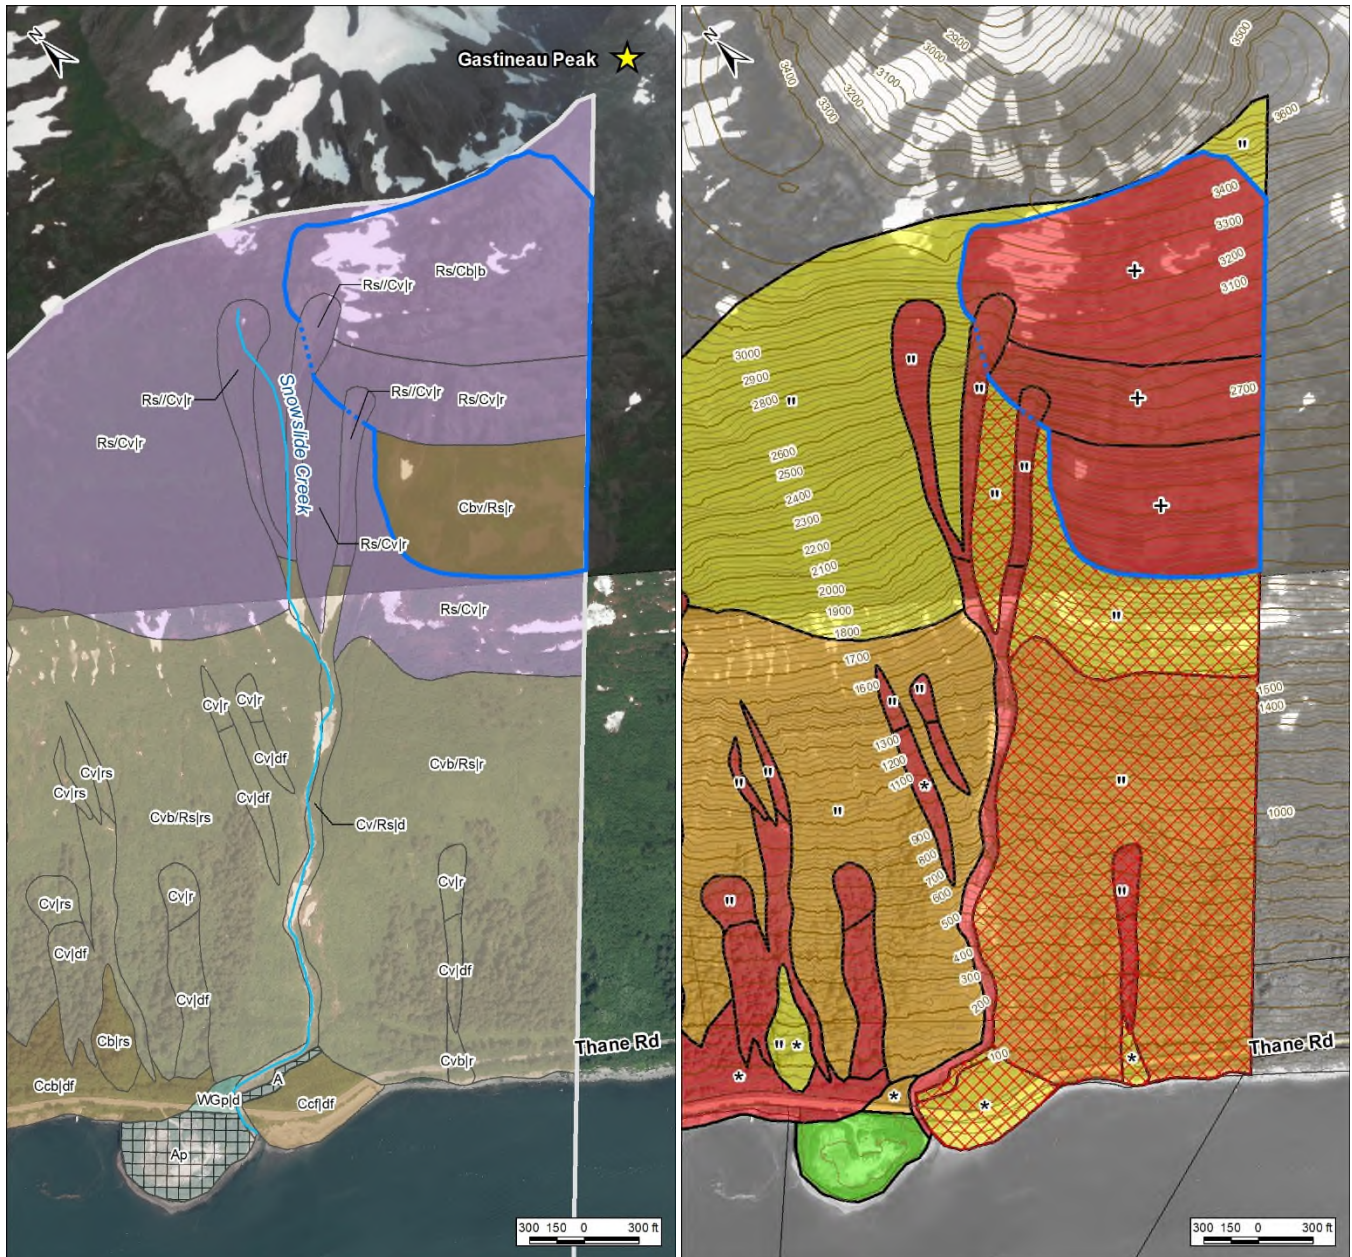
Figure 2: Excerpts from Figure 1.3c Surficial Geology (left) and Figures 1.6e and 1.6f Landslide Hazard Designation Mapping (right).
