## **Downtown Juneau Landslide and Avalanche Hazard Assessment**

PRESENTED TO  
**City and Borough of Juneau**

APRIL 27, 2022  
ISSUED FOR USE  
FILE: ENG.EARC03168-01

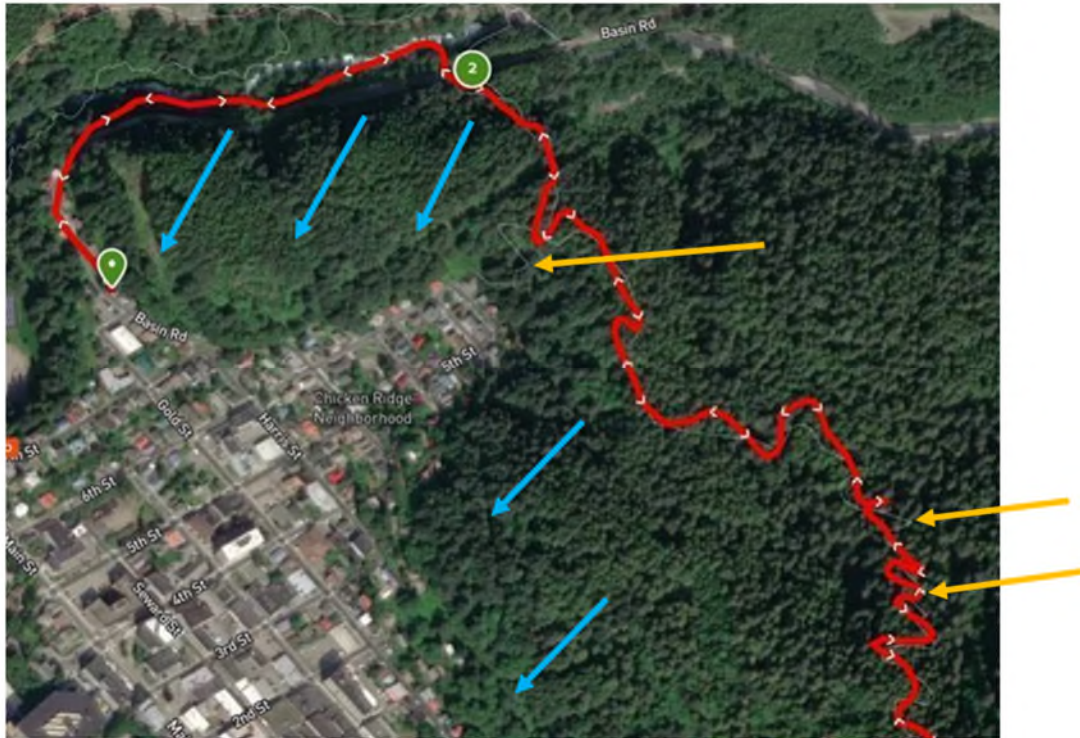
Technical Memo #3 provides an overview of the overall slope conditions above the Starr Hill subdivision, along with numerous photos and map excerpts. The main influence of human-modified terrain on the slopes around Starr Hill is the likelihood that earthworks along trails (and possibly the powerline alignments) might have blocked some of the natural swales and gullies that would ordinarily carry surface water runoff. Oversteepened cutslopes, or oversteepened or sidecast fillslopes, if present, also have the potential to result in, or contribute to, slope failures. The presence of human modifications on slopes also has implications for anticipating which slopes or slope sections might be more susceptible to landslides in the future, particularly if surface water drainage modifications or cuts and fills have disrupted the natural slope conditions. Figures 1 through 3 below present a few examples of former and/or active trails and other linear infrastructure on the slopes above Starr Hill. Conceivably, there could be still more trails not yet discovered on the imagery or historical photos.

**Figure 1: Current Mt. Roberts hiking trail (red) and former hiking trail (pale gray). Switchbacks along new and old trails (orange arrows). Powerline cutlines are also visible (blue arrows). (Image credit: AllTrails 2021.)**

As noted in Technical Memo #3, Question #12, surface water drainage along trails and other linear infrastructure, whether abandoned or actively in use, should be purposefully managed, so that the original natural drainage paths across these human-made features can be preserved or restored. For a detailed evaluation and recommendations for possible mitigations in human-modified terrain, a purpose-specific field investigation would be needed and is not part of the current scope. Recommendations for future investigation and evaluation are provided below in Section 5.0.

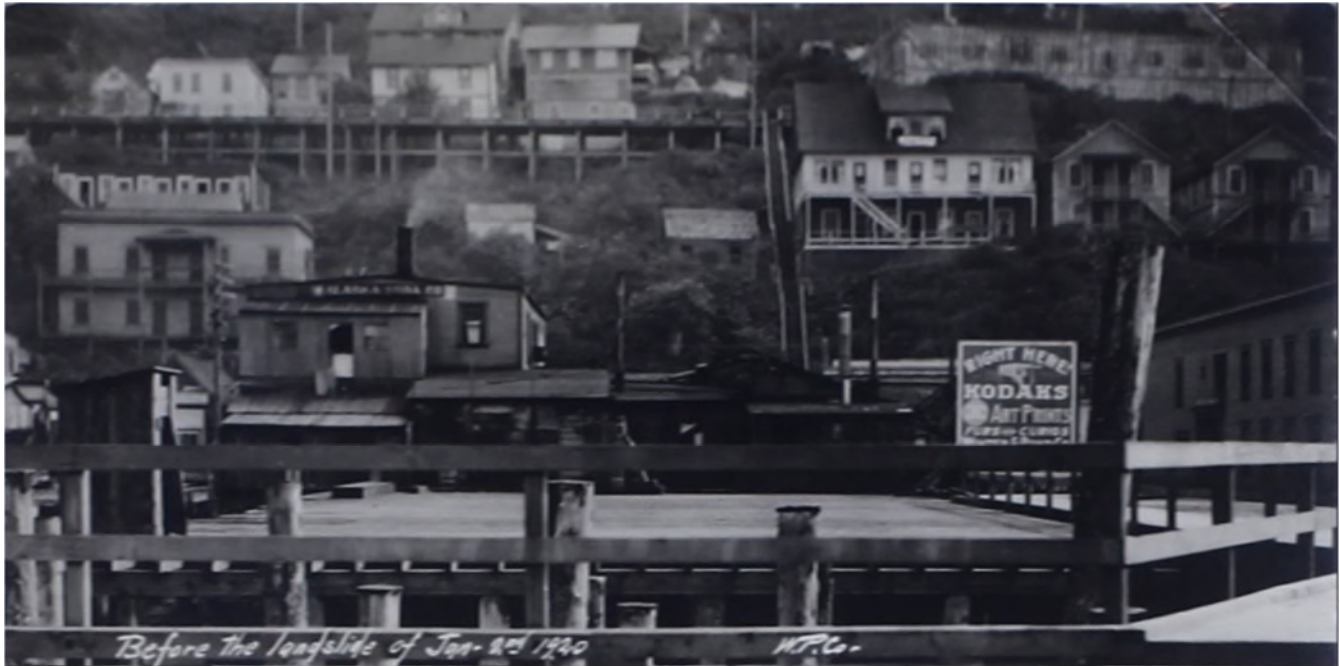
**Figure 4:** This “before” photo is from after 1914 but before 1920, and possibly from the summer of 1919. The stairway at center-right is Bulger Way. The pier-like structure is Gastineau Avenue. Decker Way (a stairway) is located just beyond the left edge of the photo. Note the numerous structures between Decker Way and Bulger Way before the landslide. Just up and left of the smoking-chimney building is the tenement building that tipped and rotated clockwise during the landslide (see Figure 5). Top right is the former Alaska Juneau Gold Mining Company (AJGMC) office building. (Photo credit: Alaska State Library – Historical Collections, PCA0154-295, Snow Family Photograph Collection. ASL 2022b.)
